COMPLETION REPORT LOWER STOKES FISH PASSAGE IMPROVEMENT PROJECT BEAVER CREEK, METHOW SUBBASIN, WASHINGTON MARCH 2004

Lower Stokes Fish Passage Improvment Project

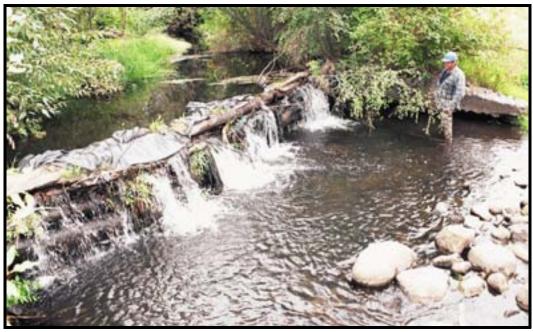
The 3½-foot-high diversion dam, made of stacked logs and lined with plastic (photo A-1), was removed entirely. To replace it, a so-called "Rosgen" rock vortex weir (Weir No. 1) was installed at the site of the new point of diversion (photo A-13). The weir formed a small pool at a higher elevation, and this allows sufficient water to be diverted into the irrigation ditch to meet the water right. The water drop over the new weir is 0.8 feet, which meets State standards for fish passage. Because the large rocks establish a hardened point, Weir No. 1 provides "grade control" which means the stream is unable to downcut its bed over time .

Photo A-1. Original Lower Stokes Diversion Dam just prior to removal; the dam height is about 3¹/₂ feet. Compare the concrete wing wall behind worker and the water elevations to that shown in Photo A-20.

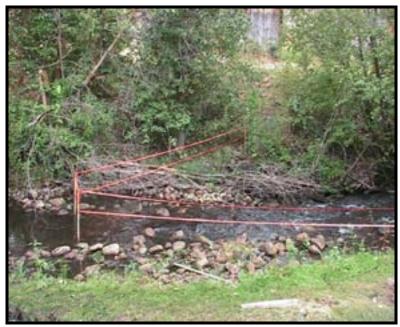
Photo A-2. Preliminary layout of upper weir (Weir No. 1); flow is from left to right.

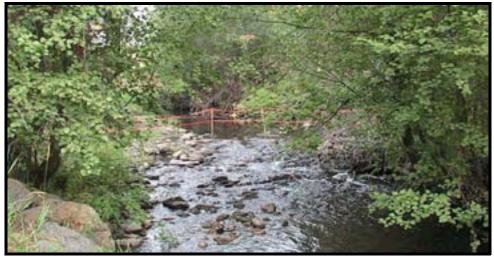
Photo A-3. Looking upstream at Weir No. 1 showing the drop to pool. The height of the riffle $(\pm 10 \text{ inches})$ equals the amount of headloss available to deliver the irrigation water.

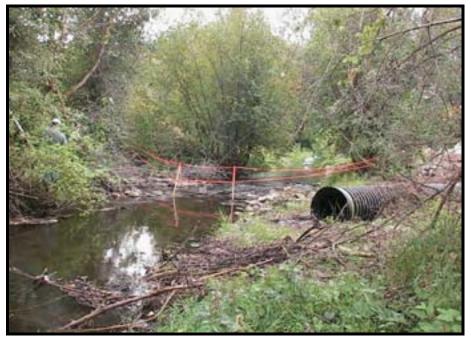
Photo A-4. Looking downstream at entrance to dewatering pipe and the Weir No. 1 layout. The cofferdam will be located between the pipe and the layout.

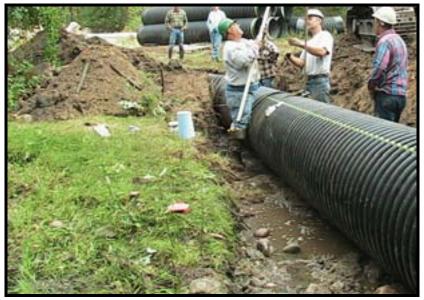
Photo A-5. Excavation crew checking for proper slope of dewatering pipe.

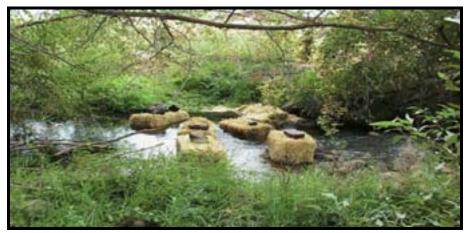
Photo A-7. Straw bales below Weir No. 1 construction area prior to dewatering. The straw bales help filter silt during and after construction.

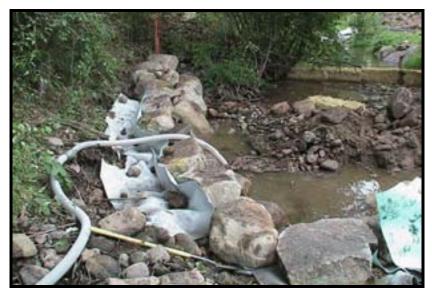
Photo A-8. Installation of geotextile fabric behind first arm of Weir No. 1. Attached to the hose is a trash pump, sending the muddy water up onto the shore so the silt can settle out while the water returns. Note the downstream straw bales.

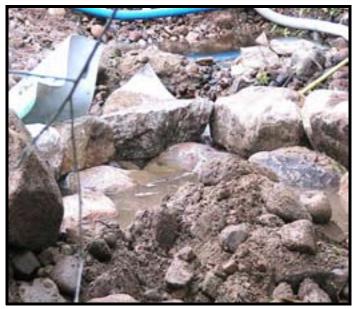
Photo A-9. Looking upstream at base rocks of Weir No. 1. To prevent downstream movement, the rocks on the top layers are behind the base rocks.

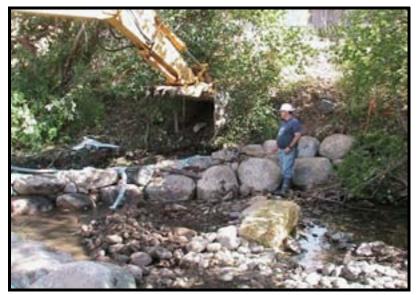
Photo A-10. Backfilling the left-bank weir arm. Note the even slope of the weir arm toward the center of the structure and the lack of spaces between rocks.

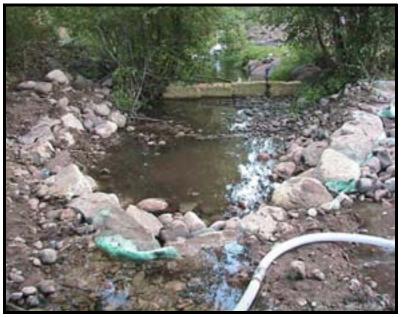
Photo A-11. Looking downstream at completed Weir No. 1 (trash pump hose in foreground).

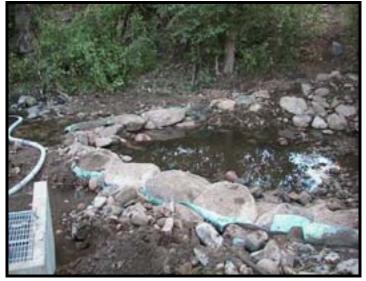
Photo A-12. Completed Weir No. 1. The new diversion box (at lower left) was placed so that it will draw water at low flows but not block water from the right-side weir arm area (foreground).

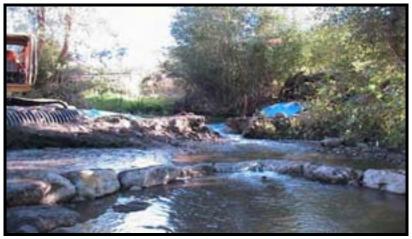
Photo A-13. Looking upstream at newly completed Weir No. 1 and the partially breached cofferdam A. To avoid releasing the backed-up water all at once, the cofferdam is breached in small sections.

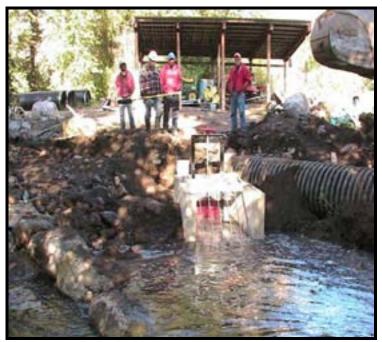
Photo A-14. The newly installed diversion box was tested and satisfied the flow requirement for the landowner's water right.

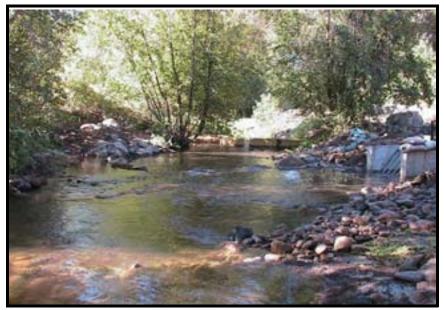
Photo A-15. Looking downstream at Weir No. 1 (center) from the remains of Cofferdam A. The new diversion box is at center right.

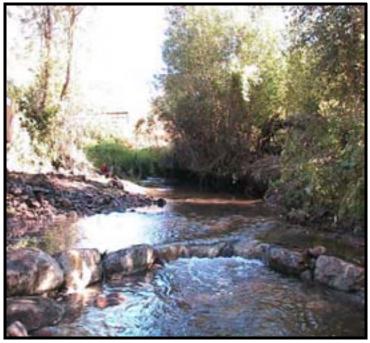
Photo A-16. Looking upstream at Weir No. 1 after Cofferdam A has been removed.

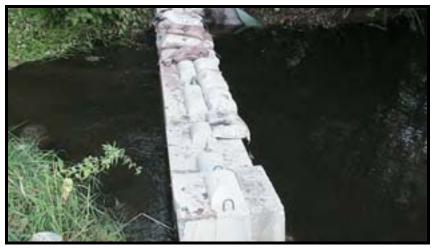
Photo A-17. Concrete "ecology blocks" were used as the core of Cofferdam B, which dewatered the construction sites for Weirs No. 2 and 3. They are cast from leftover concrete batches, reducing waste; note the rebar "lifting eyes" for placement and removal.

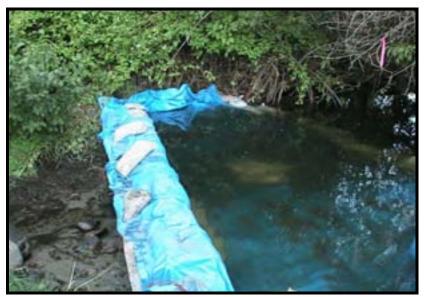
Photo A-18. Cofferdam B with sandbags holding down geotextile tarp, which holds back water.

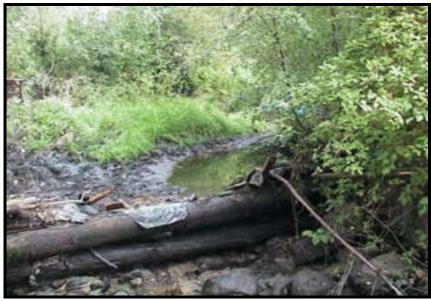
Photo No. 19. The Lower Stokes Diversion Dam was deconstructed in stages to facilitate electro-shocking and removal of fish from project area.

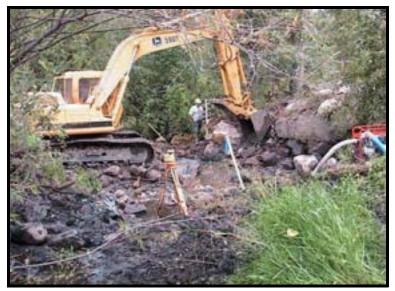
Photo A-20. Looking downstream at initial excavation of Weir No. 3. The concrete at right of photo is the upstream wall of the former diversion dam. The wall and the dam were about the same height (as shown in Photo A-1).

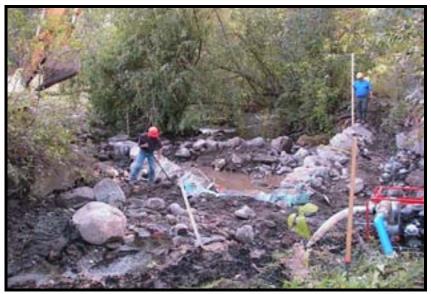
Photo A-21. Looking downstream at Weir No. 3 just prior to completion. The worker at center-left is filling the spaces between the large rocks with cobble-size material and fines.

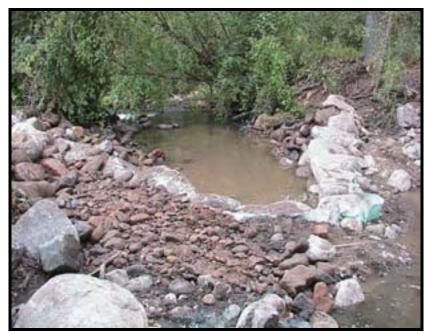
Photo A-22. Looking downstream at Weir No. 3 about 3 hours after Photo A-21 above was taken. The weir has been backfilled and the scour hole excavated.

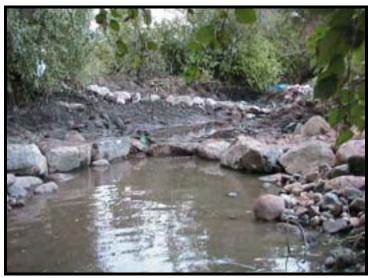
Photo A-23. Looking upstream at the lower weirs (Nos. 3 and 2).

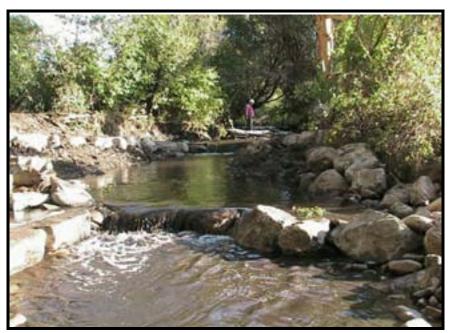
Downstream, near the location of the former diversion dam, two more vortex rock weirs, No. 2 and No. 3, were constructed; these stabilized the slope and energy of stream in this reach. These structures were designed to provide grade control and eliminate "headcutting" (the large, downward movement of a streambed that results when a stream is steepened). See Photo A-24.

Photo A-24. Looking upstream at Weirs No. 3 and No. 2 as water muddy from the removal of Cofferdam B flows past.

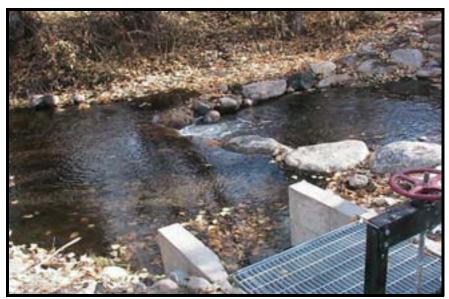
Photo A-25. This picture of Weir No. 1 was taken about mid-November 2003, about 2 months after completion. The weir was designed to pass a "bankfull" flow of 170 cfs and was tested with one minor event of about 30 cfs. The flow shown is about 6 cfs.
