**COMPLETION REPORT**  
**UPPER STOKES**  
**FISH PASSAGE IMPROVEMENT PROJECT**  
**BEAVER CREEK,**  
**METHOW SUBBASIN, WASHINGTON**  
**MARCH 2004**

# **Upper Stokes Fish Passage Improvement Project**

## **Appendix A. Construction Photographs (color)**

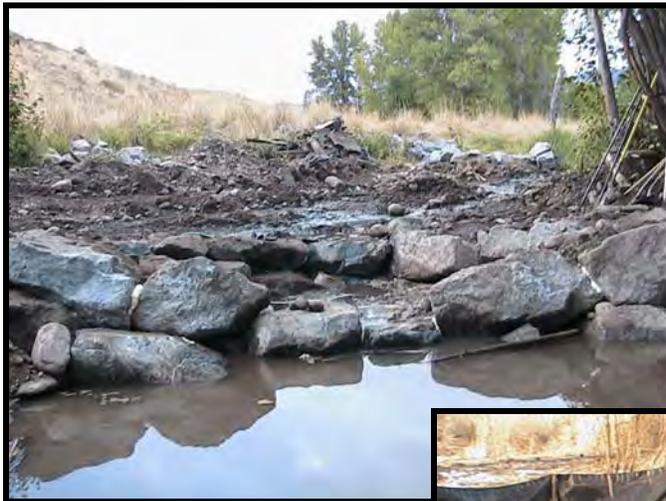
Cover Photo 1. Upper Stokes Fish Passage Improvement Project — nearly completed double-drop (A-shaped) Weir No. 1; backfill not yet done.

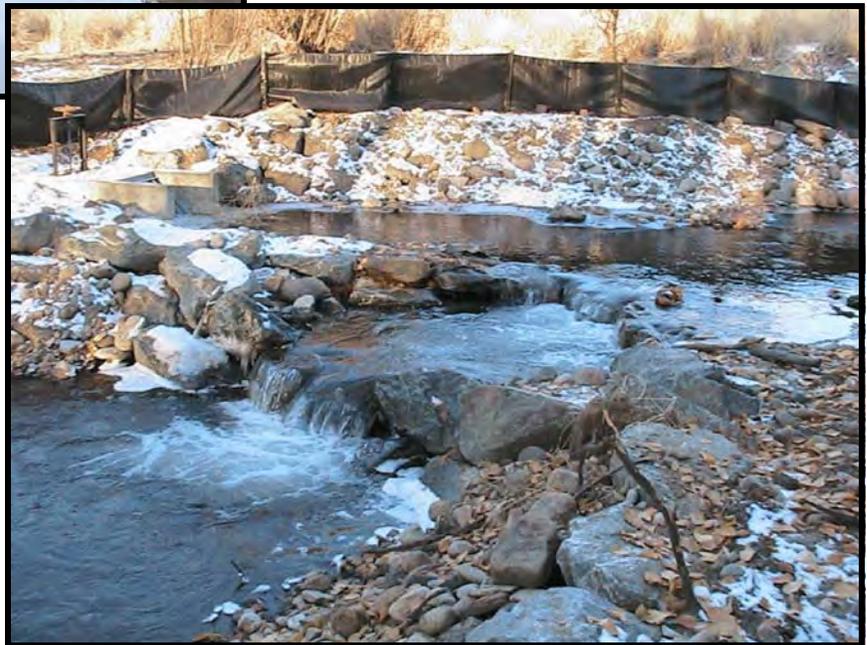
Cover Photo 2. Upper Stokes Fish Passage Improvement Project — Completed project with silt fence in place. View looking at lower position of A-shaped Weir No. 1. Headgate diversion structure is at left side of photo (photo taken November 2003).

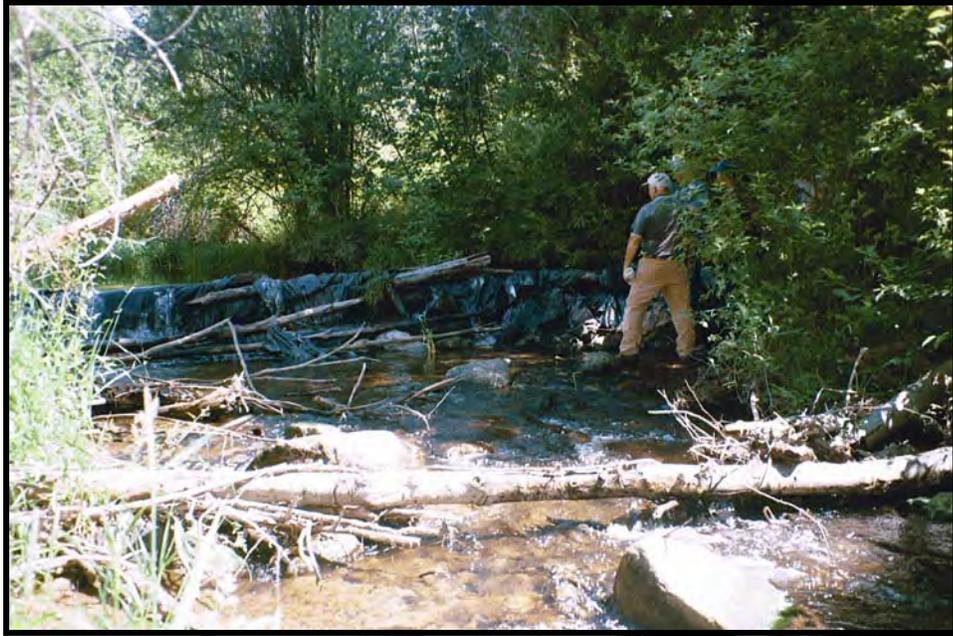
The existing 3½-foot-high diversion dam, made of stacked logs and lined with plastic (photo A-1), was removed entirely. To replace it, a so-called “Rosgen” rock vortex (A-type) weir (Cover Photo No. 1) was installed at the former site of the existing log structure. The new weir was designed with two drops, each 0.8 foot, which meets State standards for fish passage. Because the large rocks establish a hardened point, Weir No. 1 provides “grade control;” this means the stream is unable to downcut its bed over time. It also forms a small pool at the new point of diversion which was sufficient to allow diversion of the water right.

Photo A-1. Looking upstream at original Upper Stokes Diversion Dam (photo taken July 2002).

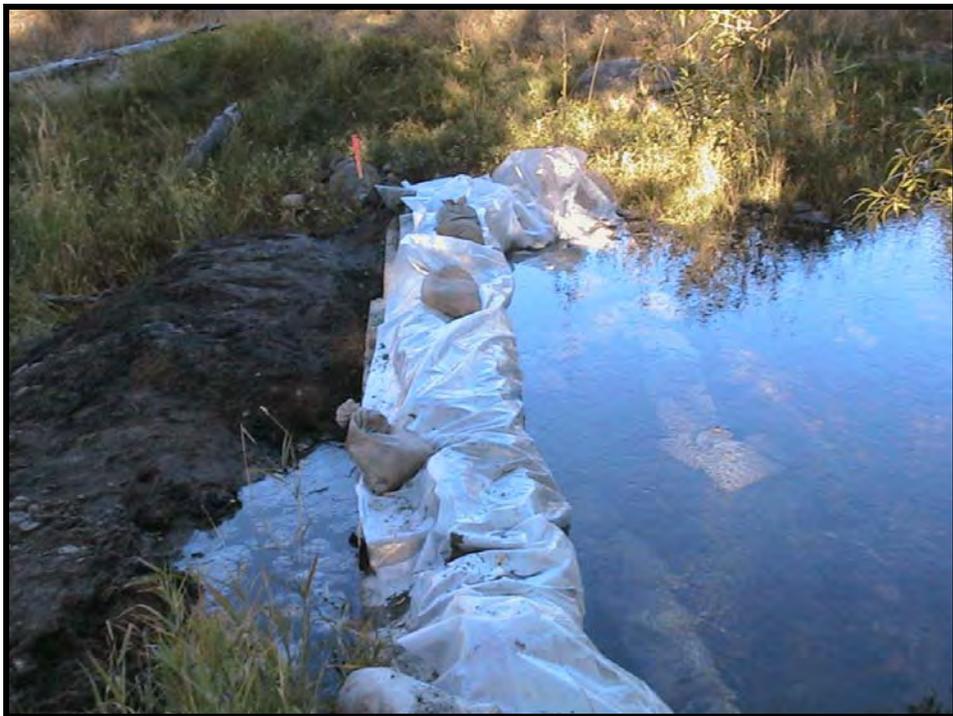
Photo A-2. The ecology block and plastic cofferdam was set about 80 feet upstream from the original diversion dam.

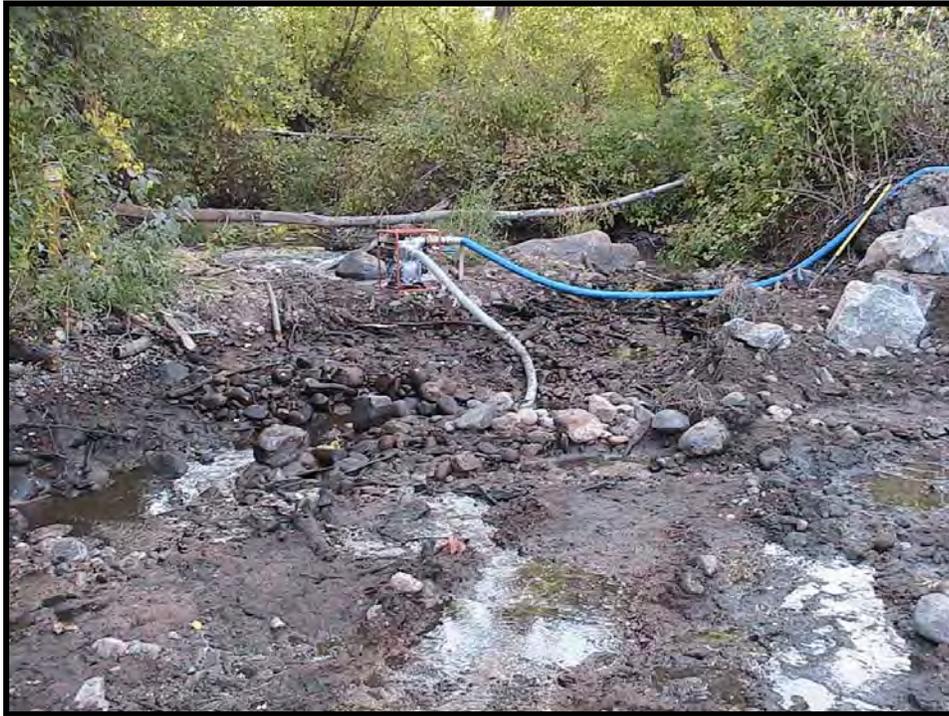
The material excavated from the two rock weir sites was similar in composition and consisted of a silt-sand-gravel-cobble mixture with an occasional large boulder (photo A-3). Typically, the material was “well graded” (evenly mixed) although along the banks of the creek, there was some layering from flood deposits and heavier percentages of fine materials.

Photo A-3. Looking downstream at the double-drop Weir No. 1; rock has been placed and tied into the right bank. This is the upper portion of the A-shaped weir. The suction pump in center picture is sending seepage water into the woods.

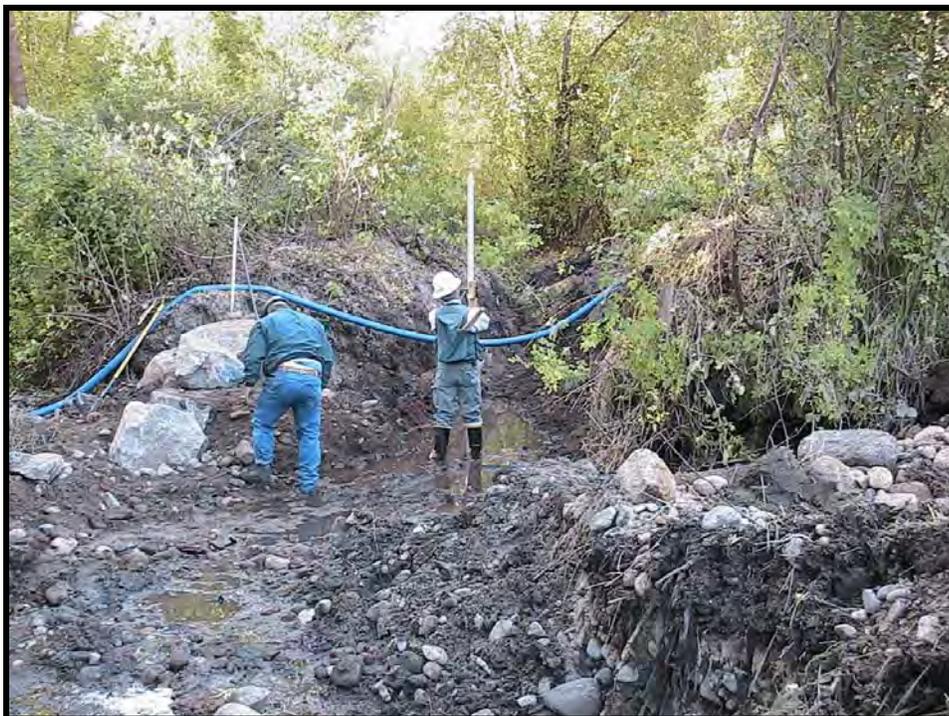
Photo A-4. Looking downstream at site of Weir No. 1 as technicians set elevation for the new diversion structure. The existing ditch was excavated about 12 inches to serve the lower elevation of the new headgate.

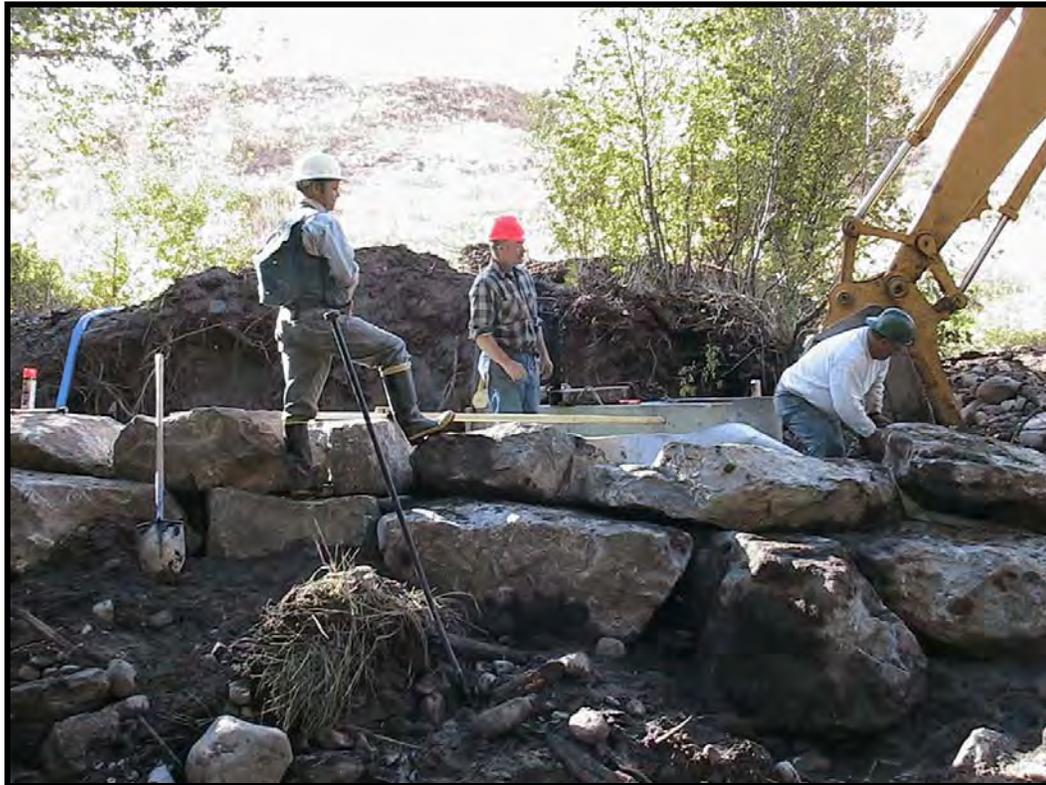
The large-diameter rocks used in this project (photo A-5) were provided by a family-owned quarry located about 30 miles east, near the town of Malott. After inspection and selection, about 100 rocks of various sizes were brought to the site around October 10th. Additional rocks were delivered from another commercial pit but calcite lenses limited their use, and no further rocks were ordered from that pit. The Malott rocks were angular and granitic ranging from just less than 2 feet in average diameter to over 4 feet. The estimated weights of the rocks ranged from 600 to 4,000 pounds.

Photo A-5. Looking upstream at the left arm of Weir No. 1. Diversion structure is set in the center of the photo. The large rocks were brought in from a quarry about 30 miles east. Note the even slope of the rocks and lack of gaps between them.

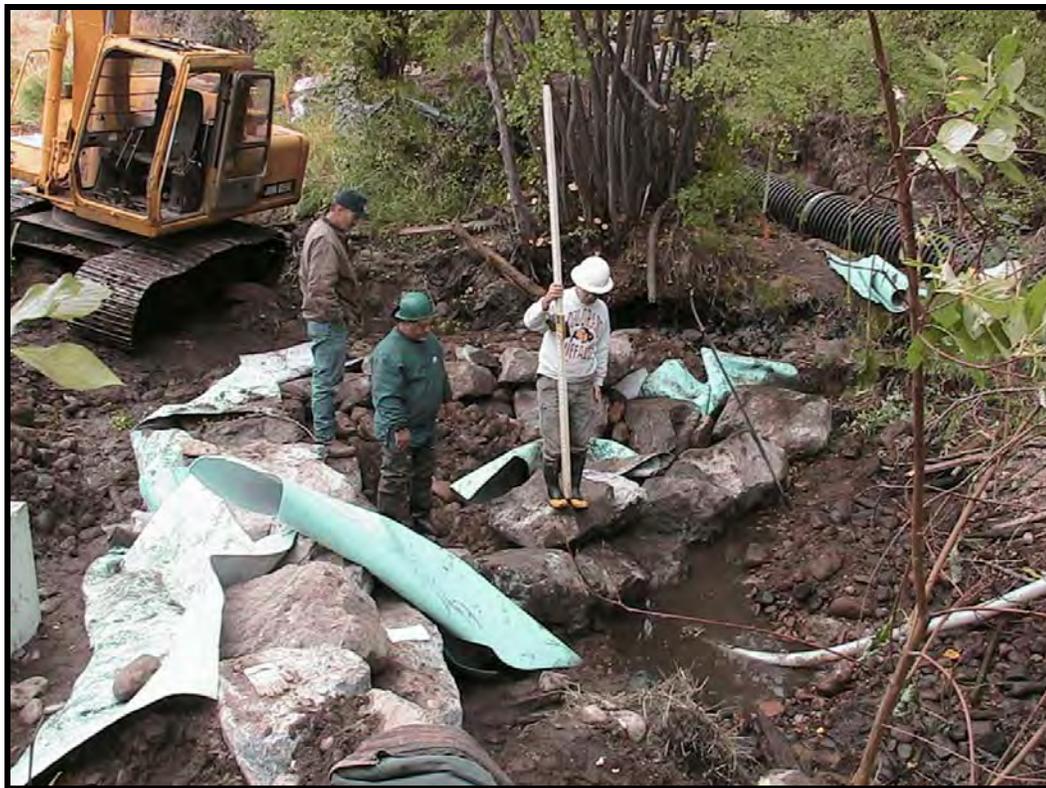
The worksite was dewatered using 30-inch-diameter, double-wall, HDPE pipe, which was routed around the construction area (photo A-6); the pipe and its watertight gaskets were manufactured by the ADS Company. A total of 200 feet of dewatering pipe and two 45-degree fittings were purchased for use on several projects. About 125 feet of dewatering pipe was used for the Upper Stokes project. No fittings were required. Surface excavation ranging in depth from 1 to 5 feet was needed to ensure proper grade. The dewatering pipeline was not backfilled unless necessary for weight on the pipe or where the equipment needed to cross. The dewatering pipe was used for other Beaver Creek projects and OCD divided the cost among them.

After the rocks for each weir were in place, an impervious “geocomposite” fabric was spread on the upstream side of each one (photos A-6 and A-7). The purpose of the fabric was to reduce or prevent water from traveling underneath the large rocks and to encourage deposition of fine materials if

Photo A-6. Looking upstream at Weir No. 1. A section of the dewatering pipe can be seen at the upper right; the seepage-pump line is at lower right; and the new diversion box is at the lower left.

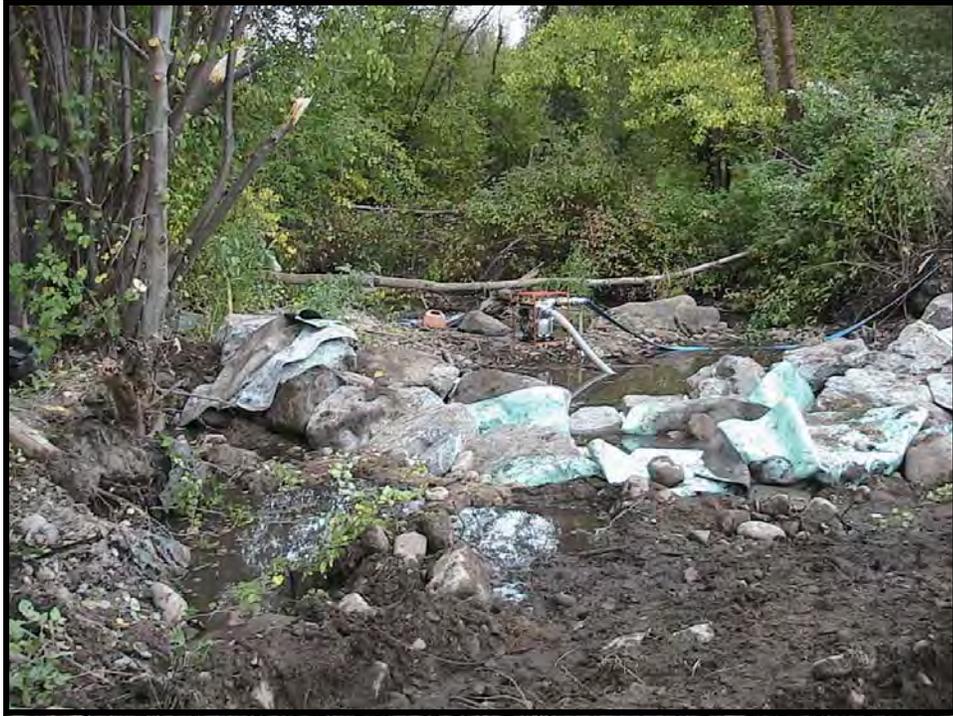
Photo A-7. Downstream view of Weir No. 1; the non-permeable geomembrane has been installed but not fully covered.

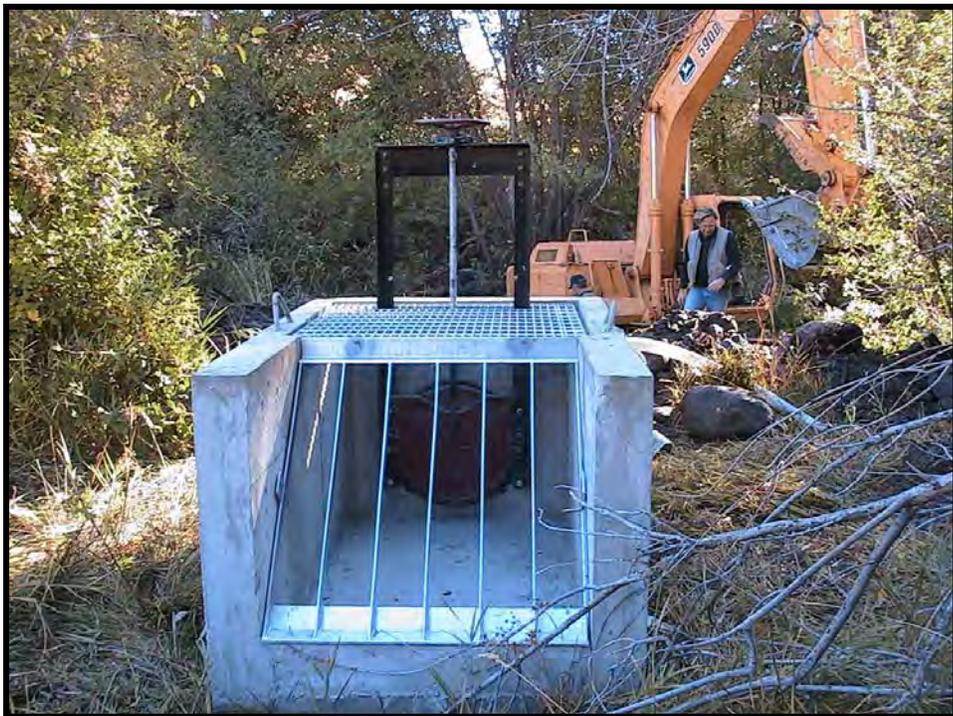
Photo A-8. The intake side of the new diversion box, before placement. Both the trashrack and the grate(on top) are galvanized.

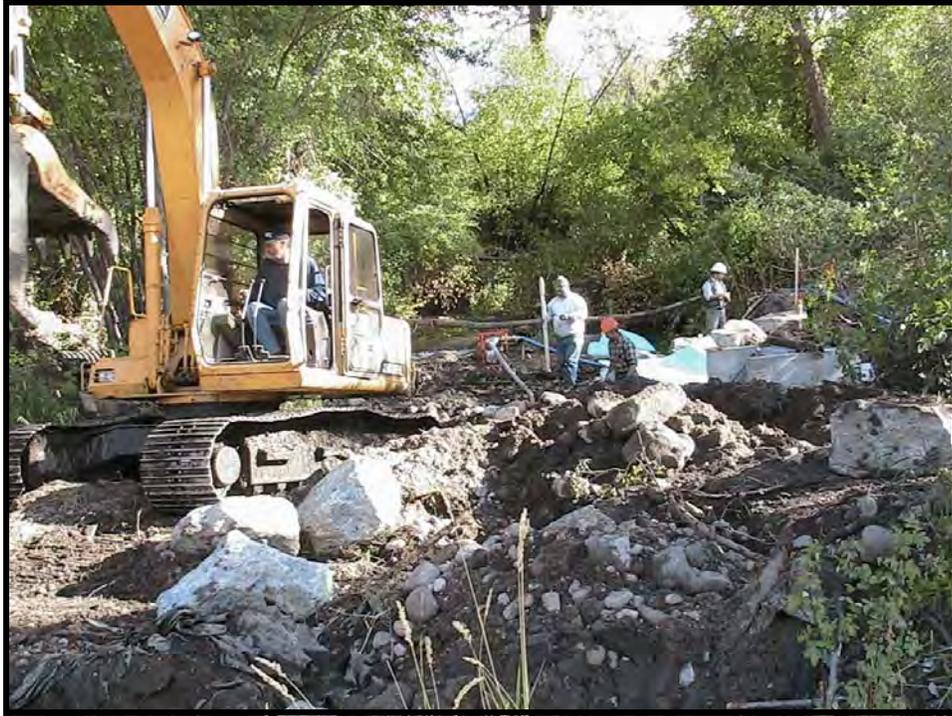
Photo A-9. Looking downstream, the new diversion structure (at middle right) has been set.

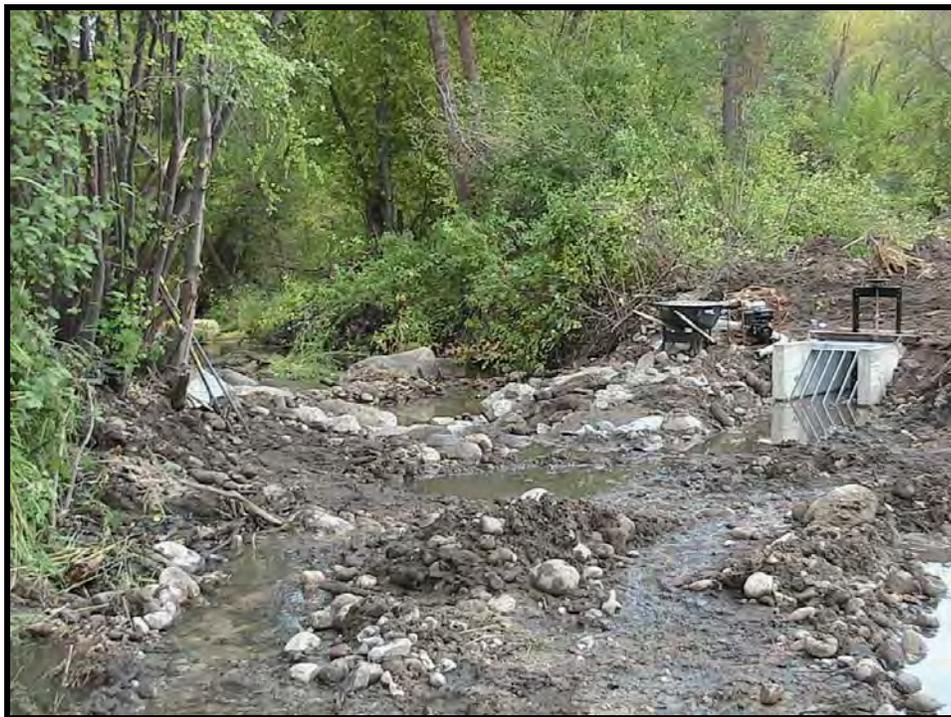
Photo A-10. Looking downstream at Weir No. 1, which has been lined with geotextile and then backfilled. The pipe trench has also been backfilled.

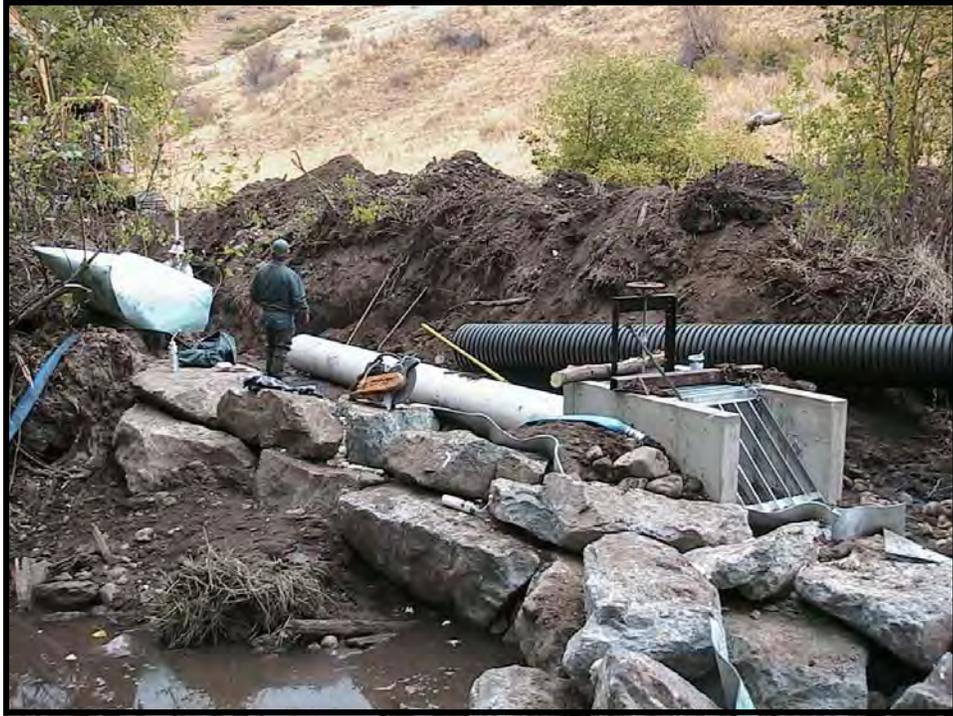
The 18-inch conveyance pipe was also PIP but rated for 63 psi; one 20-foot section was installed from the diversion box into the ditch (photo A-10). After reviewing conditions in the field, the depth of the ditch after the pipe was determined too deep to be safe. Another 20-foot section of pipe was purchased, making the total length of pipe out of the diversion box 40 feet (photo A-10). The second length is 18-inch-diameter, double-wall, HDPE (high density polyethylene) pipe.

Photo A-10. Looking upstream across the right arm of Weir No. 1. The white PVC pipe is attached to the box's "stub." In a field modification to extend the irrigation further down the ditch, the corrugated black HDPE pipe was attached to the PVC pipe.

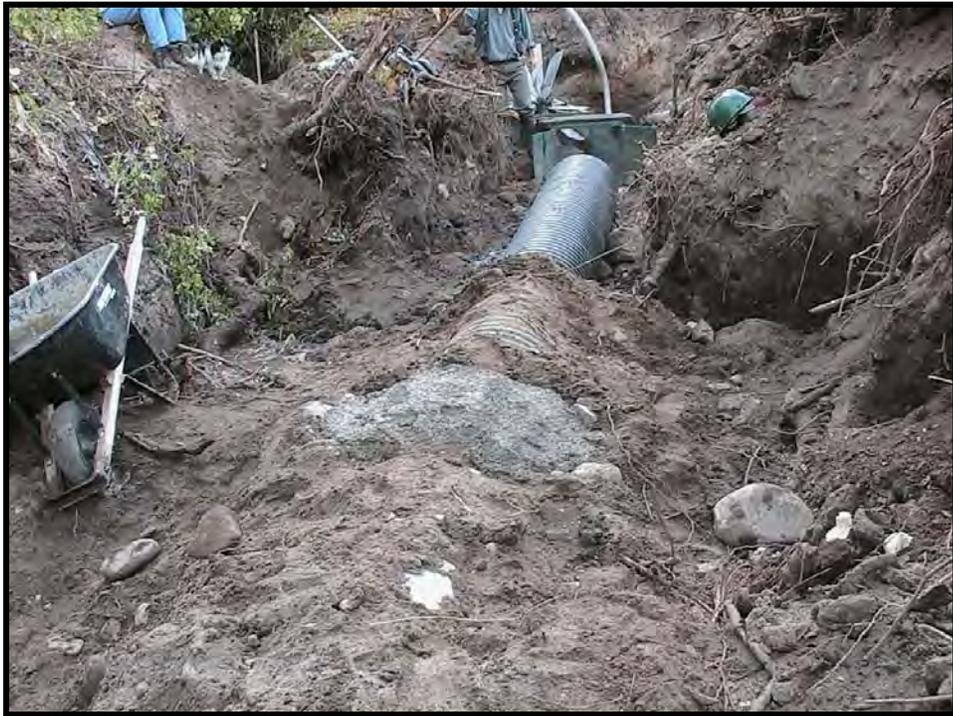
The connection between the two pipe sections was made by cutting lateral slits in the HDPE pipe and forcing it over the PIP pipe (photo A-12). The joint was then covered in concrete to a depth of three inches over the joint. Approximately eight bags of premixed concrete were used. The soils in which the pipe was placed were a sandy-silt with significant number of cobble-sized material. The average depth of fill over the pipe is about 5 feet. All pipe for this project was supplied by Cascade Pipe and Feed Supply of Twisp.

Photo A-12. The concrete protects and weights the transition between the PVC (white) and HDPE (black) irrigation pipes (see photo A-10). The fish screen is in the upper center of the photo, just above the black pipe.

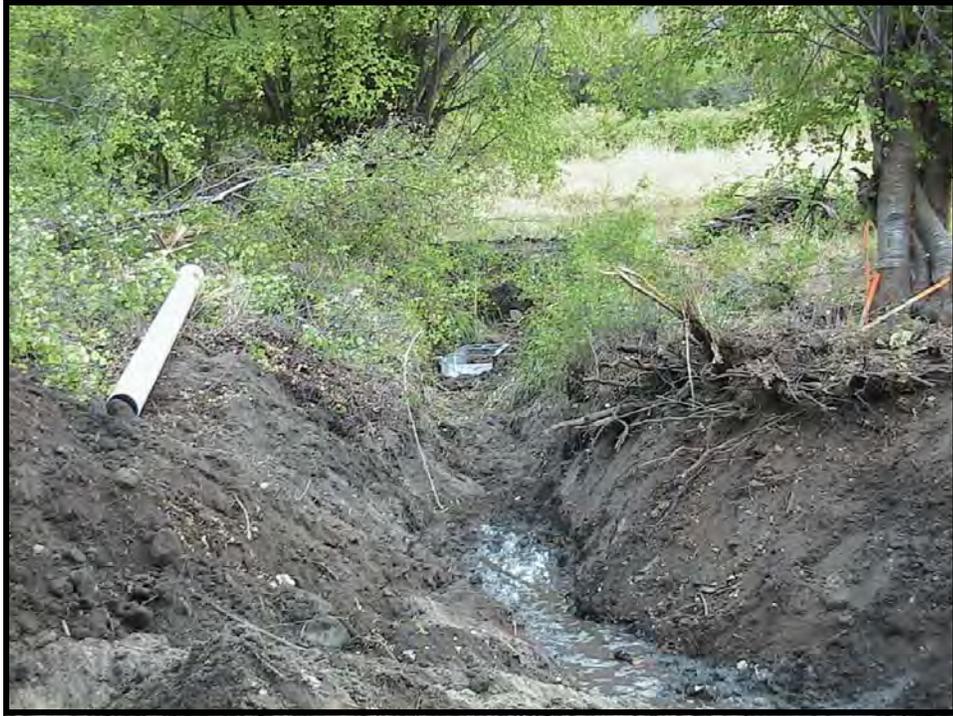
Photo A-13. Along the diversion ditch, just downstream from the fish screen. The new ramp flume is shown near the center of the picture. This portion of the ditch have been cleared of vegetation and deepened.

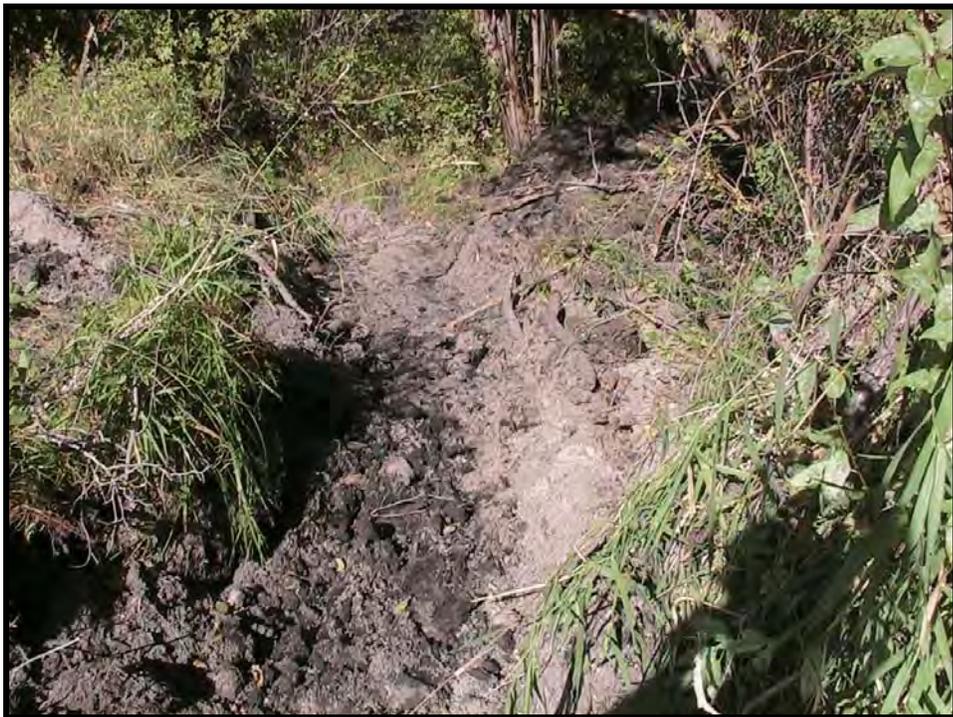
Photo A-14. Downstream of the ramp flume, more cleaned-out ditch.

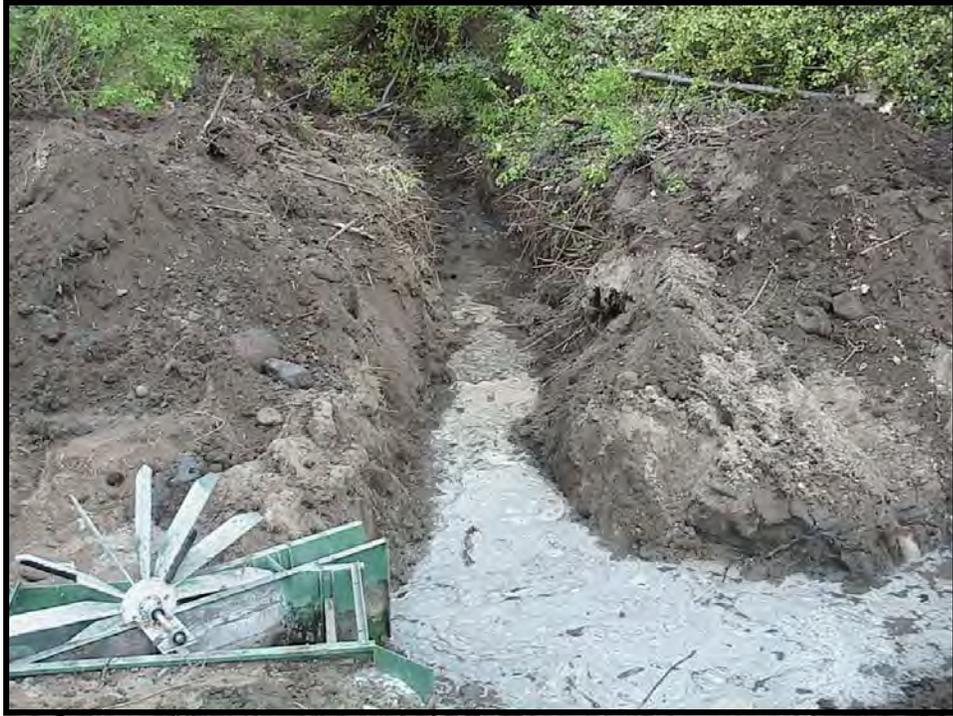
Photo A-15. The fish bypass channel, before installation of the fish bypass return pipe.

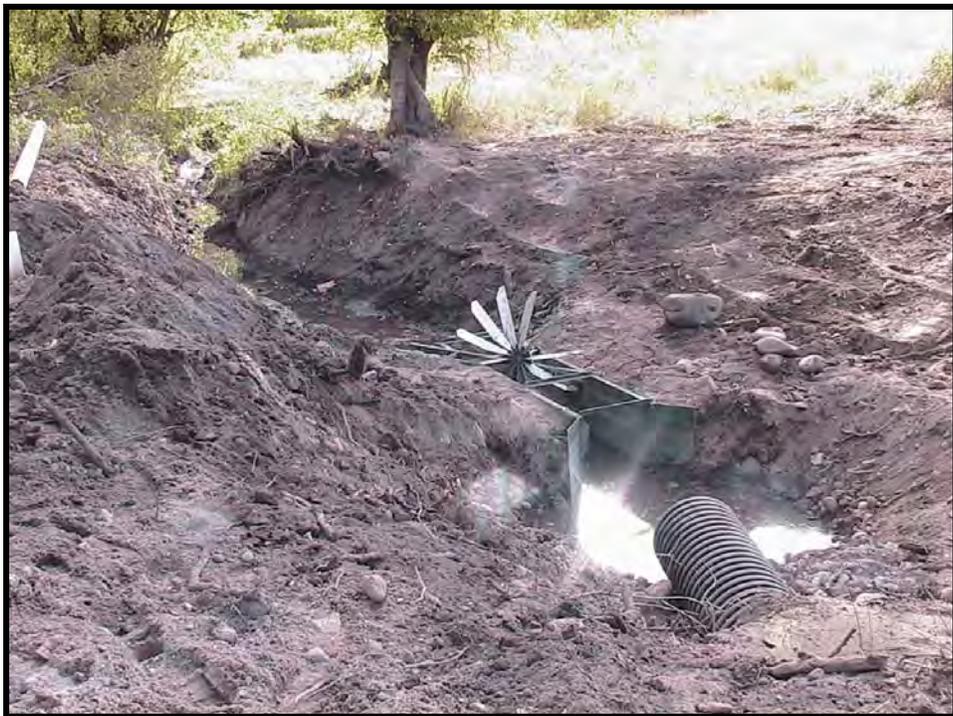
Photo A-16. The diversion pipe extension and the ditch transition at the fish screen. Note the benching of the ditch slopes.

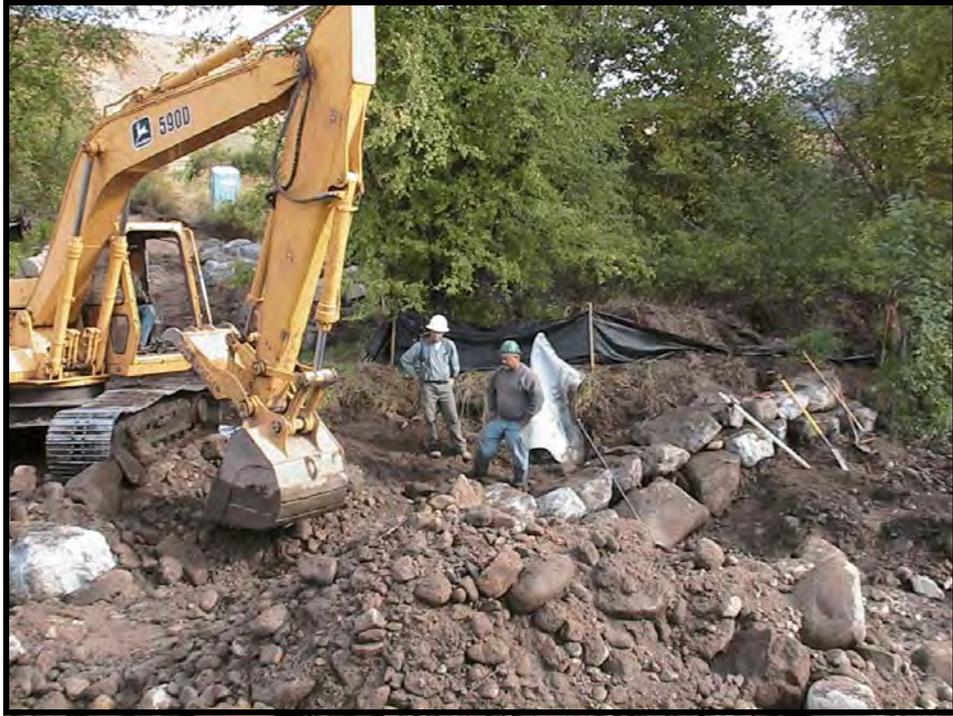
Photo A-17. Looking across Beaver Creek to the left arm of Weir No. 2.

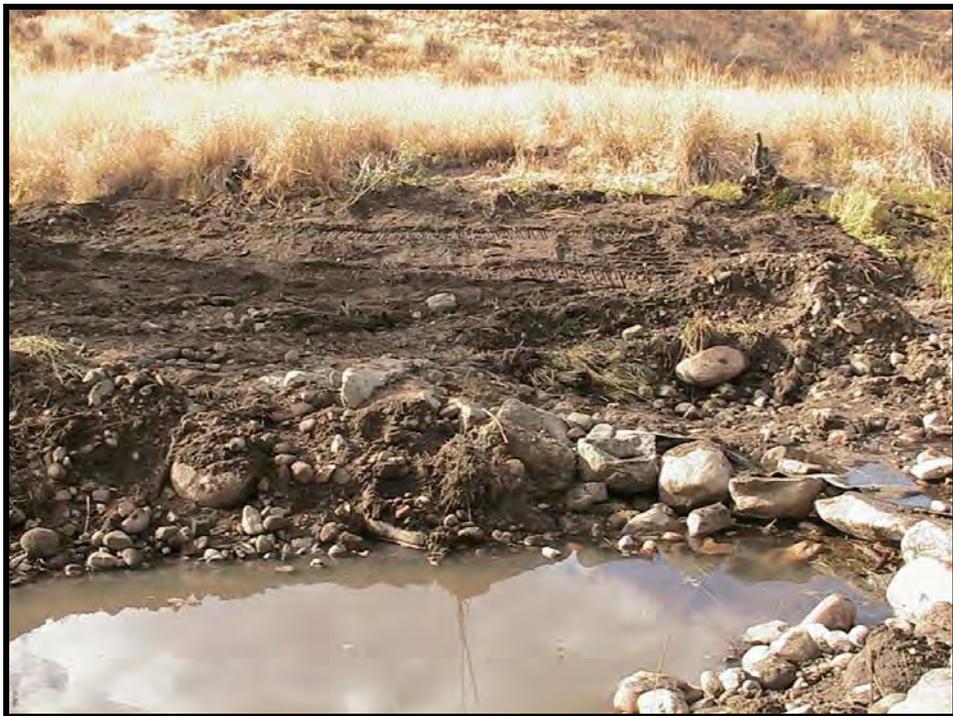
Photo A-18. Looking upstream at Weir No. 2 and the rebuilt stream bank.

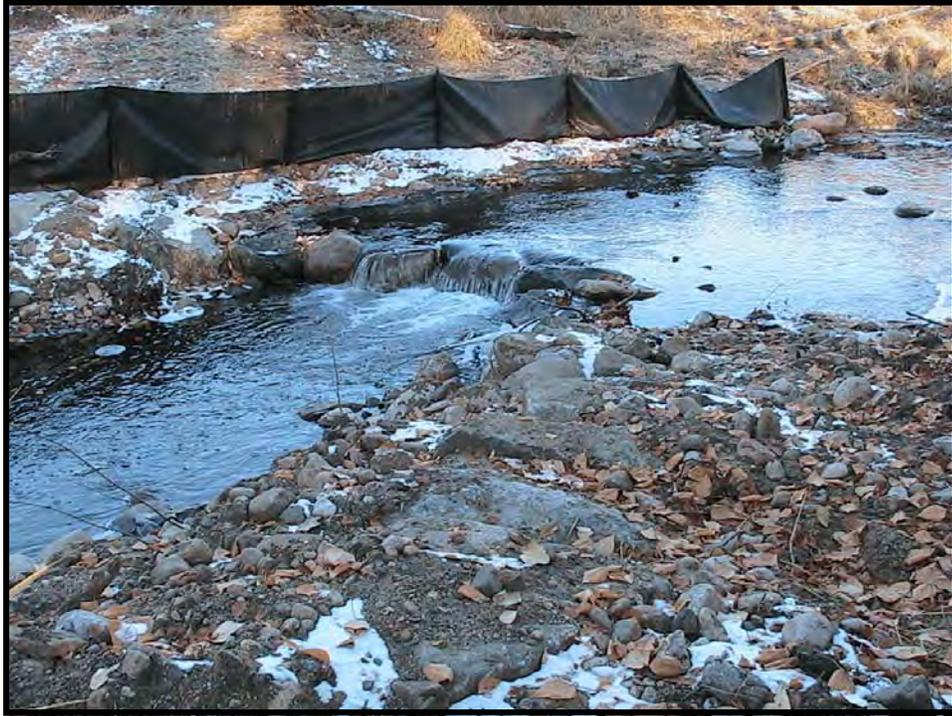
Photo A-19. Weir No. 2 during low flow on November 15, 2003. The silt fence in the background will remain in place until the spring of 2004.

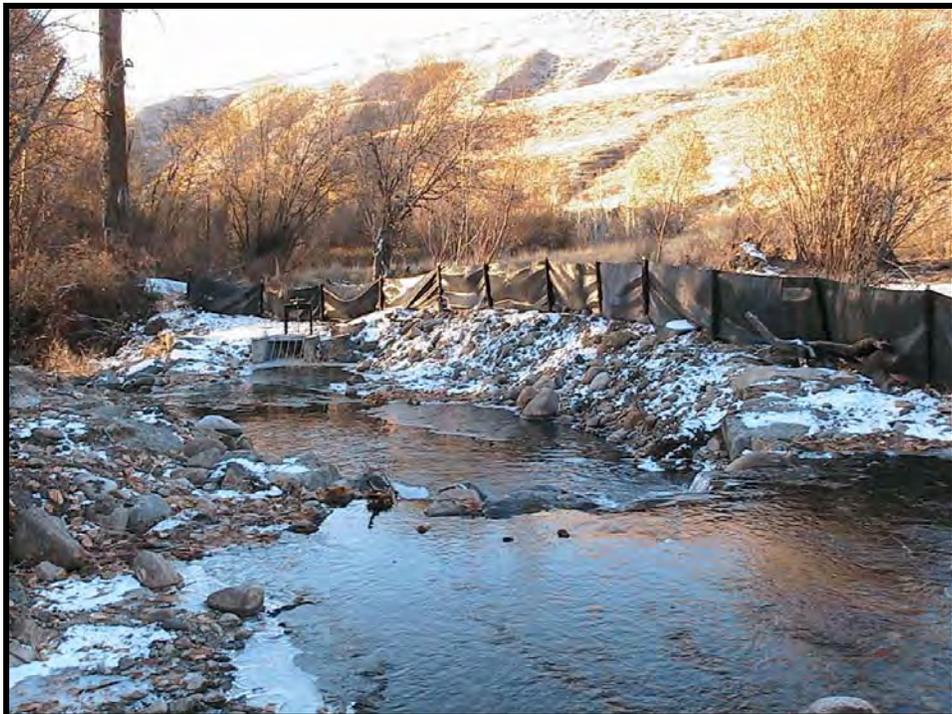
Photo A-20. Looking downstream from above Weir No. 2 on November 20. The upper position of Weir No. 1 is in the left-center of the picture. The headgate has been closed for the winter.

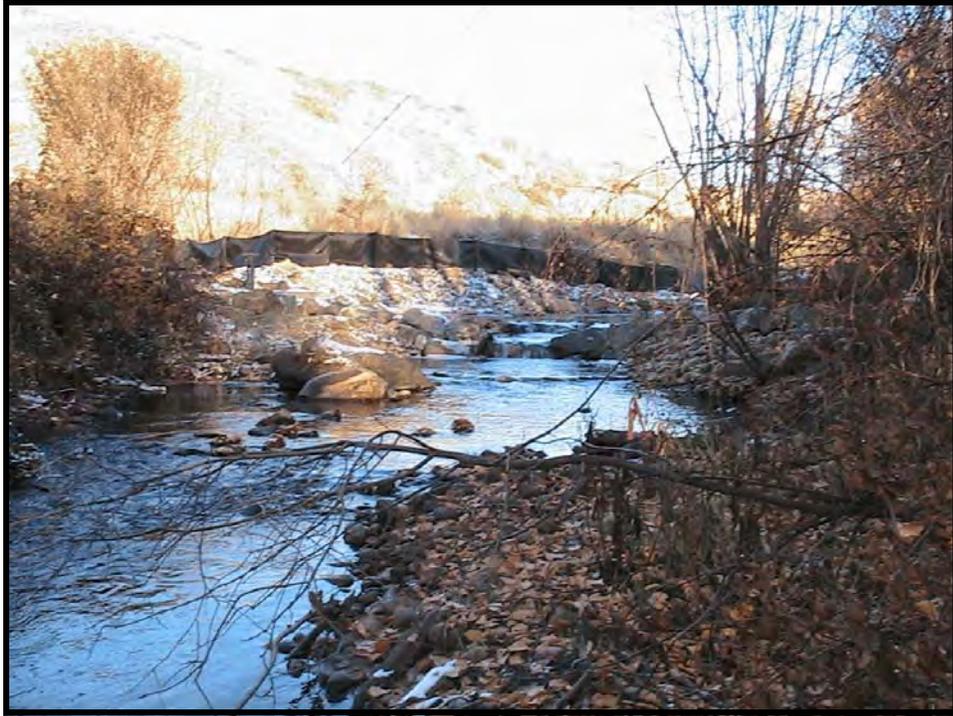
Photo A-21. Looking upstream from the exit of the fish bypass. Weir No. 1 is shown in the center of the picture.

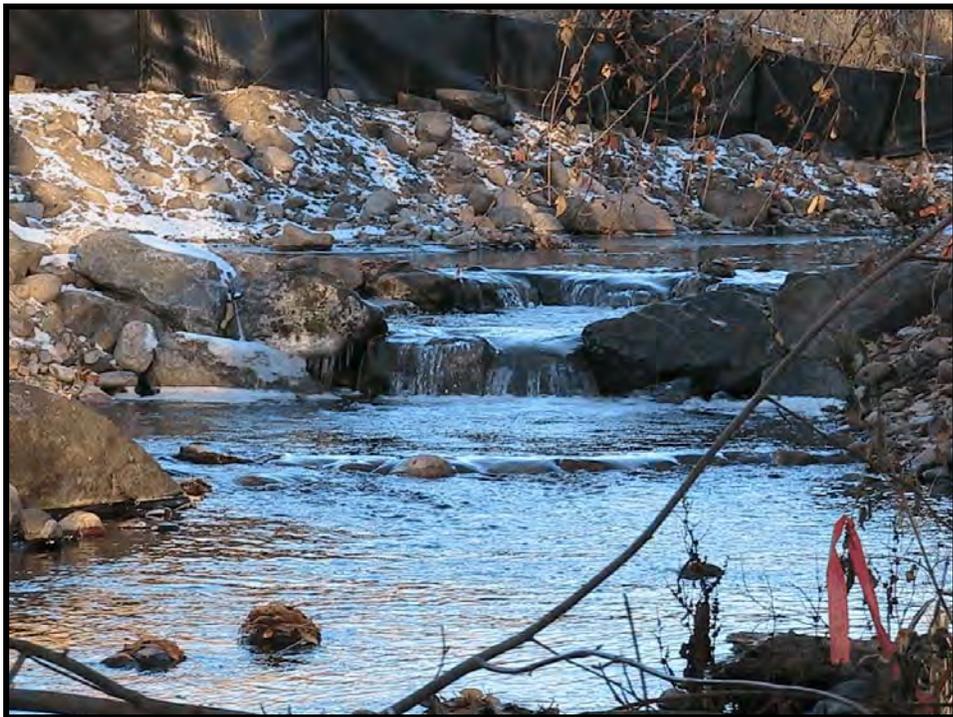
Photo A-22. A closer view of Weir No. 1 on November 15.

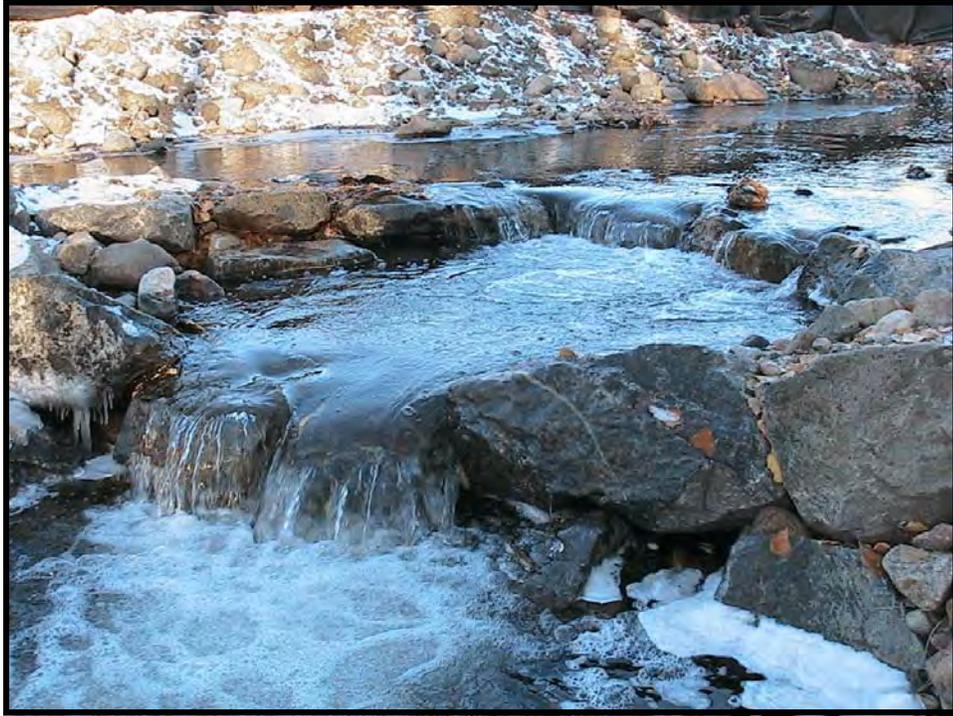
As measured after construction, the downstream drop is actually over 1 foot, mostly as a result of channel restructuring downstream. However, some bedload is expected to drop out of the stream at high flows and accumulate just downstream of the scour hole; this would reduce the drop to the 0.8 foot design standard. If necessary, modifications to the structure or to the streambed downstream of the drop will be made after highwater in the spring of 2004.

Photo A-23. At Weir No. 1, the drop at the downstream portion is greater than designed. After highwater in 2004, if the bed of the pool has not been built up by deposited gravels, the drop will be adjusted.

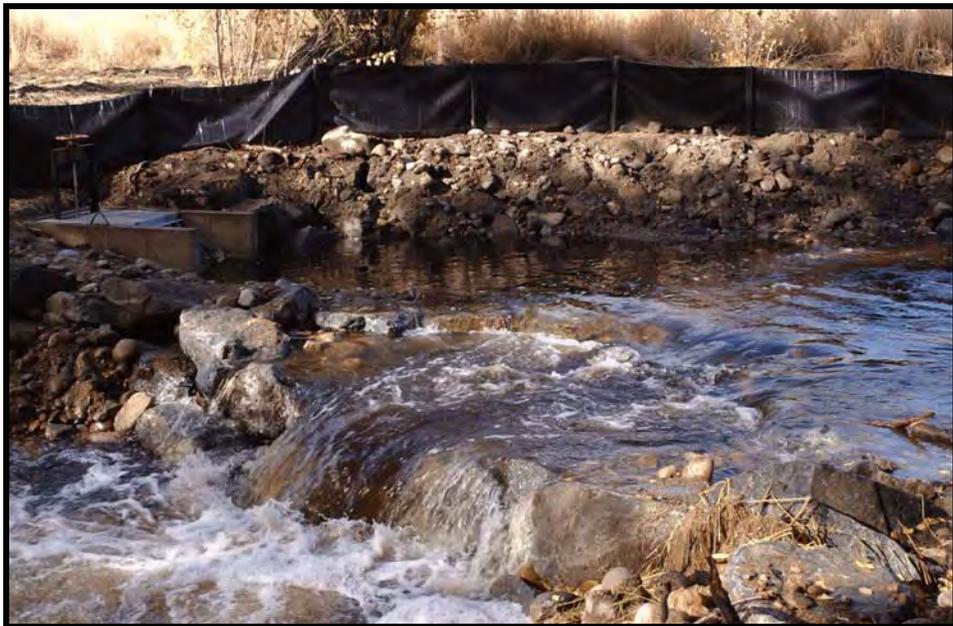
Photo A-24. November high flow over the double-drop Weir No. 1, which is the diversion control structure.

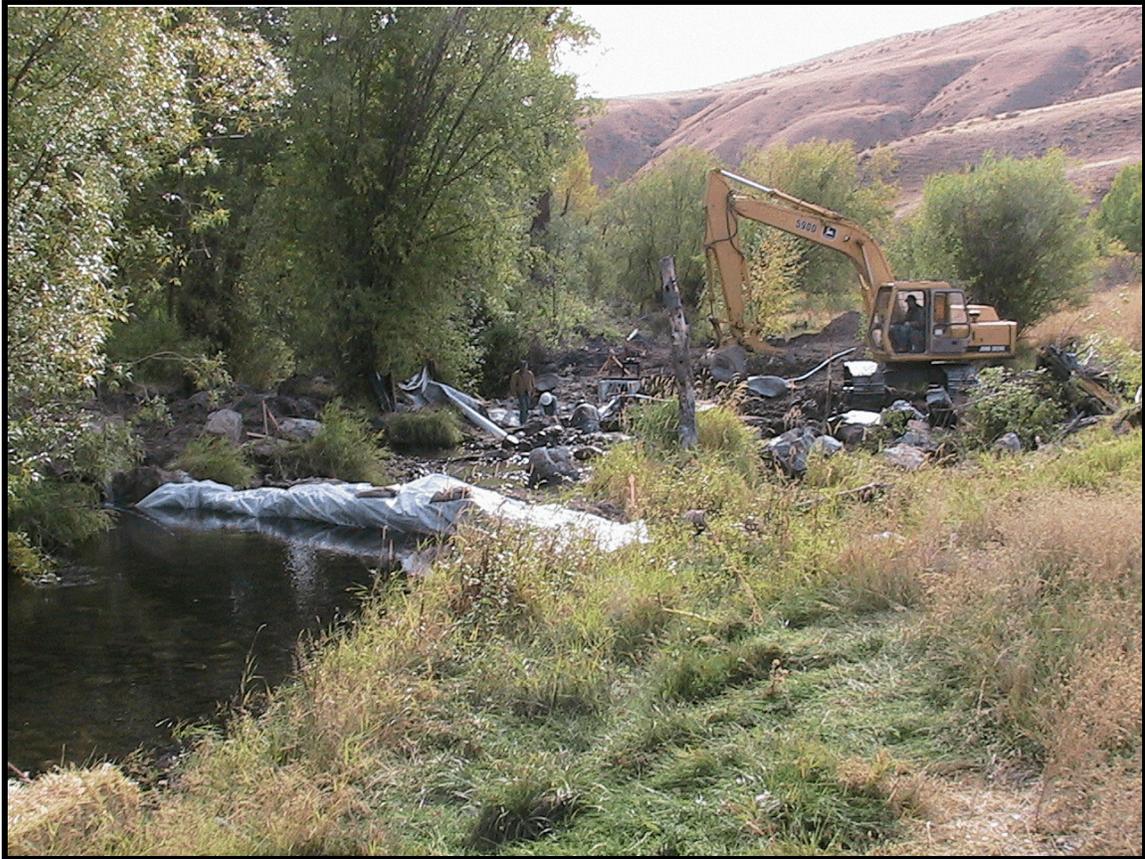
Photo A-25. The Upper Stokes project job site during construction. The cofferdam is at left center.
