***Tyler Creek
Wasteway
Stabilization***

Geology Appendix

**Reclamation's
November 30, 1993,
Geologic
Field
Review**

**Reclamation's
August 7, 1997,
Geotechnical
Field
Review**

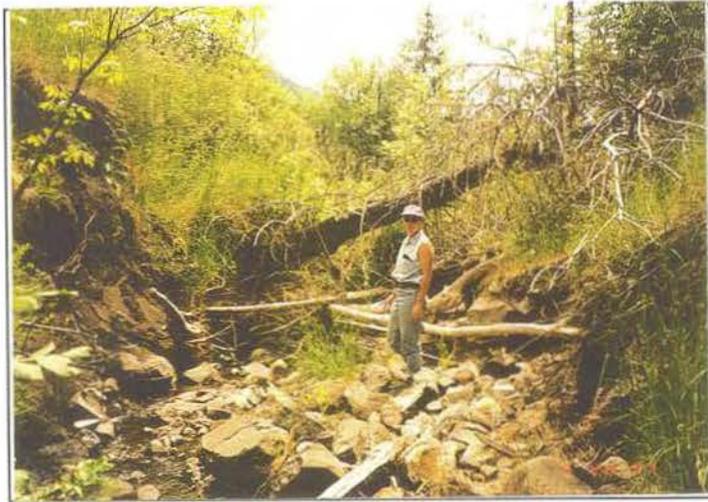
Photograph No. 1. Tyler Creek Wasteway. Looking downstream (southwest) near Station 47+33. Angular volcanic rock mostly 8 to 18 inches in size mantles channel bottom. Lateral cutting of banks is in progress. Note undercut tree toppled into channel.
USBR Photograph by B.H. Carter, 6/26/97.

RECOMMENDATIONS: Channel modification is required to stabilize this section of channel. All alluvial bars, debris bars, and downed trees should be removed and incorporated into side-slope toe protection and channel armoring. About 80 percent of the channel will need to have channel bank toe protection to stop lateral erosion. By mechanized channel modification, most of the toe protection can be obtained from rock and tree debris now within the channel. Some additional outside rock (estimated at 30 cu. yds. of 6 - 12 inch sizes) could be needed

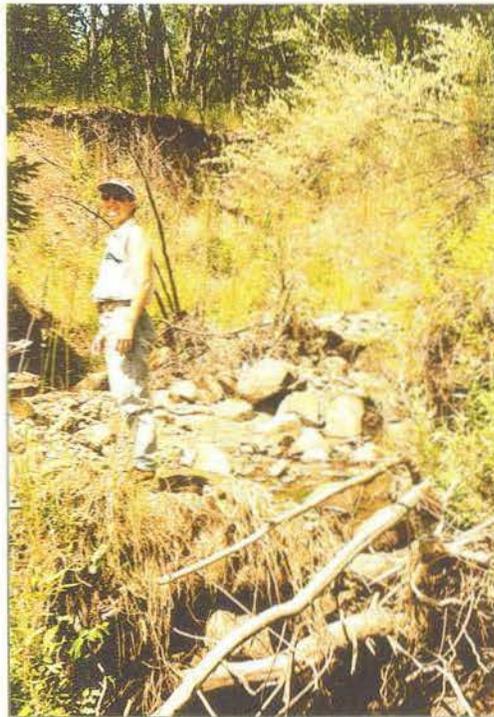
Photograph No. 2. Tyler Creek Wasteway.
Photograph taken near Station 50+80 looking northeast, upstream. Background erosional slope is about 15 feet high. Lateral erosion in this area is caused from channel organic and rock debris blockage and bar buildup.
USBR Photograph by B.H. Carter, 6/26/97.

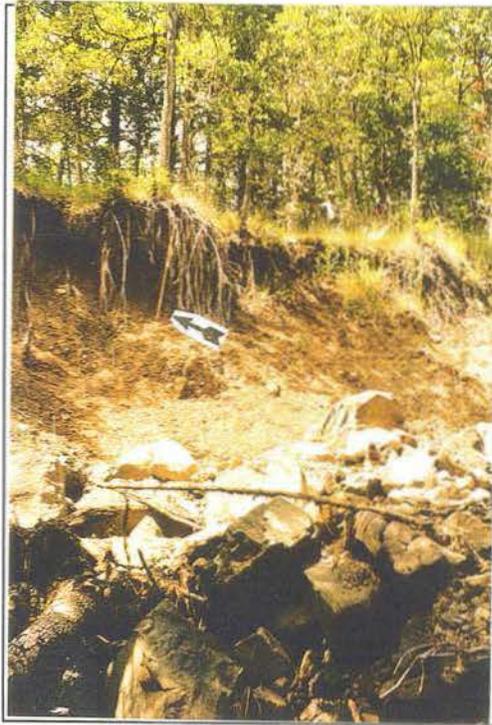
Photograph No. 3. Tyler Creek Wasteway.
Eroded slope in altered/weathered volcanics from 10 to 17 feet high. Slope materials are soil-like. No *in situ* bedrock is exposed, but channel bottom is mantled with large angular cobbles to boulder size rocks. Stake with red ribbon and pole with flag on right side of right-of-way boundary. View is looking across Station 50+90 to the northeast.
USBR Photograph by B.H. Carter, 6/26/97.

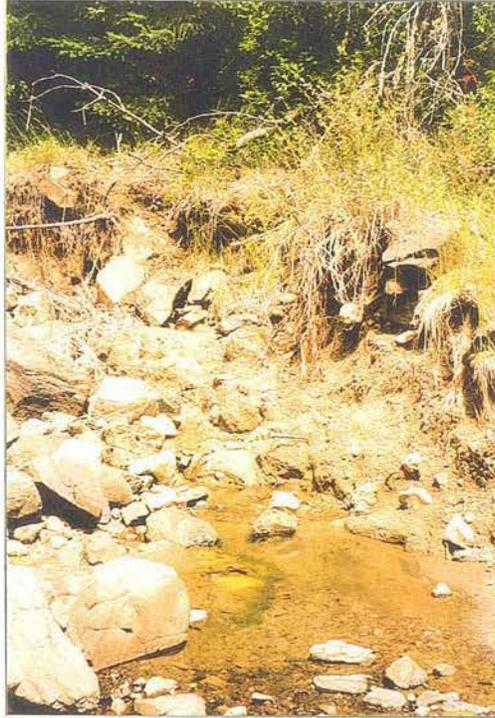
Photograph No. 4. Tyler Creek Wasteway.
Station 53+13, looking east at eroded channel bottom and eroded side slope underlain with altered/weathered, fine-grained volcanics with hard, angular clasts (gravel to boulder-size) eroding from volcanics and being deposited in channel. Channel is partially veneered with rock in this area. Note geology pick for scale.
USBR Photograph by B.H. Carter, 6/26/97.

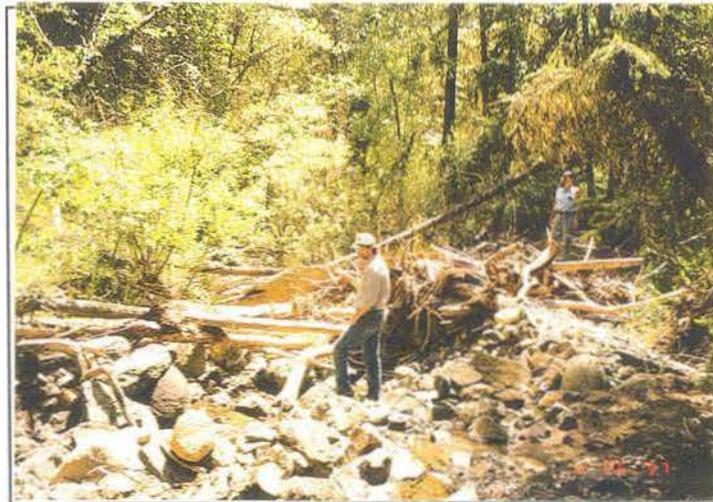
Photograph No. 5. Tyler Creek Wasteway. Looking downstream (southwest) at channel mantled with hard, volcanic gravel to boulder-size materials; Station 54+34. Channel area is well armored with tree/rock bar causing flow obstruction and lateral migration of streamflow. USBR Photograph by B.H. Carter, 6/26/97.

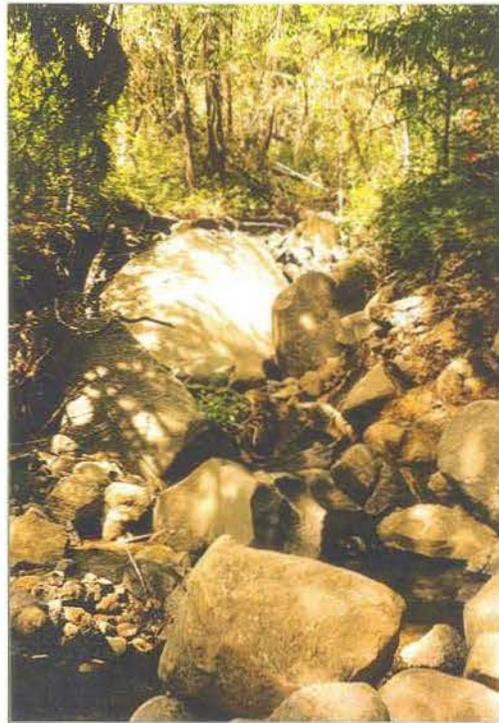
Photograph No. 6. Tyler Creek Wasteway.

Back station from 57+00, for about 150 feet, large blocks of rock have created an energy dissipation for the stream flow and very minor lateral erosion has occurred. Refer to Photograph No. 6. Very little channel modification will be required in this area.

Looking upstream (northeast) or back station, from Station 57+00. Large blocks of hard, volcanic rocks to 2 cubic yards in size have created energy dissipation of the streamflow. Very little to no lateral bank erosion has occurred in this interval of the stream channel.

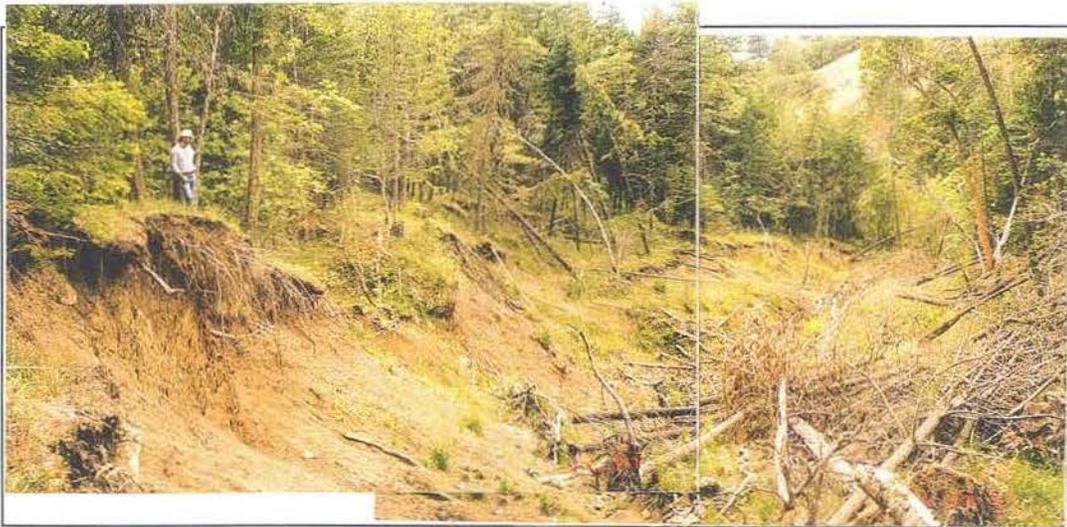
STATION 57+00 to 65+73 (old channel alignment): Deep channel degradation has occurred in this interval of the wasteway. During my visit in November 1993, near vertical unstable channel banks were observed to heights of 40 to 50 feet; refer to Photographs Nos 9 and 10. Present (1997) observations show the higher banks with near vertical slopes failed by landslide movement and erosion to a stable slope of about 1.5:1 or flatter. The present conditions are shown in Photographs Nos 7 and 8.

Panoramic Photograph No. 7. Tyler Creek Wasteway. Looking downstream from about Station 60+70 to 64+40. Photograph shows acute erosion in altered/weathered fine-grained volcanics with very few hard rock clasts exposed. Toppled trees are a result of bank undercutting. Note landslide topography in center of photograph. Maximum height of eroded bluffs is about 40 feet.
USBR Photograph by B.H. Carter, 6/26/97.

RECOMMENDATIONS: This portion of the channel has not been utilized for wasteway discharges for several years. Because of the deep section of soil-like volcanic materials (landslide materials) and lack of rock in this area, rehabilitation of the wasteway would be very costly. All debris would need to be removed from the channel and large quantities of rock would need to be hauled in and placed for channel protection. In order to provide long term stability of the oversteepened slopes, present slopes should be cut back to 1.5 to 1 or flatter.

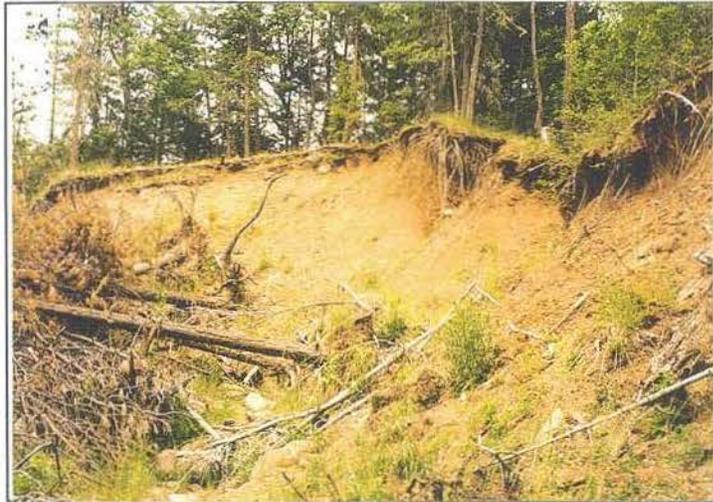
Photograph No. 8. Tyler Creek Wasteway. Looking upstream from Station 64+40 at 30-foot high erosional wall of channel. Numerous toppled trees are to the left and undercut trees are to the right. USBR Photograph by B.H. Carter, 6/26/97.

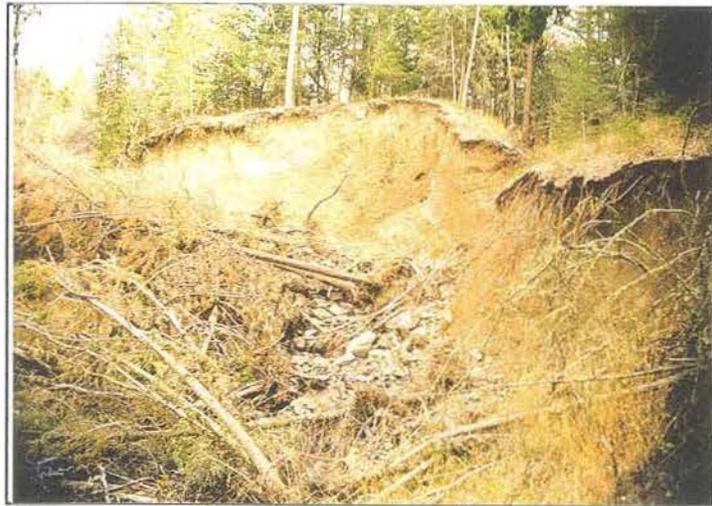
Photograph No. 9. Tyler Creek Wasteway. This photograph was taken in November 16, 1993 when the recent channel erosion had formed near vertical bluff to 40 feet in height. In comparison with Photograph No. 8 taken in 1997, note the bluff exposures have migrated upslope producing flatter slopes.

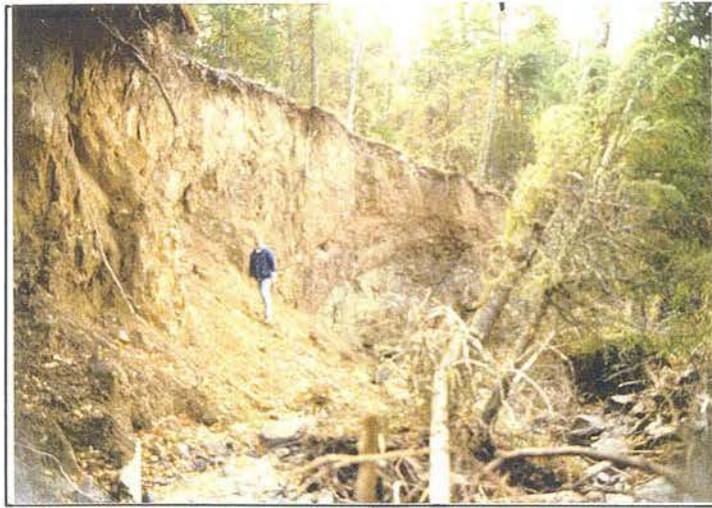
Photograph No. 10 Tyler Creek Wasteway. Looking downstream of Station 62+26, November 1993. Channel bank about 50 feet high in near vertical exposure. Panoramic Photograph No. 7, taken in 1997, shows this area failed back in flatter slope by landslide movement. USBR Photograph by B.H. Carter, 11/16/93.

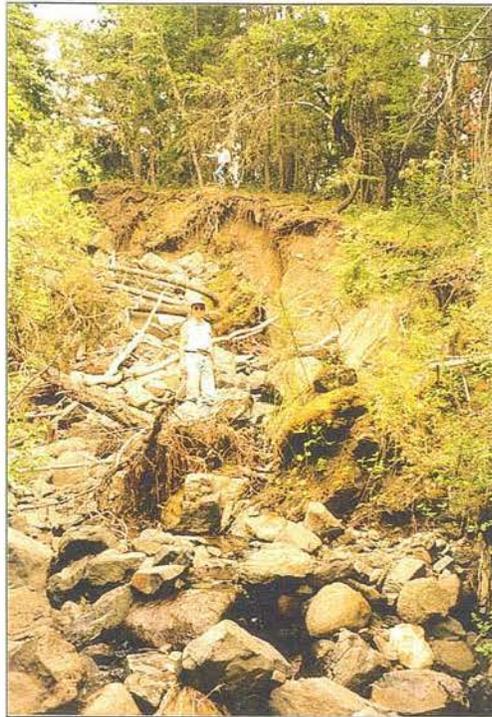
An estimated 75 percent of the alternate alignment has exposed bedrock in the channel section. Some lateral channel erosion has occurred locally as shown in Photograph No. 11. Also, alluvial bars, debris bars, and fallen trees are common.

Photograph No. 11. Tyler Creek Wasteway.
Control Point 3015, alternate channel, looking
upstream to the east. Channel bottom is mantled
with heavy rock, but stream is migrating laterally
into soft, fine-grained, altered/weathered volcanics.
USBR Photograph by B.H. Carter, 6/26/97.

RECOMMENDATIONS: Some channel modification with associated channel and side-slope protection will be required for long term channel stability. Alluvial bars and toppled trees should be removed and incorporated in the channel protection. Bedrock exposures and concentrations of loose rock debris in the channel will satisfy most of the channel protection needs. However, about 200 feet of channel will require an estimated 10 cu. yds. of additional rock. Over steepened channel slopes with heights over 10 feet should be flattened to 1.5:1.
