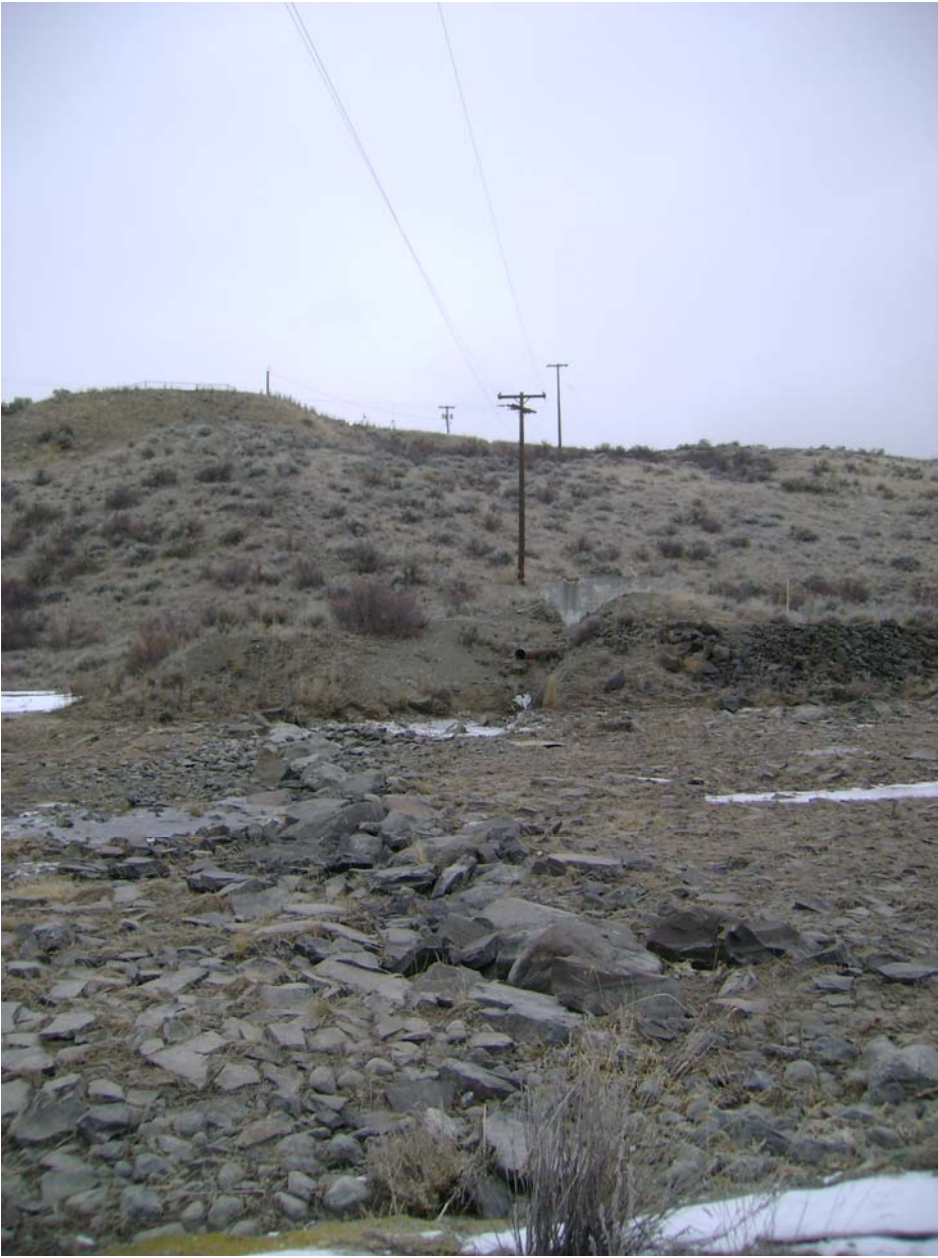
**FIGURE E-1**  
Riprap covering the East-Low Siphon

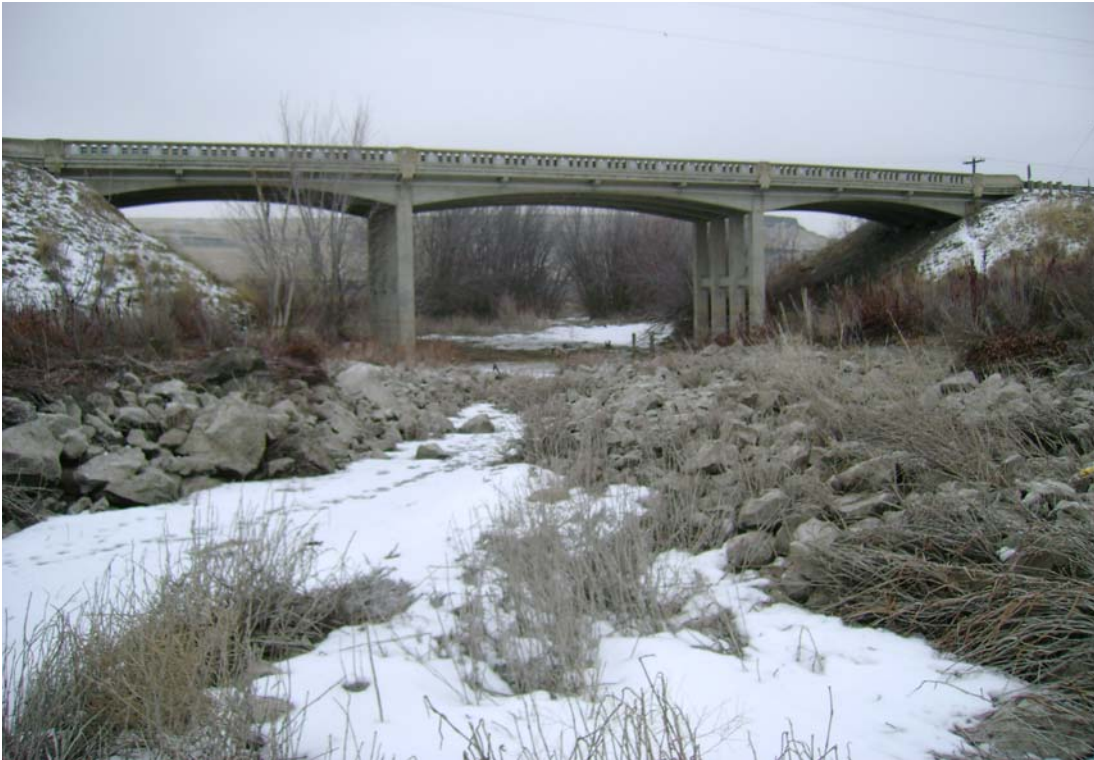
**FIGURE E-2**  
From the outlet of Brook Lake looking downstream at HWY 26

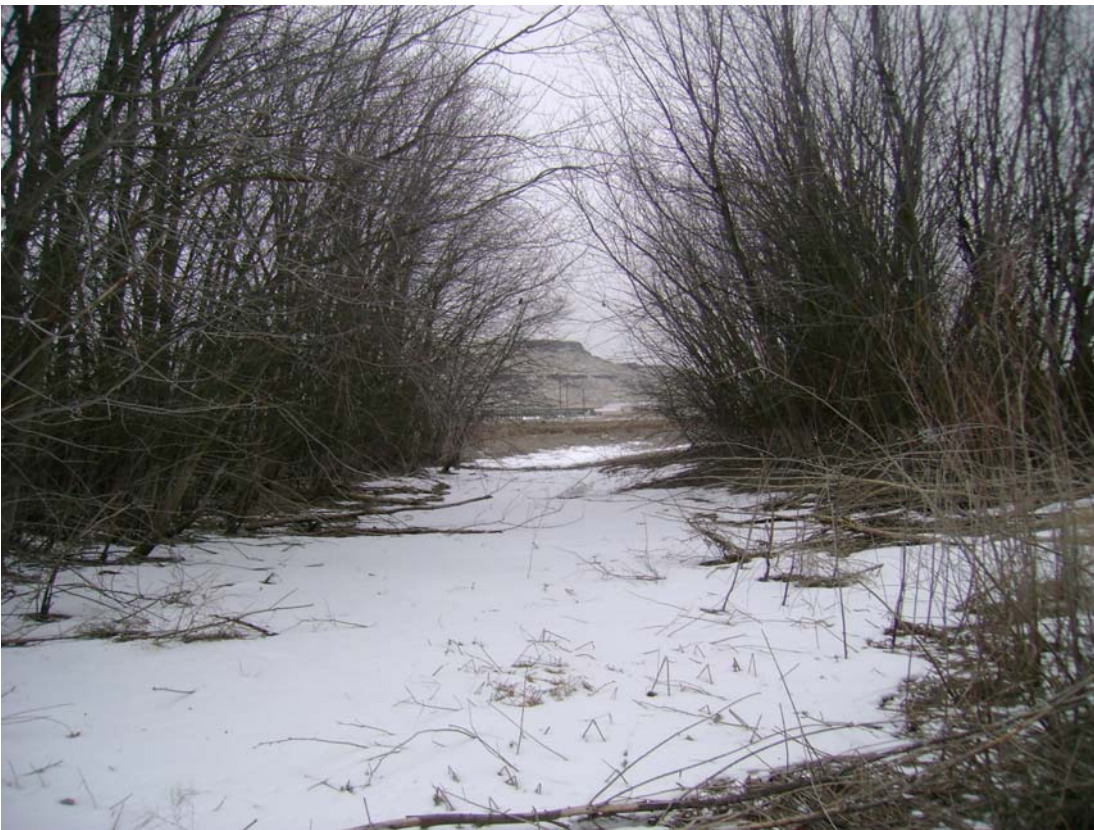
**FIGURE E-3**  
Sample photo of the channel and bank conditions just downstream of HWY 26 in Subreach 1A

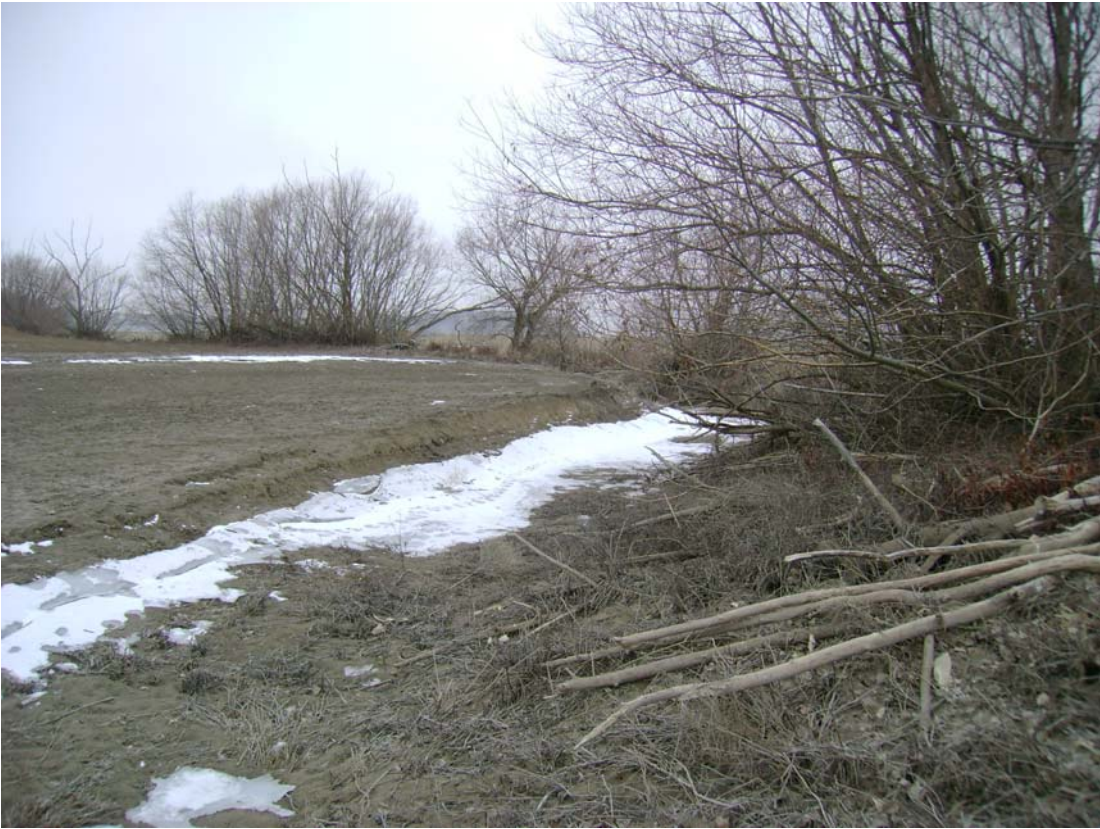
**FIGURE E-4**  
Sample photo documentation of channel and bank condition at transition from Subreach 1A to 1B

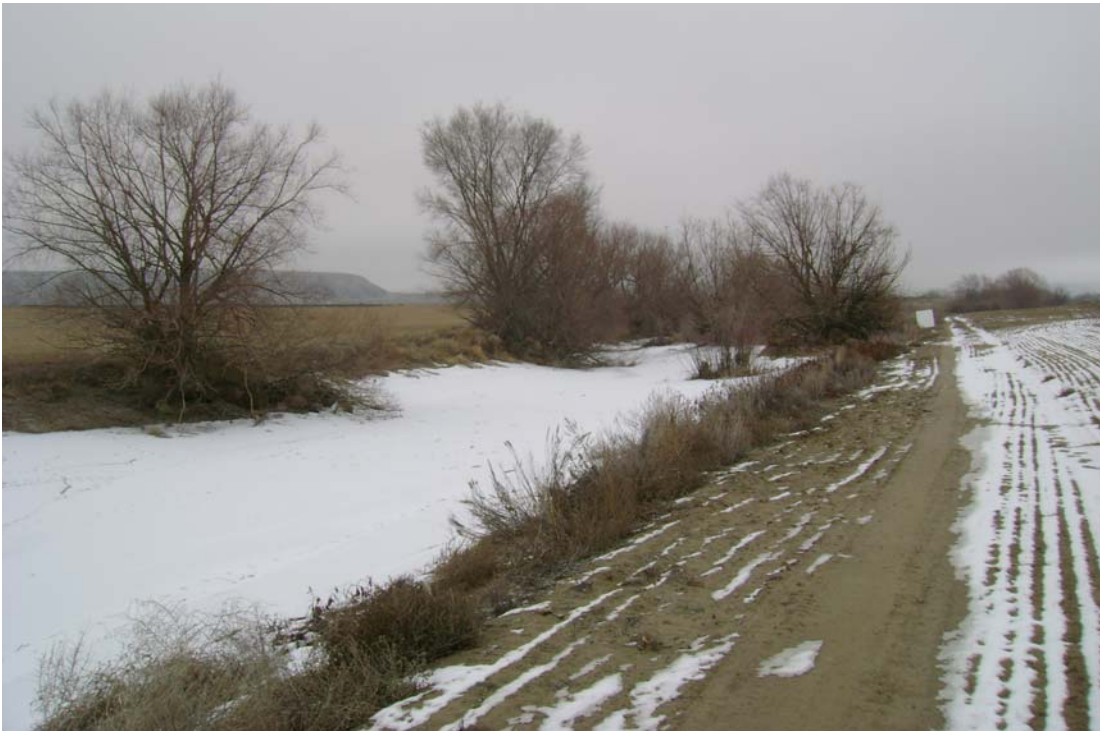
**FIGURE E-5**  
Sample photo of channel and bank condition in Reach 1C

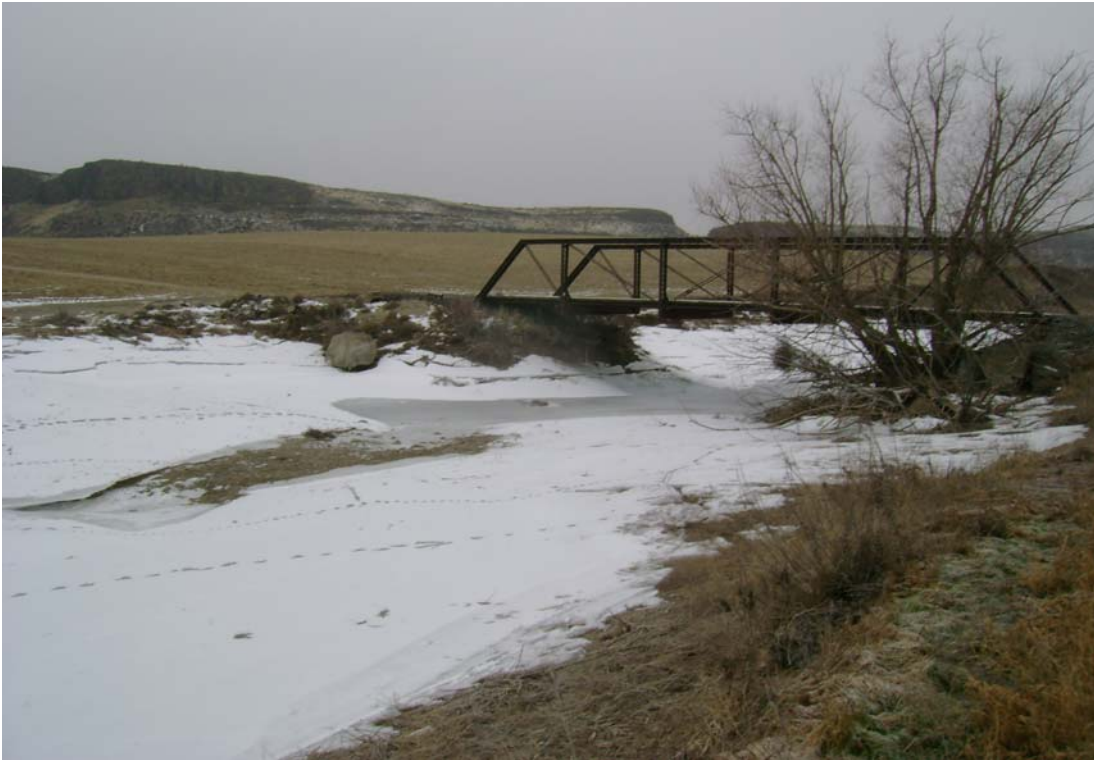
**FIGURE E-6**  
Sample photo documentation of bridge features and high water marks

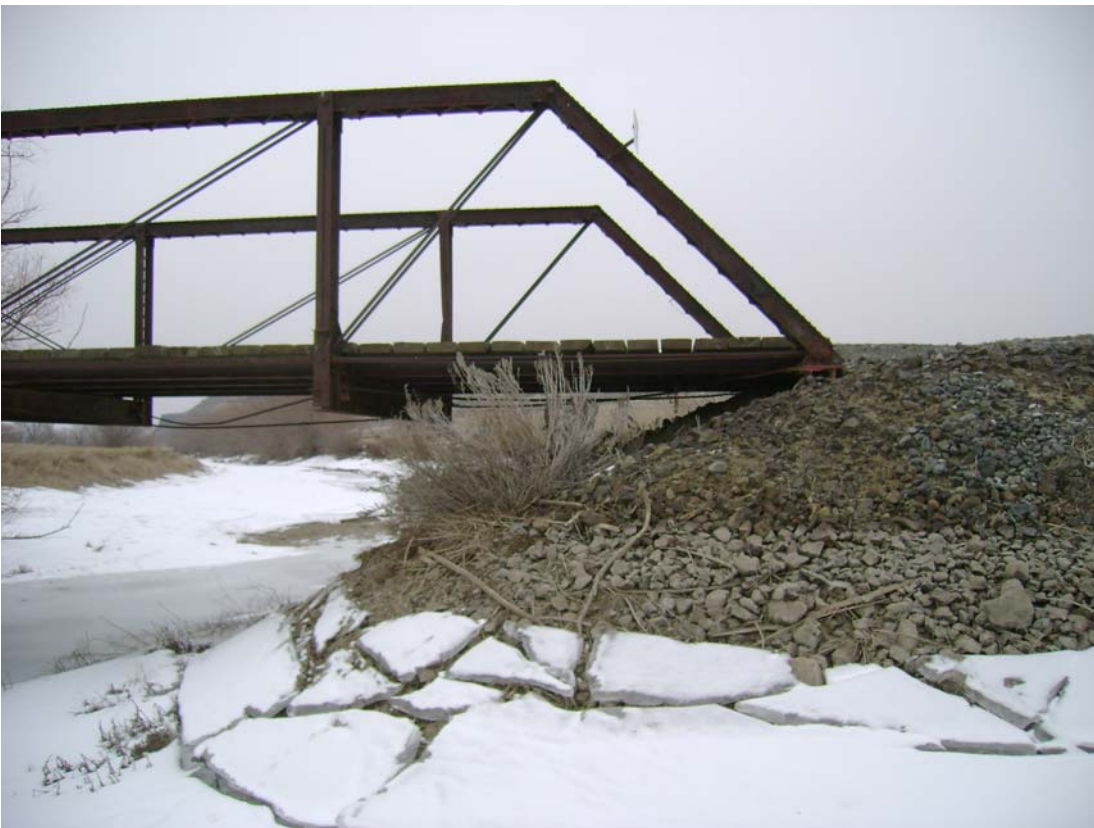
**FIGURE E-7**  
High water mark at the "Private Bridge"

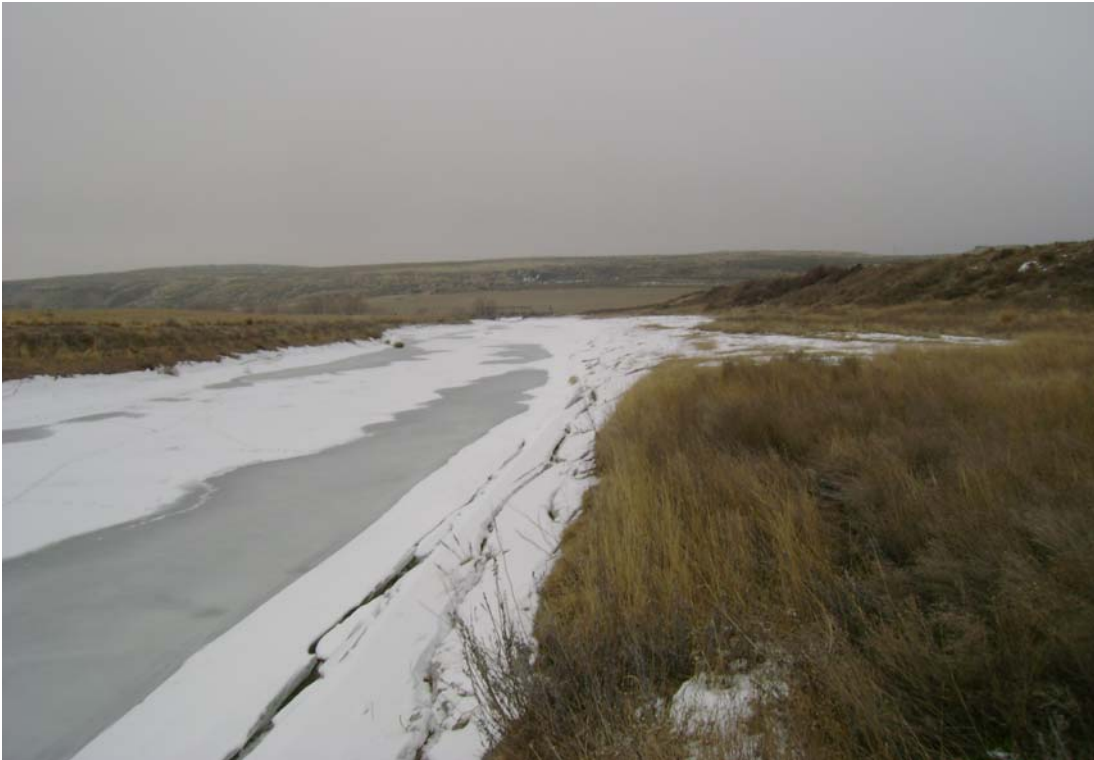
**FIGURE E-8**  
Example photo documenting bank and channel conditions in Reach 1C

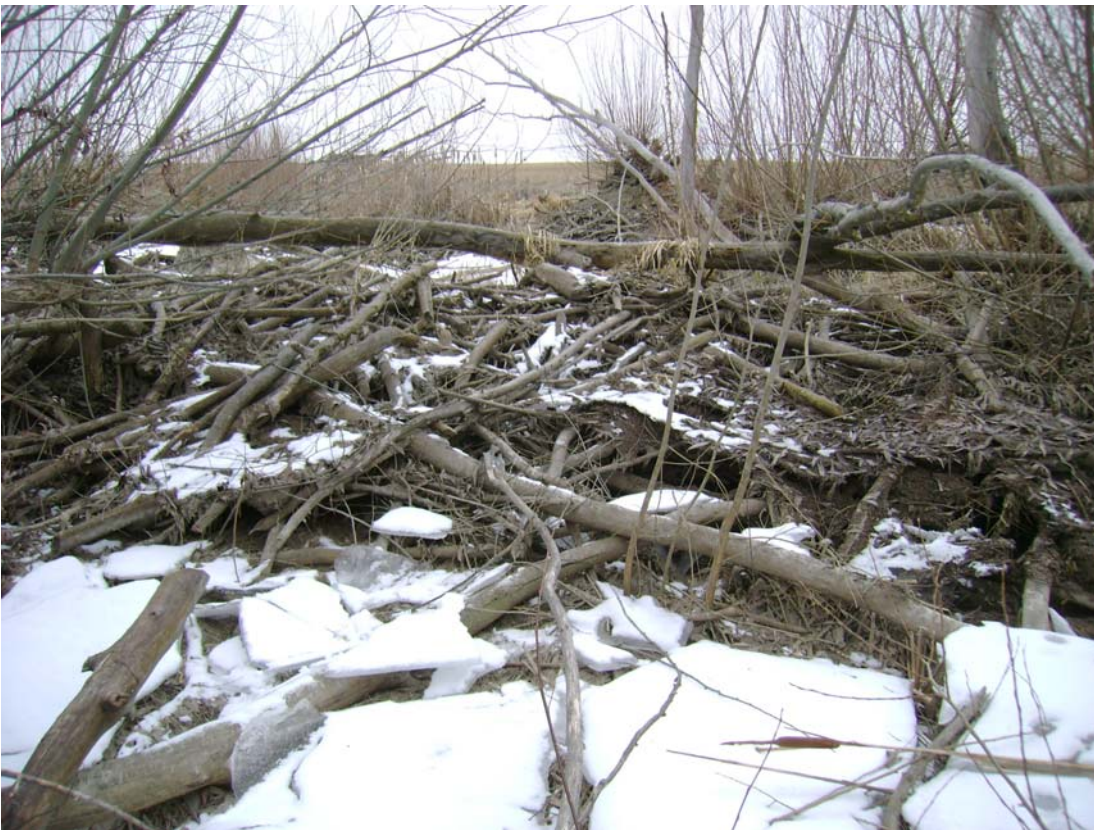
**FIGURE E-9**  
One of three beaver dams located in Subreach 1D

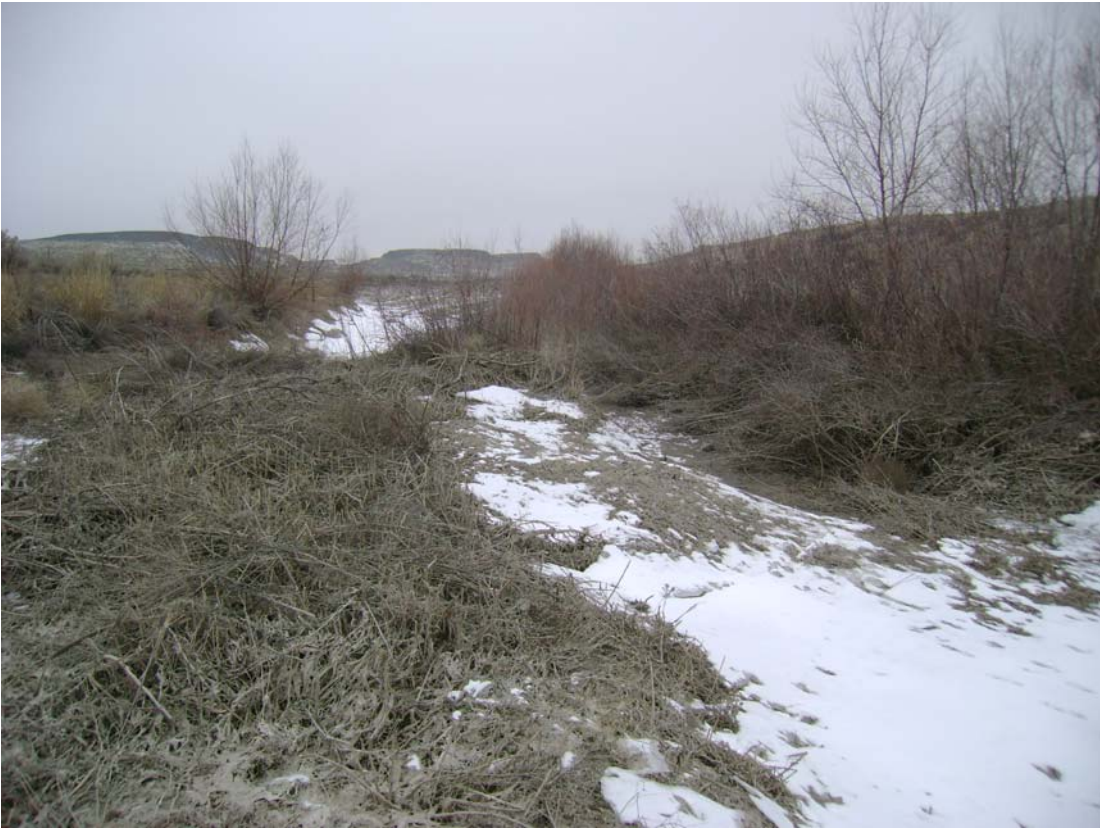
**FIGURE E-10**  
Heavy debris in the channel located in Subreach 1D

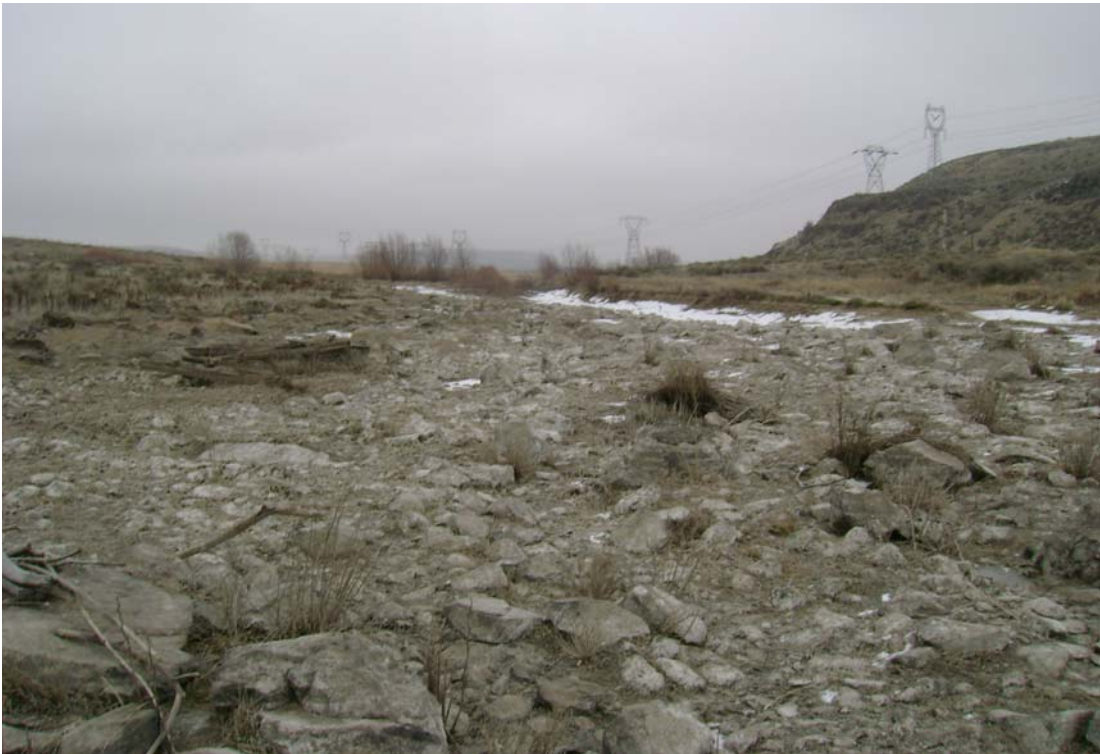
**FIGURE E-11**  
Bedrock encountered in Subreach 1E

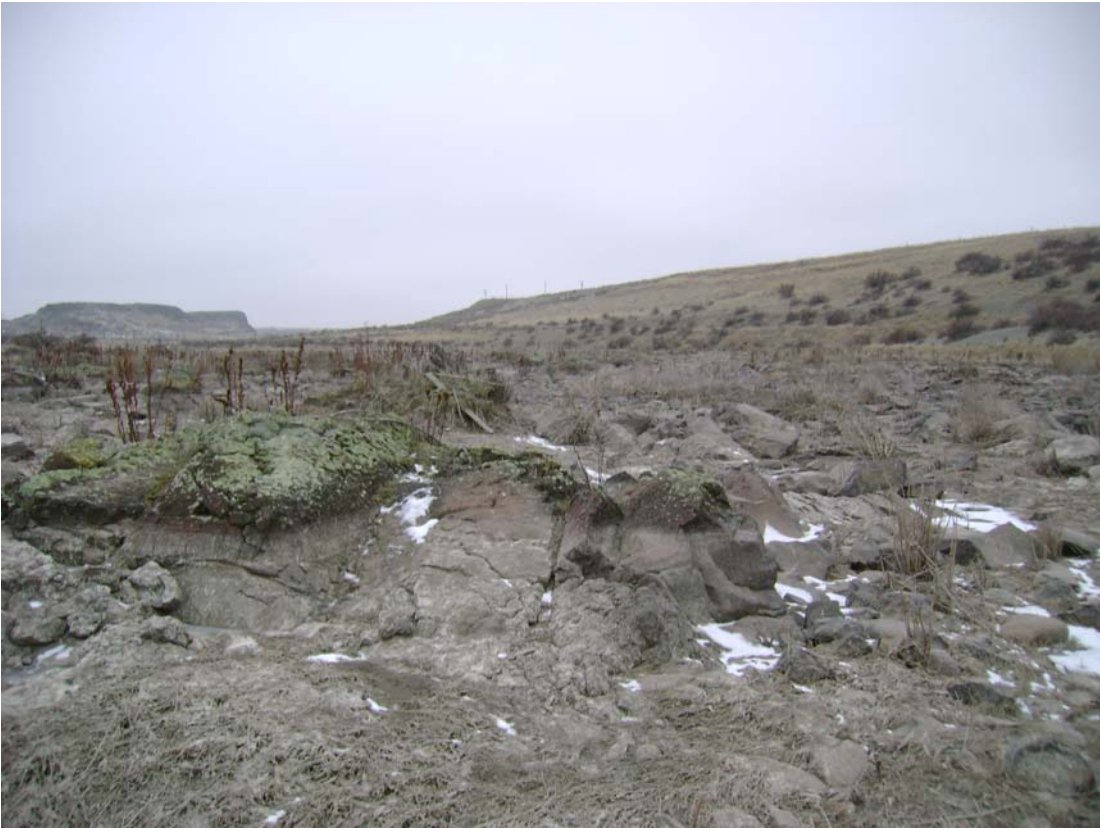
**FIGURE E-12**  
Bedrock outcrop in Subreach 1E
