R-00-01

**CANAL-LINING DEMONSTRATION PROJECT
2000 SUPPLEMENTAL REPORT**

January 2000

**U.S. DEPARTMENT OF THE INTERIOR
Bureau of Reclamation**

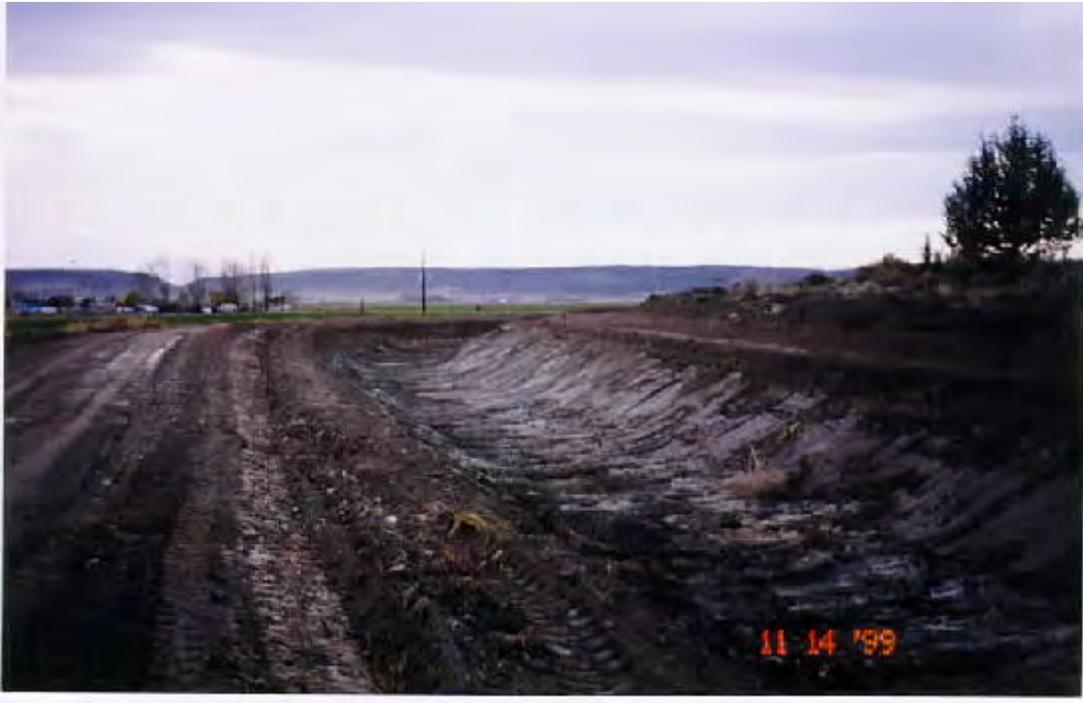
Photograph 1.—The Ochoco Irrigation District prepared the subgrade by removing vegetation, restoring the 1½:1 sideslopes, and cutting the V-notch anchor trench.

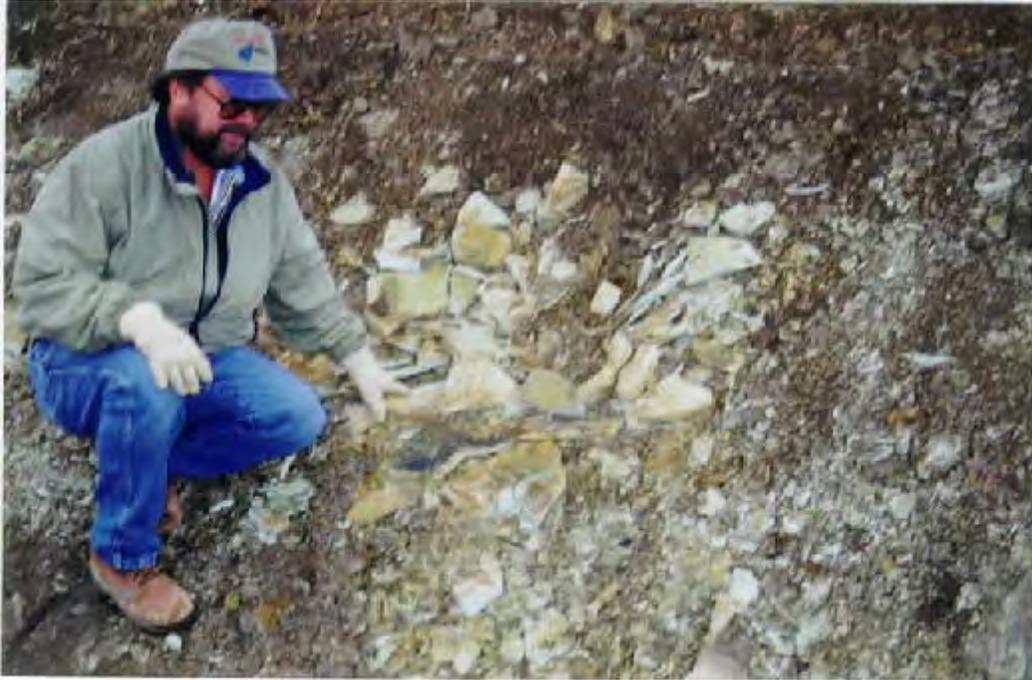
Photograph 3.—Deposits of Ochoco "Tuff" are most prevalent on the sideslopes.

Because of hard mineral deposits (locally referred to as Ochoco Tuff), the sideslopes were first covered with an 8-oz geotextile cushion, before lining the entire canal prism with the EPDM geomembrane (see Appendix B for discussion of local geology). The geotextile was installed by hand by a 4-man crew. The EPDM panels were then unrolled (by hand) along the canal access road for 200 feet. The 19-man crew then unfolded the panels into the canal prism to their full 50-ft width. The crew then pulled the panel up the far canal bank. After final positioning, the excess width (typically 5 to 8 feet) was trimmed and discarded. On canal bends, the panels were cut in half to 100-ft length. These half-size panels were much easier to handle and to fit to the canal. Adjacent panels were overlapped 6-12 inches, shingled downstream, and seamed with a special EPDM adhesive and tape provided by the membrane manufacturer. Finally, the EPDM membrane was secured by backfilling the anchor trench.

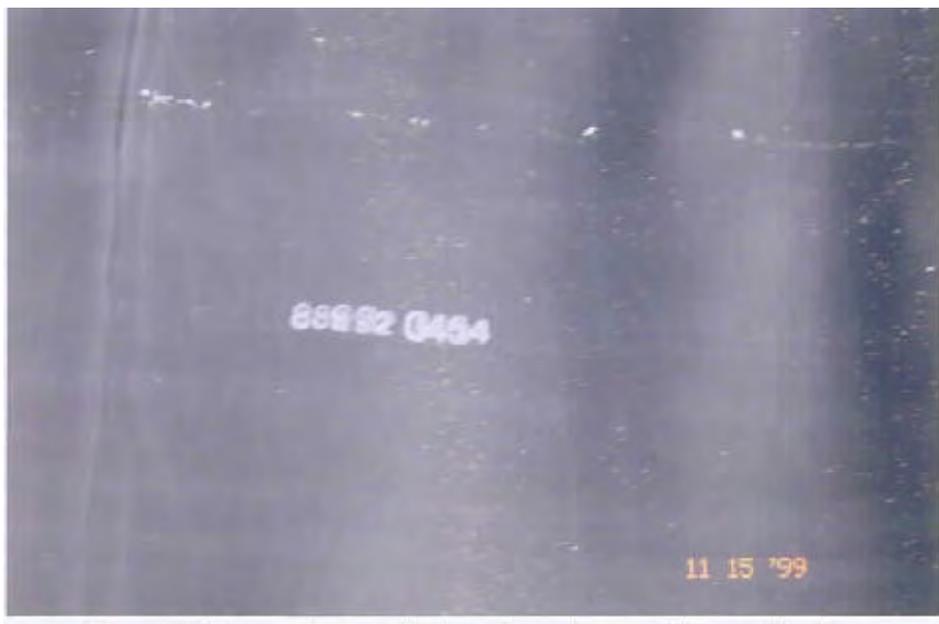
Photograph 16.—Lot numbers are printed onto the membrane at the factory. This roll was manufacturer the 88th day of 1999 (second shift). The liner thickness is 0.0454 inches.

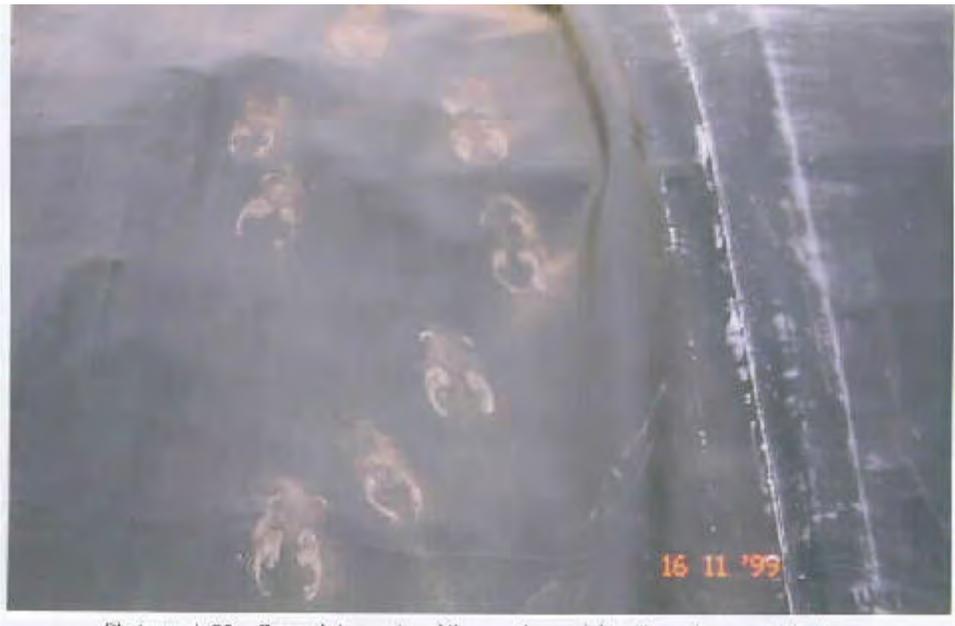
Photograph 20.—Several deer entered the canal overnight with no damage to the liner.
Also note the close-up of the vulcanized factory seam on the right.

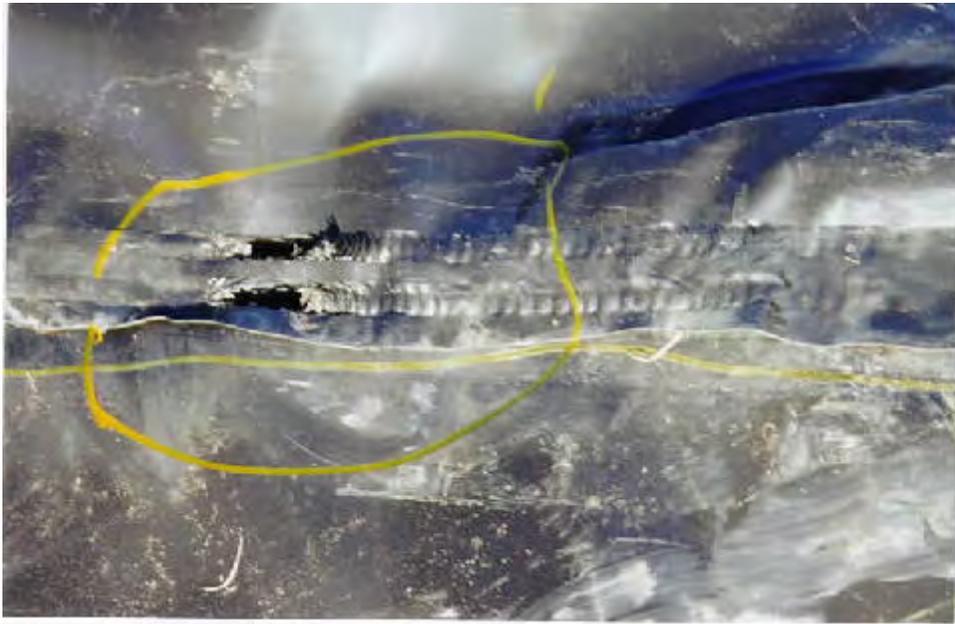
Difficulties: Deploying the first panel was quite challenging without the benefit of on-site technical support. A rainstorm during deployment of this first panel delayed final positioning until the next morning. Pumps were then needed to remove an inch of water that had accumulated on the liner overnight. Seaming was very slow because of the 1½:1 sideslopes and because of irregularities in the prepared subgrade. Also the 30-mil LLDPE is quite thin and therefore difficult to weld.

Photograph 10.—Damage to the 30-mil LLDPE caused by the wedge welder. Thicker liners are less easily damaged and easier to weld.

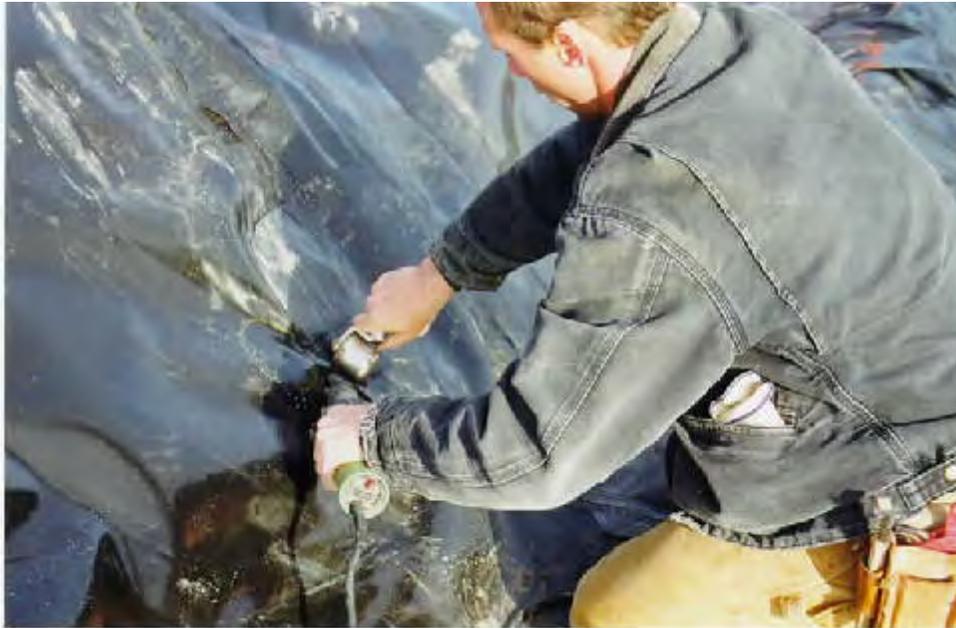
Photograph 11.—Welding technician patches the liner with hot-air welder.

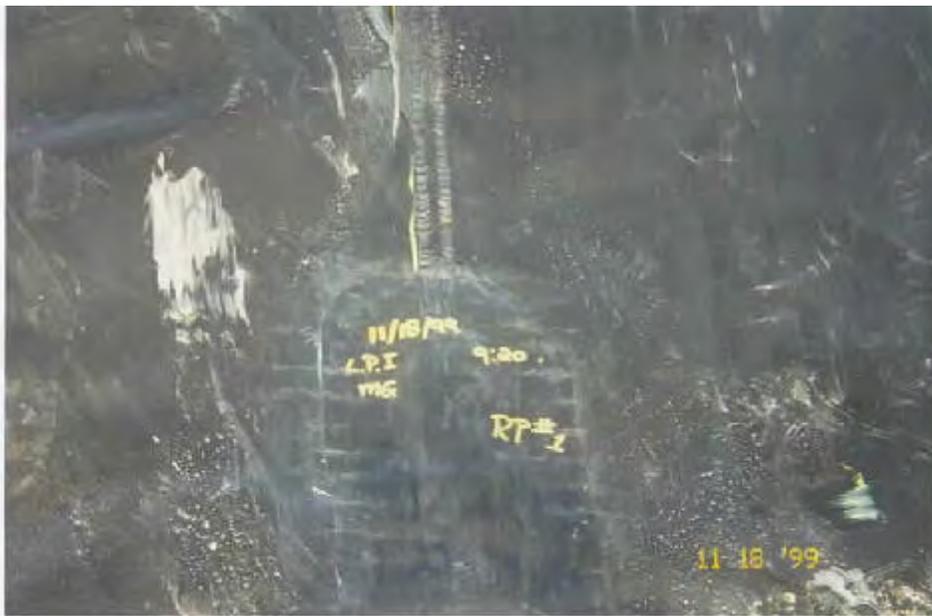
Photograph 12.—Finished patch is identified with date, time, liner manufacturer, technician initials, and patch number.

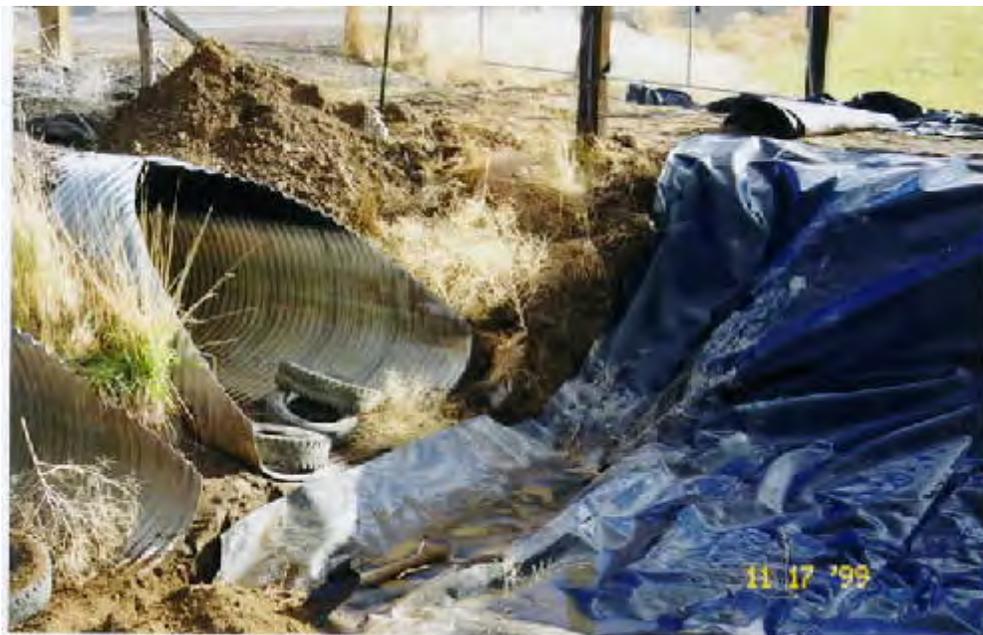
Photograph 16.—Membrane at the upstream transition is placed in a 3-ft cut-off trench to prevent water from getting under the liner.
