Research Update

S&T Program Project ID 2446
Bulletin 2017-13

Localized Saturation on Generator Neutral Current Transformers

Recreating a misoperation of a generator relay that was caused by localized current transformer saturation and identifying potential solutions

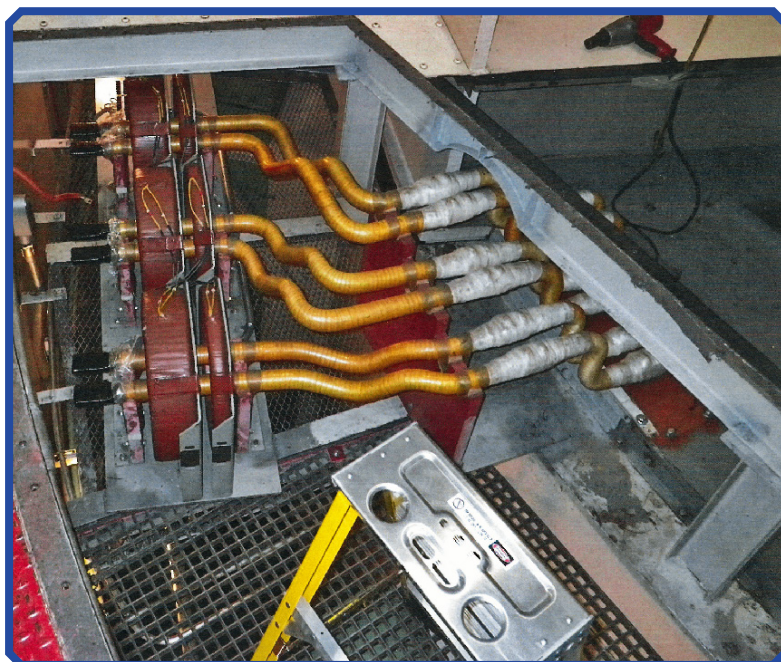
Analysis of the generator differential relay data showed that currents from the phase-B current transformers did not sum to zero. The waveform traces suggested an issue with the phase-B's neutral current transformer. Based on the physical orientation of the neutral bus connections, it was determined that the external magnetic flux generated by the fault current on the phase-A bus, the neutral shorting bar, and phase-C bus caused local saturation of the phase-B current transformer. The local saturation of the phase-B current transformer caused the current through the secondary leads to misrepresent the actual current flowing through the primary side. This misrepresentation, when summed with the phase-B generator terminal current transformer secondary current, created an operate current above the differential relay element operate point. This error unnecessarily tripped the generator offline.

Generator neutral current transformer leads.

The two identified potential solutions can be pursued in an effort to mitigate such erroneous trip situations. The first potential solution is to implement new high-security relay settings, which were recently developed for the microprocessor relay installed at the Schweitzer Engineering Laboratories. The second is to use current transformers that are designed to reject external flux for use on the generator's neutral bus.
