Qualitative Evaluation of Rock Weir Field Performance and Failure Mechanisms

U.S. Department of the Interior
Bureau of Reclamation
Technical Service Center
Denver, Colorado

September 2007

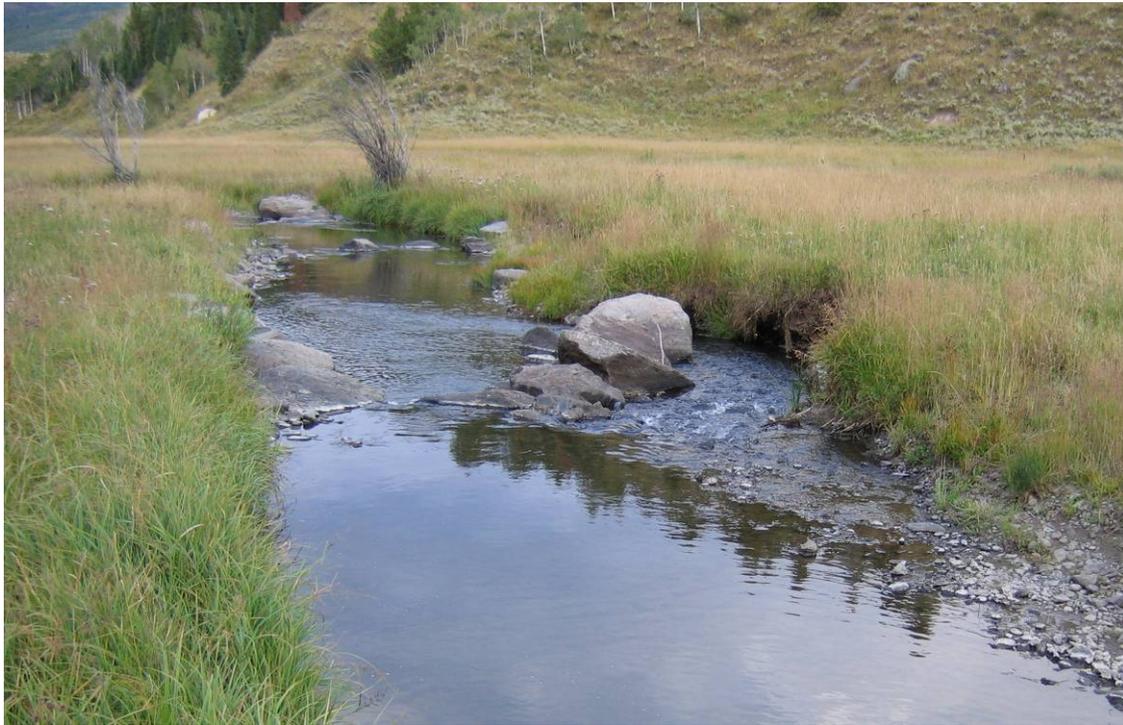
Maintaining a given water surface elevation difference across the structure is necessary for diversion purposes or for grade control. The elevation difference depends, in part, on flow rate. At high flows, the structure may become submerged and no longer alter water surface elevations (Figure 3). Site visits primarily occurred during low flow conditions and on structures designed to maintain a water surface elevation for irrigation diversions. Maintenance of a downstream pool provides depth diversity for habitat and entrance conditions for fish passage over a structure. Sedimentation filling the downstream pool can be deleterious to fish habitat and passage. Bank stabilization in the vicinity of the structure may be necessary for proper structure performance in addition to proper structure tie-in with the floodplain so that flow passing over the structure and the river do not flank it, as shown in Figure 4.

Figure 4. Example of Bank Disturbance. Little Snake River, CO.

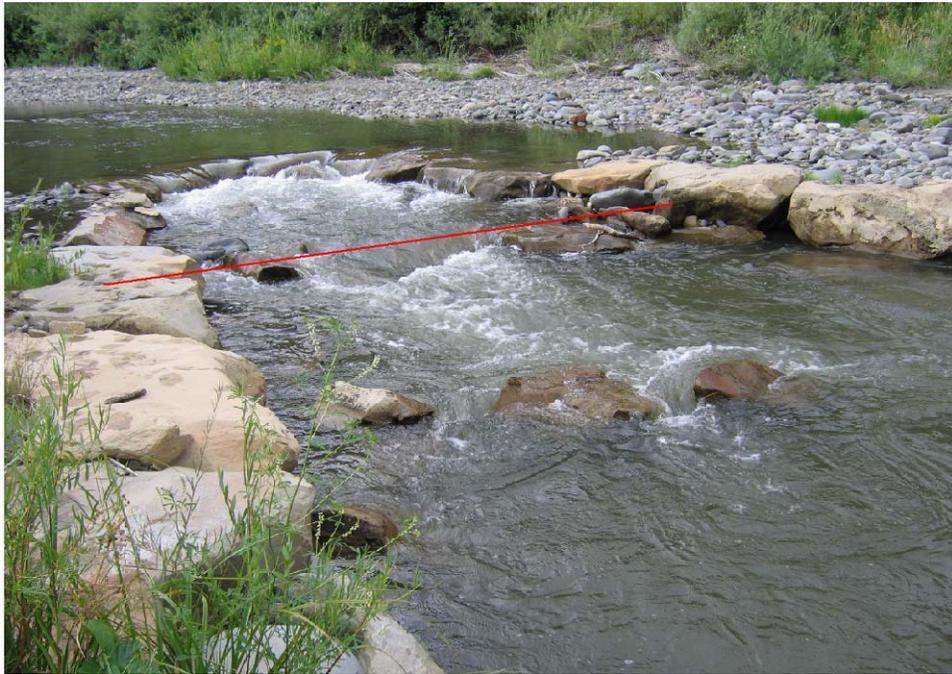
Most structures were visited during lower flow rates, conditions under which individual rocks were visible and the alignments were easily observed. Although the specific evaluation varied depending upon the type of structure, photographs of the plan and profile along the axis of each component could identify inconsistencies in alignment. Discontinuities were assumed to result from the movement of rocks. Figure 5 illustrates an example of discontinuity in structure alignment, in which some rocks appear to have become dislodged and moved downstream of their initial position in the cross bar.

Figure 5. Rocks Out of Alignment Example Photo Documentation. Rio Blanco, CO.

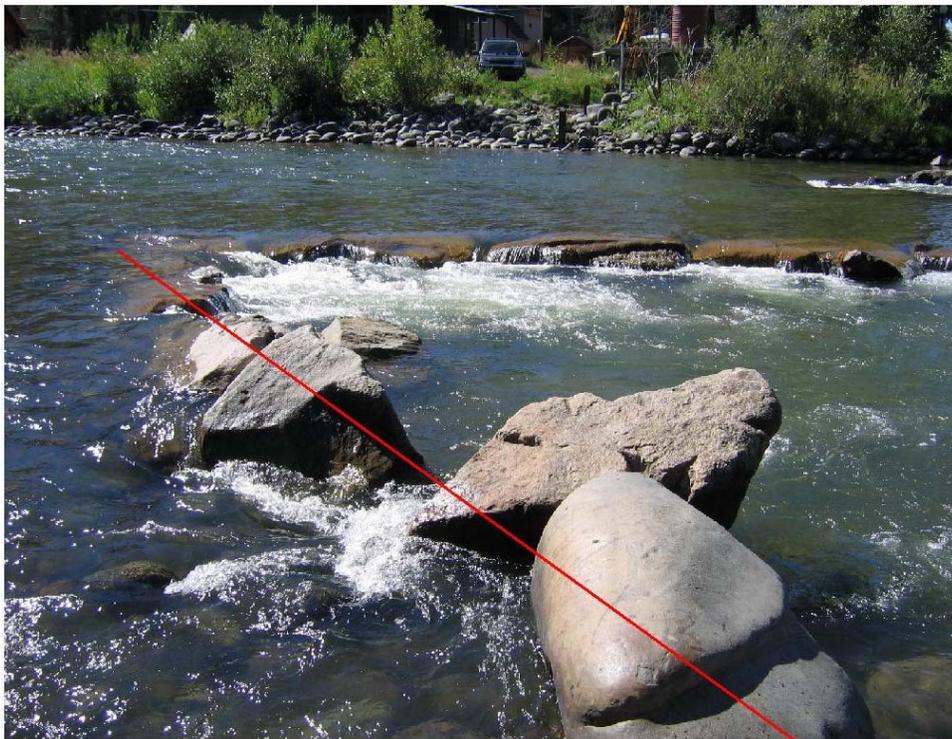
Most rock structures were intended to have a level crest. Tilting or turning was assumed to indicate motion. Figure 6 shows an example of photo documentation of tilted and rotated rocks.

Figure 6. Tilted/Rotated Rocks Example Photo Documentation, San Juan River, CO.

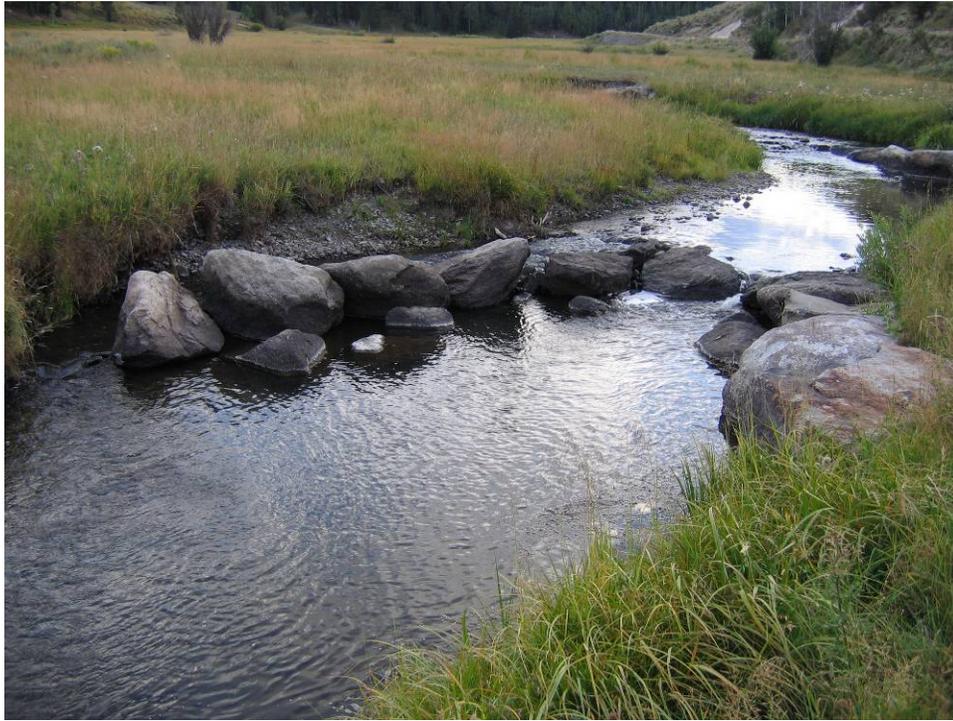
Structures were assumed to be constructed in contact with the bank. Therefore, gaps between banks and arms might indicate motion or piping processes. Figure 7 demonstrates an example of rocks appearing separated from the bank.

Figure 7. Structure without a tie-in showing flanking around the right arm. Little Snake River, CO.

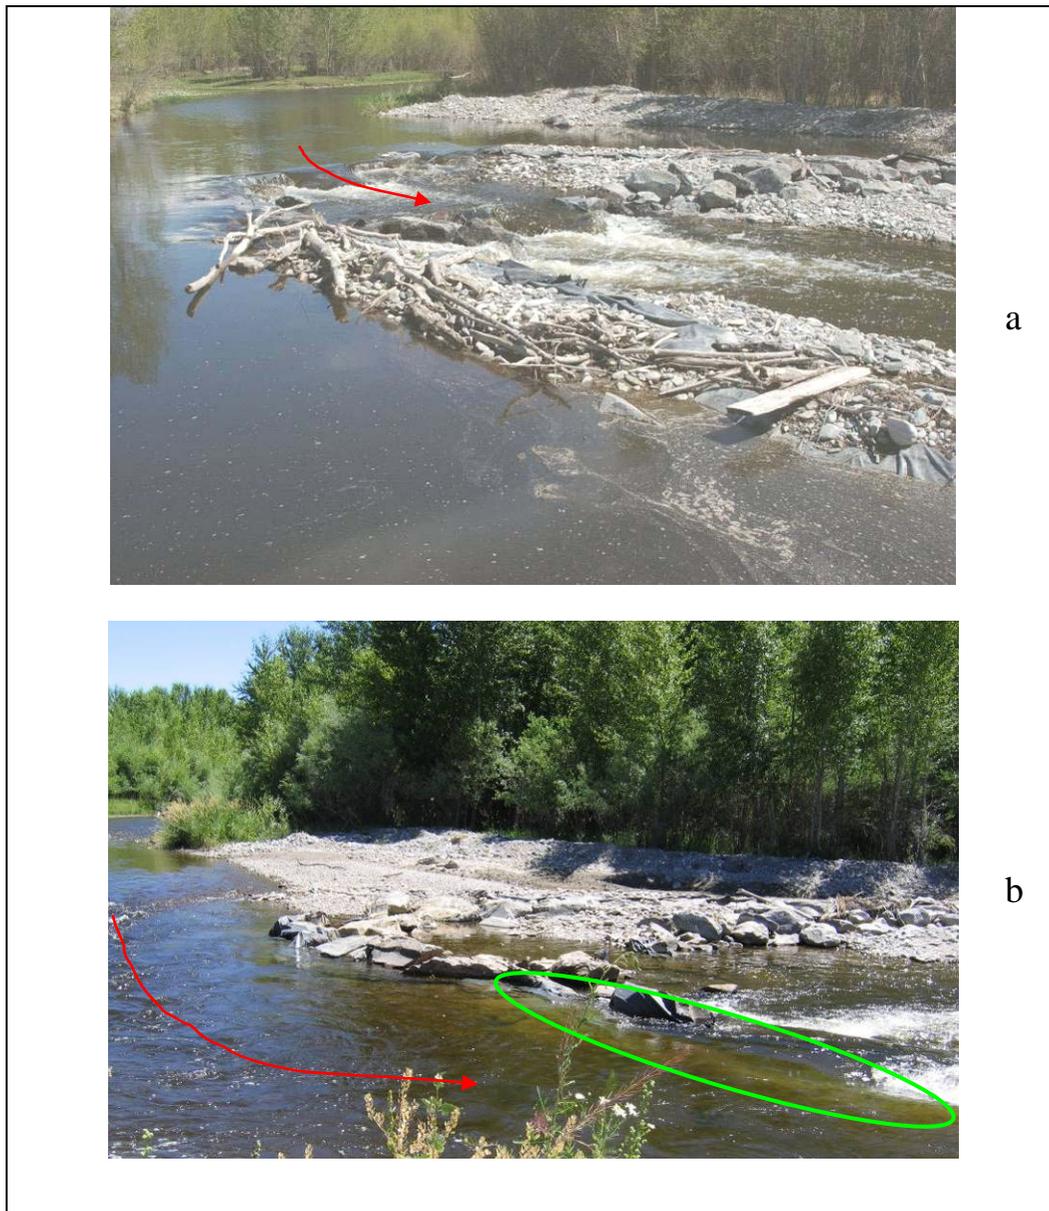
Figure 16. Lemhi River, ID a) before failure versus b) after right arm failure.

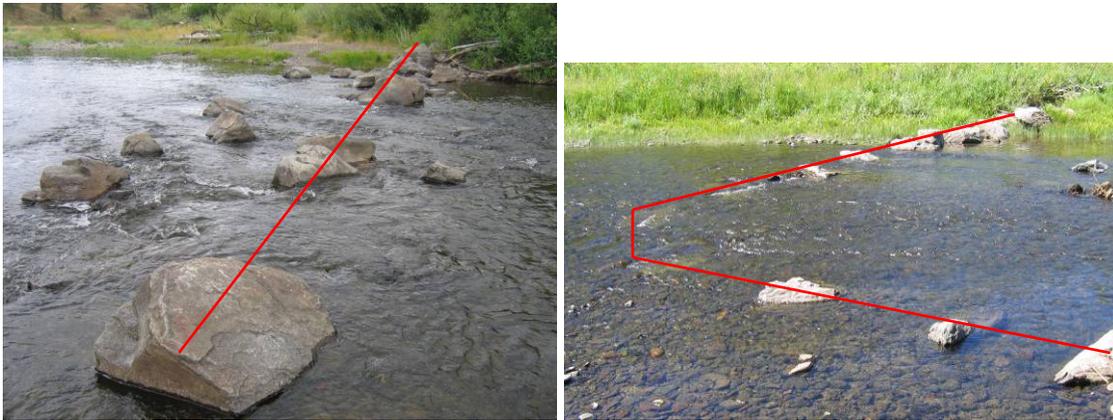
Rio Blanco and San Juan River weir rocks were placed tight together forming an interlocking arch. Little Snake River rocks varied from tight interlocking formations to large voids between crest rocks. Structures with small voids (meaning a gap less than approximately 1 foot) between the header rocks did not appear to fail any more frequently than structures with interlocking rocks. On the Little Snake River, fish frequently ran up the voids between rocks. Structures with large voids between the header rocks (meaning a gap greater than approximately 1 foot) appeared to fail more frequently than structures with small voids or no gaps at all. Failures of structures with large voids were observed to include filling and burying (Figure 18b) and movement of the headers downstream (Figure 18a).

Figure 18. Failure of structures with large voids between header rocks. Grande Ronde River, OR.

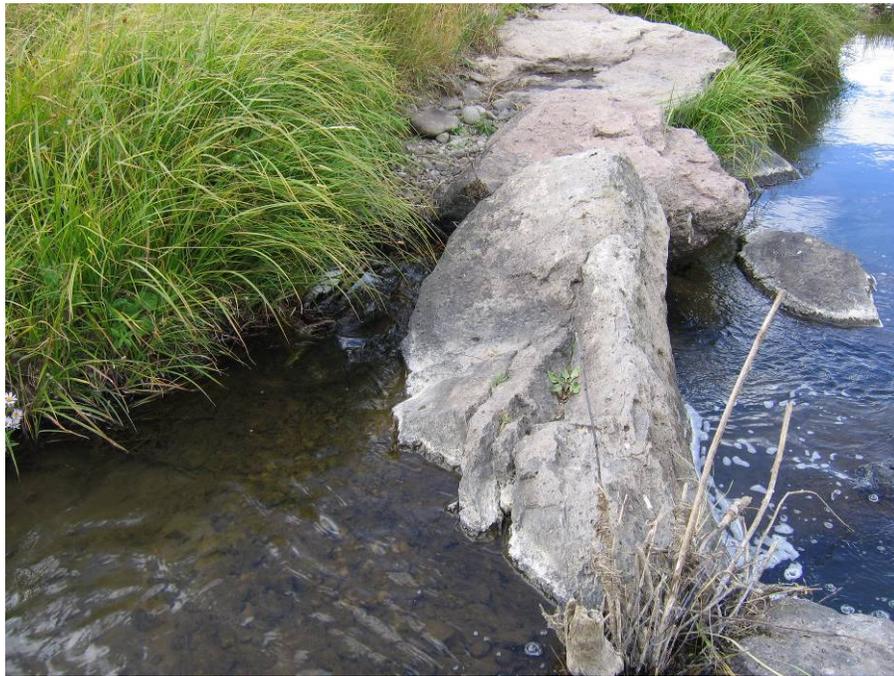
The most common failure mechanism identified was the growth of the scour pool and undermining of the footer rocks. During high flow events, increased flow velocity and depth over the crest transports material out of the scour pool, removing support for the footer rocks during a period of increased pressure and momentum transfer from upstream flow. As the scour pool grows, the footer becomes geotechnically unstable and slumps. The footer and supported header either tips upstream as in a rotational failure (Figure 22) or rolls downstream toward the scour pool (Figure 23). Observed pool depths during low flows, however may not represent the maximum depth of scour or the scour depth that resulted in failure during higher flows. During the receding limb of the hydrograph, deposition in the scour pool may refill material removed during the ascending limb.

Figure 22. Footer pushed out, header tilted upstream. Little Snake River, CO.

Evidence for the growth of the scour pool and undermining of the footer rocks includes header-footer groupings in odd alignments, footers pushed into the pool and out of contact with headers, and repositioning of original header rock locations. Many scour pools contained isolated rocks that appeared to originate from footers that have slumped into the scour hole, or headers that have fallen in after the footer shifts. Some of the rocks observed within the scour pool may actually have been placed intentionally to provide refugia and pocket-pool habitat. The determination of rock origin considered original construction plans, the distance from the crest, and correlation between gaps in the crest and size of the isolated rocks.

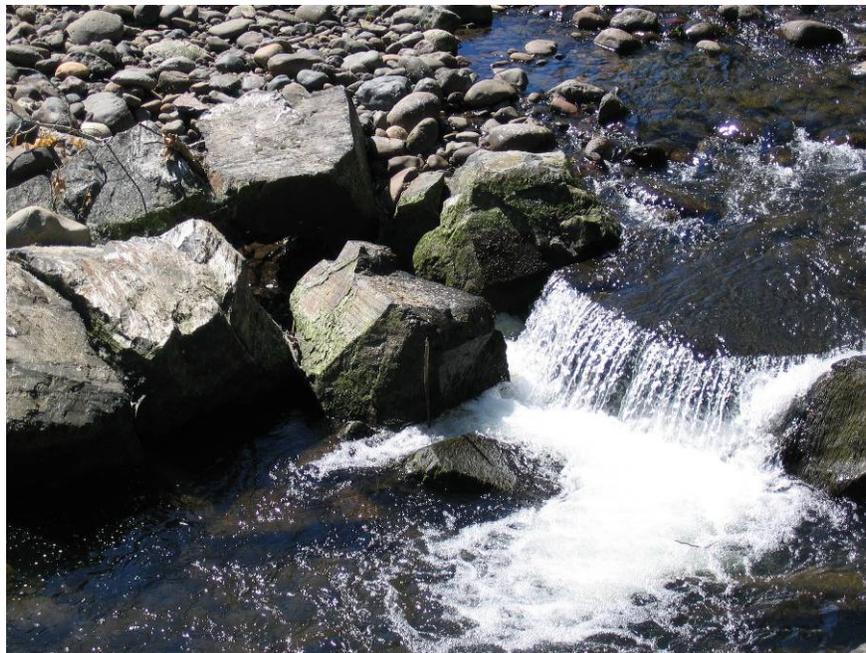
Figure 23. Footer shifted, header tilted downstream. Bear Creek, OR

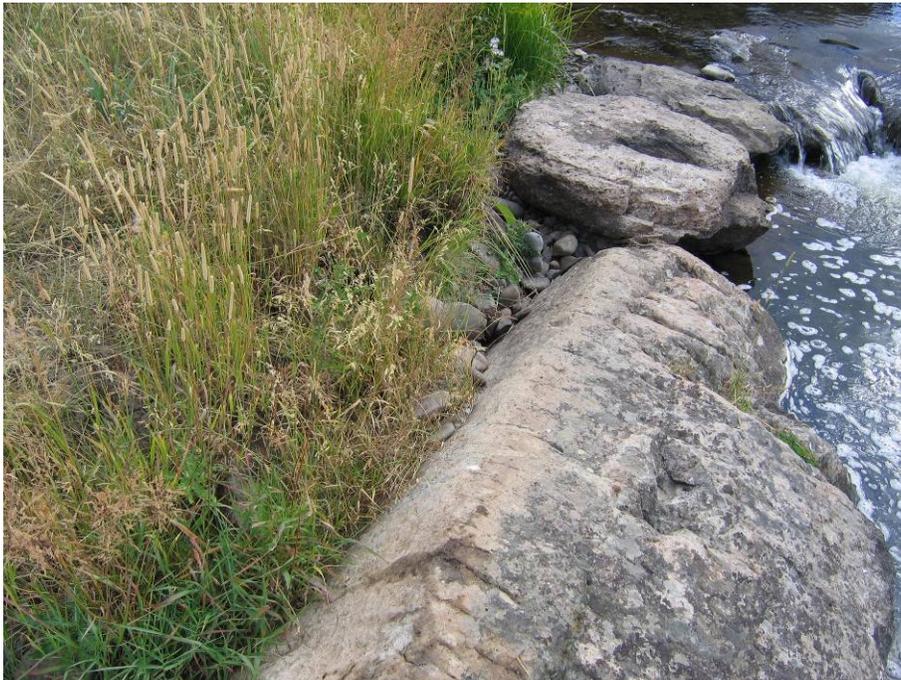
On the end of the arms, the tie-in was occasionally seen to be pulled away from the bank, and in some cases flanking was evident. Figure 24 shows an example where dislodging of the footer rock caused the header to shift away from the bank. Sloping of the arms upwards toward the bank causes the footers supporting the arms to have shallower foundations than the throat. Therefore, a lesser amount of scour is required to undercut footer rocks along the arms than those under the throat.

Figure 24. Header/footer pulled away from bank. Little Snake River, CO.

Most of the failures due to scour pool growth occurred when footer rocks along the arms became dislodged, typically located one-half to two-thirds of the distance from the crest throat to the bank tie-in. Failures are hypothesized to occur most frequently at these location due to (1) the depth of the footer rocks relative to the depth of the scour pool, and (2) the amount of drop over the structure at these locations. Under high flow conditions, the greatest drop over the structures occurs along the structure arms due to sloping toward the bank. The location where the drop height and flow rates combine to create the greatest energy for scour appears to be correlated with scour pool depth and failure location. Additional investigation through physical and numerical modeling may provide supporting evidence for these statements.

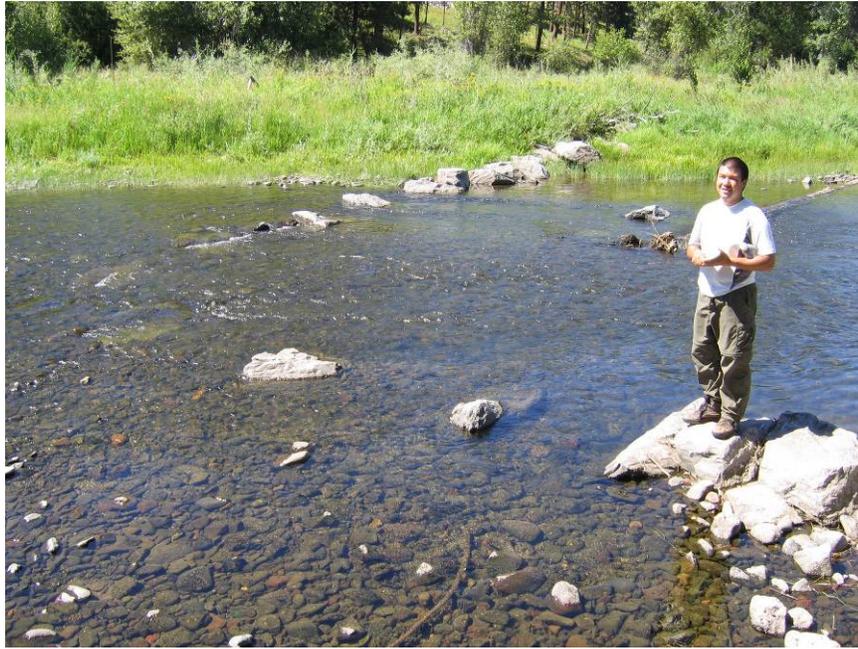
While still in place, several structures were seen to be buried by sediment and no longer maintain scour pools or drop. Figure 25 illustrates an example in which a structure was designed for the purpose of creating pool habitat and was subsequently buried due to high sediment load. Based upon fish habitat criteria, the structure has failed.

Figure 25. Structure has completely filled in with sediment. Grande Ronde River, OR

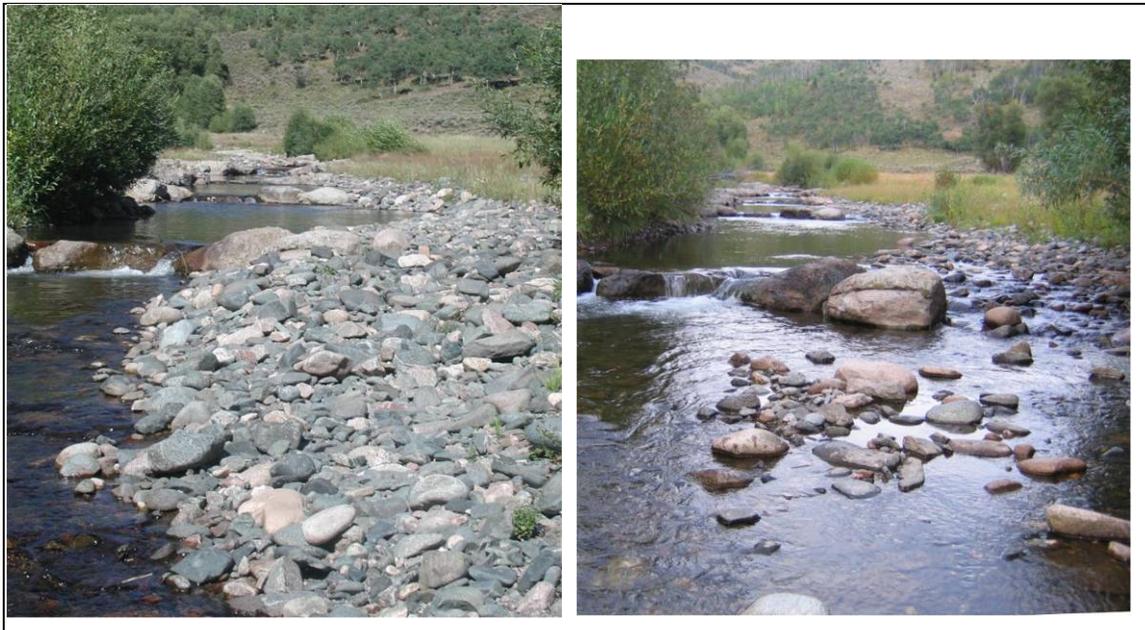
Structure tie-in appeared to be an important factor in the success or failure of many of the structures investigated. Lack of a sufficient tie-in to the bank frequently instigated the development of a flow path between the arm of the structure and the bank, resulting in major scour of bank material during high flow events. Downstream migration of point bars were also noted to cause flanking around a structure, particularly if the structure was not adequately tied into the bank. Figure 26 is an example of a structure that appeared to fail as a result of the left arm not being tied-in to the top bank. Instead, the arm was tied-in to the point bar, and higher flows were able to transport bar material downstream resulting in the failure of the structure.

Figure 26. Structure tie-in and flanking. Little Snake River, CO.

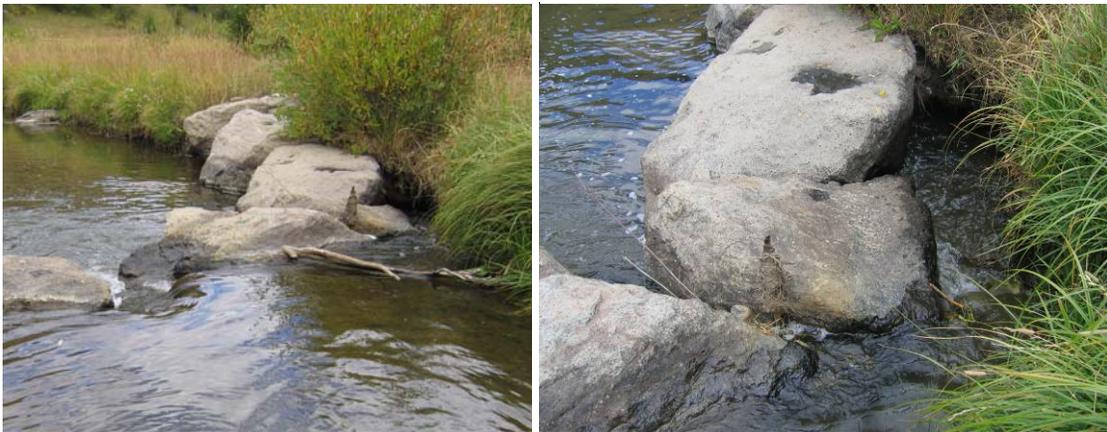
The piping failure mechanism was distinguished from general bank migration/ flanking by evidence of the processes responsible for failure and by the scale of the flanking. Structures that completely or partially failed as a result of general bank migration/ flanking typically coincided with lateral channel migration, bar migration, or lack of structure tie-in, which caused considerable flanking around the structure. Structures hypothesized to have failed from piping through the arm showed evidence of substantial seepage between the header rocks or between the header rocks and the bank, which resulted in localized erosion (Figure 27). Piping between the header rocks and the bank may act as a preliminary process for future general bank migration/ flanking. Future monitoring is recommended at those sites where this mechanism was hypothesized to observe future trends in channel adjustment.

Figure 27. Piping through the Arm Resulting in Flanking. Little Snake River, CO.
