Technical Memorandum No. MERL-2014-67

## **Foul Release Coatings Scale-Up Testing – Parker Dam Trashrack: Fiscal Year 2014 Report**

U.S. Department of the Interior  
Bureau of Reclamation  
Technical Service Center  
Denver, Colorado

July 2014

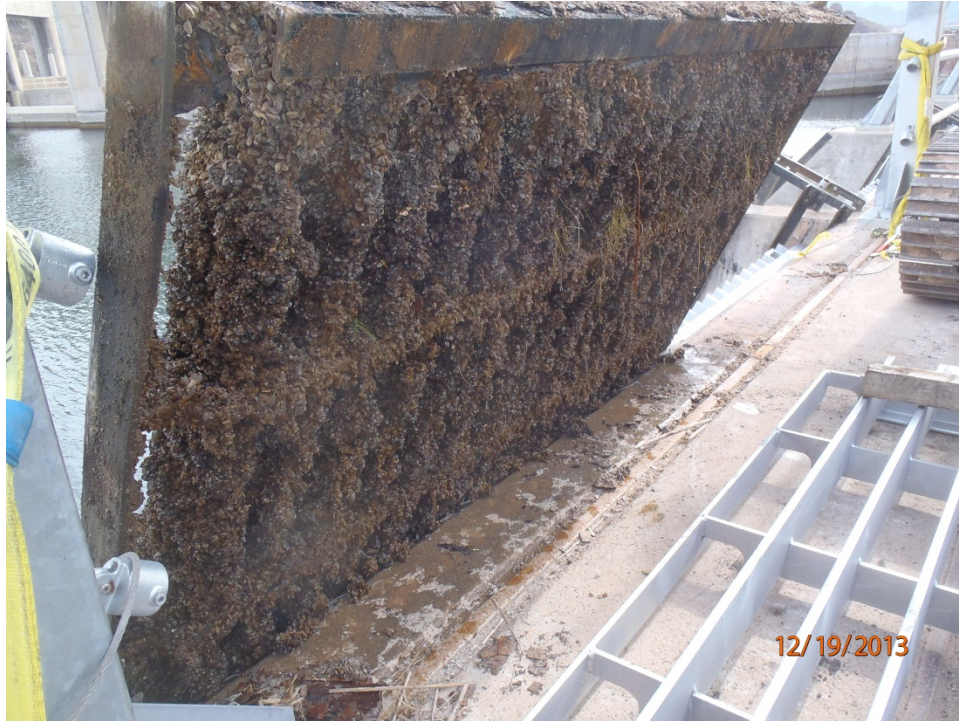
The experimental trashrack installation was completed on December 19, 2013. It was installed in Bay 9 right side (facing downstream). There were no problems extracting the existing trashrack, and it appeared to be in good condition, with no major rusting. Note that despite the presence of an automated trash rake, significant mussel buildup was present on the existing panel (figures 1–3). Figures 4–6 show the rack being installed in Bay 9.

Figure 1.—Existing trashrack heavily fouled with quagga mussels.

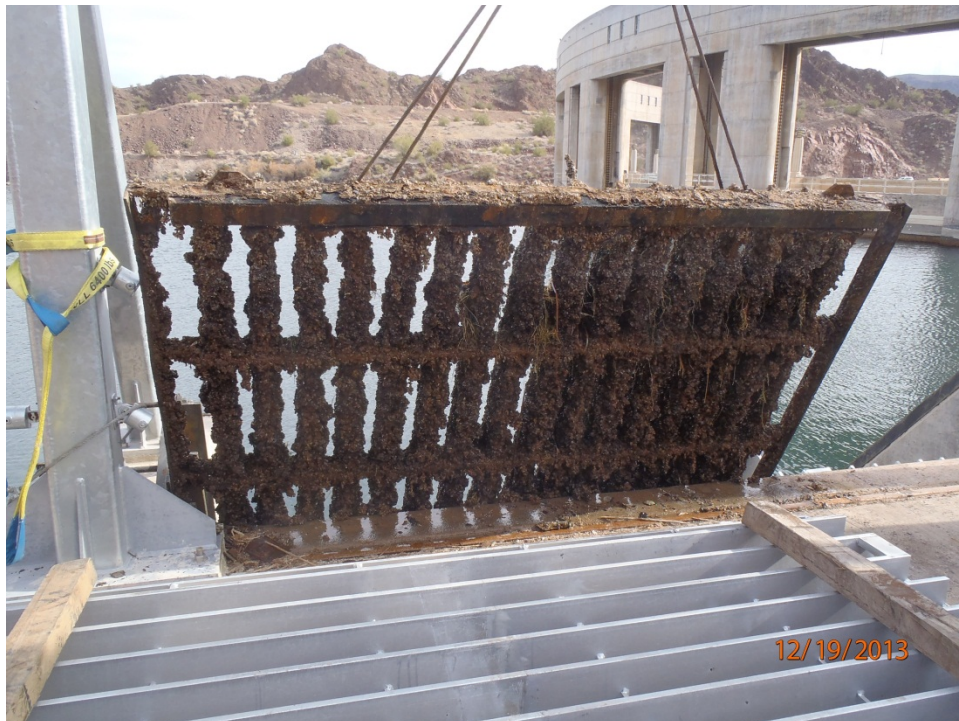
Figure 2.—Existing trashrack, view looking east.

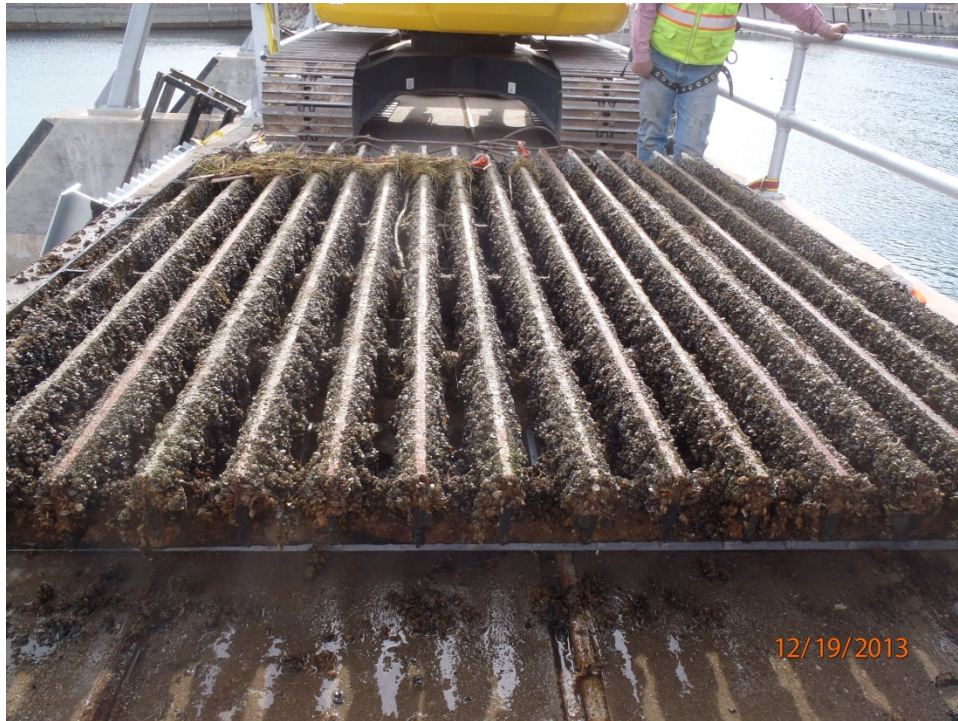
Figure 3.—Existing trashrack, view looking south on trashrack structure.

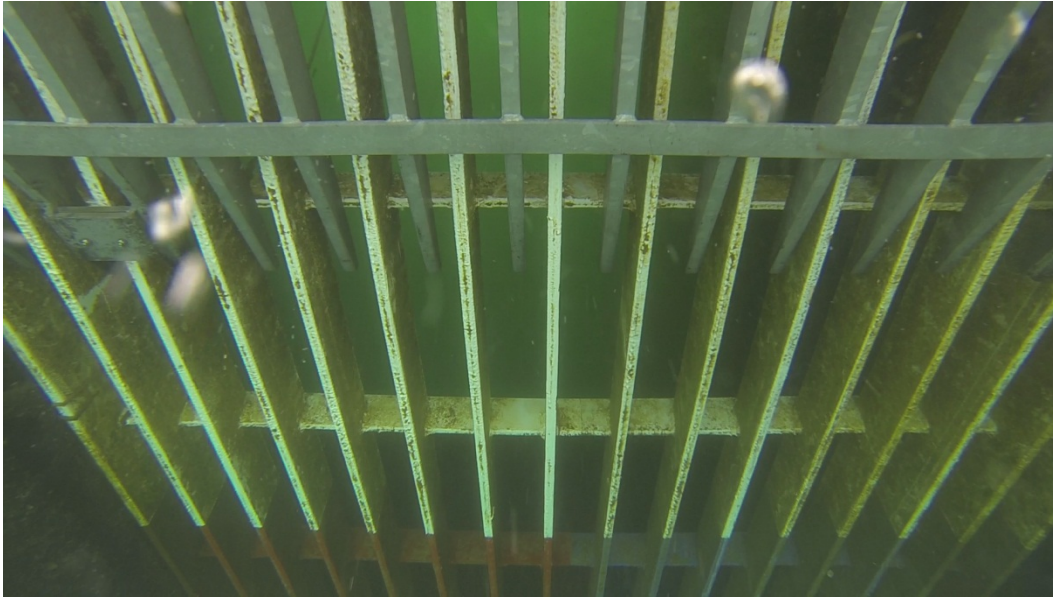
Figures 8–13 are still images captured from the GoPro video recording. Note that there has been little to no mussel settlement on the new galvanized trashrack panel above the foul release panel. Furthermore, examination of the stainless steel “control” surfaces suspended from the downstream side of the trashrack assembly revealed that very little mussel settlement/fouling has occurred since the last examination in December 2013. Low spawning rates are typical during the cooler months at Lake Havasu. Note that existing mussel settlement remains intact during the off-season (figure 14), so the total biomass from fouling tends to accumulate, barring any mitigating factors.

Figure 8.—Video still captured from May 2014 inspection—white International Intersleek 970 (left), white Fuji Sher-Release (right).

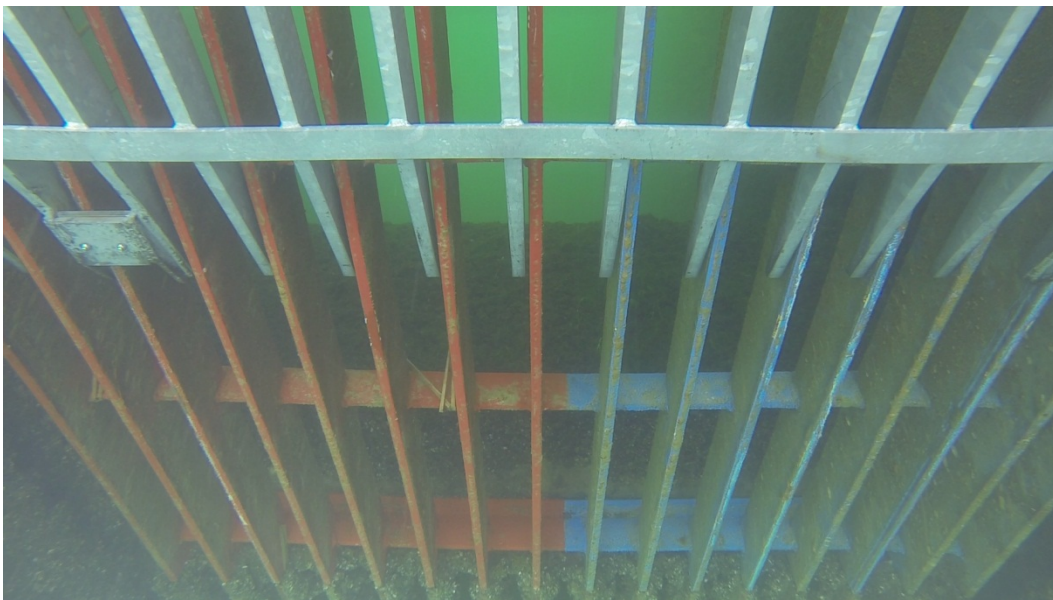
Figure 9.—Video still captured from May 2014 inspection—red PPG Sigmaglide 890 (left), blue Seacoat Seaspeed V5 (right).

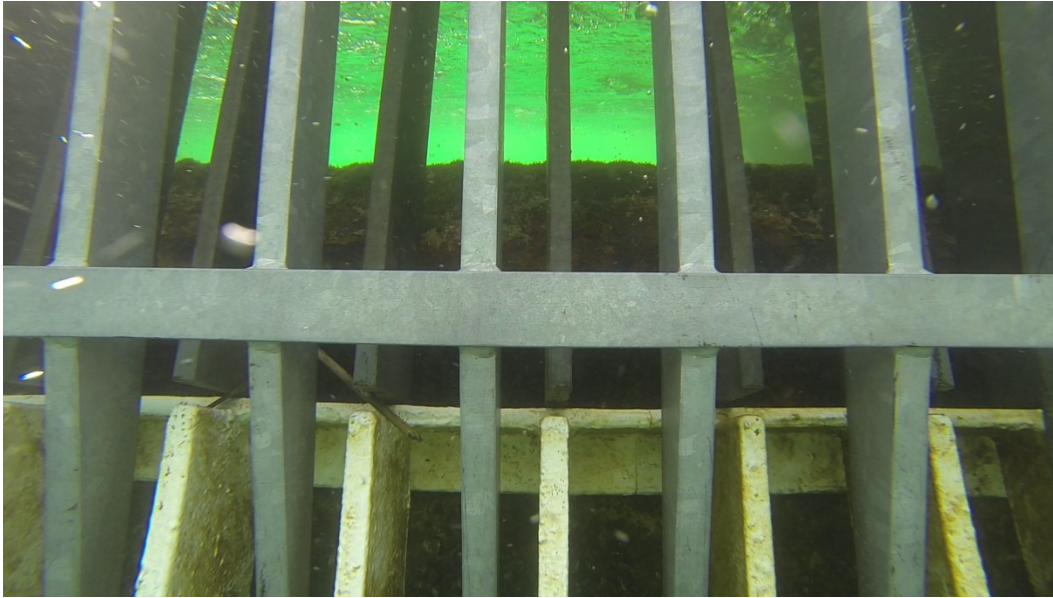
Figure 10.—Video still captured from May 2014 inspection—new galvanized panels (top), experimental foul release panel (bottom), and galvanized bars of automated trashrack cleaning system (foreground).

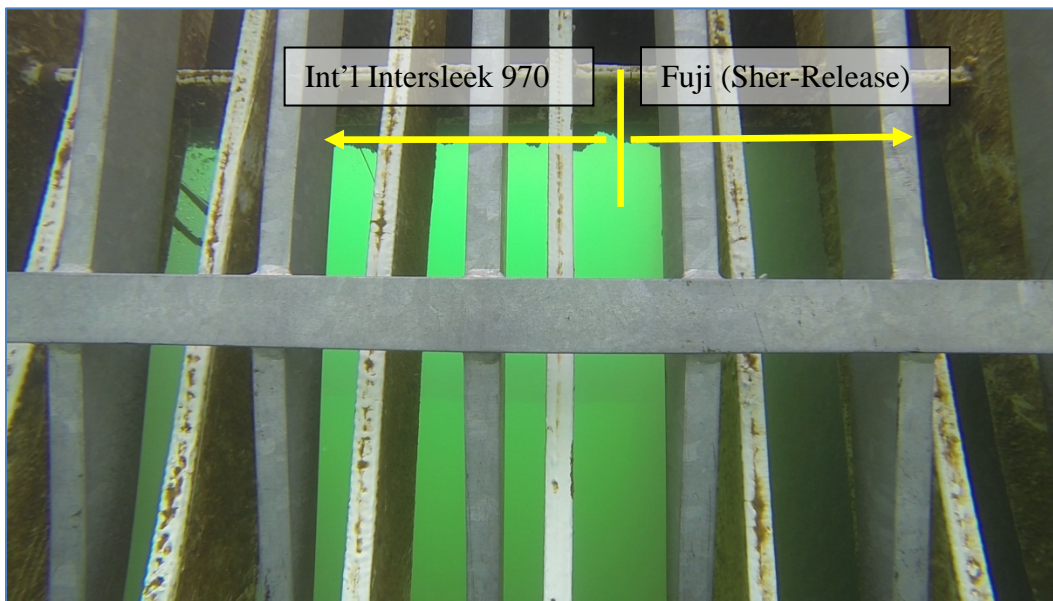
Figure 11.—Front face of the foul release panels—International Intersleek 970 (left), Fuji Sher-Release (right).

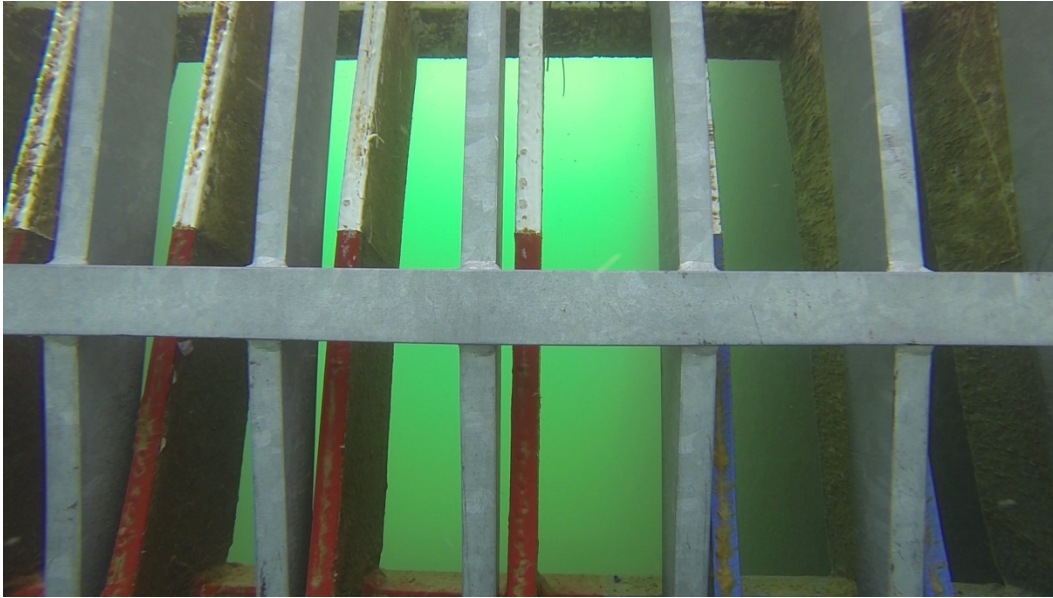
Figure 12.—Front face of the foul release panels—International Intersleek 970 (upper left), Fuji Sher-Release (upper right), red PPG Sigmaglide 890 (lower left), and blue Seacoat Seaspeed V5 (lower right).

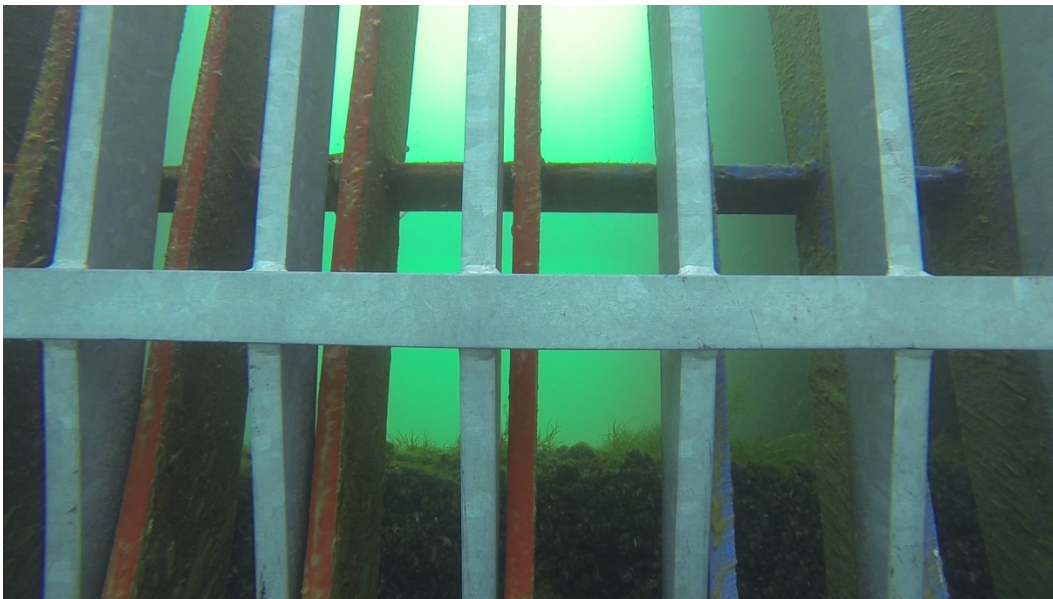
Figure 13.—Front face of the foul release panels—International Intersleek 970 (left), red PPG Sigmaglide 890 (left), and blue Seacoat Seaspeed V5 (right).

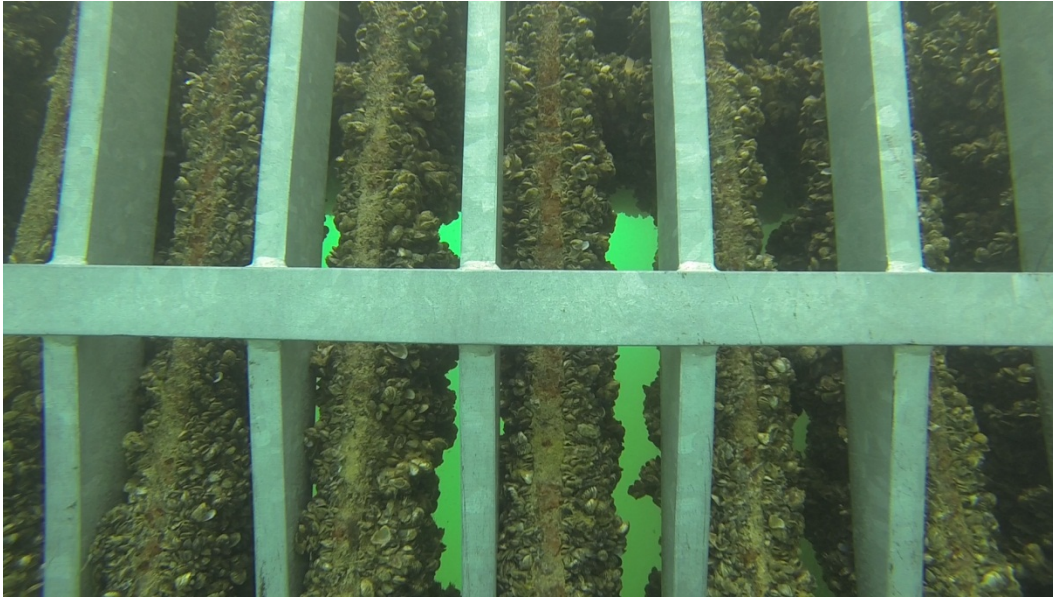
Figure 14.—Original trashrack panels in fouled condition during May 2014 inspection.

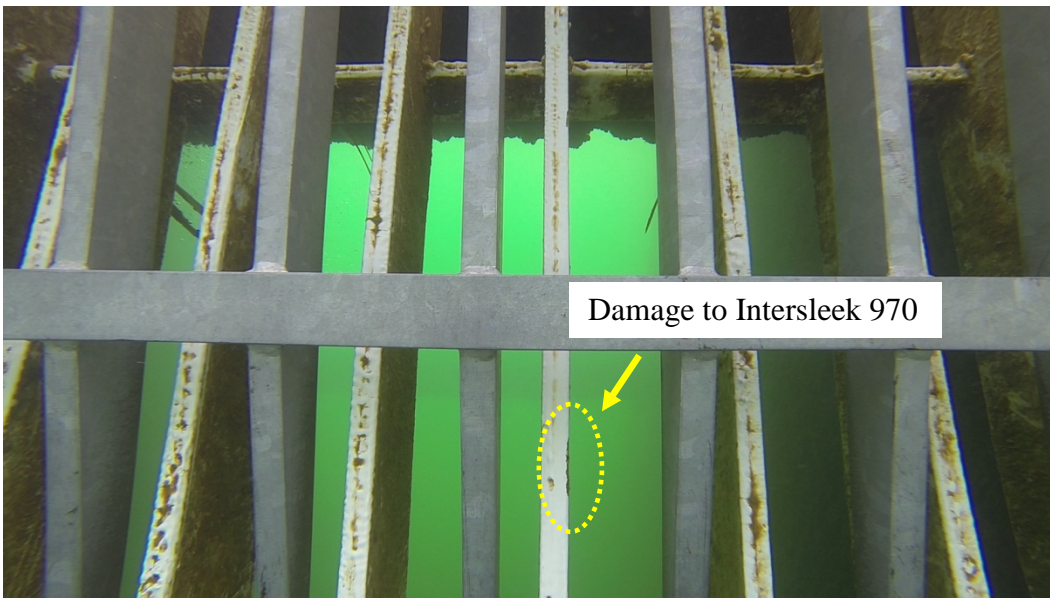
It was expected that there would be some localized damage due to the automated trash rake, which runs approximately every 7 days. Dam staff estimates the rake had been run 20–25 times since the panel installation last December. While the softer silicone foul release systems are more prone to mechanical damage from gouging and abrasion, a conventional coating such as an epoxy will eventually experience damage from the high stress loading of a trash rake. However, the hope is that the damage will be contained to areas where contact from the trash rake occurred. It is possible that any damaged areas may remain free of mussels due to regular cleaning with the trash rake.

Figures 15–16 show that there is some minor damage to the International Intersleek 970 system and the PPG Sigmaglide 890 system. From figure 17, there appears to be some wear on the front face of the Sigmaglide and Seacoat Seaspeed V5 coatings. This is expected since most of the contact occurs on the front face as evidenced by figure 14. Overall, the damage is relatively minor at this point. More time is needed to determine the longevity of the coatings and whether the damage will spread to adjacent areas. The Fuji Sher-Release system does not appear to have any notable damage thus far.

Figure 15.—Slight damage to International Intersleek 970.

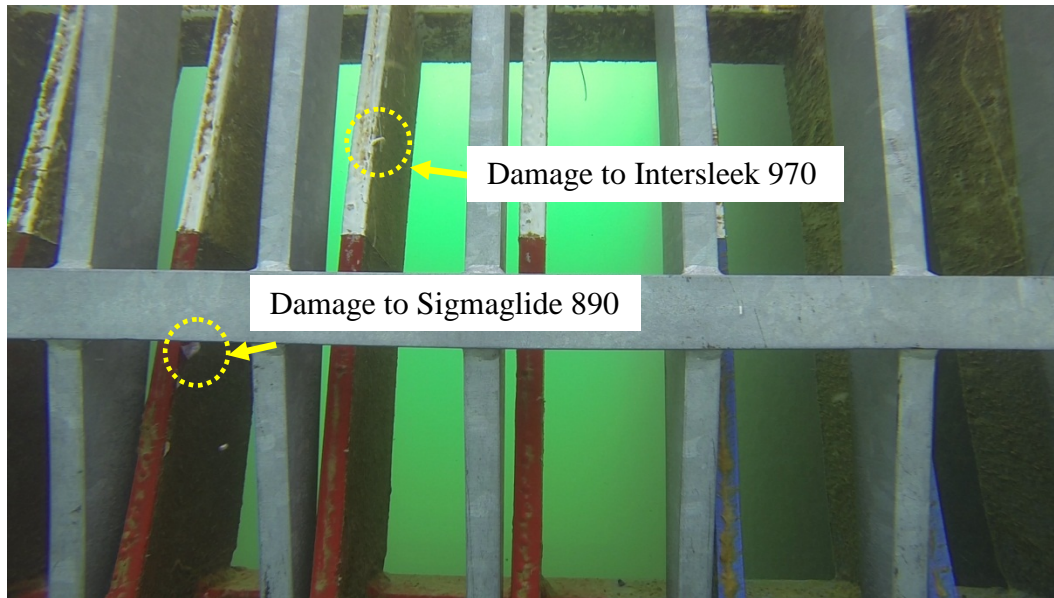
Figure 16.—Damage to International Intersleek 970 and PPG Sigmaglide 890.

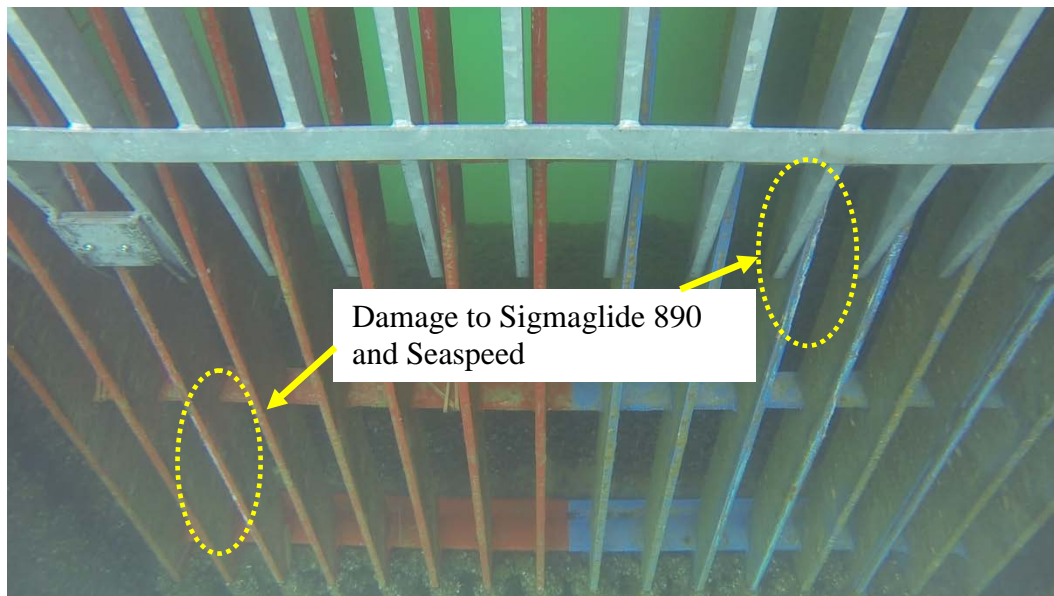
Figure 17.—Damage to International Sigmaglide 890 and Seacoat Seaspeed V5 (front face).
