Technical Memorandum No. MERL-2014-96

## Sealing Leaking Contraction Joints

Science and Technology Project ID: 3191

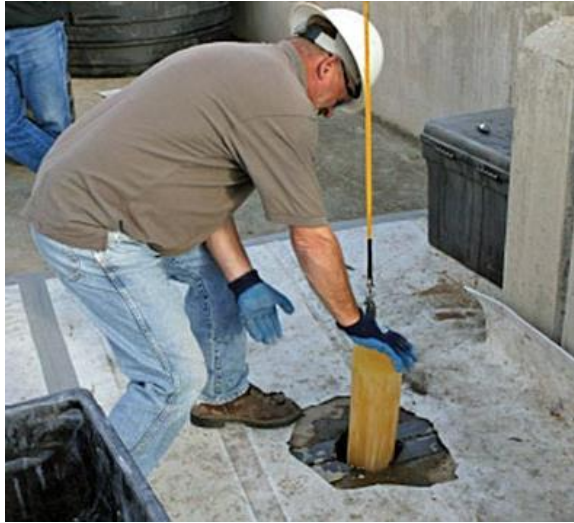
This product is a solid urethane that reacts with water and can expand to completely fill the core hole and seal the leaking joint (photo 1).

**Photo 1.—A section of cylindrical Cylutions waterstop being placed into a core hole.**

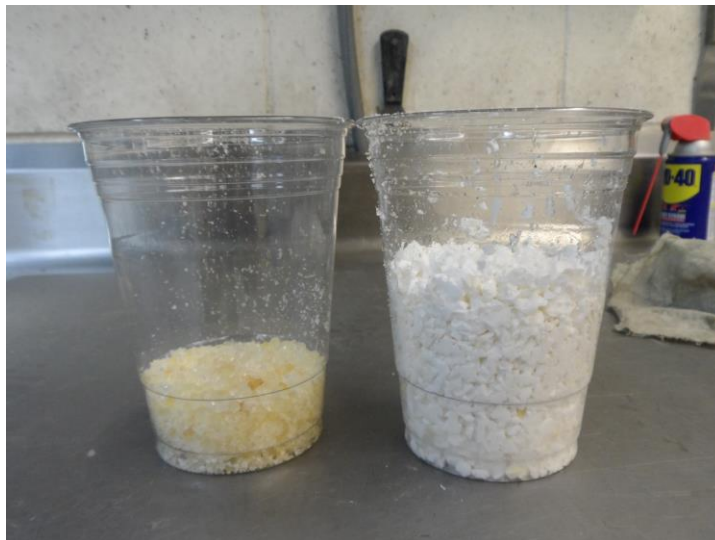
**Photo 2.—Ground up waterstop. The left side shows the product before contact with water and the right side right shows the product after water was added. The cups contain the same volume of waterstop material.**

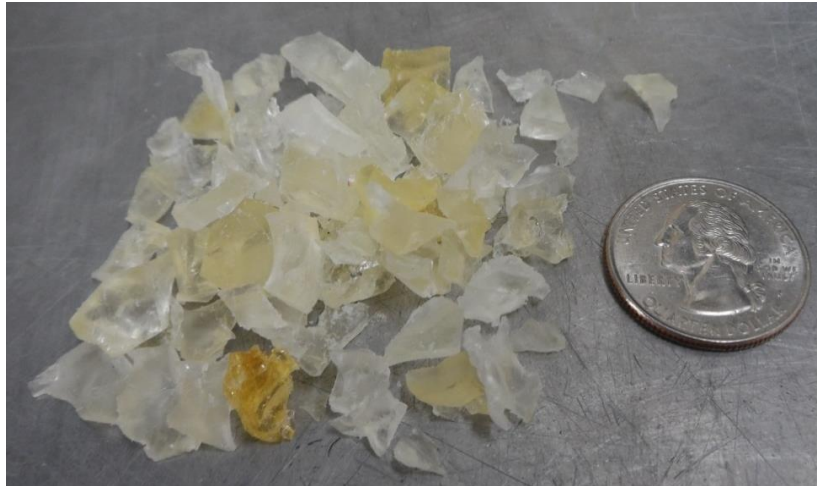
**Photo 3.—Ground-up version of Cylutions waterstop.**

Once we received the product it was too large for our applications (see photo 3). In order to create smaller particles, we ran it through a meat grinder. Figure 1 shows the gradation of the particles.

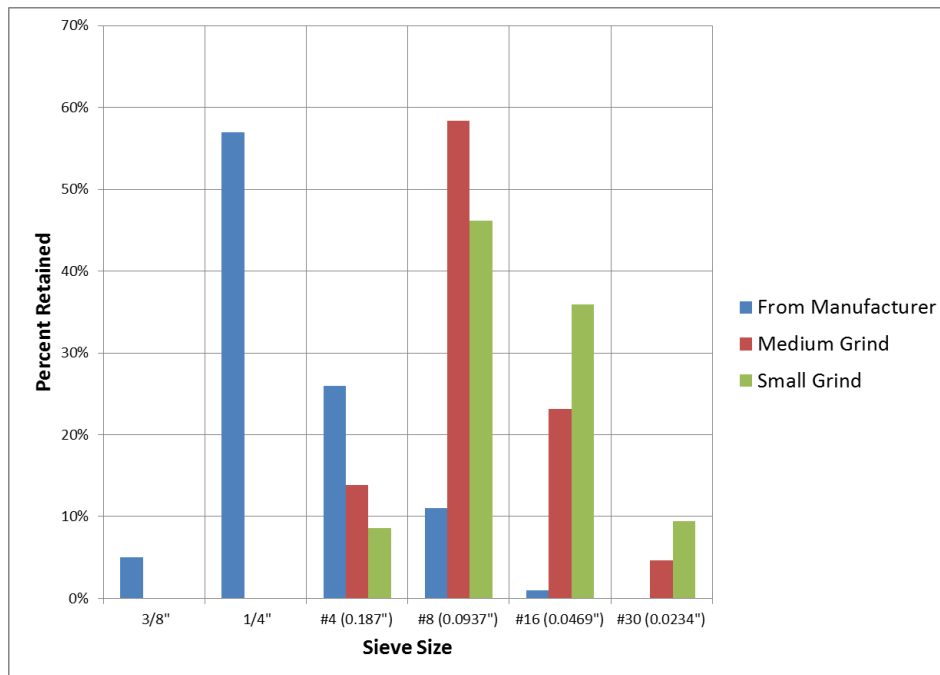
**Figure 1.—Gradation of waterstop from the manufacturer and after meat grinder.**

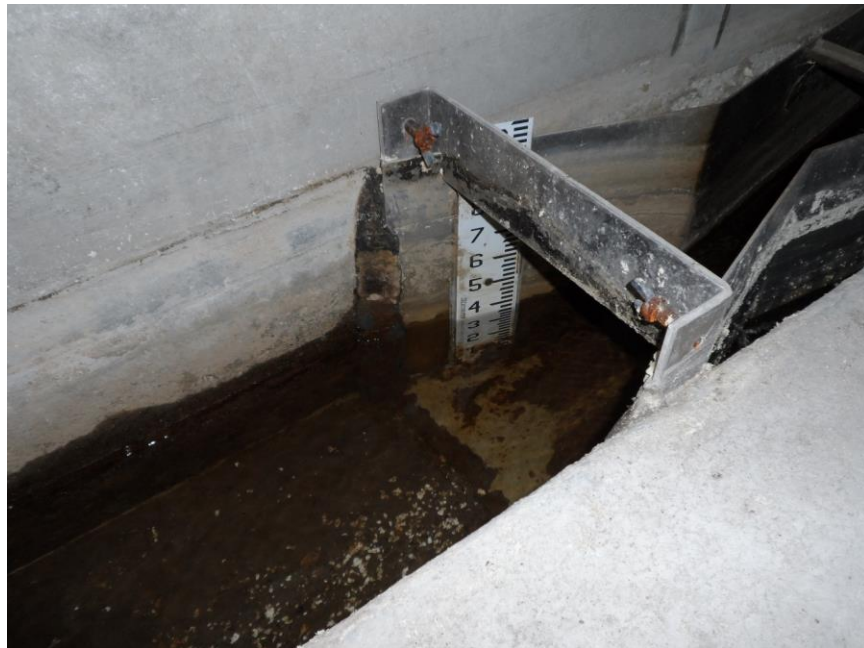
We have previously worked with personnel at Grand Coulee Dam in Washington to stop other leaks. Attempts have been made to seal up a leaking joint between blocks 81/82 using chemical grouts. These attempts have been marginally successful due to the high flows of water (about 150 GPM) this joint sees.

**Photo 4.—Weir placed in the 1000 gallery drainage ditch measuring inflow coming from the 81/82 joint area.**

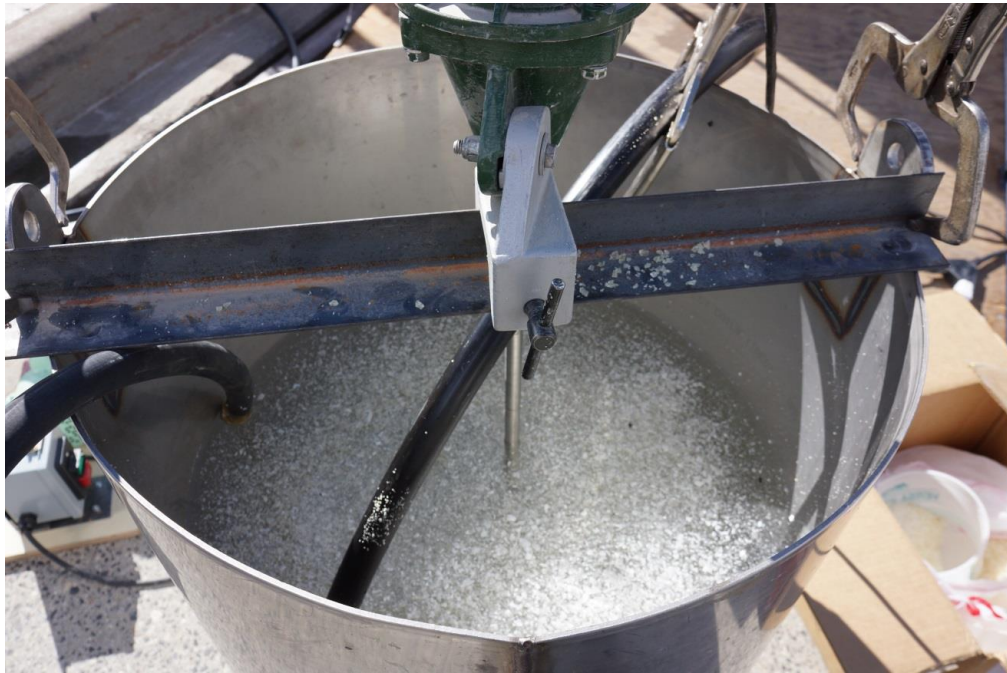
**Photo 5.—Ground-up waterstop suspended in water.**

The ground up waterstop was placed in a 55 gallon barrel with water, and an agitator was used to keep the particles suspended (photo 5). This slurry was then pumped from the top of the dam through one inch plastic tube using a screw type progressive cavity pump (photo 6). The distribution of the slurry was monitored by GC's remotely operate vehicle (ROV) (photo 7) and a downhole inspection camera (photo 8). The hose location was controlled from the top of the dam. It was raised and lowered so the outlet was close to the joint and in a place where water was actively infiltrating. A section of steel pipe was attached to the underwater end of the hose to keep it submerged and make it easier to control.

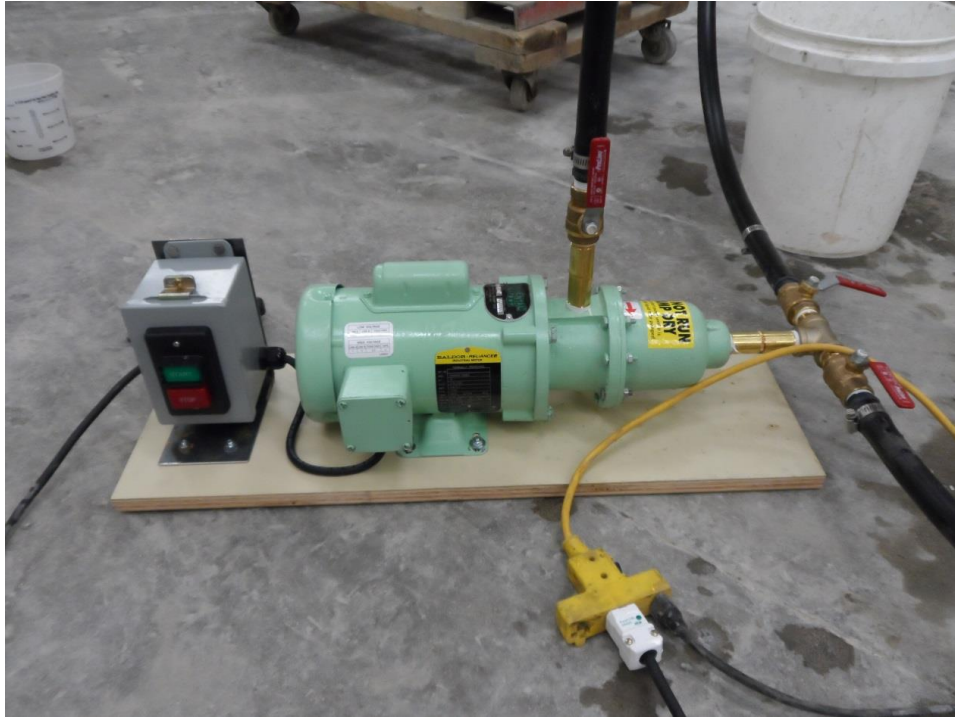
Photo 6.—Progressive cavity screw pump used to deliver water/waterstop solution.

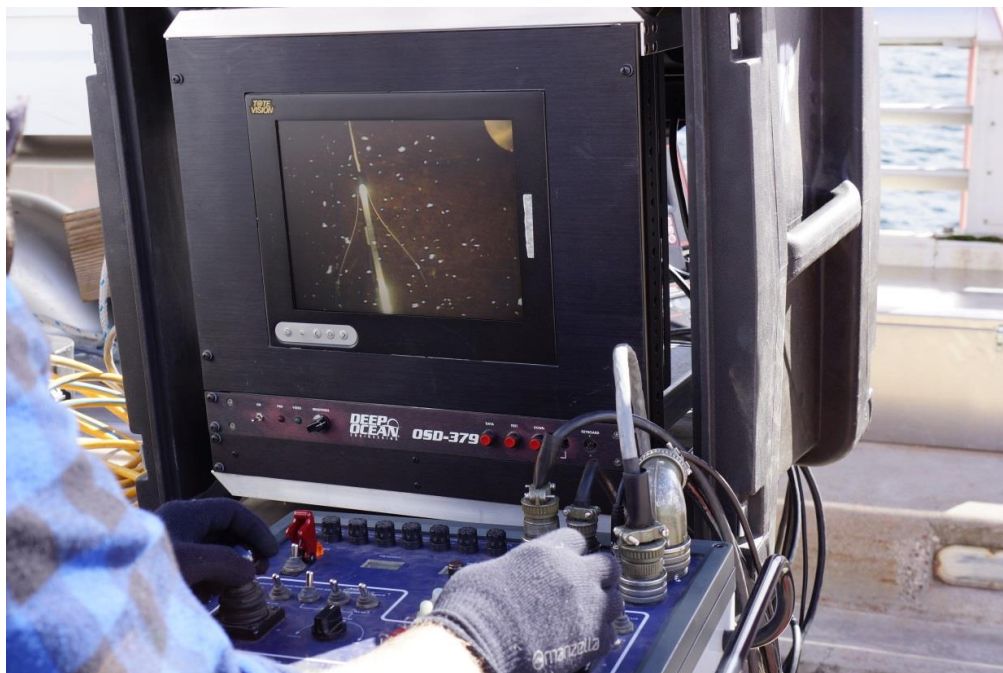
Photo 7.—Grand Coulee's ROV monitoring the waterstop placement.

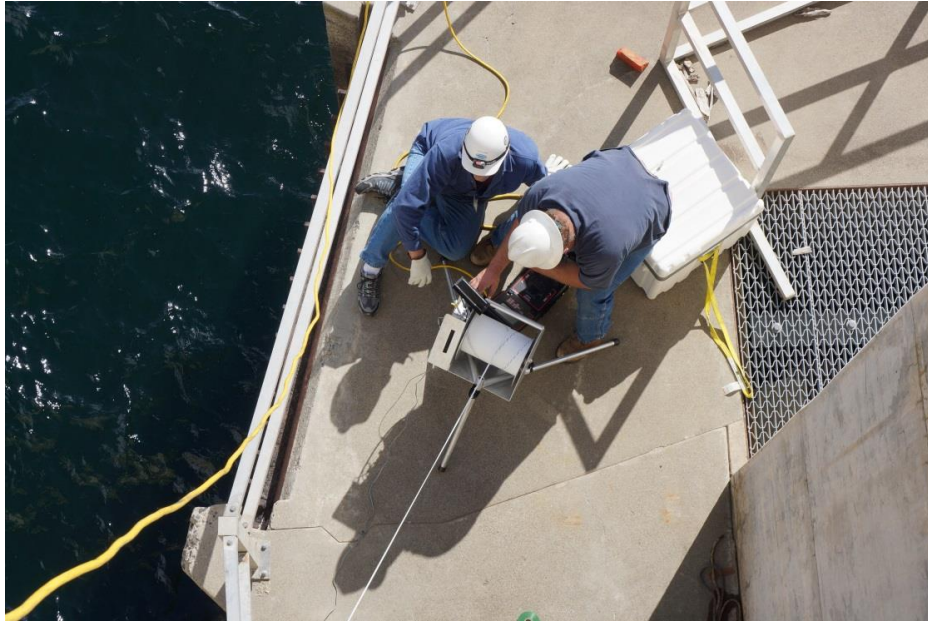
**Photo 8.—Grand Coulee personnel monitoring waterstop placement with a well camera.**

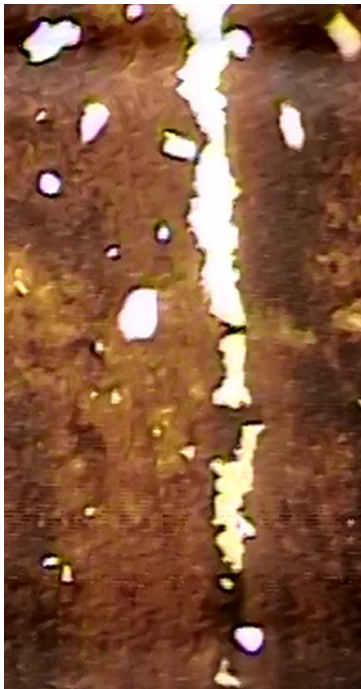
**Photo 9.—Waterstop material packing on the front and entering the joint.**

On day one, the 1000 elevation gallery flume read 0.44 foot, which corresponds to a flow rate of 145 GPM. A total of 40 lbs. of ground waterstop was placed between the 1060 and 1030 elevations. At the end of the day the flume read 0.36 foot (100 GPM). The smaller waterstop particles entered the joint while the larger waterstop particles packed on the front of the joint (photo 9).

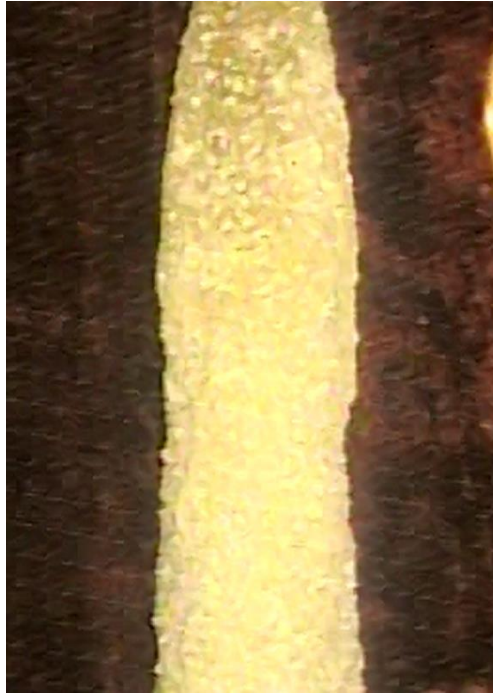
The next morning, the level in the flume was the same as the previous evening (0.36 foot or 100 GPM). An additional 50 pounds of product was mixed and placed at the 1060–1030 elevations before noon, resulting in a flume reading of 0.30 foot (71 GPM). At this point the face of the joint between the 1060 and 1030 elevations was almost completely full of particles, to the point where the particles were beginning to create a mound at the joint (photo 10). That afternoon 10 more pounds of ground waterstop was mixed and pumped, mainly into a couple of holes where the mounded up particles had been sucked into the joint. At the end of the day the flume reading was 0.28 foot (63 GPM).

**Photo 10.—Waterstop material creating a mound on the face of the joint.**
