Foul-Release Coatings Scale-Up Testing—Parker Dam Trashrack

Research and Development Office
Science and Technology Program
Final Report ST-2015-5270-1

September 2015

Foul-Release Coatings Scale-Up Testing—Parker Dam Trashrack: FY 2015 Final Report

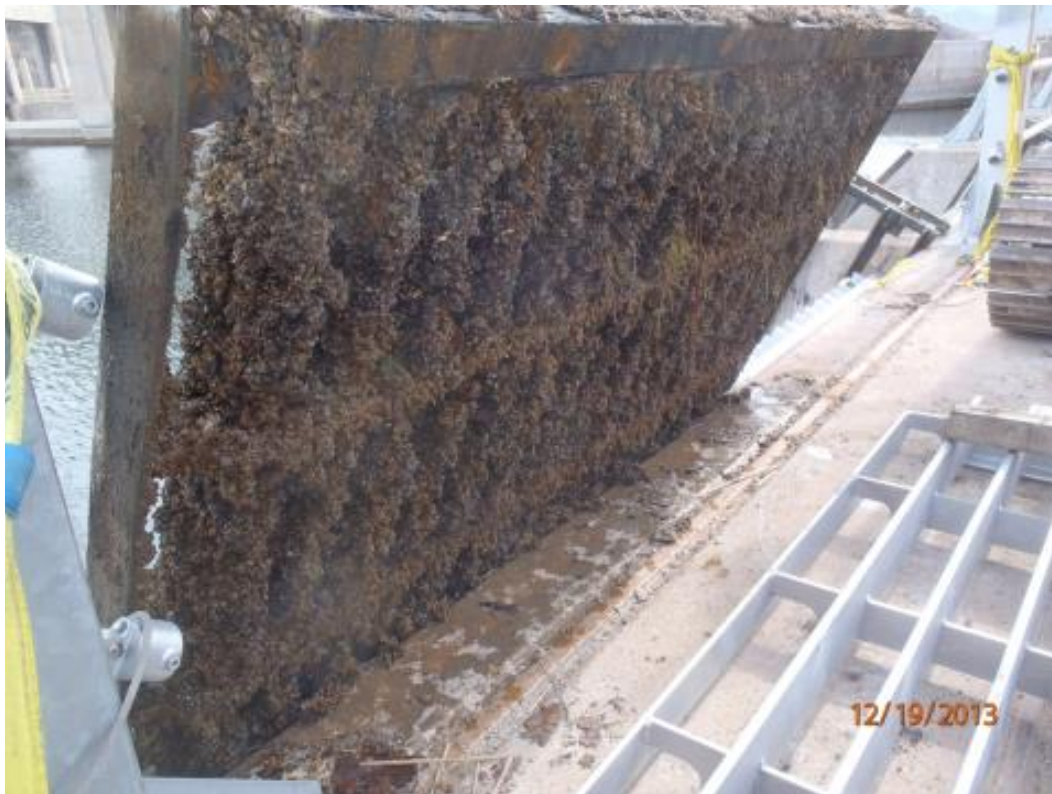
The experimental trashrack installation was completed on December 19, 2013. It was installed in Bay 9 right side (facing downstream). There were no problems extracting the existing trashrack, and it appeared to be in good condition, with no major rusting. Significant mussel buildup was present on the existing panel (figures 1–3). Figures 4–6 show the foul-release coated trashrack panel being installed in Bay 9.

Figure 1.—Existing trashrack heavily fouled with quagga mussels.

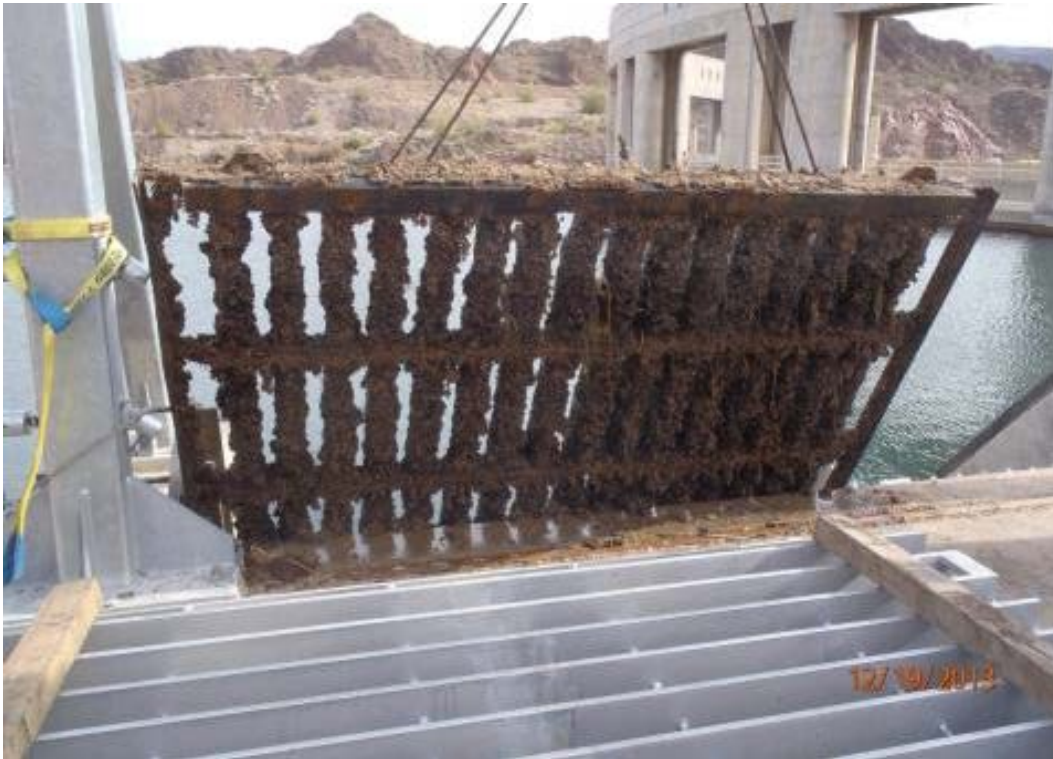
Figure 2.—Existing trashrack, view looking east.

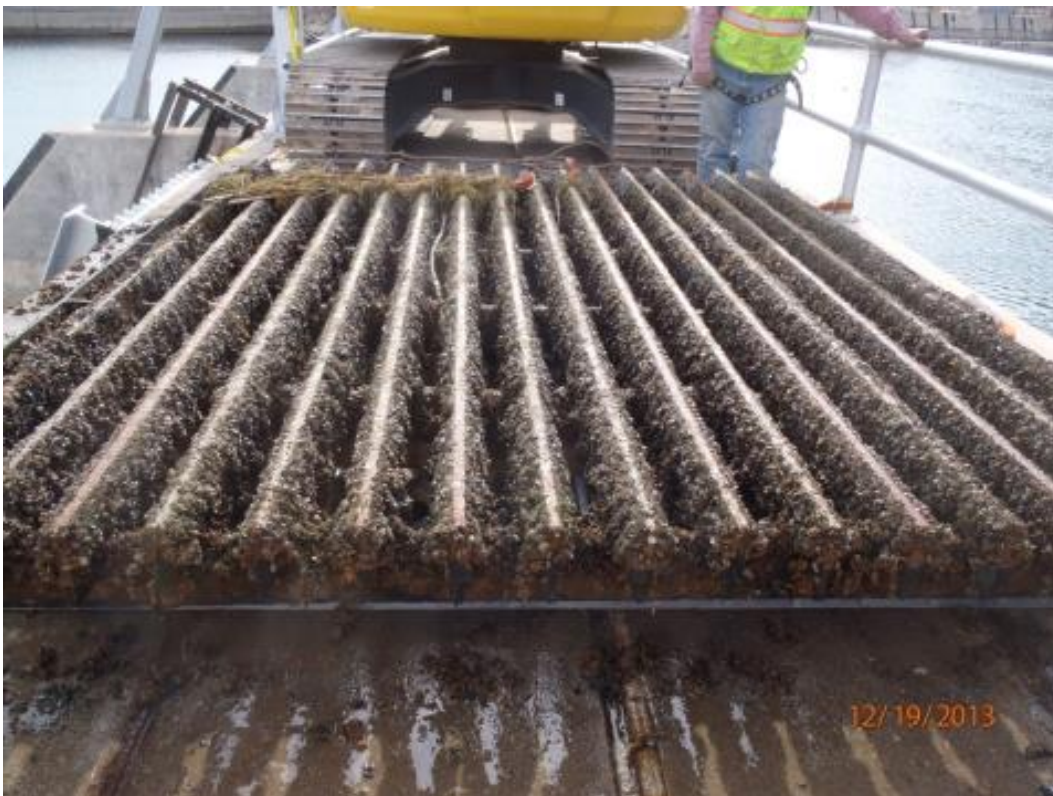
Figure 3.—Existing trashrack, view looking south on trashrack structure.

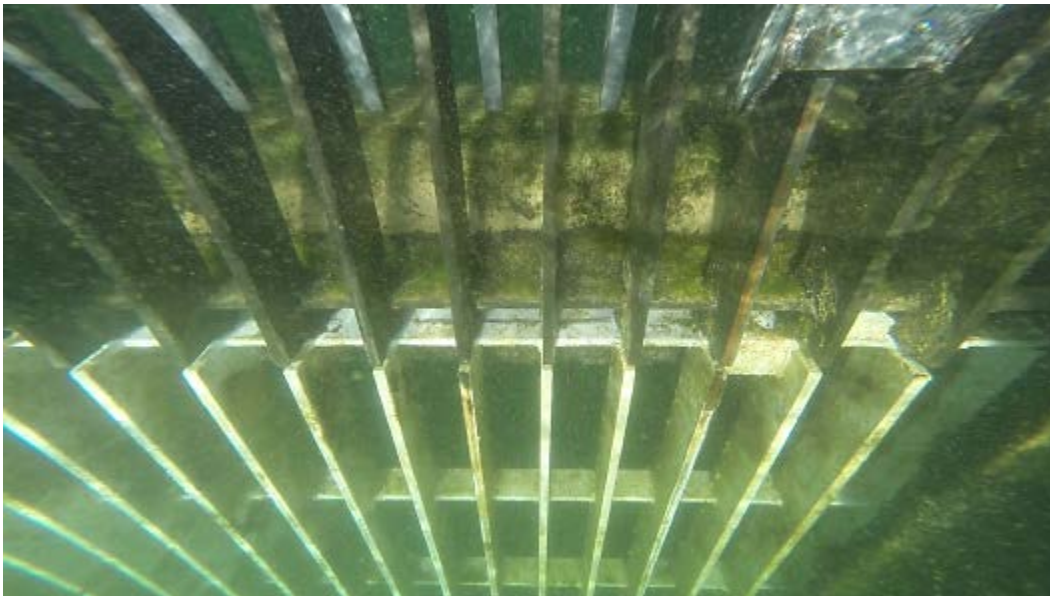
Figure 13 is a still image captured from the GoPro video recording taken during the May 2015 inspection. As of May 2015, there was no mussel settlement on the new galvanized trashrack panel above the foul-release panel, but these panels are typically only partially immersed. The trash rake guides caused damage to the metal coatings and the old coal tar enamel. One bar of the galvanized rack had scraping damage. All bars had damage on the existing trashrack panel coated with coal tar enamel.

Figure 13.—New galvanized trashrack panel shows corrosion on leading edge where trash rake guide scrapes the surface (third bar from right).

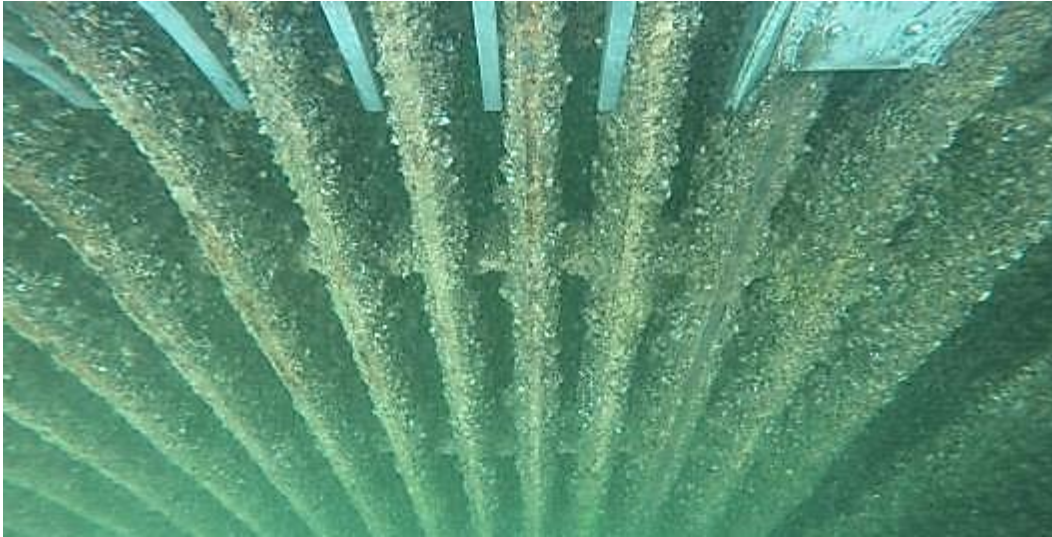
Figure 14.—Existing coal tar enamel coated trashrack.

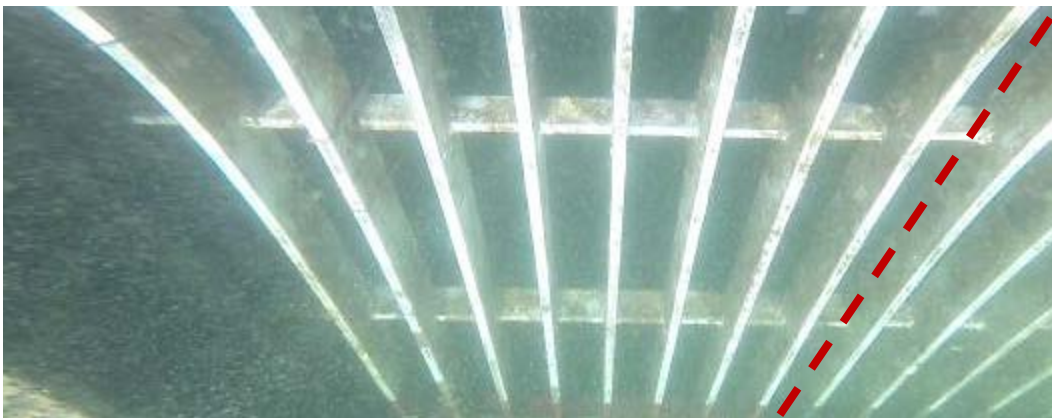
Figure 15 is an overview of the coated area of the Intersleek 970, the trash rake guide scrapes the coating on the third bar from the left, and there was very little damage on the Intersleek 970. Figure 16 is a close-up view of the coating, and no damage was observed. There were algae on the coating, but no mussels were present.

Figure 15.—International Paint Intersleek 970 after 18 months exposure—the dashed line demarcates the end of the Intersleek coating.

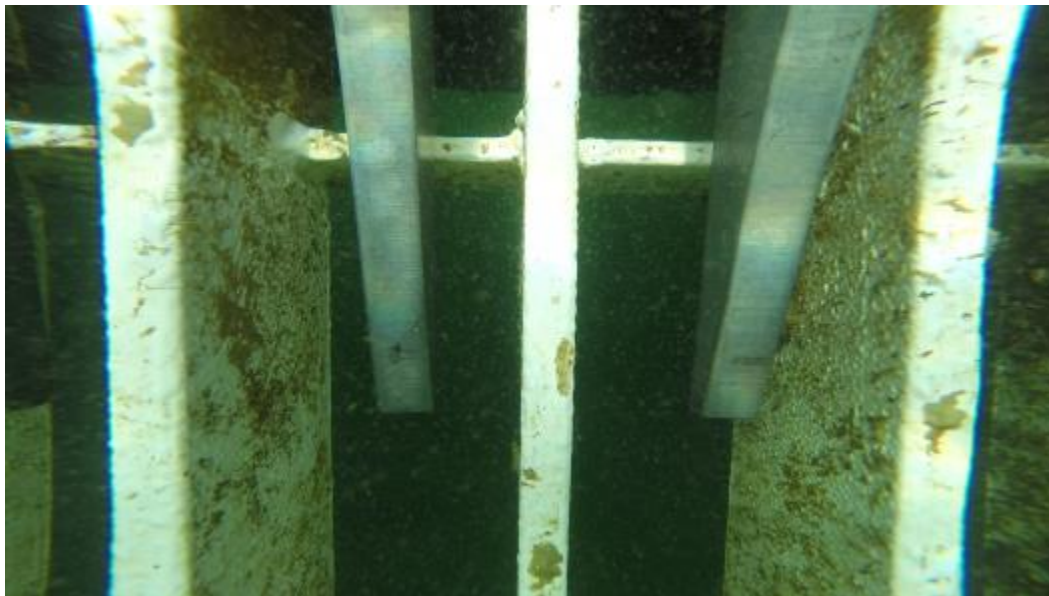
Figure 16.—International Paint Intersleek 970 after 18 months exposure.

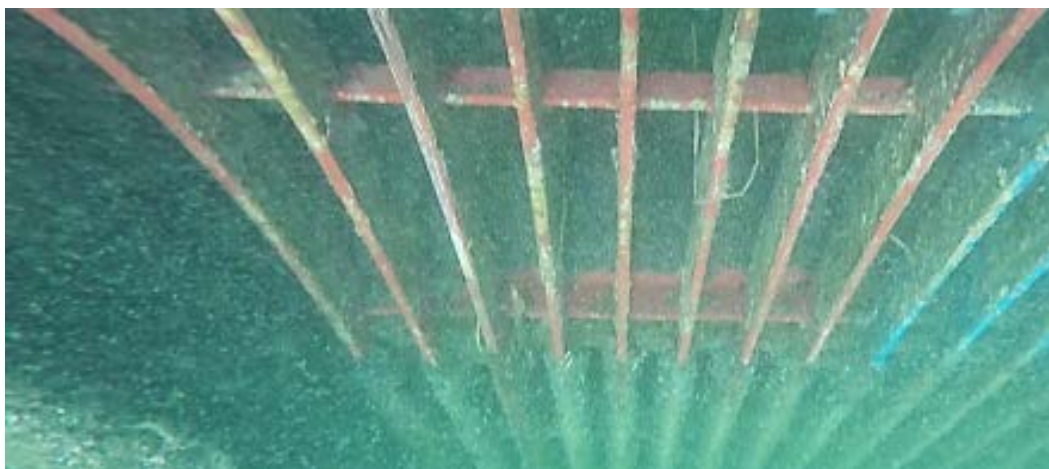
Figure 17 is an overview of PPG Sigmaglide 890. There appeared to be some scrape marks on the front face where the guide scrapes the coating (third bar from left). Figure 18 is a close-up view of the coating and shows no damage. There were some algae on the bars, but no mussels were present.

Figure 17.—PPG Sigmaglide 890 after 18 months exposure.

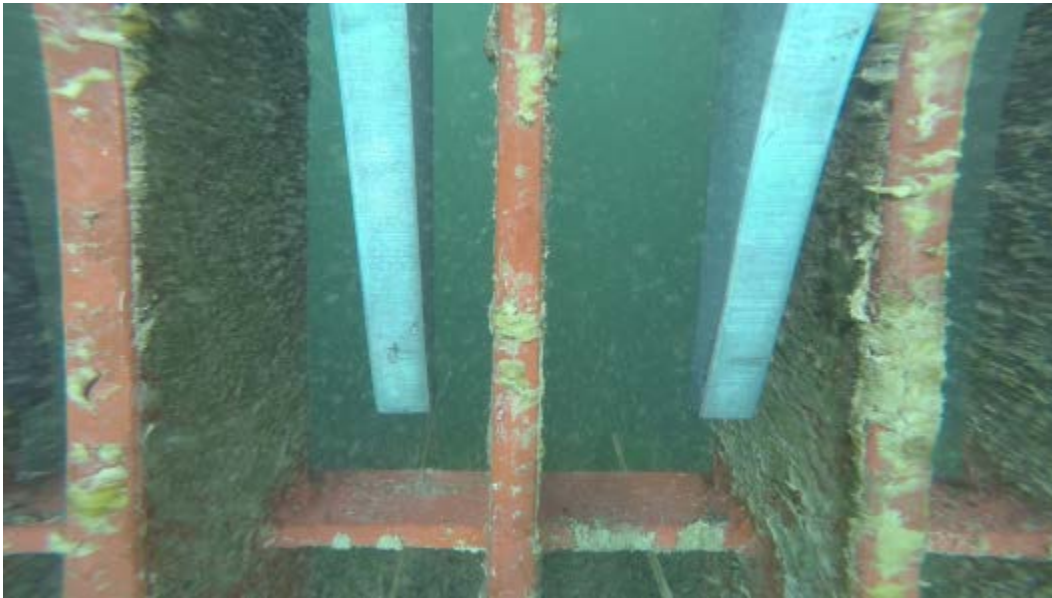
Figure 18.—PPG Sigmaglide 890 after 18 months exposure.

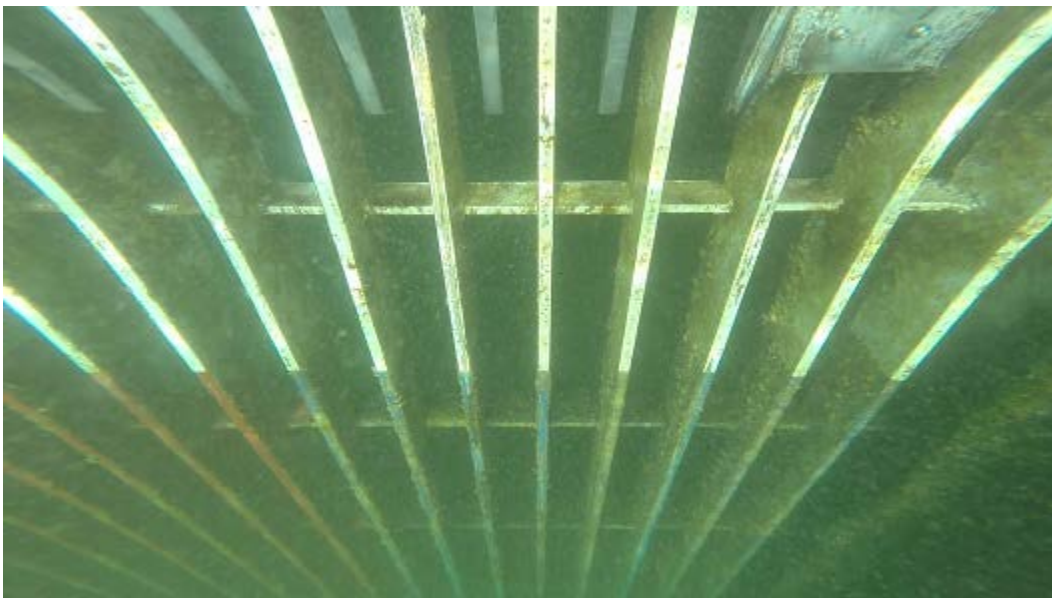
Figure 19 is an overview of the coated area of the Sherwin Williams Sher-Release. The trash rake guide scraped the coating on a few bars, and there is moderate damage on the front face. Figure 20 is a close-up view of the coating with some damage apparent. There were some algae on the coating, but no mussels are present.

Figure 19.—Sherwin Williams Sher-Release after 18 months exposure.

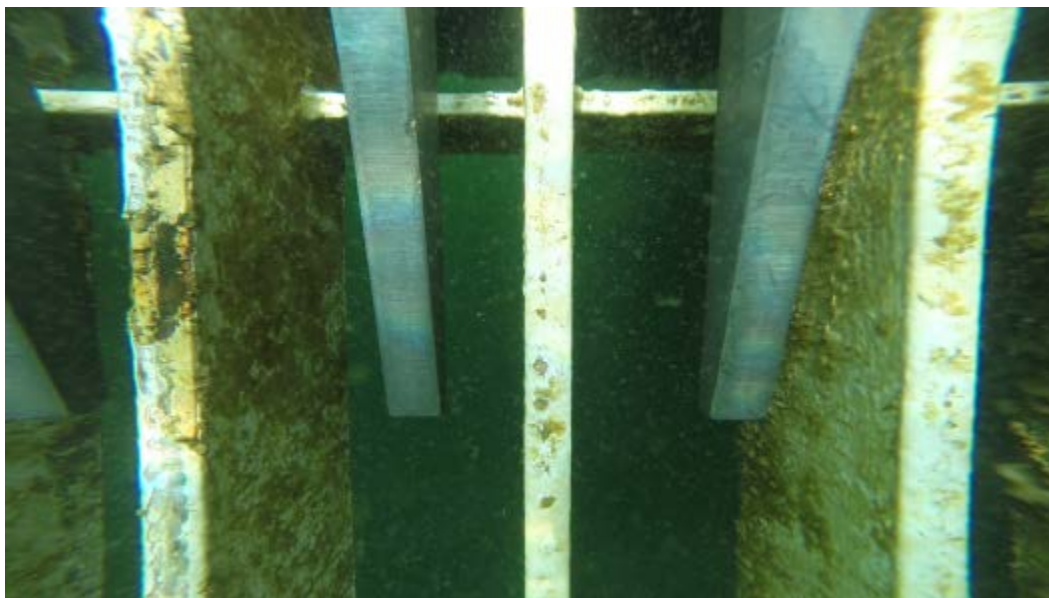
Figure 20.—Sherwin Williams Sher-Release after 18 months exposure.
Small damaged area on left bar.

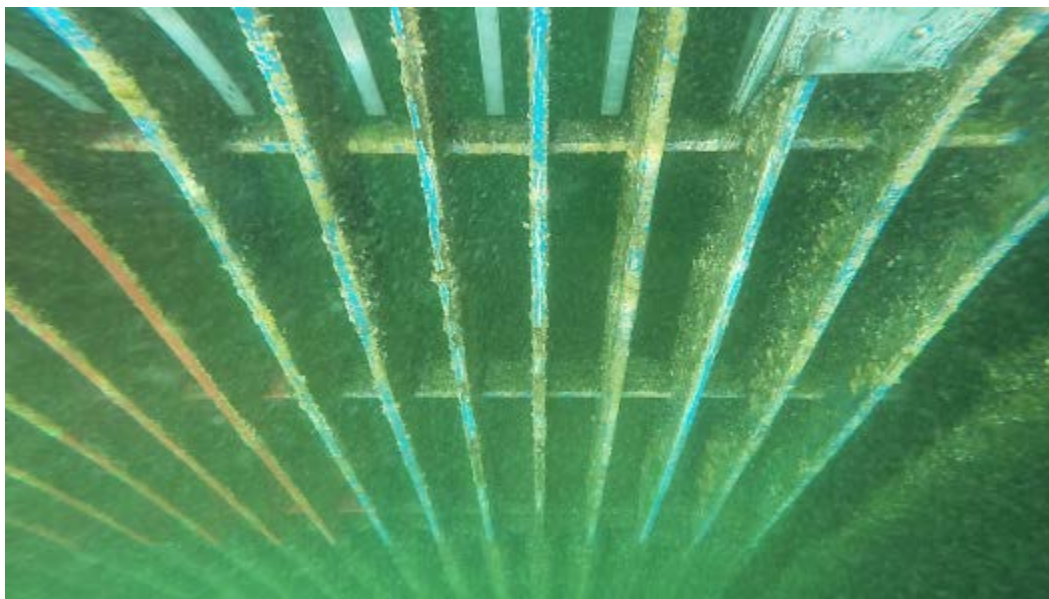
Figure 21 is an overview of the coated area of the Seacoat Seaspeed V5 coatings. The trash rake guide scraped the coating, and there was moderate damage on the front face. Figure 22 is a close-up view of this damage. There was also algae and mussels present on the coating.

Figure 21.—Seacoat Seaspeed V5 after 18 months exposure.

The epoxy silicone hybrid had damage on a number of bars. This includes damage on bars that contact the trash rake guides as well as those that contact the trash rake roller. The hard epoxy silicone hybrid, may not withstand the high loading stress (compression stress) of a trash rake. The coating may crack and be scraped from the surface.

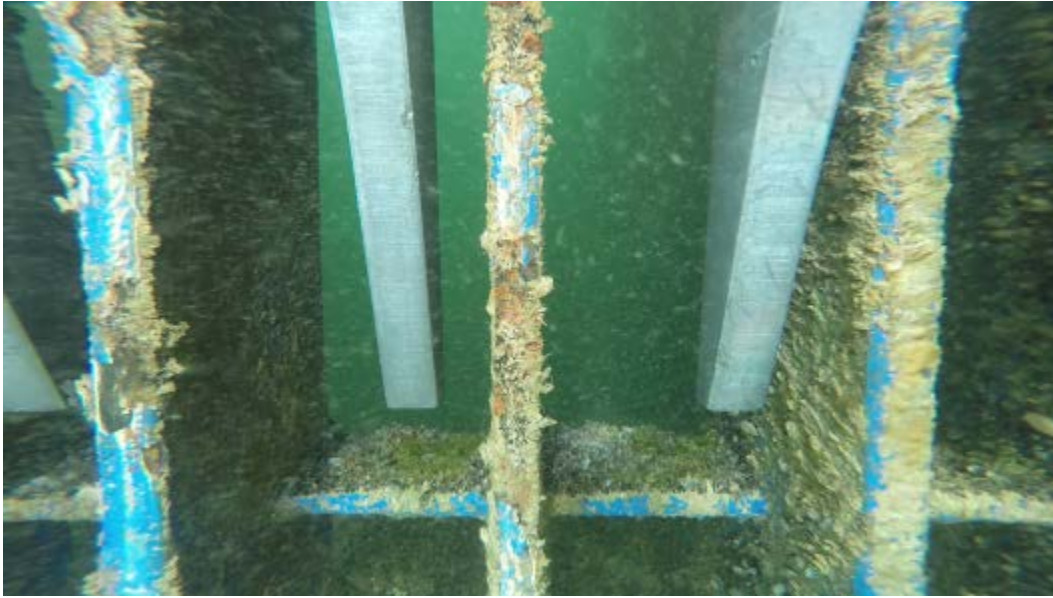
Figure 22.—Seacoat Seaspeed V5 after 18 months exposure.
