Foul-Release Coatings Scale-Up Testing—Parker Dam Trashrack: FY 2015 Final Report

Research and Development Office
Final Report ST-2015-5270-1 / MERL-2015-75

September 2015

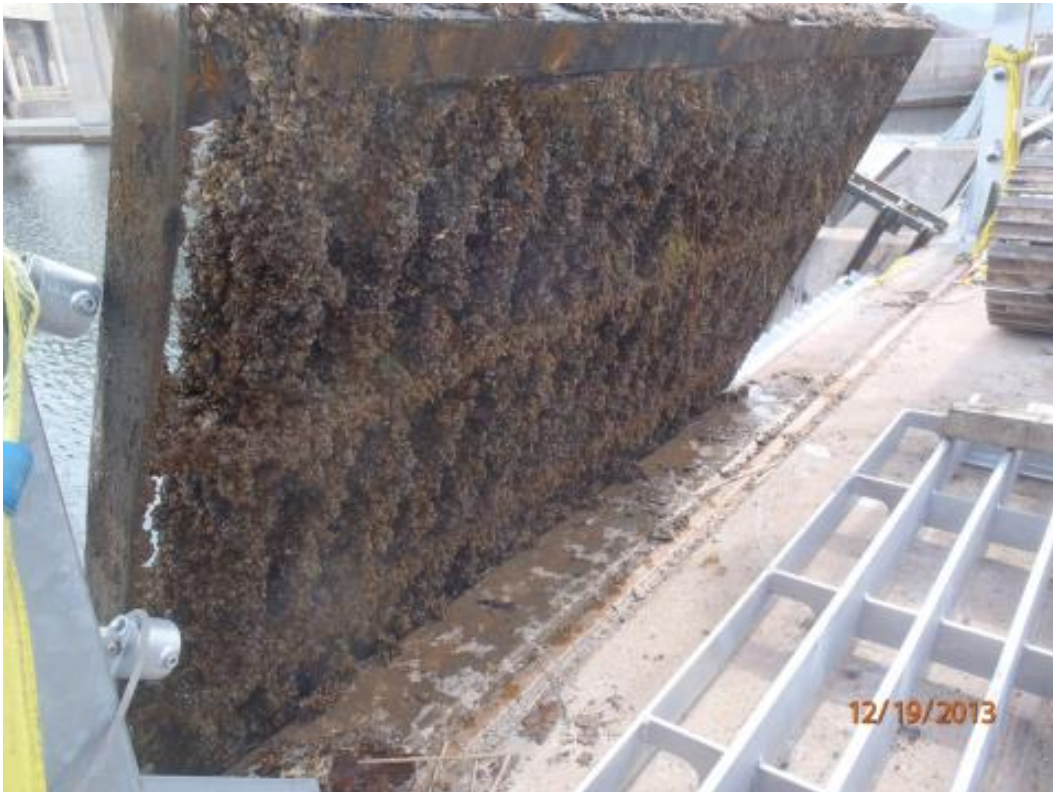
The experimental trashrack installation was completed on December 19, 2013. It was installed in Bay 9 right side (facing downstream). There were no problems extracting the existing trashrack, and it appeared to be in good condition, with no major rusting. Significant mussel buildup was present on the existing panel (figures 1–3). Figures 4–6 show the foul-release coated trashrack panel being installed in Bay 9.

Figure 1.—Existing trashrack heavily fouled with quagga mussels.

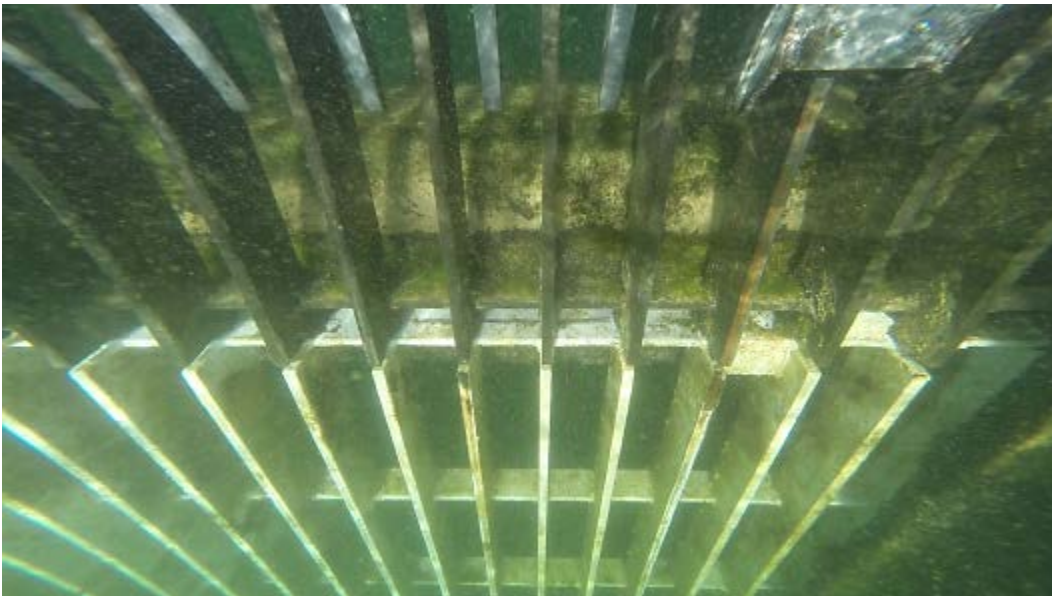
Figure 13 is a still image captured from the GoPro video recording taken during the May 2015 inspection. As of May 2015, there was no mussel settlement on the new galvanized trashrack panel above the foul-release panel, but these panels are typically only partially immersed. The trash rake guides caused damage to the metal coatings and the old coal tar enamel. One bar of the galvanized rack had scraping damage. All bars had damage on the existing trashrack panel coated with coal tar enamel.

Figure 13.—New galvanized trashrack panel shows corrosion on leading edge where trash rake guide scrapes the surface (third bar from right).

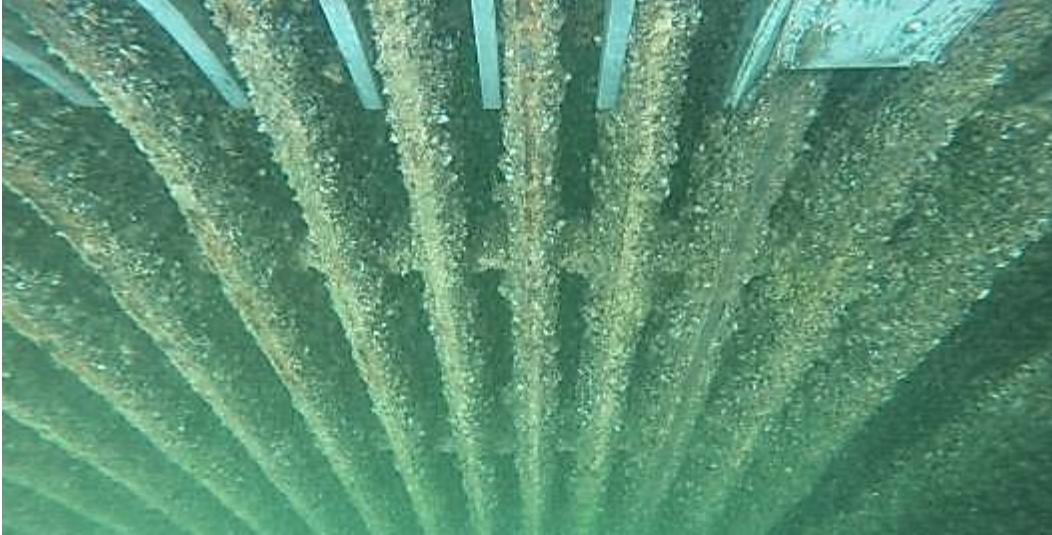
Figure 14.—Existing coal tar enamel coated trashrack.

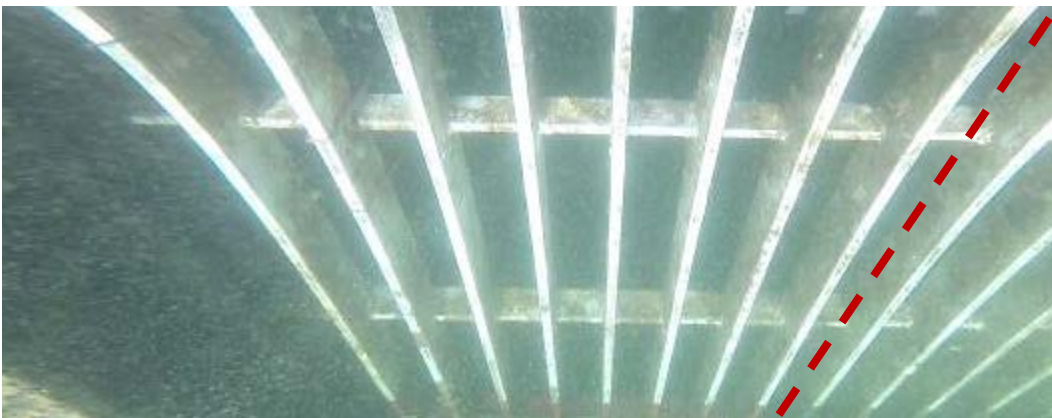
Figure 15 is an overview of the coated area of the Intersleek 970, the trash rake guide scrapes the coating on the third bar from the left, and there was very little damage on the Intersleek 970. Figure 16 is a close-up view of the coating, and no damage was observed. There were algae on the coating, but no mussels were present.

Figure 15.—International Paint Intersleek 970 after 18 months exposure—the dashed line demarcates the end of the Intersleek coating.

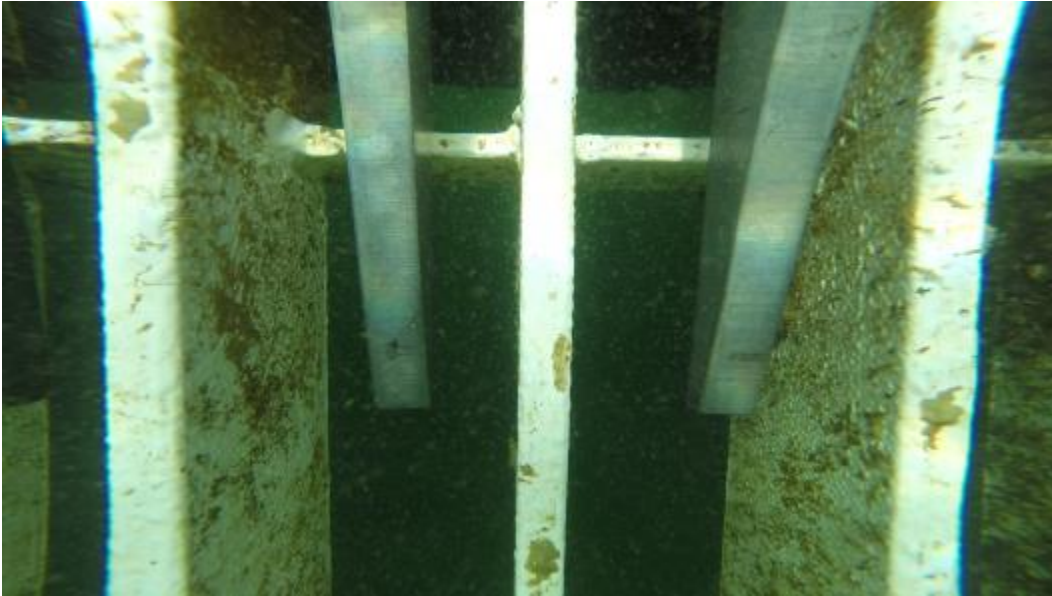
Figure 16.—International Paint Intersleek 970 after 18 months exposure.

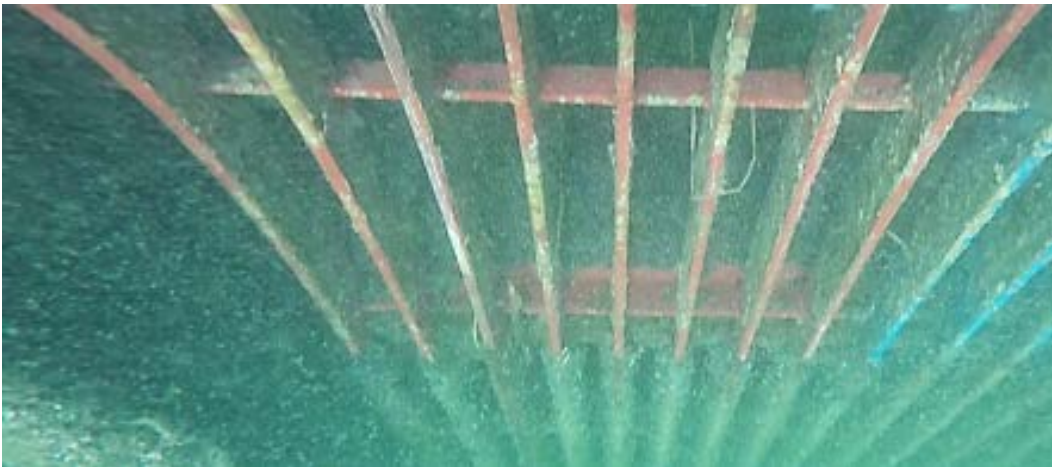
Figure 17 is an overview of PPG Sigmaglide 890. There appeared to be some scrape marks on the front face where the guide scrapes the coating (third bar from left). Figure 18 is a close-up view of the coating and shows no damage. There were some algae on the bars, but no mussels were present.

Figure 17.—PPG Sigmaglide 890 after 18 months exposure.

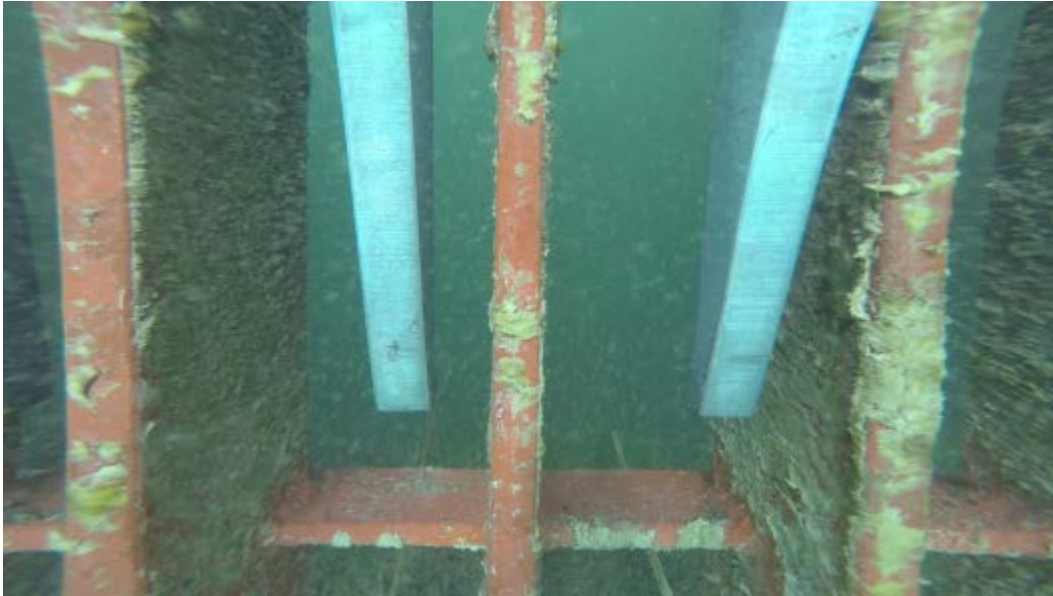
Figure 18.—PPG Sigmaglide 890 after 18 months exposure.

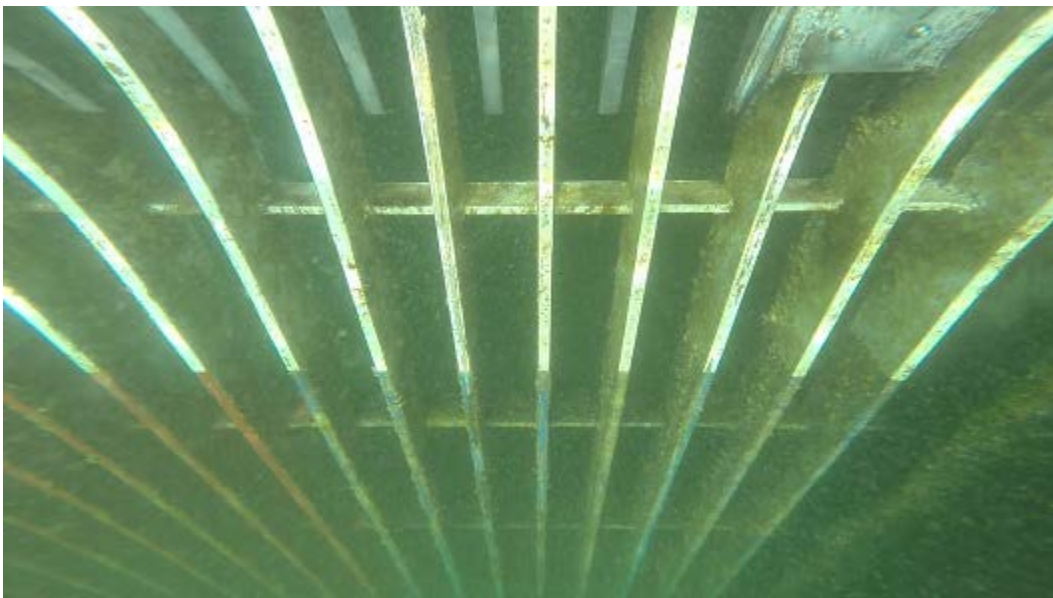
Figure 19 is an overview of the coated area of the Sherwin Williams Sher-Release. The trash rake guide scraped the coating on a few bars, and there is moderate damage on the front face. Figure 20 is a close-up view of the coating with some damage apparent. There were some algae on the coating, but no mussels are present.

Figure 19.—Sherwin Williams Sher-Release after 18 months exposure.

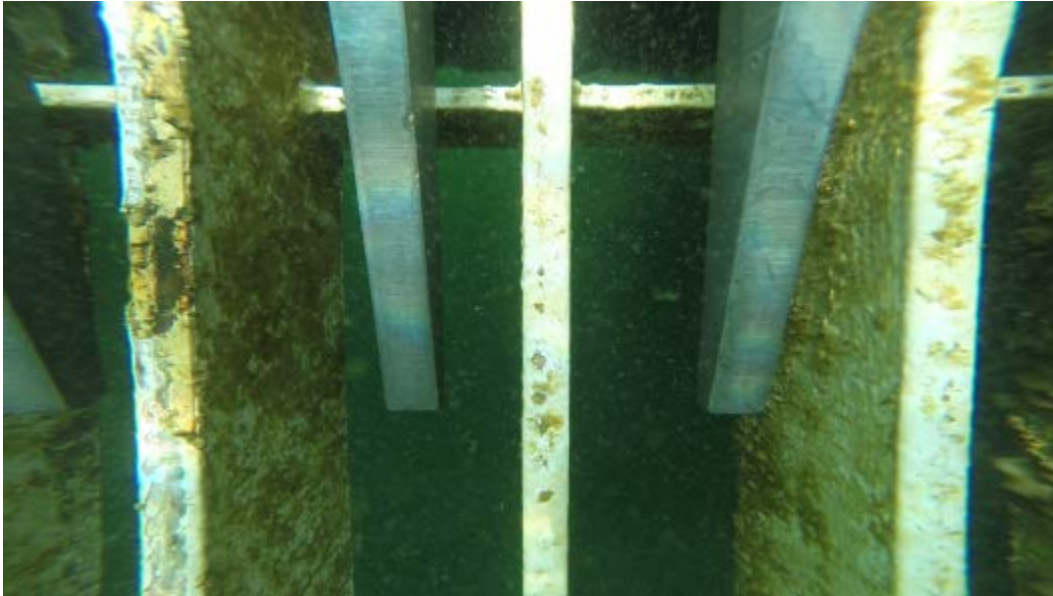
Figure 20.—Sherwin Williams Sher-Release after 18 months exposure.
Small damaged area on left bar.

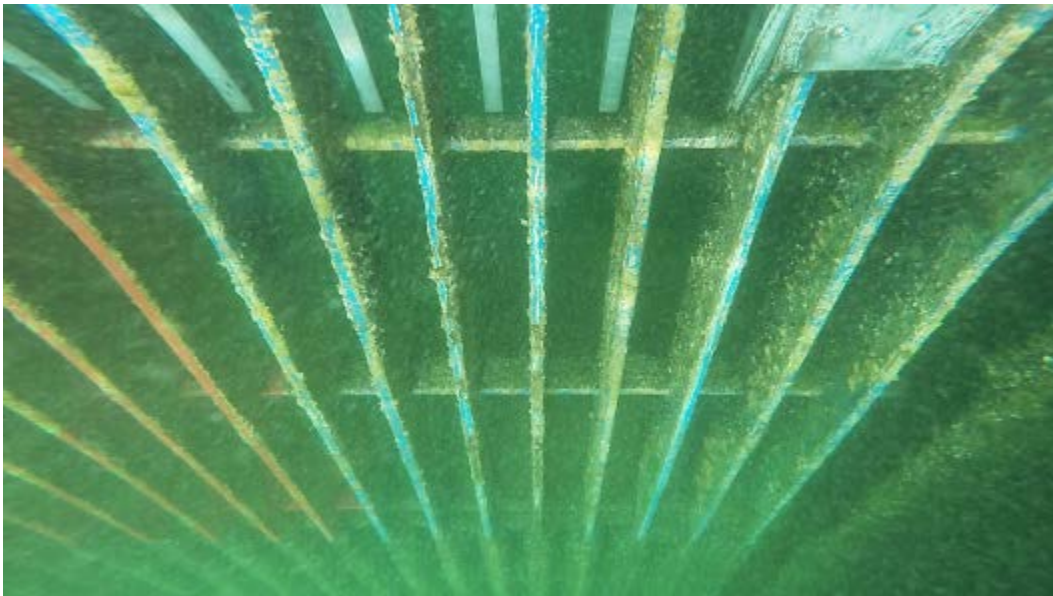
Figure 21 is an overview of the coated area of the Seacoat Seaspeed V5 coatings. The trash rake guide scraped the coating, and there was moderate damage on the front face. Figure 22 is a close-up view of this damage. There was also algae and mussels present on the coating.

Figure 21.—Seacoat Seaspeed V5 after 18 months exposure.

The epoxy silicone hybrid had damage on a number of bars. This includes damage on bars that contact the trash rake guides as well as those that contact the trash rake roller. The hard epoxy silicone hybrid, may not withstand the high loading stress (compression stress) of a trash rake. The coating may crack and be scraped from the surface.

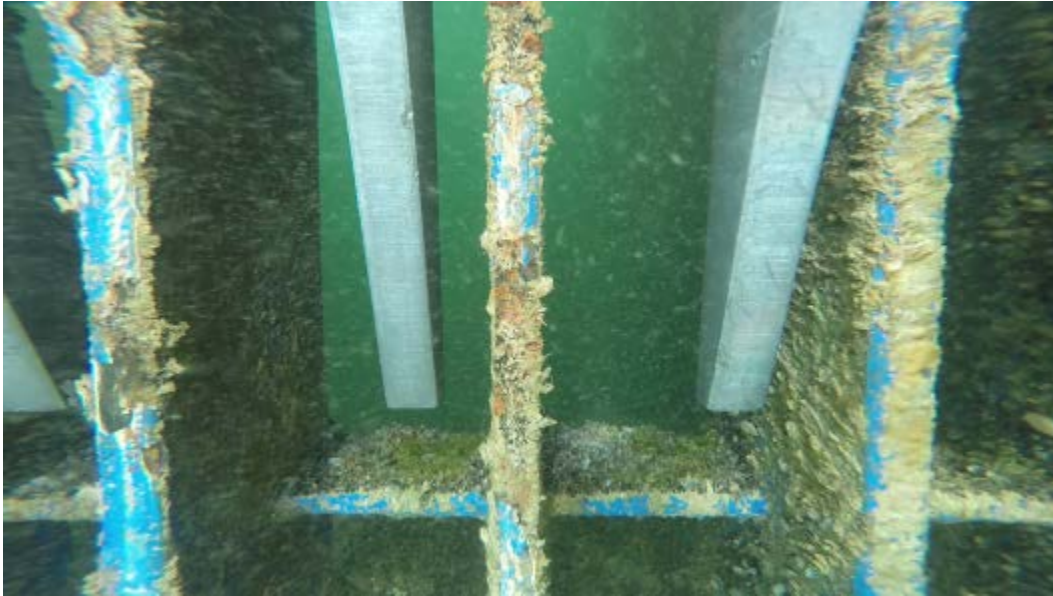
Figure 22.—Seacoat Seaspeed V5 after 18 months exposure.
