Photogrammetric Processing from Unmanned Aerial System (UAS) Data: Elephant Butte Dam

**Technical Memorandum No. 8530-2016-28
Research and Development Office
Science and Technology Program
(Final Report) ST-2016-7738-02**

August 2016

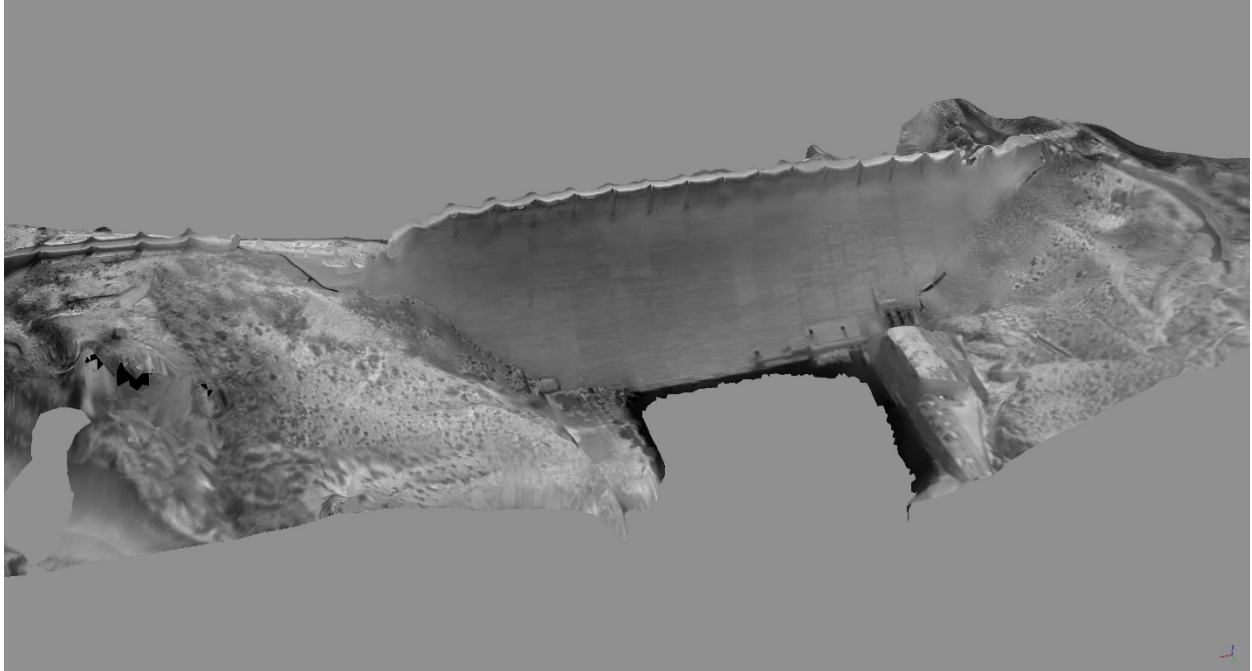
Figure 11: Downstream Face IR Model

The radiometric IR data was processed the same way the optical data was in Agisoft PhotoScan Professional. The result was two separate models as before: the dam and spillway. Because of the low resolution, simultaneous points between the two models were difficult to find and the models were left separate. The downstream face of the structure was captured when the face was in the shadow and thus the surface had not heated enough to show any noticeable defects (see Figure 11). In addition, a lack of resolution created problems at the north side of the structure (left side of Figure 11) where the crest appears to sag.

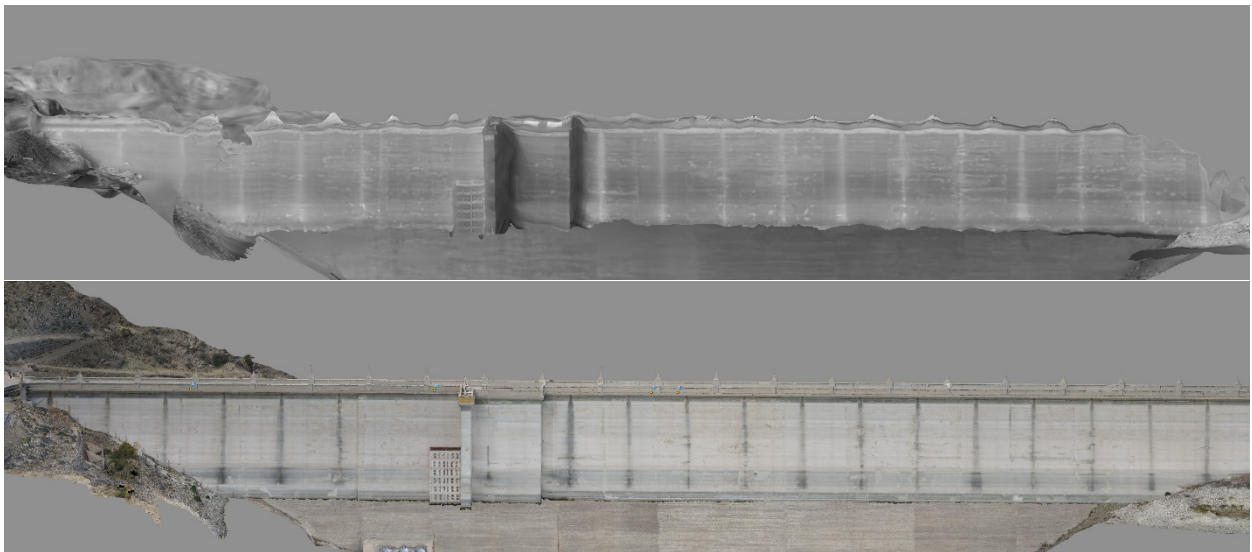
Figure 12: Upstream Face IR Model (top) and Optical Model (below)

A comparison was made between the IR and optical models in Figure 12. Note the white vertical areas in the IR model correspond with the dark stains from the crest drains in the optical model. This occurs because the dark stains absorb more heat than the surrounding areas. In addition, several other hot spots can be seen which correspond to adjacent areas where spalling has occurred. The presence of spalling is usually an indicator that deterioration is occurring adjacent to the spall.

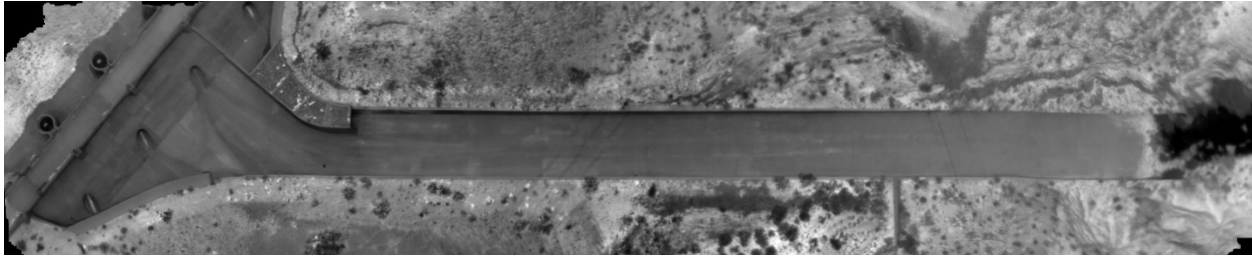
Figure 13: IR Orthophoto of the Spillway

Figure 13 shows the IR orthophoto of the spillway. While not easily visible in the document image, there are a series of hot spots indicating delaminations in locations just below the spillway gate outlets and about halfway down the spillway. These correspond to many of the mapped delaminations shown in Appendix A. The delaminations that cannot be seen in the IR image are probably due to the lack of resolution.

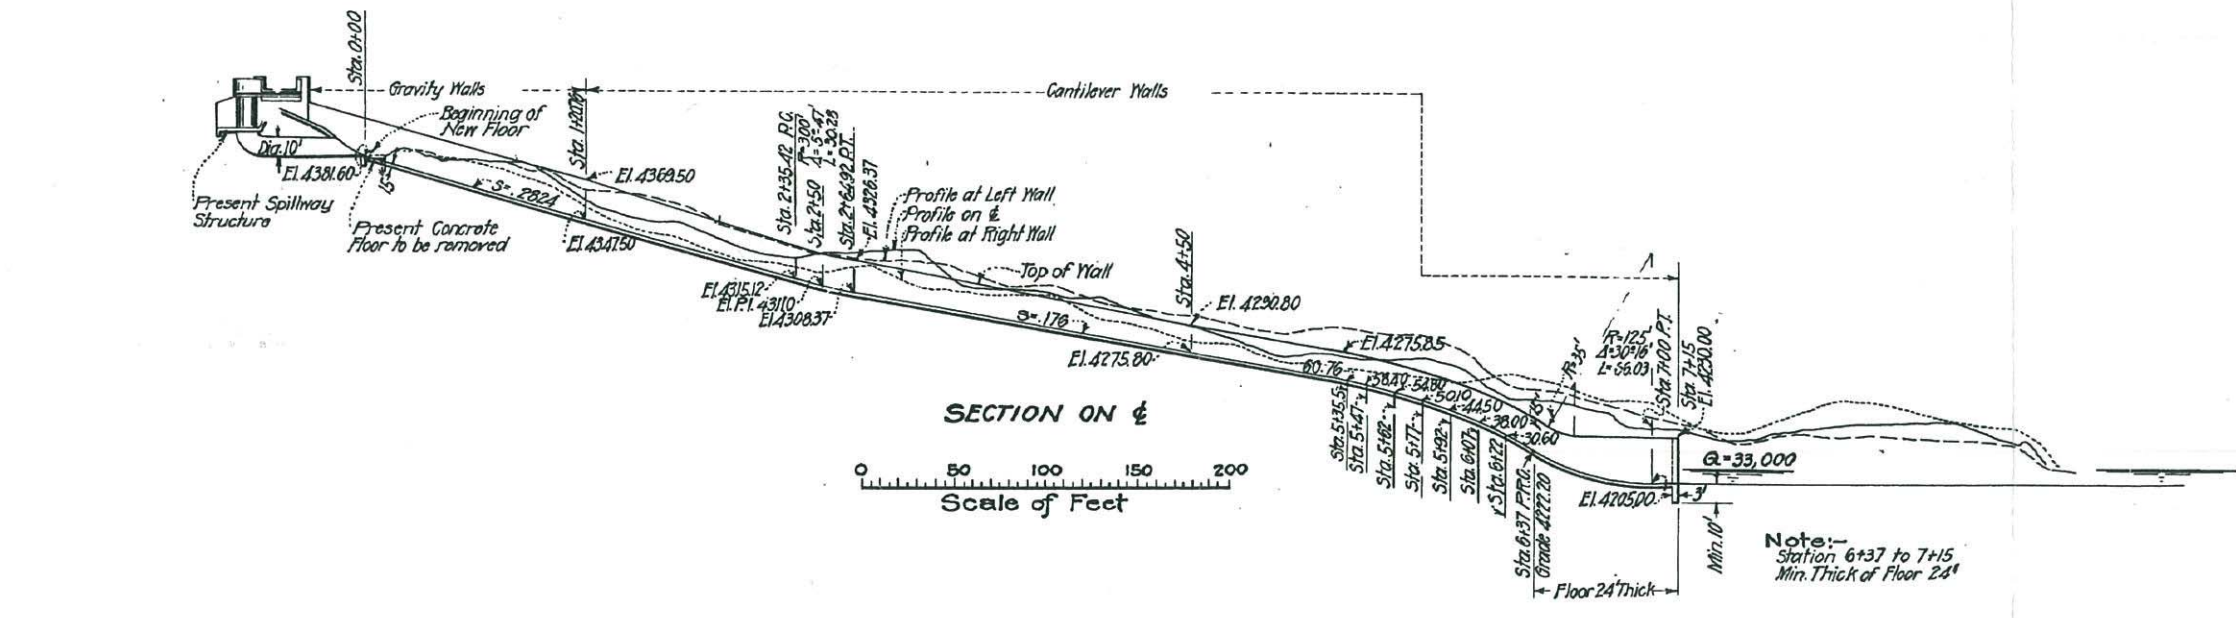
Appendix A: Delamination Map

Hollow Sounding Areas		
Hole #	Depth if drilled	APPROX. STATION
1	1'-8.4"	0+12
2	1'-6.6"	0+19
3	1'-6"	0+33
4	1'-5.4"	0+25
5	N/A	0+67
6	1'-4.2"	0+57
7	N/A	0+57
8	1'-7.4"	0+03
9	N/A	1+20.76
10	1'-8.4"	3+30
11	N/A	3+50
12	N/A	4+26
13	1'-1.8"	4+72
14	N/A	4+92
15	N/A	5+84
16	N/A	6+36
17	1'-3"	6+36
18	N/A	6+57
