Corrosion Protection of Steel Structures by Coal Tar Enamel: 80 Years of Performance

Research and Development Office
Science and Technology Program
Final Report ST-2017-1546-01, 8540-2017-45

August 2017

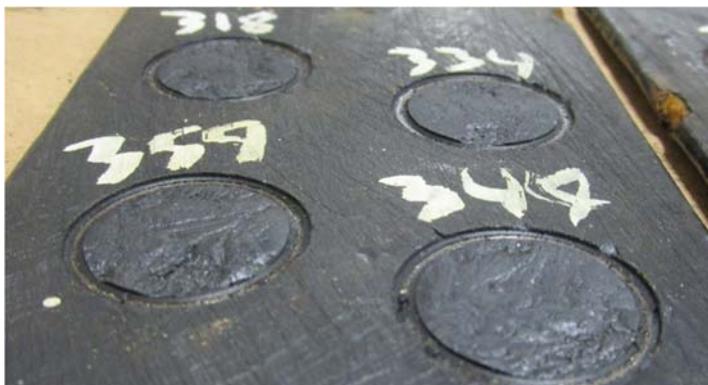
Figure 16. Coal tar enamel surface following adhesion pull-off testing.

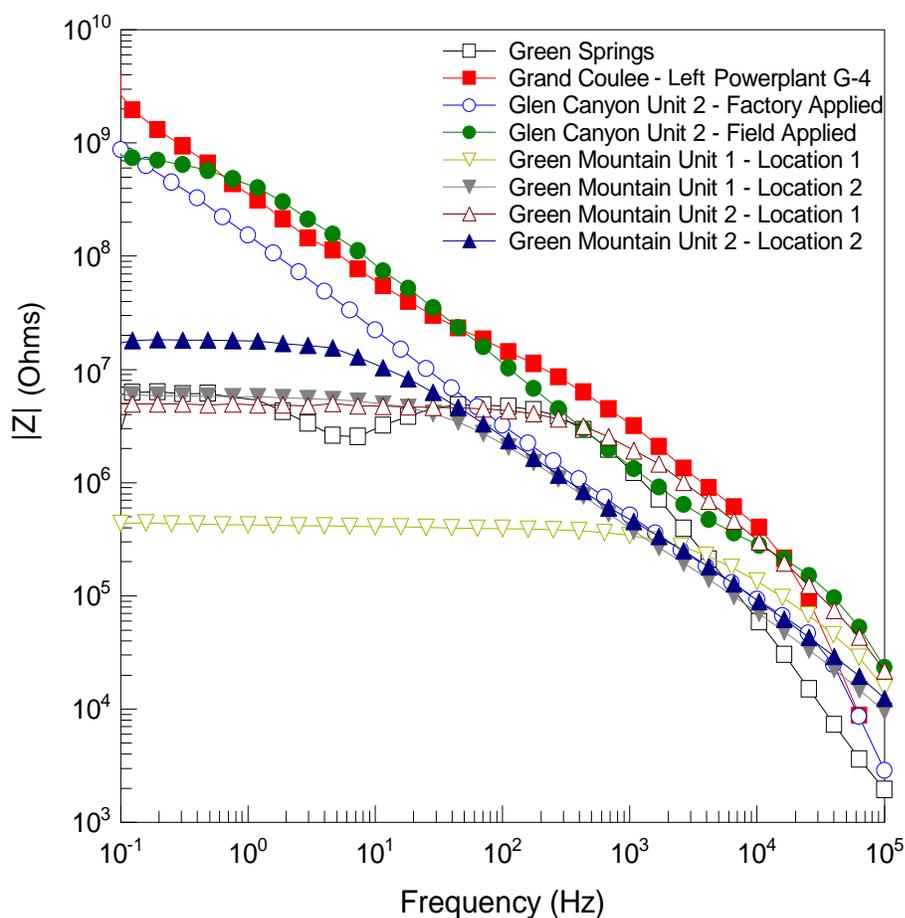
Figure 19. EIS test data for coal tar enamel penstock linings at various facilities.

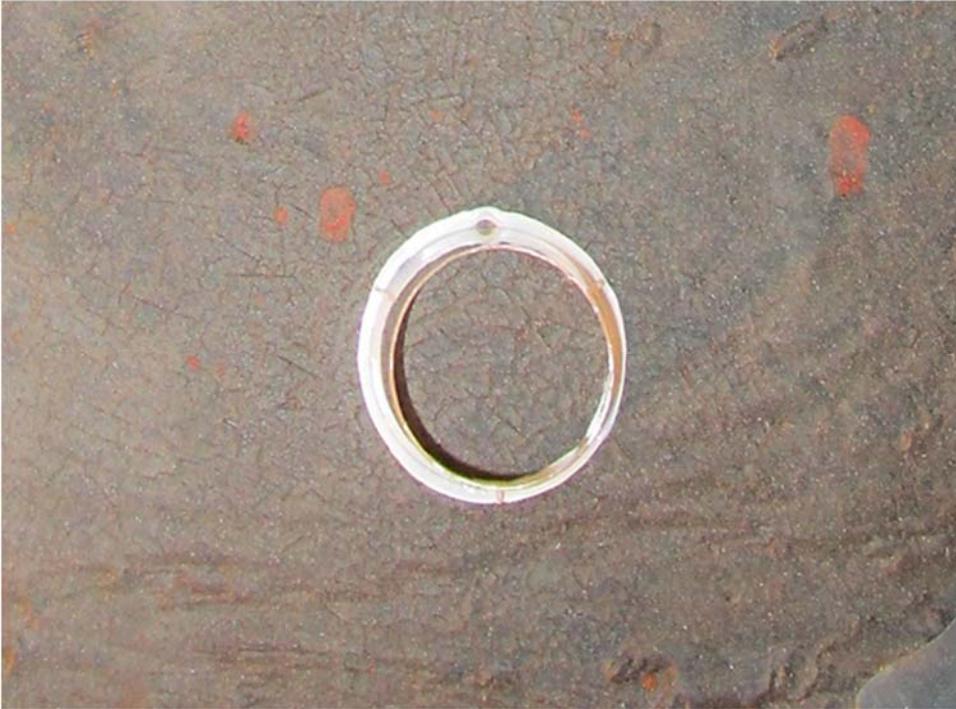
Figure 20. Coal tar enamel coating condition at EIS test cell at Grand Coulee Powerplant G-21 with minor surface cracking.

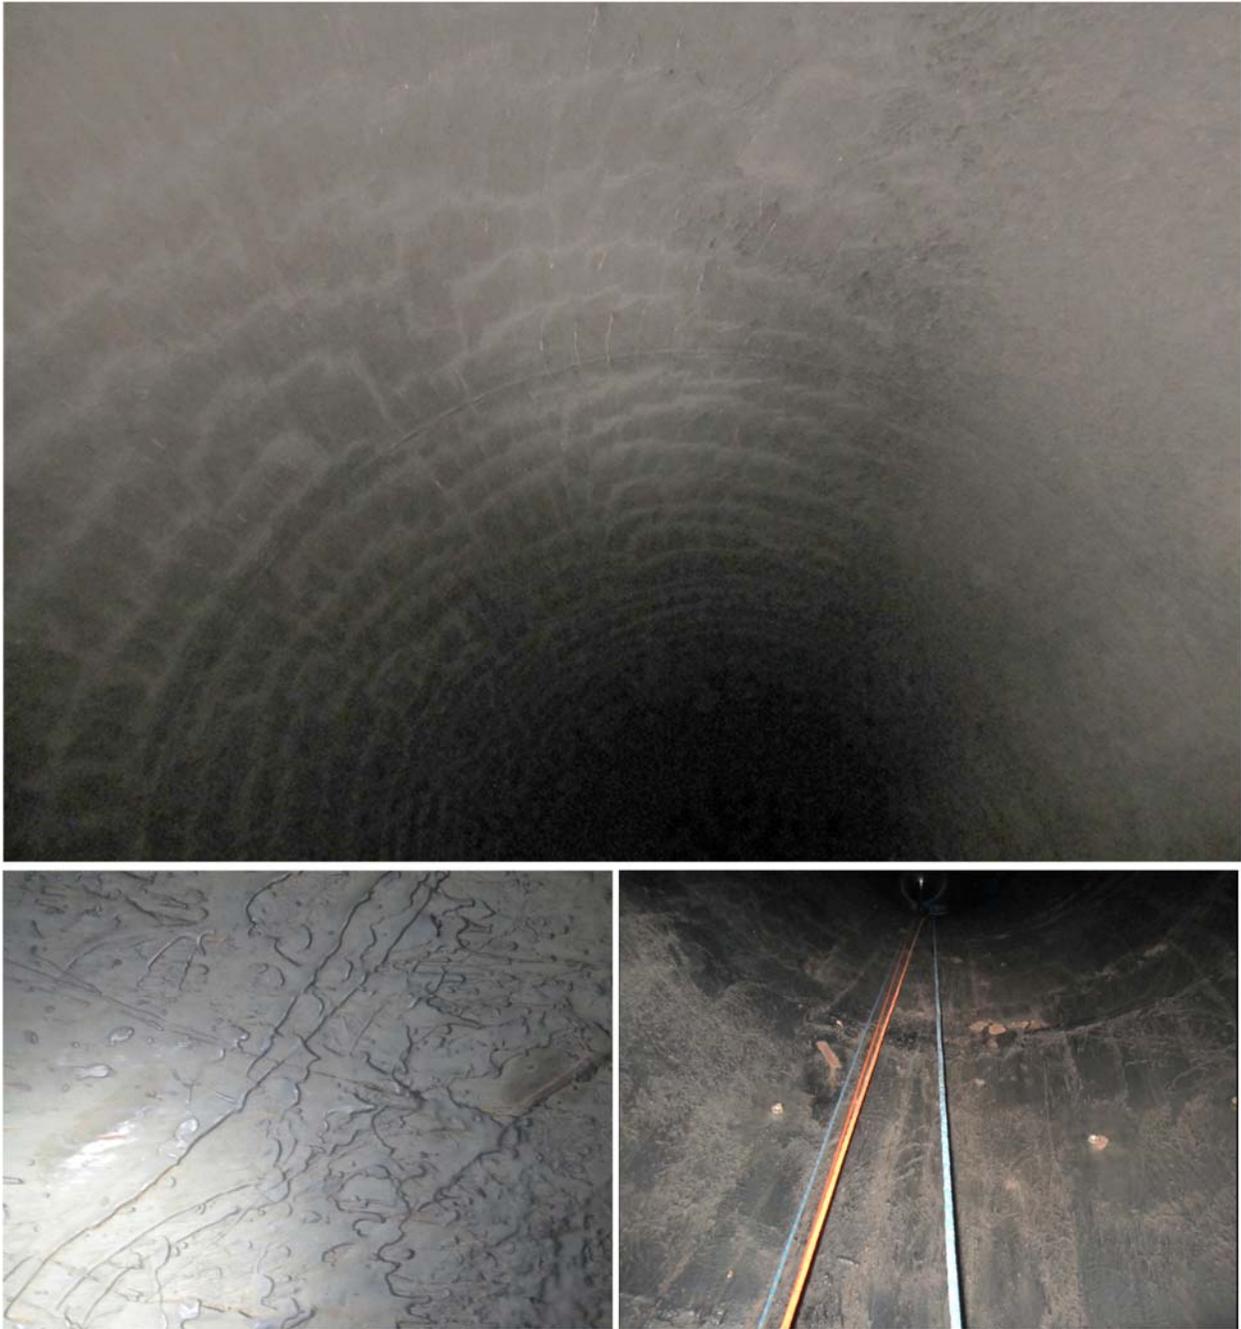
Figure 21. Coal tar enamel (top) applied by hand-dauber in good condition, (bottom-left) applied by mop in good condition, and (bottom-right) applied by hand dauber beginning to crack, chip, and degrade.

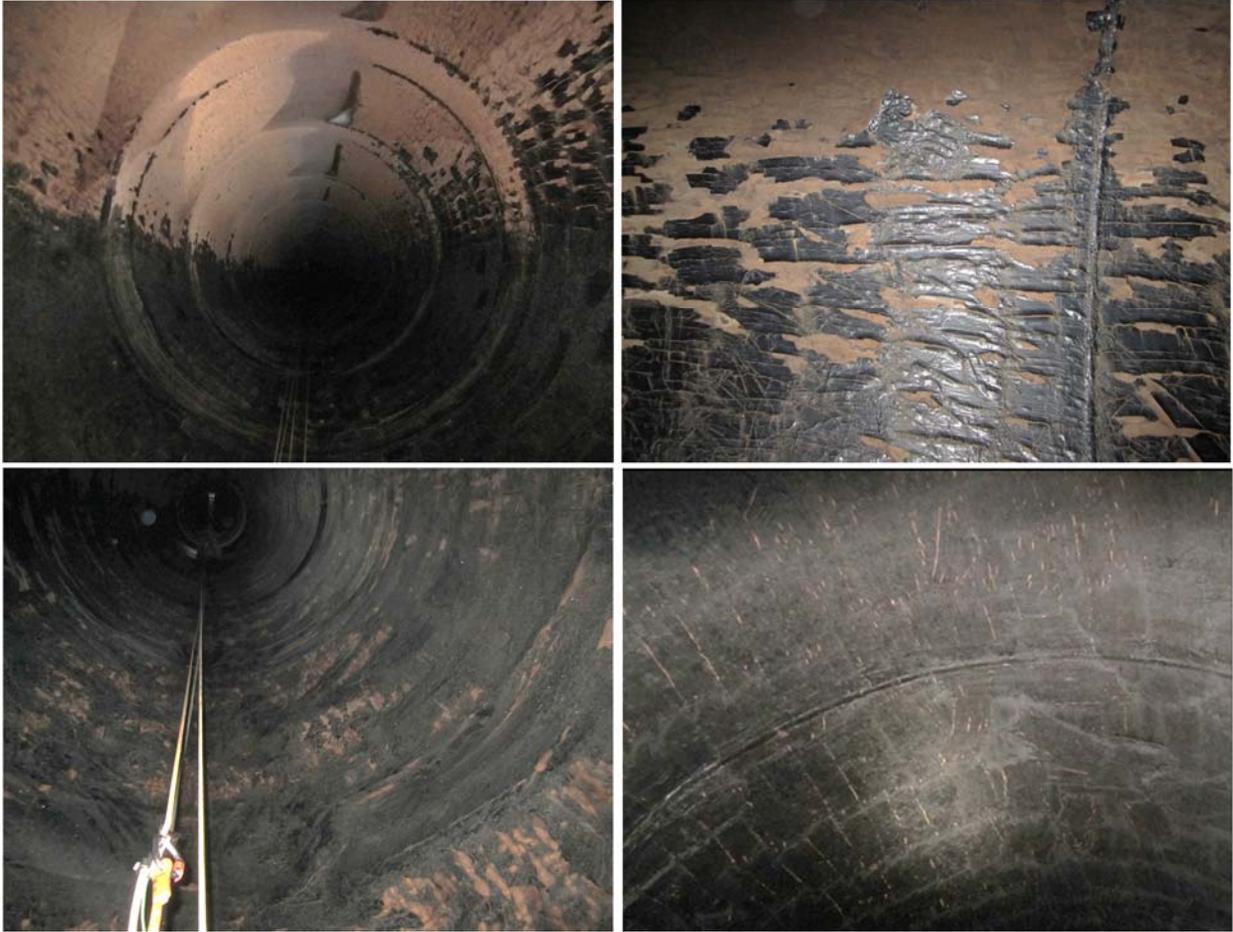
Figure 22. Coal tar enamel hand-dauber degrees of degradation in service: (top-left) severe with close-up at (top-right), (bottom-left) moderate, and (bottom-right) minor-to-moderate.

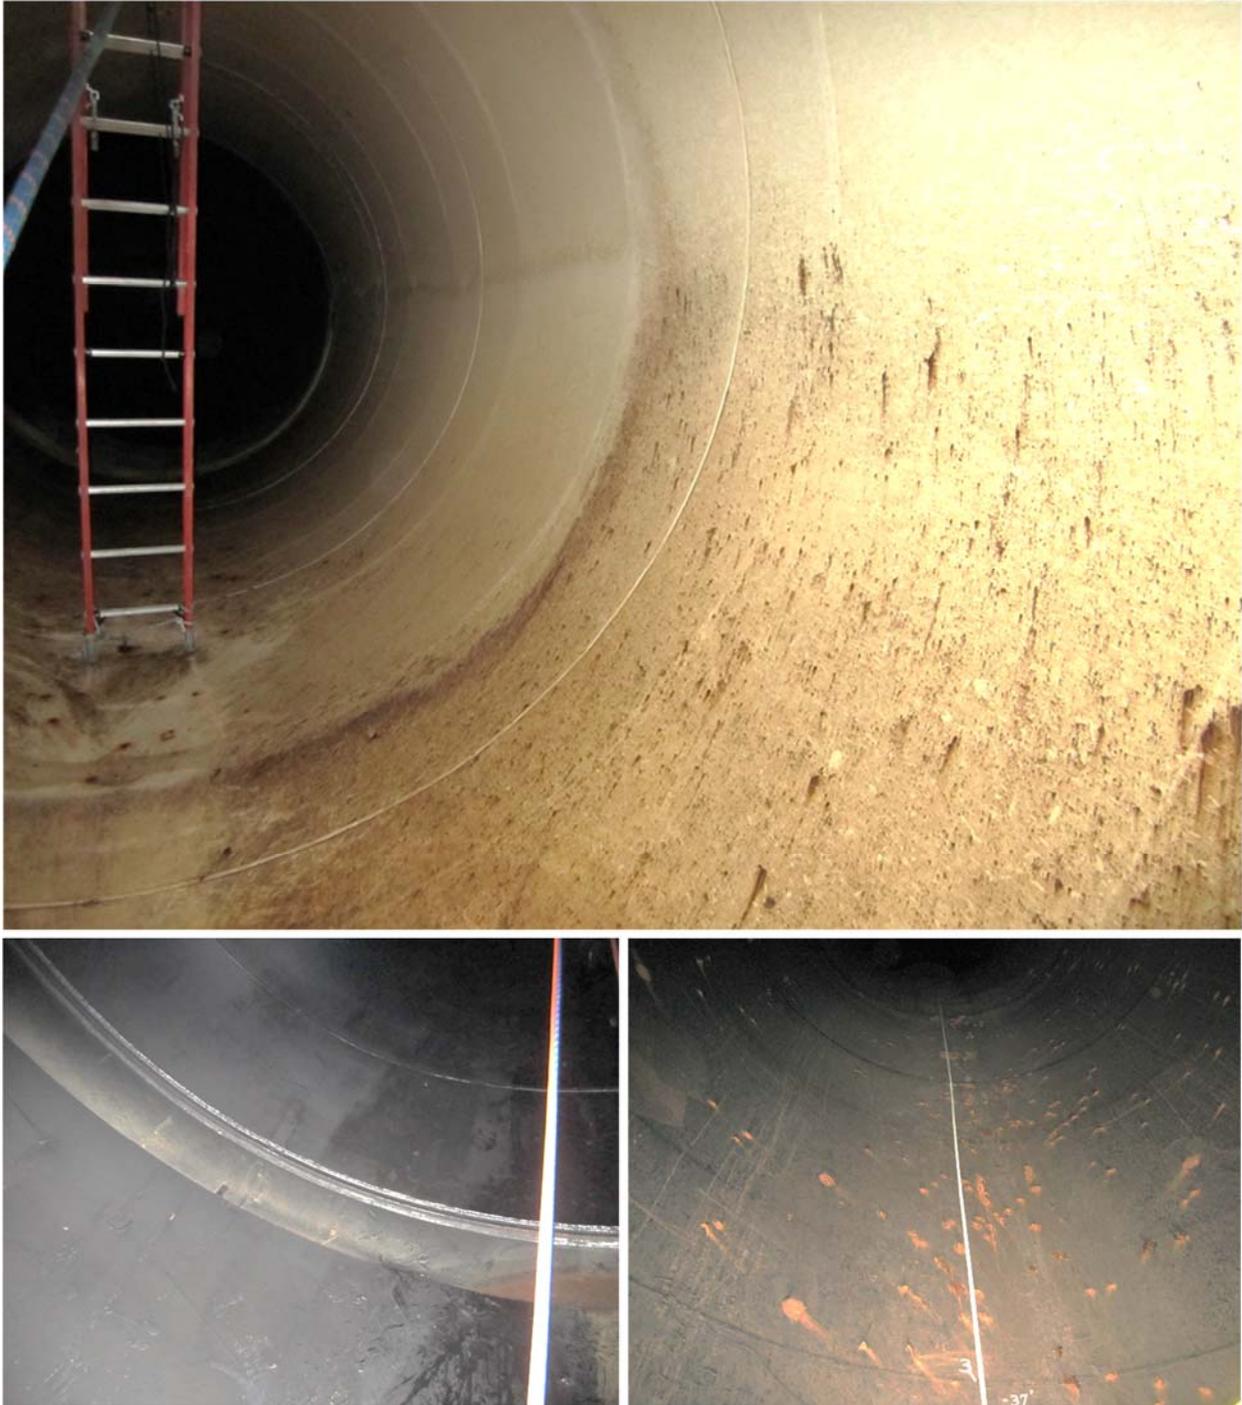
Figure 23. (top) Assumed to be epoxy coating with moderate degradation and coal tar epoxy (bottom-left) in good condition and (bottom-right) with moderate degradation.

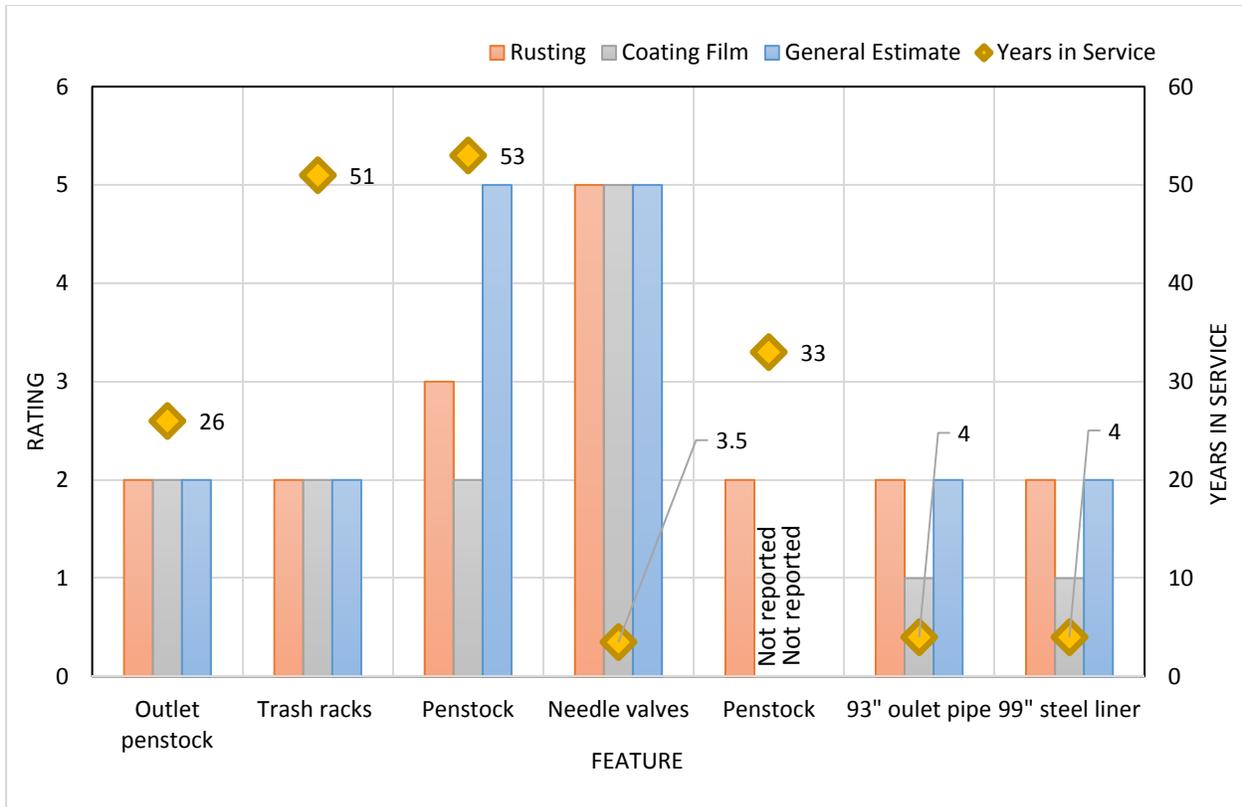
Figure 25. 1985 survey data for coal tar enamel in immersion service, including film condition assessments and years in service.
