Contraction Joint Leak Repair Collaboration

Research and Development Office
Science and Technology Program
Final Report ST-2018-7139-01 (8530-2018-60)

Subject: Travel to Dardanelle Lock and Dam, Arkansas to observe installation of retrofit waterstop through a contraction joint on dam.

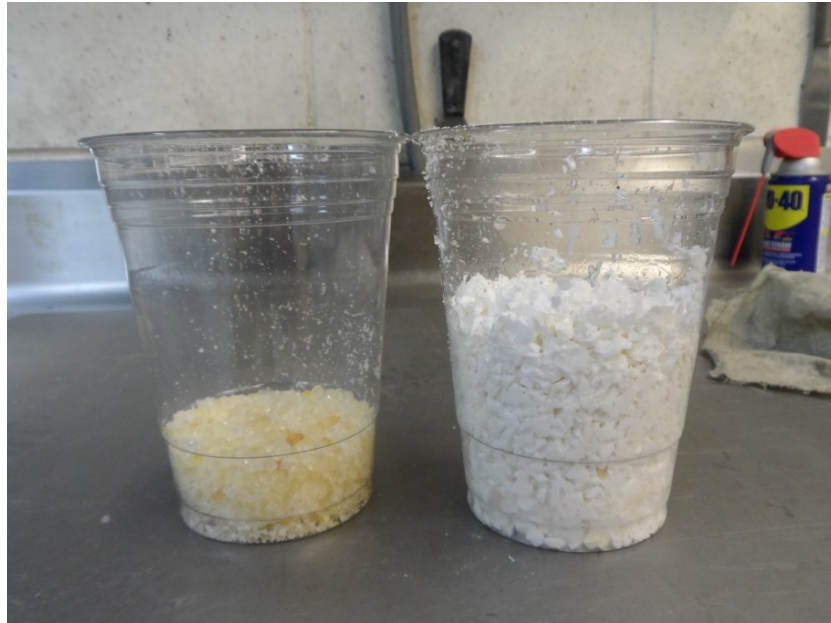
In 2013, the Concrete, Geotechnical, and Structural Laboratory (CGSL) performed work at Grand Coulee Dam using a material called Cylutions, which is manufactured by Imagineered Solutions. The material is of a rubber consistency that was ground-up to the size of very small gravel. When it comes in contact with water it reacts and swells approximately 300% (figure 1). The material was placed into the reservoir at Grand Coulee and allowed enter the contraction joint via water flow from the reservoir into the leaking joint. This field work was shared with others in this collaboration group.

Figure 1. Ground-up Cylutions waterstop. Left side before water and right side right after water was added. The cups contained the same volume of waterstop prior to contact with water.

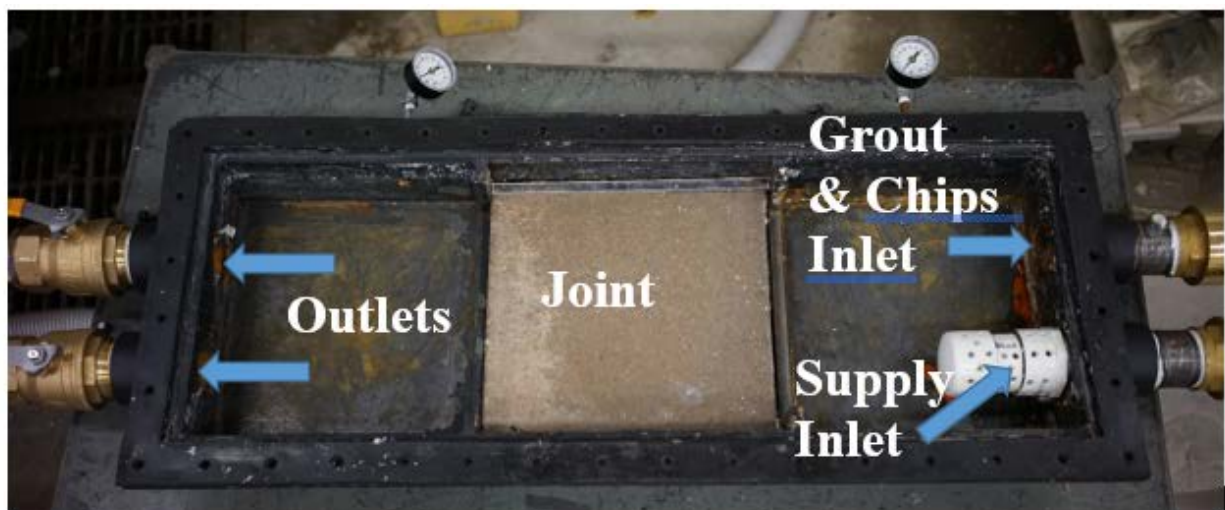
Additional research was performed in the lab using this ground-up Cylutions material and grout. This research involved using a laboratory fixture that closely mimicked the conditions of a leaking contraction joint. The fixture can be seen below in figure 2. The ground-up Cylutions material was used in conjunction with chemical grouts that are used for water leak repairs. The results of that testing was summarized in a report (ST-2016-7688). That report was also shared with this collaboration group.

Figure 2. Internal view of teste fixture mimmicking a leaking contraction joint.

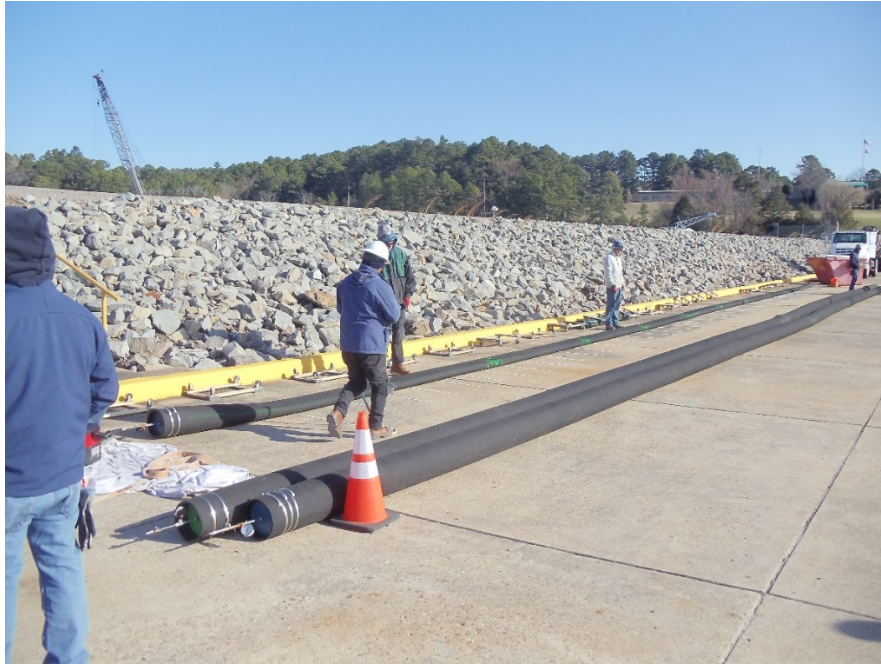
Prior to installation the tubes are pressure tested out in the open to ensure there are no leaks. They are pressurized to 8 psi for about 15 minutes, then at 5 psi for 12 hours while the pressure is monitored. The first step in installing these rubber tube waterstops is to core drill a hole, centered along the contraction joint. The core holes at this dam were 10-inch diameter. The waterstop tube was also 10-inch diameter (pre-filled size). To aid in installation, the tube is first evacuated with a shop vacuum (see Figure 3). Afterwards, the contractor installs zip ties and duct tape at specific intervals to hold the shape of the collapsed membrane, and then disconnects the vacuum. The membrane is loaded onto multiple dollies (spread out along the length) and moved to location by hand (see Figure 4). A spindle assembly is installed near the core hole, and the membrane is then manually inserted into the hole (see Figure 5). As the membrane is installed the zip ties are cut and removed. Once installed, the contractor pulls up on a steel wire which cuts the duct tape, and also collects the pieces as the wire is retracted (see Figure 6 and 7). The contractor then slightly lifts up on the membrane to lift the waterstop off the bottom of the hole, and fills the membrane with approximately 5 gallons of water to seat the membrane. After seating, the contractor lets the waterstop rest again on the bottom of the hole, and then fills the remainder of the membrane up with water. The contractor was using tap water for this application. The contractor has indicated that in very cold climates, clear glycol fluid has been used. In this particular location, the concrete cover was sufficient enough that freezing would not be an issue. After filling, the contractor inserts a CCTV camera and inspects the length of membrane to ensure the membrane has opened up completely (sealed), and there are no tears or bulges. The use of clear water is also important for this very purpose. The contractor indicated that in certain climates, if the water is clear enough in the reservoir, tap water is not necessary. In this particular location, the Arkansas River is extremely muddy and would not allow for inspection if used. Prior to installation of this waterstop, the seepage through the contraction joint was visible on the downstream side (see Figure 9). After installation and filling, the seepage appeared to be eliminated effectively. However, the lock was in the closed position during installation (filled with water), and was in the open position after installation (water was approximately 45 feet lower). The lock was filled again after installation, and the seepage was verified to have been significantly reduced (see Figure 10). After installation and inspection, the tube is cut off flush with the surface and sealed at the top. At a later date, the contractor installs an inspection cover (see Figure 8).

Figure 5 – View showing three waterstop membranes. The two membranes in the foreground are currently being tested with pressure. The membrane in the background is being collapsed with a vacuum.

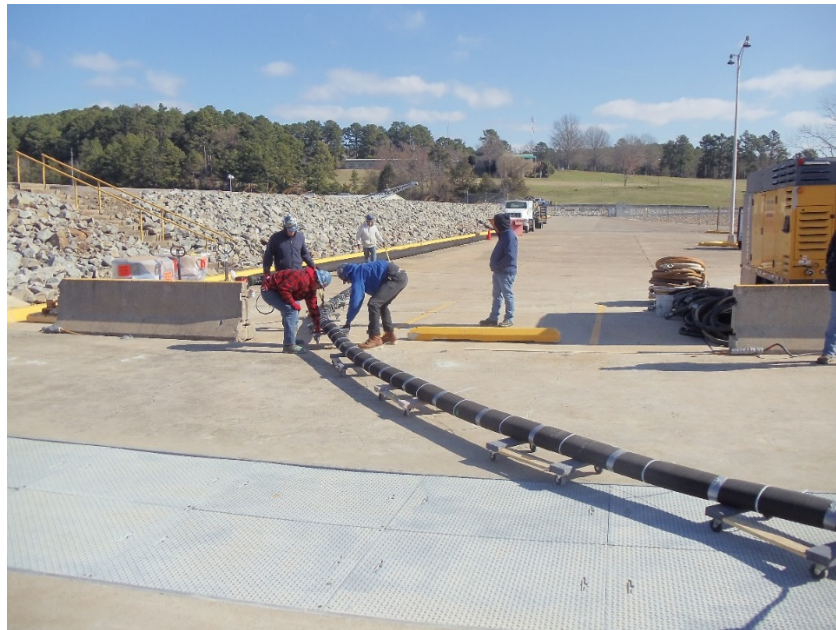
Figure 6 – View showing the waterstop membrane being transported to the core hole via dollies. Note duct tape and zip ties holding the collapsed shape.

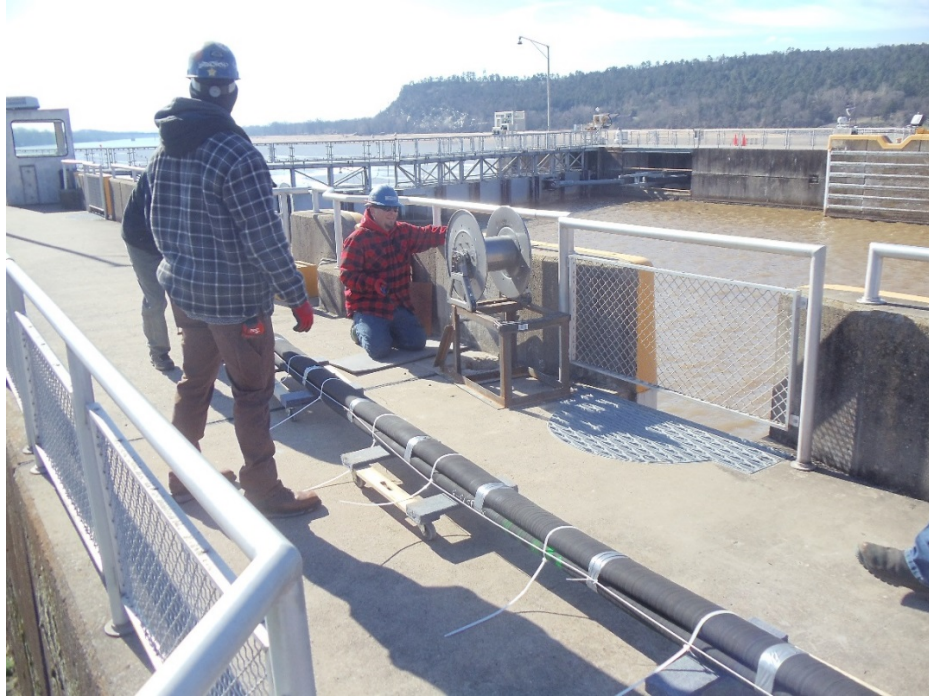
Figure 7 – View showing the waterstop membrane just prior to install into the core hole. Note the spindle used to aid in dropping / guiding the membrane into the core hole.

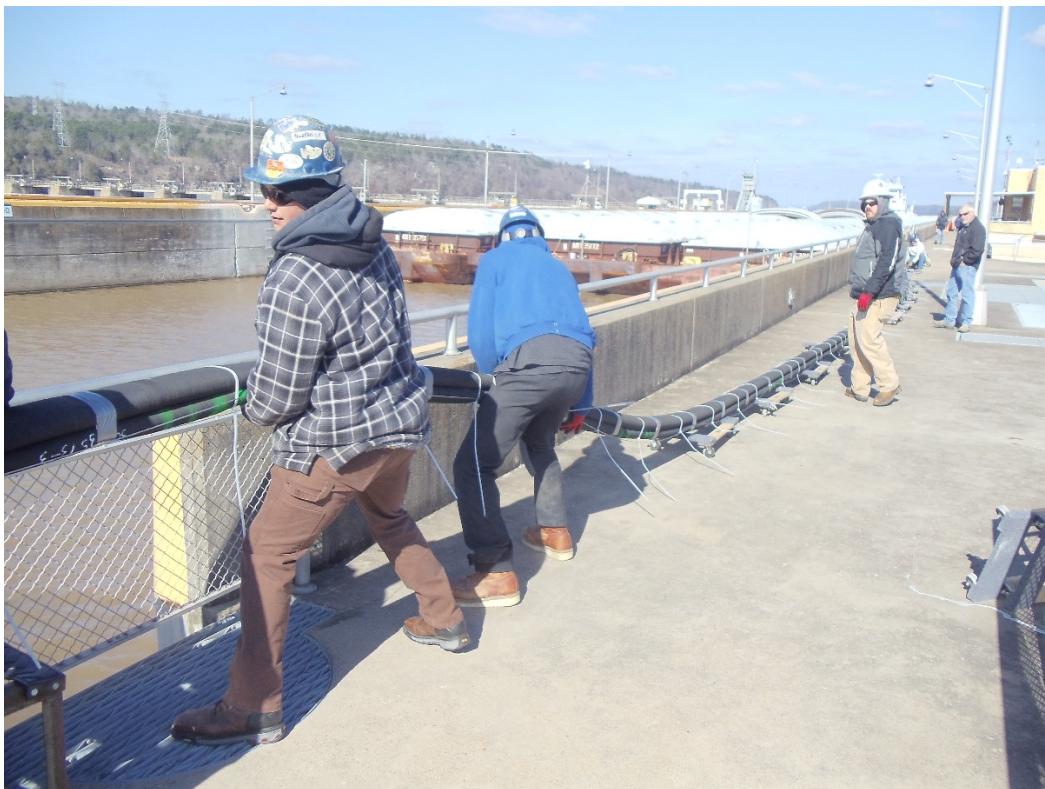
Figure 8 – View showing the manual installation of the membrane into the core hole.

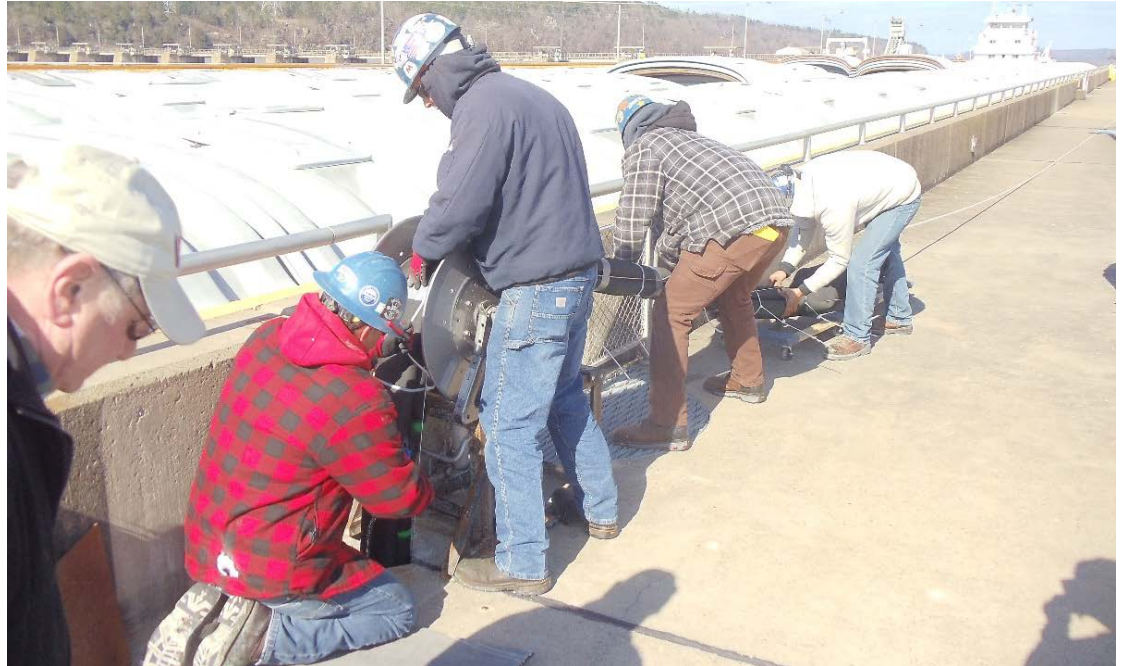
Figure 9 – View of showing the contractor cutting the zip ties as the membrane is inserted. The metal wire is used to cut and remove the duct tape after installation.

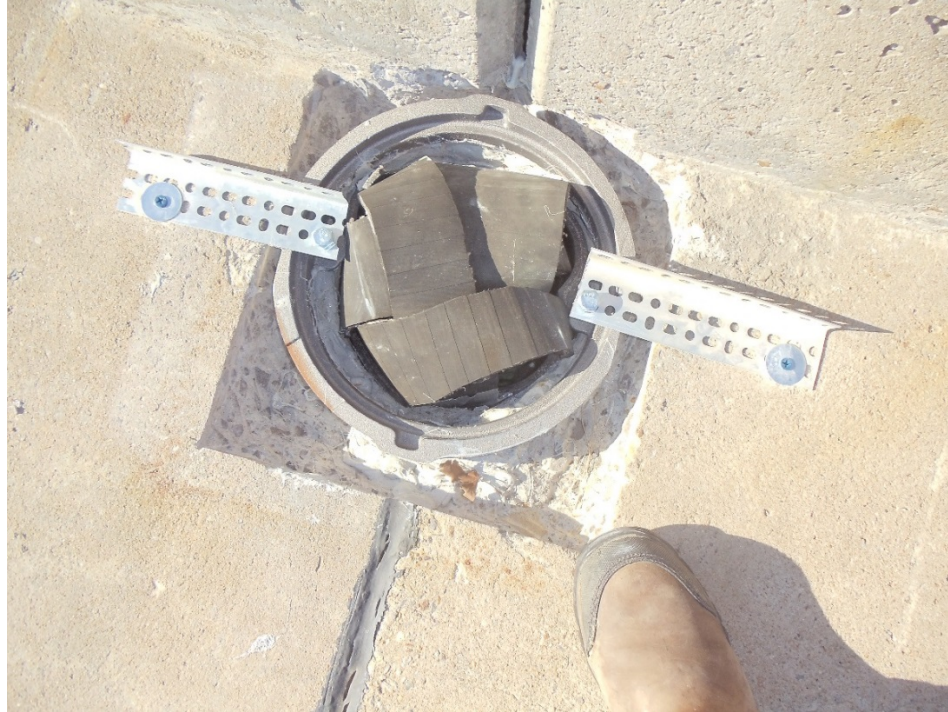
Figure 10 – View showing a previously completed installation. The concrete was cut out to allow installation of the inspection cover (to be filled in with repair mortar at later date). The temporary brackets will be removed after the repair mortar has set.

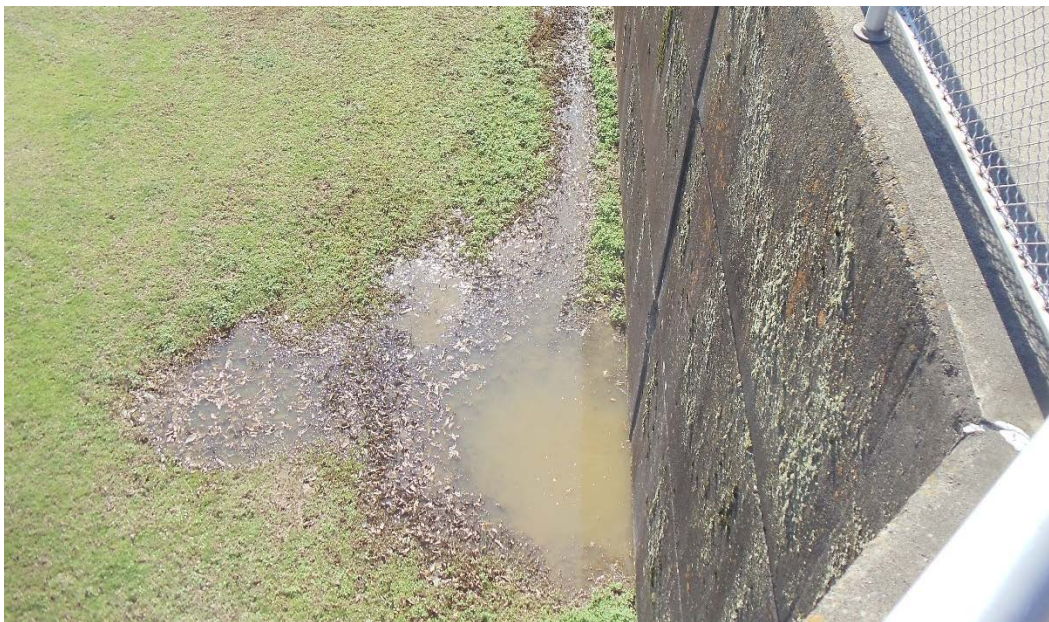
The waterstop tubes are located along the contraction joints of the dam and lock, in areas where seepage has been problematic. The seepage through the contraction joints was attributed to the metal waterstop (from original construction) failing. Metal waterstops were commonly installed along contraction joints in many Reclamation facilities from the early 1920's up to the 1970's. Rubber waterstops were introduced in the 1950's, and PVC waterstops in the 1970's. Unfortunately, use of these flexible materials was not readily accepted until years later. In many cases, rubber waterstops were installed in combination with metal waterstops, due to the uncertainty with the rubber waterstops. Pueblo Dam has a similar feature in which a metal waterstop was installed as the first line of defense (upstream most waterstop), followed by a formed drain and then a PVC waterstop. The PVC material was new at the time of construction (1970's), and faith in the material was limited at the time. Metal waterstops have been shown to be effective, if ideal conditions are present. These conditions include proper consolidation of the concrete around the waterstop, and very little movement of the joint (if any at all). Metal waterstops are commonly constructed from copper, or other form of non-deleterious metal. Dardanelle Dam (and Pueblo Dam) continually expands and contract throughout the year, and the metal waterstop has likely failed due the repetitive cyclic movement. During the winter months, when the water in the Arkansas River is coldest, the seepage through the contraction joints at Dardanelle Dam is greatest. During the summer months, the seepage significantly decreases, and in many of the joints, completely stops all together. Pueblo Dam is also located on the Arkansas River, however, the water temperature fluctuations at Pueblo Dam are significantly less than those seen at Dardanelle Dam. The water that is stored at Pueblo Dam is snow runoff water, and is very cold even in the summer months. The seepage at Pueblo Dam also fluctuates from summer to winter due to the temperature changes, although not nearly as much as what is reported at Dardanelle Dam.

Figure 11 – View showing seepage at the contraction joint prior to insertion of waterstop membrane. Water could be seen exiting face, and percolating upwards from soil.

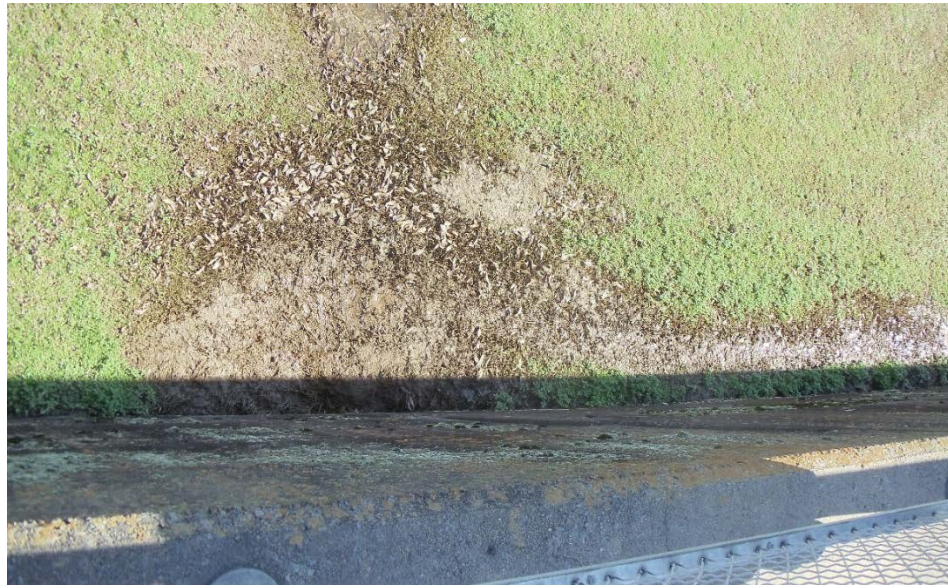
Figure 12 – View showing seepage at the contraction joint after installation and filling of the waterstop membrane.

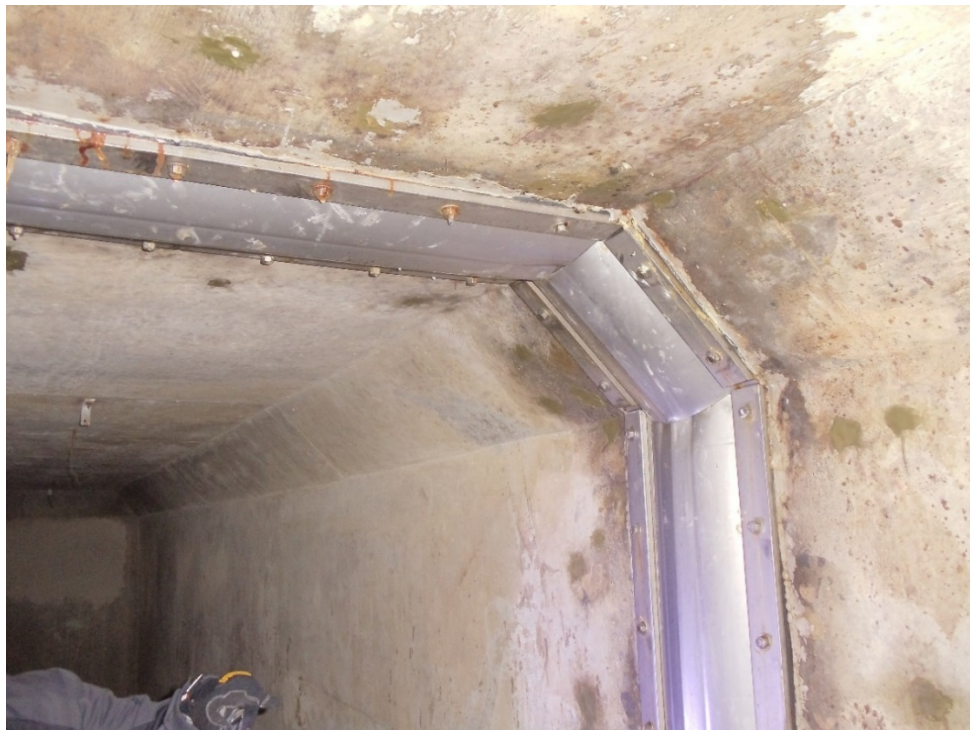
Figure 13 – View showing a waterstop system installed along a contraction joint within the inspection gallery. Note the waterstop is bulged outwards due to the water pressure.

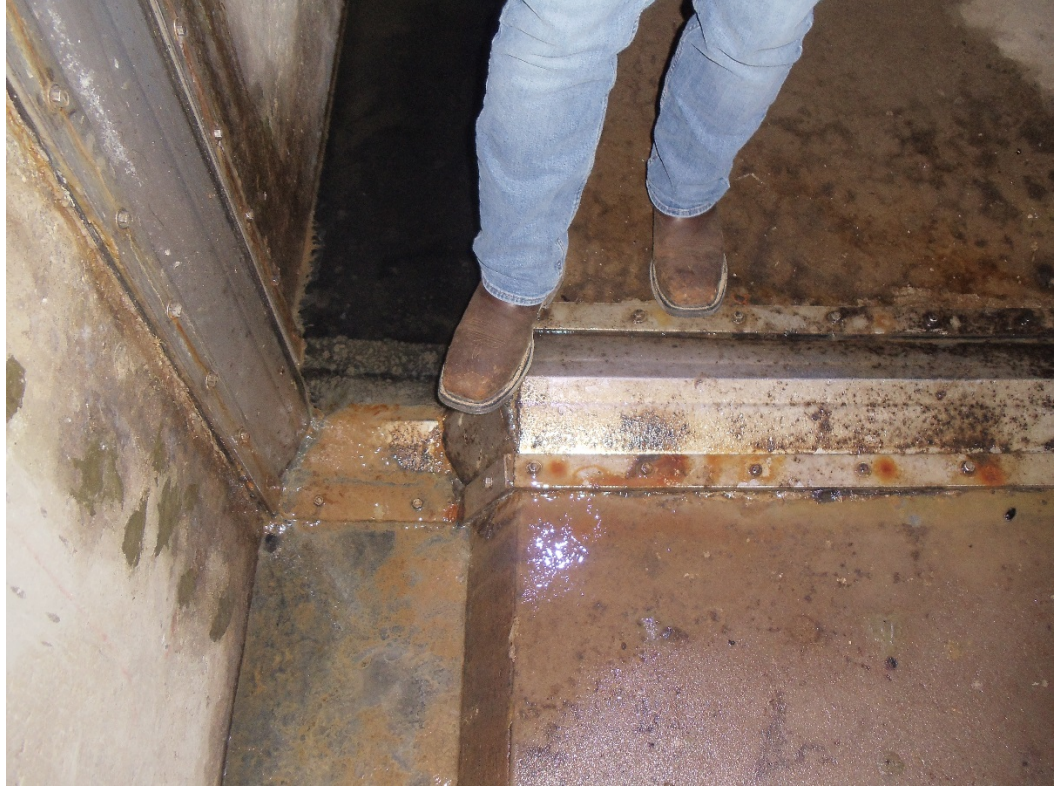
Figure 14 – View showing the bottom portion of waterstop system shown in Figure 11. Note the waterstop is bulged outwards due to the water pressure.
