Technical Memorandum No. 8540-2017-028

Condition Assessment of FRP Composite Pipe and Tanks

Research and Development Office
Science and Technology Program
Final Report ST-2017-1701-01

September 2017

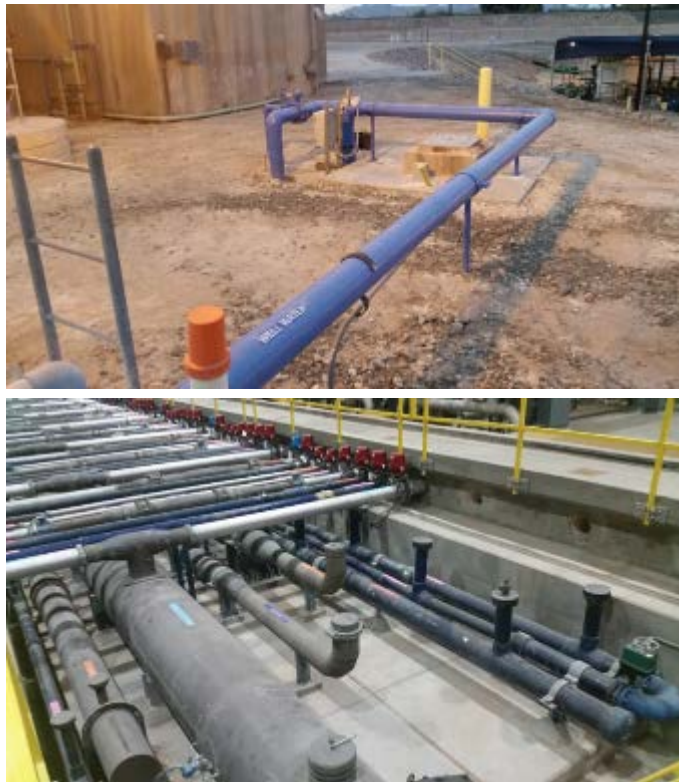
The GRP aboveground pipeline at Yuma Desalting Plant range between 20 to 30 years old. There are also some new pipelines that are shown in figure 2. Pipelines are mostly used for low and moderate pressure water (~ 0.7 MPa) as well as for cleaning chemicals. All the pipelines were produced by Koch Fiberglass. Failures have only occurred at the fittings (taper fit elbows and quick key couplings) and faulty assembly procedures (disengagement of the fittings due to bad bonding practice) during original construction. Visual inspection has been performed whenever a problem occurs by disassembling the pipe. Visual inspection has found no evidence of degradation of the pipe. There are also some 30-year-old GRP tanks at Yuma Desalting Plant and they have not shown any issues.

Figure 2. — GRP aboveground pipelines at Yuma Desalting Plant.

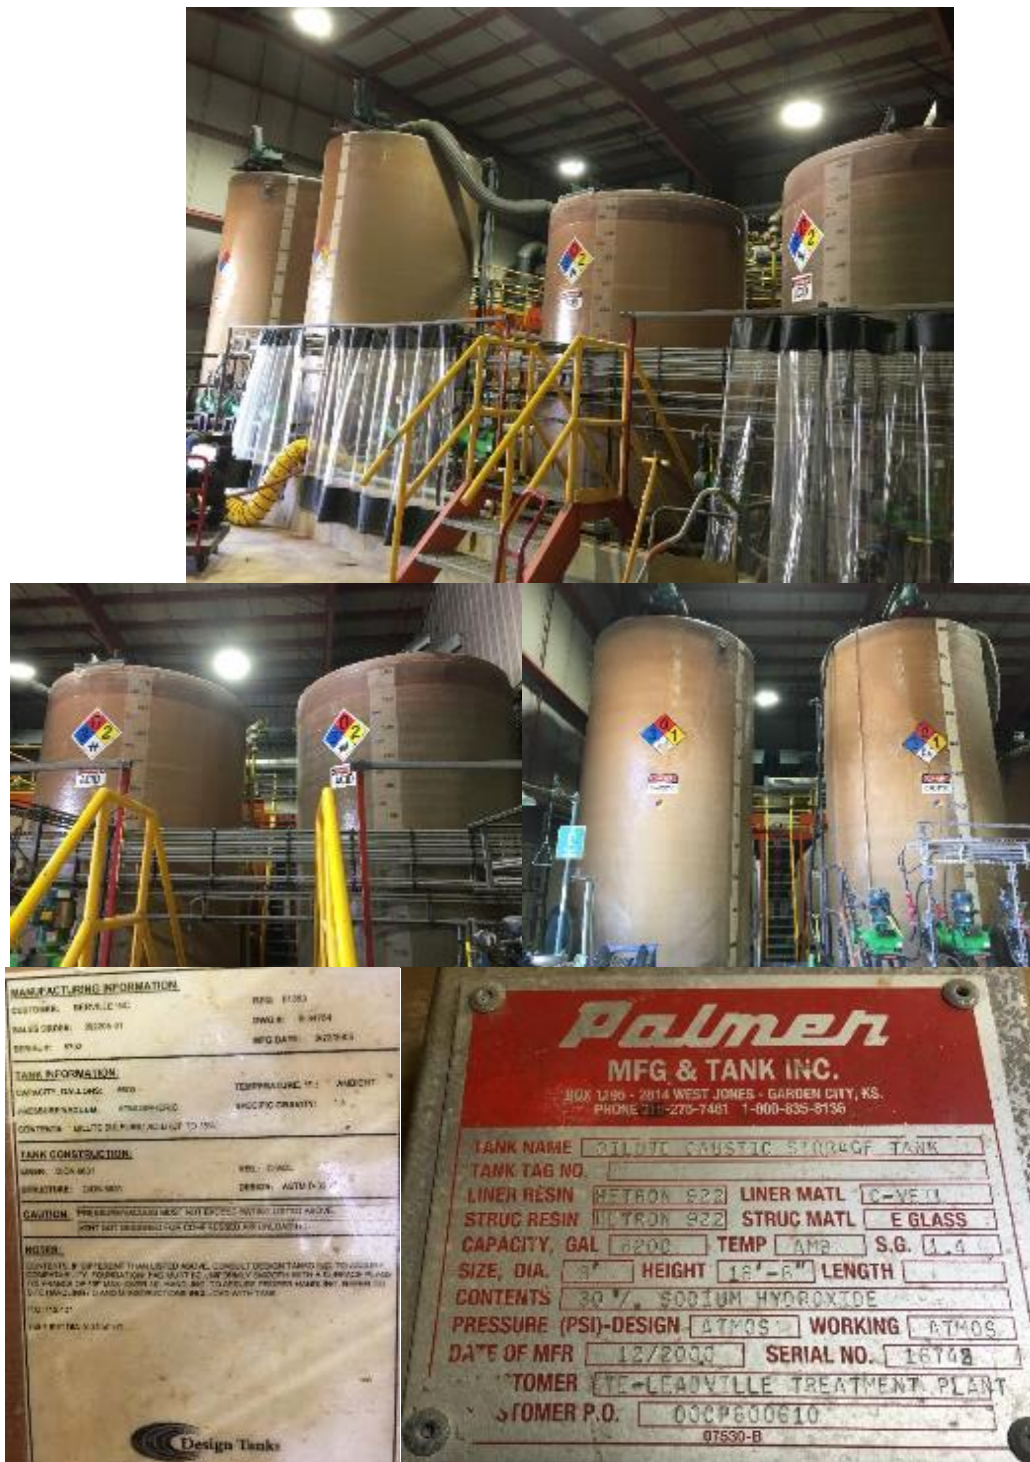
Inspection was performed on both acid and caustic tanks (figures B-1 and B-2). These tanks are used for chemical treatment and cleaning water. Visual inspection was a reliable and easy method to detect blisters, air pockets, voids, and delamination in FRP tanks. Digital tap hammer could also be used as a tool for detecting delamination by change in the sound.

Figure B-1.—Acid and caustic tanks used for water treatment with their manufacturing information

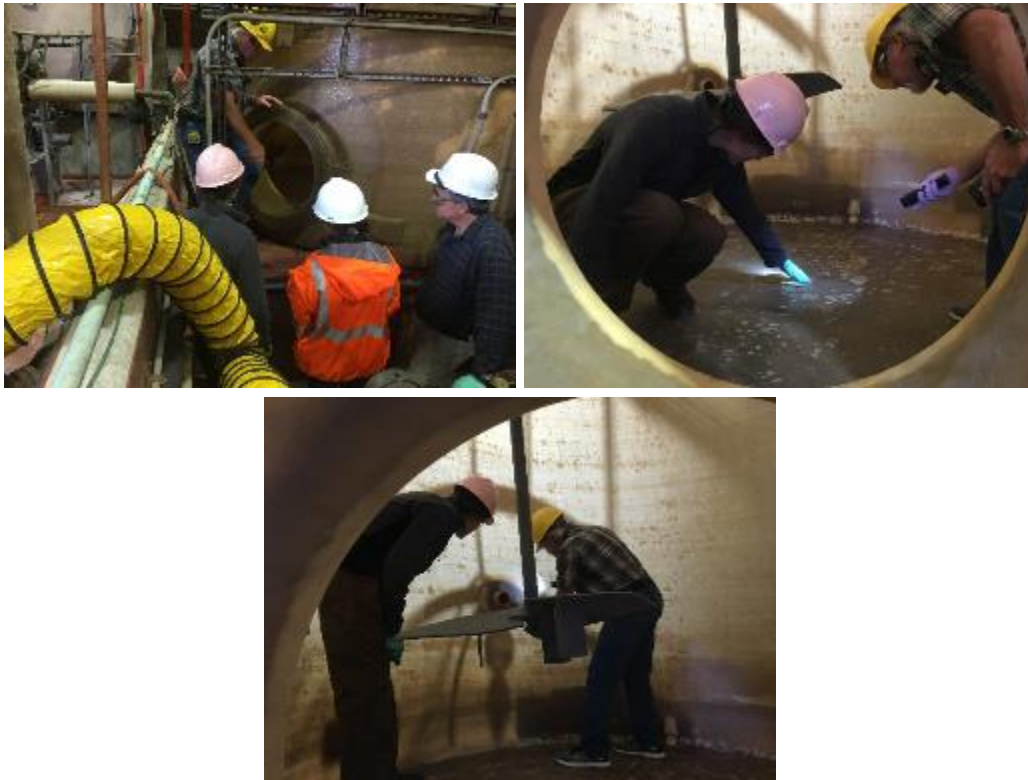
Figure B-2.—Visual inspection of the acid tank interior
