HY11491

**Uplift Pressures Below Spillway Chute Slabs at Unvented Open Offset
Joints**

Tony L. Wahl, Member, P.E.¹; K. Warren Frizell²;
and Henry T. Falvey, Life Member, Dr.Ing., Hon. D.WRE³

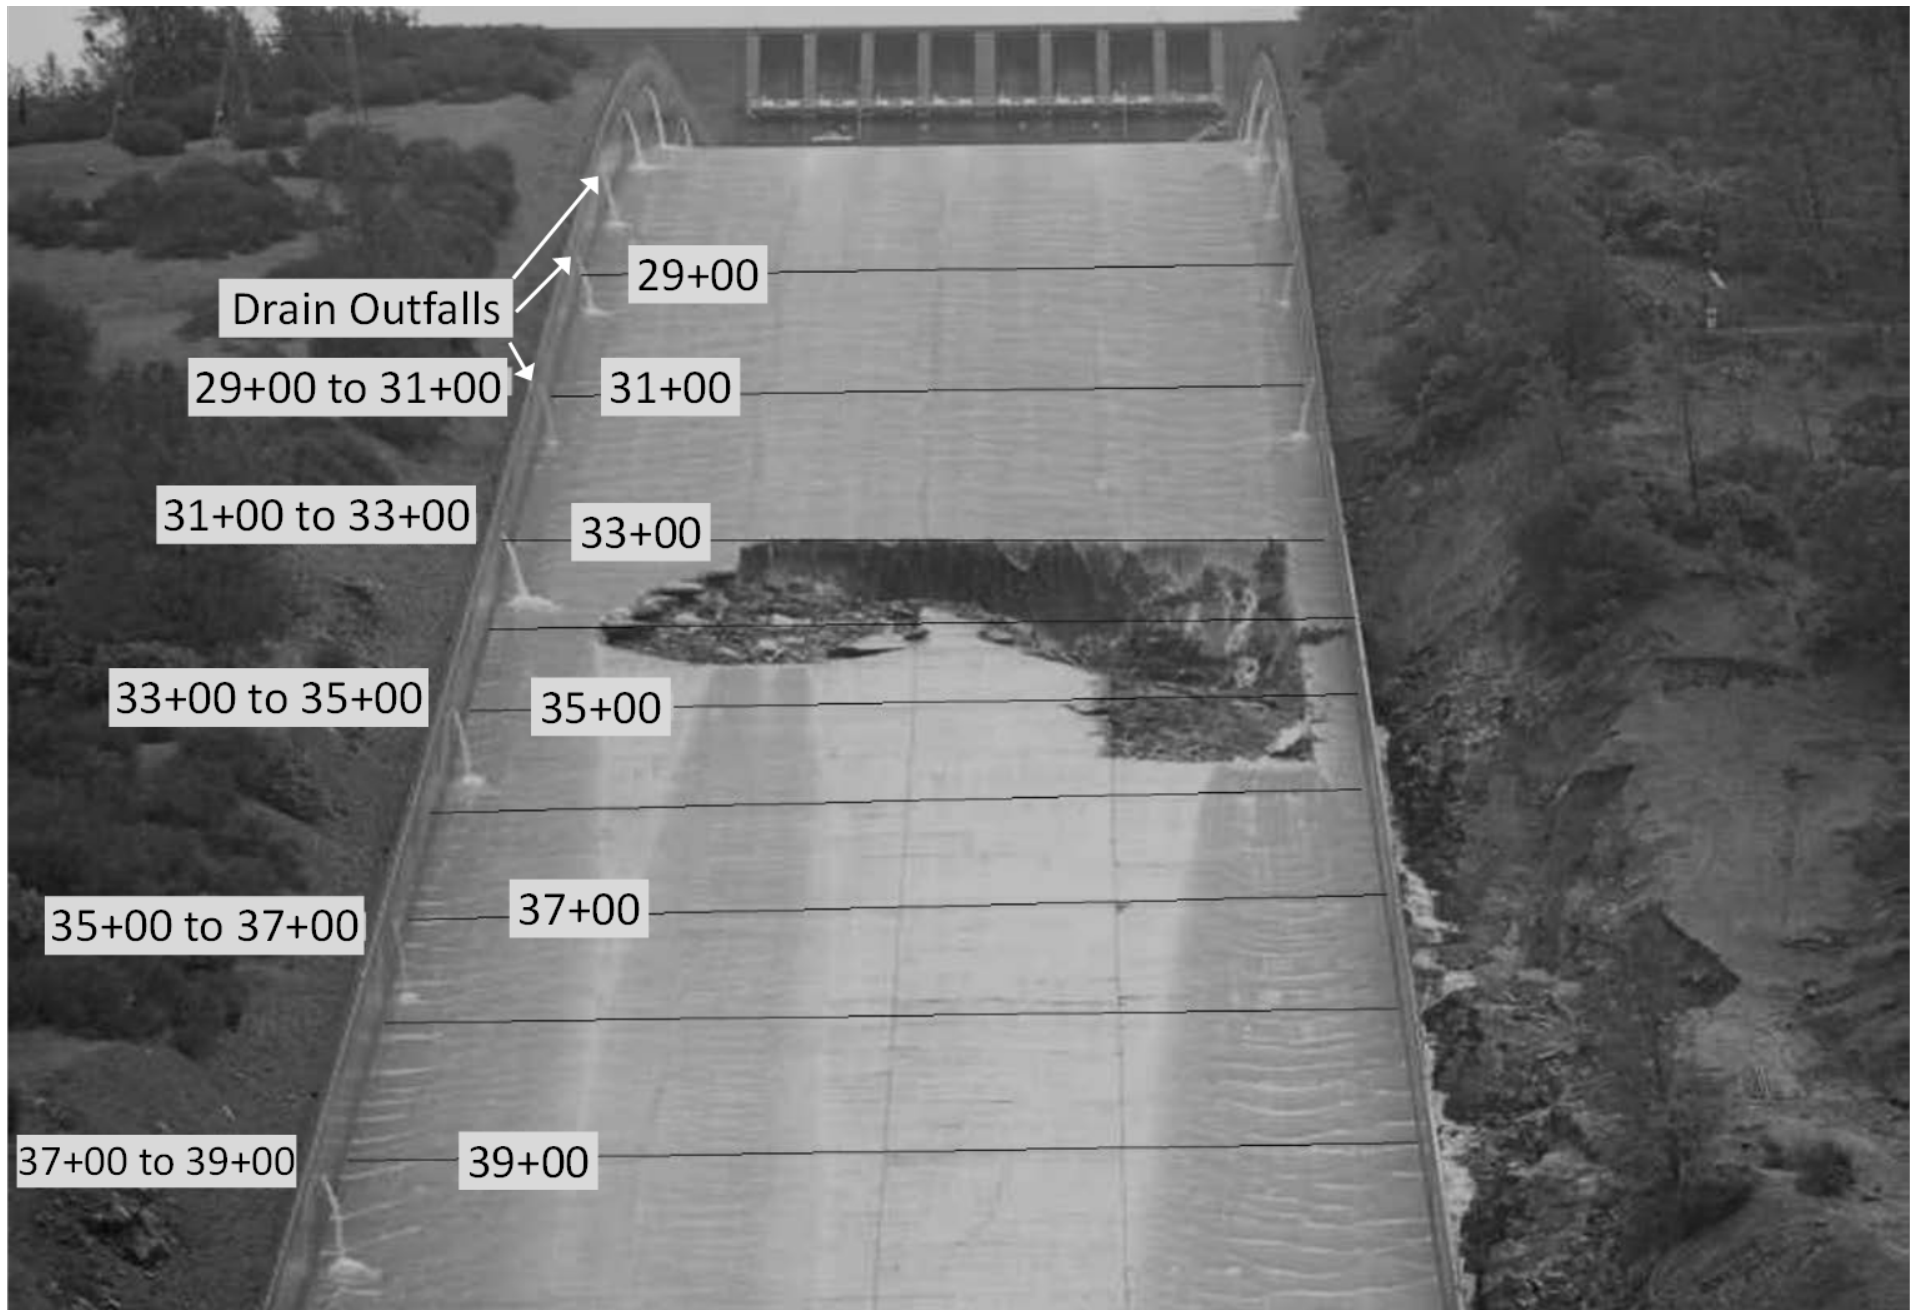
139 12:25 p.m. the spillway gates were closed, revealing the damage shown in Figure 1.

172 The IFT concluded that the spillway chute failure most likely was initiated by uplift and removal
173 (hydraulic jacking) of a section of the chute slab near Sta. 1020 m (33+50 ft), just downstream
174 from the end of the vertical curve in the chute that transitions from a 5.67% slope to a 24.5%
175 slope. High-velocity flow then rapidly eroded moderately to highly weathered rock and soil-like
176 foundation materials beneath adjacent slabs. The initial uplift failure was believed to have affected
177 only part of one of the 12.2- by 15.2-m (40- by 50-ft) chute slab panels, and could have removed
178 something as small as a localized repair patch or a spall above a drain, or as large as a 6-m (20-ft)
179 section located between cracks that existed above the herringbone drains partially embedded in the
180 bottom of the slab. Once the initial portion of the slab failed, it probably triggered a rapid chain of

Figure 1. — Spillway damage observed after gates were initially closed at midday, February 7, 2017 (DWR photo; reprinted from IFT 2018, with permission).

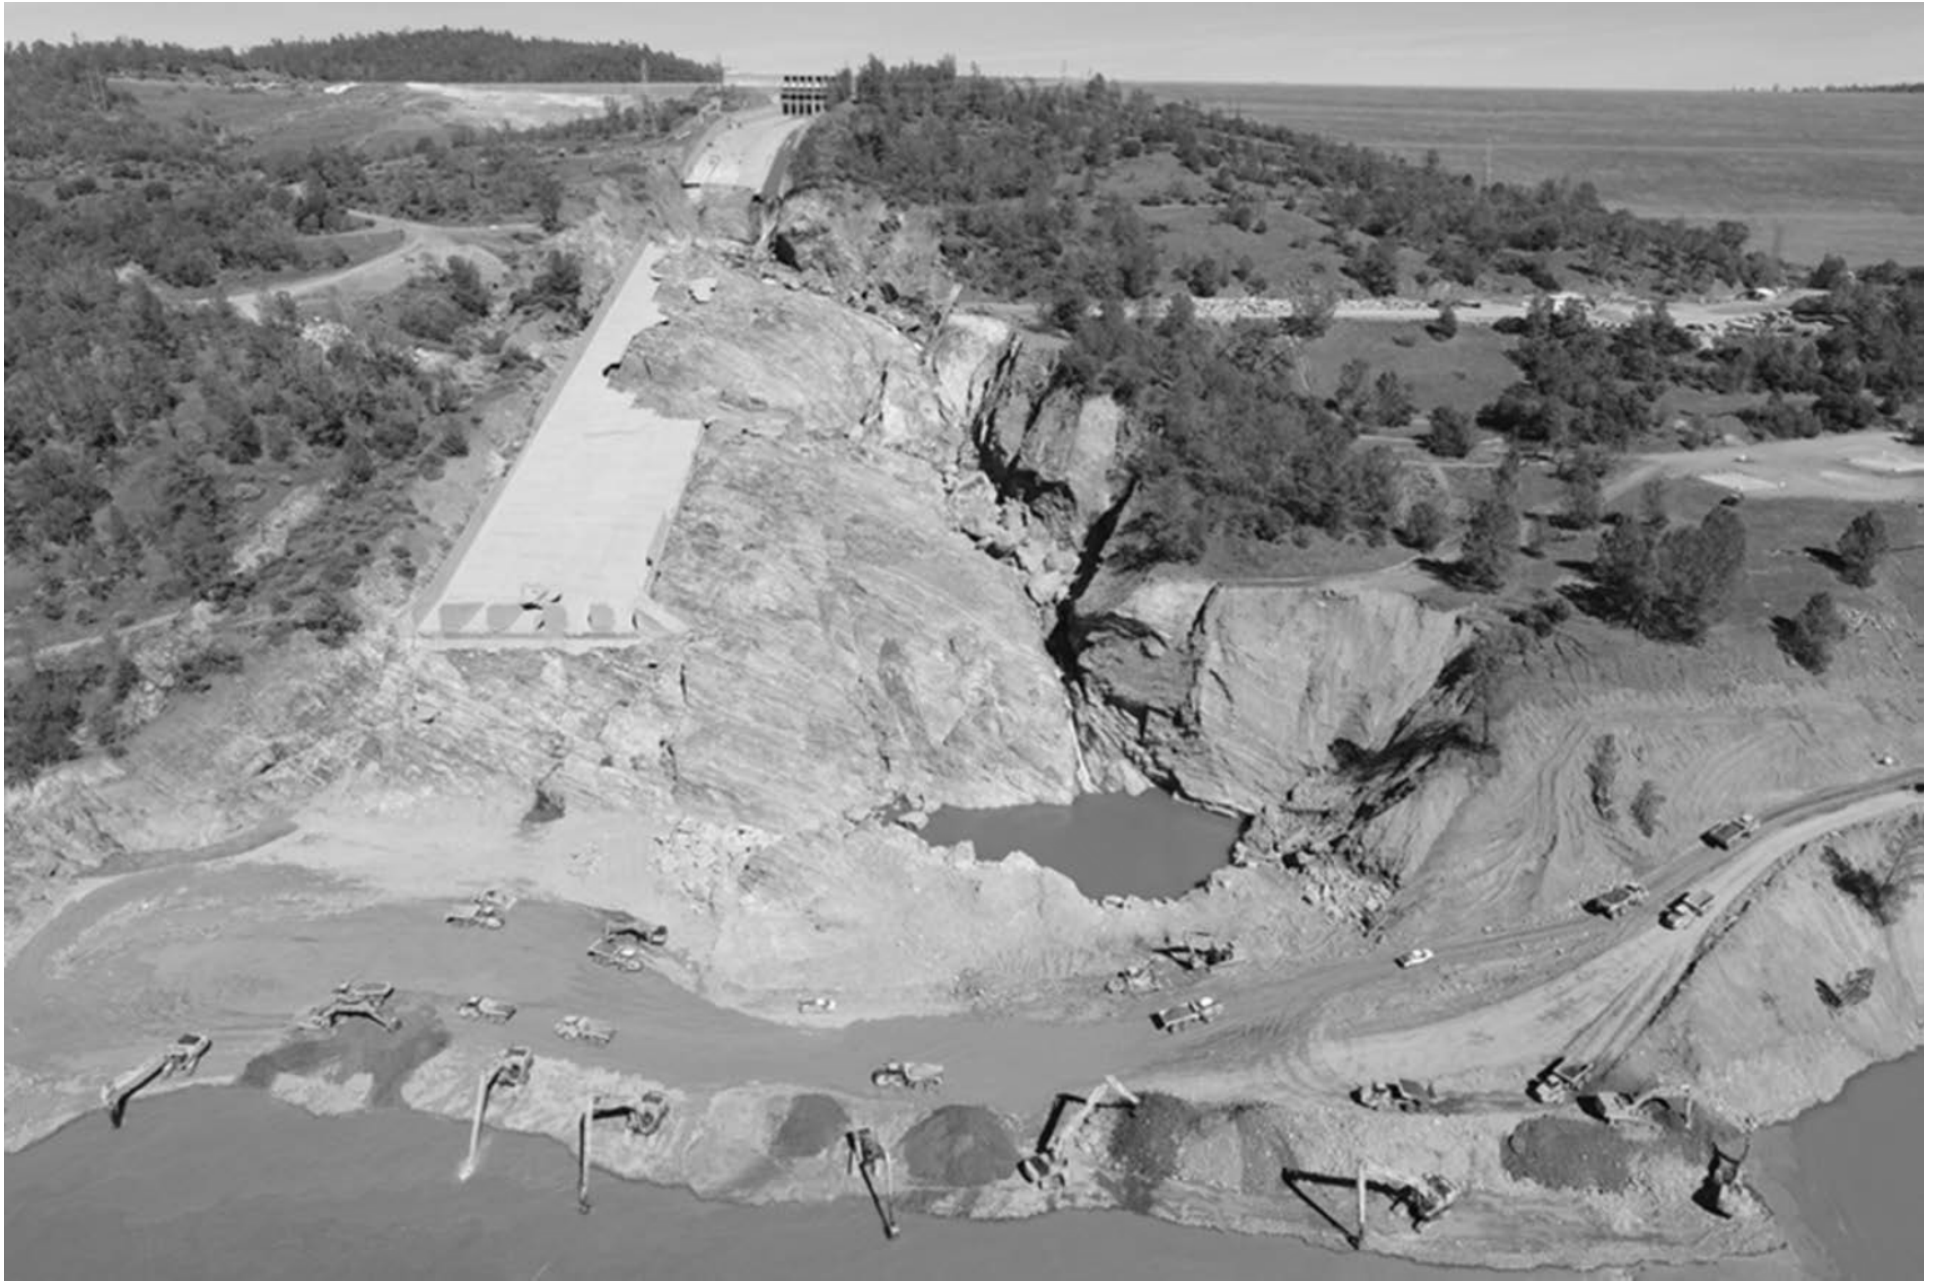
3:00 a.m. on February 12, with a peak flow of about 354 m³/s (12,500 ft³/s) over the emergency spillway crest. There was extensive erosion and headcutting in the natural channel below the emergency spillway crest, and headcuts advancing upstream toward the spillway crest threatened its stability. At 3:35 p.m. on February 12 the service spillway gate openings were increased to draw the reservoir down and reduce flows over the emergency spillway crest. At 3:44 pm on February 12, an evacuation order was issued for about 188,000 downstream residents due to the rapidly progressing erosion in the emergency spillway discharge channel. The service spillway flows reached 2830 m³/s (100,000 ft³/s) by about 7:00 p.m. on February 12 and were maintained there for about 3.5 days through 8:00 a.m. on February 16. During this period the reservoir levels dropped significantly and the situation stabilized. Service spillway flows were gradually reduced over subsequent days until the spillway was shut down again on February 27. After new inspections, the service spillway was placed back into operation in early March and operations continued until it was shut down for the season on May 19. The damage to the spillway at the end of the operating season is shown in Figure 2.

Figure 2. — Ultimate damage at the Oroville Dam service spillway in May 2017 (DWR photo; reprinted from IFT 2018, with permission).
