## Leaking Crack Repair Using Chemical Grouts

U.S. Department of the Interior  
Bureau of Reclamation  
Technical Service Center  
Civil Engineering Services Division  
Materials Engineering and Research Laboratory  
Denver, Colorado

September 2005

# Leaking Crack Repair Using Chemical Grouts

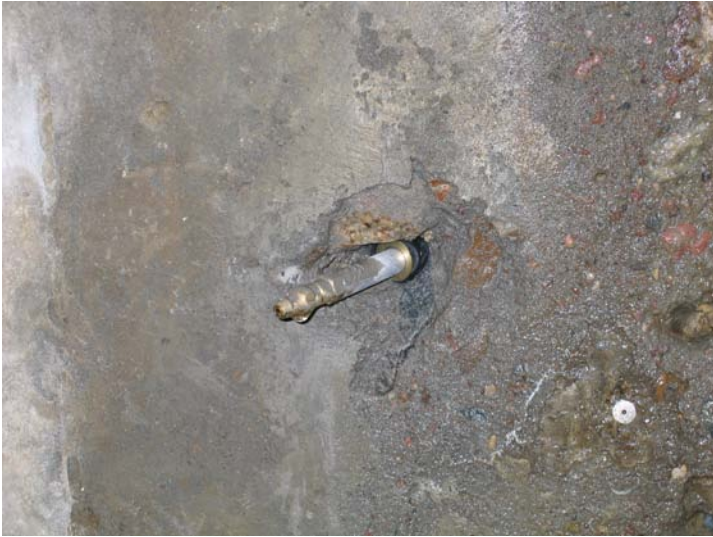
**Figure 7. - A mechanical packer with a longer tube, useful for insertion into deeper holes. Note water dripping from end, indicating water bearing crack has been intercepted.**

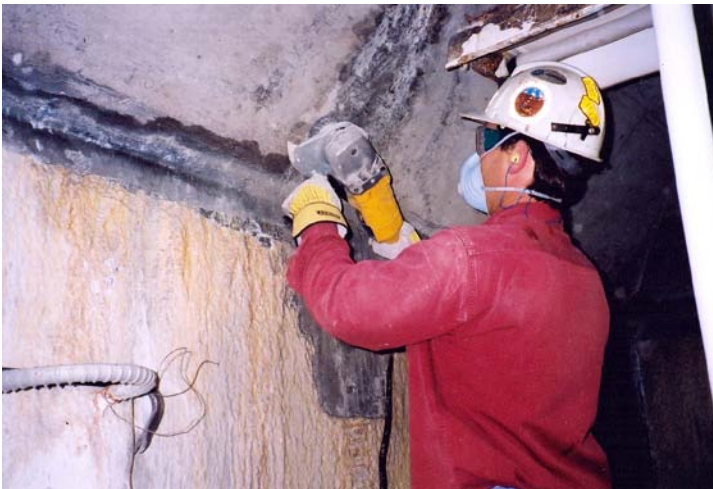
**Figure 8. - Grinding surface deposits from face of crack.**

The first step involved cleaning the exposed opening of the crack to be injected (Figure 8). Many of the cracks had extensive deposits of calcium carbonate that made it difficult to see exactly where the crack was. This step required grinding and chipping to expose the crack, and was fairly labor intensive. Several methods were tested to determine the best way to remove the surface deposits. The best method was to use a surface grinder with a stiff metal brush.

- 5) Using a surface grinder with a stiff metal brush effectively removed surface deposit of calcium carbonate to expose crack openings.

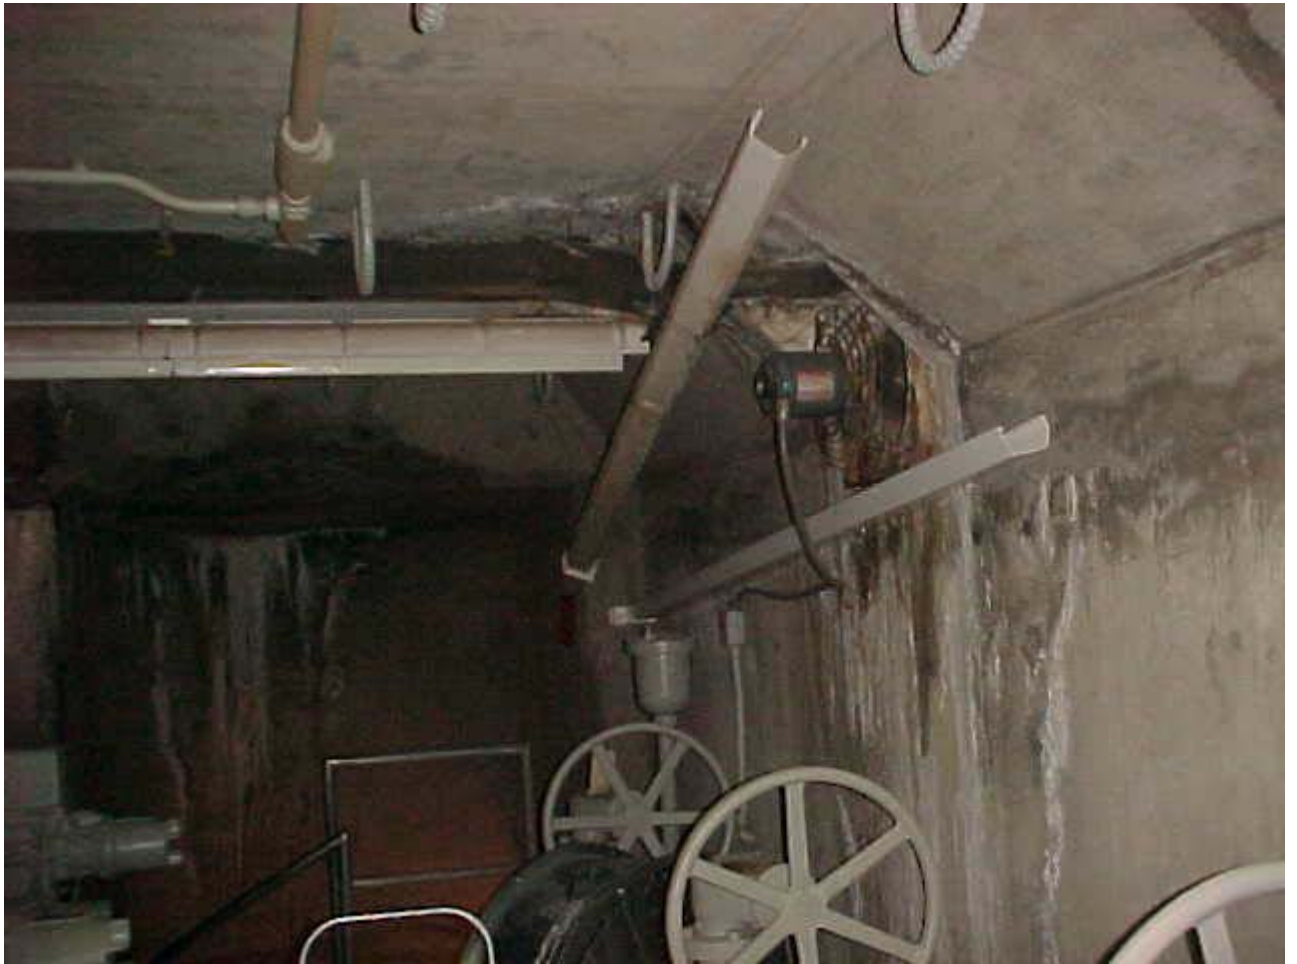
Figure 4. - Fish hatchery outlet works gate chambers water leaks.

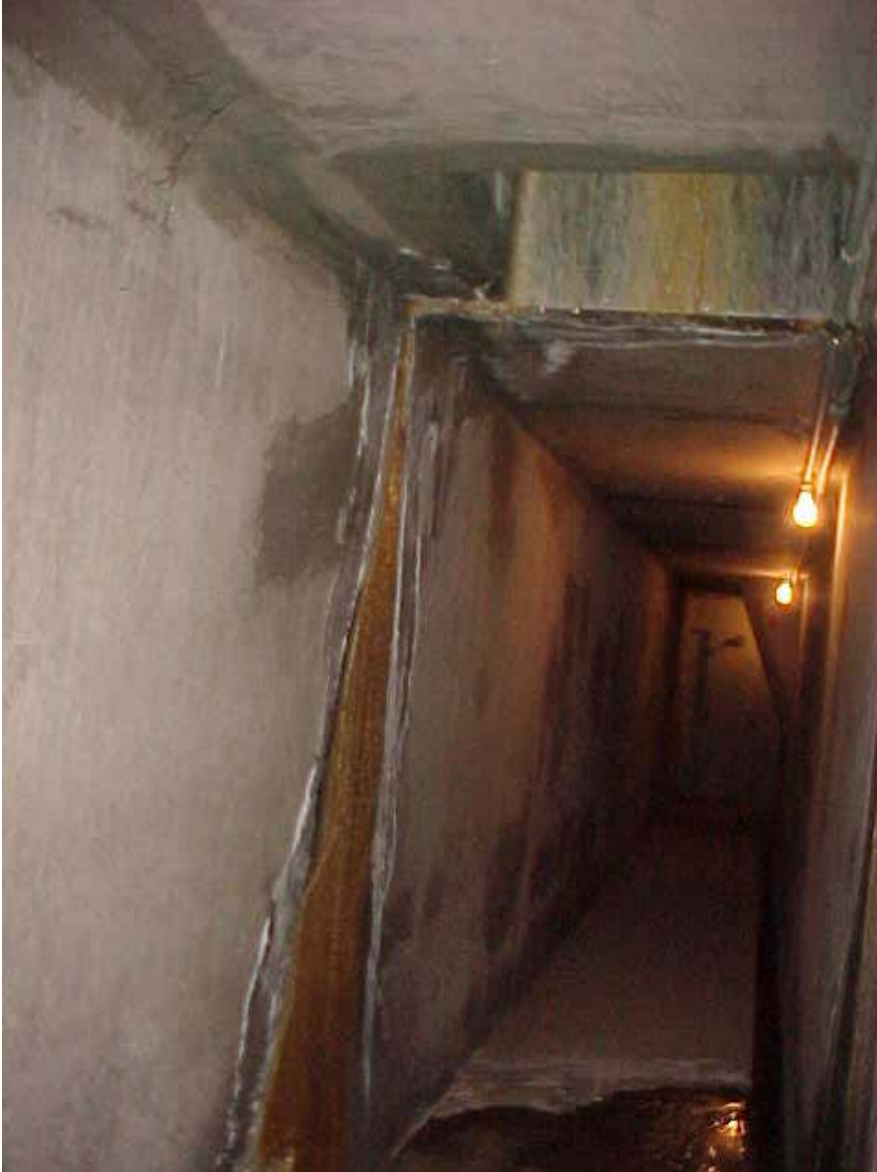
**Figure 5. - Buttress 8 equipment area water leaks.**

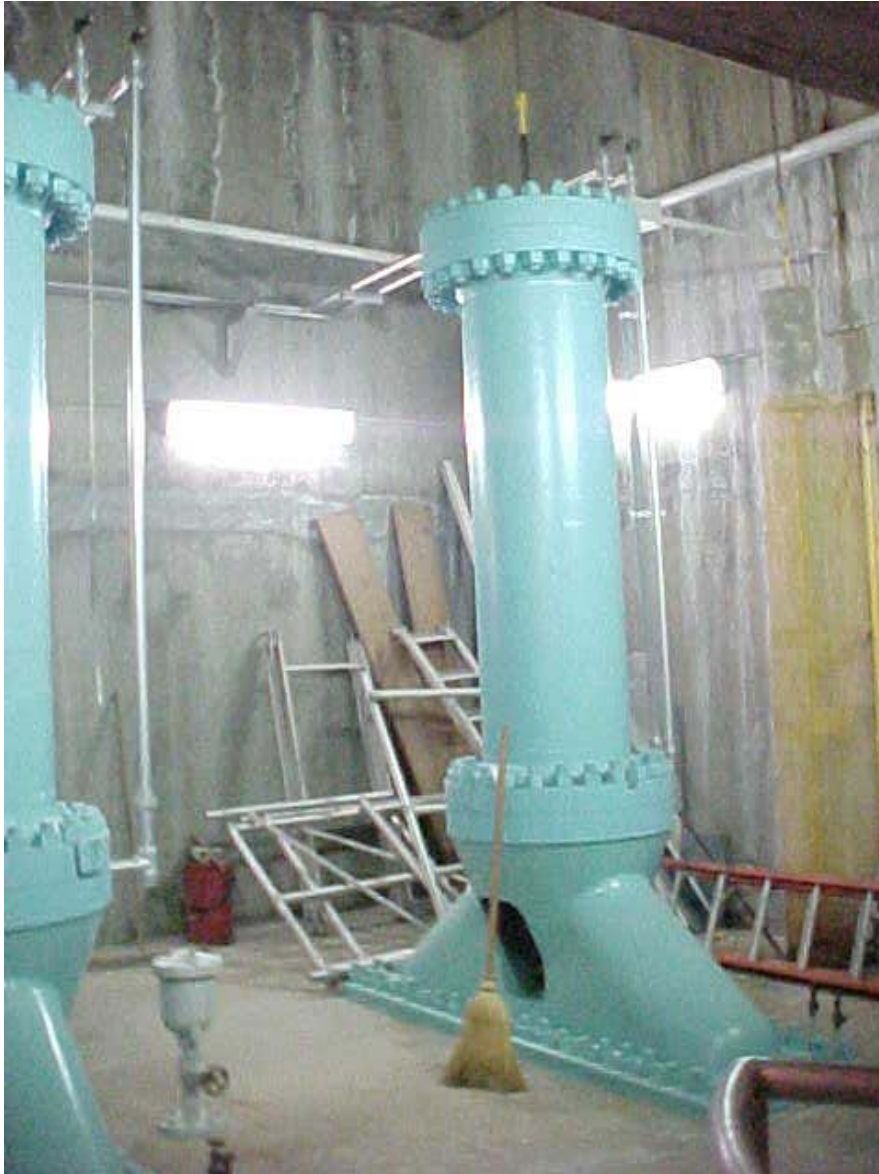
**Figure 6. - Butress 9 gate chamber water leaks along joint in wall.**

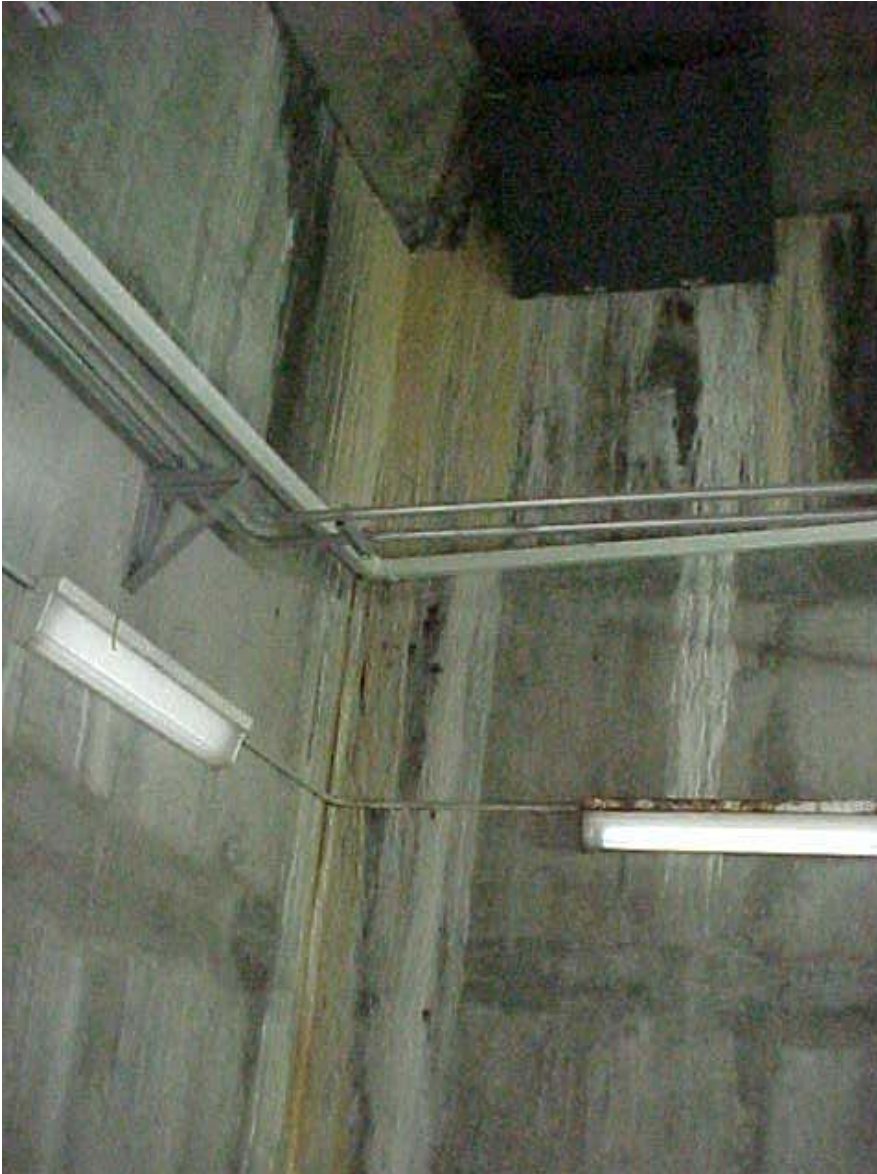
**Figure 7. -Buttress 11 gate chamber water leaks through joints.**

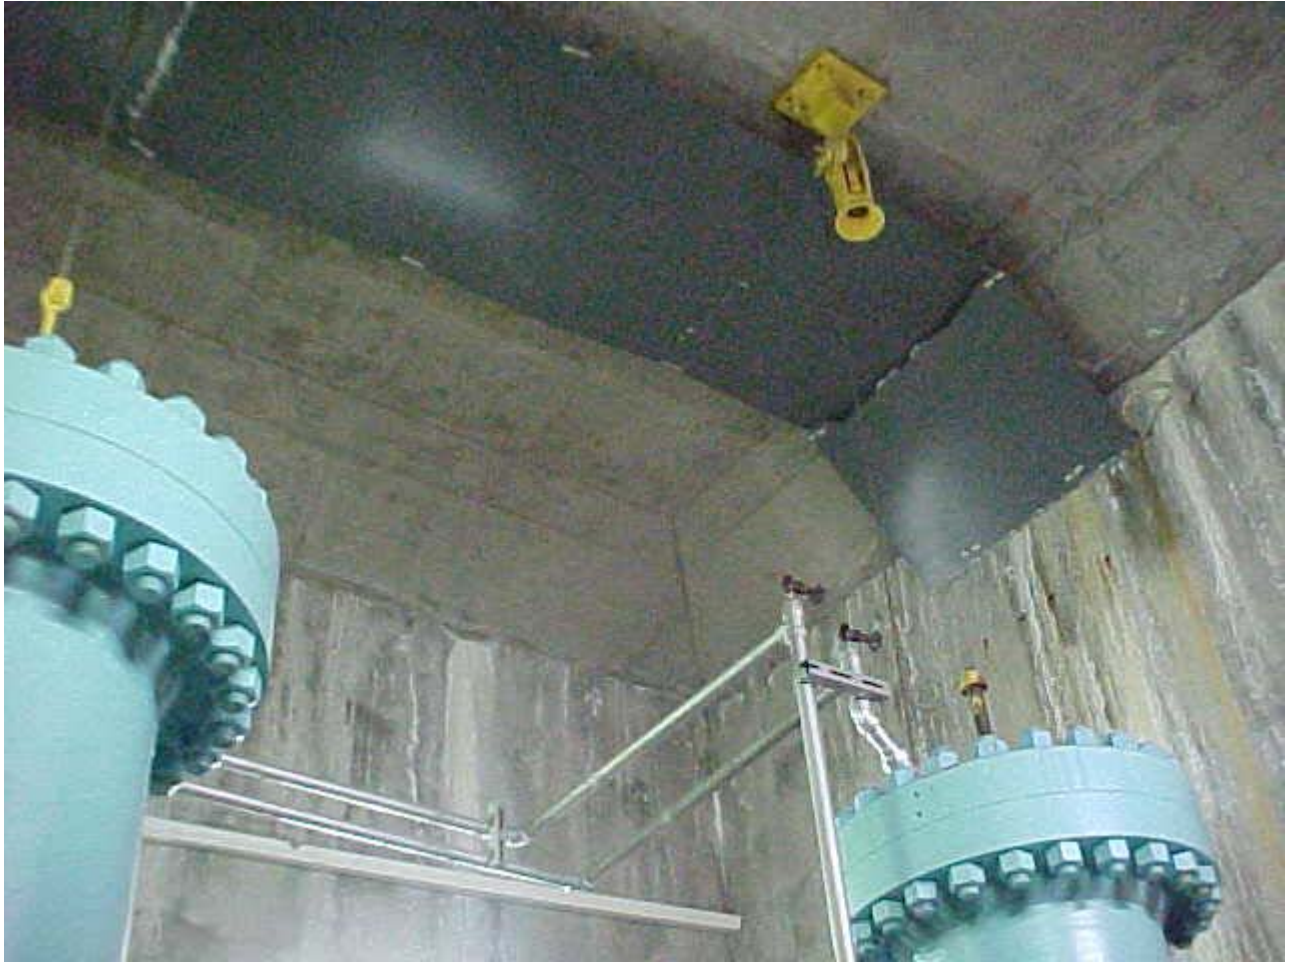
**Figure 8. - Buttress 13 gate chamber leak and water deflection sheeting across roof.**

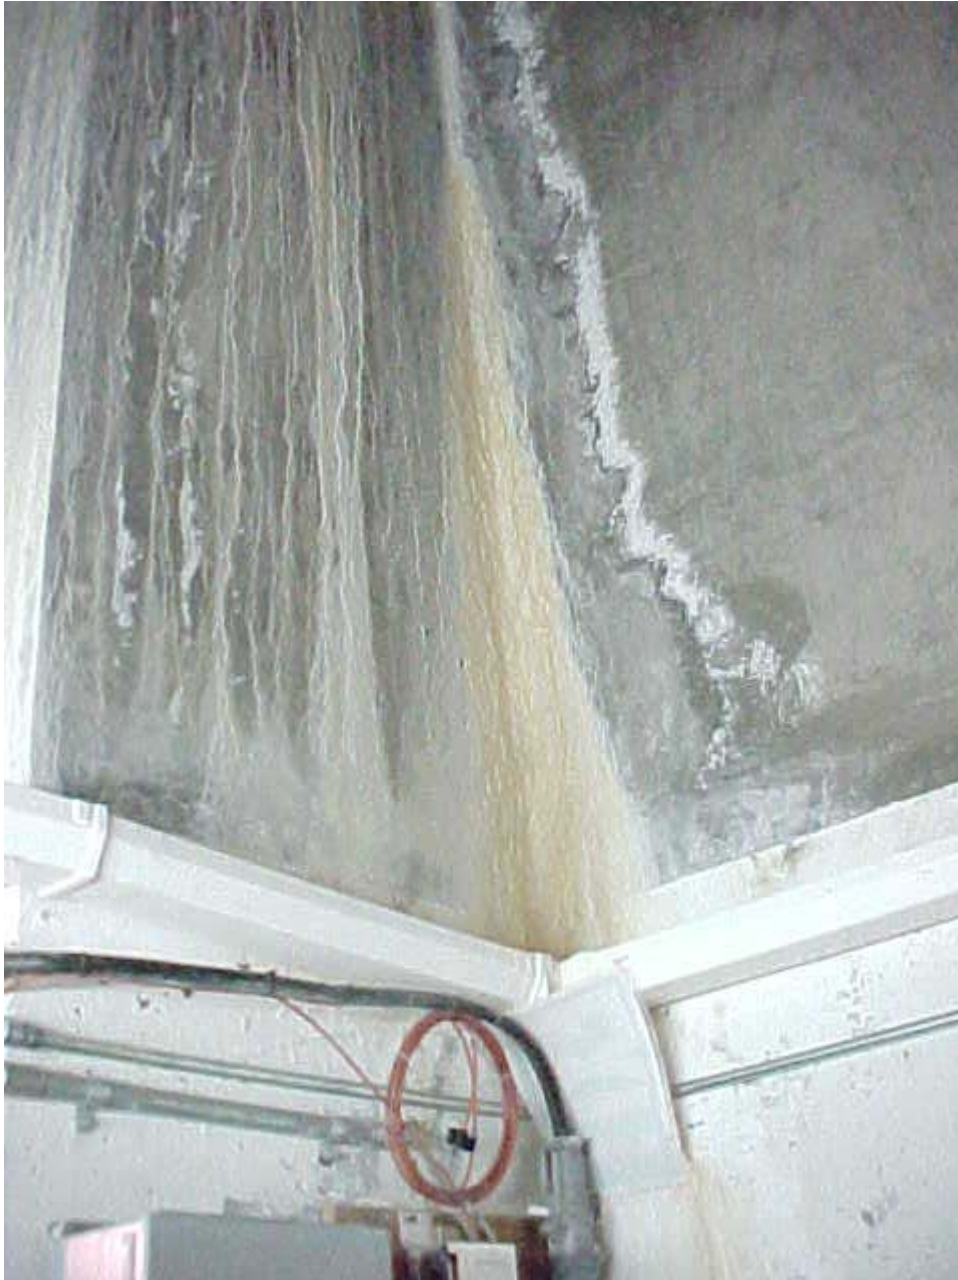
**Figure 6. - Buttress 17 entry adit water leaks.**

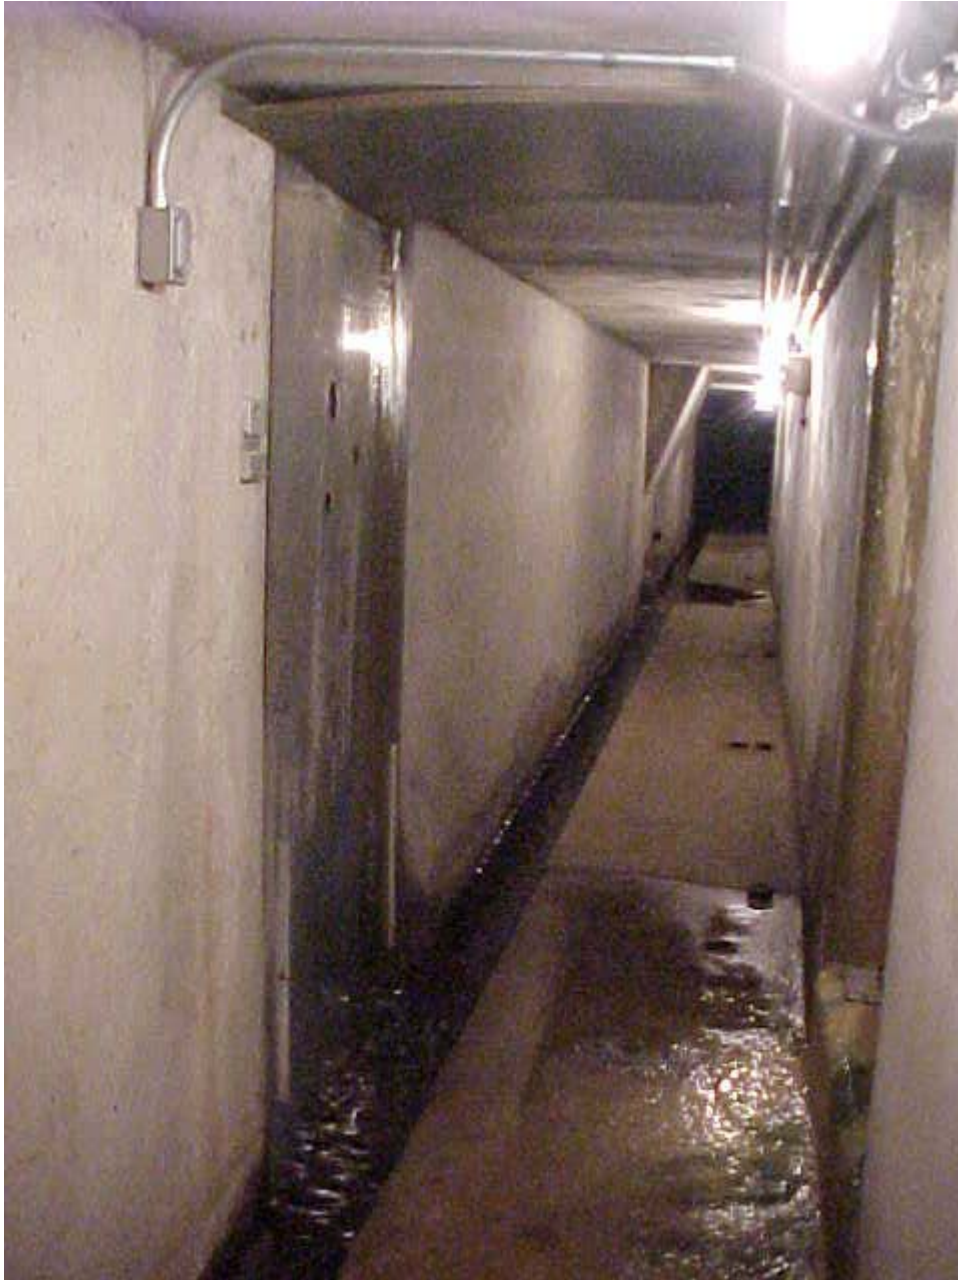
**Figure 7. -Buttress 10 inspection and equipment gallery area water leaks.**

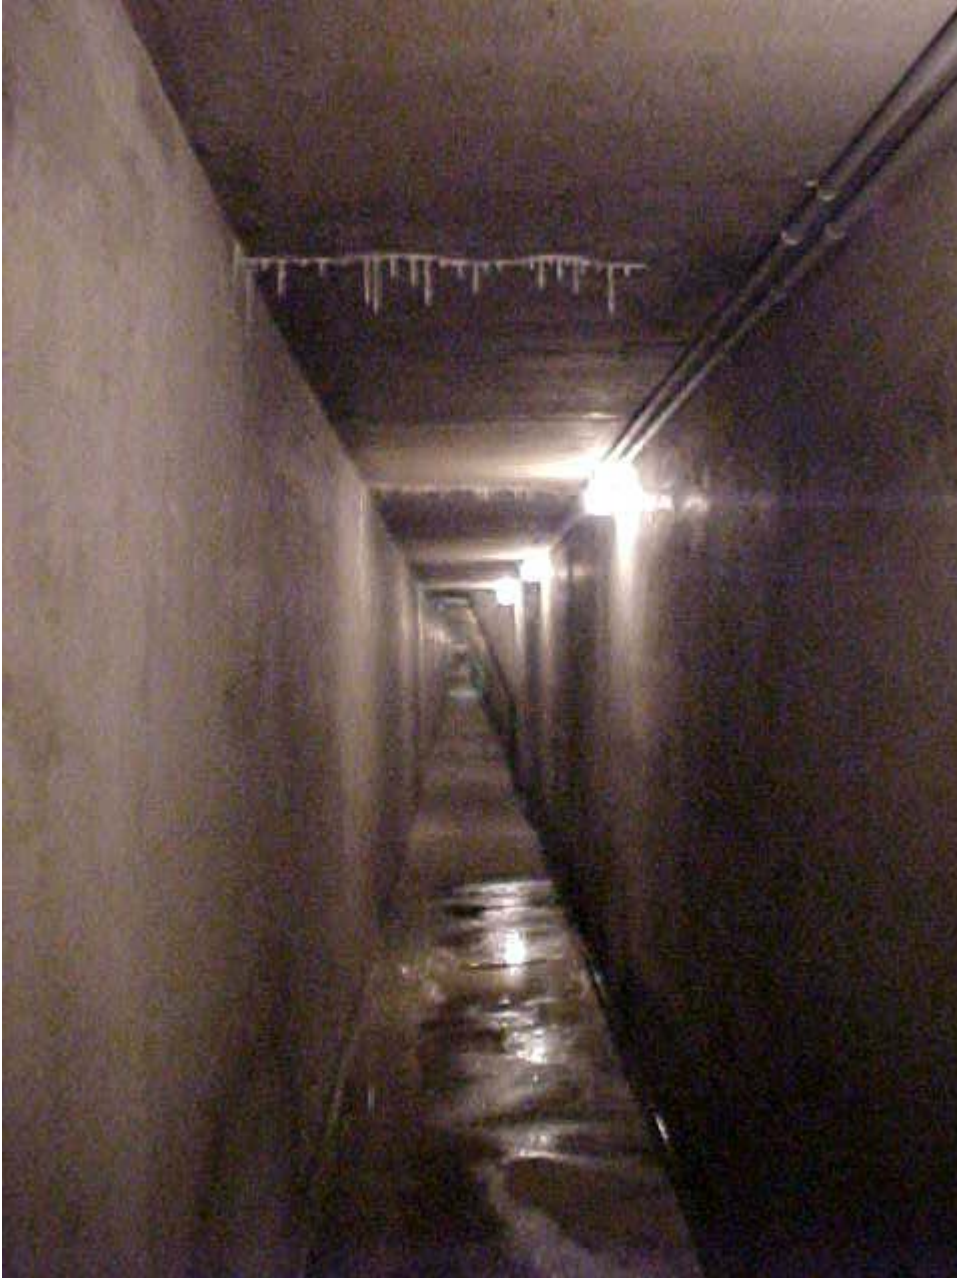
**Figure 8. Buttress 15 inspection and equipment gallery area water leaks.**

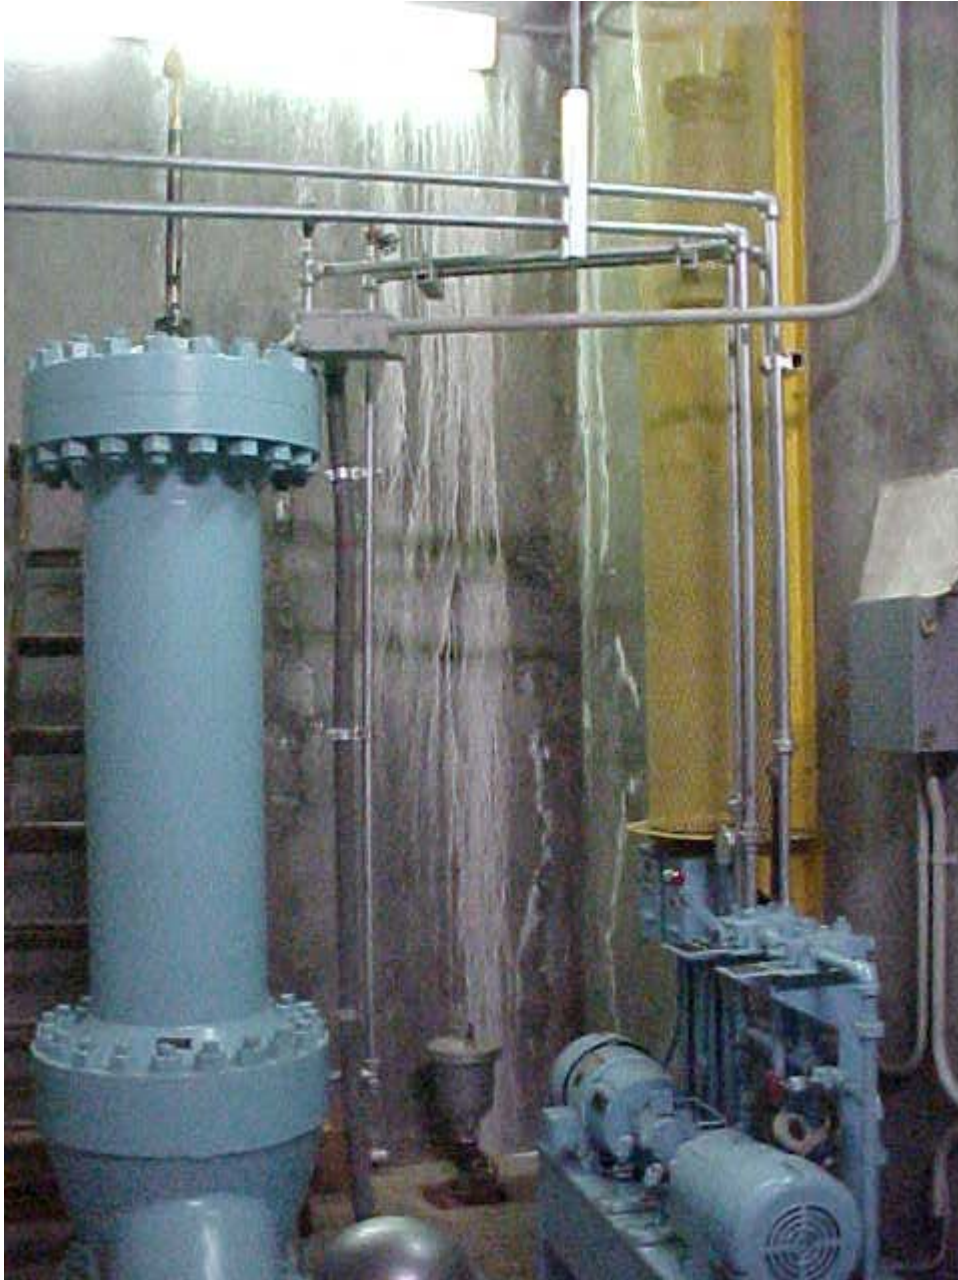
**Figure 9. - Buttress 16 gate and equipment gallery water leaks.**
