Memorandum Number MERL 2011-34

Evaluation of New Concrete Shrinkage Reducing Additive for Glen Elder Dam Spillway Inlet Slab Repair

**Missouri River Basin Project –
Solomon Division – Glen Elder Unit - Kansas
Great Plains Region**

Glen Elder Dam

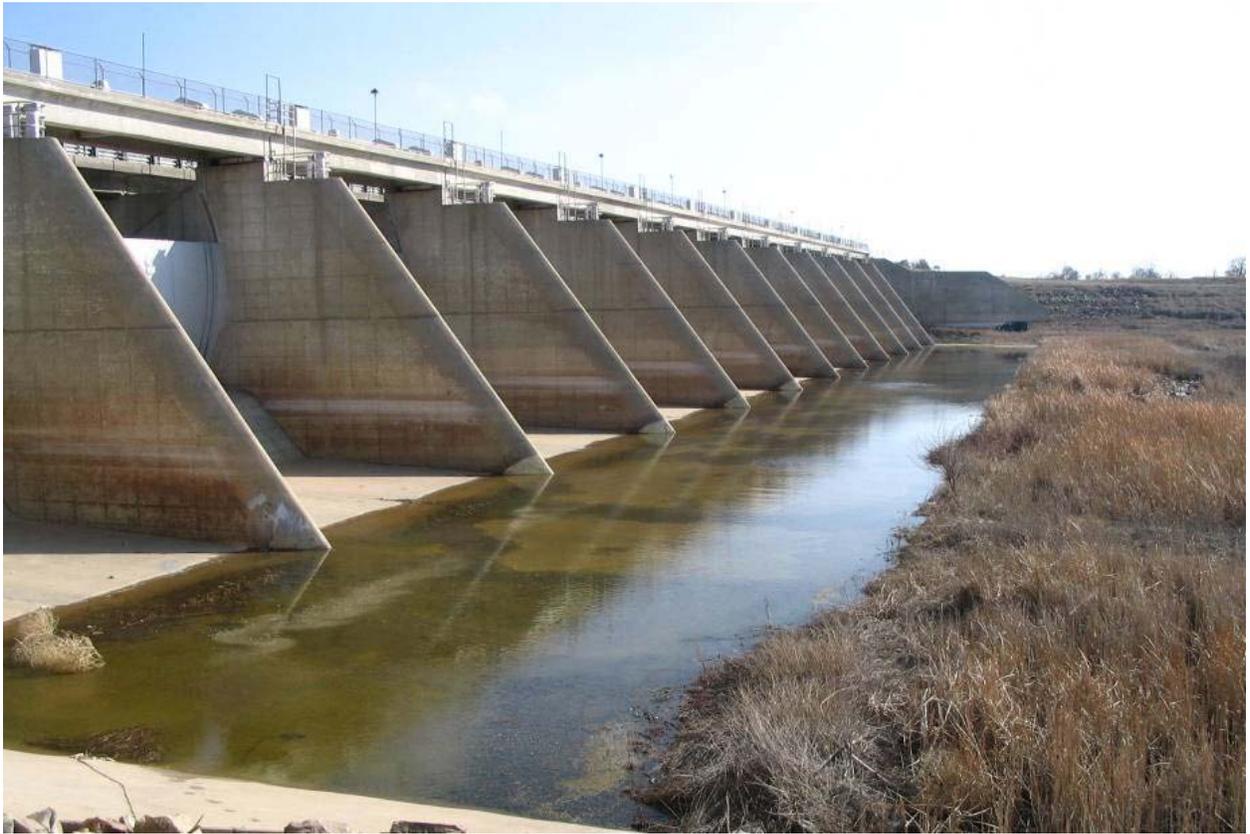
The invert of the excavated inlet channel upstream of the inlet apron is approximately 1 foot higher than the inlet apron invert which creates a grassy berm upstream of the spillway. As a result, water which is located on top of the inlet apron (either from receding reservoir levels or precipitation) becomes trapped and remains ponded in this area (Figure 2).

Figure 2. – View of approach area of spillway. The soil berm trapped water on the apron, leading to deterioration of the concrete.

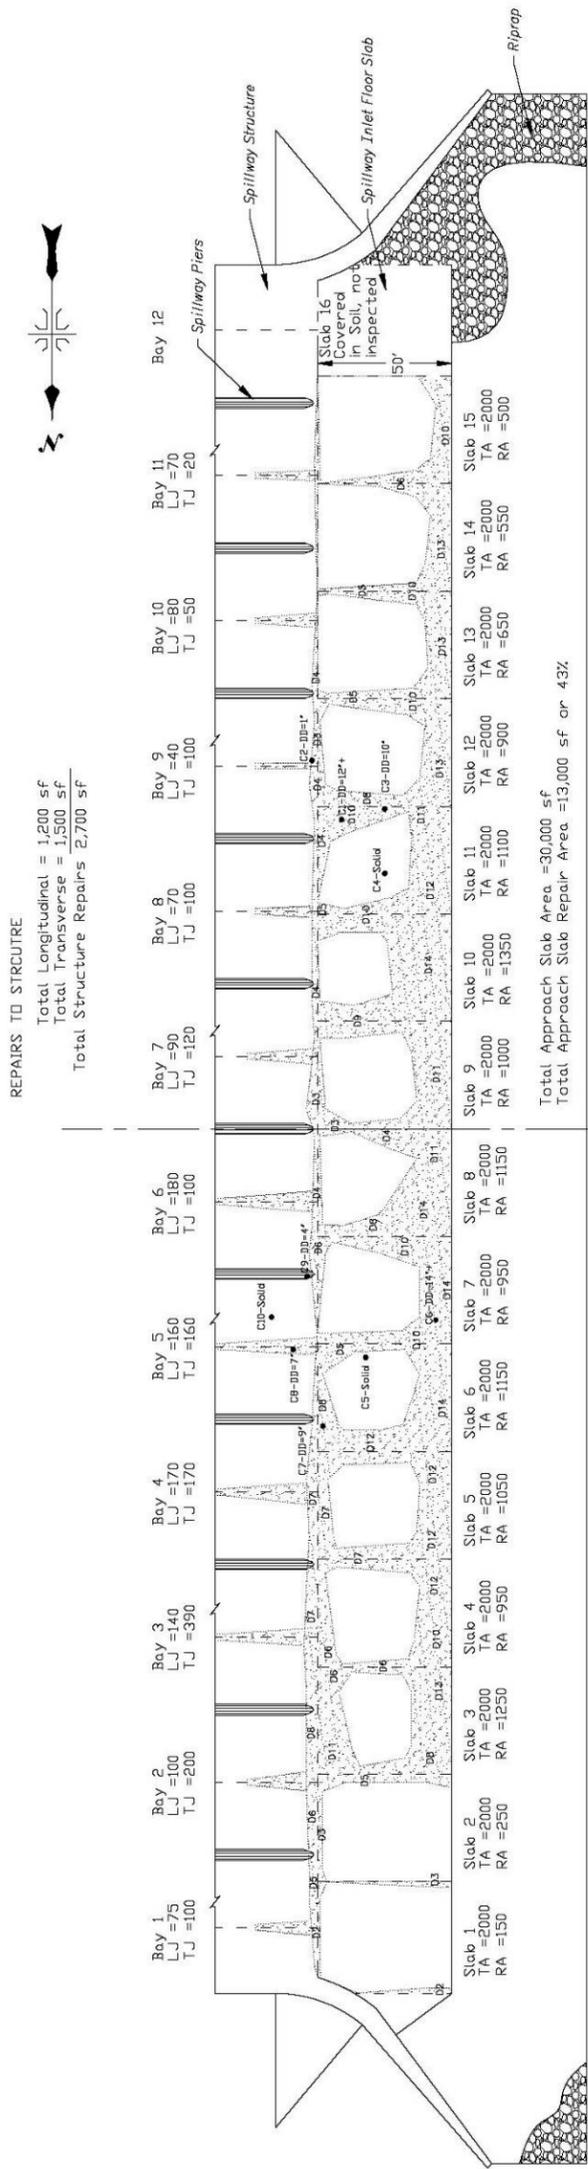
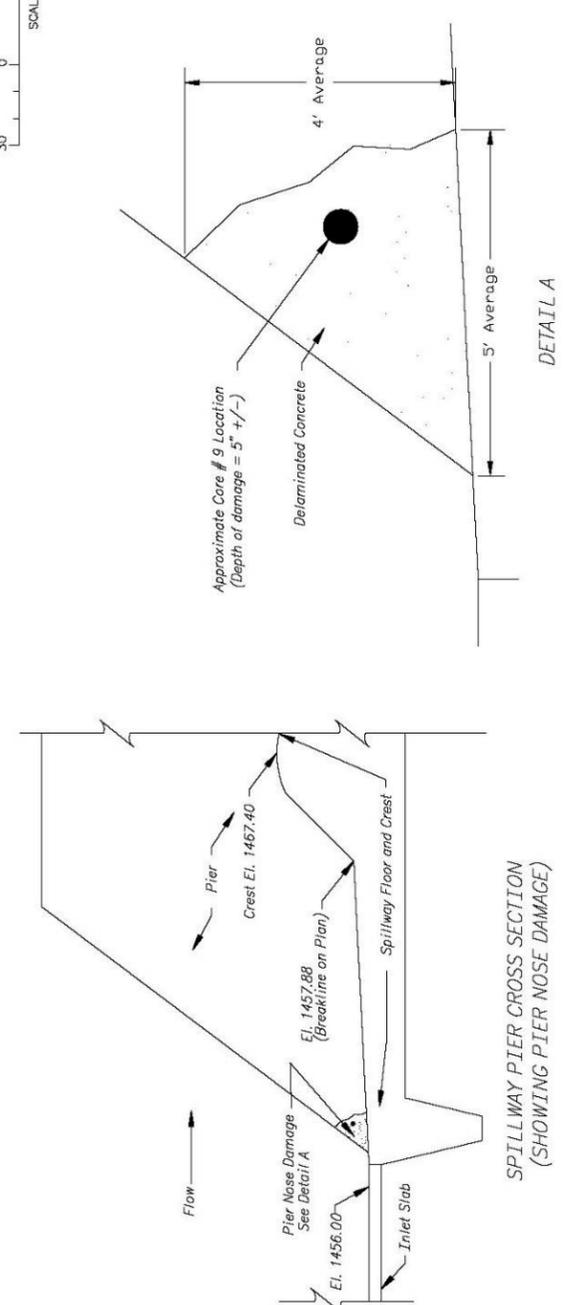
DELINEATION OF DAMAGED CONCRETE SPILLWAY INLET FLOOR SLAB, PIERS AND UPSTREAM STRUCTURE GLEN ELDER DAM

The concrete in both the inlet apron and the pier noses/gate structure were exhibiting areas of extensive deterioration. Results of a concrete core testing program [1] showed that the structure was suffering from freeze-thaw damage largely caused by absorptive aggregate. Cracking from freezing and thawing was then promoting alkali-silica reaction. There was also evidence of carbonation which could lead to susceptibility to reinforcement corrosion. Early evaluation of the approach apron of the structure indicated that about 43 percent of the inlet slab area was in need of repair with deterioration measured as deep as 14-inches during the concrete coring program [2]. A plan view (Figure 3) shows which areas were originally thought to be sound concrete and rough estimates of the depth of deterioration in the areas of damaged concrete. However, once repairs were started, the amount of damaged concrete was discovered to be much larger (Figure 4).

Figure 1. – Early estimate of damaged concrete.

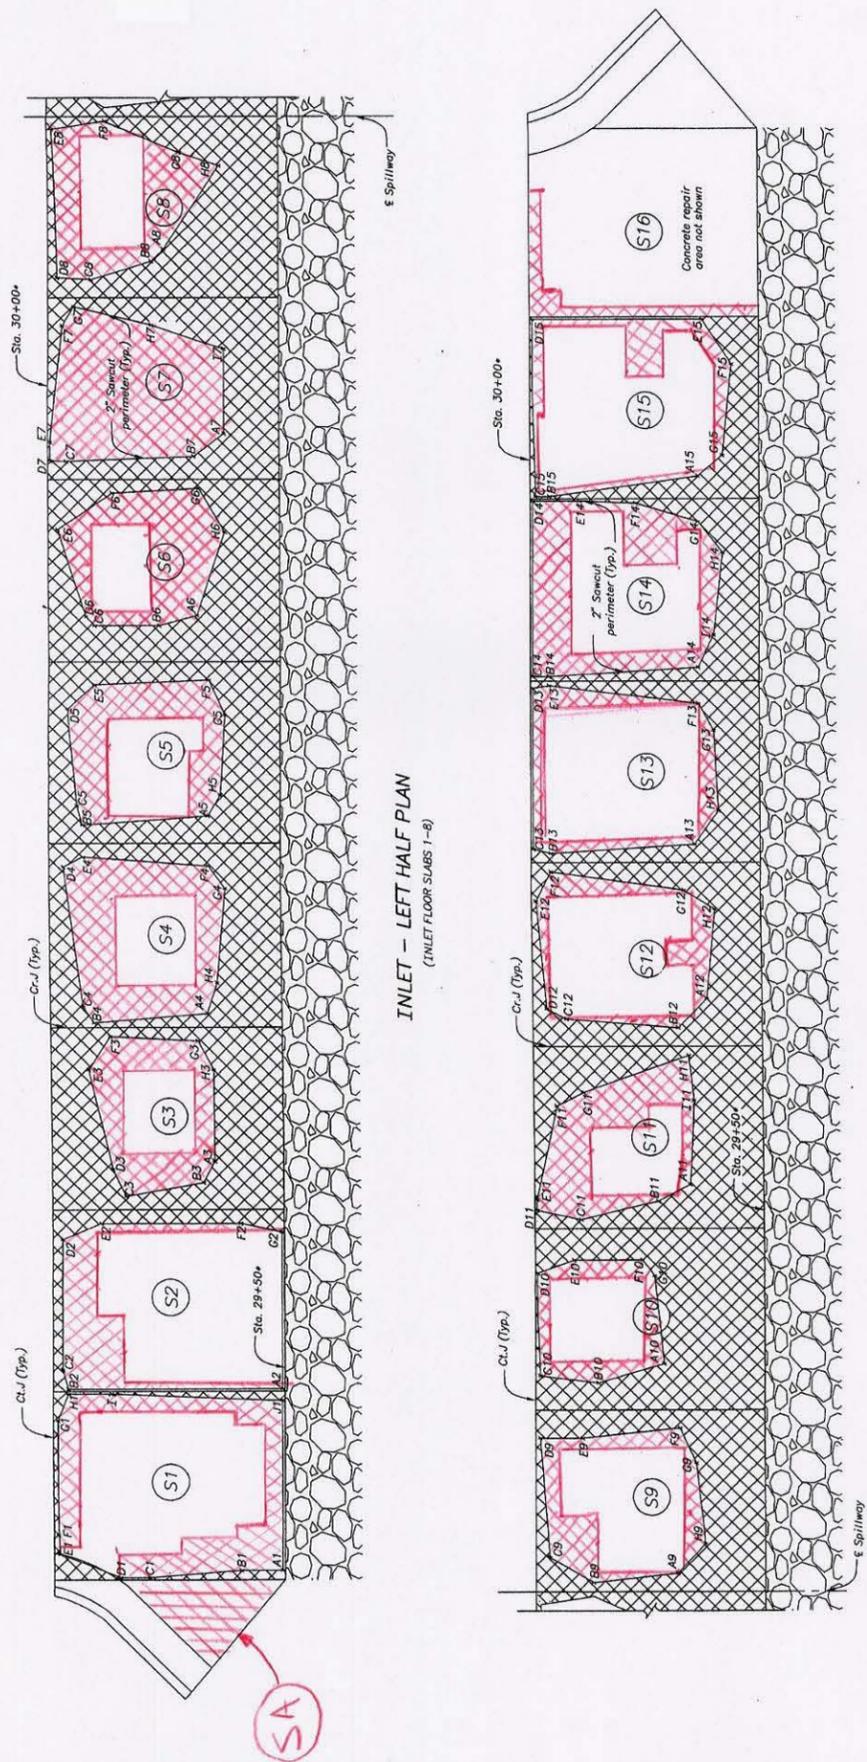
Figure 4. – Revised area of concrete damage.

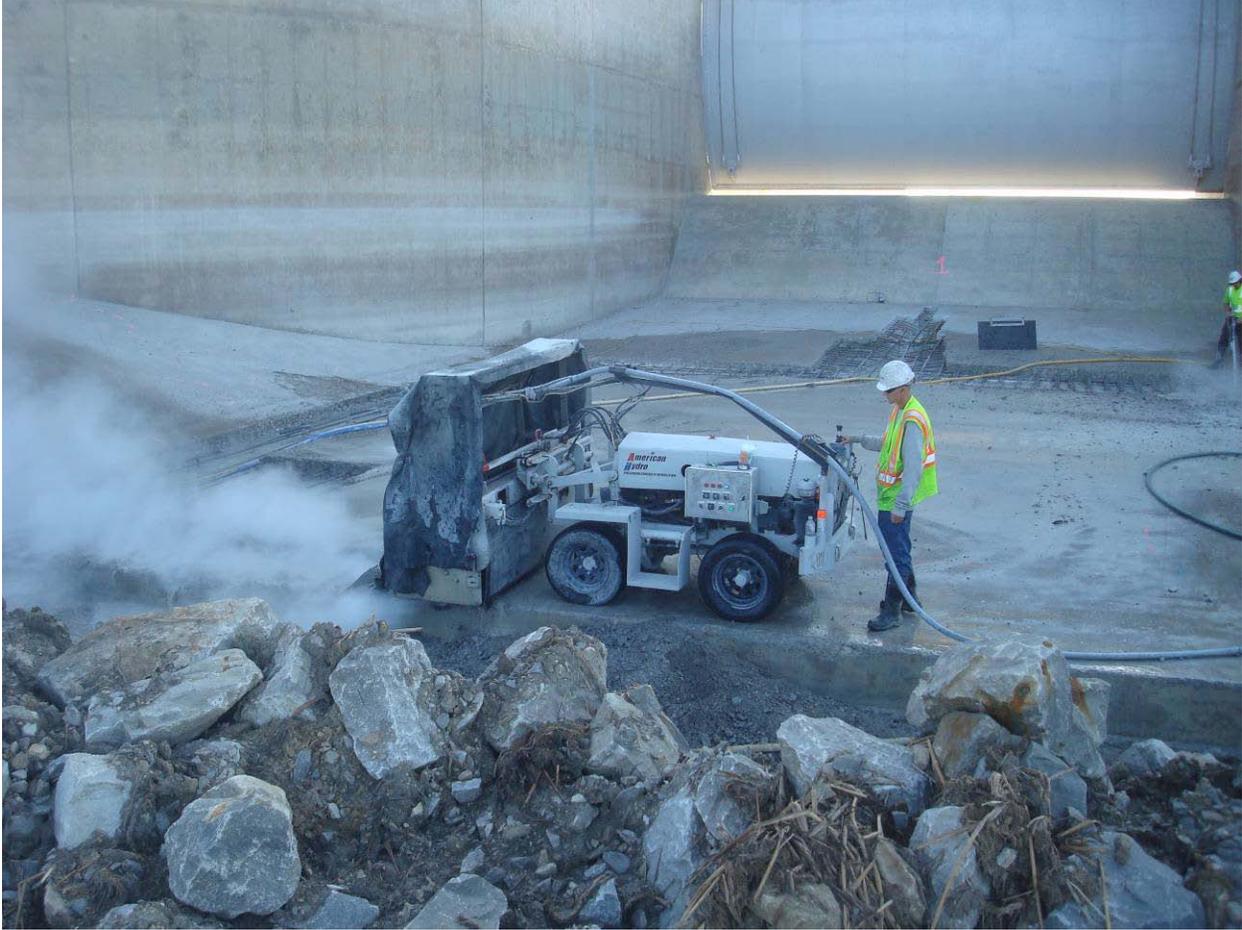
Figure 5. – Hydrodemolition of damaged concrete

The repair consisted of removing deteriorated concrete using hydrodemolition (Figure 5) methods and then placing new concrete back to the existing lines and grades. In most areas, damaged concrete was removed to a depth of about 6-inches, leaving about 12-inches of the original concrete. In some areas, due to the poor quality of the concrete, it was excavated down

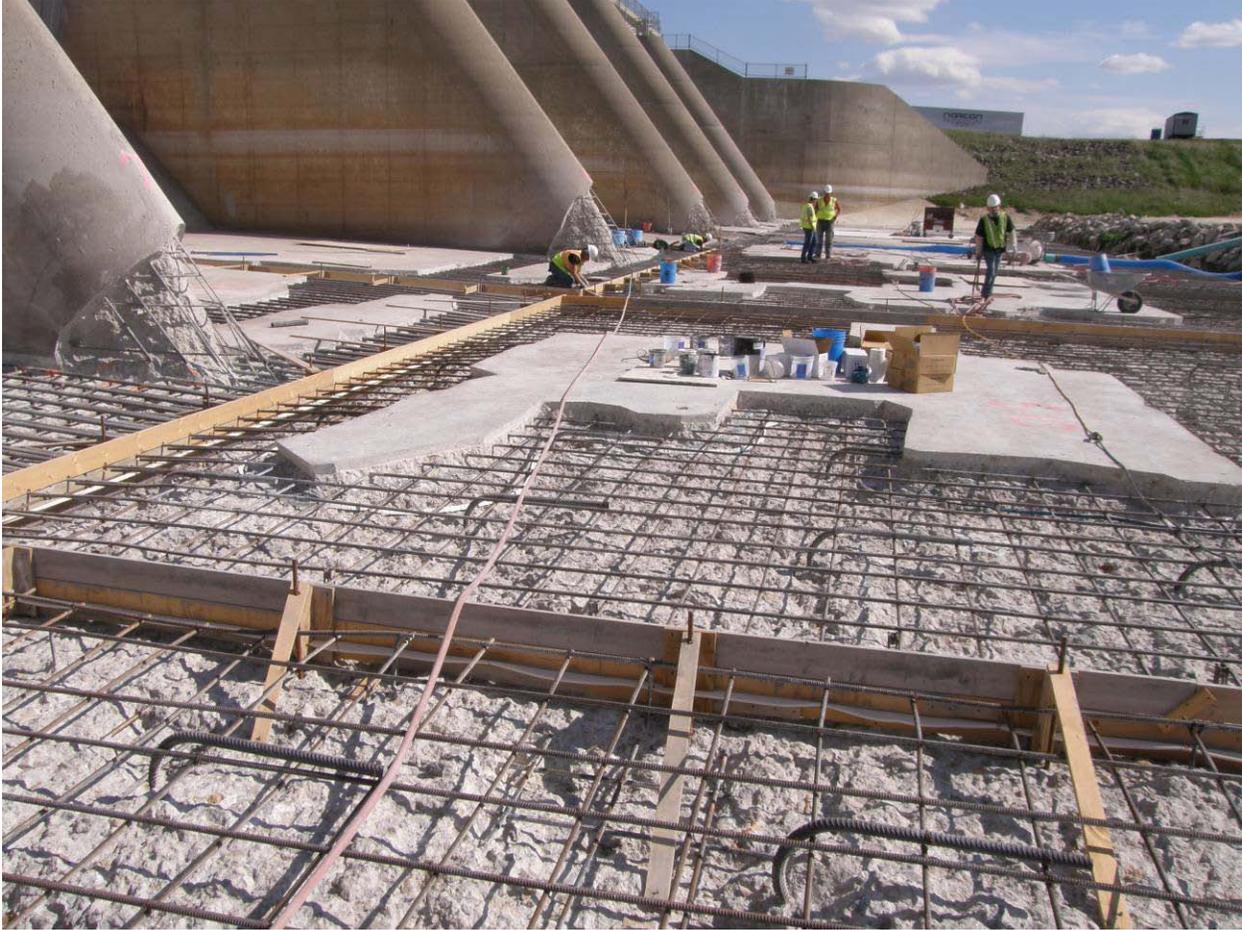
to the foundation. In addition, for some areas, no concrete was removed, so full depth areas of existing concrete were left in place (Figure 6).

Figure 6. – Example of concrete removal with some original concrete remaining.

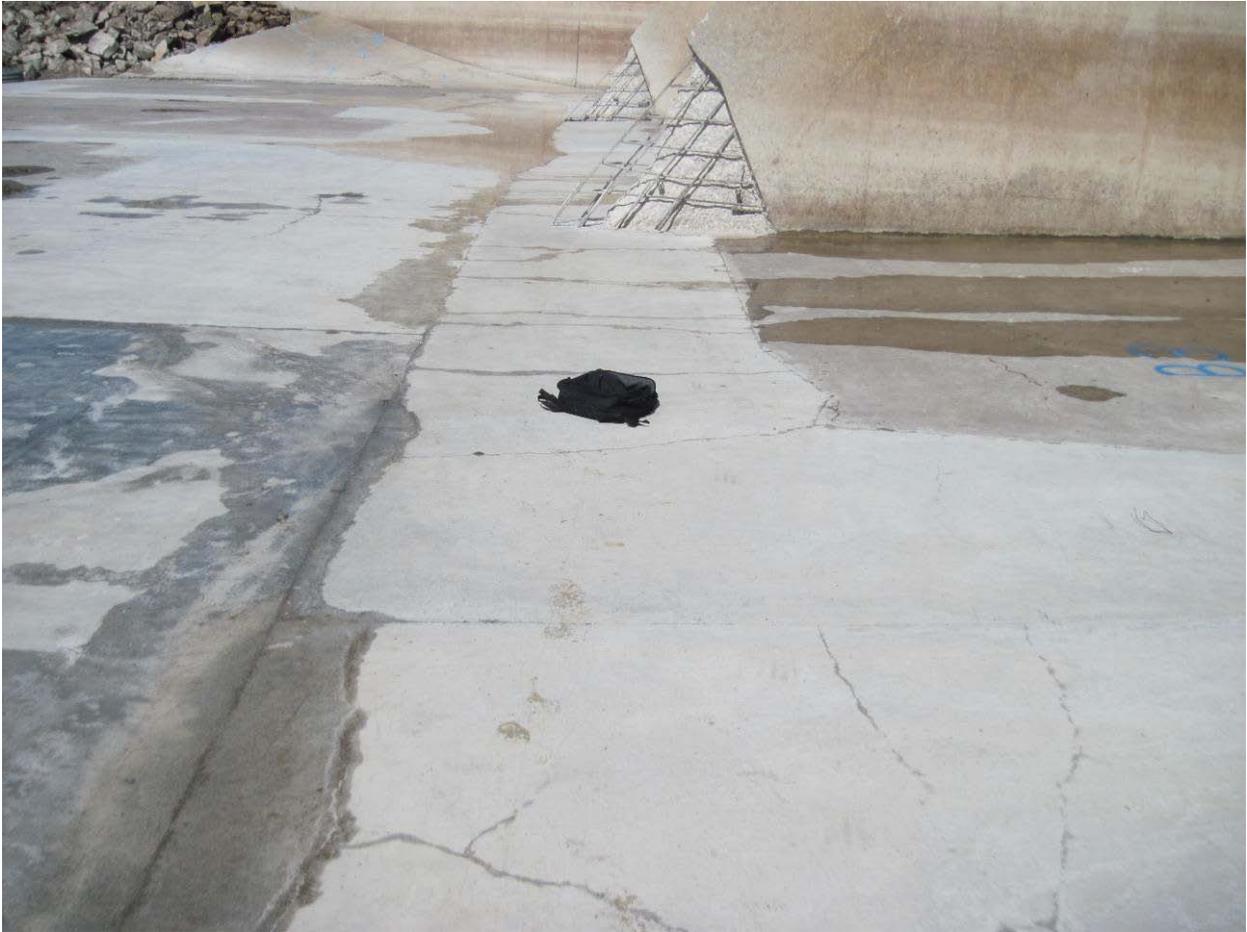
Using smaller aggregate usually increases the paste content of the concrete, which can exacerbate shrinkage problems. The smaller aggregate size used by batch plants in this area of Kansas is typical, since sources with larger aggregate are not readily available. Obtaining larger aggregate to use for the replacement concrete was deemed too costly and restrictive.

After initial placements were performed in the late summer and fall of 2010, restrained shrinkage cracking was observed in the new concrete (Figure 7). The occurrence of this cracking was not unanticipated, but the number and size was disconcerting.

Figure 7. – View of shrinkage cracking first observed within one to two weeks of concrete placement.

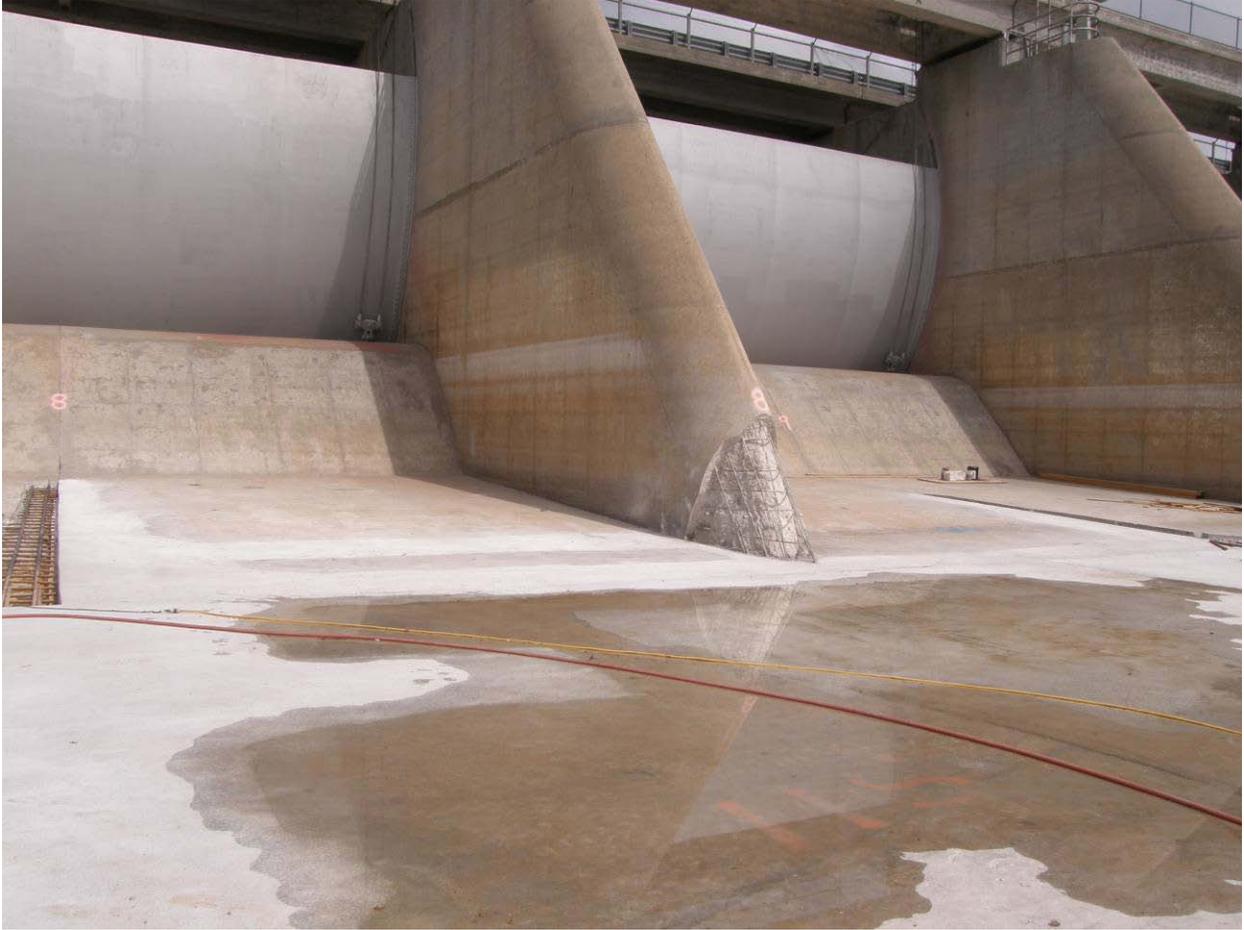
Figures 19 and 20 are drawings showing the approximate crack locations and widths of the observed cracks. Since the placement for Bay 8/9 was not in the original plan, a comparable placement from last year was not evaluated. However, there was no cracking observed in that placement. Results show that cracking was either greatly reduced or completely eliminated when cracking was compared between concrete with and without the additive. In addition, surface areas of open cracks were estimated from crack length and opening data. Table 2 shows those comparisons.

Figure 12. – Placement B8/9 made with concrete containing the Premier Magnesia additive.

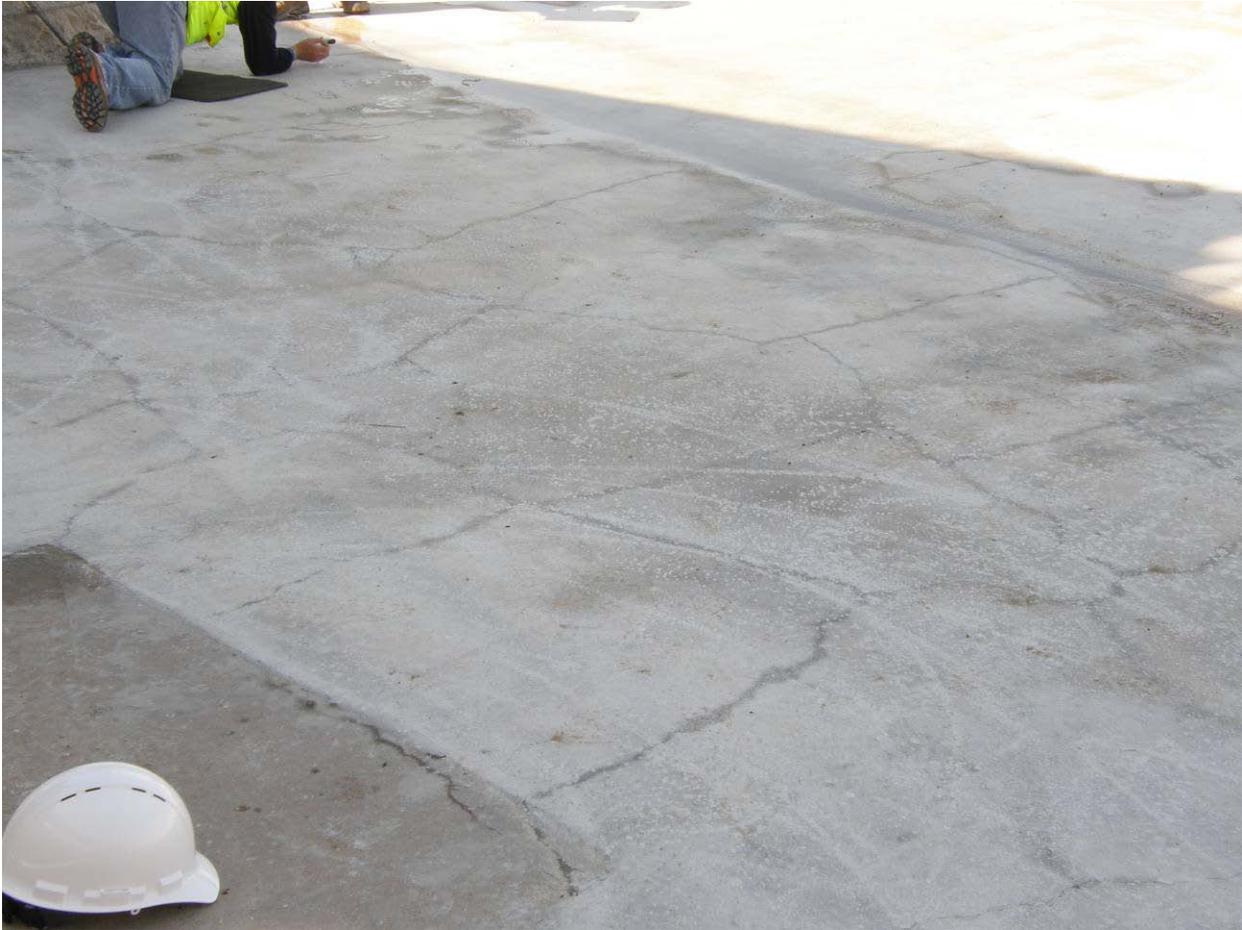
Figure 13. – Typical shrinkage cracking that was measured and mapped.

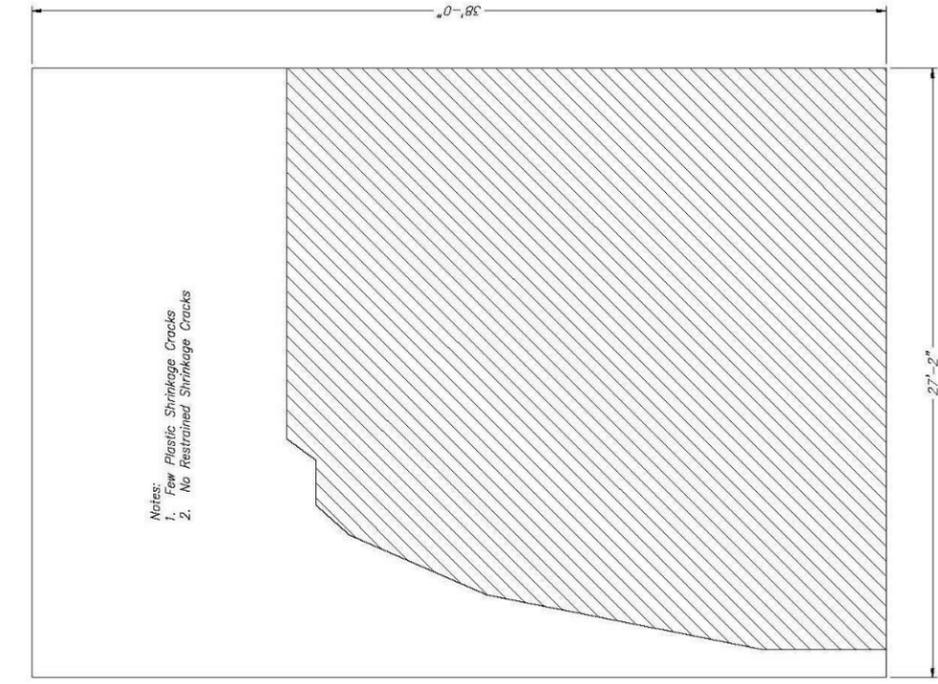
BAY 7 — WITH ADDITIVE

Figure 19. - Comparison of bay placements made with and without the shrinkage reducing additive.

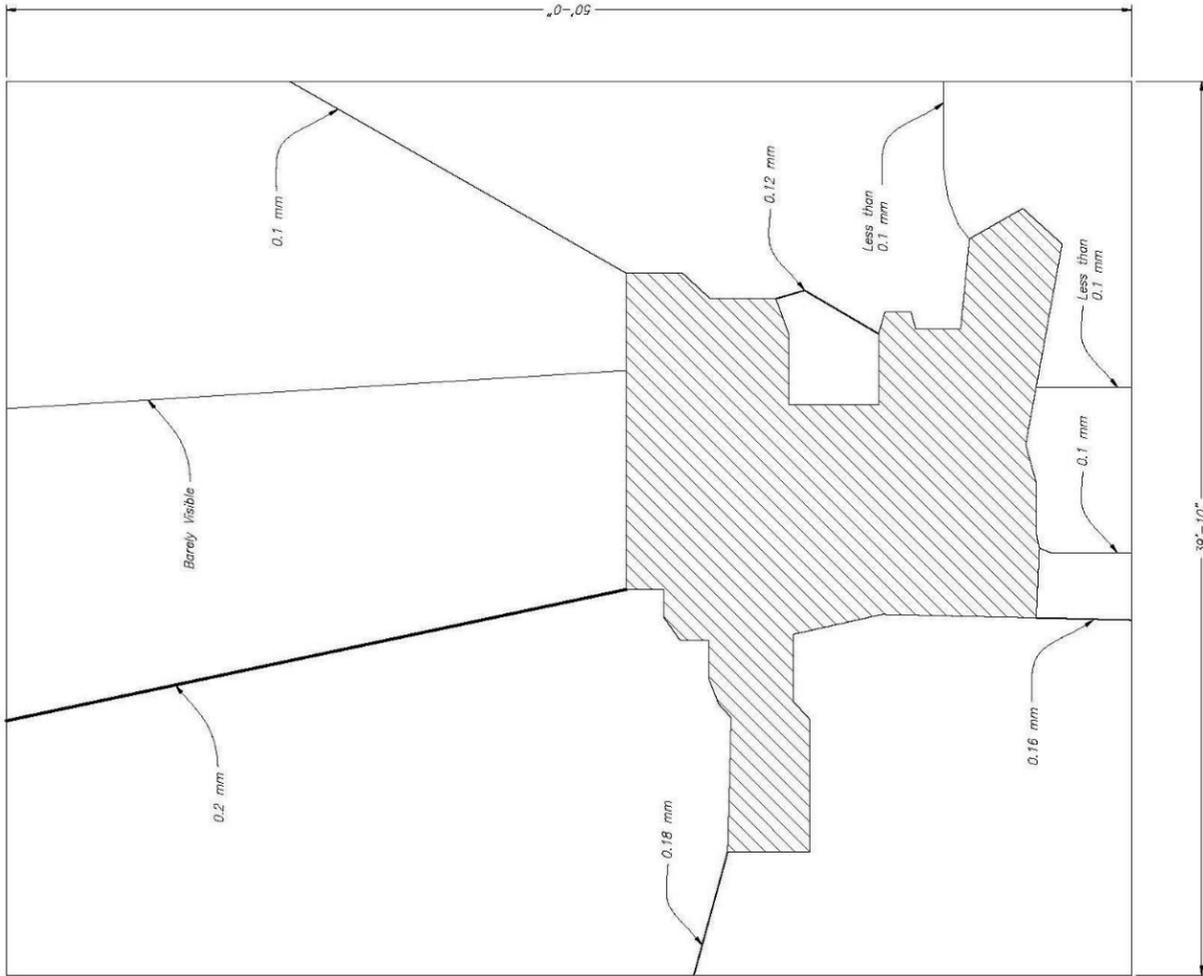
SLAB 10 – WITH ADDITIVE

Three weeks later, personnel from MERL and executives from Premier returned to the site to examine the trial concrete placements. Only the placement for slab 10 (S10) showed any cracking (Figure 17), and that was significantly less than cracking observed in the comparison slab. The cracking in S10 was measured and documented in a drawing. The next day, construction activities at the site were halted due to flooding (Figure 18), and as of the middle of August, the area is still underwater.

Figure 20 – Comparison of slab placements for concrete placements made with and without the shrinkage reducing additive.
