Memorandum Number MERL 2011-34

Evaluation of New Concrete Shrinkage Reducing Additive for Glen Elder Dam Spillway Inlet Slab Repair

**Missouri River Basin Project –
Solomon Division – Glen Elder Unit - Kansas
Great Plains Region**

Glen Elder Dam

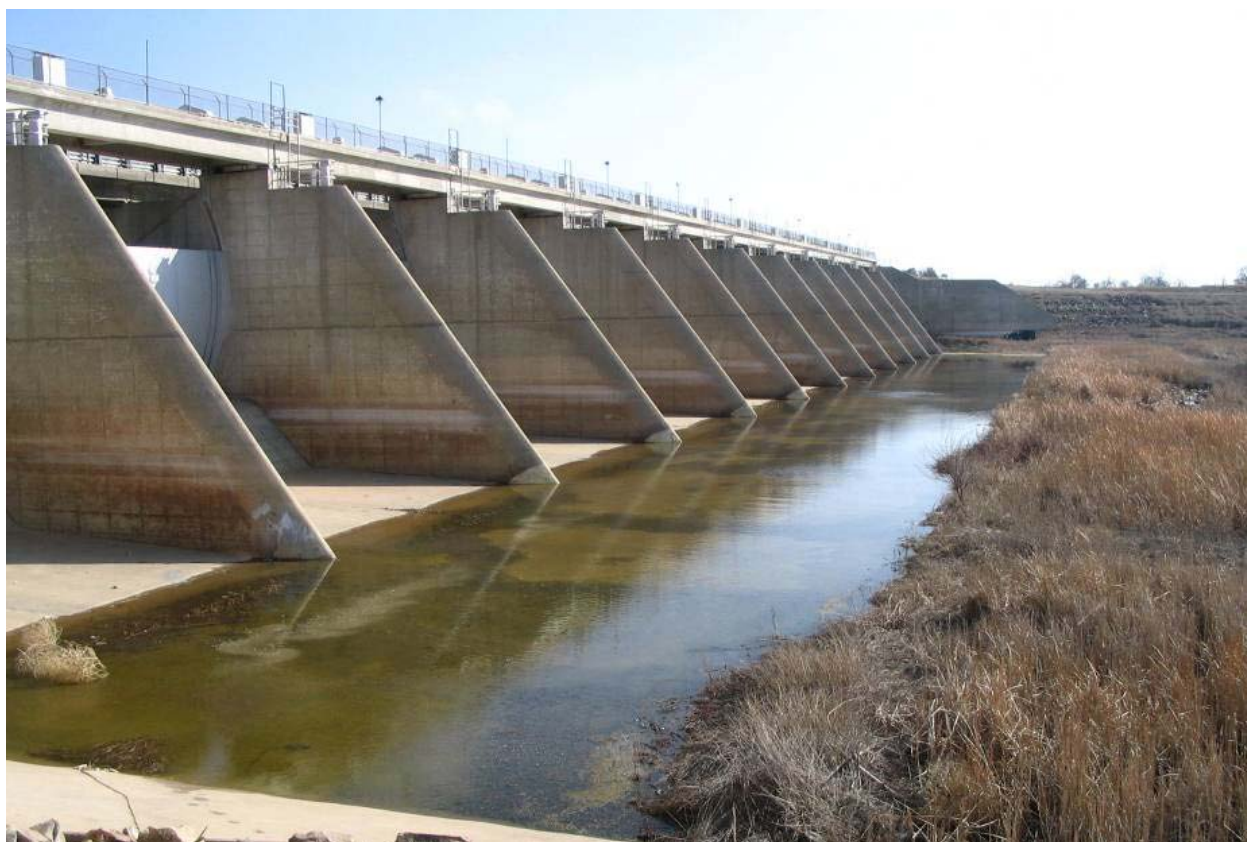
The invert of the excavated inlet channel upstream of the inlet apron is approximately 1 foot higher than the inlet apron invert which creates a grassy berm upstream of the spillway. As a result, water which is located on top of the inlet apron (either from receding reservoir levels or precipitation) becomes trapped and remains ponded in this area (Figure 2).

Figure 2. – View of approach area of spillway. The soil berm trapped water on the apron, leading to deterioration of the concrete.

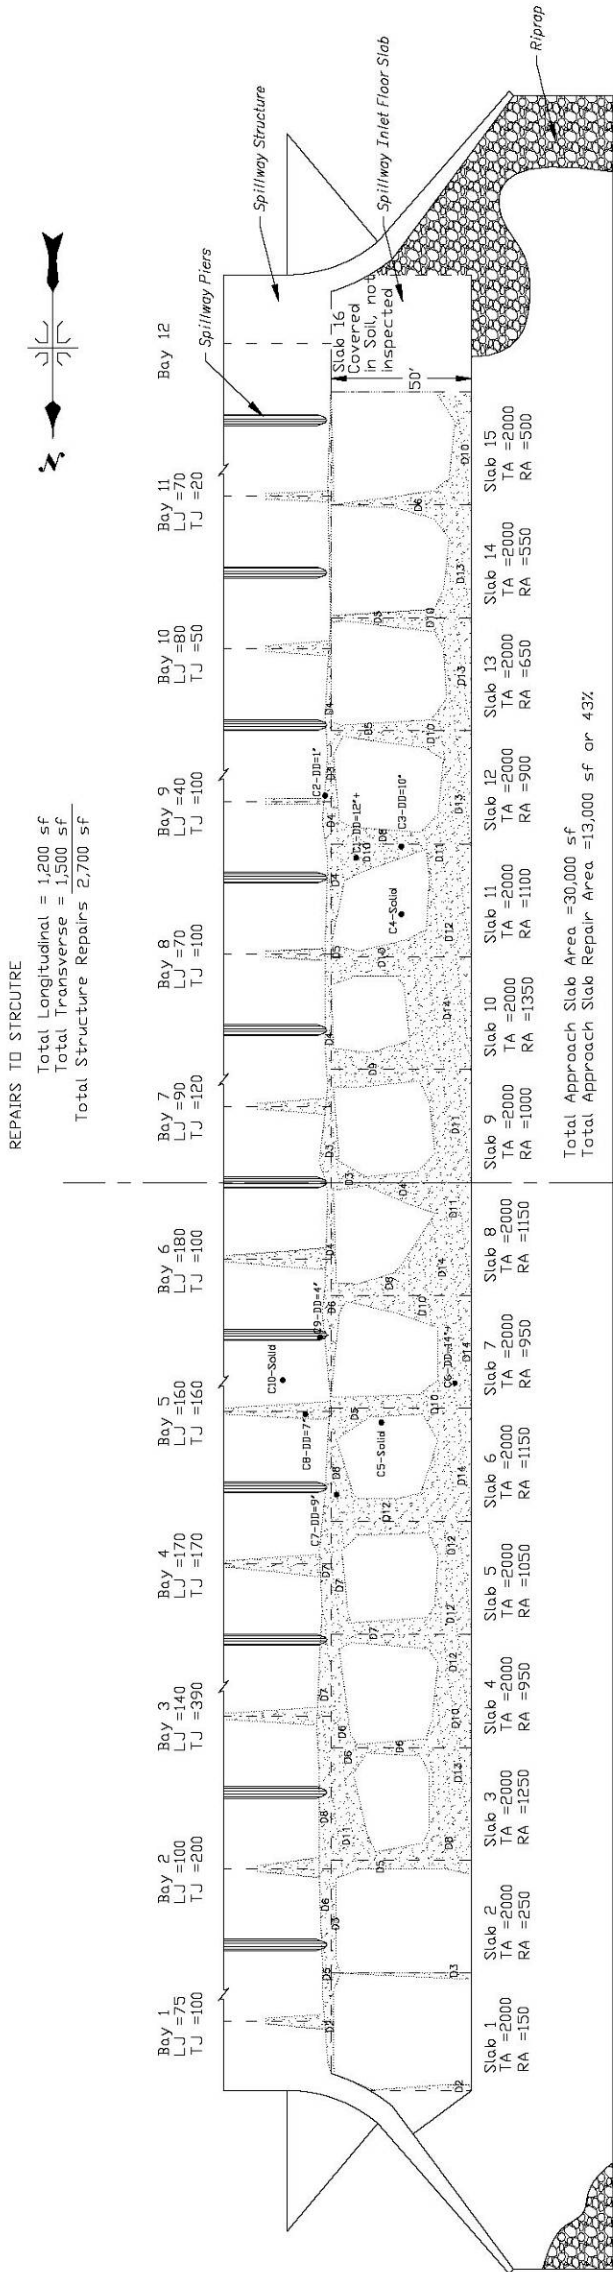
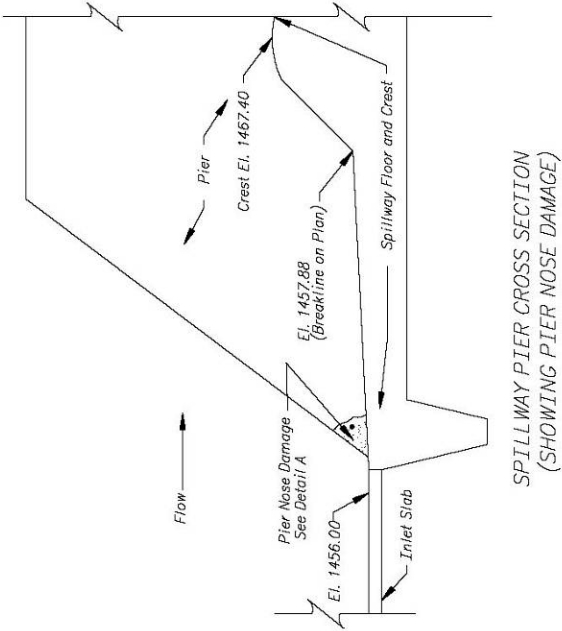
Figure 1. –
Early estimate
of damaged
concrete.

The concrete in both the inlet apron and the pier noses/gate structure were exhibiting areas of extensive deterioration. Results of a concrete core testing program [1] showed that the structure was suffering from freeze-thaw damage largely caused by absorptive aggregate. Cracking from freezing and thawing was then promoting alkali-silica reaction. There was also evidence of carbonation which could lead to susceptibility to reinforcement corrosion. Early evaluation of the approach apron of the structure indicated that about 43 percent of the inlet slab area was in need of repair with deterioration measured as deep as 14-inches during the concrete coring program [2]. A plan view (Figure 3) shows which areas were originally thought to be sound concrete and rough estimates of the depth of deterioration in the areas of damaged concrete. However, once repairs were started, the amount of damaged concrete was discovered to be much larger (Figure 4).

DELINEATION OF DAMAGED CONCRETE
SPILLWAY INLET FLOOR SLAB, PIERS AND UPSTREAM STRUCTURE
GLEN ELDER DAM

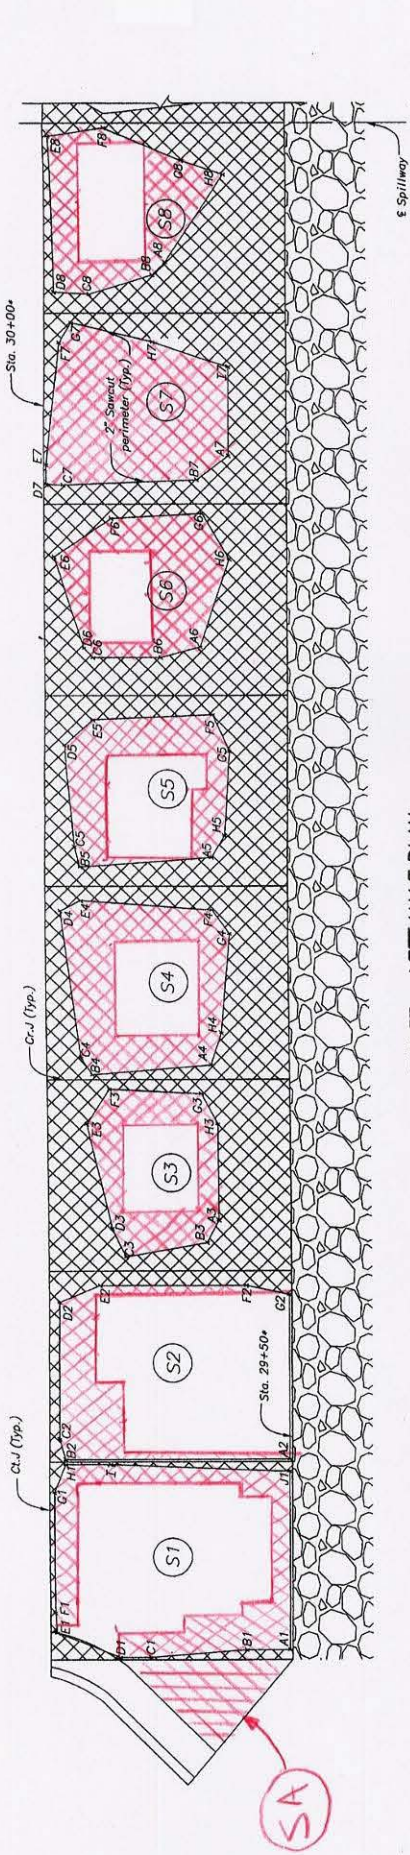
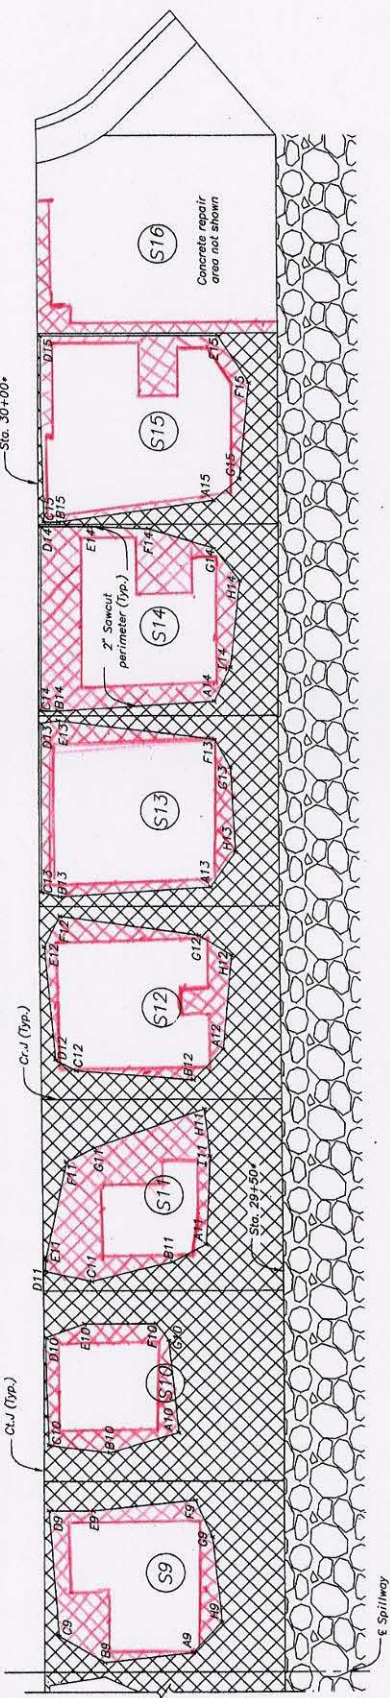
Figure 4. – Revised area of concrete damage.

INLET - LEFT HALF PLAN
(INLET FLOOR SLABS 1-8)

INLET - RIGHT HALF PLAN

REPAIR AREAS
AS MARKED
ON 9/20/2010.
REPAIR AREAS
ARE DRAWN
APPROXIMATELY
TO SCALE.

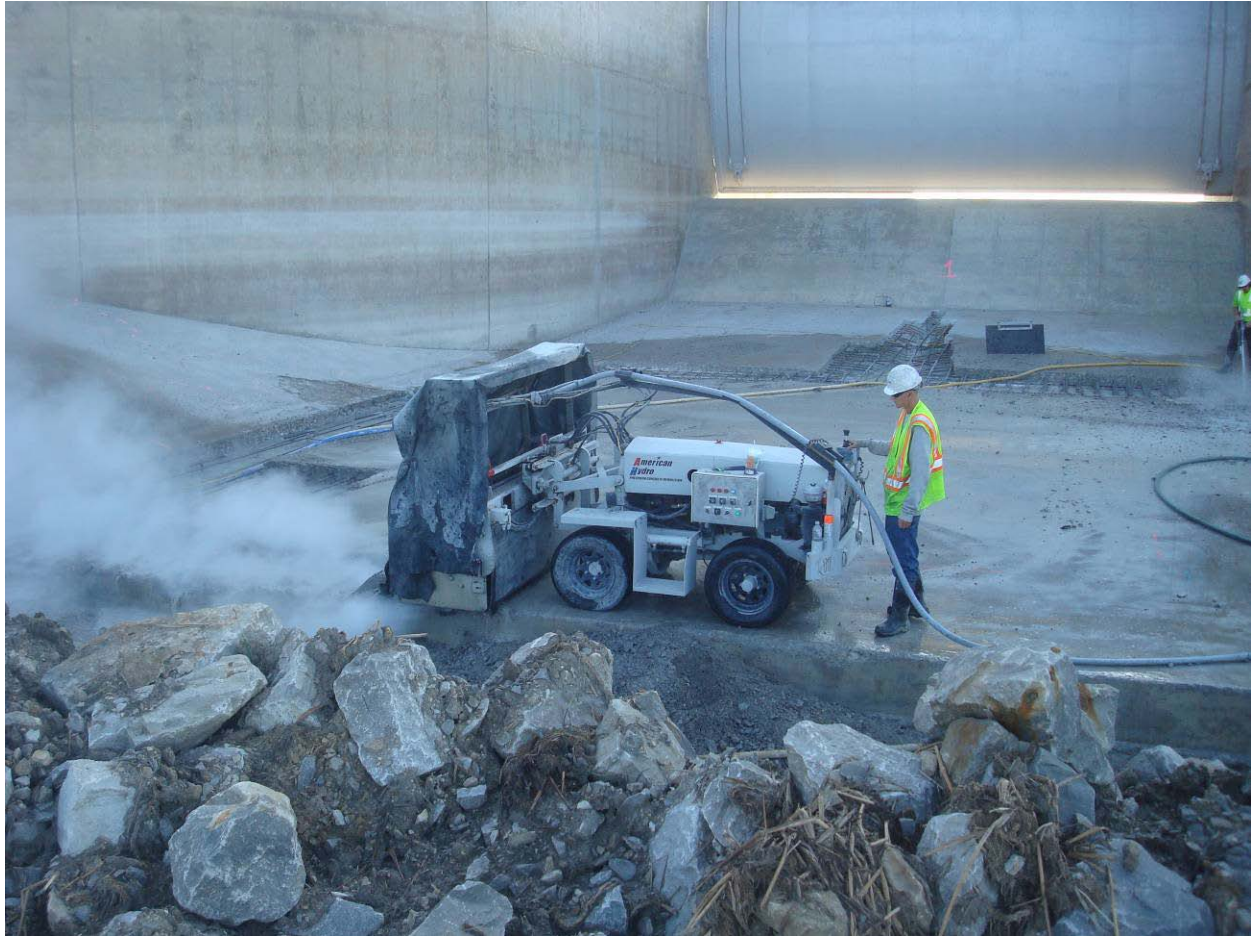
Figure 5. – Hydrodemolition of damaged concrete

The repair consisted of removing deteriorated concrete using hydrodemolition (Figure 5) methods and then placing new concrete back to the existing lines and grades. In most areas, damaged concrete was removed to a depth of about 6-inches, leaving about 12-inches of the original concrete. In some areas, due to the poor quality of the concrete, it was excavated down

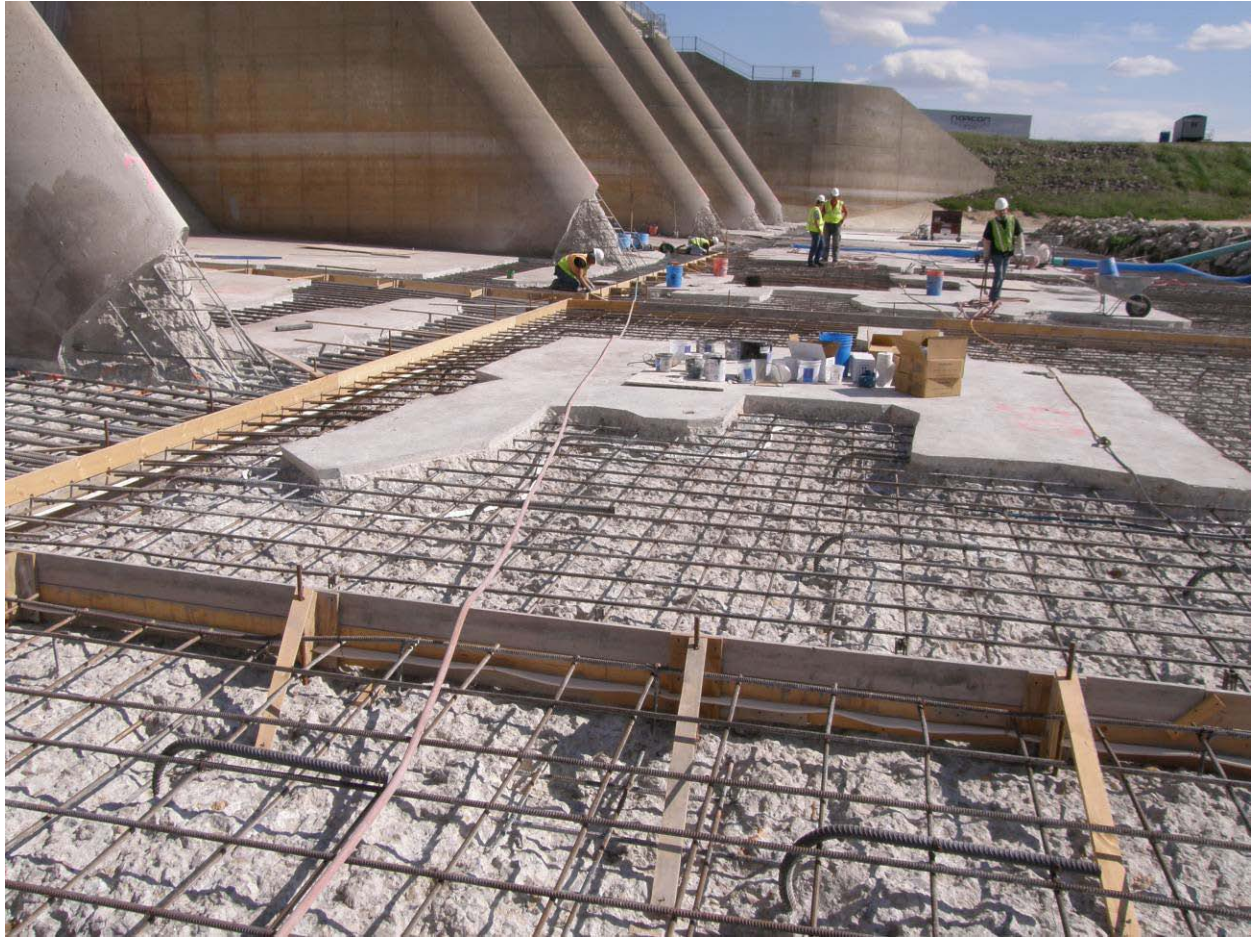
to the foundation. In addition, for some areas, no concrete was removed, so full depth areas of existing concrete were left in place (Figure 6).

Figure 6. – Example of concrete removal with some original concrete remaining.

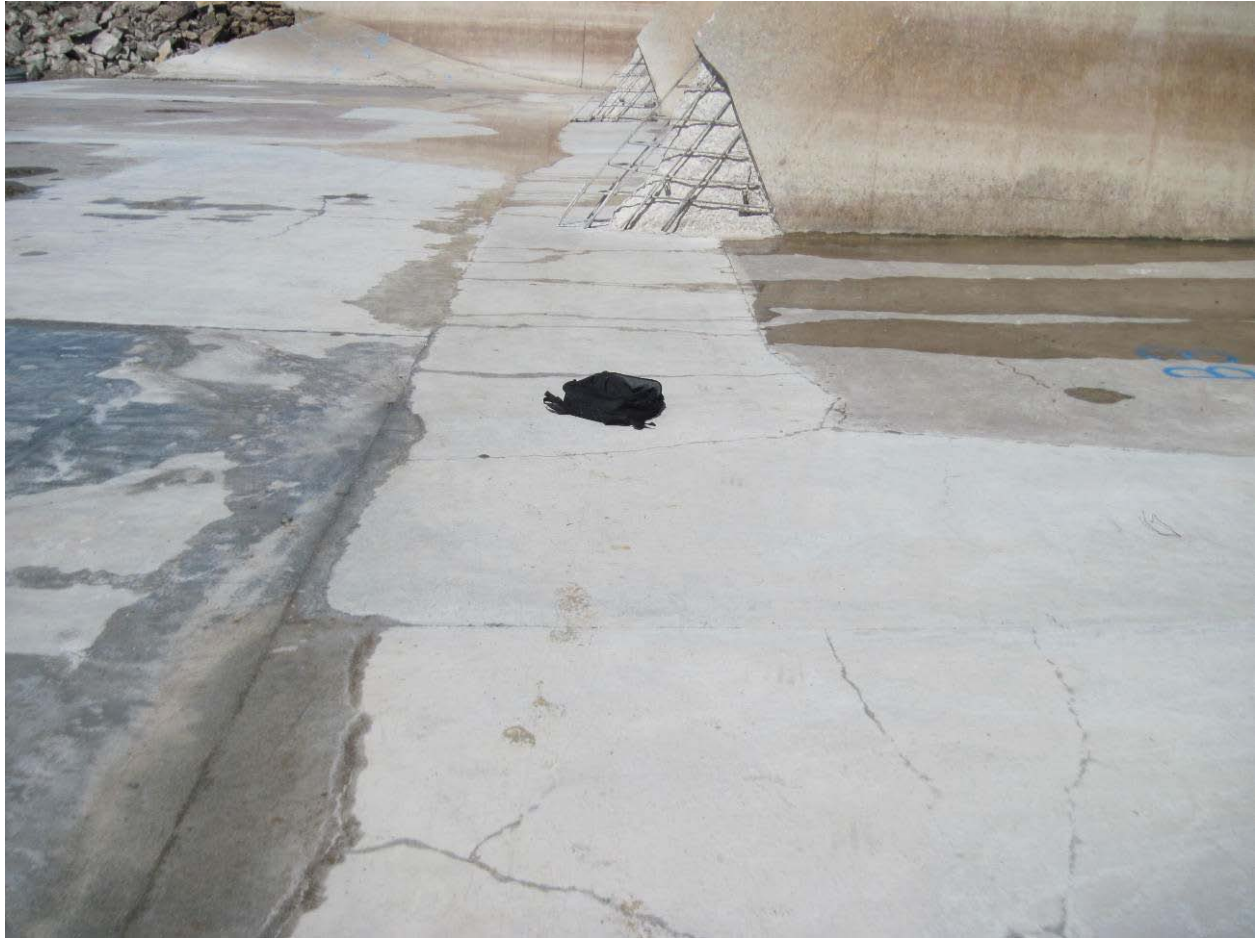
Then, in late winter of this year, MERL staff was contacted by representatives for the Inlet Slab Concrete Repair project that was ongoing at Glen Elder Dam in Kansas. One of the engineers for that project was not happy with the quality of the concrete that was placed. The replacement concrete had numerous restrained shrinkage cracks. His observations indicated that the cracks appeared within one to two weeks after concrete placement.

Using smaller aggregate usually increases the paste content of the concrete, which can exacerbate shrinkage problems. The smaller aggregate size used by batch plants in this area of Kansas is typical, since sources with larger aggregate are not readily available. Obtaining larger aggregate to use for the replacement concrete was deemed too costly and restrictive.

After initial placements were performed in the late summer and fall of 2010, restrained shrinkage cracking was observed in the new concrete (Figure 7). The occurrence of this cracking was not unanticipated, but the number and size was disconcerting.

Figure 7. – View of shrinkage cracking first observed within one to two weeks of concrete placement.

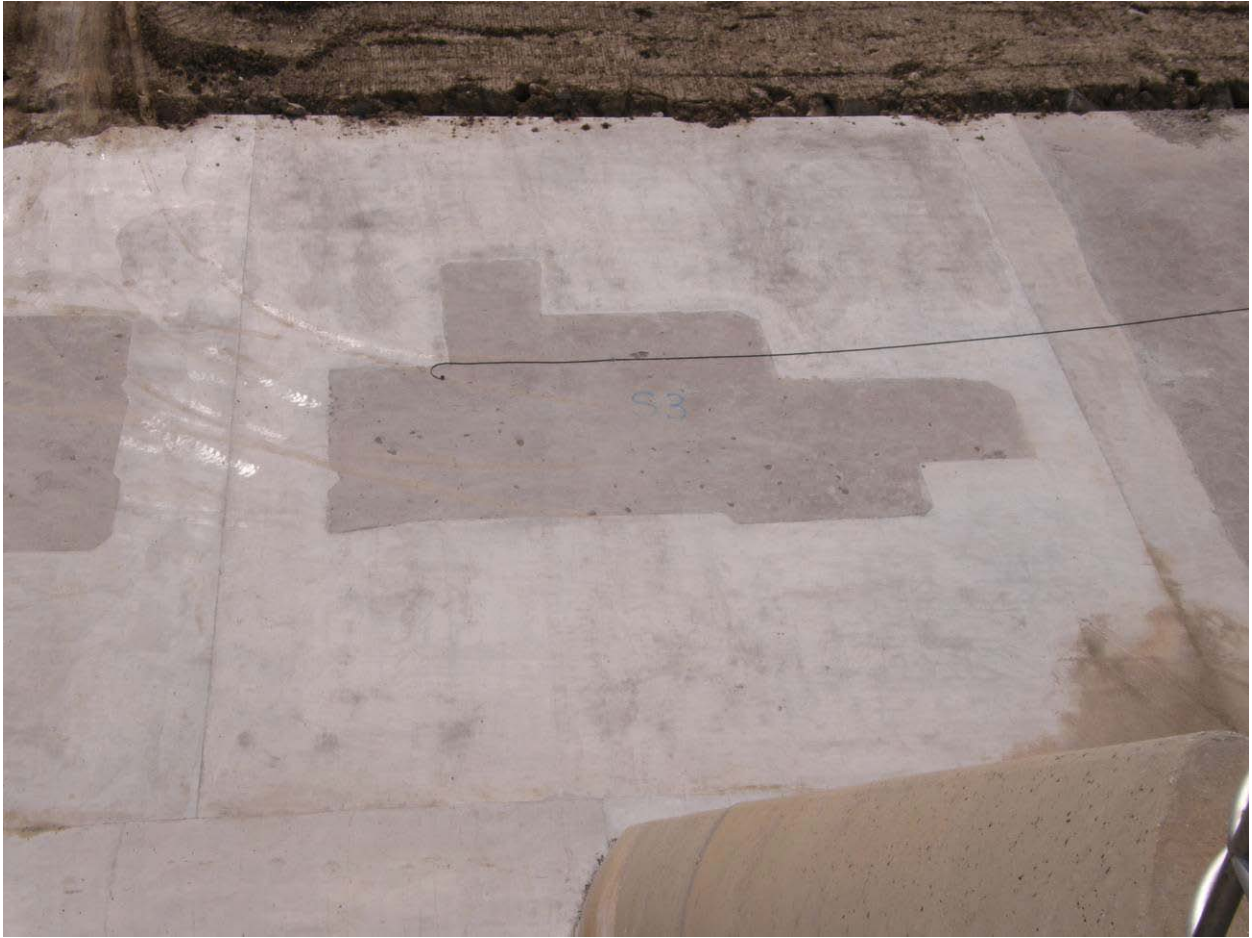
Figure 10. – Slab 3 placement made with concrete without the Premier Magnesia additive.

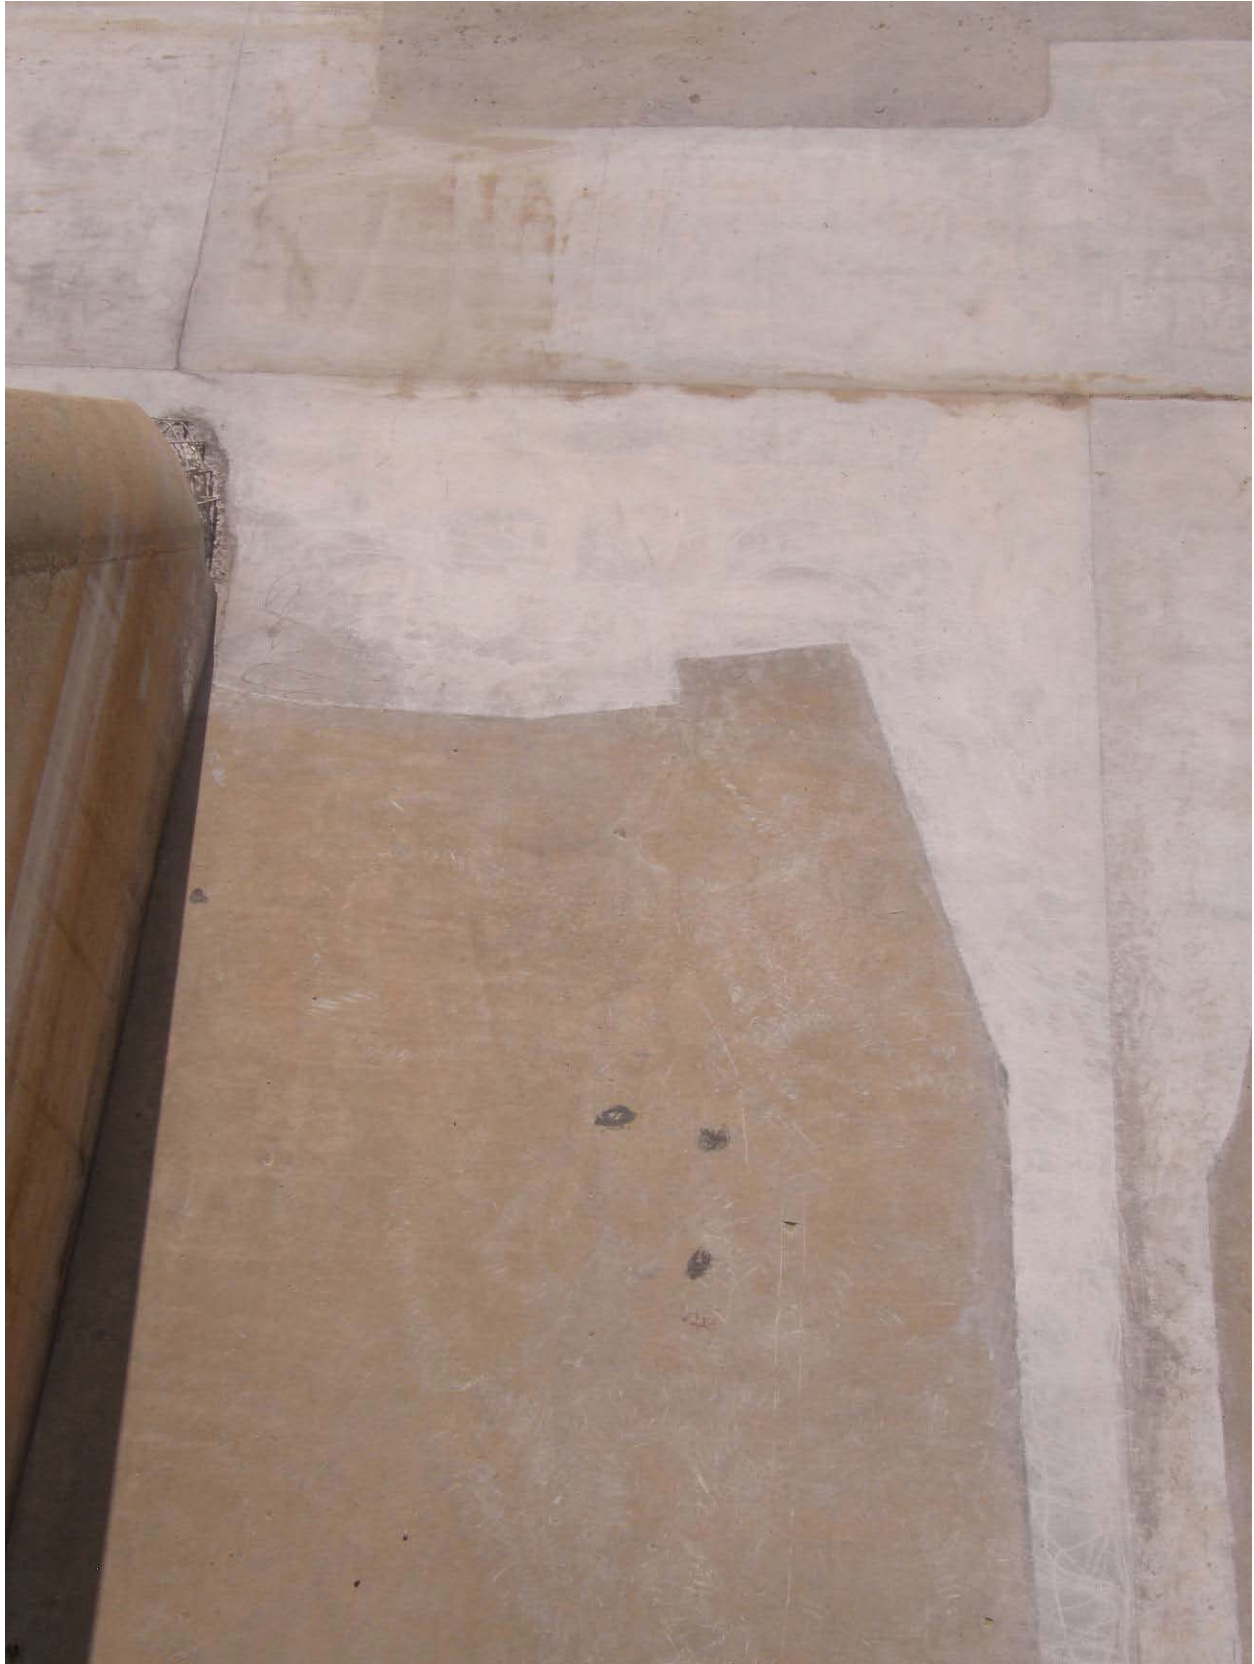
Figure 11. – Bay 7 placement made with concrete without the Premier Magnesia additive.

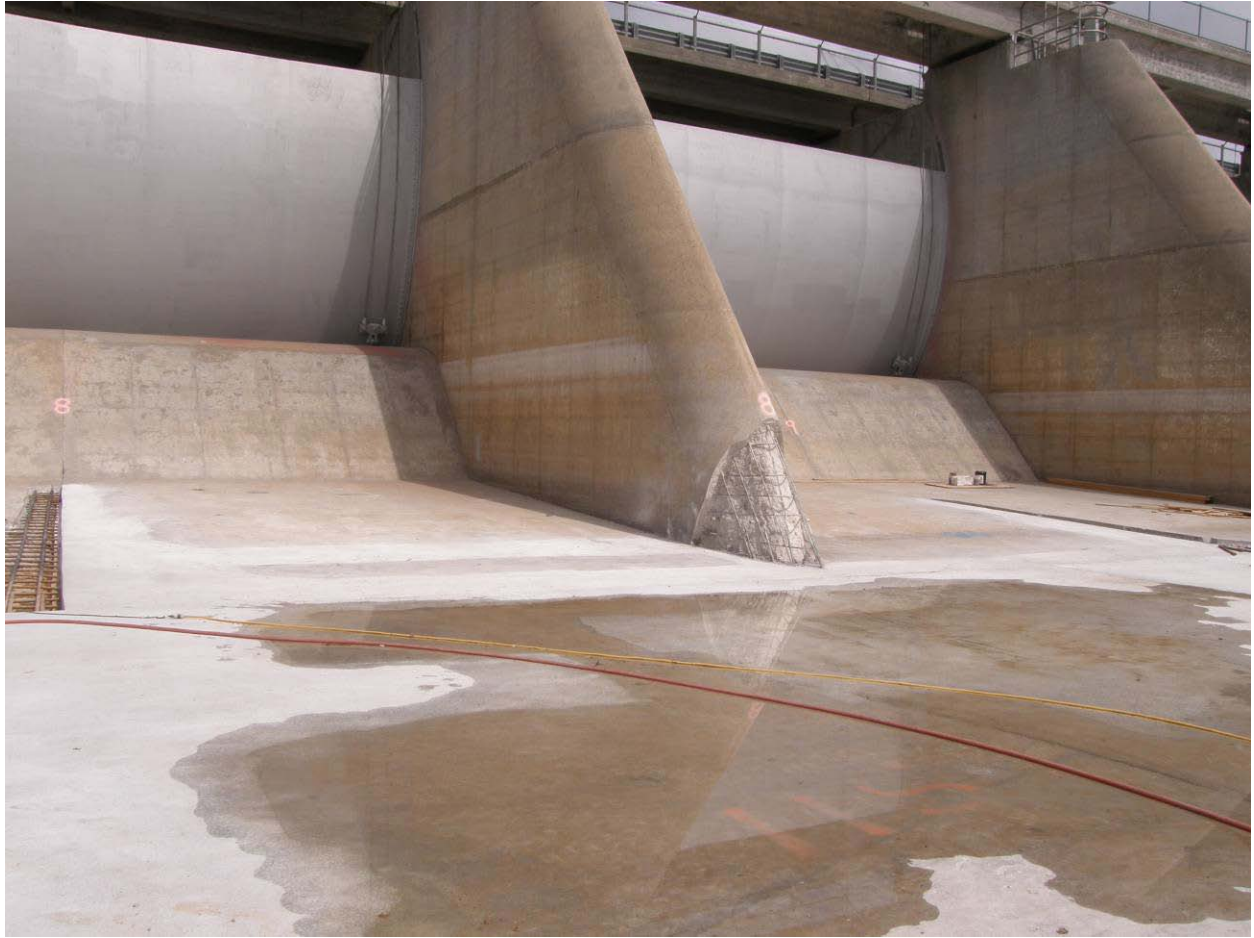
Figures 19 and 20 are drawings showing the approximate crack locations and widths of the observed cracks. Since the placement for Bay 8/9 was not in the original plan, a comparable placement from last year was not evaluated. However, there was no cracking observed in that placement. Results show that cracking was either greatly reduced or completely eliminated when cracking was compared between concrete with and without the additive. In addition, surface areas of open cracks were estimated from crack length and opening data. Table 2 shows those comparisons.

Figure 12. – Placement B8/9 made with concrete containing the Premier Magnesia additive.

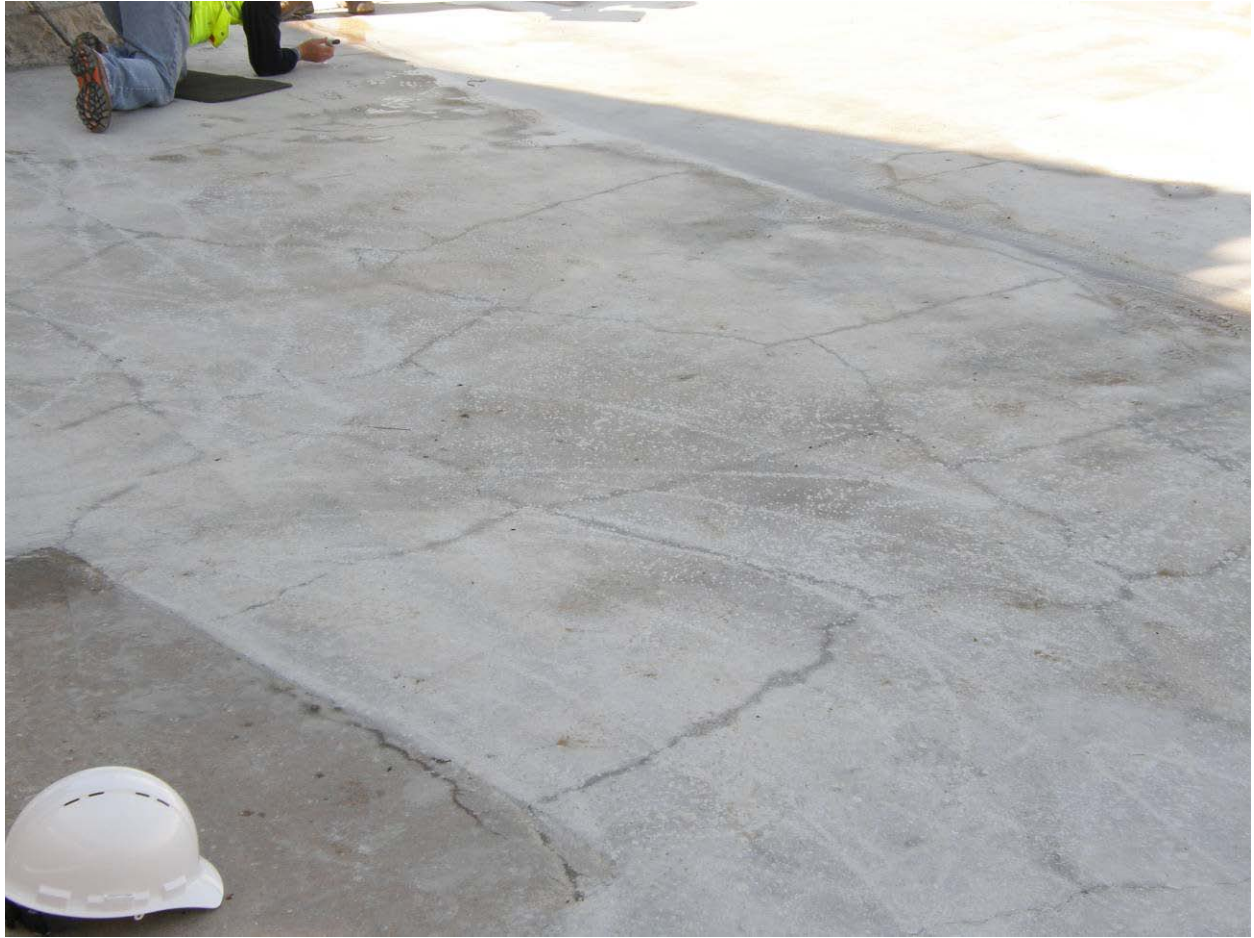
MERL personnel traveled to the site just prior to the placements to map cracks from comparable placements made the fall before (Figures 13 and 14).

Figure 13. – Typical shrinkage cracking that was measured and mapped.

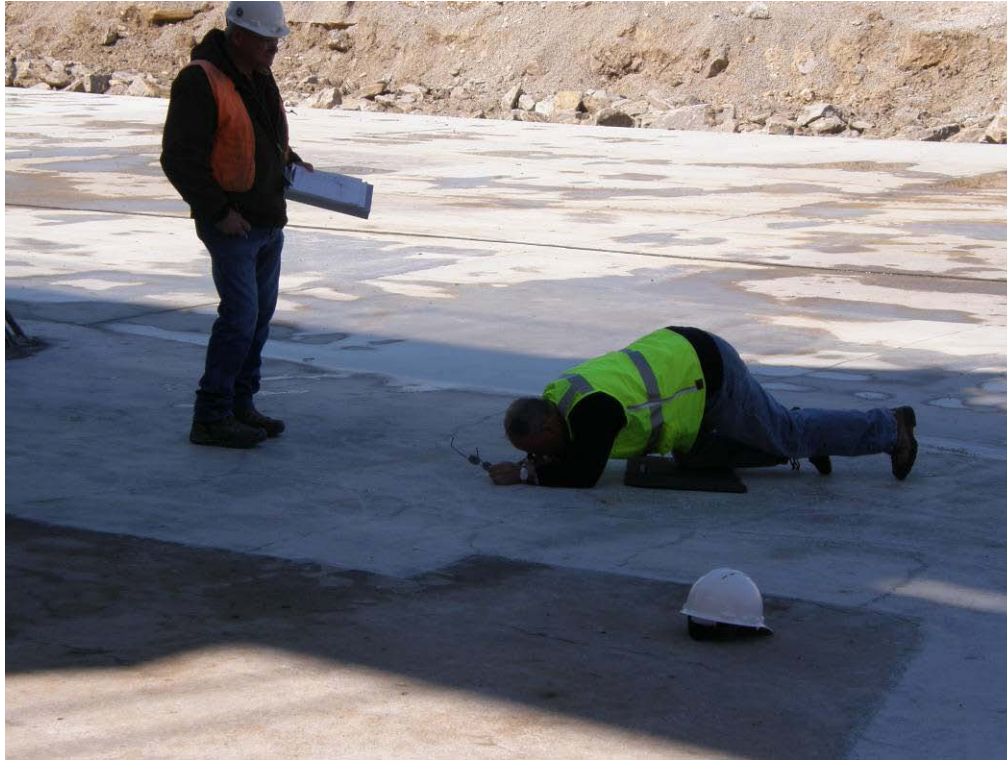
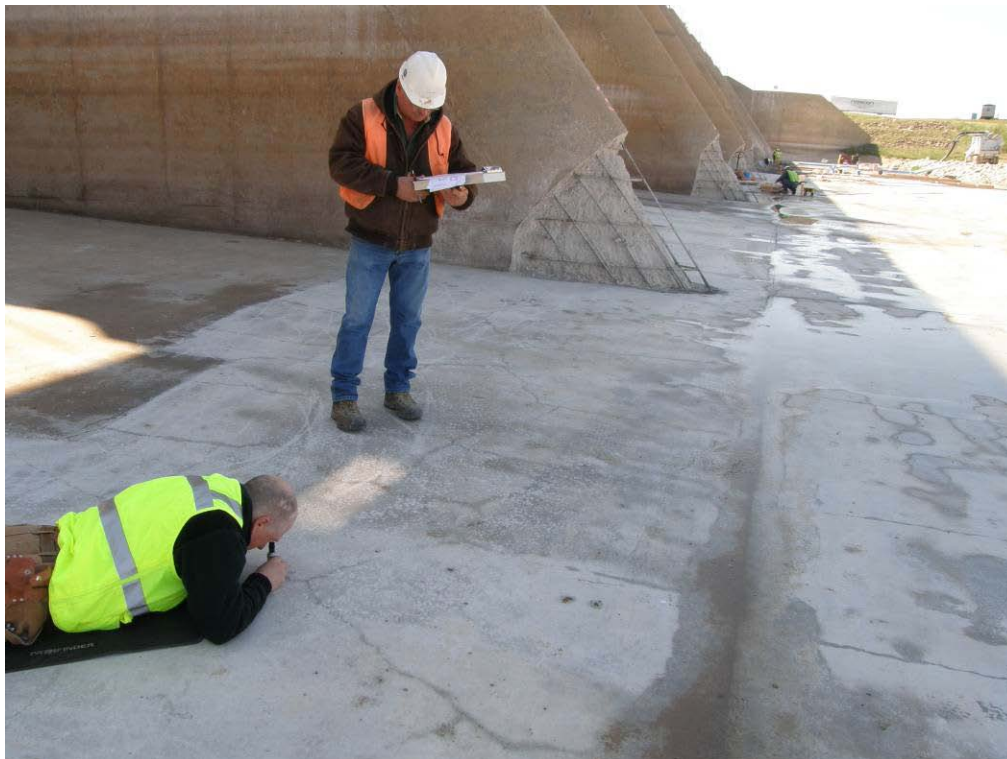
Figure 14. – Measuring crack openings.

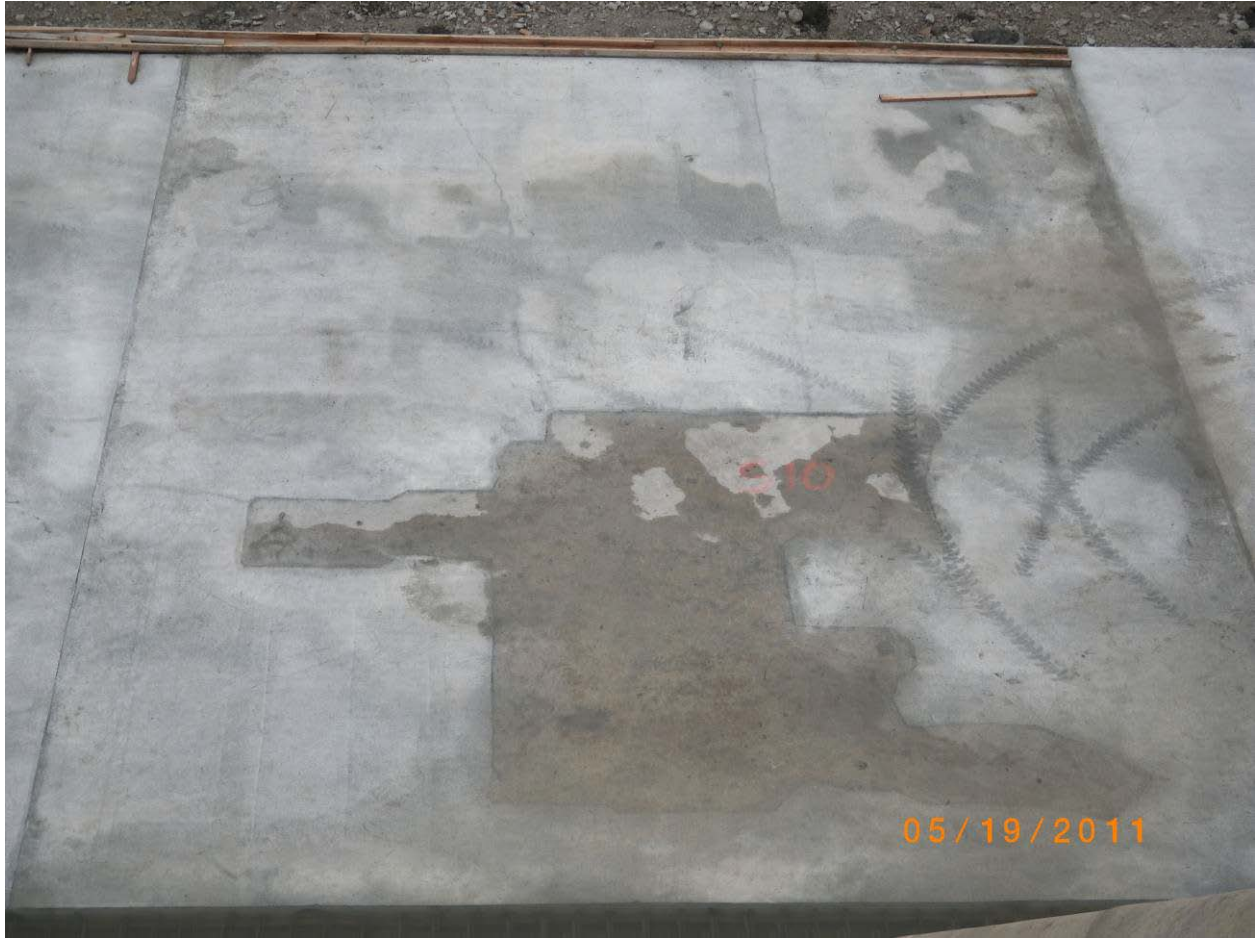
Three weeks later, personnel from MERL and executives from Premier returned to the site to examine the trial concrete placements. Only the placement for slab 10 (S10) showed any cracking (Figure 17), and that was significantly less than cracking observed in the comparison slab. The cracking in S10 was measured and documented in a drawing. The next day, construction activities at the site were halted due to flooding (Figure 18), and as of the middle of August, the area is still underwater.

Figure 17. – Slab 10 repair made with the trial concrete.

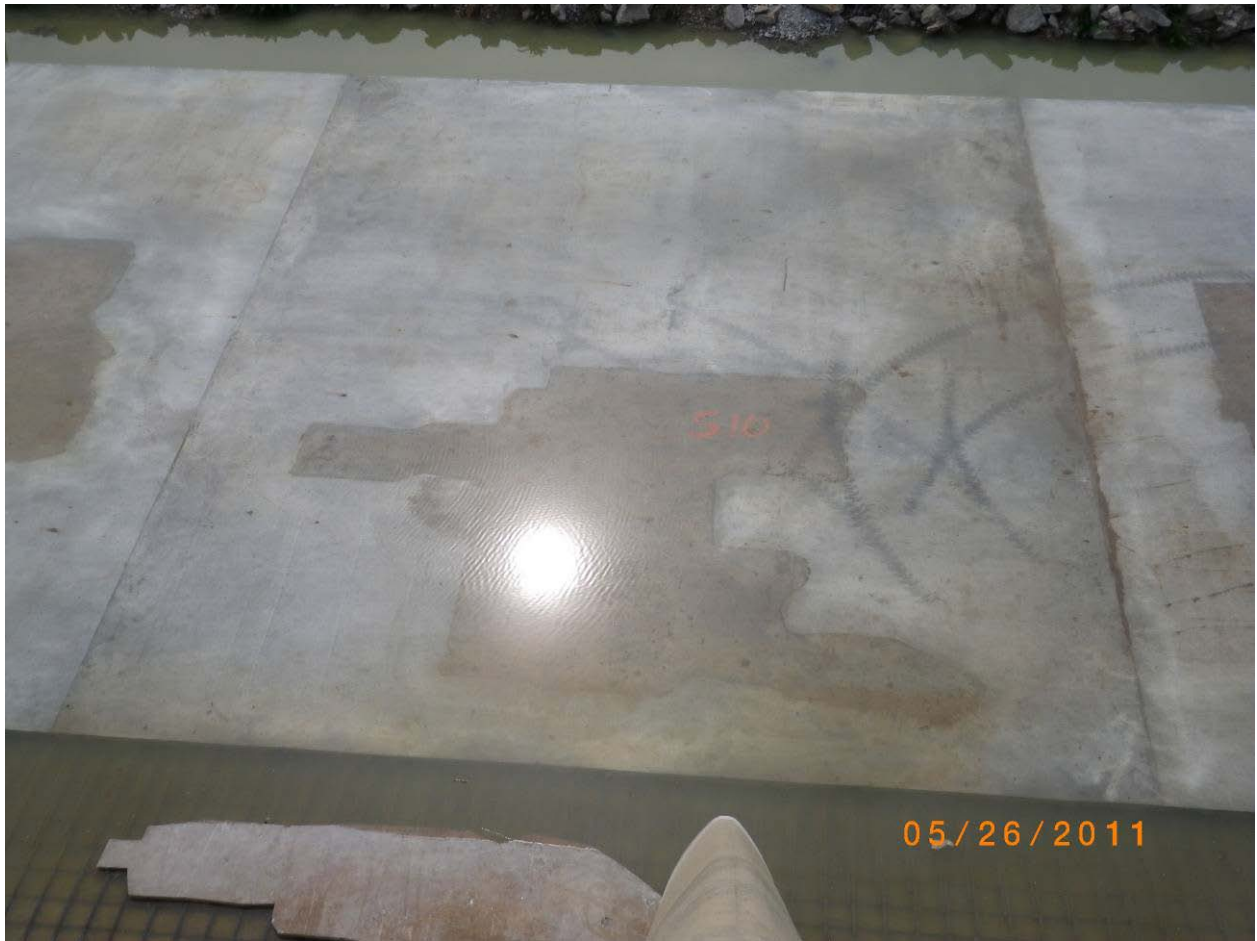
Figure 18. – Approach apron under water after flooding.

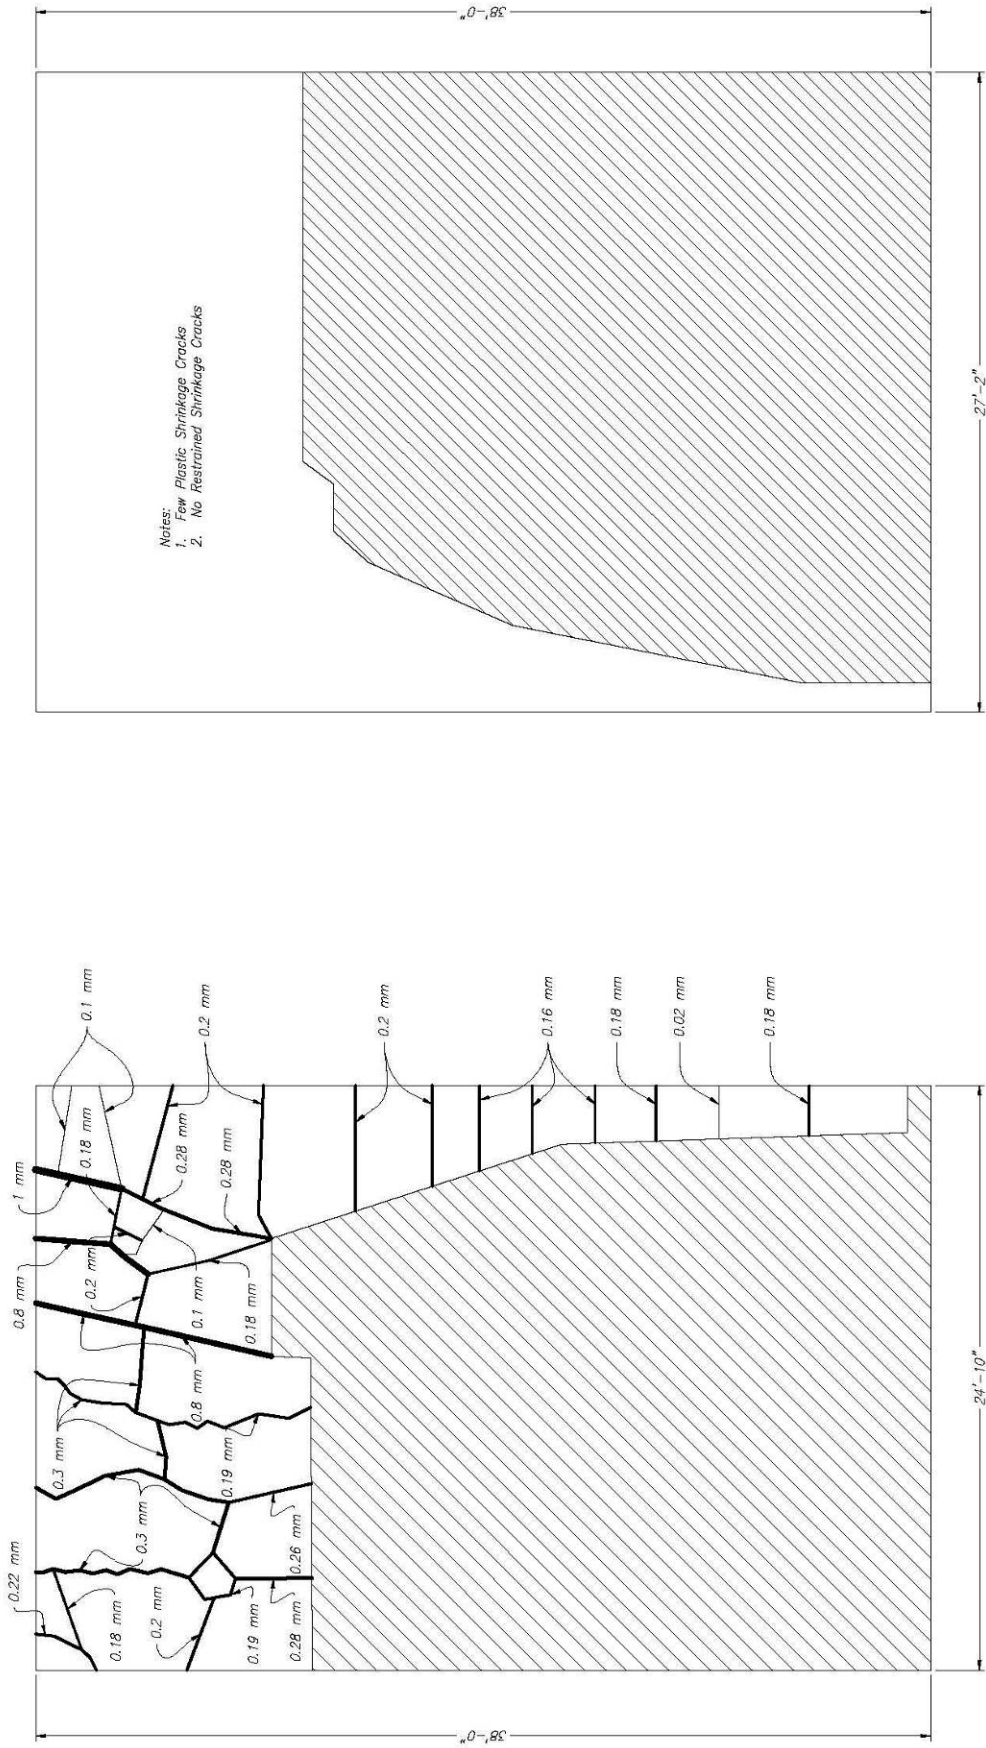
Figure 19. - Comparison of bay placements made with and without the shrinkage reducing additive.
