Memorandum Number MERL 2011-34

Evaluation of New Concrete Shrinkage Reducing Additive for Glen Elder Dam Spillway Inlet Slab Repair

**Missouri River Basin Project –
Solomon Division – Glen Elder Unit - Kansas
Great Plains Region**

Glen Elder Dam

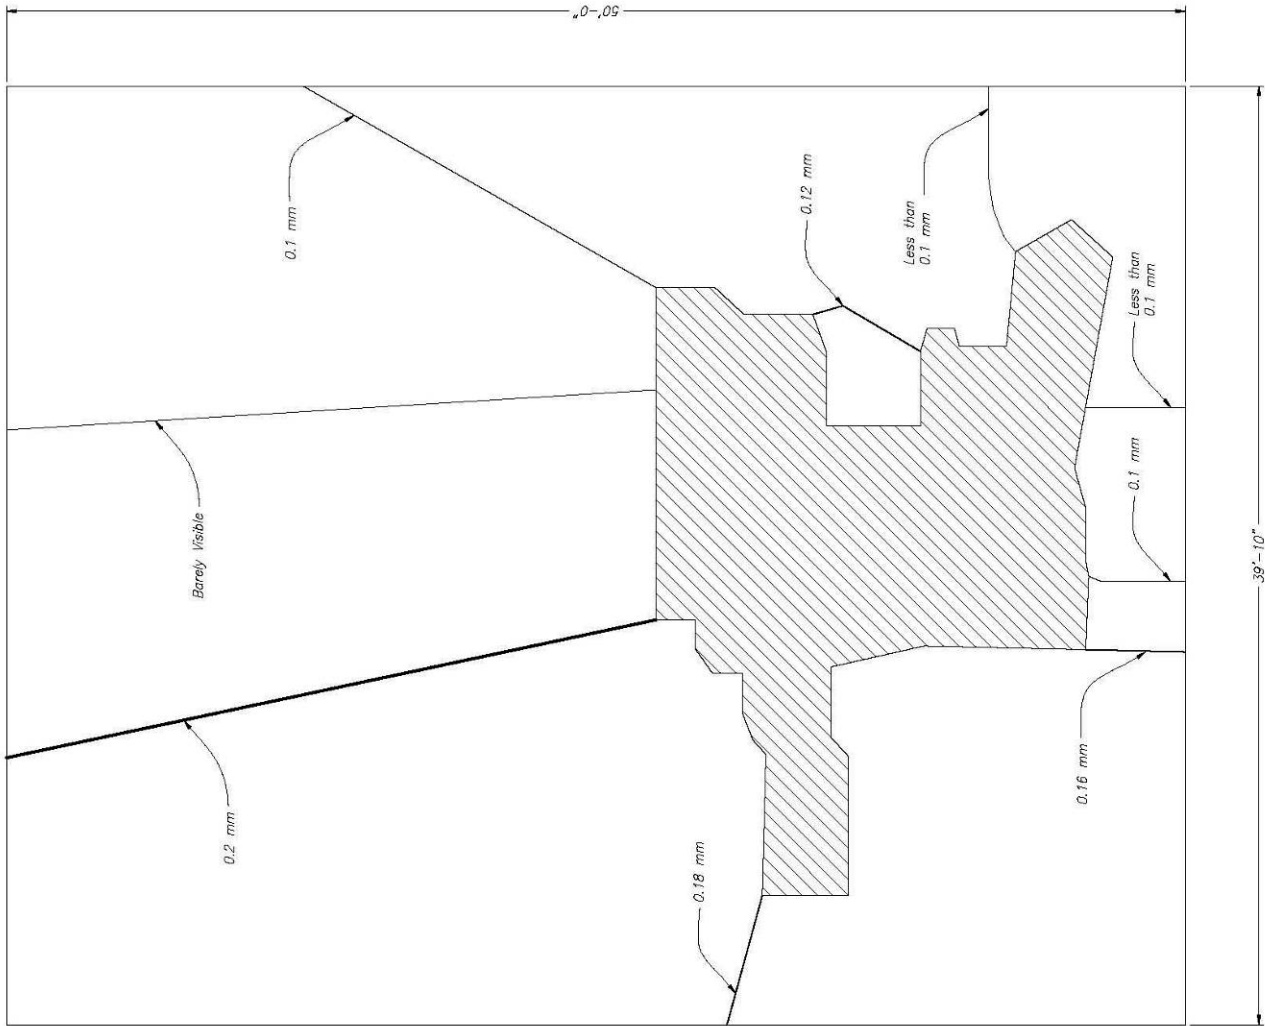
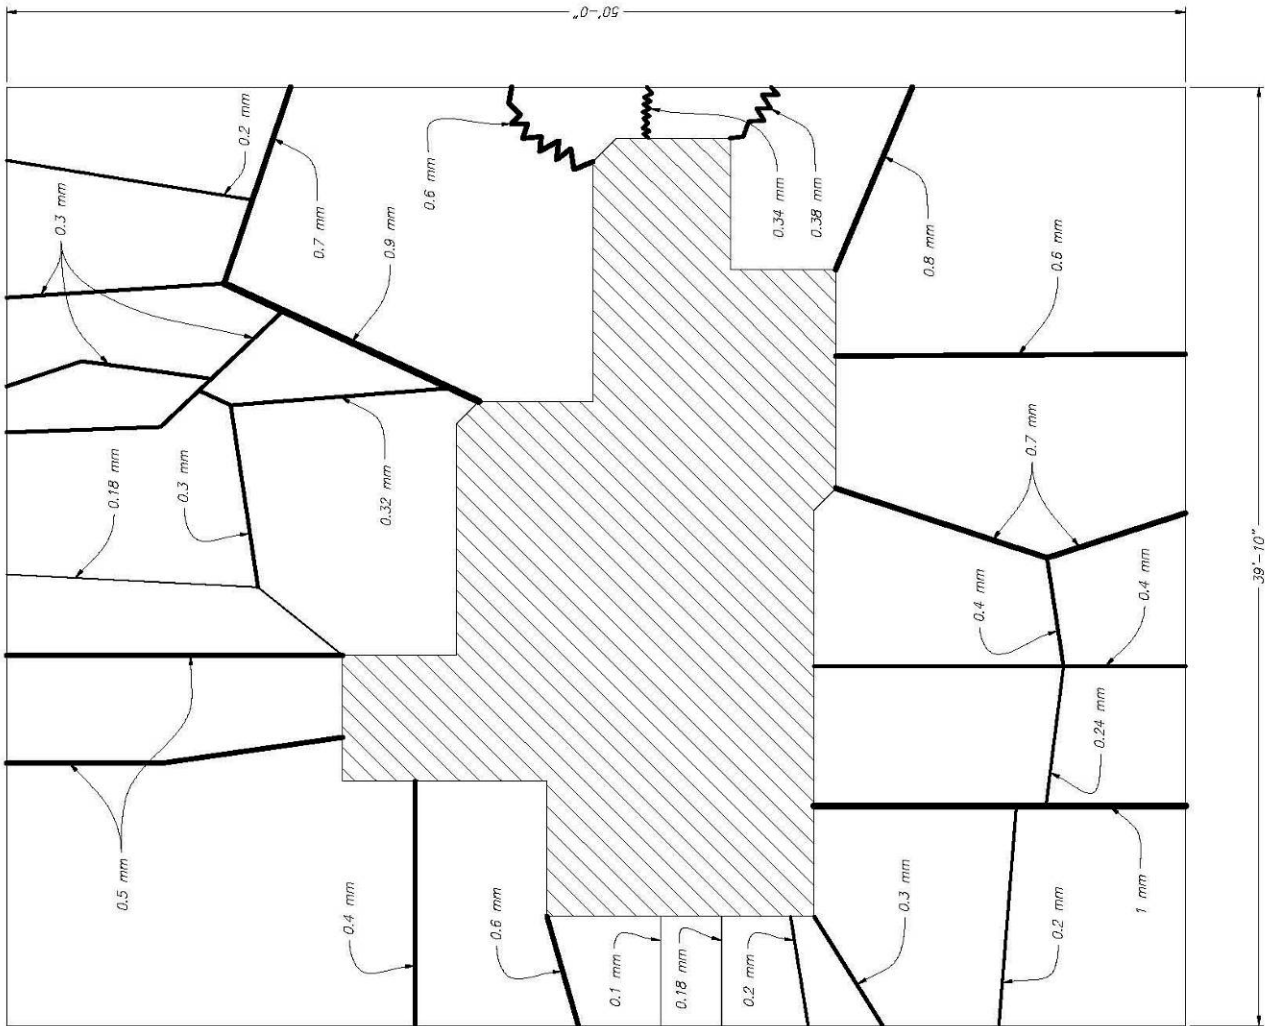
Figure 20 – Comparison of slab placements for concrete placements made with and without the shrinkage reducing additive.

Figures 19 and 20 are drawings showing the approximate crack locations and widths of the observed cracks. Since the placement for Bay 8/9 was not in the original plan, a comparable placement from last year was not evaluated. However, there was no cracking observed in that placement. Results show that cracking was either greatly reduced or completely eliminated when cracking was compared between concrete with and without the additive. In addition, surface areas of open cracks were estimated from crack length and opening data. Table 2 shows those comparisons.

SLAB 10 – WITH ADDITIVE

SLAB 3 – WITHOUT ADDITIVE
