Aqualastic® Repair to Encapsulate Degraded RCC Lining in Canals

Research and Development Office Science and Technology Program Final Report ST-2015-786-1

Document: Final Report ST-2015-786-1

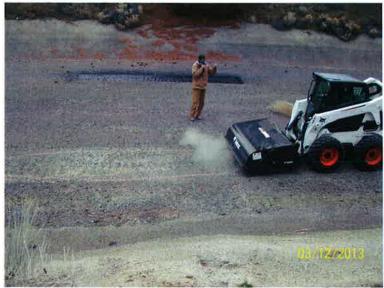
Test Section 1 is a dozer track mark in a relatively wide section of the canal. The surface preparation is brushed.

Photo 1 Test Section 1 Brush surface preparation.

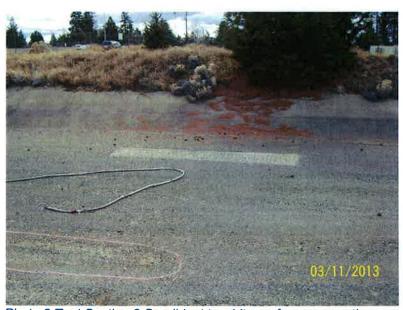
Test Section 2 is a track mark in a relatively wide section of the canal. The surface preparation is sandblast to white.

Photo 2 Test Section 2 Sandblast to white surface preparation.

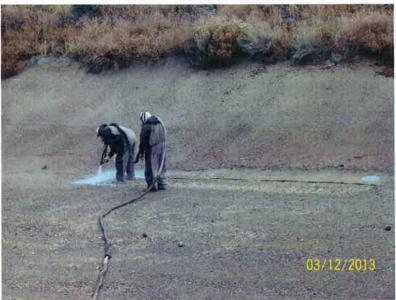
Test Section 3 is the feathered edge between the RCC invert and the shotcrete side slope in a wide section of the canal. The surface preparation is brushed.

Photo 3 Test Section 3 Brushed surface preparation. Starting the Aqualastic application.

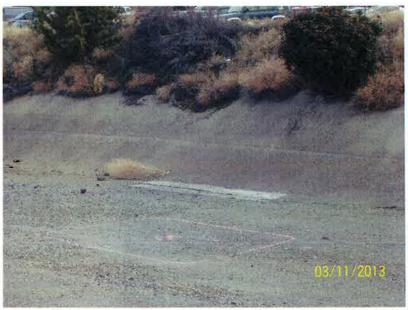
Test Section 4 is the feathered edge between the RCC invert and the shotcrete side slope in a wide section of the canal. The surface preparation is sandblast to white.

Photo 4 Test Section 4 in the background. Sandblast to white surface preparation.

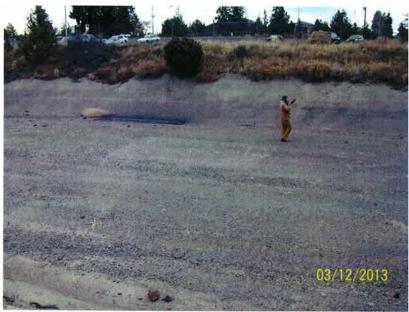
Test Section 5 is a general patch near the center of the canal. The surface preparation is brushed.

Photo 5 Test Section 5 Brushed surface preparation.

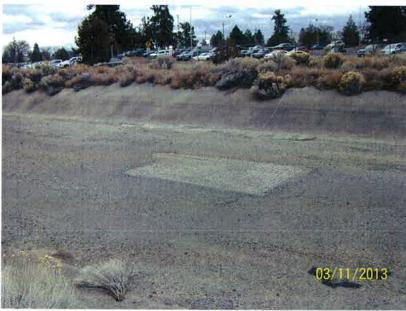
Test Section 6 is a general patch near the center of the canal. The surface preparation is sandblast to white.

Photo 6 Test Section 6 Sandblast to white surface preparation.

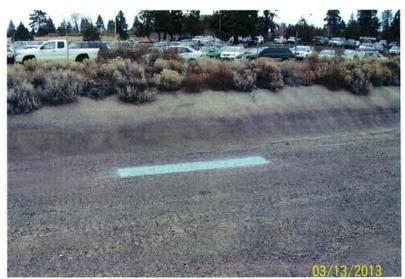
Test Section 7 is a track mark in a relatively narrow section of the canal. The surface preparation is sandblast to white.

Photo 7 Test Section 7 Sandblast to white surface preparation.

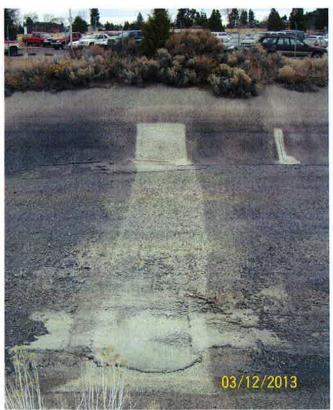
Test section 8 is a strip across the canal in a relatively narrow section. The strip covers a track mark, a repair patch, and feathered edges. The surface preparation is sandblast to white.

Photo 8 Test Section 8 Sandblast to white surface preparation.

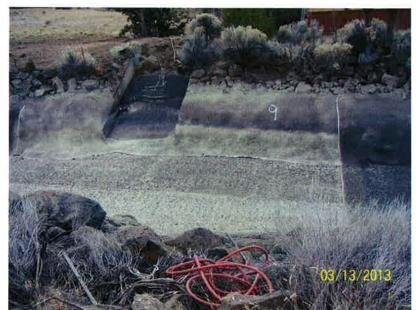
Test Section 9 is a large side by side patch in a narrow section of the canal. The left side is sandblast to white. The right side is brushed.

Photo 9 Test Section 9 Sandblast to white surface preparation on the left, brushed surface preparation on the right. This is a narrow deep section of the canal that has higher velocities.

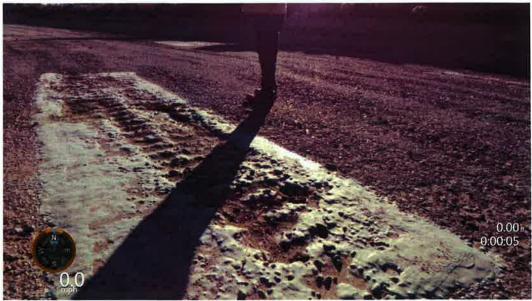
Photo 10 Test Section 1 Spring 2015

Test Section 1 is a track mark in a relatively wide section of the canal. The surface preparation is brushed. No alligator cracking and/or bubbling found. The Aqualastic ® is still strongly bonded to the RCC.

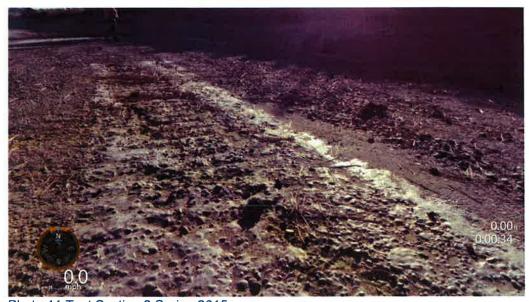
Photo 11 Test Section 2 Spring 2015

Test Section 2 is a track mark in a relatively wide section of the canal. The surface preparation is sandblast to white. No alligator cracking and/or bubbling found. The Aqualastic ® is still strongly bonded to the RCC.

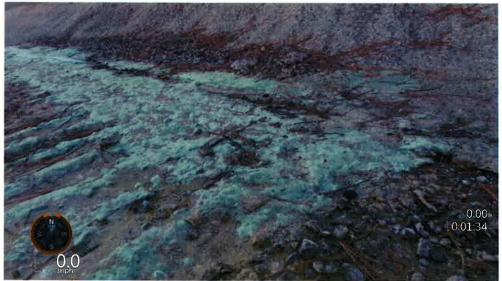
- What the results were After two years of service, all test sections are performing well. One test section (Test Section 3) has developed a small pocket on the leading edge. This test section is over the feathered edge of the side slope to invert transition and the surface preparation was brushed.

Test Section 3 is the feathered edge between the RCC invert and the shotcrete side slope in a wide section of the canal. The surface preparation is brushed. No alligator cracking and/or bubbling found. The Aqualastic ® is still strongly bonded to the RCC. The leading edge has a small pocket that has formed where some loose material washed out.

Photo 12 Test Section 3 Spring 2015 a small pocket has formed right at the edge of the RCC and side slope shotcrete.

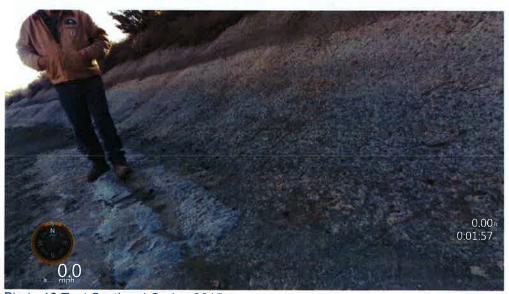
Photo 13 Test Section 4 Spring 2015

Test Section 4 is the feathered edge between the RCC invert and the shotcrete side slope in a wide section of the canal. The surface preparation is sandblast to white. No alligator cracking and/or bubbling found. The Aqualastic ® is still strongly bonded to the RCC.

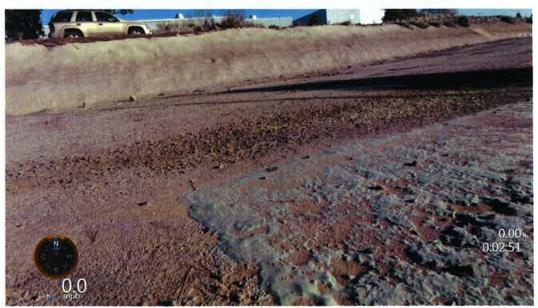
Photo 14 Test Section 5 Spring 2015

Test Section 5 is a general patch near the center of the canal. The surface preparation is brushed. No alligator cracking and/or bubbling found. The Aqualastic ® is still strongly bonded to the RCC.

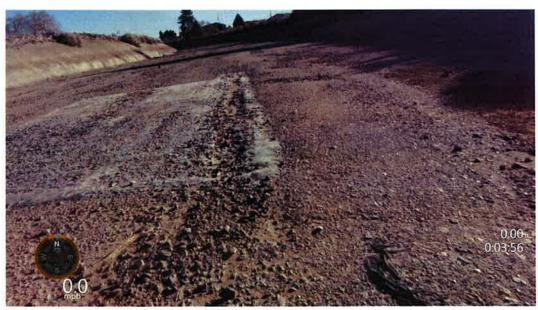
Photo 15 Test Section 6 Spring 2015

Test Section 6 is a general patch near the center of the canal. The surface preparation is sandblast to white. No alligator cracking and/or bubbling found. The Aqualastic ® is still strongly bonded to the RCC.

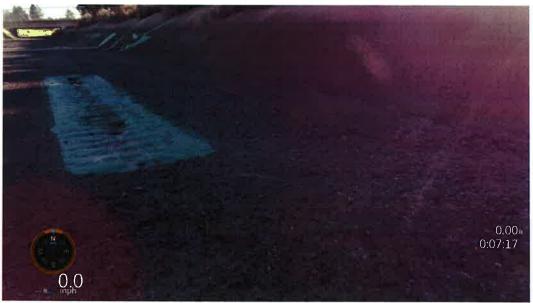
Photo 16 Test Section 7 Spring 2015

Test Section 7 is a track mark in a relatively narrow section of the canal. The surface preparation is sandblast to white. No alligator cracking and/or bubbling found. The Aqualastic ® is still strongly bonded to the RCC.

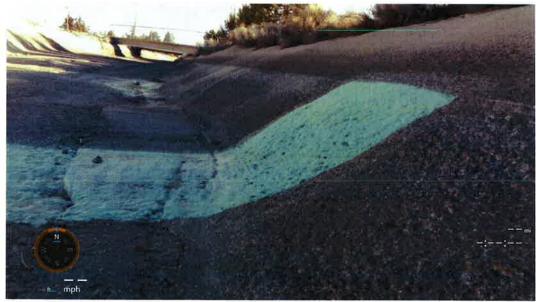
Photo 17 Test Section 8 Spring 2015 Right side leading edge

Test section 8 is a strip across the canal in a relatively narrow section. The strip covers a track mark, a repair patch, and feathered edges. The surface preparation is sandblast to white. No alligator cracking and/or bubbling found. The Aqualastic ® is still strongly bonded to the RCC.

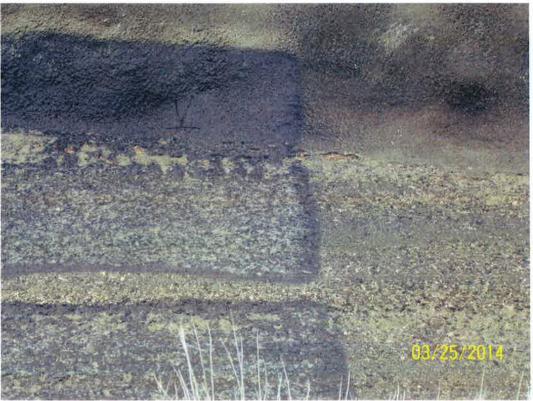
Photo 19 Test Section 9 Spring 2014

Test Section 9 is a large side by side patch in a narrow section of the canal. The left side is sandblast to white. The right side is brushed. No alligator cracking and/or bubbling found. The Aqualastic ® is still strongly bonded to the RCC.
