Localized Saturation on Generator Neutral Current Transformers

Research and Development Office
Science and Technology Program
(Interim Report) ST-2016-2446-1

10/31/2016

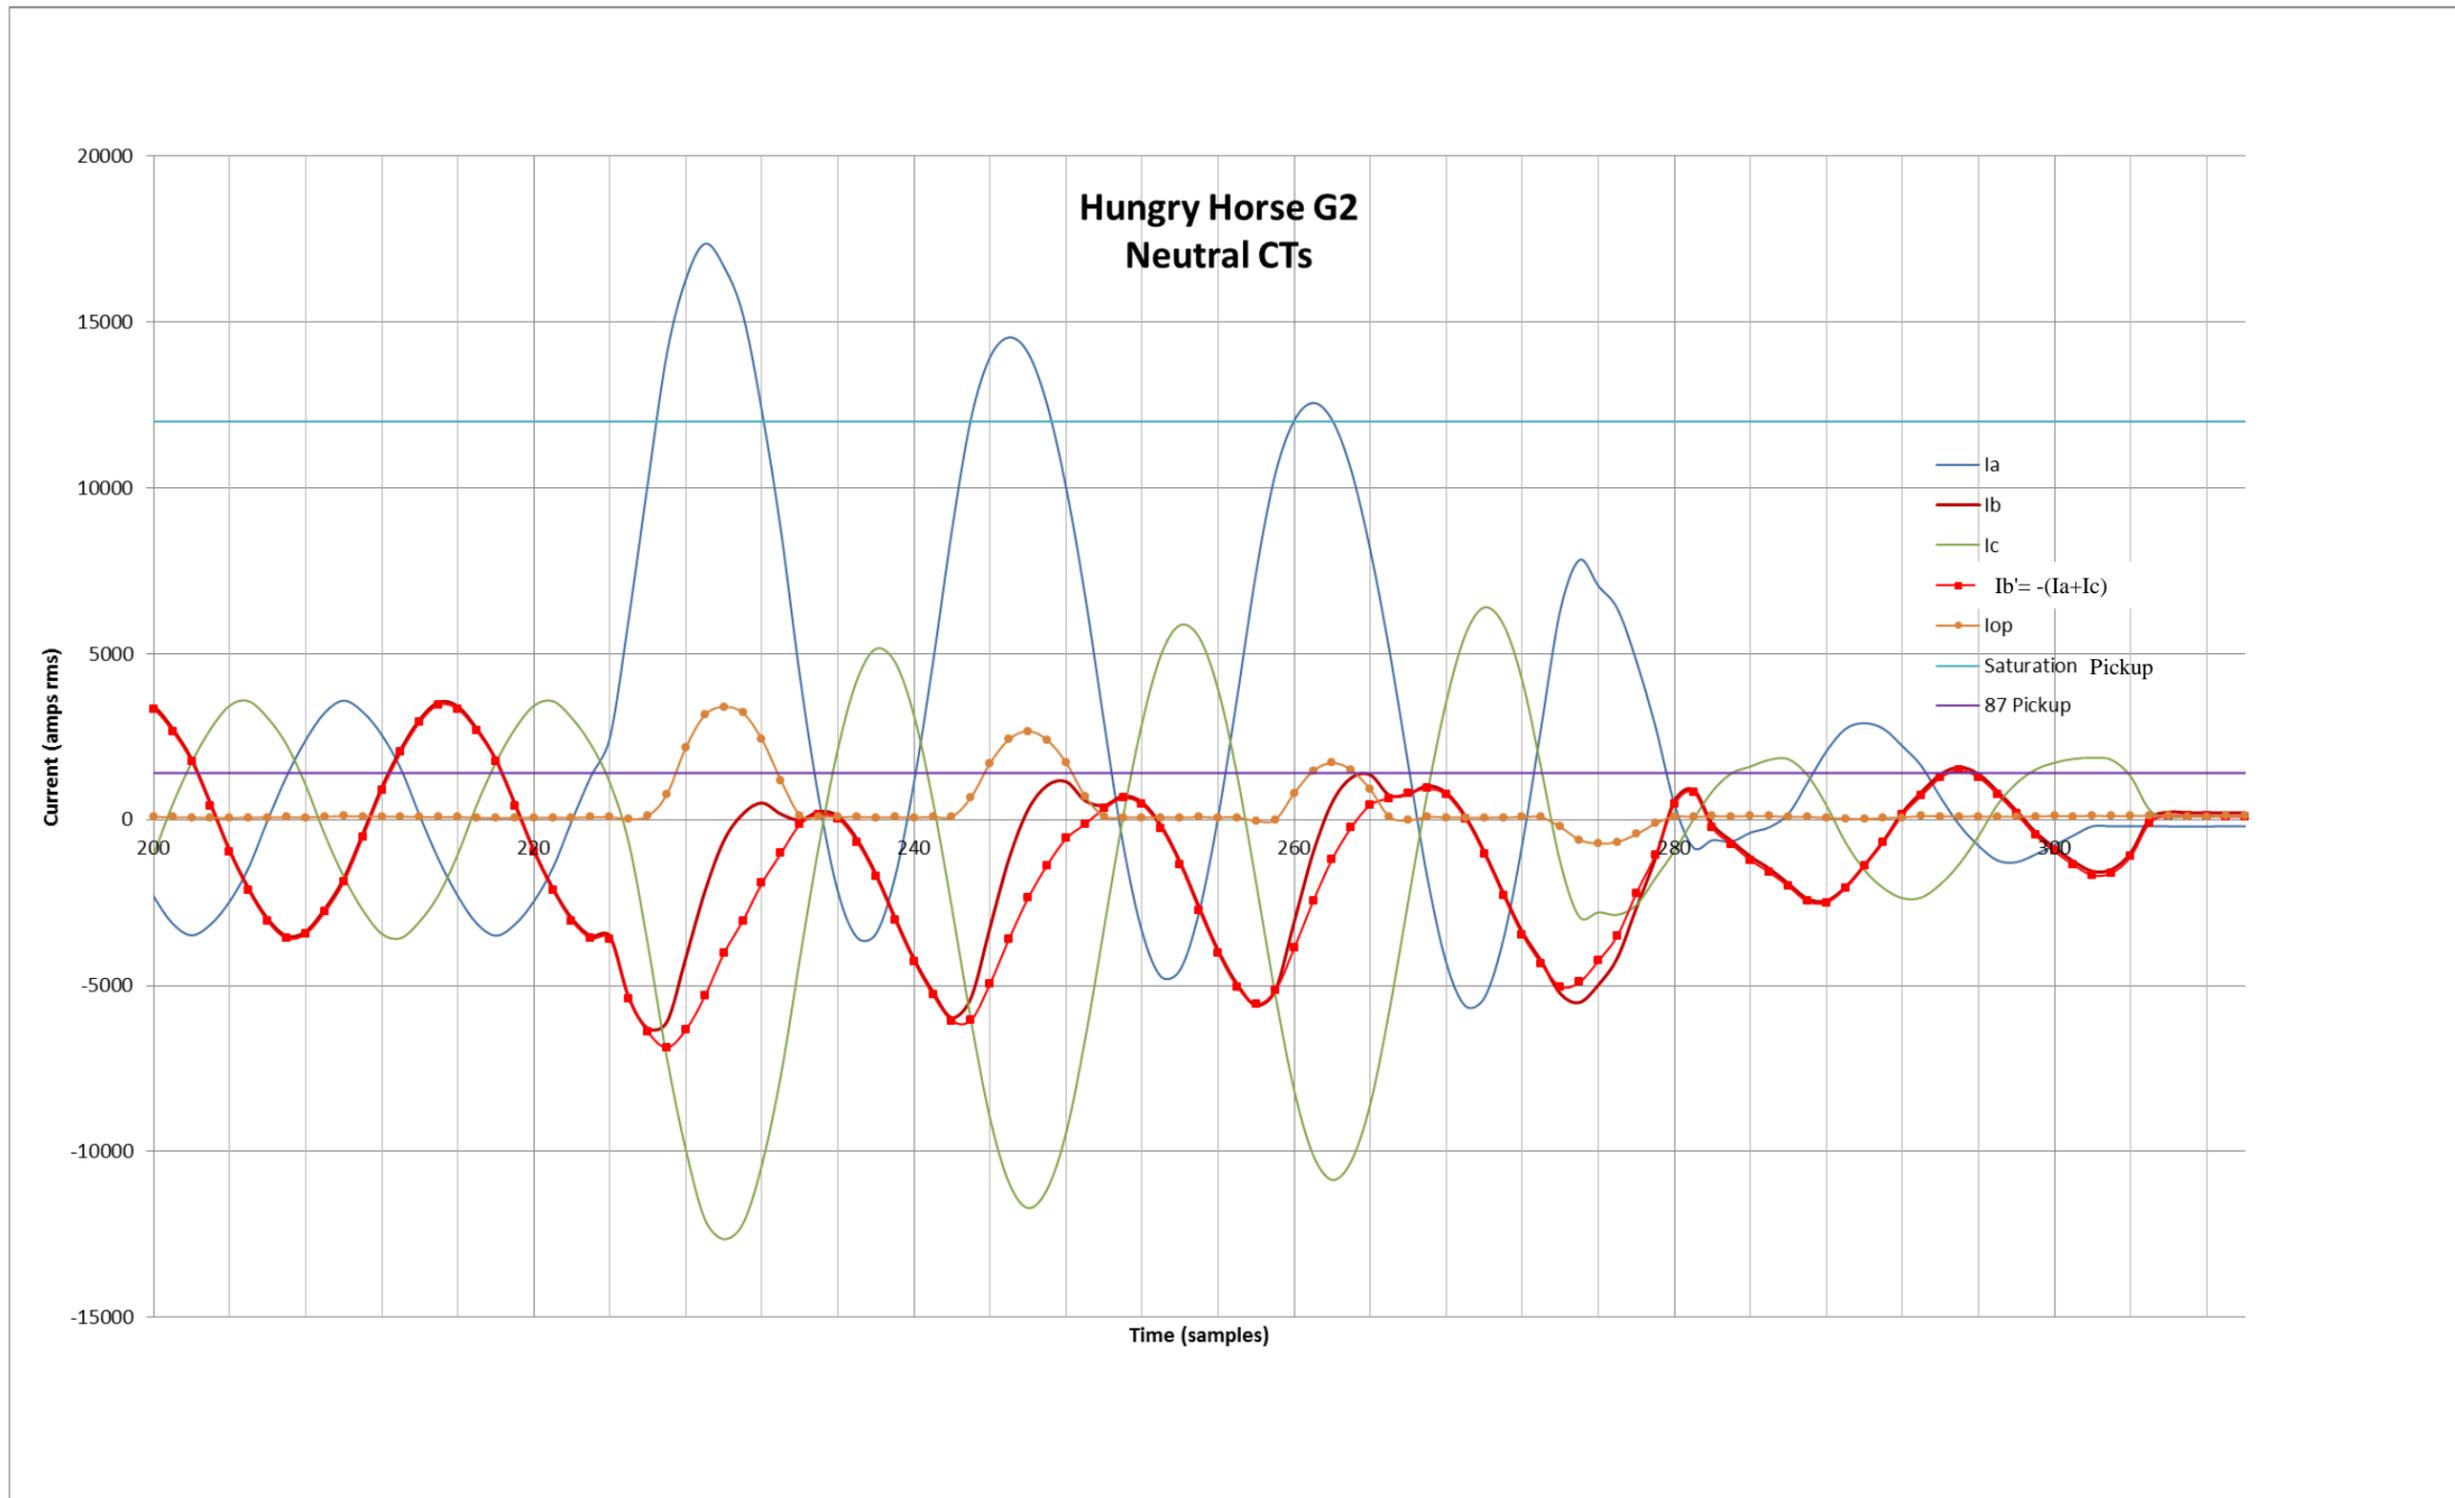
On June 3, 2014 at approximately 2000 hours, Generator G2 at a Reclamation Powerplant tripped off-line due to a differential relay element (87) operation. Generation protection is provided by a SEL-300G relay which recorded the event. The recorded data exported from the relay can be seen in Figure A1 (traces- Ia, Ib, Ic). Concurrent to this event, a phase-A line-to-ground fault occurred on the 230kV transmission system.

The operation of the differential relay element was caused by a mismatch between the neutral and terminal phase-B secondary currents. Analysis of the 3-phase neutral CT secondary current waveforms shows that the 3 neutral phase currents did not sum to zero and the phase-B waveform is not sinusoidal. The waveform traces suggest that there was an issue with the neutral phase-B CT secondary current during the fault. The burden class of the neutral CT is C800 and the ratio is 5000:5.

This effect is observed in the original fault traces shown in Figure A1. Phase-A current reaches a peak of the 17,000Arms during the first cycle of the fault. It is when the phase-A magnitude exceeds about 12,000A that the phase-B secondary current becomes non-sinusoidal and the waveform deviates from the phase-B terminal CT current. This non-linear behavior is the result of local saturation of the phase-B CT core. The localized saturation of the CT core caused the differential relay to operate and trip the unit offline.

Figure A1 - G2 Neutral CT Current Traces (Ib' = calculated Ib secondary current without CT saturation.)

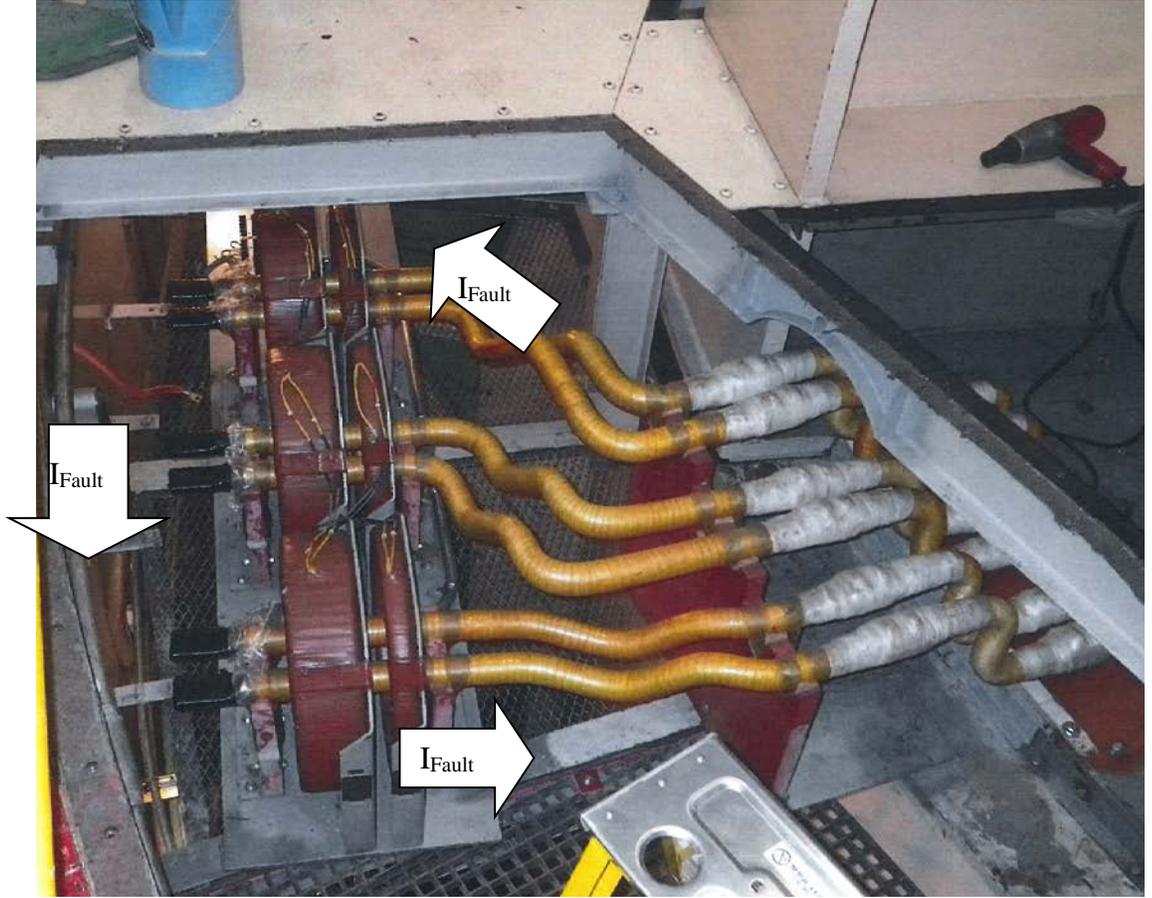
G2 tripped off line during an external 230-kV line-to-ground fault. The line-to-ground fault on the 230-kV system resulted in line-to-line fault current at the generator due to the 230/13.8kV Y-Δ transformer. This can be seen in the fault traces for phase-A and -C, the phase fault current magnitude is around 15,000 amps (A) and 180 degrees out of phase. The phase-B current magnitude remains relatively unchanged although it does have a DC offset when the fault occurred. As shown in Figure A2, the fault current from phase-A and -C in-circle the phase-B CT and thus the magnetic flux produced by the fault current is additive at the phase-B CT. Because the magnetic flux adds during the fault, a strong external magnetic flux density is present at the phase-B CT.

Figure A2 - Photo of Neutral CT Leads (note: the neutral shorting bar between phase A, B and C is removed in this picture)

New neutral CTs on the differential circuit are recommended as they present the easiest method to correct this localized saturation issue. As mentioned above the new CTs should have a larger core, or incorporate a core balance compensation circuit.

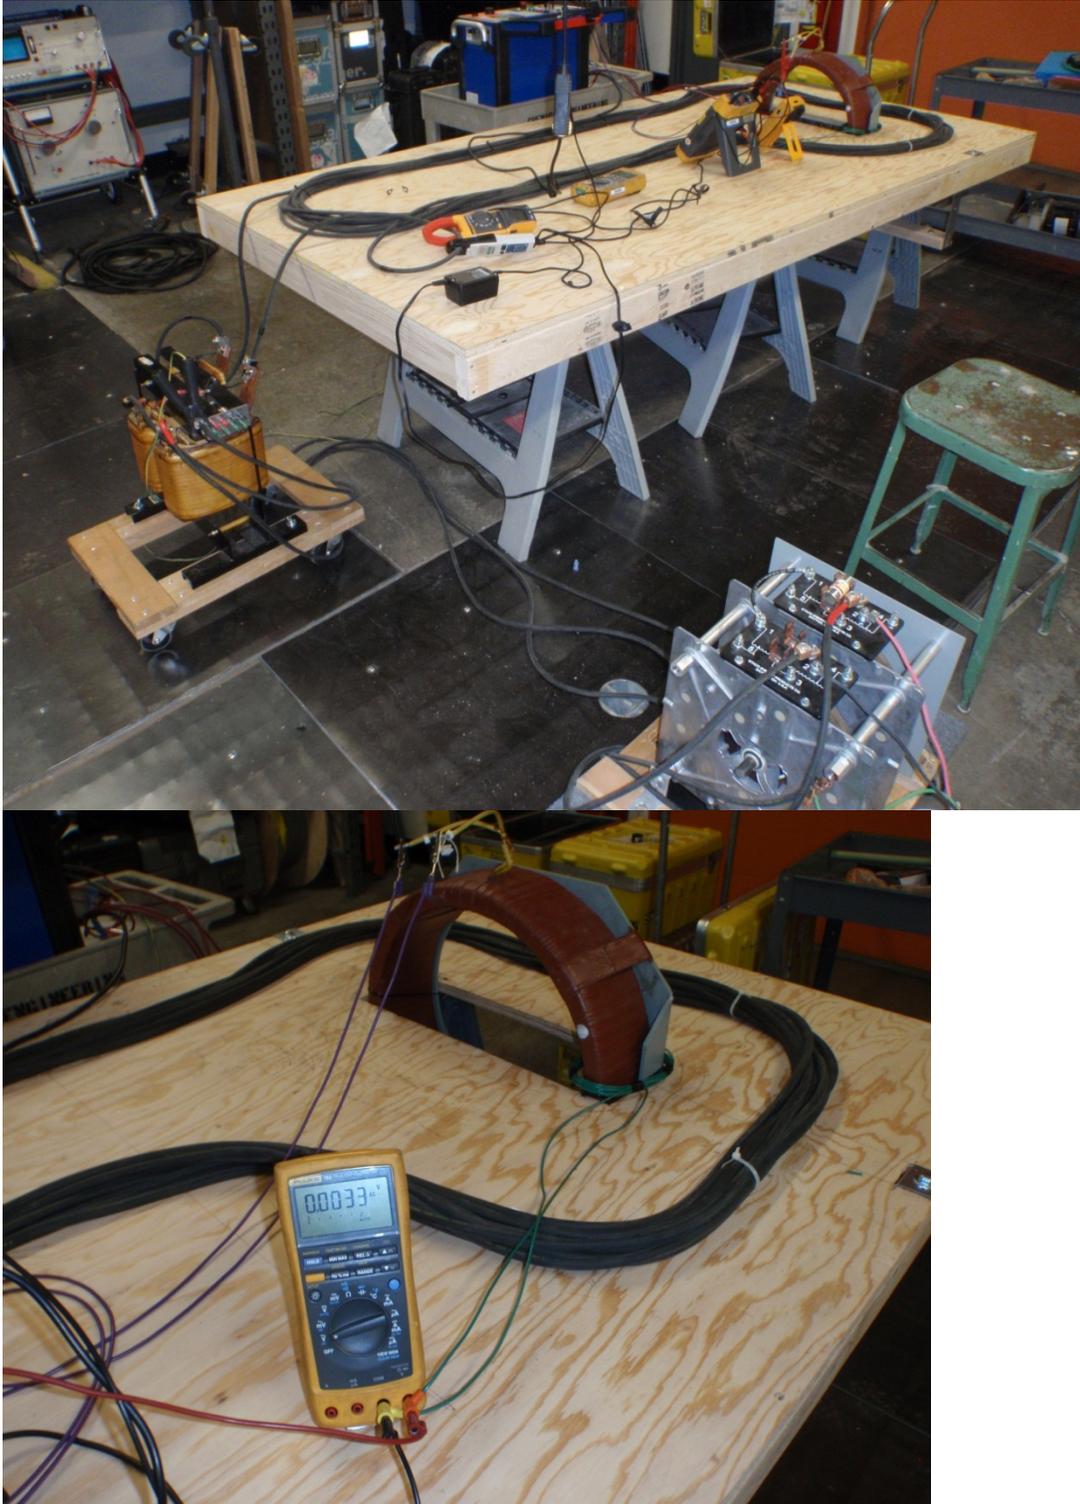
To measure the impact that this external stray magnetic flux has the neutral phase-B CT, a spare CT was tested in the laboratory. The position of the CT with respect to external conductors was simulated by mounting the CT on a 4x8 piece of plywood and a looping an external conductor around the outside of the CT at the same spacing as the conductors exist at the generator neutral, see Figure A3. Ten turns of 4-AWG wire was used to simulate the primary conductor. A 480-V autotransformer and a 500/50V transformer were used to energize the loop. With this configuration about 100A of continuous current could be supplied to the loop with a maximum short term load of about 250A. At 10 turns, this is equivalent to 1,000A and 2,500A, respectfully.

Figure A3 - Spare CT under test in the laboratory (overview and close up)

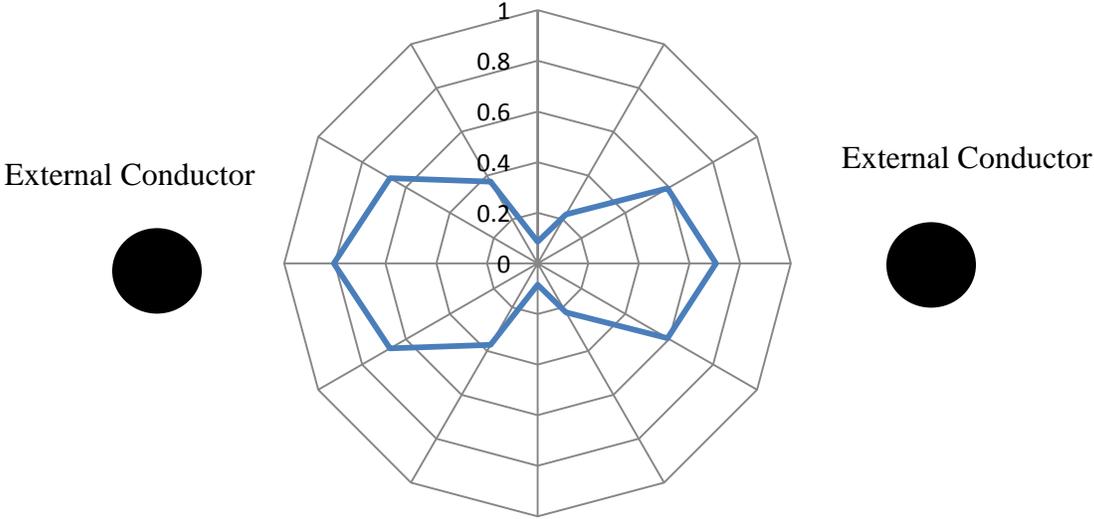
To measure the localized magnetic flux density, the search coil voltage was measured at various points around the CT window while passing an equivalent of 1,000A through the external conductor. A radar plot of these measurements is shown in figure A4. From this plot it is evident that the flux density within the CT core is not uniform. The data show that the maximum magnetic flux density occurs at 0 and 180 degrees, or in the same plane as the external conductors.

Figure A4 - CT core flux density test

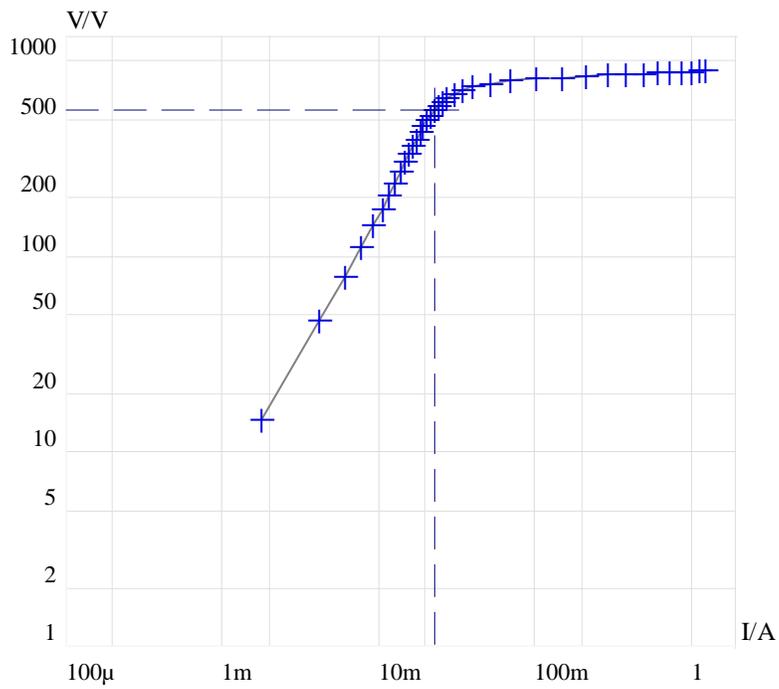
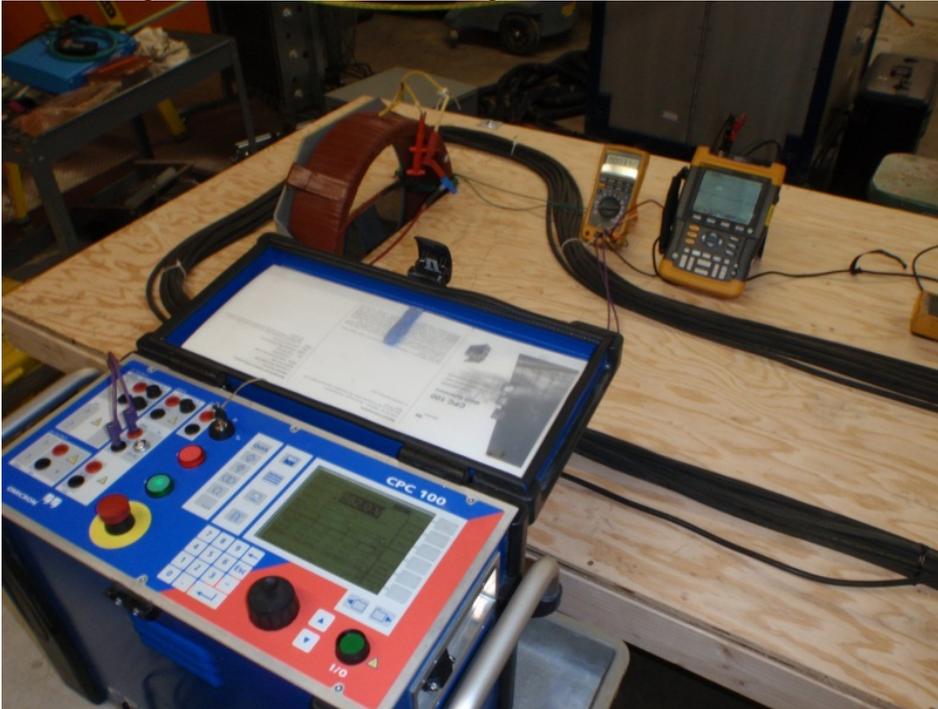
Non-uniform flux density within the core effects the operation of the CT when the core starts to saturate. The saturation characteristics of a CT are measured by means of a CT excitation test. An excitation test was performed on the spare CT and the results can be found in figure A5. The 45 degree knee point on the curve is measured at 560V, 23mA. Below this point on the curve the CT core is not saturated and the secondary current is proportional to the primary current (ratio=1000:1). The excitation current remains small. Above the knee the CT starts to saturate, the excitation current becomes significant, and the secondary current is no long proportional to the primary current. As shown in figure A5 at 900V secondary voltage, the excitation current is 1.4A.

The search coil voltage during an excitation test can be calculated from this curve. The CT ratio is 1,000:1, thus there are 1,000 turns on the secondary winding. Given that the search coil has 10 turns the ratio between the secondary CT winding and the search coil winding is 100:1. During the excitation test the search coil voltage also was measured and this calculated ratio was verified. From the excitation curve it is now possible to calculate the degree of core saturation based on the search coil voltage measurement. The core will start to saturate at a search coil voltage of 5.6Vrms (560V/100) and at 9Vrms (900V/100) the core will be significantly saturated.

ANSI 45deg knee = 560V at 23mA, significant saturation at 900V, 1.4A.

Figure A5- CT excitation test

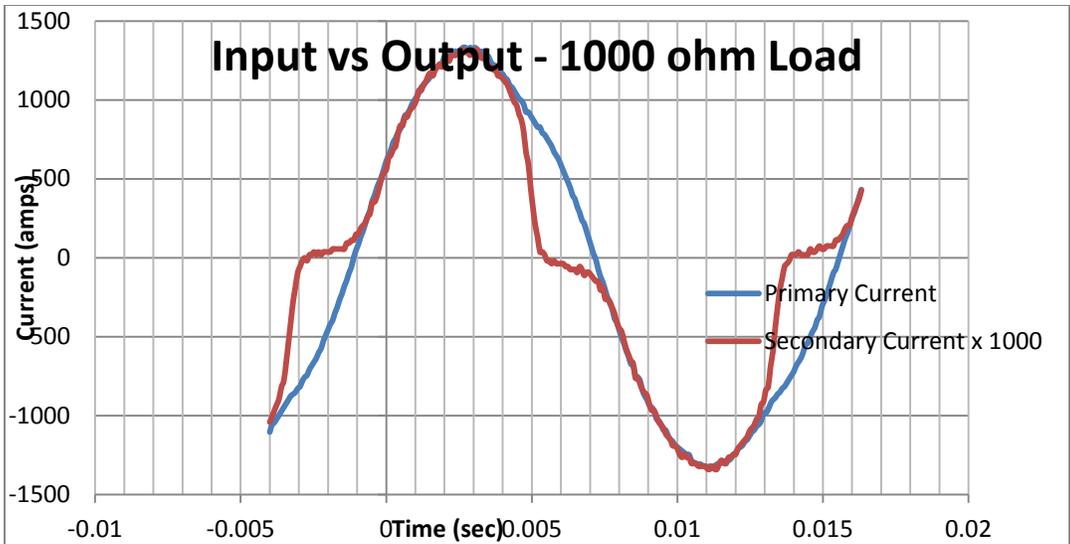
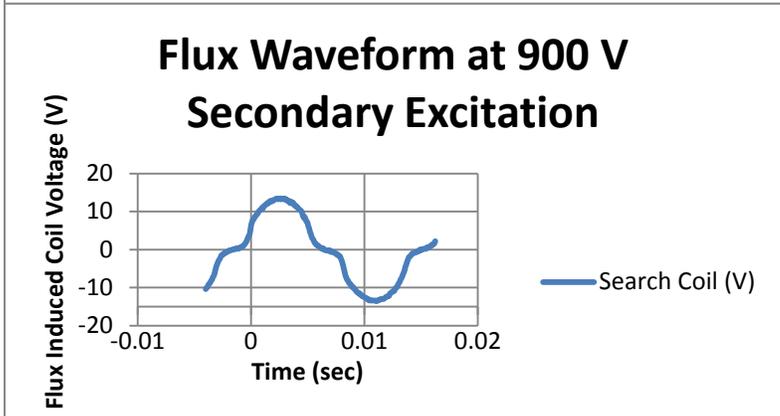
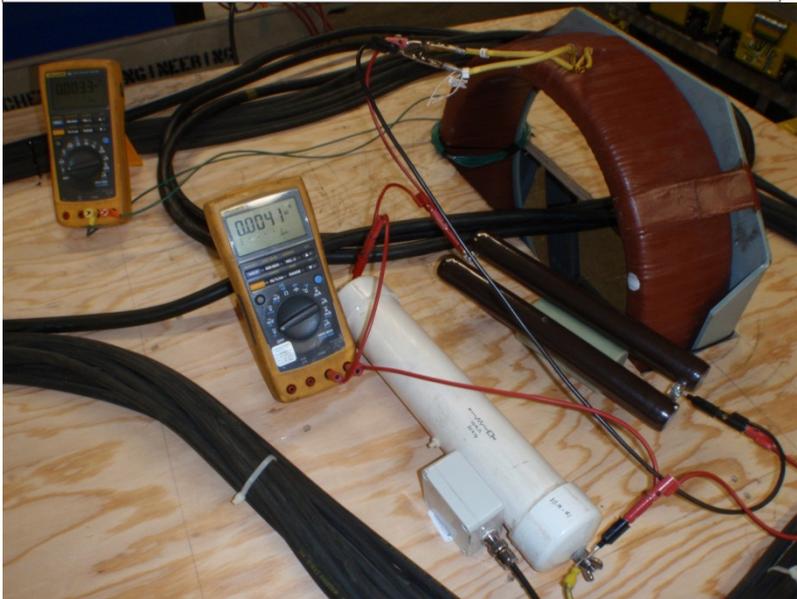
To demonstrate the effect that saturation has on the CT performance, the CT was intentionally saturated by placing a 1,000 ohm resistor on the CT secondary leads. At 900A primary current the resultant secondary current waveform is shown in Figure A6. The search coil voltage was measured at 9Vrms.

Figure A6 – Effect of saturation on CT secondary current (search coil voltage = 9Vrms)

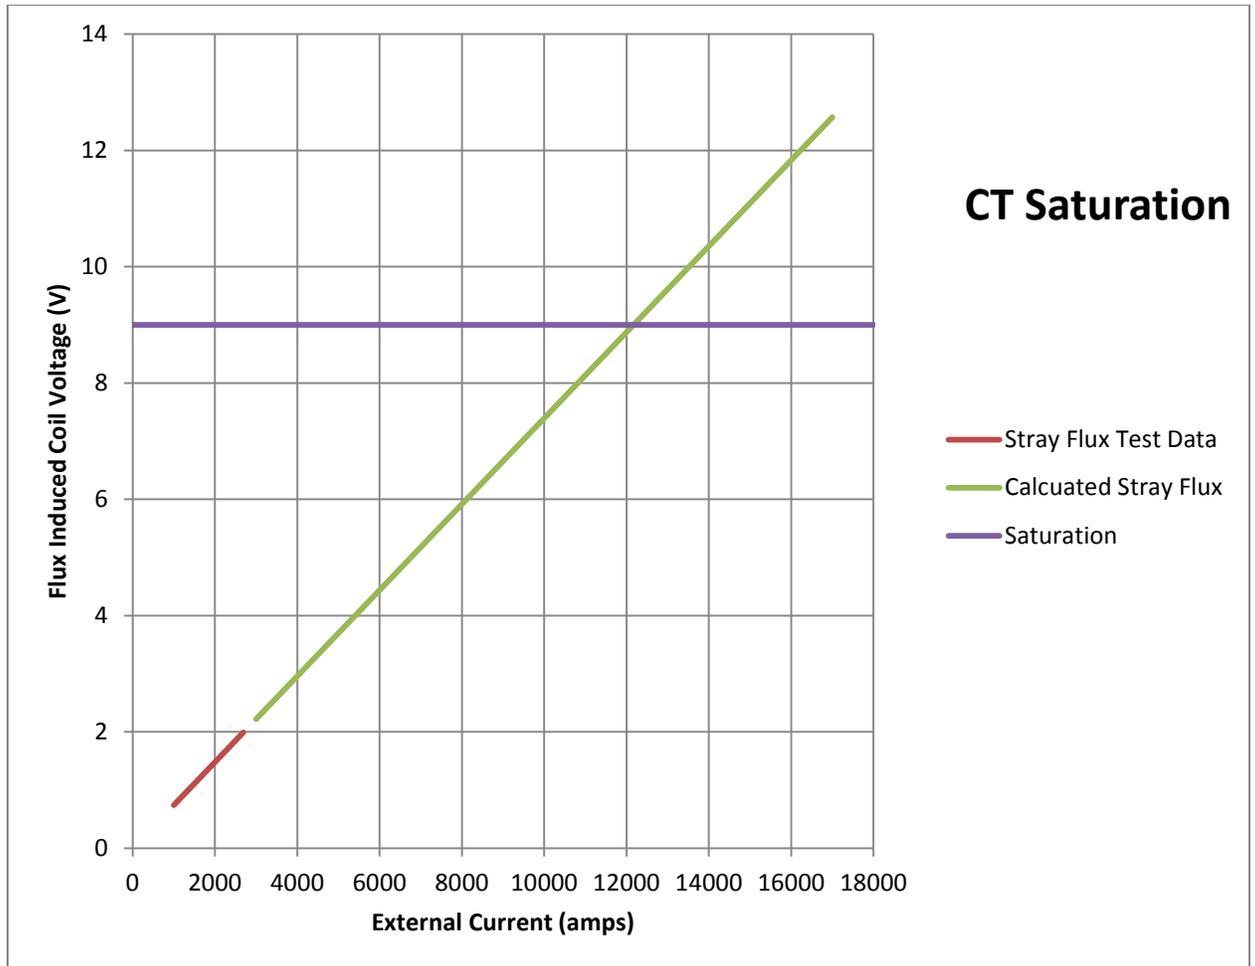
Thus the flux density level, measured using the search coil, recorded at low test currents can be scaled to fault current levels by maintaining the same ratio between the measured and calculated values. Given this relationship, the search coil voltages as plotted in Figure A4 that were recorded at 1,000A can be scaled up to fault current levels as high as 17,000A as shown in figure A7. Additional measurements were also recorded up to 2,700A to demonstrate the linear relationship.

From the discussion in the previous section it was shown that the core is significantly saturated when the search coil voltage is 9V. From Figure A7, an external current of 12,000A will result in a search coil voltage of 9V. Thus for an external loop current above 12,000A, the phase-B neutral CT will experience localized saturation.

Figure A7 - Linear relations between loop current and magnetic flux
