Photogrammetric Processing from Remotely Operated Vehicle (ROV) Data: Trinity Dam Intake Tunnel

**Technical Memorandum No. 8530-2016-31
Research and Development Office
Science and Technology Program
(Final Report) ST-2016-7738-01**

September 2016

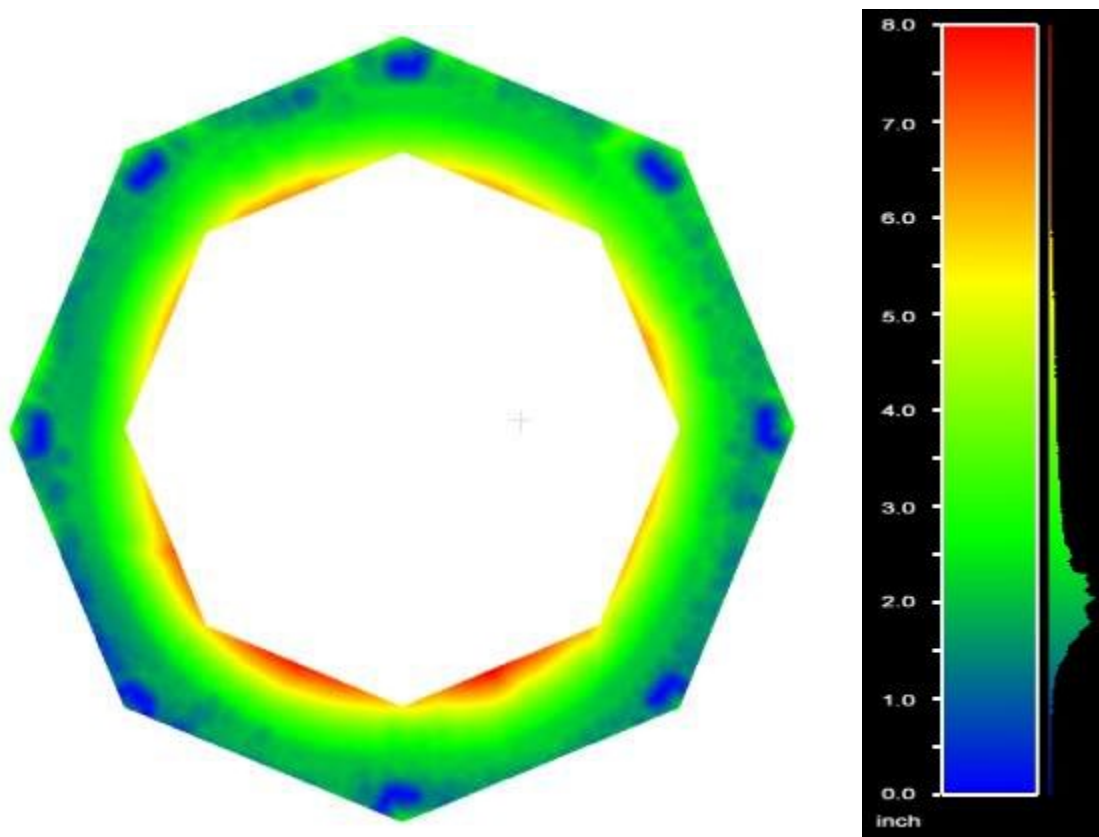
Figure 11: Height Map of the Bulkhead Seal

Figure 11 shows the height map of the bulkhead seal 3D scan. The seal location is uniform and free of any defects or anomalies. The model was composed of 16 total scans.

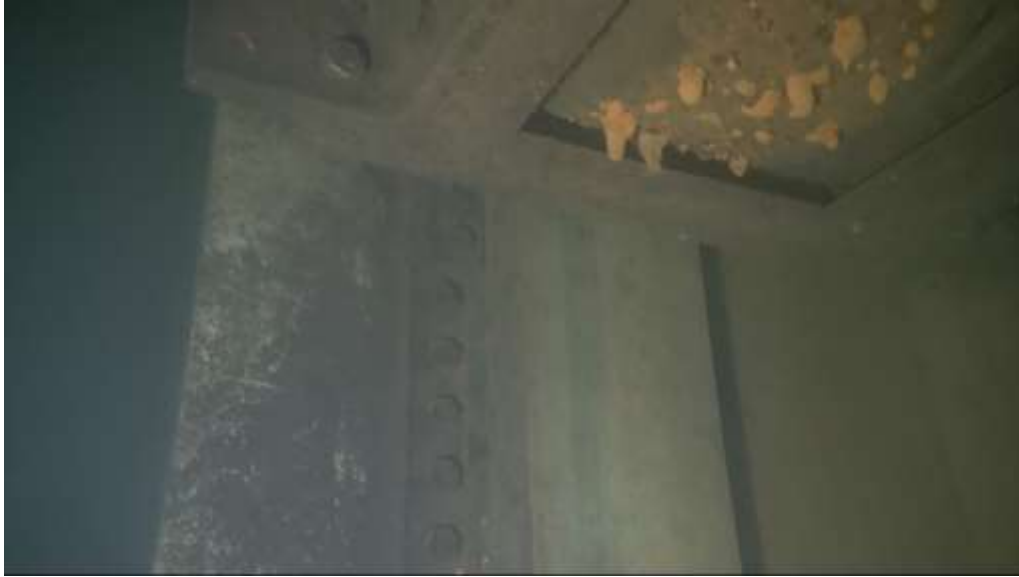
Figure 8 - Upper edge of right roller plate on Fixed Wheel Gate

The fixed wheel gate was in the up position during the inspection. The position of the gate allowed an inspection of the gate slots with seal plates and roller guides. The right gate slot was inspected first with a focus on the roller plate on the downstream side of the right gate slot shown in Figure 8. The bottom right wheel had some tuberculation and the rest of the metal surfaces showed a light amount of corrosion. The roller plate had all of its bolts and was free of cracks, heavy corrosion or apparent misalignment. This was the same condition of the left roller plate.

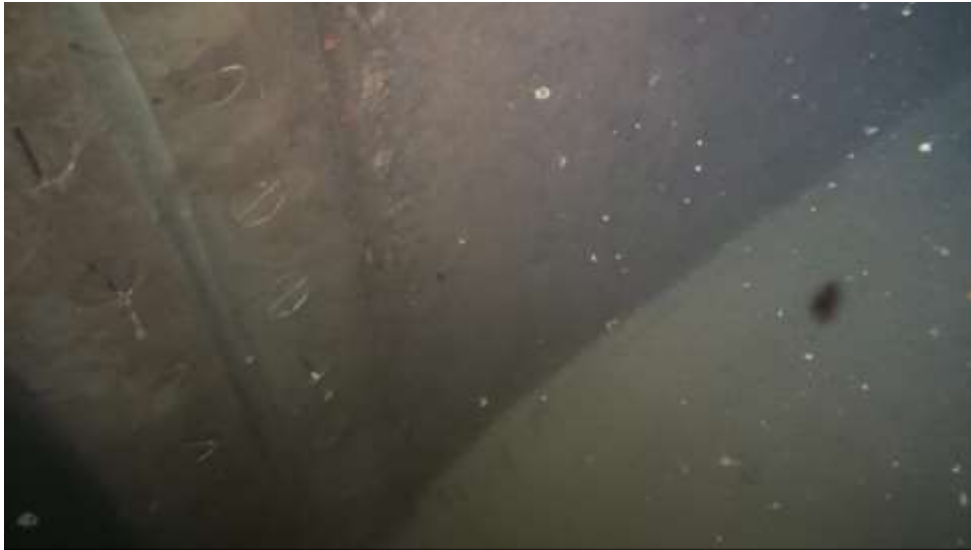
Figure 9 - Bottom of left seal plate on Fixed Wheel Gate

The seal plates had all of their bolts and displayed light corrosion or fouling and free of apparent misalignments. There were signs of wear consistent with mating seal plates.

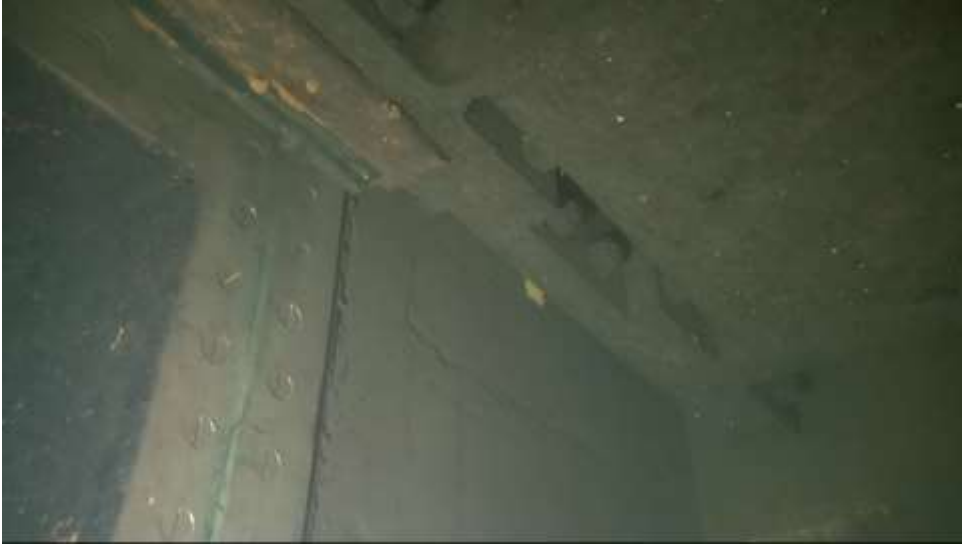
Figure 10 - Top left seal plate on Fixed Wheel Gate

The top seal plate was visible below the gate. The bottom seal of the gate was also inspected and shown to have light corrosion.

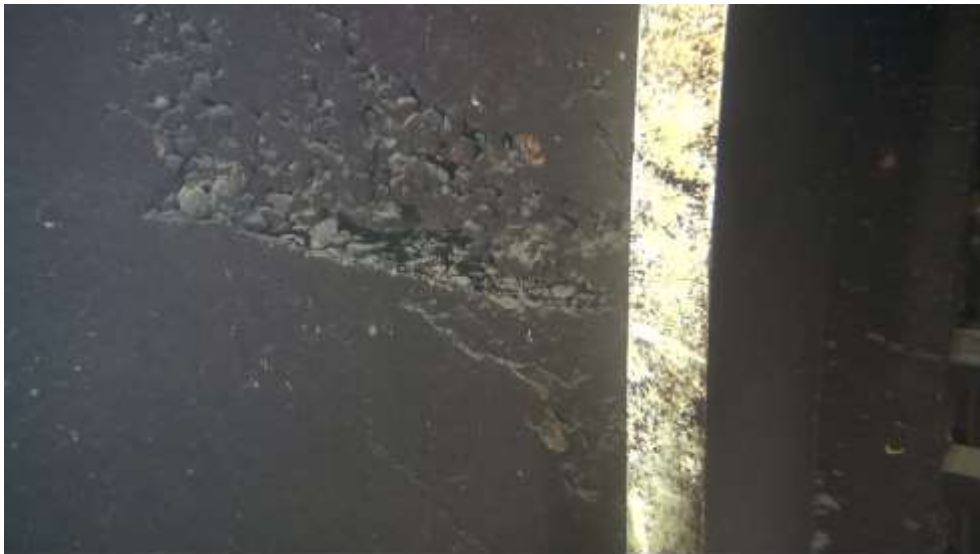
Some small areas of exposed aggregate were visible downstream of the right roller guide plate. Shown in Figure 12 - Exposed aggregate downstream of right roller plate is minimal and is flat without spalling or concrete surface separation.

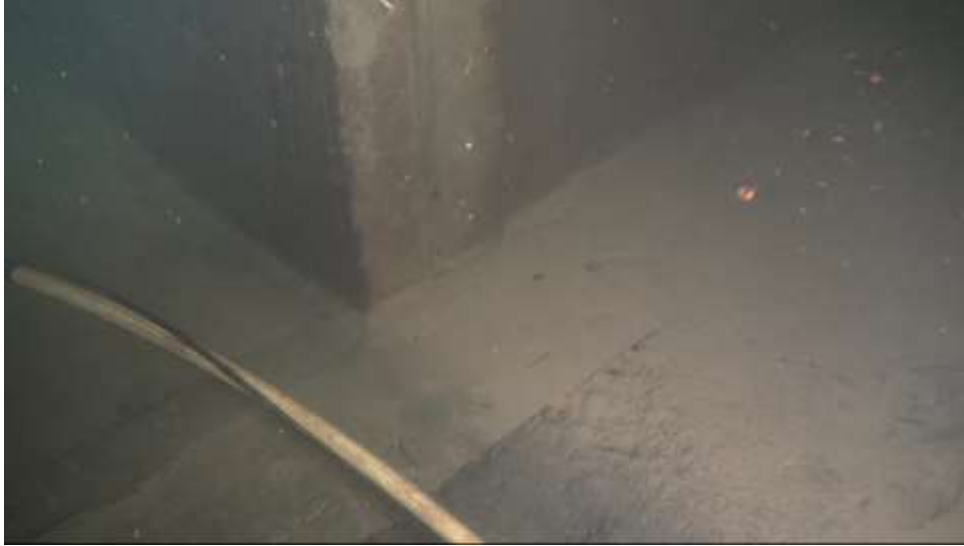
Figure 13 - Exposed aggregate on invert downstream of the bottom right seal plate

The concrete near the bottom seal also had some exposed aggregate as shown in Figure 13. The seal plate doesn't have any apparent mis-alignment or excessive wear.

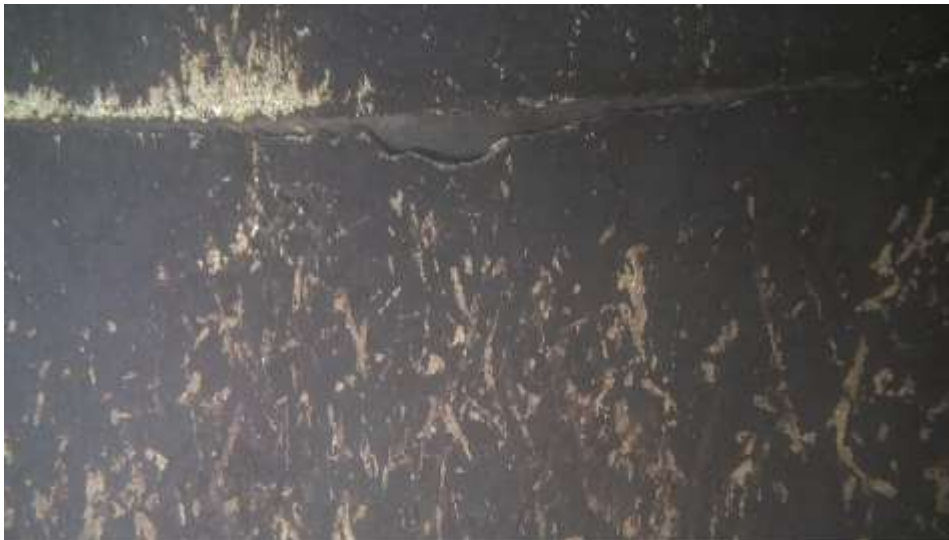
Figure 14 - Joint at bottom of shaft and top of elbow

The elbow was visually inspected with 360 degree rotations at increasing elevations with a total of 5 revolutions. The condition of the concrete was consistent with the exception of the clean spots on the transition of the elbow at the location of the tether contact. This area was cleaner with the fouling removed from the concrete surface. The joint between the bottom of the shaft and the top of the elbow was the most pronounced joint with slight separation and edge spalling as seen in Figure 14.

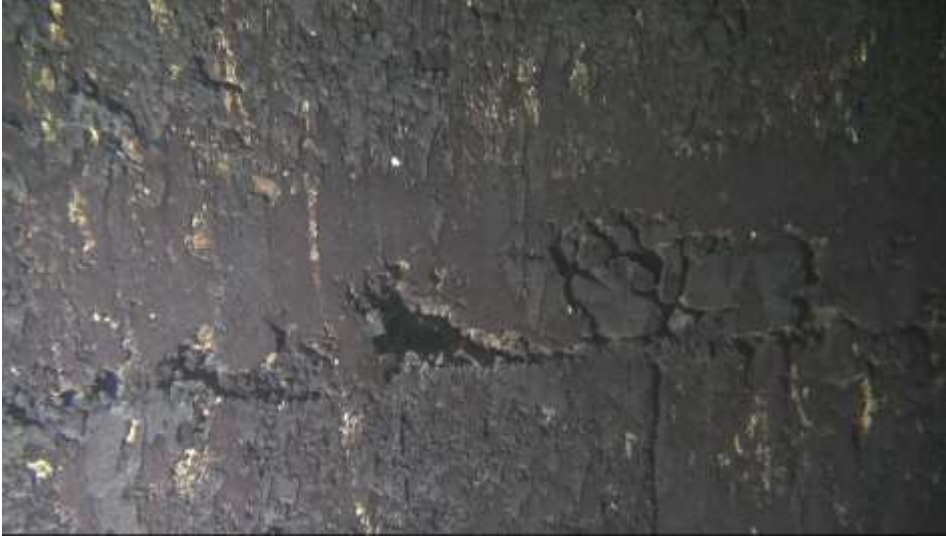
Figure 15 - Exposed aggregate at joint in shaft on second 360 from bottom

The joints were free of cracks and edge spalling in most locations. Some exposed aggregate was located on the second 360 in the elbow shown in Figure 15.

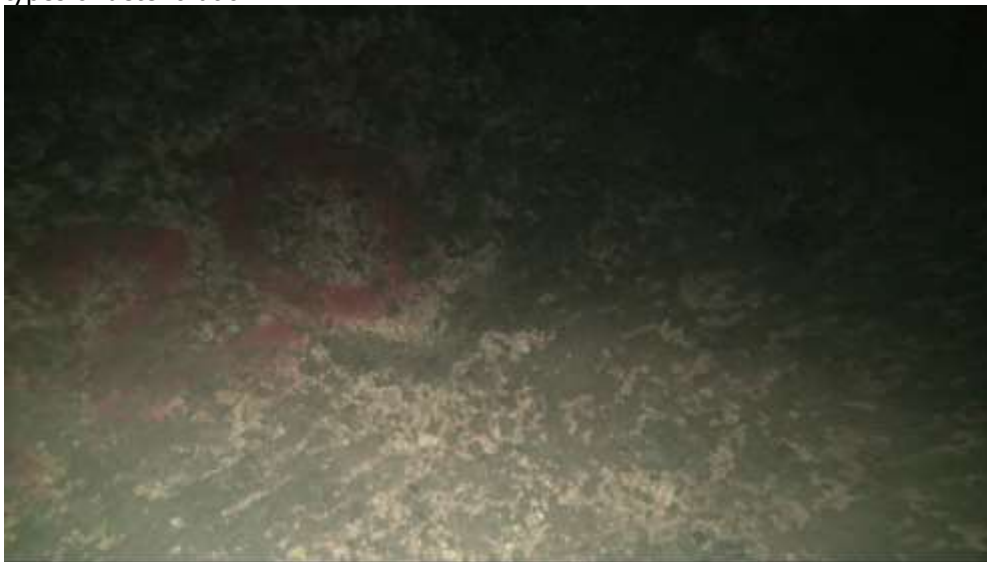
Figure 18 - Paint on crown at a depth of 218.8 ft. and heading 156.4

At several locations, spray painted numbers were observed possibly referring to the project stationing. If the paint was applied prior to putting the structure in service over 50 years ago, it would seem to indicate that the concrete is generally in very good condition without erosion abrasion, chemical attack or other types of deterioration.

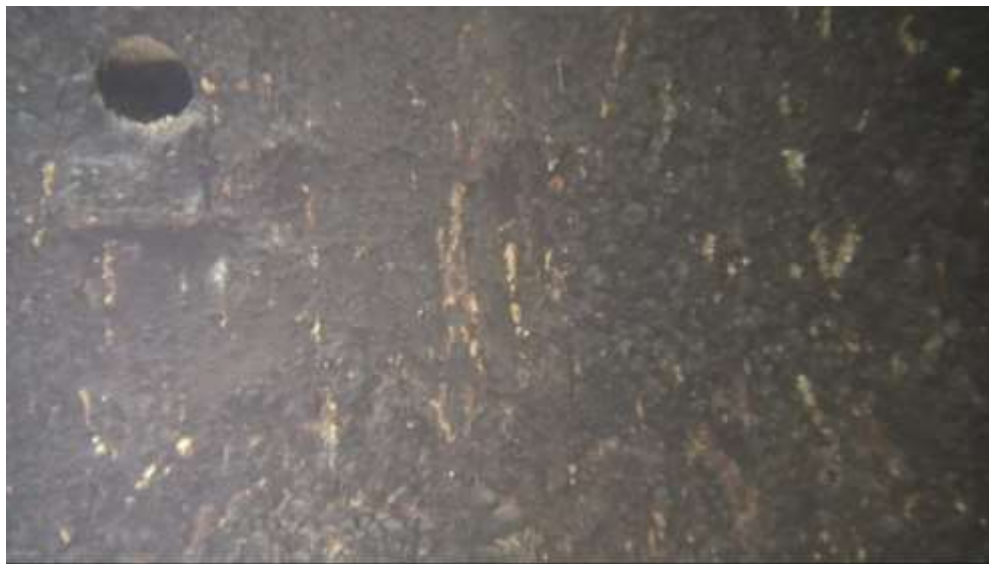
**Figure 21 - Tie rod bolt hole in concrete at a depth of 120.1 ft. and heading 234.8**

Date	Time	Description	Depth	Heading
10/24/2015	13:32:03	South end of pass at 109 ft. with several tie rod bolt holes	109.4	201.4
10/24/2015	11:55:35	South end of pass at 116 ft. with several tie bolt holes open	116	147.4
10/24/2015	11:44:51	Four more tie rod bolts at 119 ft. depth and 250 degrees heading	118.5	252
10/24/2015	11:41:45	Four tie rod bolt holes at 160 degrees at 118 ft.	118.6	155.9
10/24/2015	11:45:07	One more tie rod bolt at 119 ft. depth and 250 degrees heading	118.6	265.2
10/24/2015	11:48:55	Most tie rod bolt holes open above and below joint	118.6	186.2
10/24/2015	11:33:41	Tie rod bolt hole open at 119 ft. depth and 205 degrees heading	119.6	196.1
10/24/2015	11:38:43	Tie rod bolt hole	119.8	334.4
10/24/2015	11:39:00	Tie rod bolt hole	119.9	295.7
10/24/2015	11:39:39	Tie rod bolt hole with depth less than 1 inch	120.1	234.8

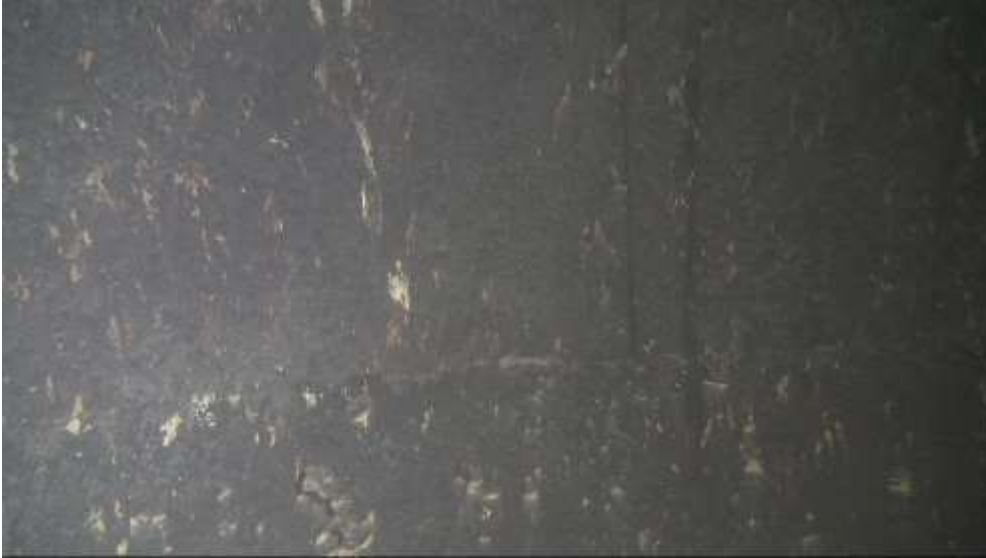
Figure 22 – Honeycombed concrete featuring exposed aggregate at a depth of 94.5 ft. and heading 216.6

The characteristics of the concrete were consistent with similar texture, little to no spalling, erosion or other defects, until 94 feet of depth. At 94 feet, some honeycombing in the concrete was discovered. The honeycombing featured exposed aggregate although it appeared that the aggregate was coated with a layer of cement paste.

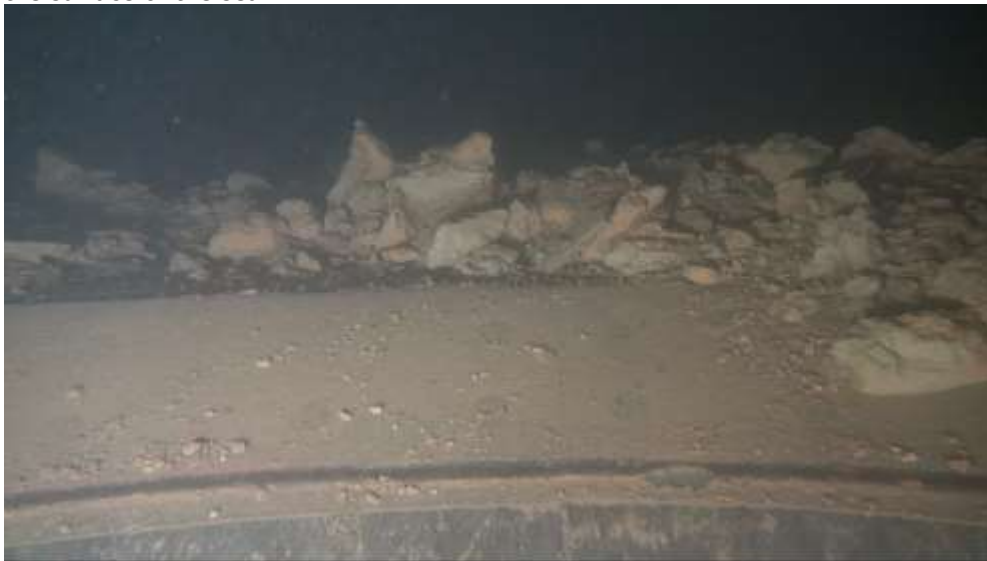
Figure 25 - Hemispherical bulkhead seal plate after cleaning at a depth of 82.0 ft. and heading 103.7

The seal plate is at 82 feet of depth. Substantial sediment was located on the seal plate making inspection impossible. The ROV was flown around the seal allowing the frame of the ROV to plow the sediment off of the seal. This combined with the disturbance from the thrusters cleared most of the sediment from the seal plate. The seal plate had no signs of corrosion and all fasteners were flush with the surface of the seal.

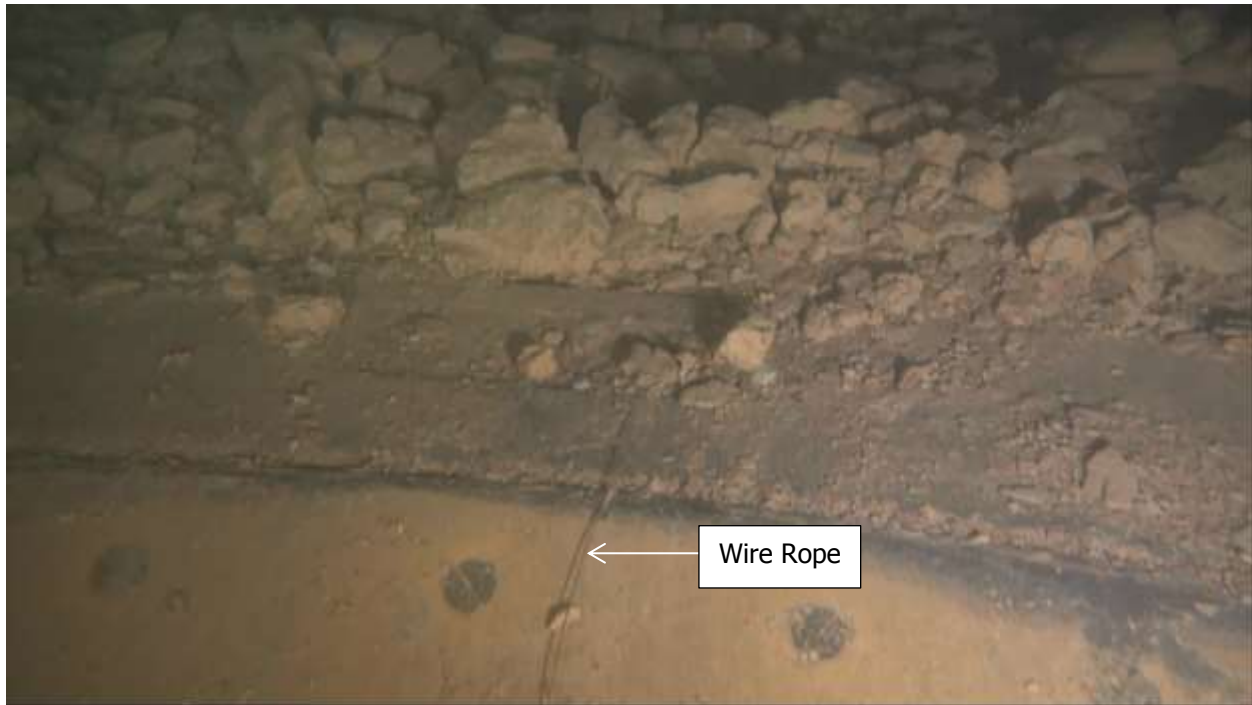
Figure 27 - Uppermost visible portion of Wire Rope at a depth of 81.9 ft. and heading 17.7

The bulkhead seal was coated with several inches of sediment. The ROV operator used the ROV sled and thrusters to clean off a large portion of the sediment. A small diameter (~3/16 inch) wire was found draped over the bulkhead seal.

Dive five was performed on October 25th. The water elevation at the start of the dive was 2186 ft. It included the visual inspection of the elbow, the trash racks, and portions of exterior of the intake structure as well as laser scans of the bulkhead seal plate. A small diameter wire rope was observed hanging over the top of the vertical conduit and the bulkhead seal plate between columns 4 and 5 extending to a depth of 95 feet. The wire rope was about 4 mm (0.16 inch) in diameter.

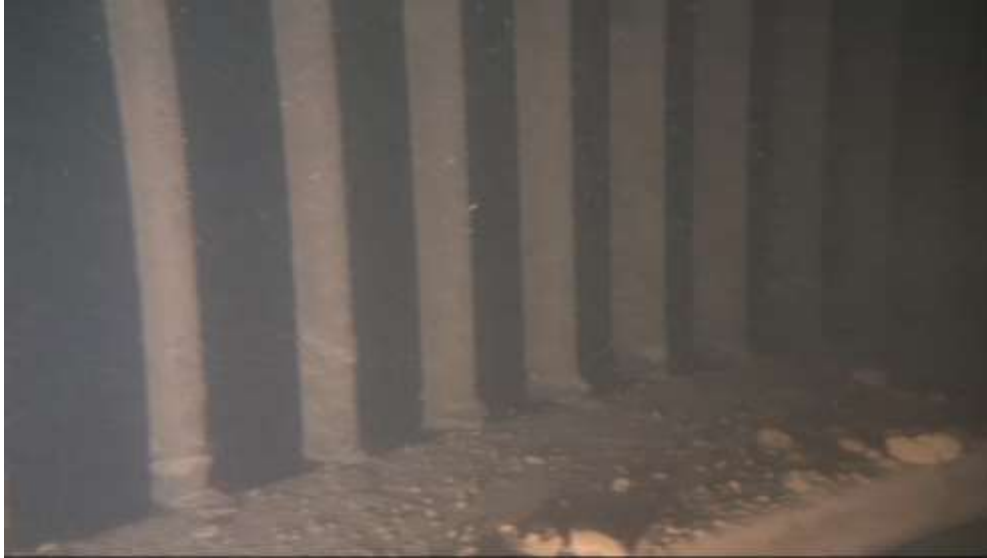
Figure 29 - Typical trash rack condition with some sediment on horizontal member between columns 3 and 4 on first trash rack slot at a depth of 67.5 ft. and heading 60.0.

No issues were observed with the trash racks. There was minimal corrosion detected and little to no coating loss. Most horizontal surfaces were coated with a layer of sediment. Some foreign objects were noted caught in the trash racks such as buoys and wood.

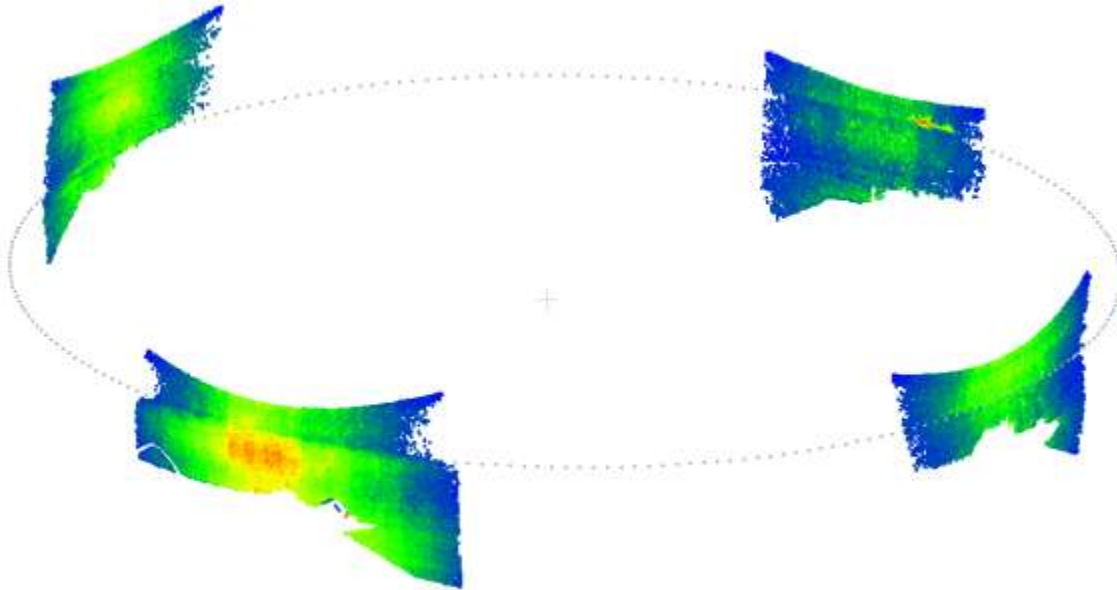
Figure 35 - Composite 3D model (degree of reflectance) of the joint between the vertical shaft and the elbow

The joint between the elbow and the bottom of the shaft was imaged with four scans. The four scans didn't overlap due to turbidity of the water. The interior diameter of the tunnel is 16 feet at this area. The scans conformed to an ideal cylinder with little error. The joint can be seen in all four scans and was consistent. The joint had little to no spalling or separation.

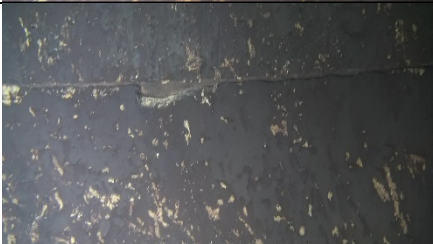
Spall
173728	6:01

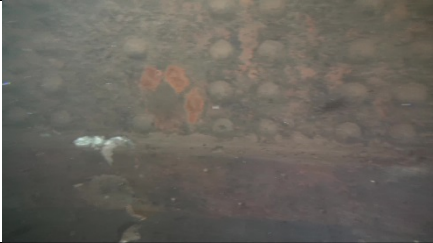
Rust – near bottom of gate
143550	9:28

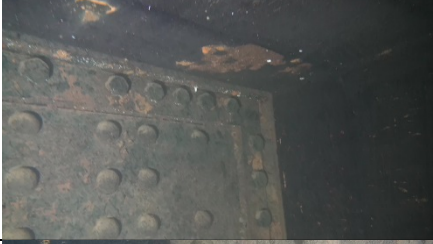
Rust – near top of gate
144550	3:37

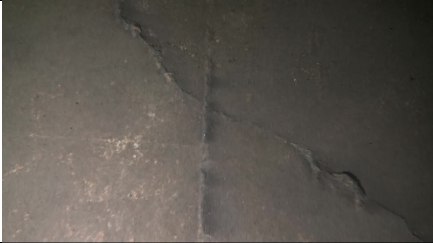
Crack near joint
083244	0:40

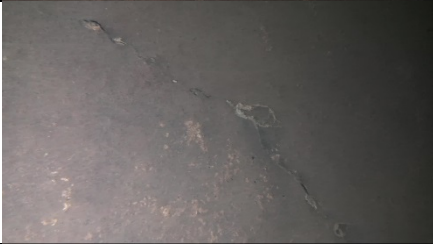
Crack
083244	1:06

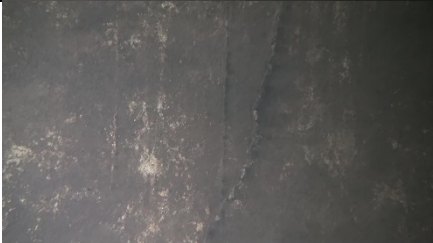
Crack near joint
083244	1:24

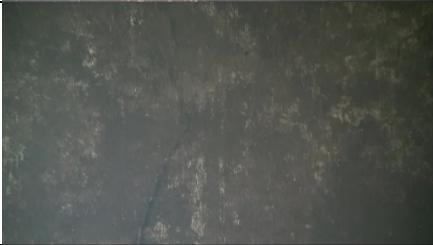
Crack
083244	3:19

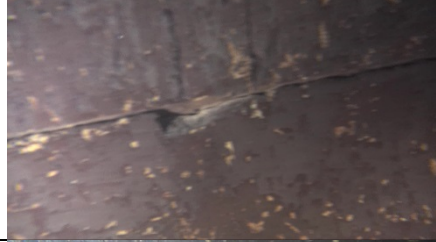
Joint spall near 199 ft
090308	3:13

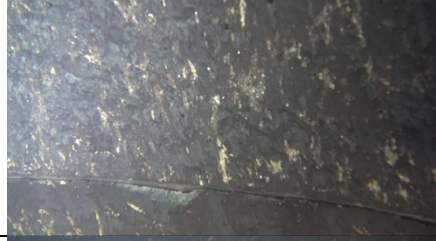
Joint spall near 199 ft
091851	4:40

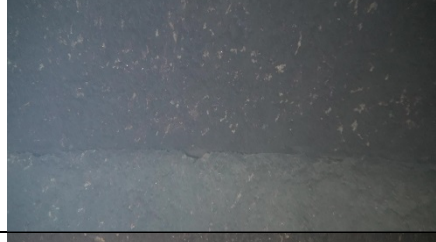
Joint spall near 199 ft
113851	2:53
