## Research Update

S&T Program Project ID 7738-01  
Bulletin 2017-05

## ROV Data Collection and Photogrammetry From Trinity Dam Intake Structure

*Building a photogrammetric 3D model from ROV-collected data as supplement for underwater condition assessment*

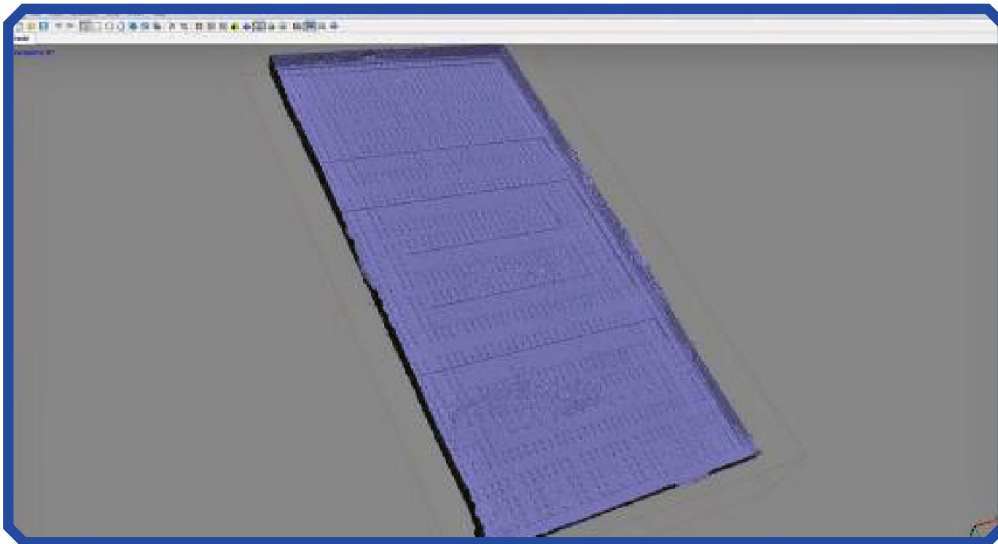
A 3D model of the upstream face of the fixed wheel gate at Trinity Dam, California.

The results of the inspection showed that there was no major deterioration within the structure or mechanical equipment. The inspection showed that a long-range ROV can be used to inspect difficult-to-access features within Reclamation's infrastructure.
