Technical Memorandum No. 8540-2017-028

## Condition Assessment of FRP Composite Pipe and Tanks

Research and Development Office  
Science and Technology Program  
Final Report ST-2017-1701-01

September 2017

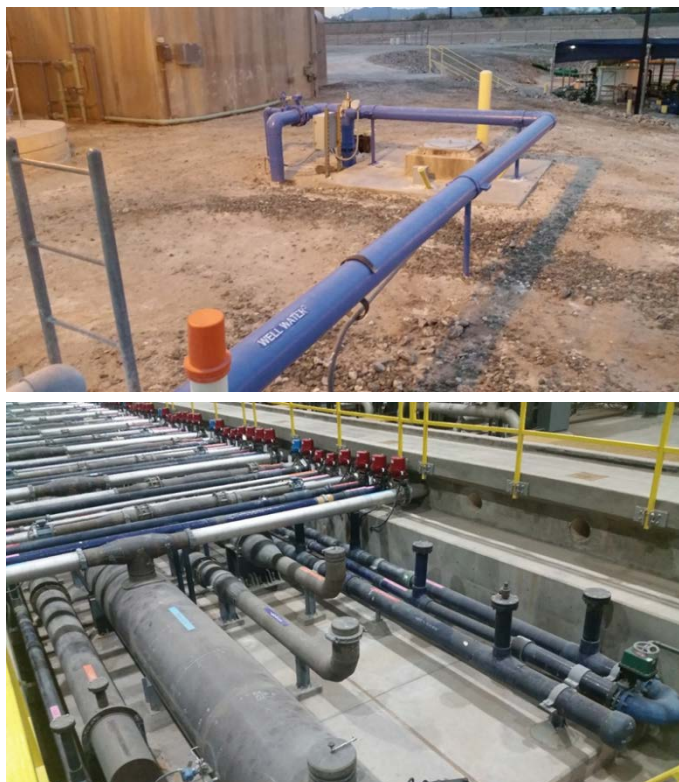
and moderate pressure water ( $\sim 0.7$  MPa) as well as for cleaning chemicals. All the pipelines were produced by Koch Fiberglass. Failures have only occurred at the fittings (taper fit elbows and quick key couplings) and faulty assembly procedures (disengagement of the fittings due to bad bonding practice) during original construction. Visual inspection has been performed whenever a problem occurs by disassembling the pipe. Visual inspection has found no evidence of degradation of the pipe. There are also some 30-year-old GRP tanks at Yuma Desalting Plant and they have not shown any issues.

Figure 2. — GRP aboveground pipelines at Yuma Desalting Plant.

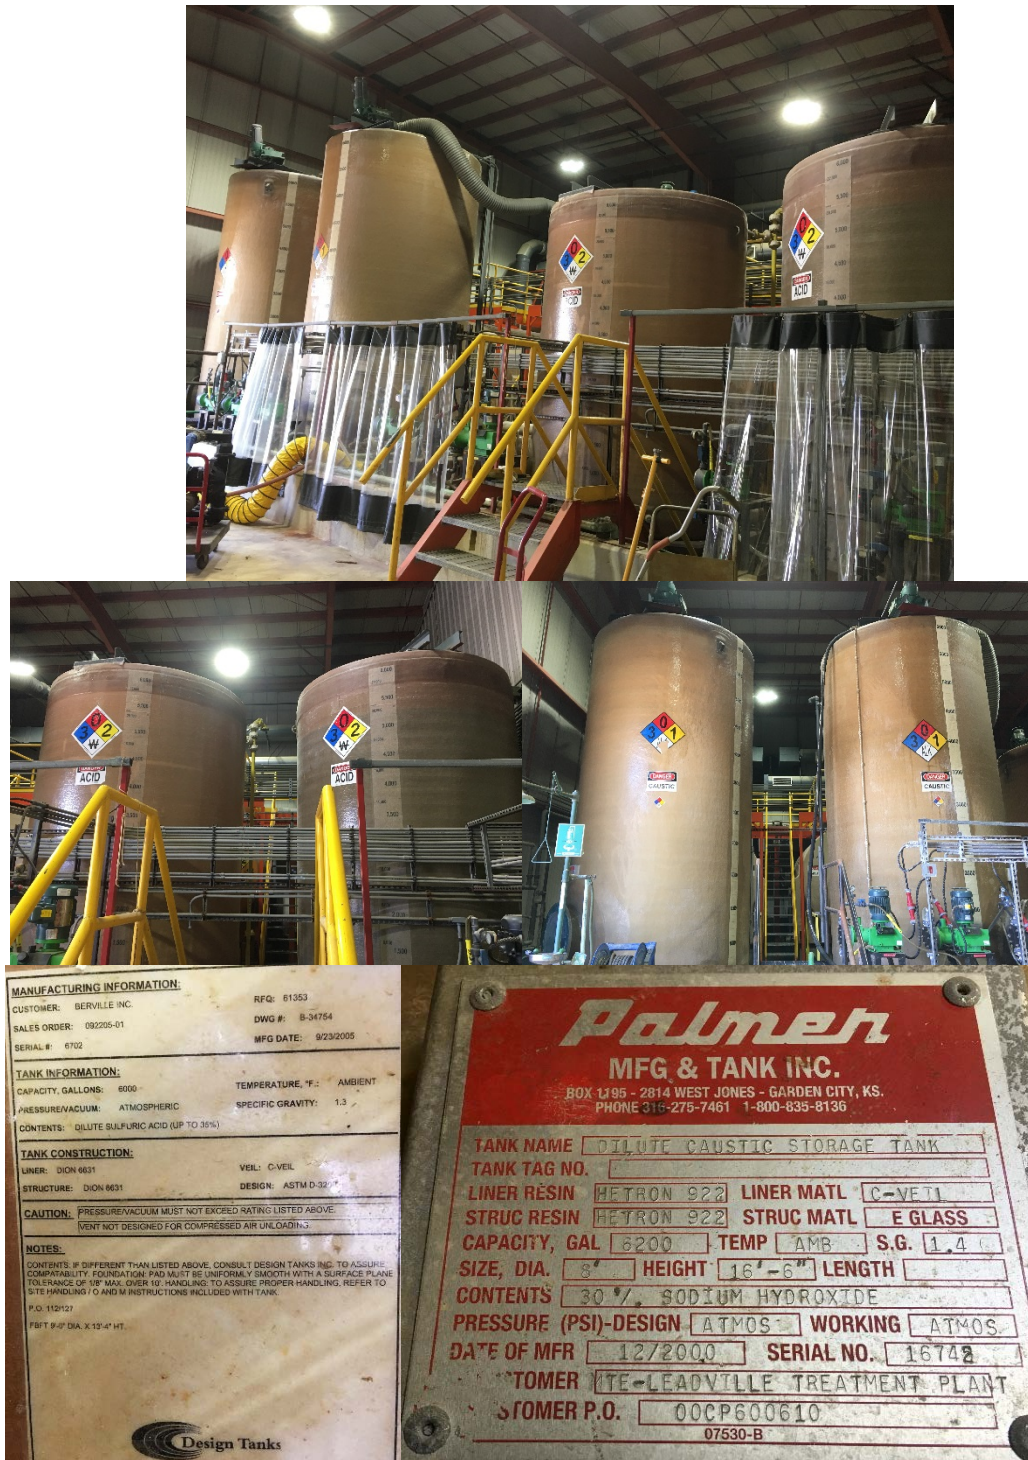
Inspection was performed on both acid and caustic tanks (figures B-1 and B-2). These tanks are used for chemical treatment and cleaning water. Visual inspection was a reliable and easy method to detect blisters, air pockets, voids, and delamination in FRP tanks. Digital tap hammer could also be used as a tool for detecting delamination by change in the sound.

Figure B-1.—Acid and caustic tanks used for water treatment with their manufacturing information

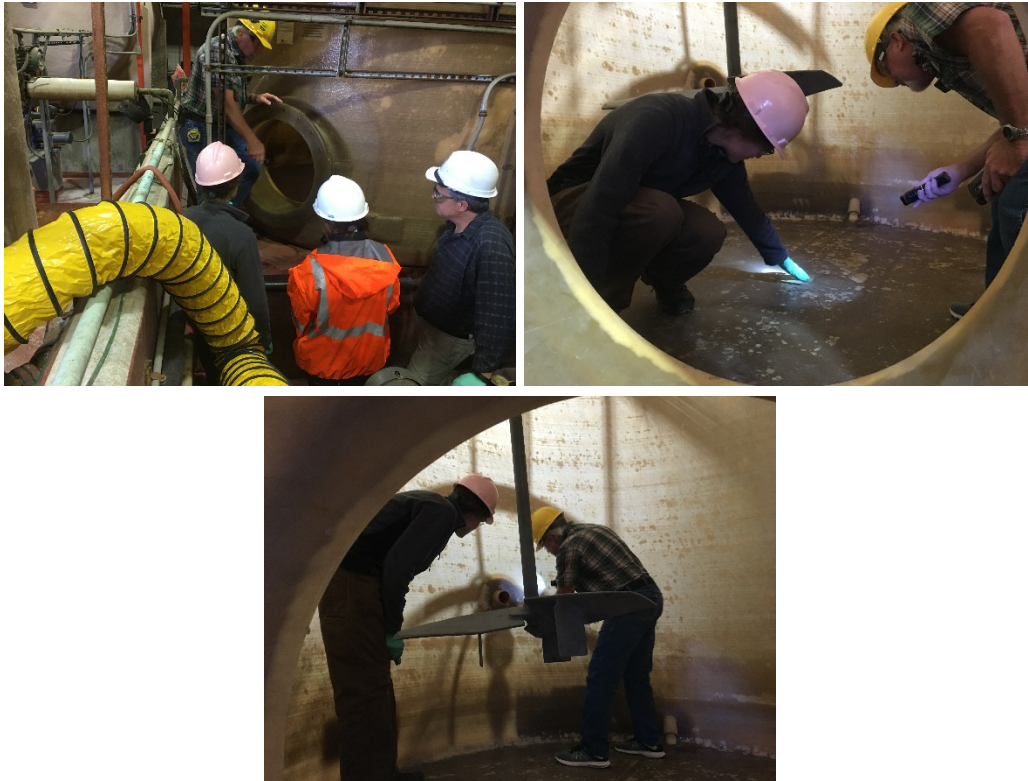
Figure B-2.—Visual inspection of the acid tank interior
