## Canal Lining Demonstration Project – Year 25 Durability Report

Research and Development Office  
Science and Technology Program  
Final Report ST-2019-1743-01, 8540-2019-33

September 2019

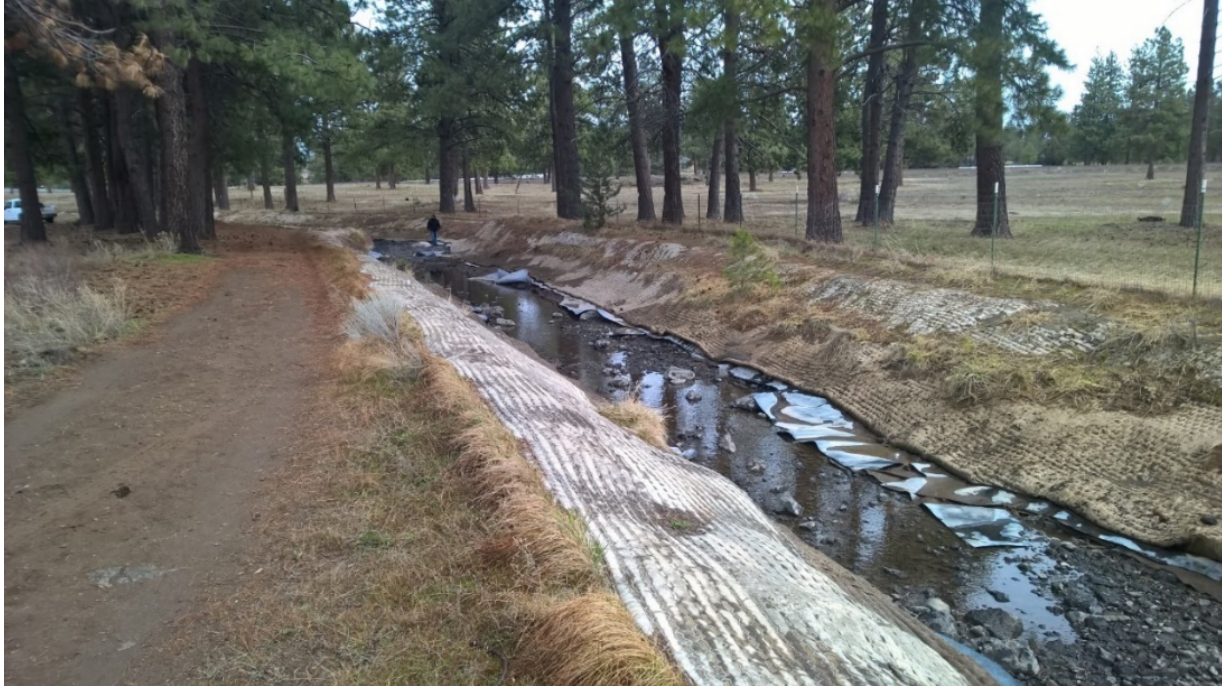
**Failure Analysis:** Figure 1 shows a downstream view of test section A-9. The liner was installed in late 1992 and began to experience problems almost immediately. During the 1993 irrigation season, cuts were made in the liner to ease pressure caused by “whales”. Liner whales are caused by water, sand, gas, sediment, or other materials that become trapped underneath the liner. In this case, the whales were caused by gas, water, and sand. Sand and water were able to penetrate the liner through tears, cuts, and punctures along the length of the canal. Poly-Flex, Inc. attempted to repair the liner on multiple occasions in 1994 and 1995. The problems persisted and the decision was made to remove the invert liner after 28 months of service. In the future it would be advisable to extend the grout mattress cover across the entirety of the canal. The cover serves three main functions: (1) protection of the underlying membrane from mechanical damage from wildlife, debris, and vandals, (2) protection of the underlying membrane from ultraviolet (UV) degradation, and (3) preventing liner whale formation. Test section A-7, a 3-inch grout mattress (across the entire canal) over a PVC membrane, resulted in a much better B/C ratio than test section A-9 for the above reasons.

**Figure 1. View of test section A-9 with standing water in the invert. Note: The 3-inch grout mattress is still functioning while the geomembrane has been removed from the invert. Vegetation can be seen growing on the side slopes. A small amount of geomembrane liner can be seen in the invert at the grout mattress interface.**

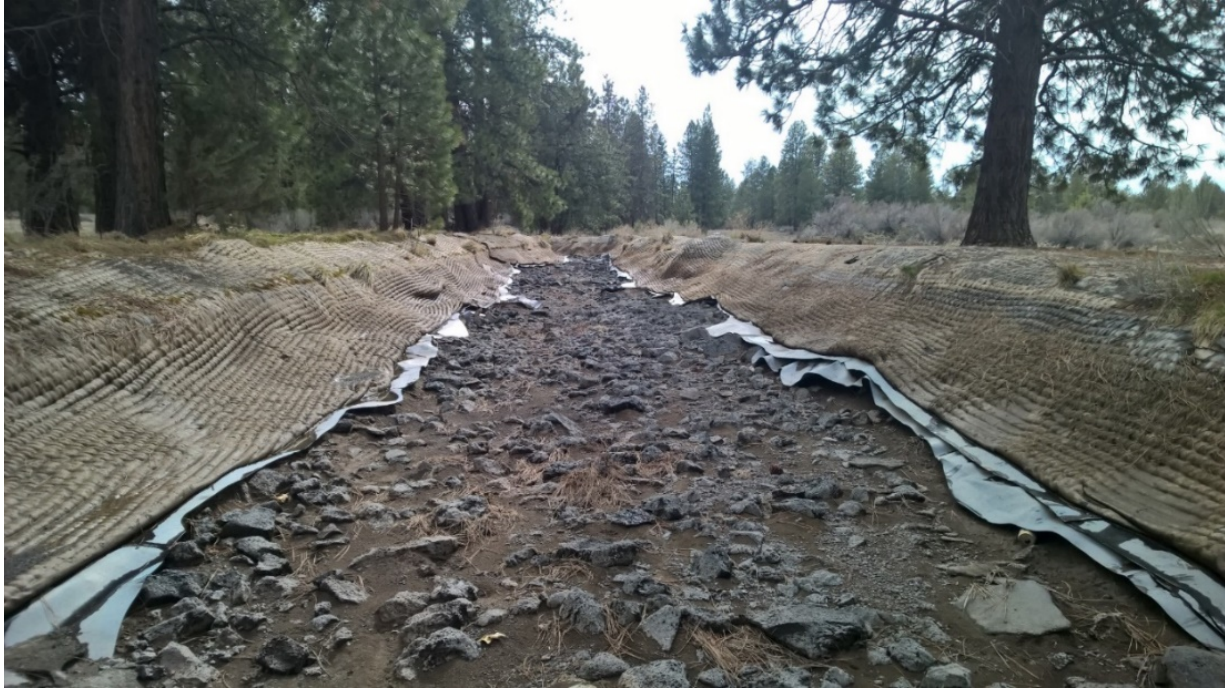
**Failure Analysis:** This test section was also abandoned after 28 months because of whales in the liner. Refer to the failure analysis of test section A-9 for a more detailed explanation of the failure mechanism. Unlike test section A-9, this test section contained Portland cement deposits throughout the length of the canal. The liner was likely damaged as a result, causing more significant liner whales. The cement likely came from the grout mattress in A-10 and/or upstream from other grout mattress test sections. However, a definitive explanation was never found. Like test section A-9, it is recommended to extend the grout mattress cover across the entirety of the canal rather than leaving an exposed geomembrane invert.

**Figure 2. View of test section A-10 with fractured basalt invert. Note: The 3-inch grout mattress is still functioning while the section of exposed geomembrane has been removed from the invert.**

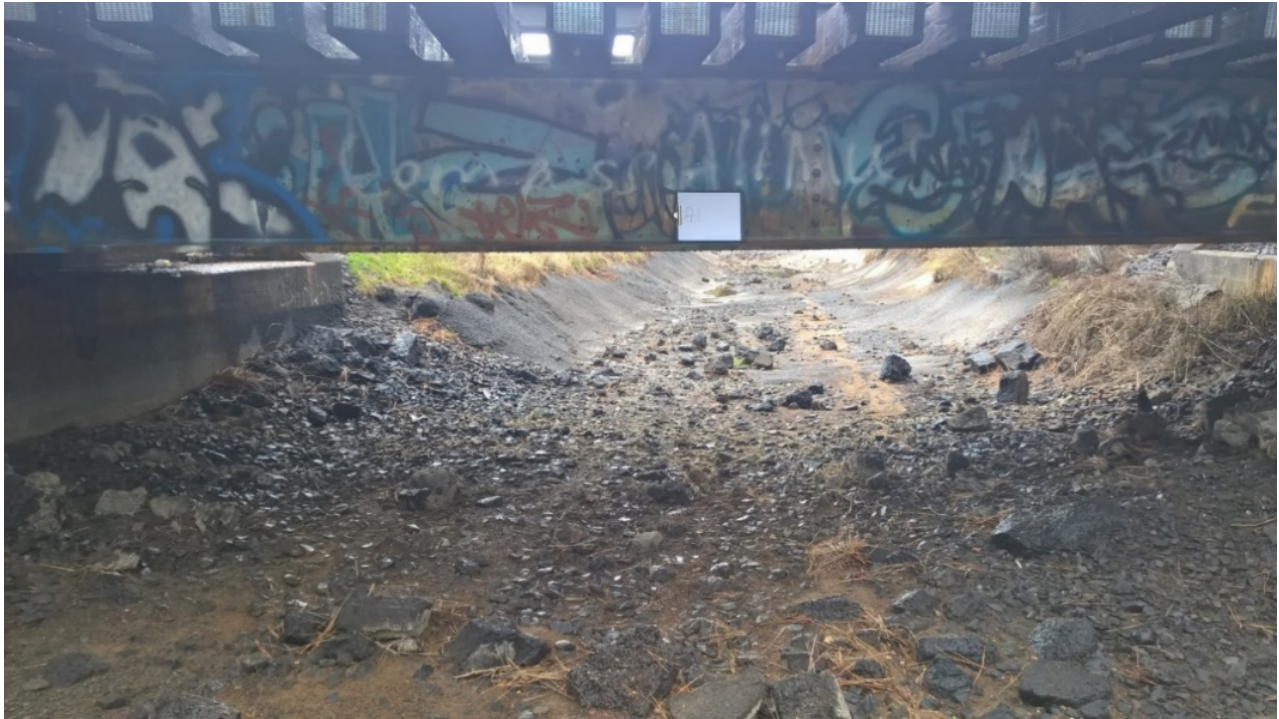
**Condition (25 years):** Excellent – the shotcrete cover is performing very well and still adequately protecting the underlying geomembrane liner. The cover holds the membrane in place, preventing movement and providing tear protection. Small cracks and other minor imperfections are present above the waterline. The cracks are not wide enough to expose the underlying geomembrane layer to UV degradation. Most of the cracking is located near the anchor trench where the shotcrete was tapered down from 3 inches to approximately 1 inch. In future projects, shotcrete thickness should remain constant at all locations. Shotcrete repair should be performed at consistent intervals to optimize service life. Figure 3 shows rocks and debris that have settled in the canal invert impeding water flow. Concrete liners provide ballast for the canal. This ballast prevents liner uplift and soil migration which allows the canal to retain

its overall capacity and efficiency. Concrete covers also provide protection from physical (wildlife/debris) and UV damage. An estimated service life for this material is 50 years, assuming continuation of the presently observed degradation at a constant rate.

**Figure 3. Debris and rocks in the invert of test section A-1 (test section begins on the far side of the bridge). Shotcrete is in good shape and functioning properly.**

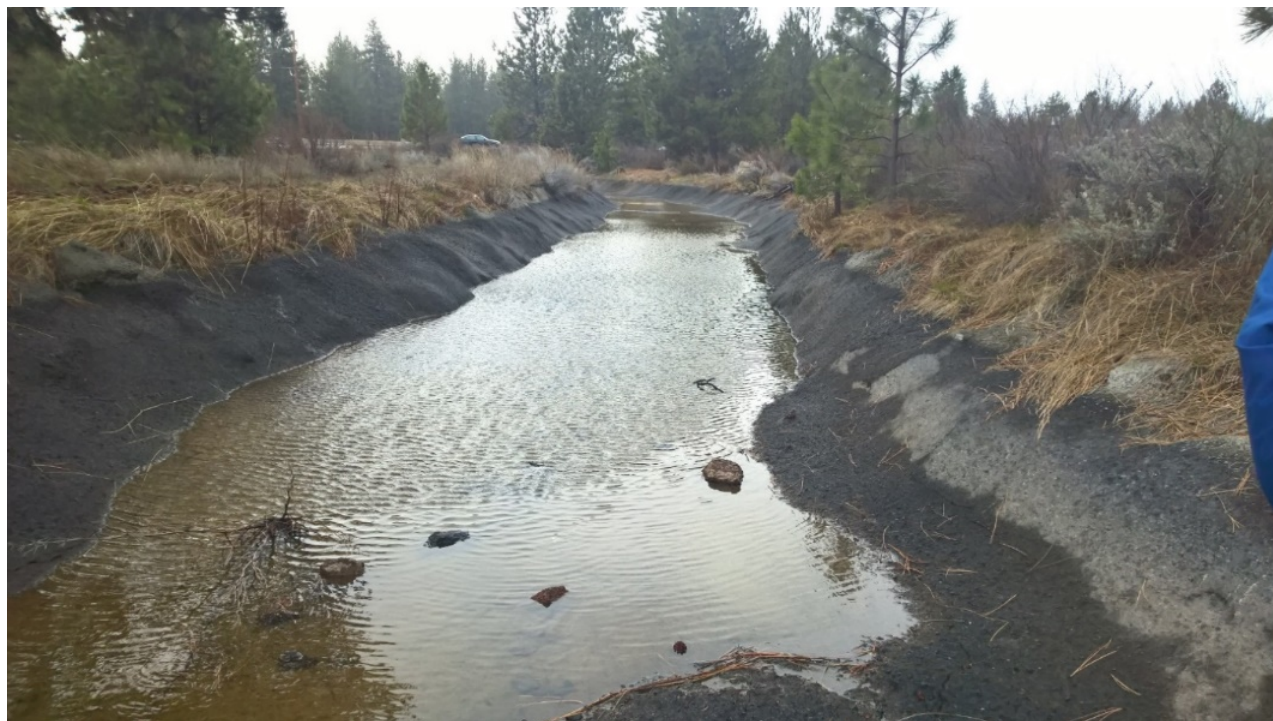
**Condition (25 years):** Excellent – there is no visible difference between test section A-1 and A2. The shotcrete cover is performing very well and still adequately protecting the underlying geomembrane liner. Small cracks and other minor imperfections are present above the waterline. Most of the cracking is located near the anchor trench where the shotcrete was tapered down from 3 inches to approximately 1 inch. In future projects, shotcrete thickness should remain constant at all locations. Shotcrete repair should be performed at consistent intervals to optimize service life. Small amounts of sediment and debris can be seen in the canal invert. Figure 4 shows standing water that may be present year-round. Standing water in the canal invert indicates that the liner is providing effective seepage control. During winter months, this water can turn to ice, minimizing water flow, and potentially damaging the liner. Neither the rocks, debris, or ice seem to have damaged the shotcrete cover or compromised its performance. Canal capacity and efficiency remain unchanged from the time of construction due to ballast and protection provided by the concrete liner. Seepage studies should be done on test section A-1

**Figure 4. Debris, rocks, and standing water in the invert test section A-2. Shotcrete is in good shape and functioning properly.**

and A-2. This would provide valuable information to determine which geomembrane materials/thicknesses are most cost effective underneath concrete covers. An estimated service life for this material is 50 years, assuming a continuation of the presently observed degradation at a constant rate, and consistent maintenance practices.

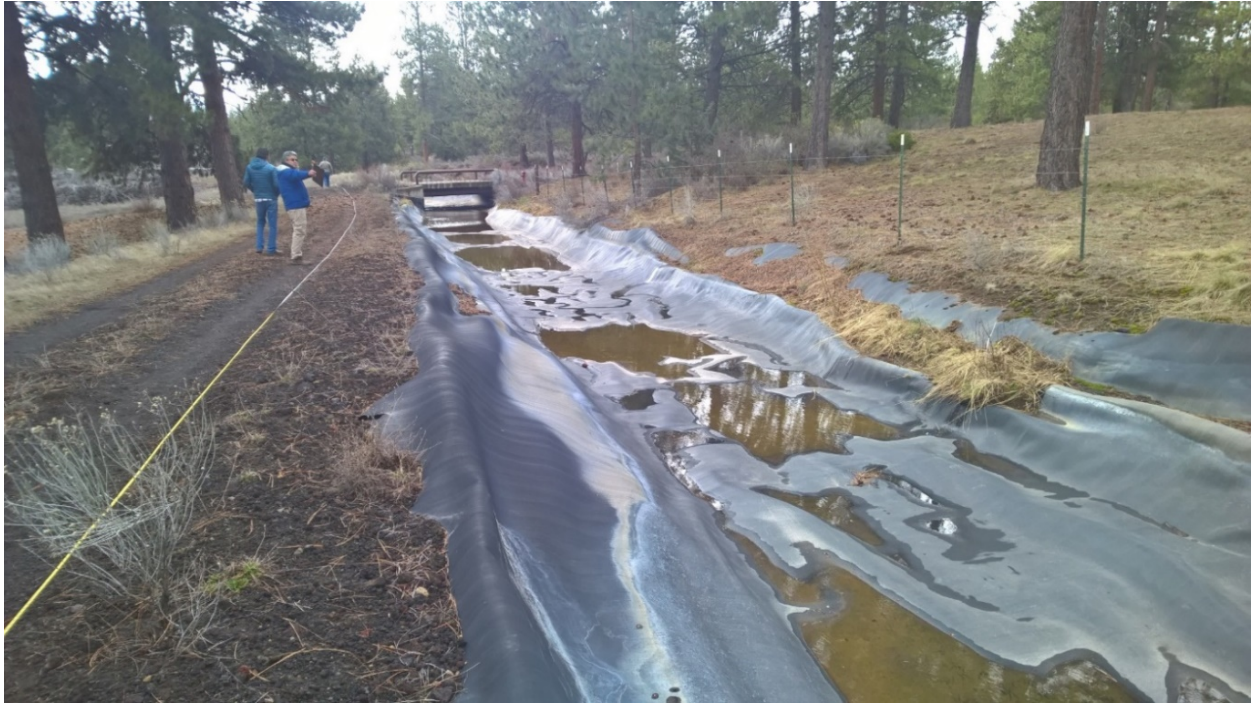
**Condition (25 years):** Excellent – at one location above the waterline a piece of rebar was driven through the liner, causing a 6-inch crack to form. This was most likely a result of stress cracking due to HDPE's high propensity for this type of damage. Several small cracks and/or tears were observed in the geomembrane liner but do not appear to be affecting performance. Discoloration can be seen on the surface of the liner in Figure 5, which is likely a result of organic material deposits. Figure 5 also shows slight displacement from soil migration underneath the liner. The displacement is minimal and does not appear to have caused any damage; however, this should be monitored moving forward. The soil migration could be a result of ground water, side slope sloughing, and/or voids in the liner (unlikely to be caused by voids in this case as the liner has very few). Figure 5 shows pools of water in the canal invert from the uneven subgrade. This is another indication of soil migration, but also suggests that the

liner is still adequately preventing seepage. A small amount (under 2 inches) of sediment can be seen in areas where water has pooled. Grass and vegetation have grown over the top of the liner on the side slopes but have not penetrated the membrane. The metal batten strips attaching the membrane to the bridge abutment are in excellent shape. An estimated service life for this material is 30 years, based on current performance, material thickness, service conditions, coupon testing, and knowledge of HDPE.

**Figure 5.** View of the HDPE liner in test section A-3 looking toward the bridge. **Note:** Grass has grown over the top of the liner on the side slopes but has not penetrated the liner. Soil migration is apparent based on the uneven subgrade which is common with exposed geomembranes.

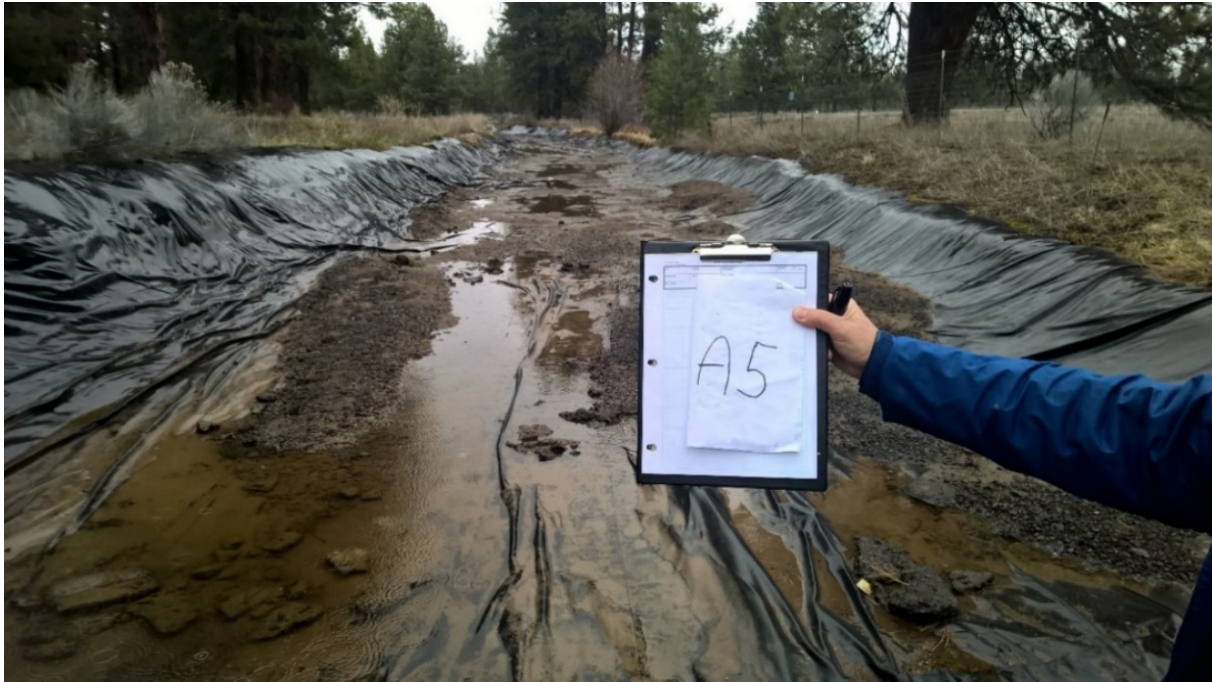
**Condition (25 years):** Failed – the Hypalon membrane has experienced tears, UV embrittlement, wrinkling, and degradation. Large tears (Figure 8) in the invert of the canal are allowing water and sediment to migrate under the liner, decreasing canal capacity and efficiency. A large amount of sediment and debris is sitting in the invert (Figure 7). Sitting water will freeze during the winter and turn to ice. During winter run-offs the ice can collect at structures (ice jamming), reducing efficiency and, in some cases, causing canal overflow. The ice can also cause damage to the liner as it makes its way down the canal. Sediment buildup will also decrease capacity, diminishing the canal's ability to deliver water downstream to irrigation districts. This liner has exceeded its useful service life and should be replaced when viable. During liner replacement, excavation will be necessary to repair the subgrade and restore canal capacity. Based on liner thickness (45-mil), and all previous condition assessments, an estimated service life for this material is between 11 and 25 years. An 18-year service life will be used for all calculations in this report

**Figure 7. Downstream view of CSPE liner in test section A-5. Note: sediment and water can be seen in the canal invert. Tears have allowed water and sediment to migrate underneath the liner.**

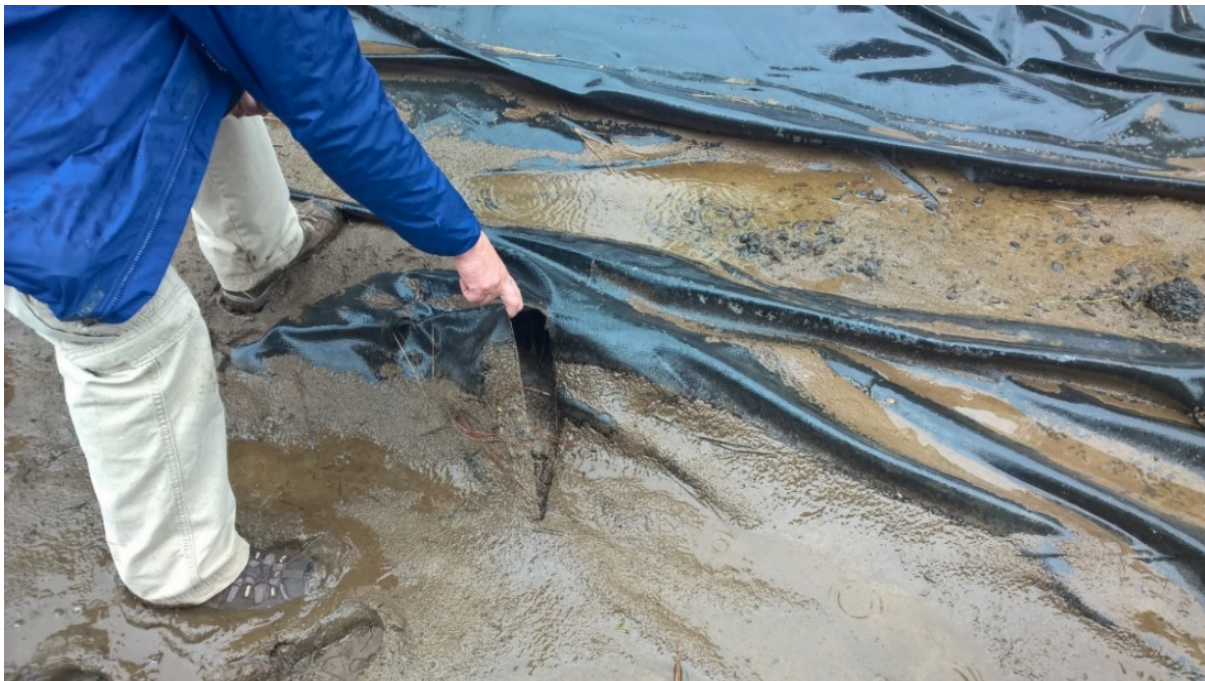
**Figure 8. A large tear in the liner on the canal invert in test section A-5. Tears allow sediment and water to migrate underneath the liner, decreasing canal capacity and efficiency.**

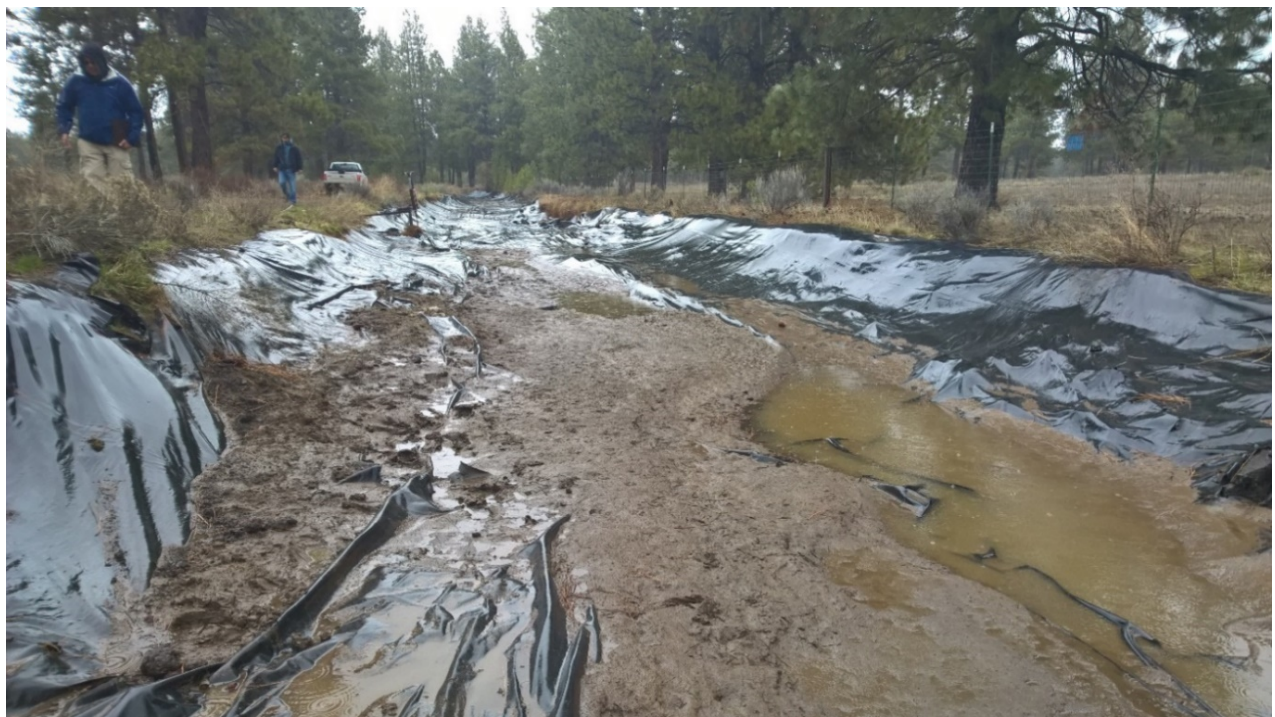
**Condition (25 years):** Failed – Test section A-6 is in similar but slightly worse condition compared to test section A-5. Wrinkles, sediment build up, UV embrittlement, and tears are all slightly more pronounced. This is likely due to differences in thickness and reinforcement between the liners. Large tears in the invert of the canal are allowing water and sediment migration under the liner, (Figure 9) decreasing canal capacity and efficiency. A large amount of sediment and debris is sitting in the invert, similarly to test section A-6. This test section experiences ice jamming which is explained in the condition assessment for test section A-5 above. This liner has exceeded its useful service life, no longer provides seepage control, and should be replaced when viable. Based off test section A-5 (thicker than A-6 and reinforced), an estimated service life for this material is between 11 and 20 years. A 15-year service life will be used for all calculations in this report.

**Figure 9. Downstream view of the liner in test section A-6. Sediment and water can be seen in the invert. Tears have allowed sediment migration under the liner. Canal capacity has diminished.**

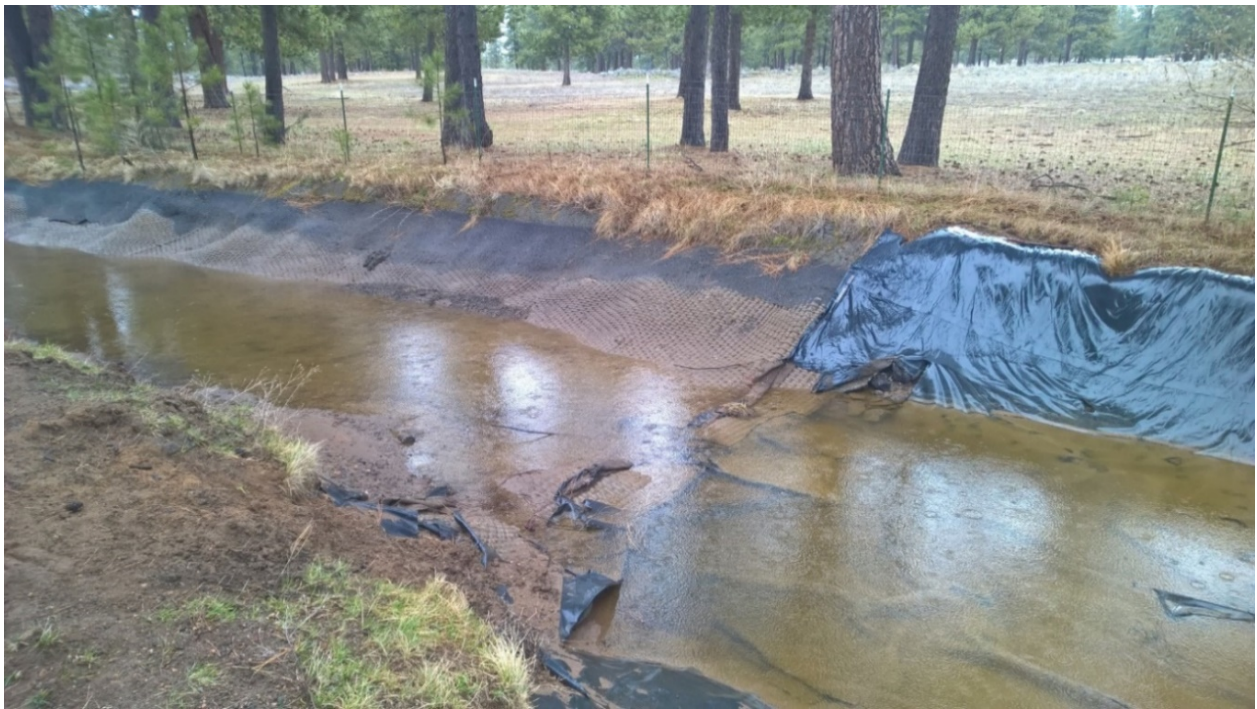
**Condition (25 years):** Excellent – the grout filled mattress is in excellent condition after 25 years of service. The cover has provided protection from UV degradation and held fixed the underlying liner material, providing a measure of tear protection. The cover has also protected the underlying liner from physical damage. The grout filled mattress does not appear to have experienced any freeze-thaw damage; however, some of the grout has begun to degrade above the waterline. Additional grout should be applied to these areas to mitigate further degradation. The darker color seen in Figure 10 towards the top of the canal is dirt that has settled on the grout mattress but does not appear to be affecting liner performance. Below the waterline appears to be in excellent condition. A small amount of sediment can be seen in the canal invert which is likely a result of slow-moving water. The grout mattress provides ballast for the canal, preventing liner uplift and soil migration. This test section appears to be sufficiently preventing seepage. An estimated service life for this material is 50 years, assuming continuation of the presently observed degradation at a constant rate.

**Figure 10.** The part of the canal where test sections A-6 and A-7 meet. Note: standing water and sediment in the canal invert.

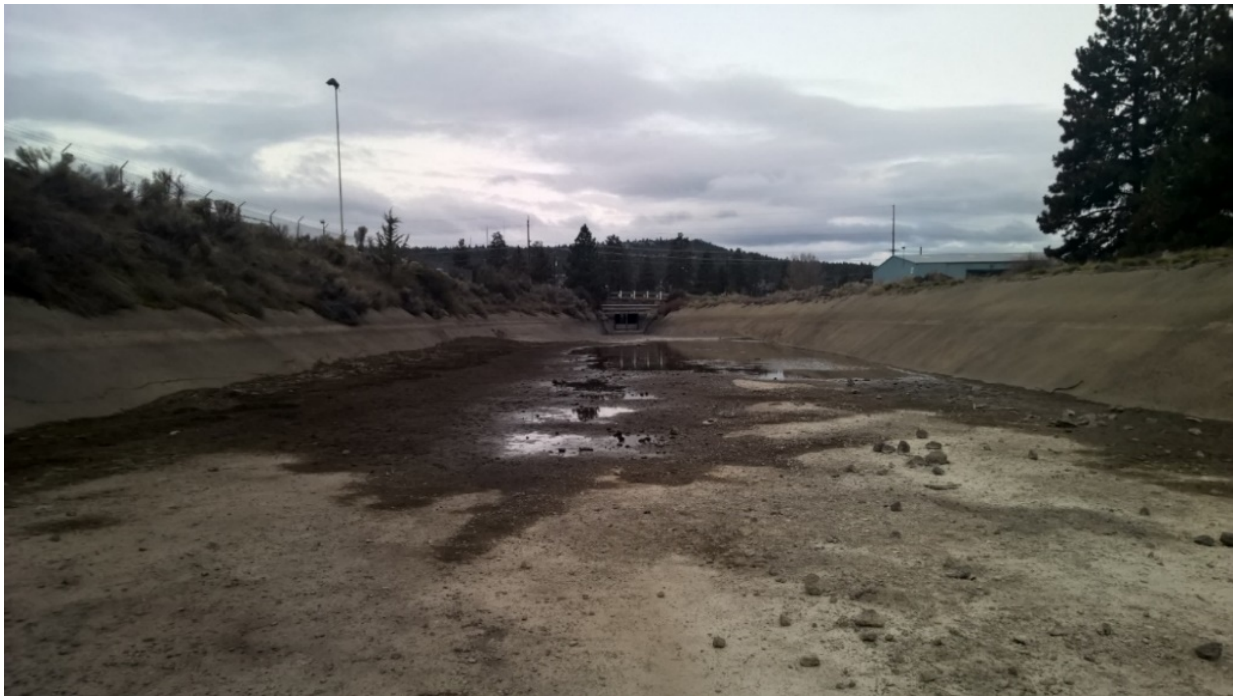
**Condition (18-19 years):** Very Good to Excellent - Installed RCC invert and shotcrete side slopes between 1998 and 1999. The rather thick RCC invert has decreased canal capacity from 1,000 cubic feet per second (cfs) to 800 cfs. The canal invert and side slopes are in very good to excellent condition (Figure 11); however, some repairs have been required over the years (Figures 12 and 13). Areas of erosion can be seen throughout the invert in and around cat tracks (Caterpillar heavy machinery). Locations where cat tracks are not present remain in excellent condition. Minor cracking can be seen on the side slopes. Further repairs will need to be made to limit concrete degradation and maintain performance. The repairs have proved very effective at maintaining seepage control in the canal and will go a long way towards maximizing service life. An estimated service life for this material is 50 years, assuming continuation of the presently observed degradation at a constant rate.

**Figure 11.** View of RCC invert canal looking upstream. Some sitting water can be seen in the invert.

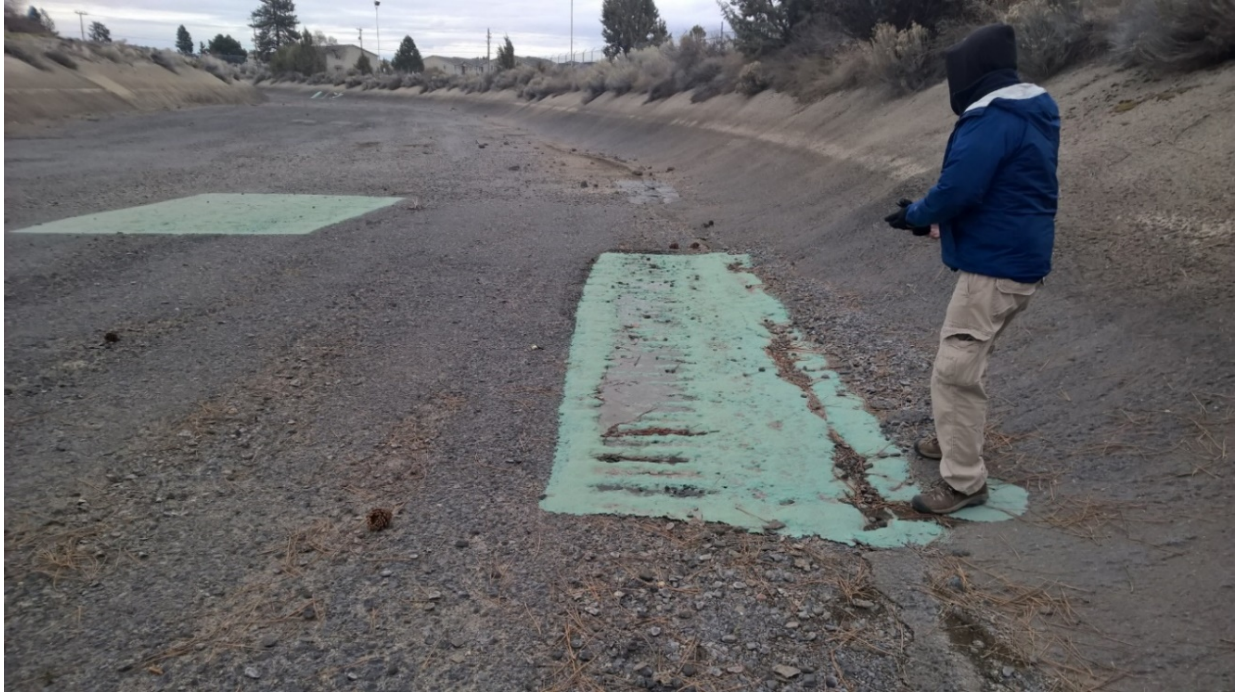
**Figure 12. Repairs made to the RCC invert. The repairs proved to be very effective.**

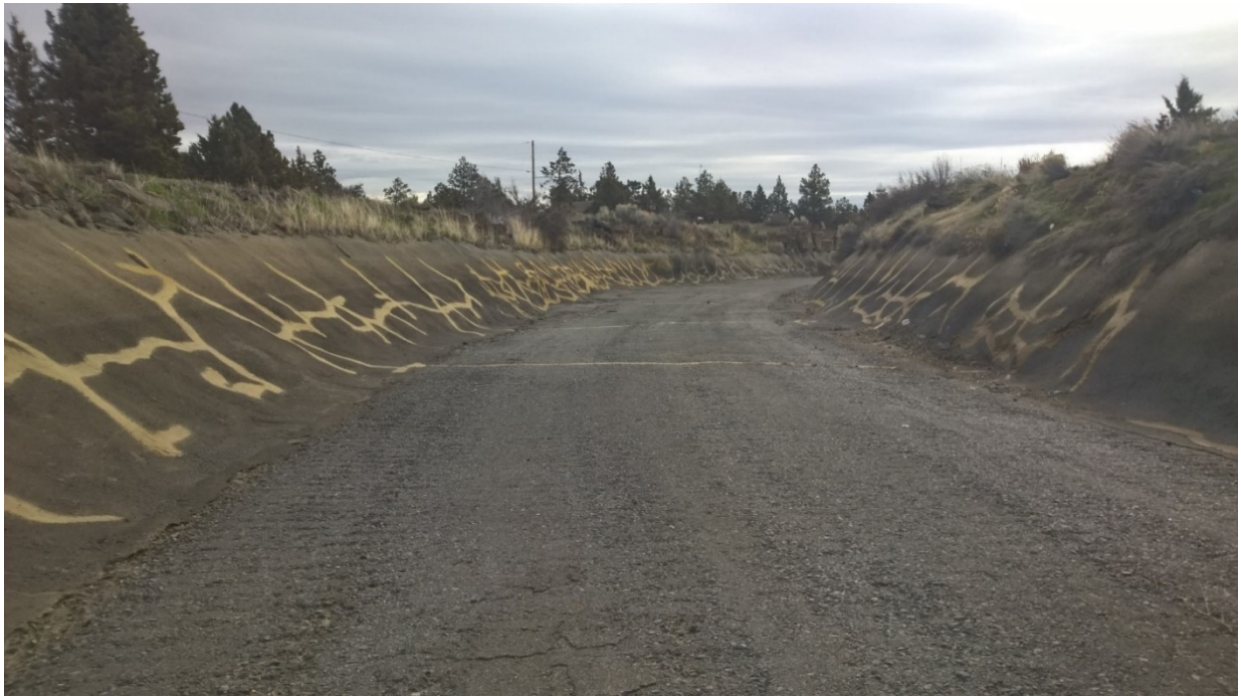
**Figure 13. Repairs made to the shotcrete side slopes. The repairs proved to be very effective**

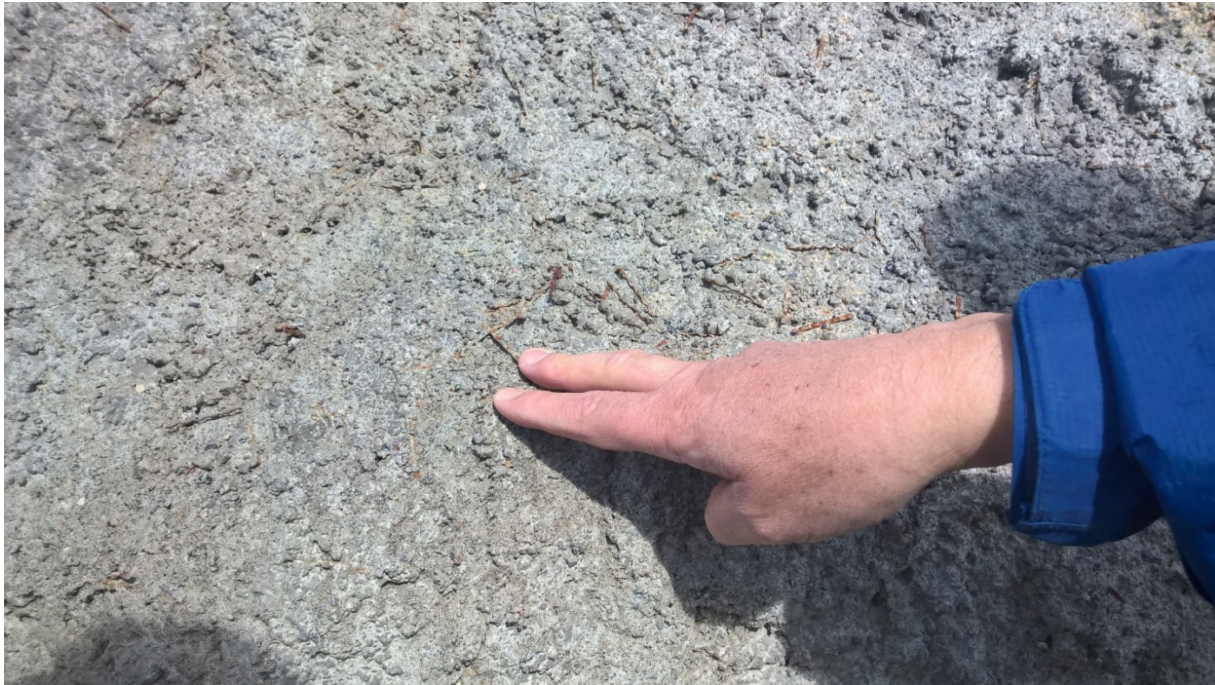
**Condition (25 years):** Very Good to Excellent – overall the test section is in very good condition. Figure 14 is a close-up view of the 1 ½ inch Novocon steel fibers imbedded in the shotcrete. The value of the steel fibers was indeterminate; in addition, no difference was observed between the first and second half of the test section containing 50 and 25 lb/yd<sup>3</sup> of fiber respectively. Small to medium sized voids can be seen in the invert of the canal which is somewhat common in shotcrete test sections. District personnel have been very diligent with concrete repair, which should maximize service life and minimize seepage. Small cracks were observed on the invert and side slopes. Figure 15 shows sediment build up on the canal invert, which was likely deposited from slow-moving water. Rocks and debris are scattered throughout the invert and could be removed; however, the impact on canal flow is likely negligible, so any removal efforts are unlikely. An estimated service life for this material is 50 years, assuming continuation of the presently observed degradation at a constant rate.

**Figure 14. Steel fibers embedded in the shotcrete side slope in test section N-6. Shotcrete appears to be in very good condition in the surrounding area with no visible cracks.**

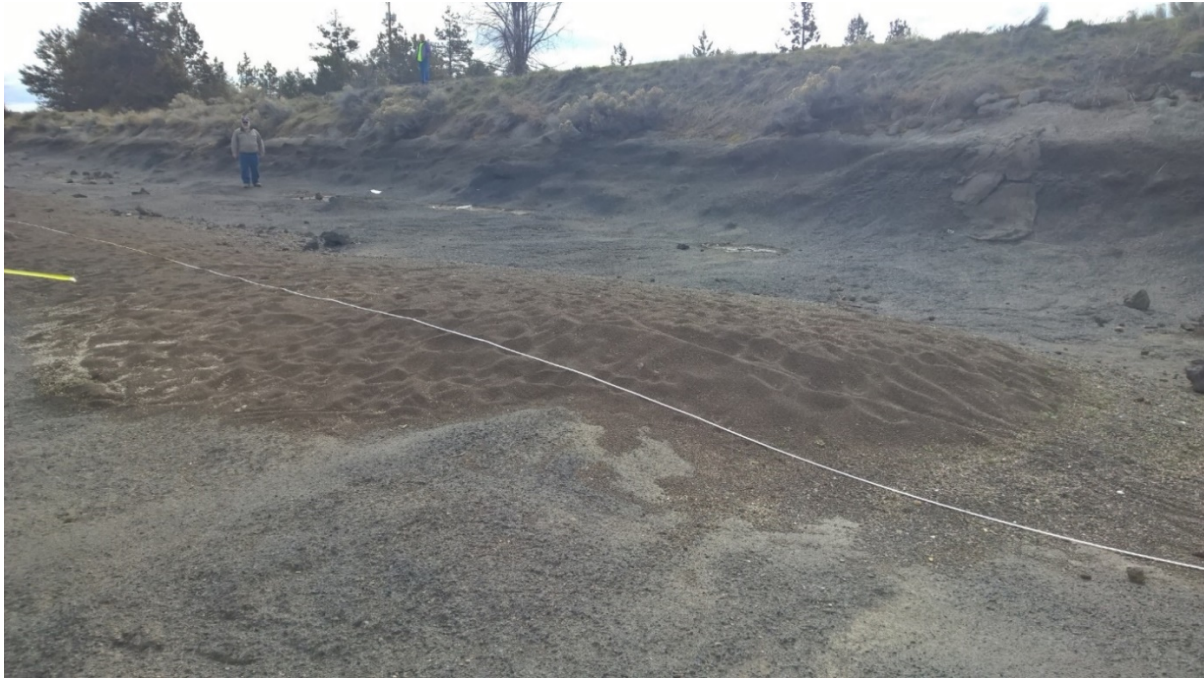
**Figure 15. Sediment build up in the canal invert in test section N-6 that will decrease overall efficiency and capacity.**

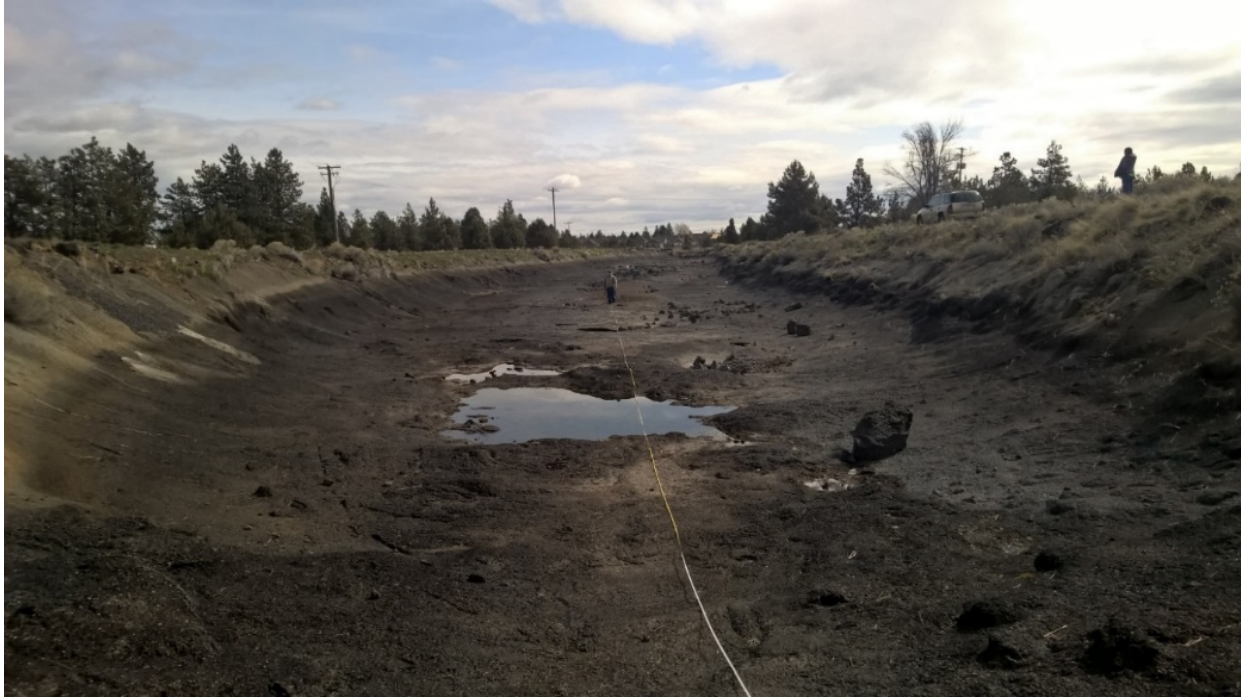
**Condition (25 years):** Very Good to Excellent – overall the test section is in very good condition, similar to test section N-6. Figure 16 shows an area of erosion where water has pooled in the invert. Large rocks and other debris are scattered around the invert which may have contributed to the minimal shotcrete damage seen. The water line on the side slopes is visible in Figure 16. Small cracks and voids were observed throughout the invert and side slopes. District personnel have been very diligent with concrete repair which should maximize service life by preventing further degradation. The value of polyfibers was indeterminate; in addition, no difference was observed between the first and second half of the test section containing 3 and 1 ½ lb/yd<sup>3</sup> of fiber respectively. If continued maintenance occurs, an estimated service life for this material is 50 years, assuming continuation of the presently observed degradation at a constant rate.

**Figure 16. Downstream canal view in test section N-7. Note: sitting water and rocks scattered throughout the invert of the canal.**

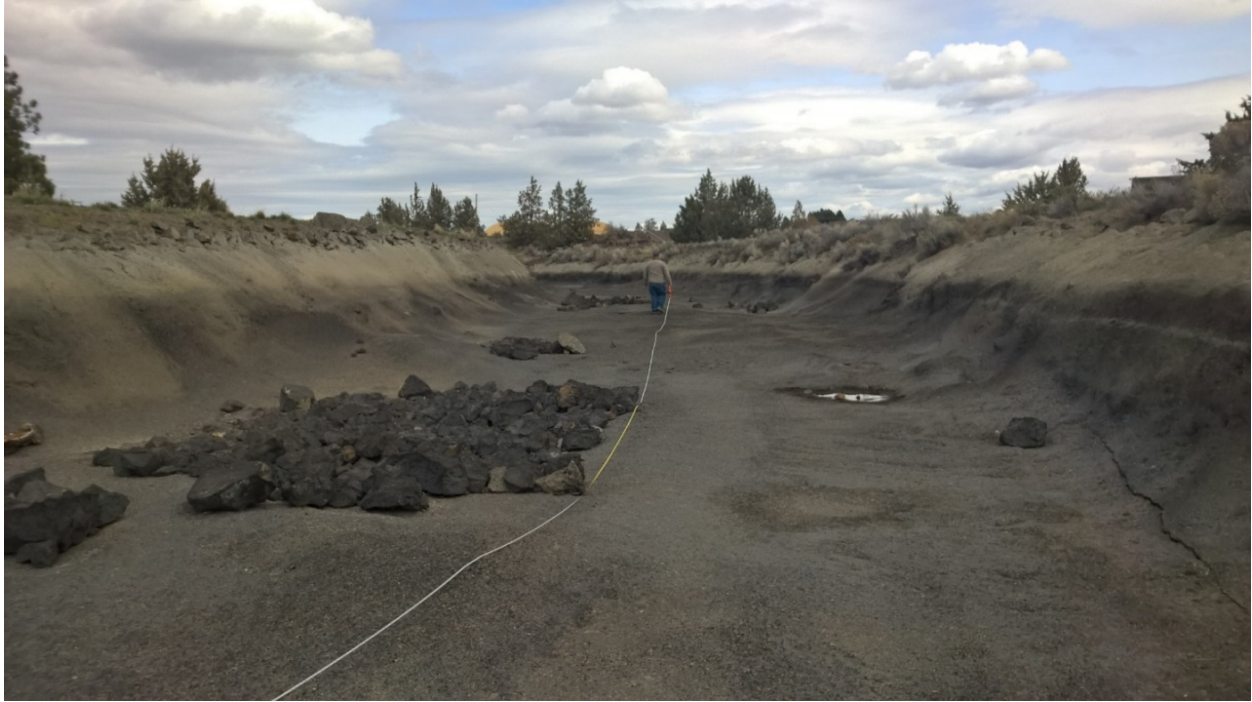
**Condition (25 years):** Very Good to Excellent – overall the test section is in very good condition, similar to test section N-6. Figure 17 shows an area of erosion where water has pooled in the invert. Large rocks and other debris are scattered around the invert which may have contributed to damaging the shotcrete. The water line on the side slopes is visible in Figure 17. Small cracks and voids are visible throughout the invert and side slopes. District personnel have been very diligent with concrete repair which should maximize service life by preventing further degradation. The value of polyfibers was indeterminate; in addition, no difference was seen between the first and second half of the test section containing 3 and 1 ½ lb/yd<sup>3</sup> of fiber respectively. If continued maintenance occurs, an estimated service life for this material is 50 years, assuming continuation of the presently observed degradation at a constant rate.

**Figure 17. Group of rocks in the canal invert. Small void can be seen on the right, filled with water. A long but narrow crack can be seen on the side slope. Overall the test section is in very good condition.**

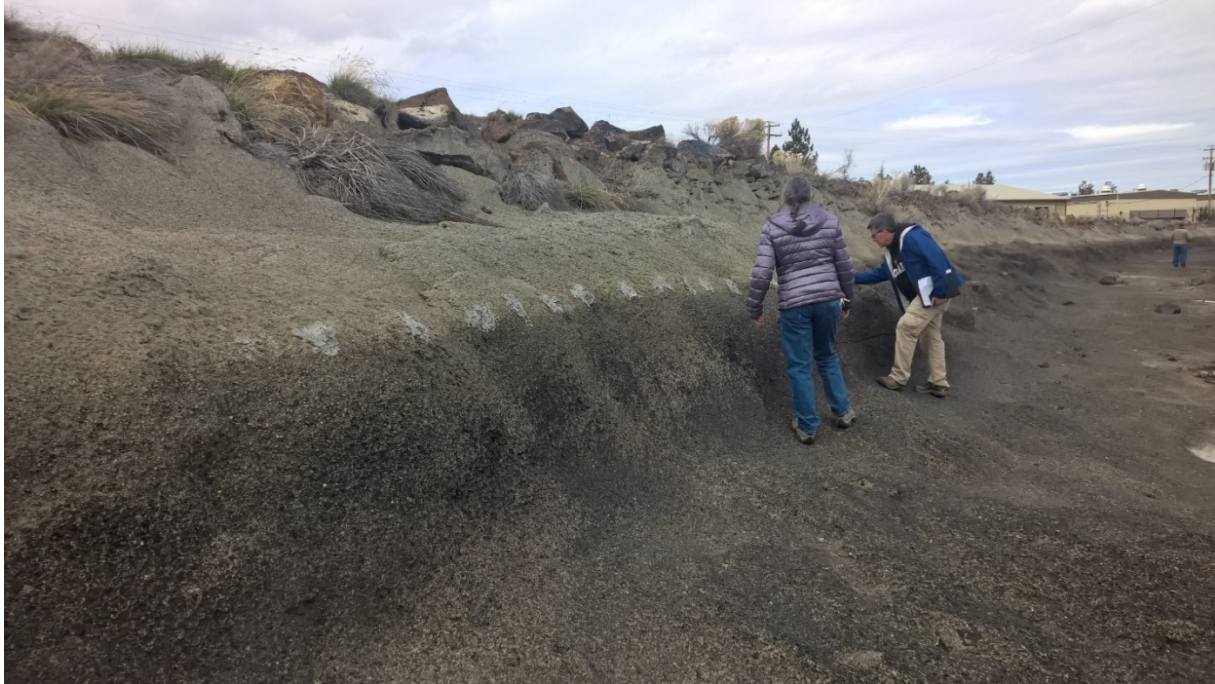
**Condition (25 years):** Very Good to Excellent – there is no visible difference between reinforced and unreinforced shotcrete. Seepage studies should be considered in the future to provide valuable performance data that a condition assessment cannot. Small voids and cracks are present throughout the test section. District personnel has been diligent with concrete repairs which increases service life and effectiveness of the liner. Overall this test section is still in very good condition and functioning efficiently. An estimated service life for this material is 50 years, assuming continuation of the presently observed degradation at a constant rate.

**Figure 18. Portion of canal in test section N-9. Marks can be seen on the side slopes where kayakers have tied off. Water line is visually represented as a color transition on the side slopes. Small voids can be seen in the canal invert.**

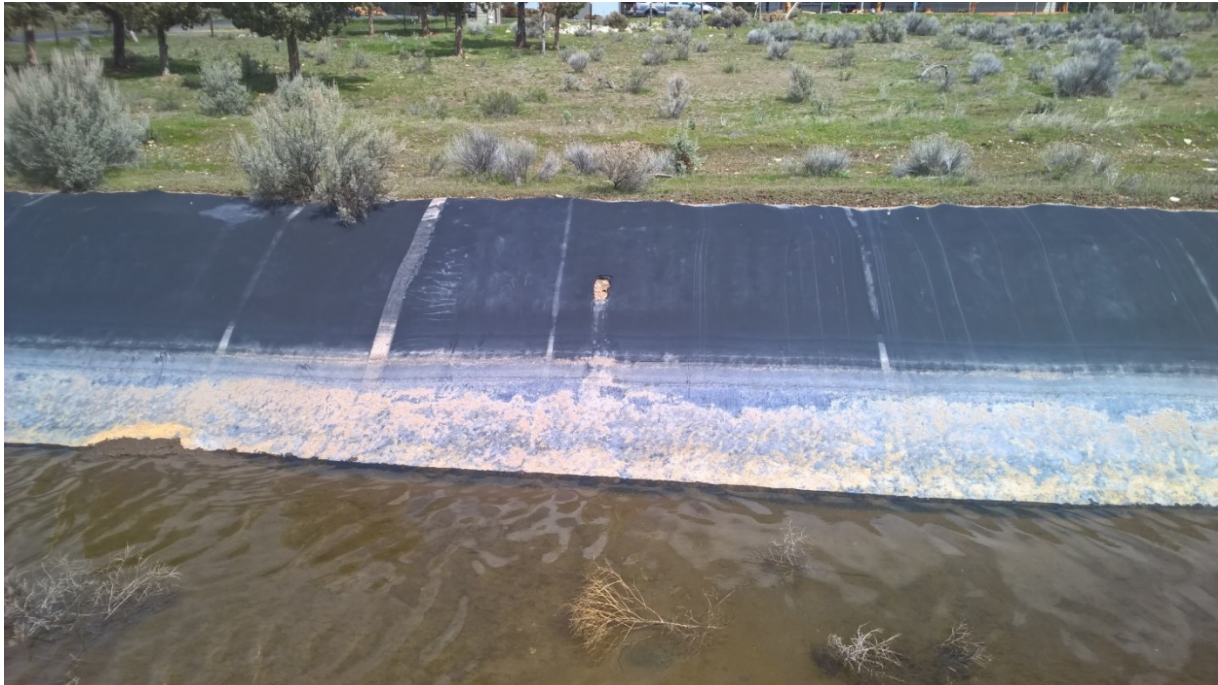
**Condition (17 years):** Good – the exposed and covered EPDM membrane both appear to be in good condition. EPDM has excellent weathering properties due to its chemical structure. However, the liner is still susceptible to degradation from environmental factors. The covered invert and running water did not allow for detailed inspection of the canal invert. No visible tears or rips were observed on the side slopes; however, small holes can be seen near the water line, which were likely caused by wildlife. Figure 19 shows discoloration below the water line on the side slopes, which is likely a result of organic material deposits on the liner. Coupon sample testing will reveal more about the degradation level of the liner. Based on the visual condition assessment, an estimated service life for this material is 20 years, assuming continuation of the presently observed degradation at a constant rate.

Figure 19. Shows exposed EPDM liner in test section O-3a and O-3b with covered invert. Note: discoloration on the side slopes up to the water line due to organic material deposits. Debris and sediment build-up can be seen in the canal invert.

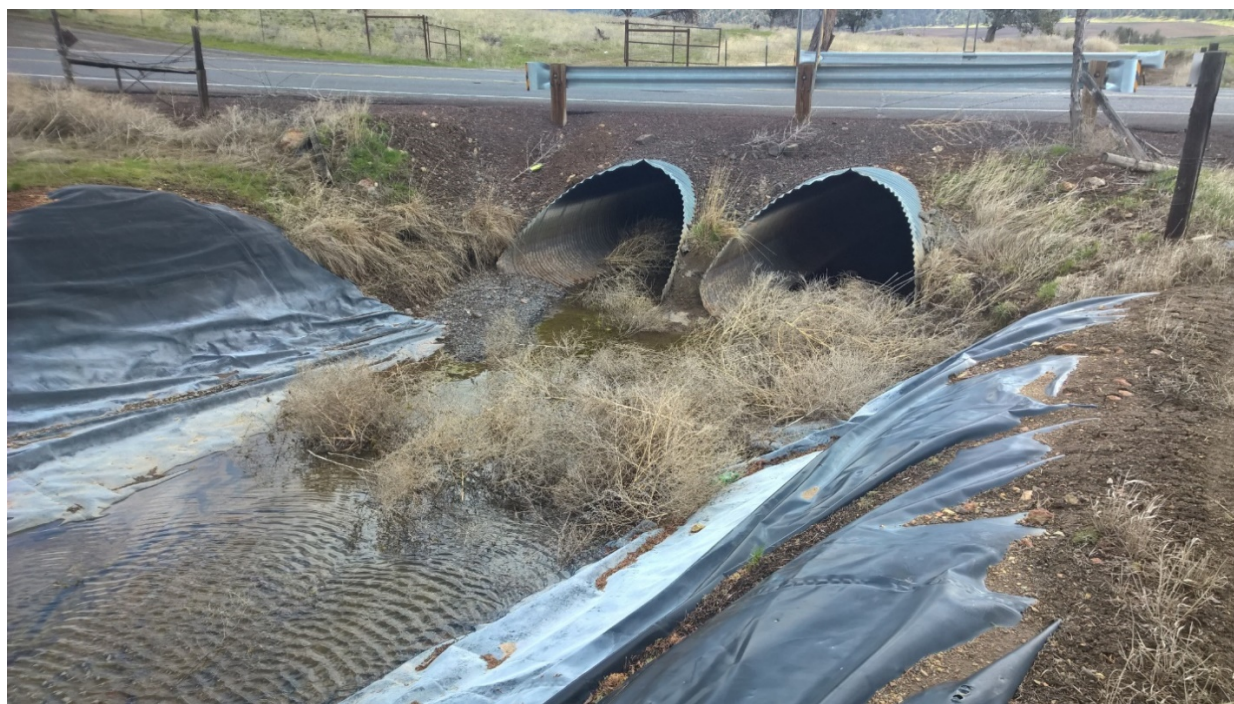
**Condition (17 years):** Good – the exposed LLDPE liner is in good condition after 17 years of service. Little to no maintenance has been done over the last 14 years. District personnel would like to remove the sediment in the invert to increase flow but have not done so due to concerns about damaging the liner. The canal section seems to flush out enough sediment so that additional sediment removal is not necessary. There is minor tearing and wrinkling throughout the canal; however, the wrinkling does not appear to have caused any damage which is likely a result of LLDPE's elongation properties. Wrinkling is an indication of subgrade movement which could lead to future liner damage. Exposed geomembranes are susceptible to physical (wildlife and debris) and thermo-oxidative (light and heat) damage. Over time this can lead to soil migration, reduced capacity, and loss of functionality. Based on the visual condition assessment, an estimated service life for this material is 20 years, assuming continuation of the presently observed degradation at a constant rate

**Figure 20.** Exposed 30-mil LLDPE liner in test section O-4. Note: wrinkles can be seen throughout the liner and sediment deposits can be seen in the invert.
