Future Utilization of Electro-Osmotic Pulse Technology on Concrete Structures

Science and Technology Program

Final Report No. ST-2020-1764-01, 8540-2020-13

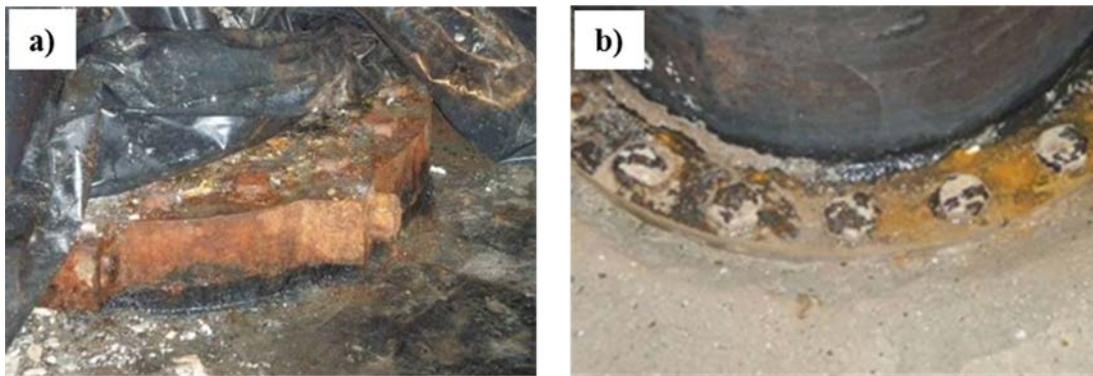
Electro-Osmotic Pulse systems were installed at Trinity Dam near Redding, California, to test the technology's ability to stop water leaking into the headgate shaft. Standing water on the bonnet chamber floor was causing corrosion of the headgate bonnet cover, air inlet pipe, and other metal structures, as shown in Image 1a and b. Failure of the air inlet pipe would result in complete flooding of the chamber and cause water to flood the tunnel to the powerplant yard if the door was not sealed shut. Sealing this door was difficult due to the corrosion and calcium carbonate build-up on the walls and door hinges. The leaks are mainly from cracks and joints in the shaft. The specific cause of the cracks was not determined; however, it was determined the cracks are not from a concrete deterioration mechanism and most likely from initial concrete shrinkage.

Image 1. Corrosion of the bonnet cover and air inlet pipe due to the standing water [1,2].

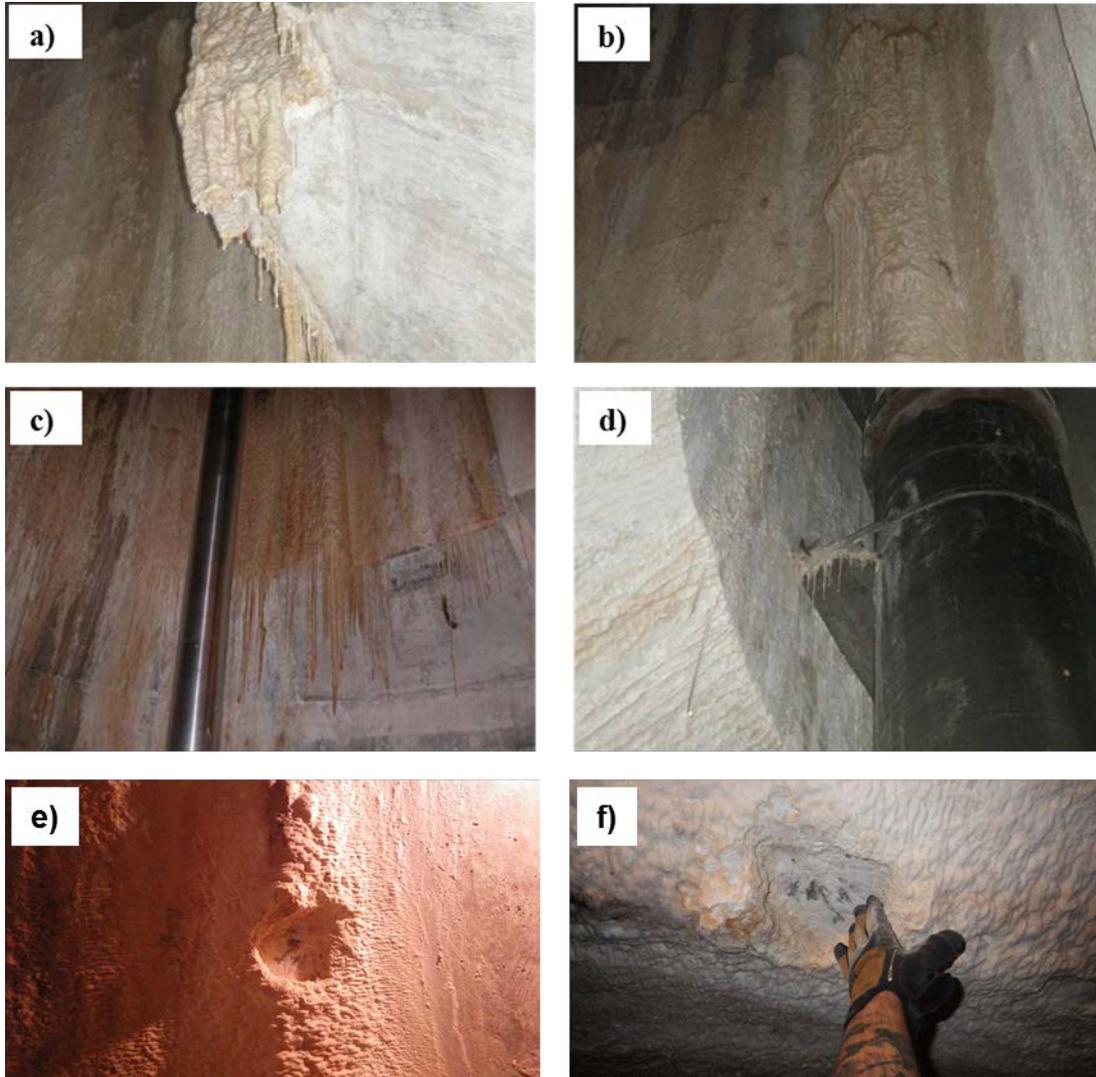
Water leaks had caused significant calcite build-up in the shaft, preventing removal of the headgate for maintenance and repair. Calcium carbonate (calcite) forms when water containing calcium ions reacts with carbon dioxide in air. In some areas, the seepage over time resulted in stalactite formation. The walls of the shaft were covered with calcite as shown in **Error! Reference source not found.** Image 2a - f. In some areas of the shaft it was reported that the calcite was as thick as 6 to 8 inches [3]. Calcite in the gate shaft guides prevents removal of the headgate for inspection and maintenance. The upstream face of the gate has not been inspected since installation other than an underwater inspection utilizing a remotely operated vehicle in October 2016 [4].

Image 2. Calcite deposits observed on the walls of the headgate shaft. Excessive seepage over time has resulted in stalactites and corrosion of air vent supports [1,2].

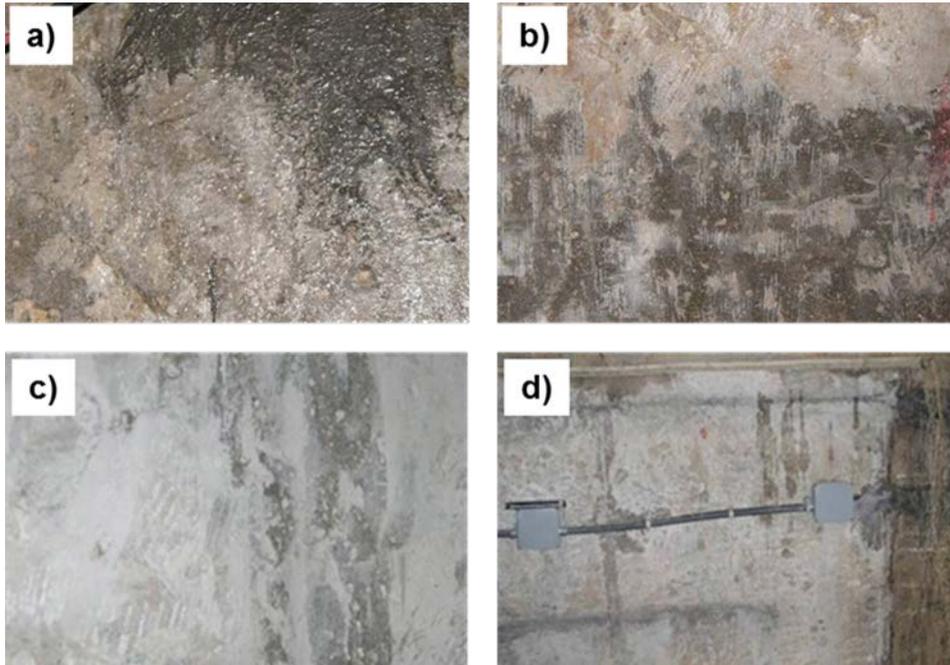
Visual Inspection The wall of the chamber prior to installation was wet both to sight and touch, as shown in Image 7a and b. These photos document the visual conditions to determine if the system was operating. The Phase 2 test area showed that after only two weeks of operation the concrete wall surface was dry both visually and to touch as shown in Image 7c and d.

Image 7. Condition of wall at installation prior to energizing of the system is shown in a) and b). Note the wall was damp to sight and touch. The wall was dry to sight and touch over most of the test section after two weeks of system operation as shown in c) [1].

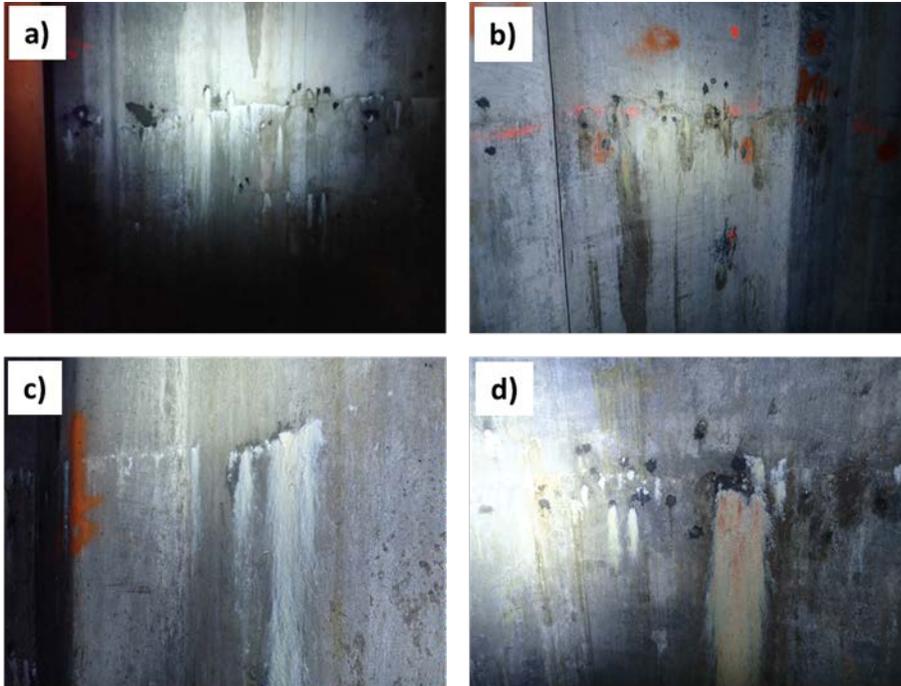
A visual inspection of the Phase 3 installation performed on September 13, 2017 by the Reclamation climb team indicated the continued presence of water seepage outside of the EOP installation (Image 8). These photos show locations where leaks were grouted and are still leaking, along with areas of cracks that were not grouted.

Image 8. Photos of areas above the EOP installation zones. Photos show locations where grouting was performed which are still leaking and areas of cracks which were not grouted [2].

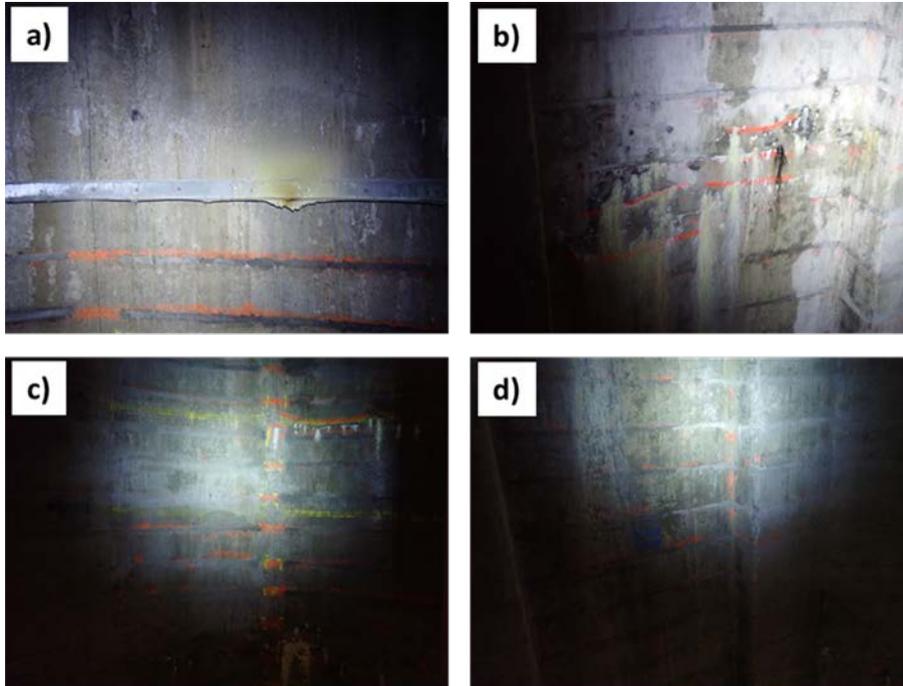
Photos from the EOP zone indicated that water was still leaking in the area above the EOP installation zone causing calcite to build up on the drip tray installed above the EOP zone (Image 9a). Not all cracks were successfully grouted in the EOP zone (Image 9b, c, and d).

Image 9. Photos from the EOP zone indicating water coming from above and from cracks in the EOP zone. The photo in a) shows the calcite building up on the drip tray which was installed. The photos in b), c), and d) shows calcite build up due to seepage from the cracks which were not successfully grouted [2].

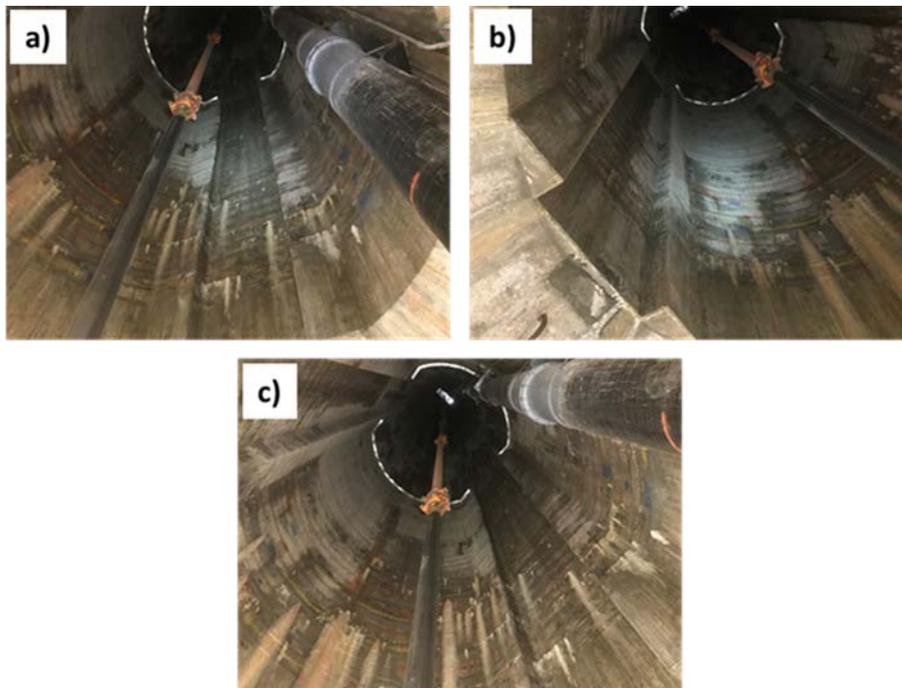
Photos of the EOP zone, shown in Image 10 and Image 11 show moisture on the surface of the walls and new calcite formed over 12 months of operation. Calcite is due to water leaking from some of the cracks, grout ports, and anode and cathode locations. Some of the calcite is also due to the continued leakage from the walls getting past the drip tray above the EOP system. These photos emphasize the importance of grouting all locations where water seepage is occurring and limiting the flow rate allowing EOP to operate more successfully. Work performed by USACE-ERDC-CERL to implement EOP did not address either the maximum head pressure limitations or the critical crack size. The critical crack size refers to the maximum size of crack opening and flow rate required for the technology to successfully mitigate water seepage without the need for grouting. Future EOP installations should prioritize data collection related to crack size i.e. size of the cracks not addressed during grouting repairs and quantifying leakage rate reduction.

Image 10. Photos were taken looking up from the bottom of the shaft. The photos in a), b), and c) all show new calcite formation over the first 12 months after the installation of the Phase 3 EOP system [2].

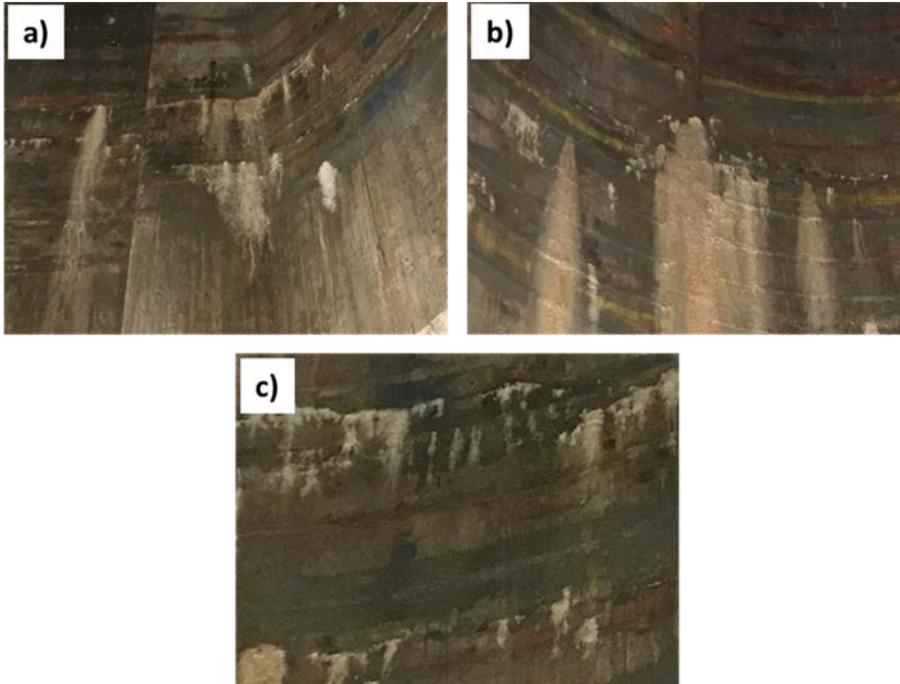
Image 11. Photos were taken of the shaft in various areas in the EOP installation zone. The photos in a), b), and c) all show new calcite formation over the first 12 months after the installation of the Phase 3 EOP system [2].

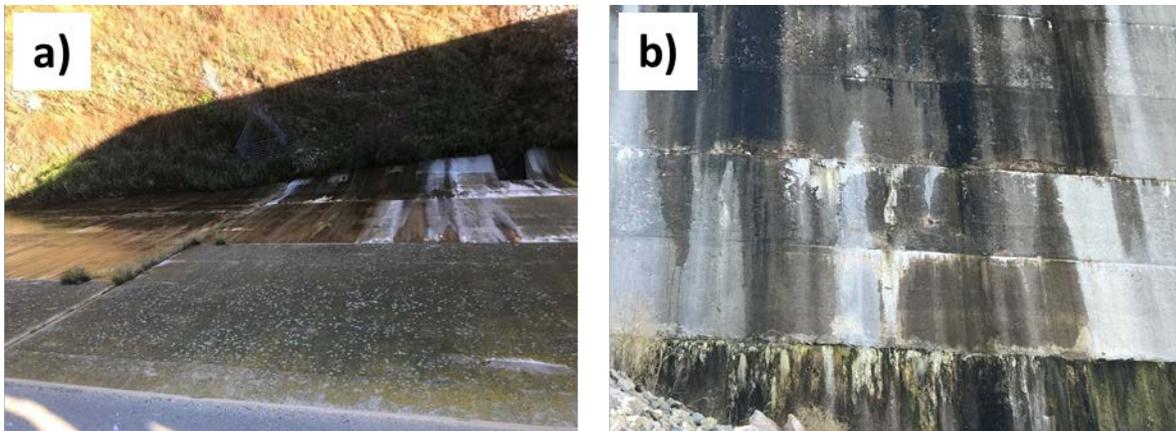
Image 12. Water leaking through the lift lines on the downstream face at Angostura Dam Picture a) shows calcite formation emanating from the joints. Picture b) shows additional damage to the concrete due to the probable freeze-thaw.

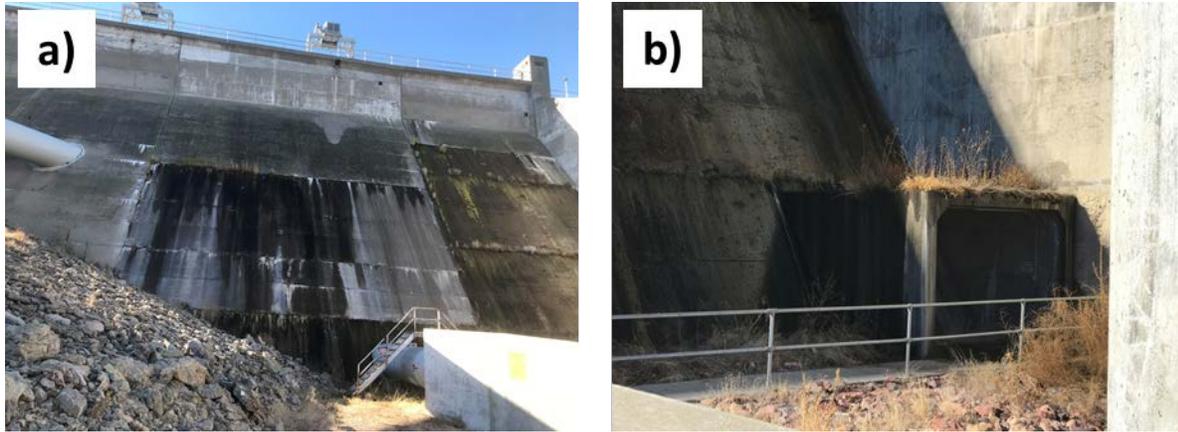
Image 13. Ice formation at Angostura Dam can lead to damage of the discharge pipe shown on the bottom of a) as well as damage to the entrance area shown in b). This also could lead to a risk of injury to dam personnel.

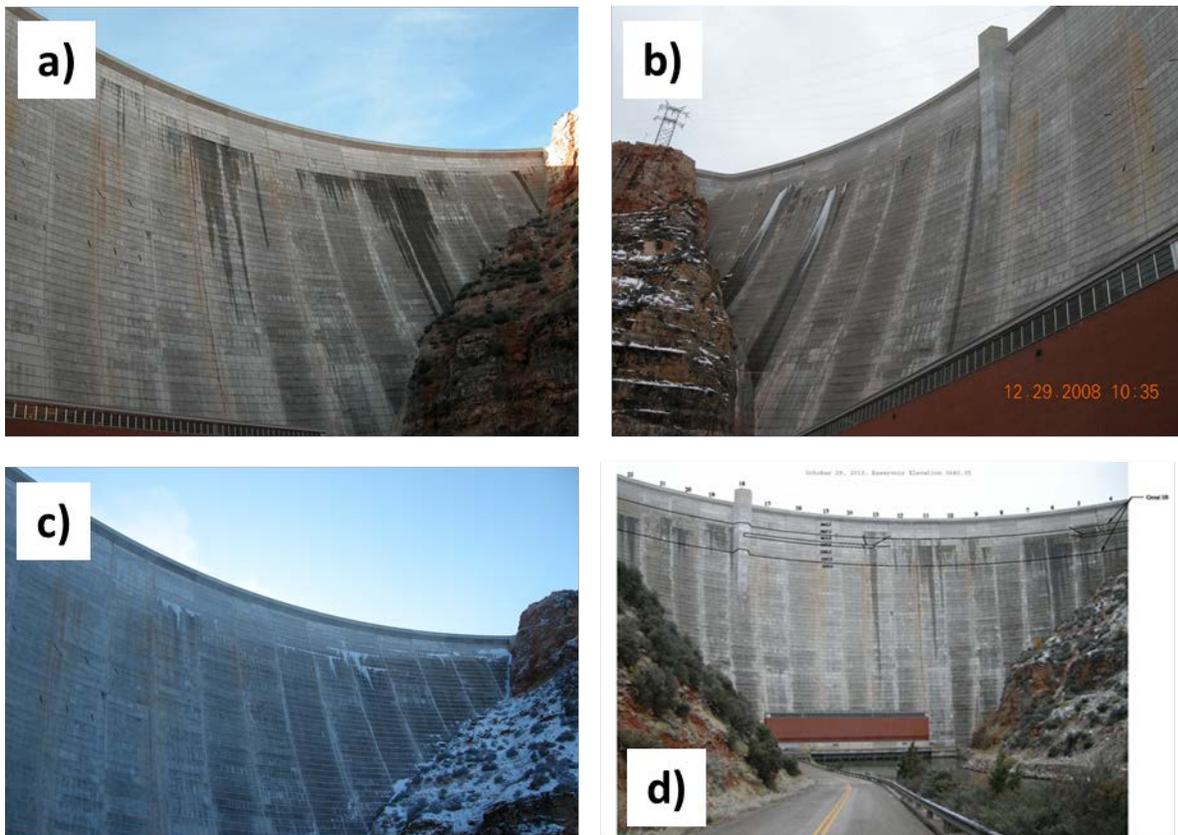
Image 14. Water leaking through the lift lines on the downstream face at Yellowtail Dam shown in a). The pictures in b) and c) show ice formation observed during the freezing winter months. An overall view of the leakage from the lift lines in shown in d).

The source of the water is primarily in the contraction joints between each block of concrete. The water leaks on the downstream face are due to water moving along these contraction joints and bypassing the internal formed drains which lead to the gallery. There are 5 drains between each contraction joint, roughly one every 11 feet. At some locations, the water is then entering the lift

It has been proposed to utilize EOP to direct water from lift lines into the internally formed drains designed to drain water from lift lines and other areas into the galleries where the water can be directed to sump pumps. This work would involve possibly some grouting of the concrete in some areas and inserting the anodes into the gallery wall. Typically, anodes are only embedded about an

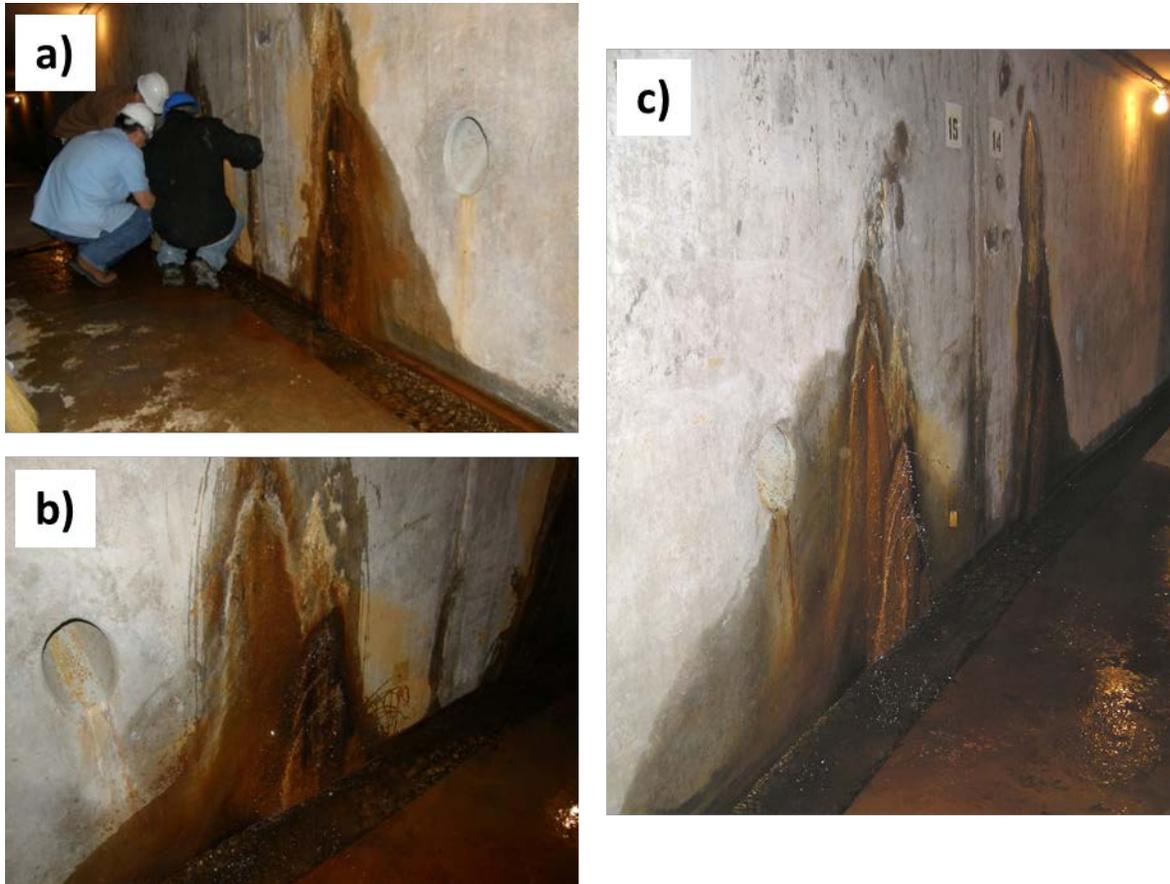
lines and emerges onto the downstream face. Some water leakage is occurring through other areas such as cracks and water is entering the gallery as shown in Image 15. As shown in Image 15, little to no water flow is exiting many of the internal drains while water is seen coming from these other locations like cracks.

Image 15. Water leakage into the gallery through cracks in the walls. Note that little to no water is exiting through the drain as was originally designed. As shown in c) that water pressure and flow rate can be significant.

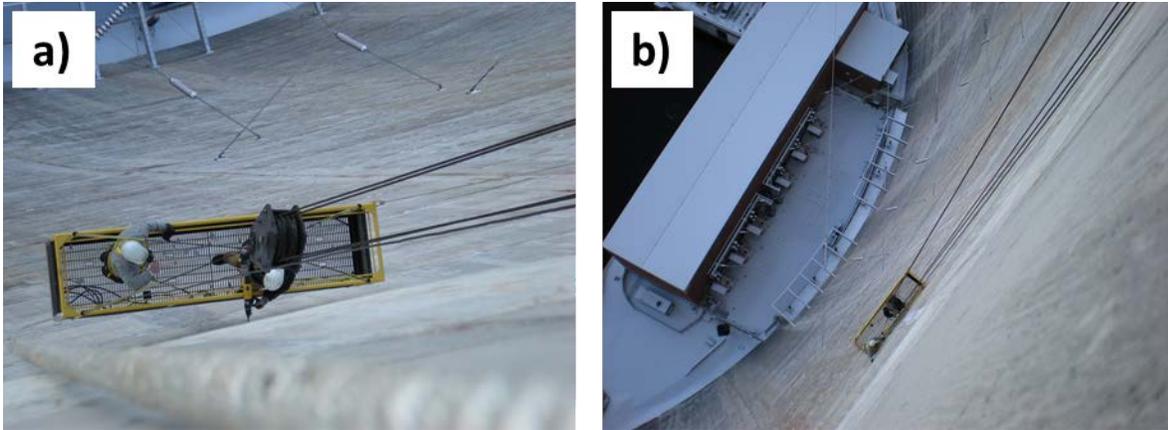
Yellowtail Dam has a powerplant at the base of the downstream face as observed in the photos in Image 16. The switchyard is located at the base and some of the areas where the lift lines are leaking are located above the powerline connections to the dam as can be observed on Image 16. Ice formation at the lift lines is common during the winter months and some of these formations require removal to prevent extensive damage. Leaks from lift lines on Blocks 11, 12, and 13 are all above the powerline connections and personnel must remove the ice manually by chipping (Image 17). In order to get to the ice, personnel must be lowered on a platform with a crane (Image 16). Therefore, there is the potential for ice to fall and damage critical power components. Leaks on Blocks 6-7 and 23-24 consistently have large amounts of ice build-up, and the leaks on 23-24 is one of the big contributors of ice fall on the parking area near the powerplant.

Image 16. Access required to remove the ice is performed using a man basket lowered from the top as shown in a) and b). These photos show the proximity of the ice formation in relation to both the powerline connections and switchyard.

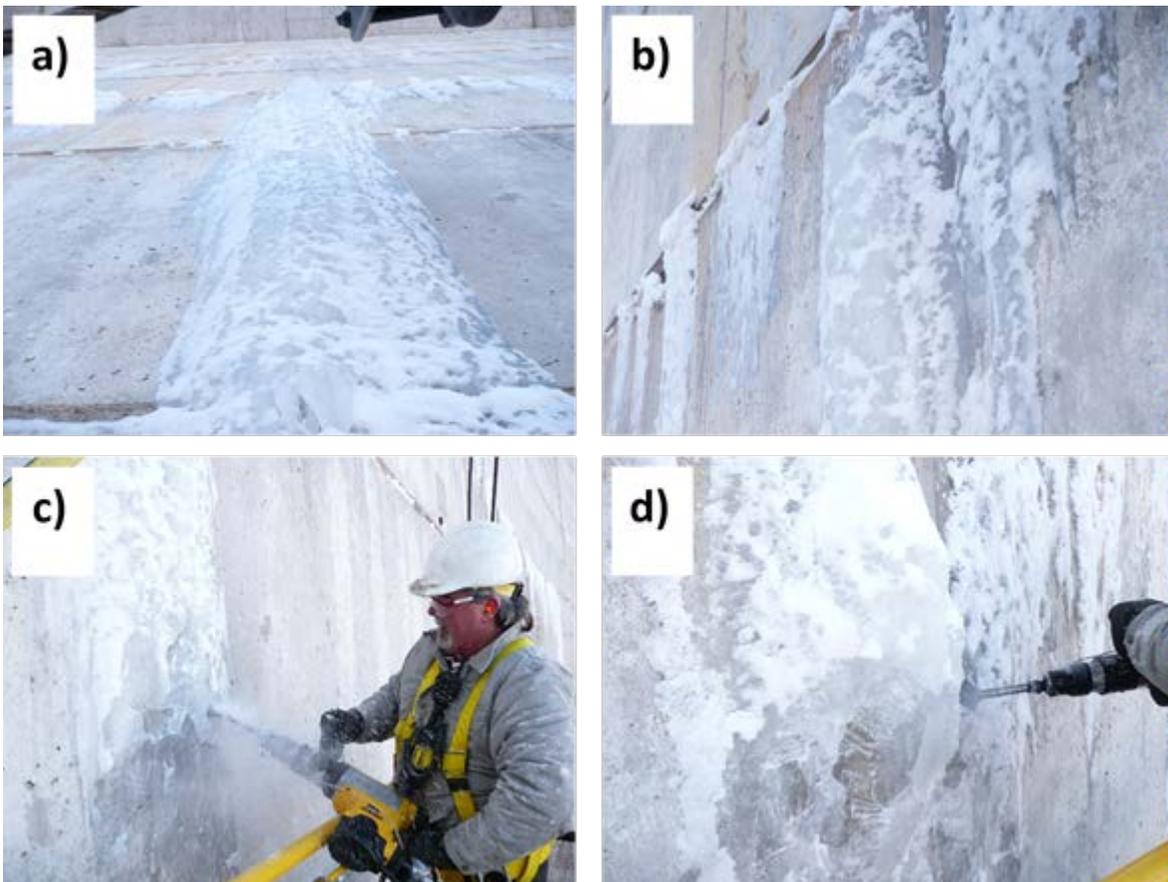
Image 17. Ice formation on the downstream face of the dam caused by water leakage at the lift lines as shown in a) and b). As shown in c) and d) the ice must be manually removed with a chipper.
