Technical Memorandum No. MERL-2012-11

## Coatings for Mussel Control — Three Years of Laboratory and Field Testing

U.S. Department of the Interior  
Bureau of Reclamation  
Technical Service Center  
Denver, Colorado

March 2012

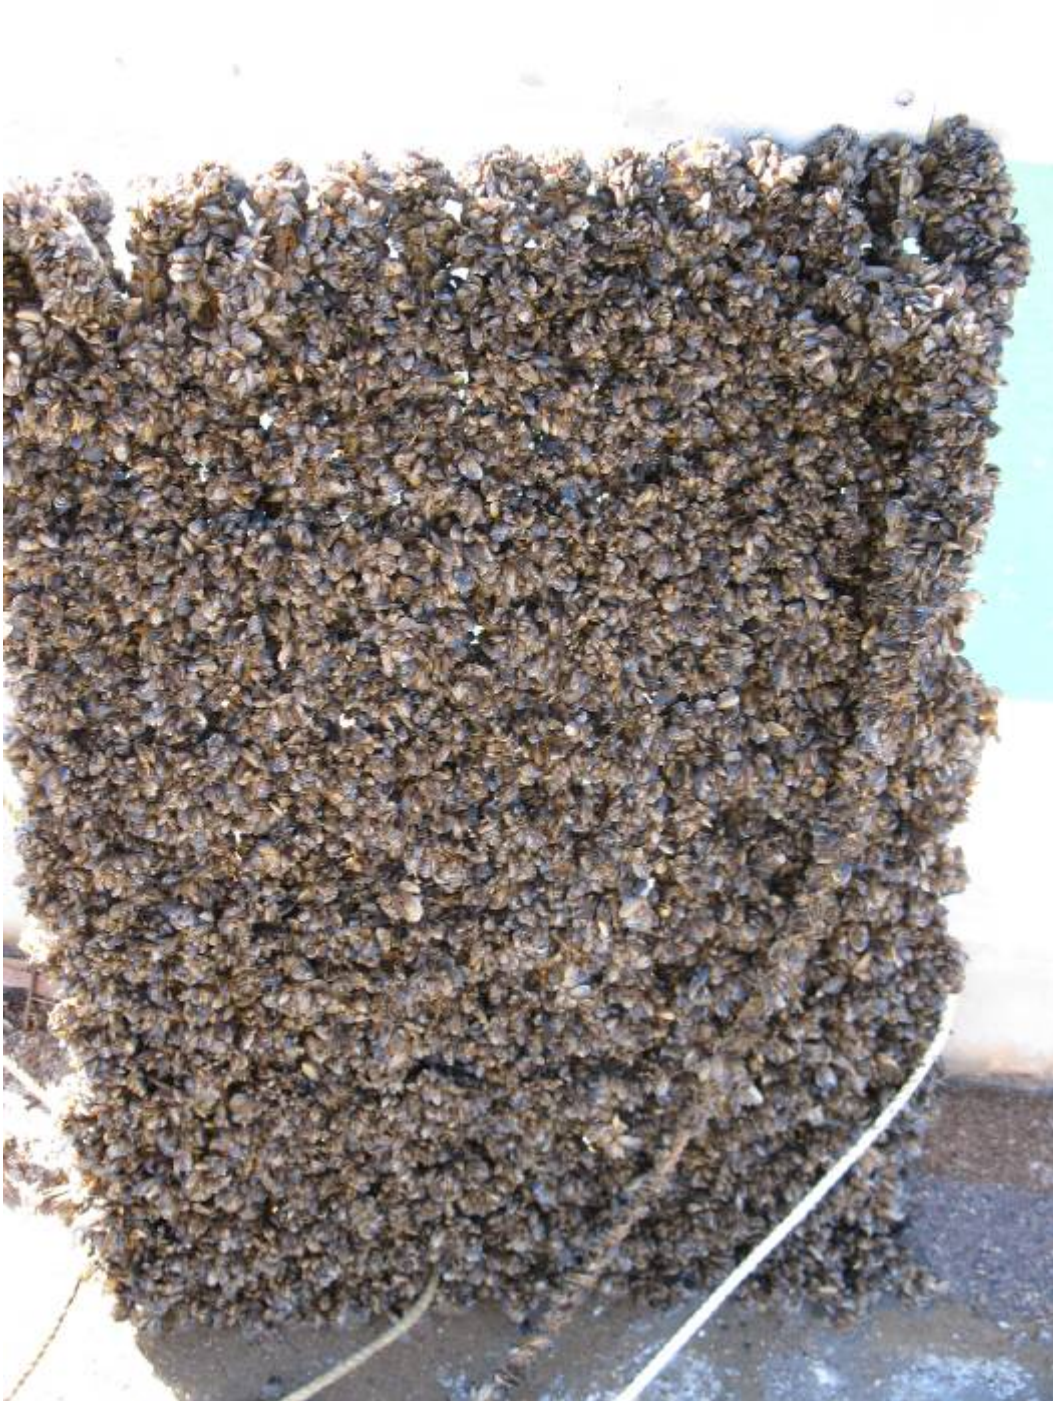
Figure 4.—Uncoated steel after 7 months of exposure in dynamic conditions. Test period May 2008 to December 2008.

ASTM A788 steel and 304 stainless steel were used to verify the presence of mussels and to determine a fouling rate to be compared to coatings.[5] Both steel and stainless steel foul quickly; within a year the mussel completely block the grate so no water was flowing through the 1-inch openings. Over 1.7 pounds of force was needed to remove a single mussel.

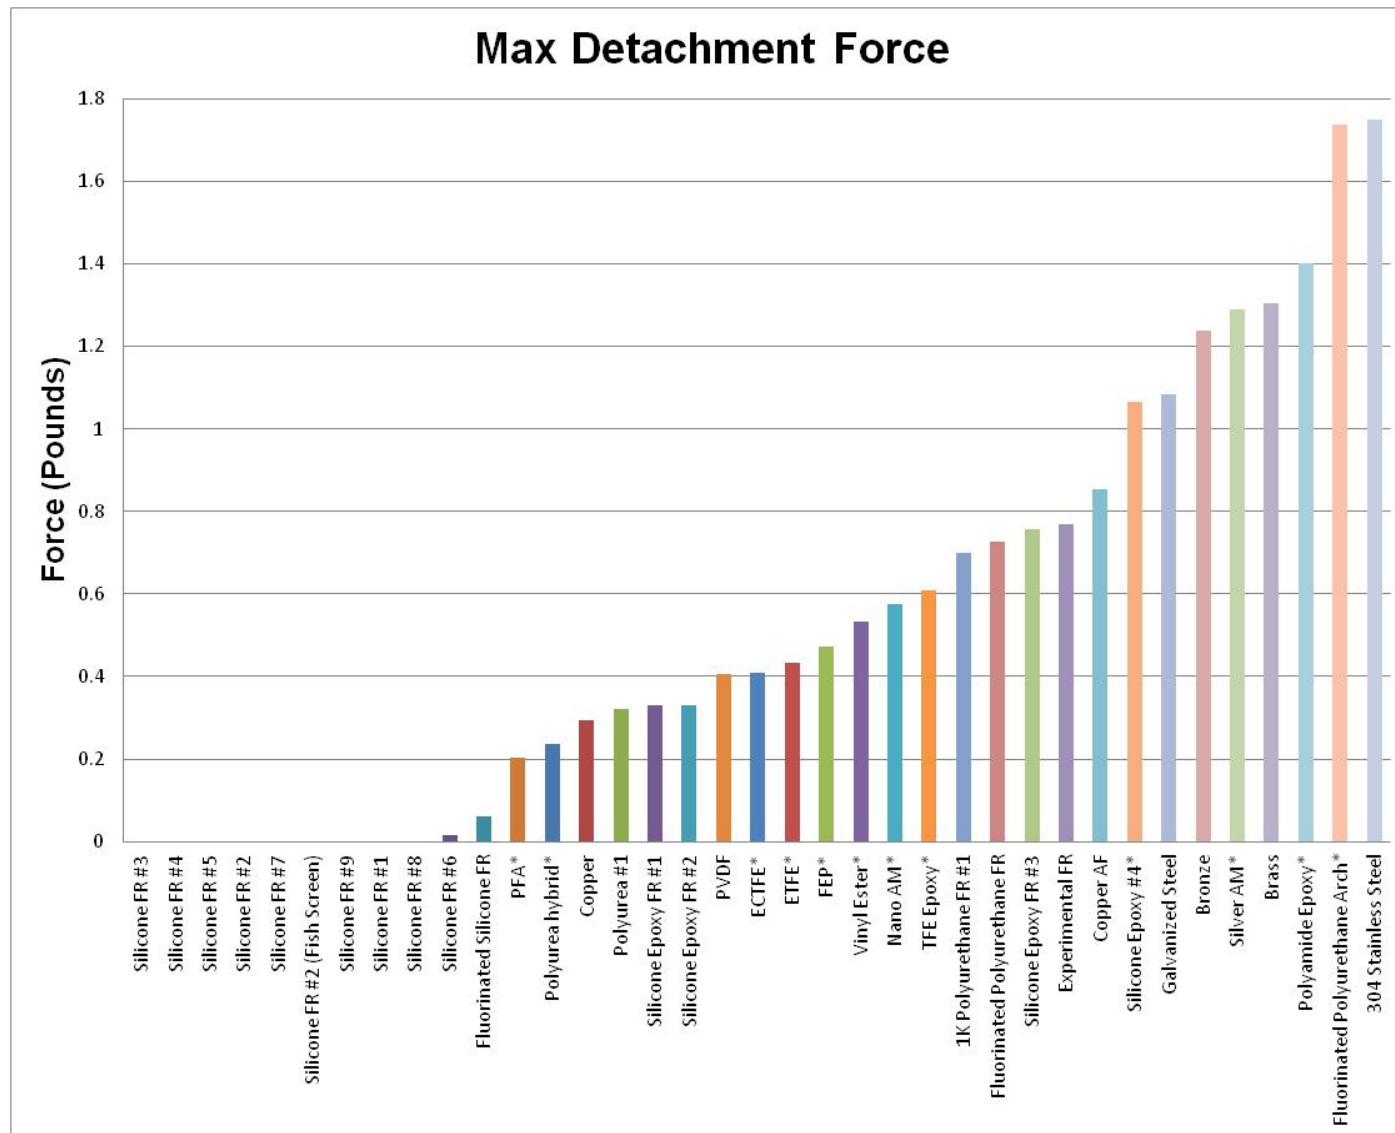
Figure 11.—Maximum attachment force on coated test plates suspended in static water. The symbol \* means that the coating is not marketed specifically for fouling control.

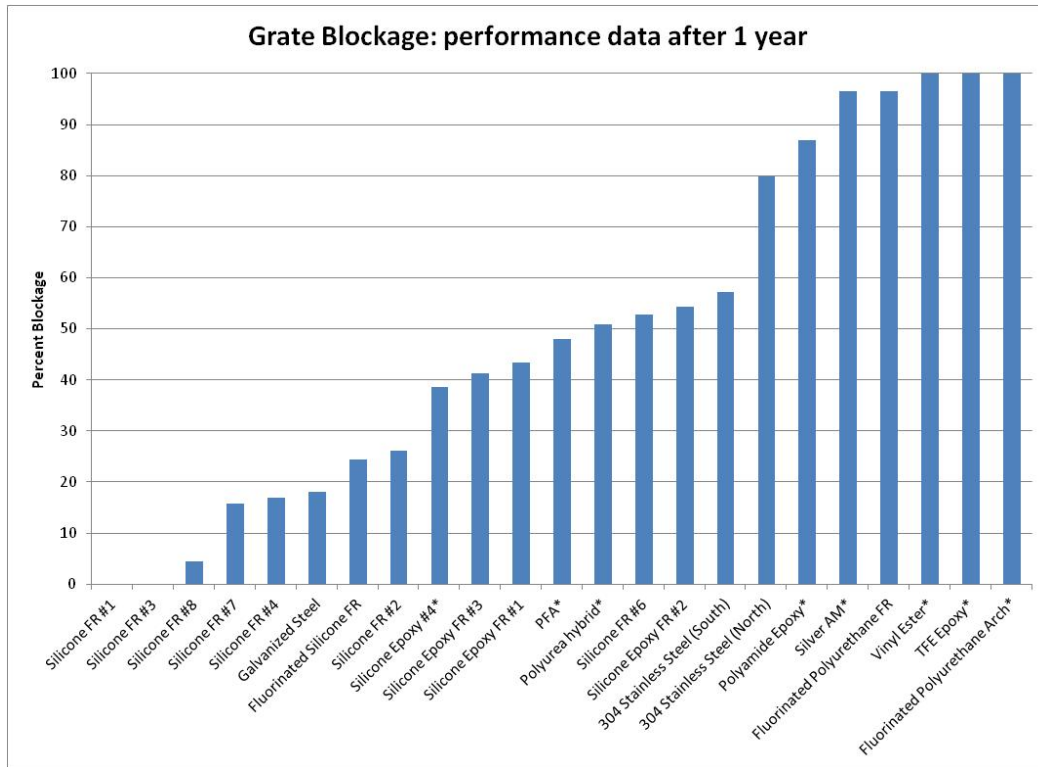
Figure 12.—Performance data for grates after 1 year of exposure.

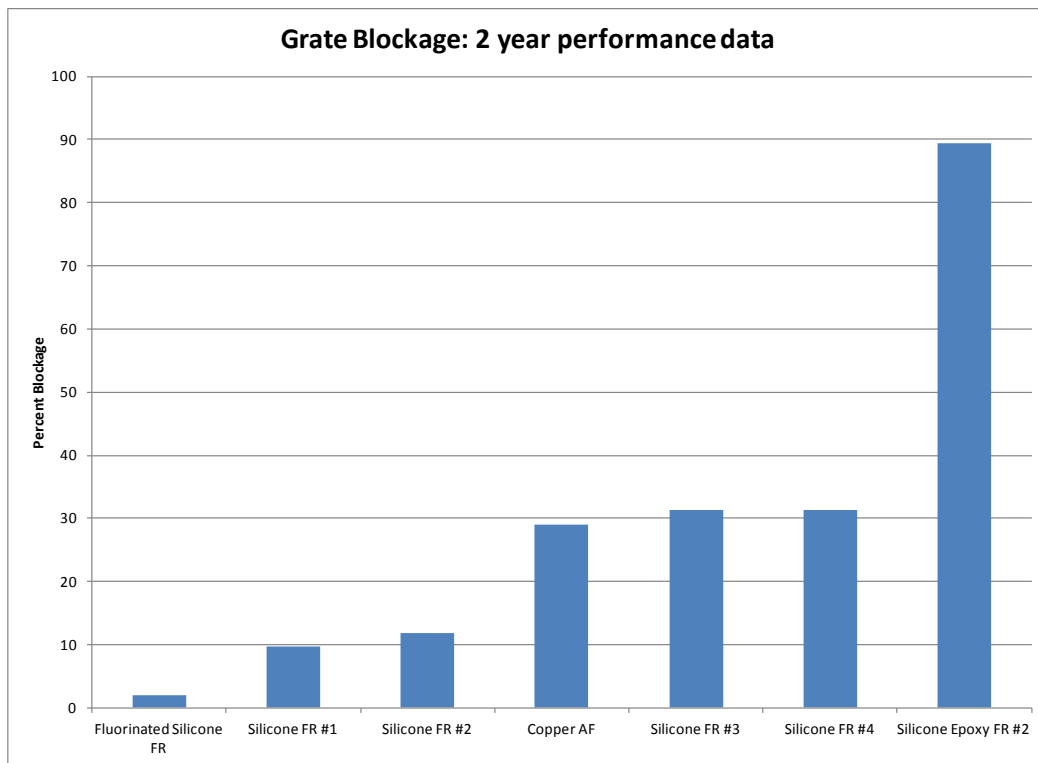
Figure 13.—Performance data for grates after 2 years of exposure.

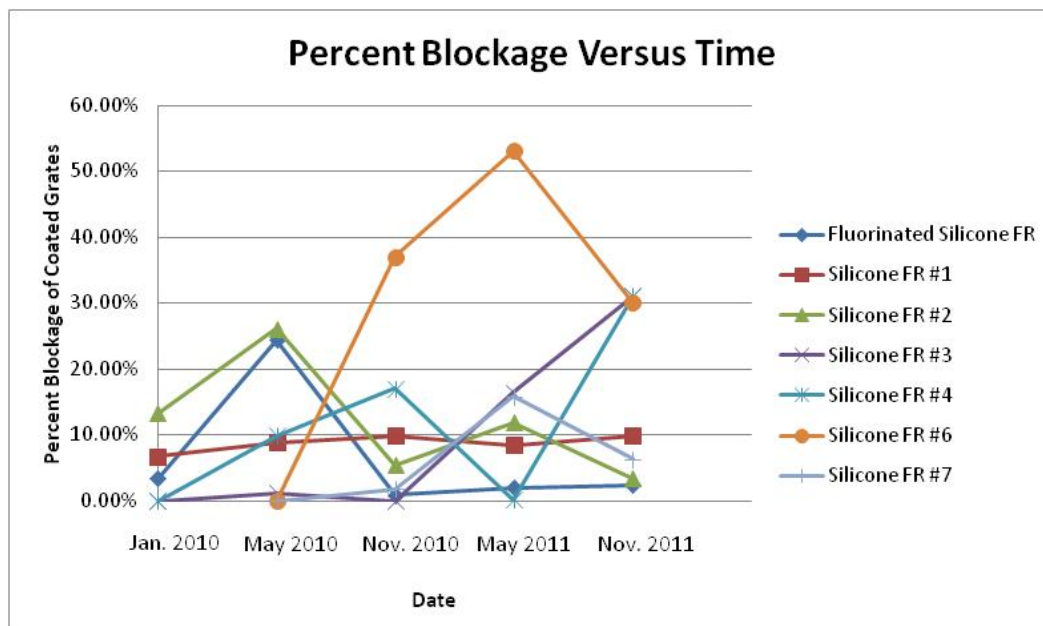
accumulation of algae, slime, and bryozoans. Quagga mussels do not attach to the silicone surfaces. For some foul release coatings, there was a decrease in percent blockage of the grate from season to season as seen in figure 14. The silicone and fluorinated silicone foul release coatings showed releases once fouling had built up enough for drag forces to exceed the bond strength and peel the fouling off the surface. Another possible explanation is that during the summer months flow rates and hence velocities are higher due to an increased power demand (peaking power) and water demand for irrigation which subjects the fouling to larger shear forces. During fall inspections, there was significantly less fouling on the silicone and fluorinated silicone foul release coatings than during the spring inspections. The velocity range during the summer months (or when all units are operating) was between 1.8 and 2.4 ft/s. The sloughing off has only been documented with the silicone and fluorinated silicone foul release systems.

Figure 14.—Percent blockage of the silicone foul release coatings seasonal variation.

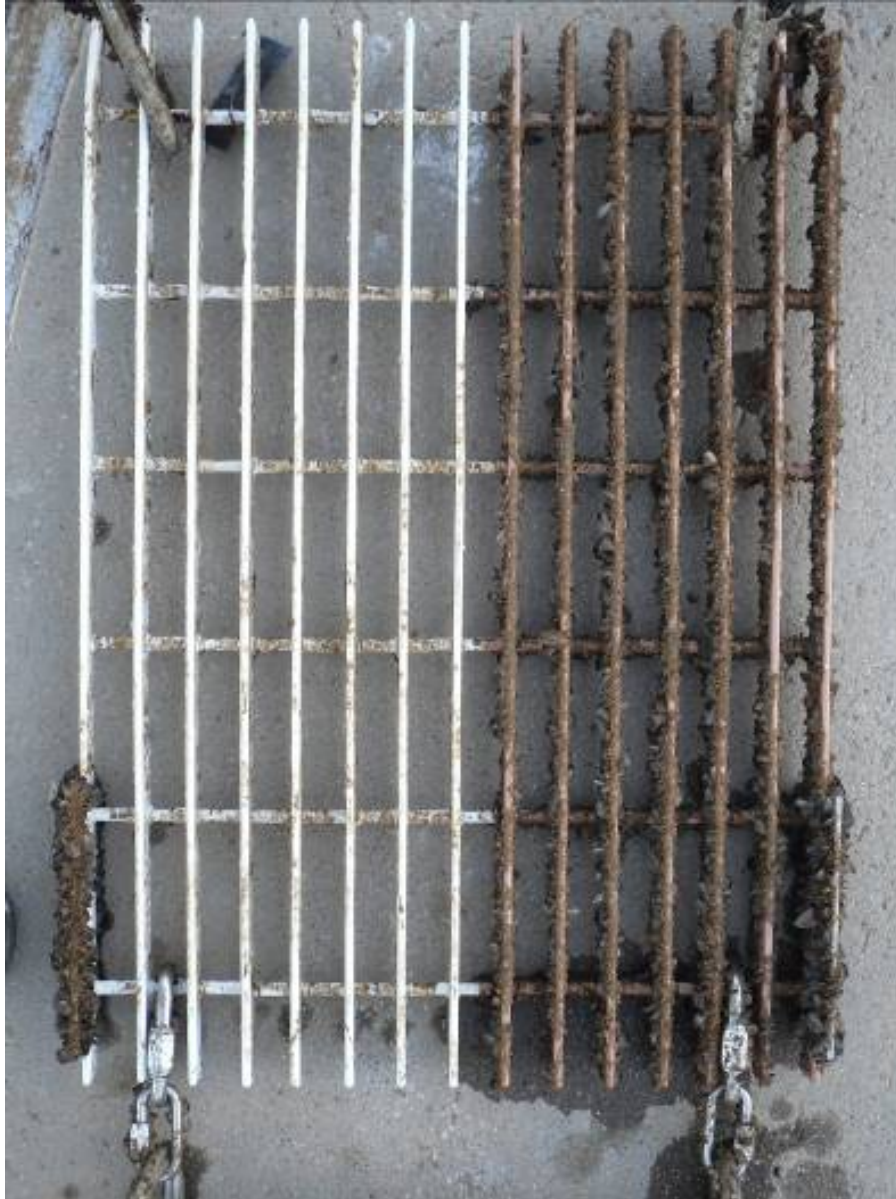
The silicone FR #6 is actually a tie coat of one of the silicone foul release coatings and does not release the fouling as easily as the silicones. Figure 11 shows that the mussels barely attach to the surface of the tie coat (silicone FR#6 requiring only 0.02 pound of force to remove a mussel). This was the lowest measureable force for any of the coatings tested that actually allowed the mussels to attach to the surface. This coating system was selected to demonstrate the self-cleaning process. Silicone FR #6 fouled up to approximately 25 percent from May 2010 to November 2010 as shown in figures 15 and 16. Between November 2010 and May 2011, Silicone FR #6 fouled up to 50 percent as shown in figure 17. Sometime between May 2011 and November 2011, the mussels sloughed off and the November inspection showed the grate to only be 17 percent blocked as shown in figure 18. There appears to be a critical flow rate or drag force when the fouling sloughs off. It is well known that the critical flow rate for mussels to attach to any surfaces is 4.9 ft/sec [5]. Therefore, it can be assumed that there are different critical flow rates for fouling to be released from the various types of foul release coatings. We believe that the force to remove mussels is dependent

Figure 16.—Silicone FR #6 on the right and Silicone FR #7 on the left after 6 months in dynamic exposure (November 2010).

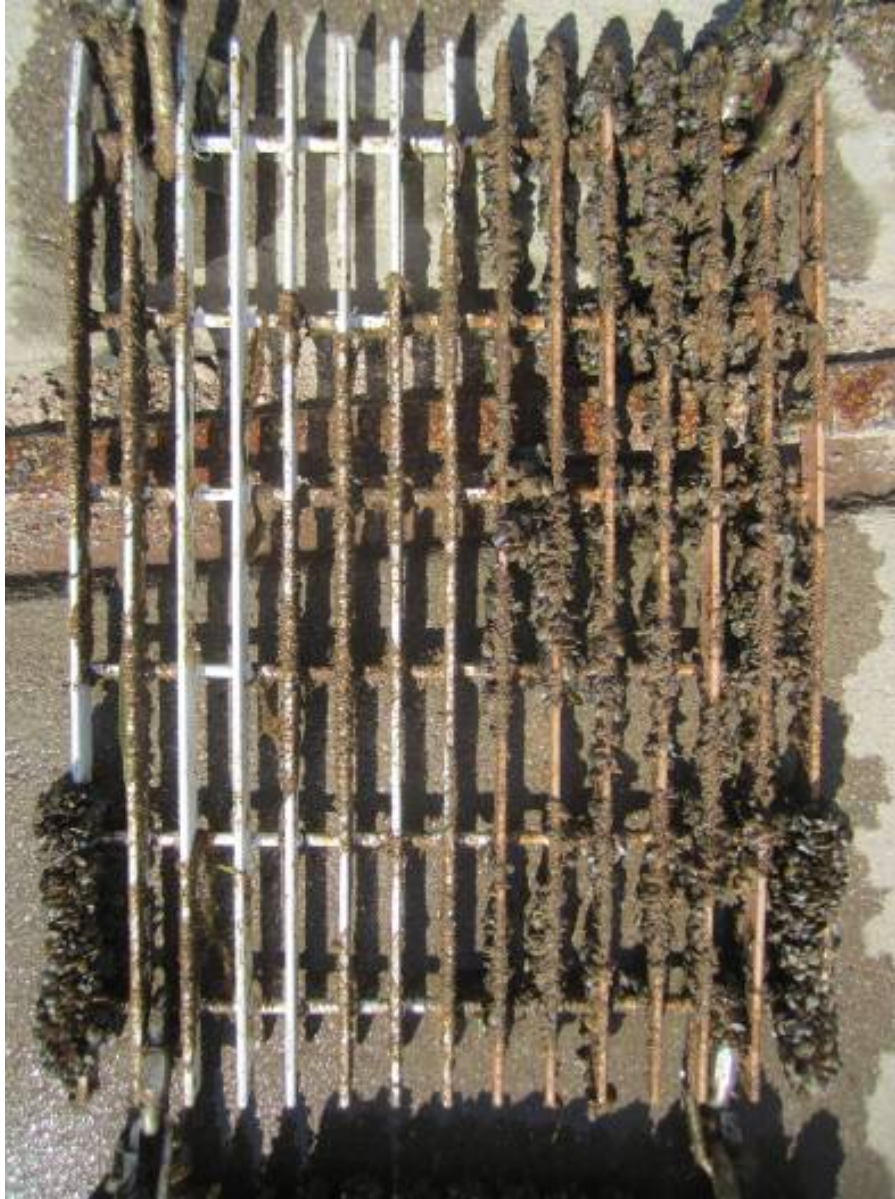
Figure 17.—Silicone FR #6 on the right and Silicone FR #7 on the left after 1 year in dynamic exposure (May 2011).

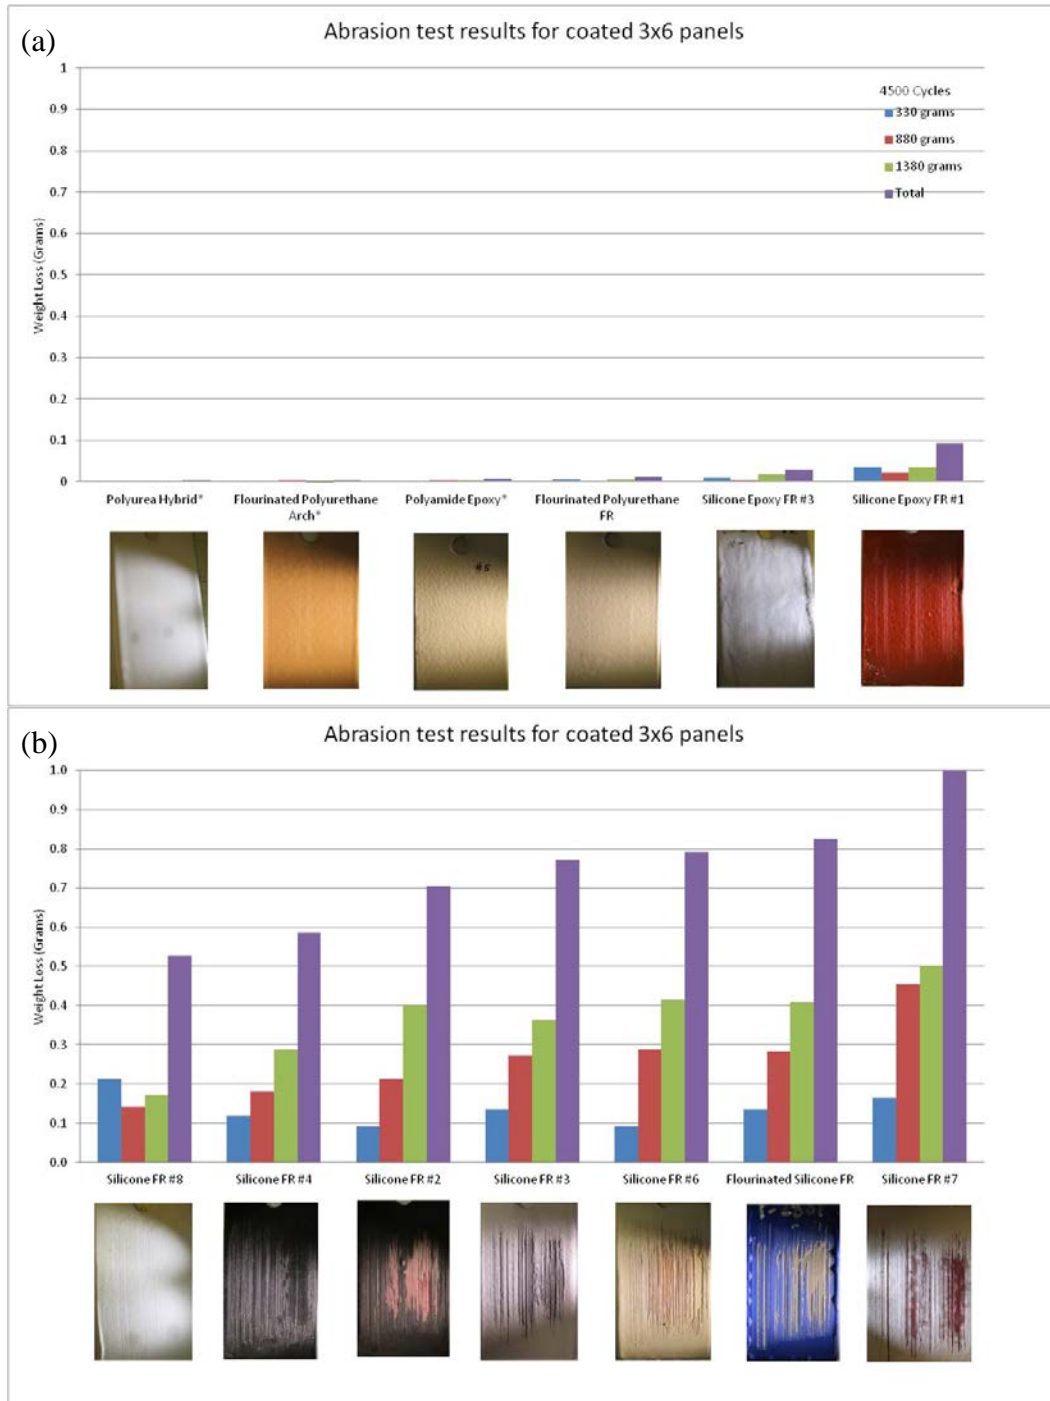
The abrasion test produced visible scratching on nearly all of the samples. A commonly used polyamide epoxy was selected as a control to provide a baseline for comparison. On the polyamide epoxy as well as other durable samples (fluorinated polyurethane architectural coating\*, and polyurea hybrid\*), the scratches appeared to be fairly superficial on each of the test tracks. There was no significant difference in damage as additional weight was added to the brush. The weight losses were negligible for each of these samples (i.e., less than 10 milligrams).

The hard durable foul-release coatings resisted abrasion damage effectively and showed only slightly more physical damage and weight loss compared to the control samples. The durable foul release coatings tested included silicone epoxy FR #1 and #3 and the fluorinated polyurethane FR systems. There was a clear distinction between these coatings and softer silicone foul release coatings. The silicone foul release all experienced damage to a much higher degree with weight losses that ranged from 17 to 37 times greater than the best performing silicone epoxy.

Figure 22.—Abrasion test results for (a) control samples and durable foul release coatings and (b) silicone foul release coatings.

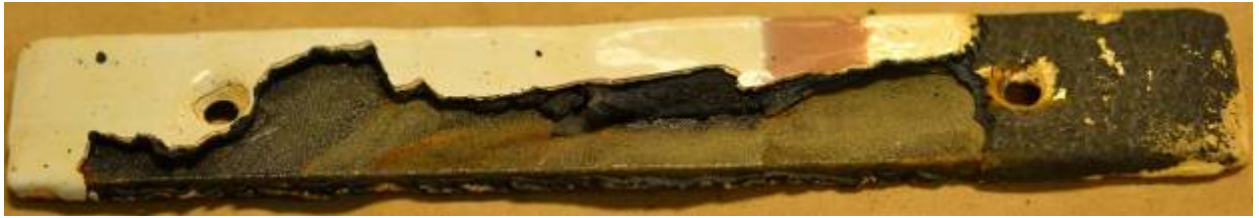
All four coating systems used to overcoat coal tar experienced failures in the high flow test. Typically, the coal tar experienced a disbondment from the metallic substrate on the overcoated portion as shown in figure 23. Neither static immersion in a dilute Harrison solution or in deionized water produced catastrophic failure, but cracking was observed in several samples along the interface between coal tar enamel and the primers. It is believed that internal stresses, perhaps due to expansion/contraction of the primer and subsequent layers, caused the low strength coal tar enamel to fail. It is unlikely this problem is unique to foul release coating systems, but the extra coats that were required may aggravate the effect.

Figure 23.—Failure of overcoated coal tar during a high flow test.

Several foul release coatings outperformed the epoxy controls in erosion testing, but abrasion resistance was much lower. Failure of one of these tests does not automatically eliminate a coating system from consideration, but it is important to recognize each product's limitations when developing performance specifications. Successful deployment of a silicone-based foul release coating will depend strongly on the service environment. Environments where silicone-based foul release coatings have contact with equipment or floating debris is likely should be avoided. Silicone epoxy coatings appear to be more resistant to this type of abrasion damage. None of the coating systems are recommended for application over coal tar enamel.

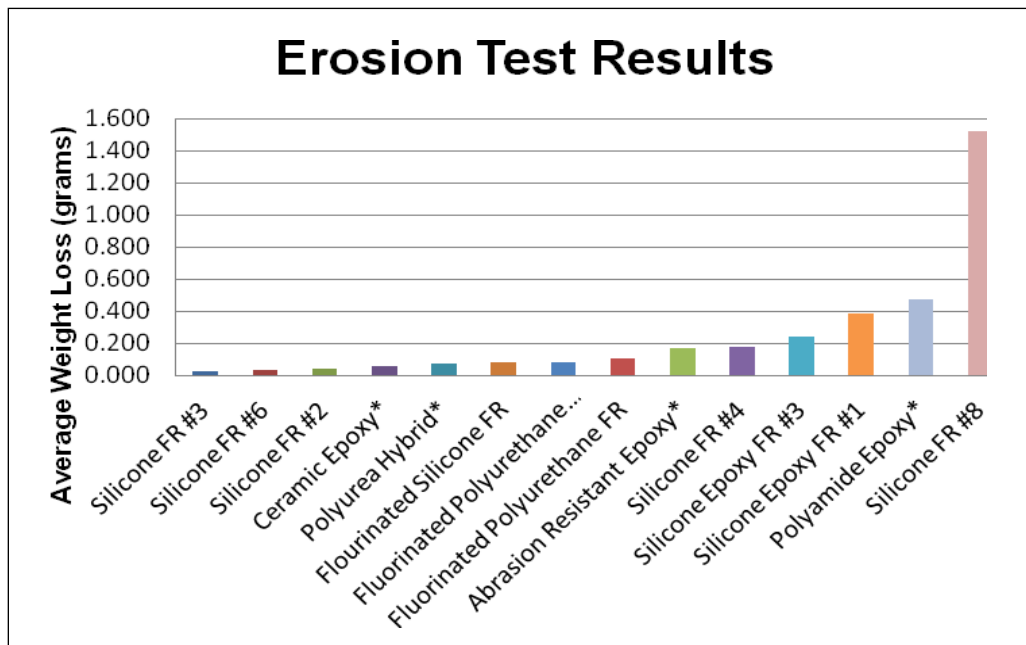
The most notable physical change observed on the samples was a loss of gloss. It was difficult to gage the damage using visual inspection, so the samples were weighed to quantify the damage. Figure 24 shows the silicone foul release coatings exhibited excellent erosion resistance, comparable to an abrasion resistant epoxy. It outperformed the polyamide epoxy by more than 10 times less weight loss. One notable exception was Silicone FR #8, which experienced damage far greater than any other coating system. Silicone FR #8 was also unique in that the cured coated panel had a very oily feel in comparison to the other samples. Some silicone foul release coatings also outperformed a ceramic epoxy specifically designed to withstand erosion. However, the densities of the materials were significantly different, and the coating thickness loss was more important than the weight loss. Unfortunately, some of the coating densities were unknown, so the data could not be compared using the calculated thickness loss.

Figure 24.—Erosion test results for foul release coatings and controls. “\*” denotes non-foul release systems.
