## **RCEM – Reclamation Consequence Estimating Methodology**

### **Dam Failure and Flood Event Case History Compilation**

**U.S. Department of the Interior  
Bureau of Reclamation**

**June 2015**

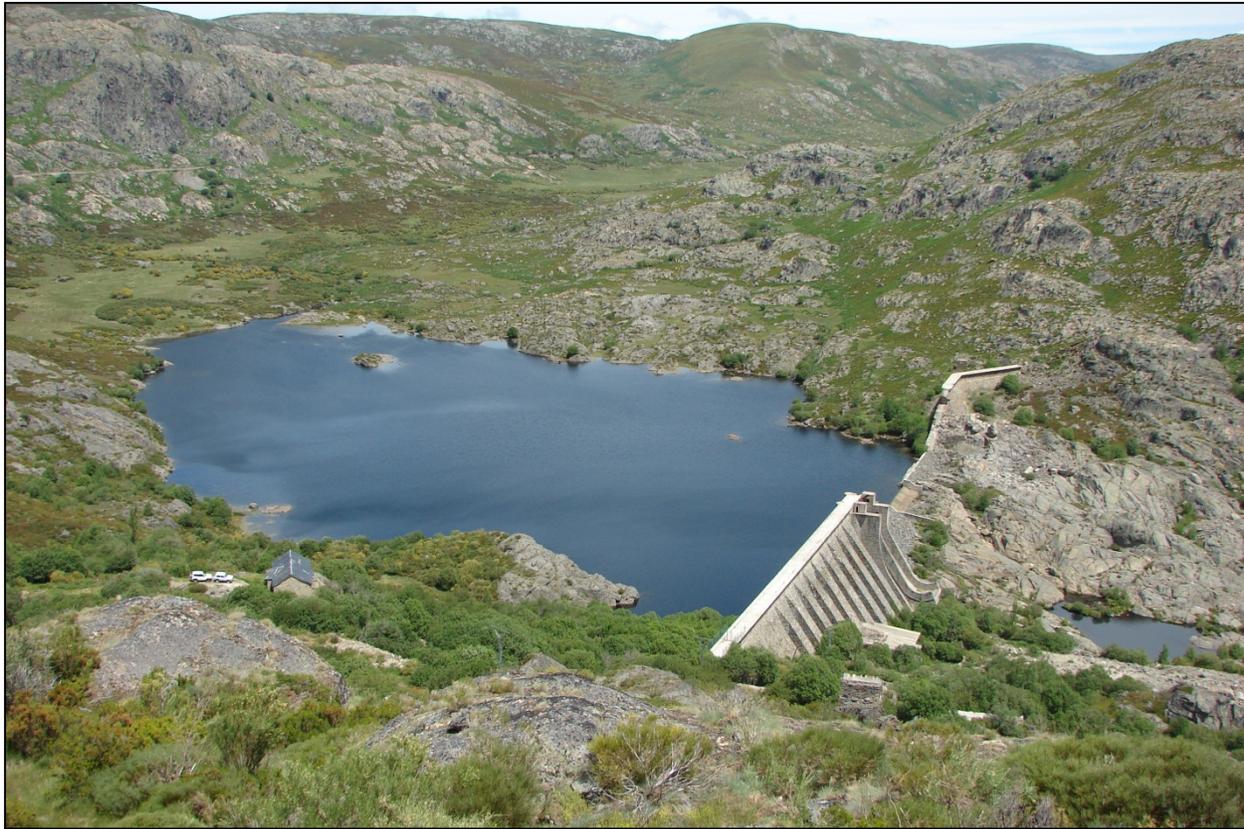
**Figure 1. Remains of Vega de Tera Dam**

Vega de Tera Dam was a concrete slab and buttress structure located in the northwestern zone of the Iberian Peninsula, in the Zamora district of Spain. The 112 foot high dam was constructed from 1954 to 1958. The dam failed suddenly and without warning near midnight, releasing the full storage of the reservoir. The village of Ribadelago, located five miles downstream, was almost completely destroyed. There were 144 deaths at Ribadelago and the fatality rate was about 30 percent. The builders of the dam followed the practice of suspending work during winter. As a result of inadequate preparation of joints on resumption of placement, poor bond was established between old and new masonry. The subsequent heavy leakage through the masonry marked the zones of weakness in the dam. Failure was said to have started in a buttress standing on a sloping foundation near the left abutment at a joint between the masonry and the concrete. This triggered the collapse of 17 buttresses in succession. A 330-foot long section of the structure, including a ski-jump spillway, broke apart and was washed away. The breach width covered about one-half the length of the dam's crest. The powerplant at the site was also demolished.

DV and rate of rise is not precisely estimated, but DSO-99-06 considered this dam failure flood event to be high severity. Reasons for this are probably due to the sudden failure of the relatively tall concrete dam and the resulting devastation in Ribadelago. Travel times are not known, but maximum depth is cited as having been about 20 feet at a location 3.1 miles downstream from the dam.

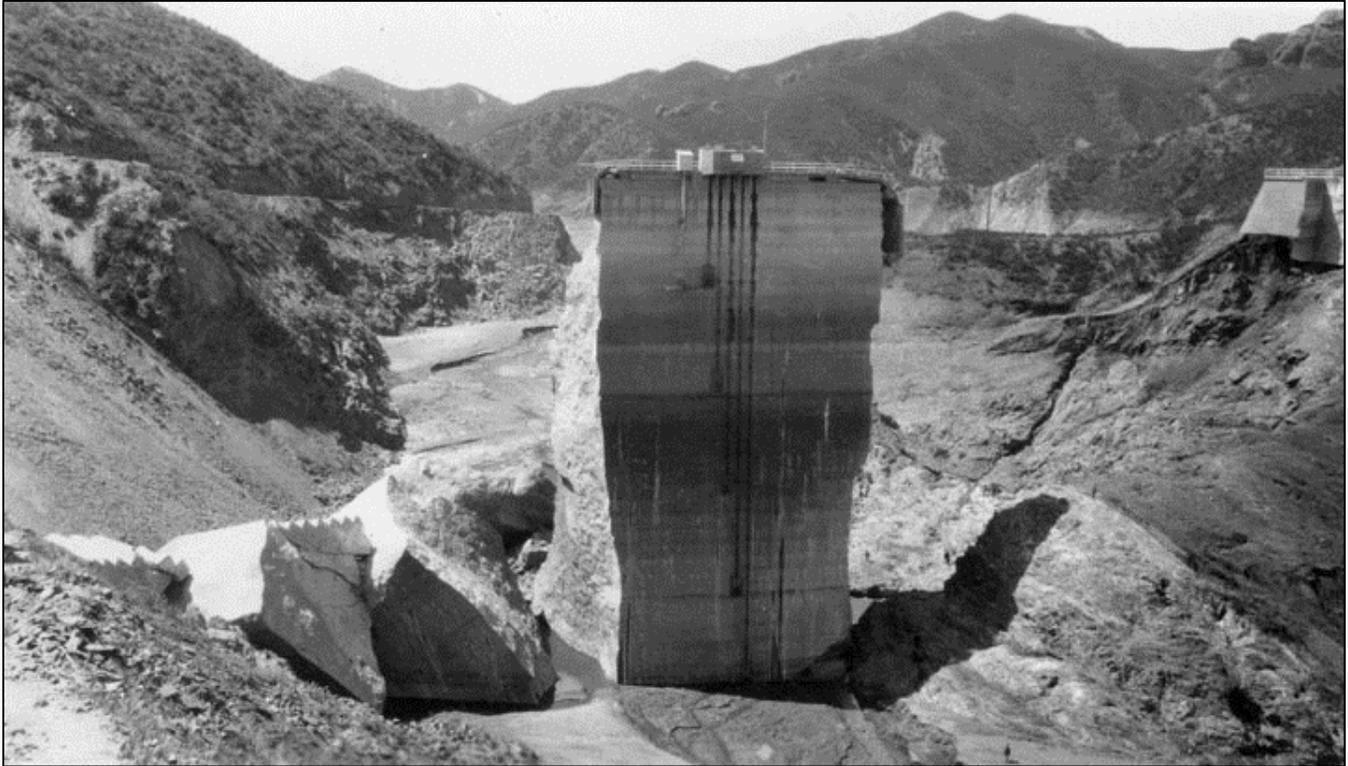
**Figure 3. The breached St. Francis Dam, looking downstream**

St. Francis failed at about midnight, March 12-13, 1928. The flood traveled 54 miles from the dam to the Pacific Ocean in a five and one-half hour period during the early morning hours of Tuesday, March 13. The dam had been completed in 1926, and was 2 years old when it failed. Failure of this dam was caused by sliding along a weak foliation planes within the schist comprising the left abutment, suspected of being part of an old landslide.

St. Francis Dam had a height of 188 feet, and the reservoir volume at the time of failure was about 38,000 acre-feet. The reservoir was about 3 feet below the crest of the parapet at the initiation of dam failure.

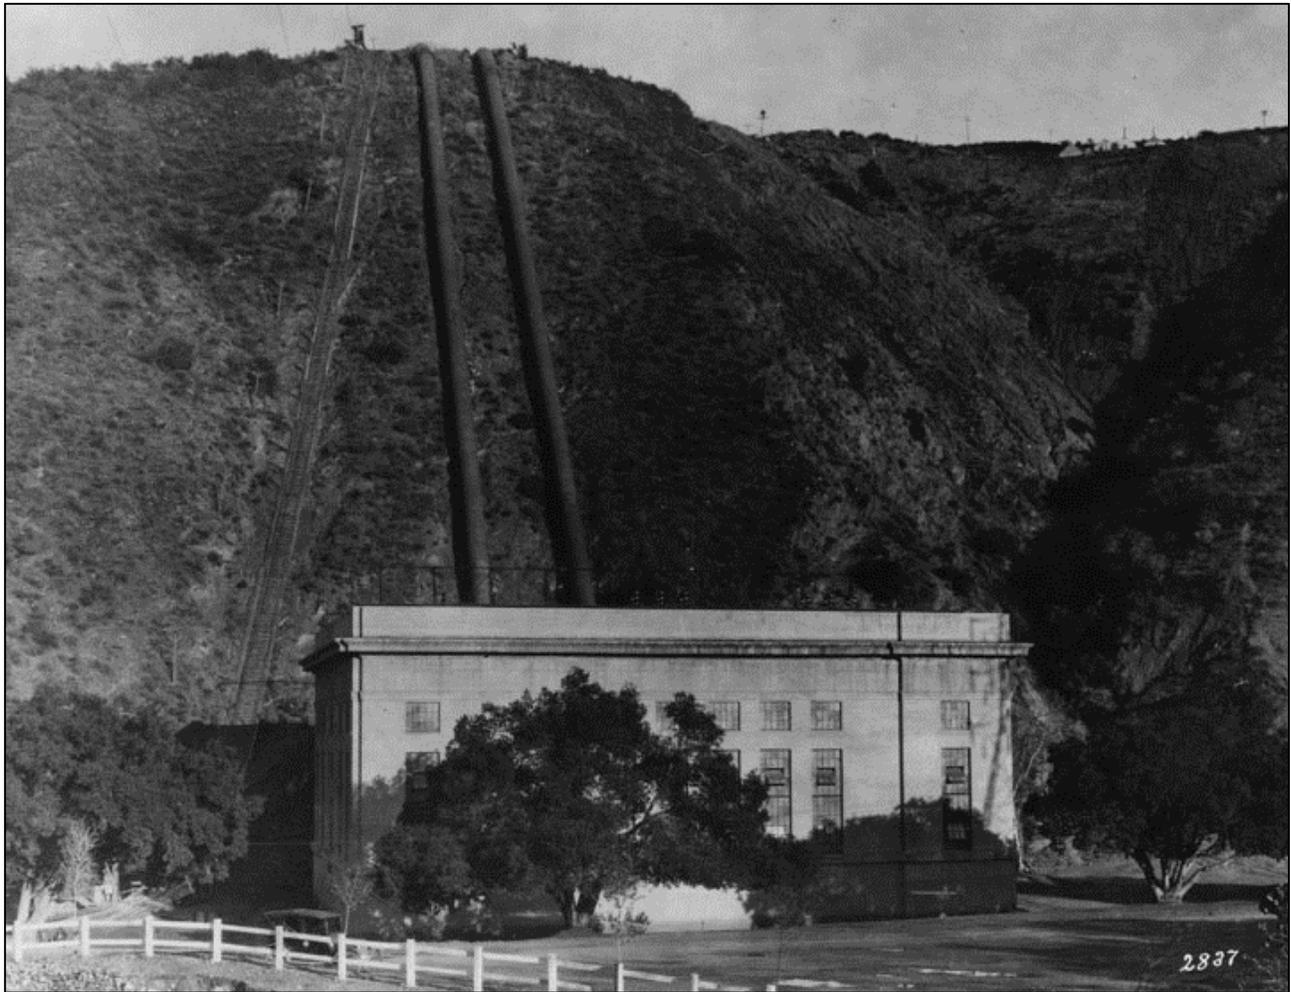
**Figure 4. Powerhouse No. 2 before its collapse**

Two downstream areas are of particular interest. Powerhouse No. 2 was located in the San Francisquito Canyon, about 1.4 miles downstream from the dam. The flood arrived at this location as a wall of water, about five minutes after the dam had failed. This was the classic example of high

severity flooding with an estimated maximum flood depth of 120 feet and peak discharge of 1.3 million ft<sup>3</sup>/s. The 60-foot tall concrete powerhouse was “crushed like an eggshell” and the area swept clean. Warning time was zero. Twenty eight workers and their families had lived at the site. There were three survivors.

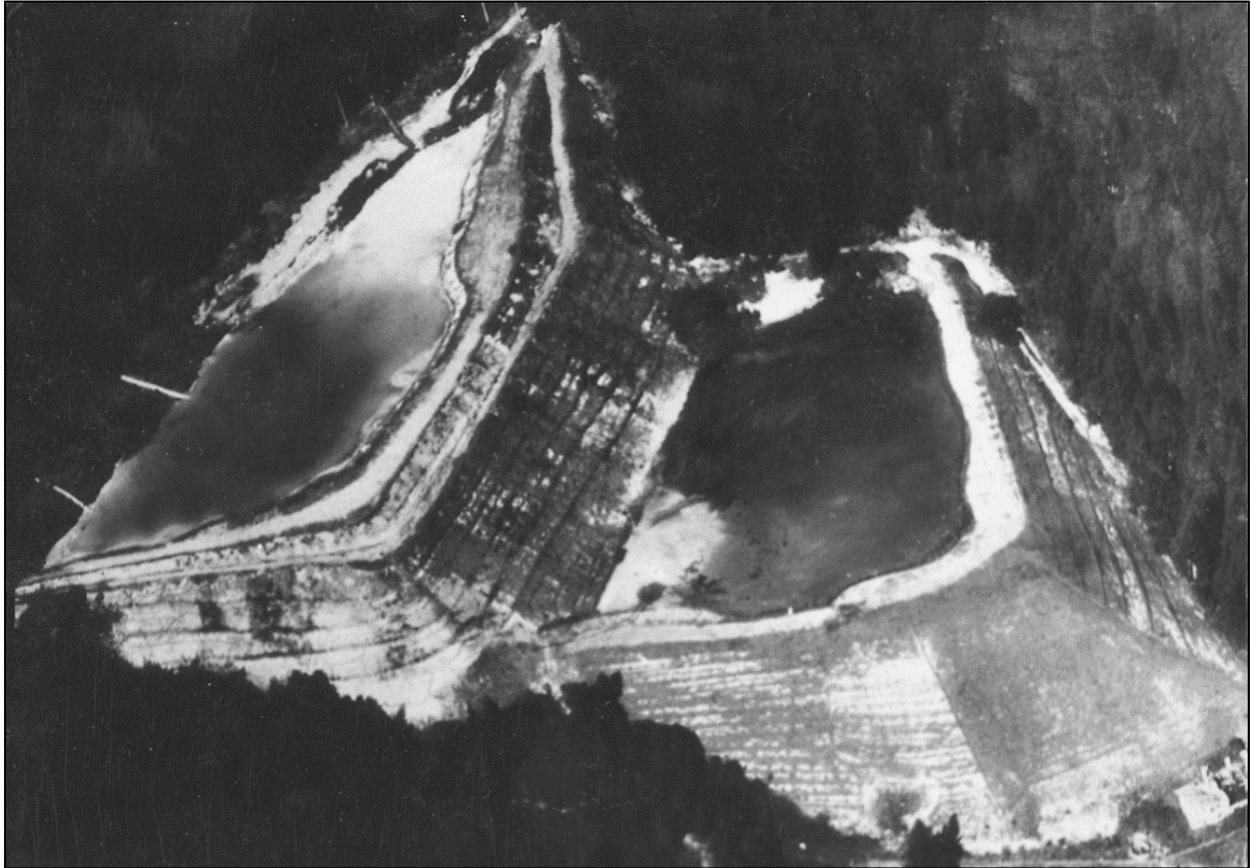
**Figure 9. Upper and Lower Stava Tailings Dams**

On July 19, 1985, a fluorite tailings dam failed at Stava, Trento, Italy. The tailings dam consisted of two basins built on a slope. The failure started at just after noon at about 12:20 pm with a collapse of the up-slope basin. The inflow of the released material caused the overtopping and subsequent collapse of the lower basin. The resulting slurry wave traveled to Stava at an estimated speed of 26 ft./s; later it is reported to have reached almost 80 ft./s.

The flood wave killed people, destroyed trees, buildings and everything in its path, until it reached the river Avisio. Few of those hit by this wave of destruction survived. Along its path, the mud killed 268 people and completely destroyed 3 hotels, 53 homes, and six industrial buildings; 8 bridges were demolished and 9 buildings were seriously damaged. The mudflow reached the village of Stava after 50 seconds, and then continued for three minutes until it reached the Avisio River 2.5 miles away.

The failure of Stava Tailings Dam is considered to have been high severity flooding due to the rapid failure of the embankments which resulted in very fast flood flow velocities and the complete destruction of the downstream community. Maximum flooding depths appear to be unavailable, but the river valley at the community of Stava was “swept clean” and this is another classic example of high severity flooding.

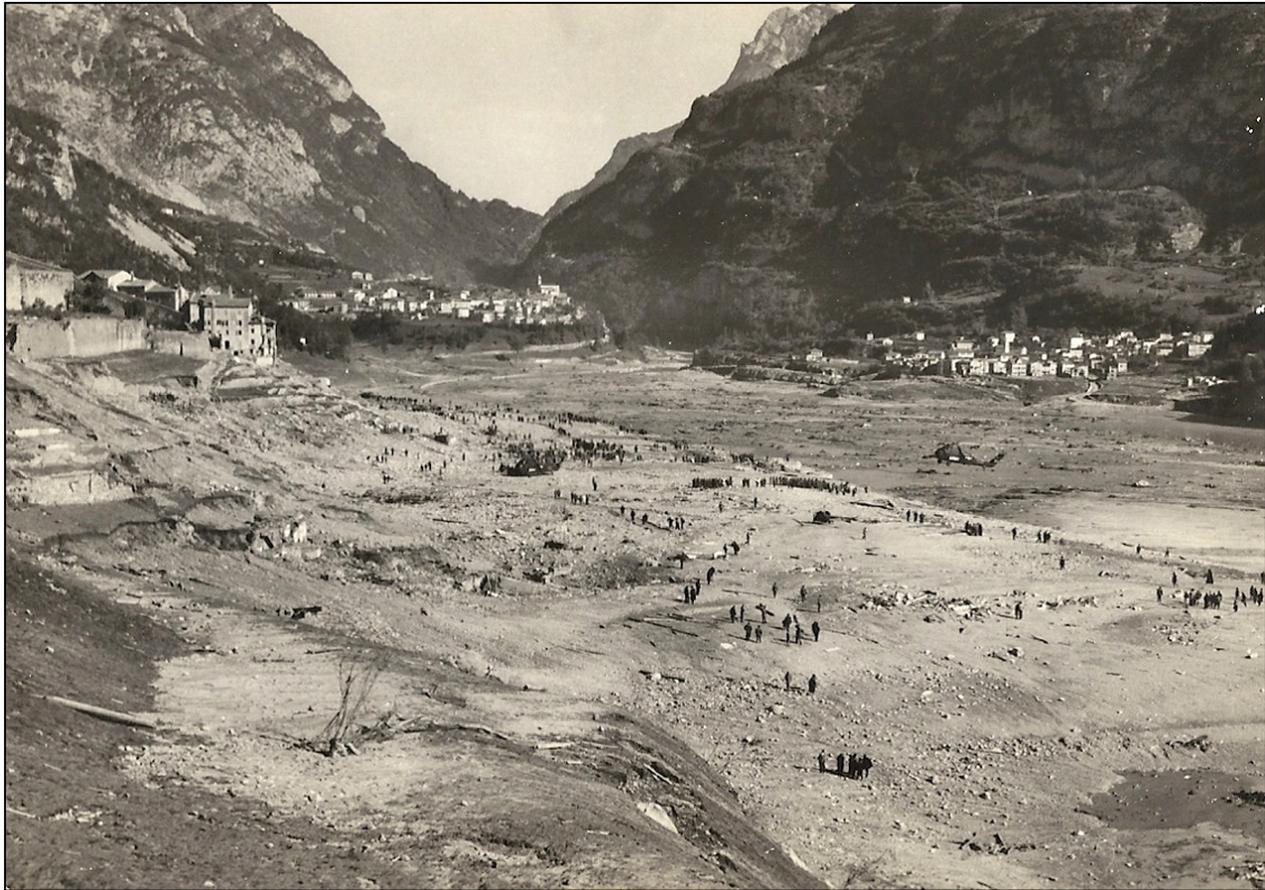
**Figure 14. Remains of Longarone**

The landslide occurred at 10:39 pm. Surviving witnesses from Longarone said that a flood wave came down the canyon at 10:43 p.m., and that a strong wind broke windows. There were strong earth tremors caused by the flood. By 10:55 p.m. the flood had passed, and the valley was silent.

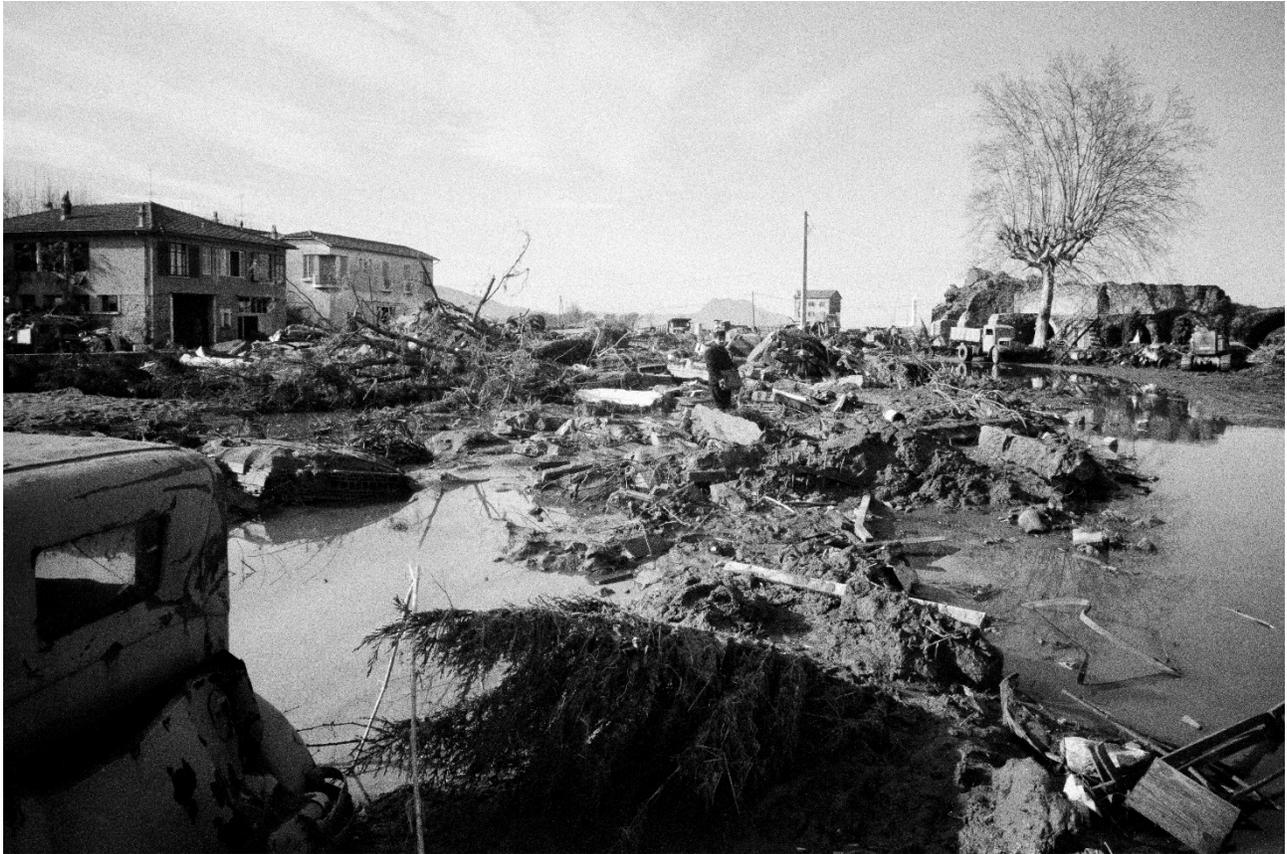
**Figure 16. Flood Damage near Frejus**  
Source: Licensed by Corbis Images

A 50 mph, 100-foot high wall of water reportedly descended on downstream areas. A large number of people were killed in Frejus, and some who heard the crashing of the approaching flood wave knew what it was, but no warning was issued. Many of the fatalities at Frejus were people in houses which either collapsed or filled with water.

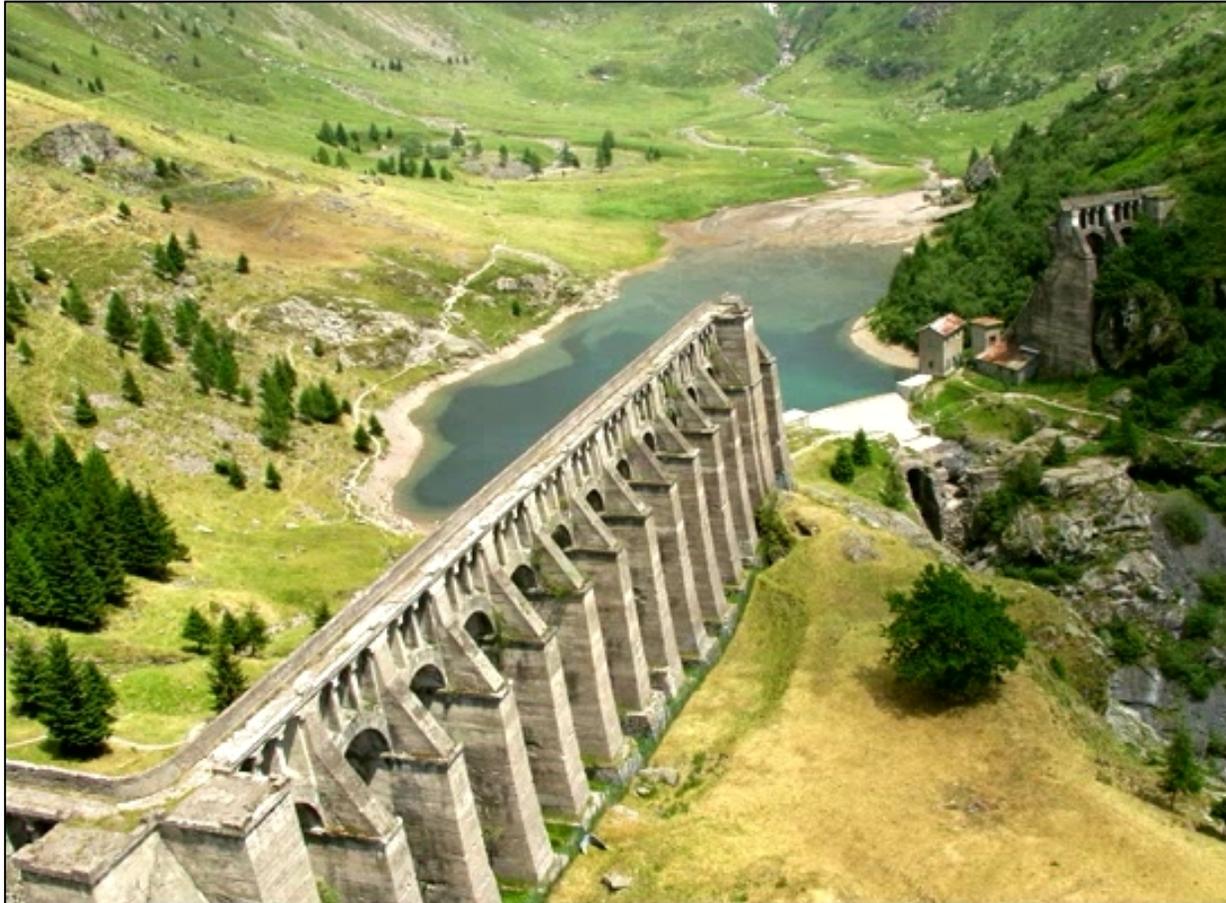
**Figure 24. The breached Gleno Dam**  
Source: Foto Giorgio, [www.scalve.it](http://www.scalve.it)

Gleno Dam was a multiple arch, concrete dam located about 30 miles northeast of the town of Bergamo in the Alps of north-central Italy. The dam had been completed in the same year of its failure which occurred 30 or 40 days after first filling and following a period of heavy rainfall. Destruction was widespread along the Dezzo River in the 13 mile reach to its confluence with the Oglio River at the town of Darfo. Lesser flood damage occurred in the Oglio Valley, for the remaining 5 to 6 miles to Lake Iseo. (Dams and Public Safety)

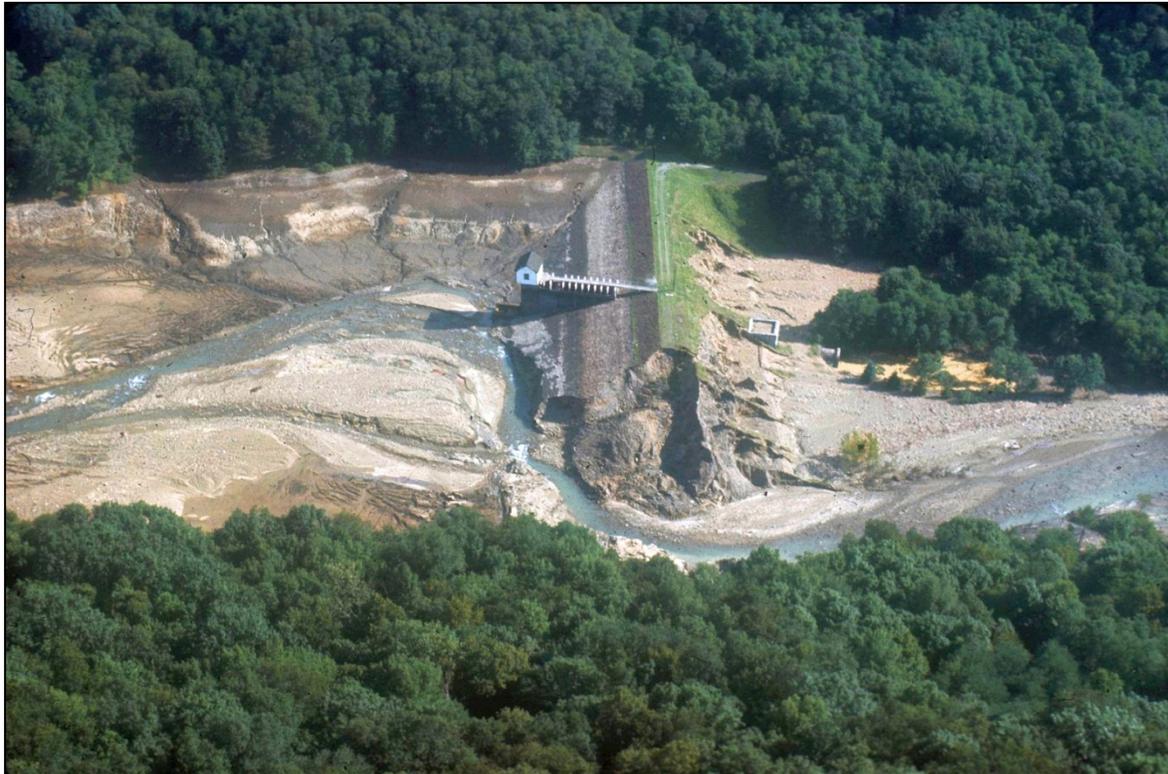
Figure 39. Remains of Laurel Run Dam

Laurel Run had the largest reservoir of the seven dams to fail between July 19 and 20, 1977. The dam is reported to have failed at 2:35 am on the morning of July 20, after a period of heavy rain. 11.82 inches of rain fell over the Laurel Run basin in 10 hours, and this was estimated to be between a 5,000 to 10,000 year rainfall event. About 41 people were killed in the town of Tanneryville, located in a three-mile long valley, immediately downstream of the dam. Most residents were asleep when the dam failed and no warning was issued. In addition, the rain and night-time conditions limited any escape. Many of the homes in Tanneryville were either damaged or destroyed. Laurel Run Dam was not rebuilt.

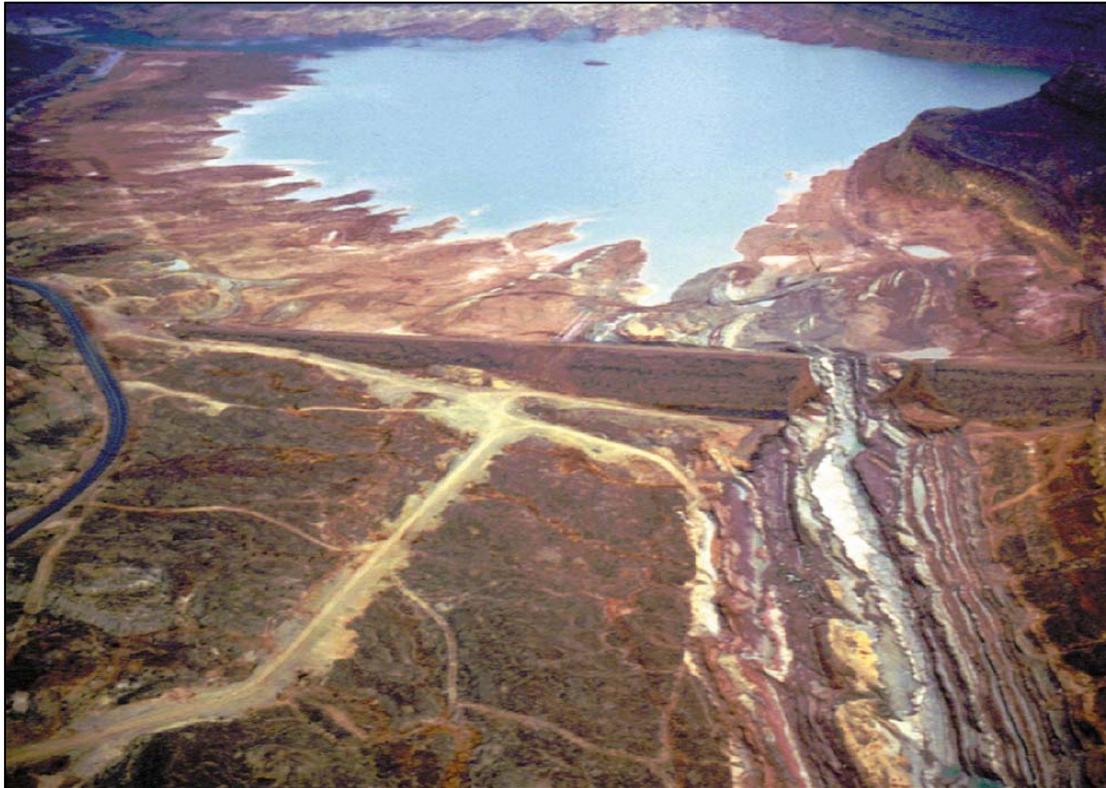
**Figure 114.**View of the breached Quail Creek Dike  
**Source:** Utah Geological Survey/photo by Ben Everitt, Special Study 133

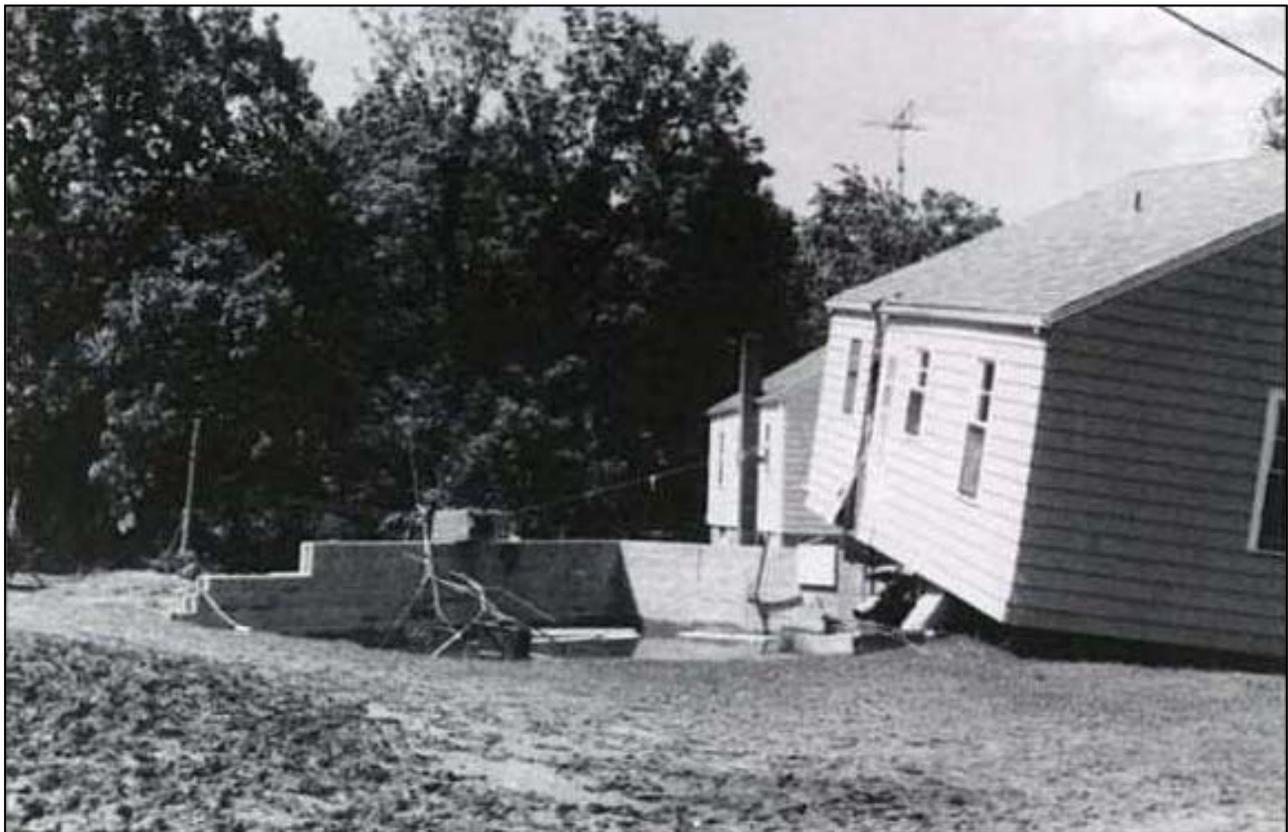
**Figure 117.** Photo showing houses lifted off their foundations at Ivoryton, but not destroyed.  
Source: Photo courtesy of Leslie Barlow
