Failure of Radial (Tainter) Gates Under Normal Operational Conditions

Best Practices in Dam and Levee Safety Risk Analysis

Chapter G-1

Last modified June 2017, presented July 2019

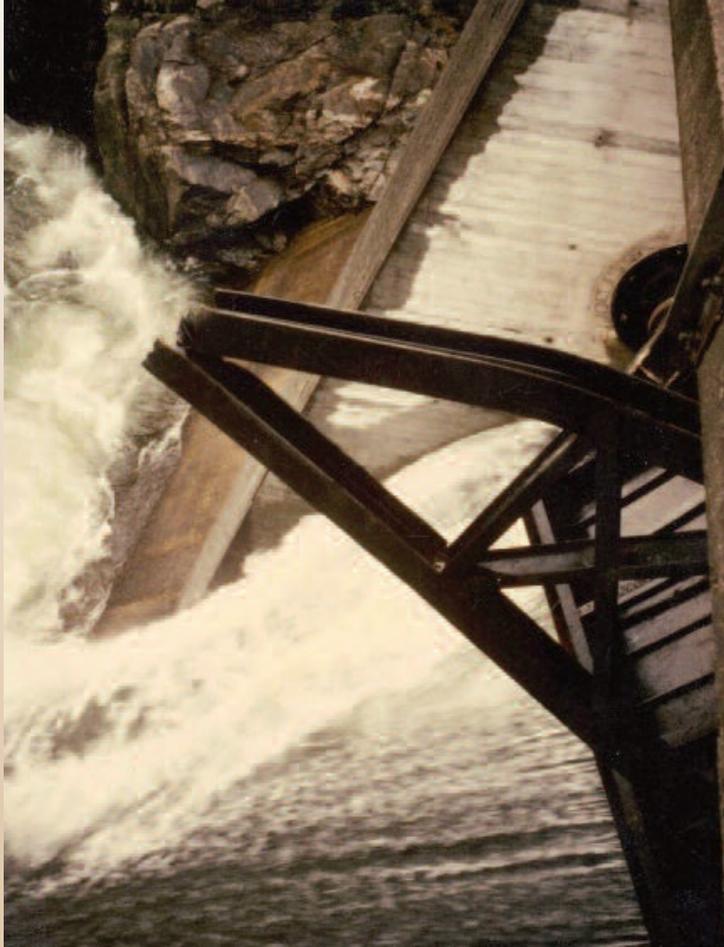
Ulefoss Dam Gate No. 1 Failure (1984)

- Dam is located in Norway
- Failed during normal operation – cause attributed to trunnion friction
- Dam was constructed in 1961; Two radial gates
- 14.0 meters wide x 4.8 meters (46 x 16 ft); max. head 4.8 meters (16 ft)
- Trunnion pin dia. 300 mm/11.8 inches.
- Norconsult planned the repair works, including stop logs in running water, recovery of gate body, redesigning of bearings and gate arms.

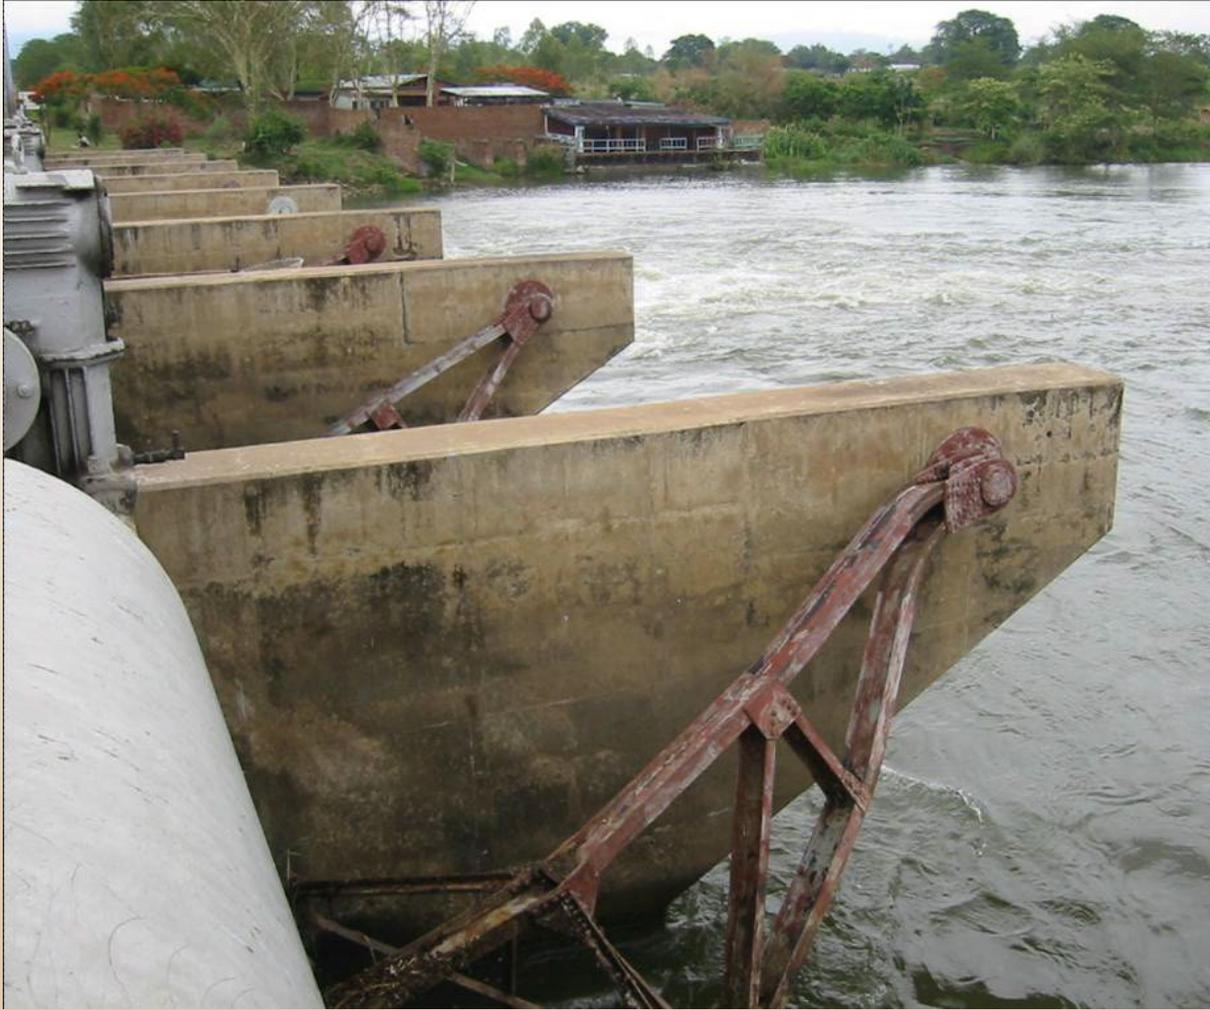
Liwonde Barrage Tainter Gate Failure: Malawi, Africa

- Dam was constructed in 1965
- Maximum differential head of only 4 meters (13 feet)
- Small diameter trunnion pins
- Poorly maintained
- Date unknown when trunnion bearing seized and arm was bent.
- *Gate continues to be operated in severely damaged condition today.*
- A new dam with new gates is currently being constructed.

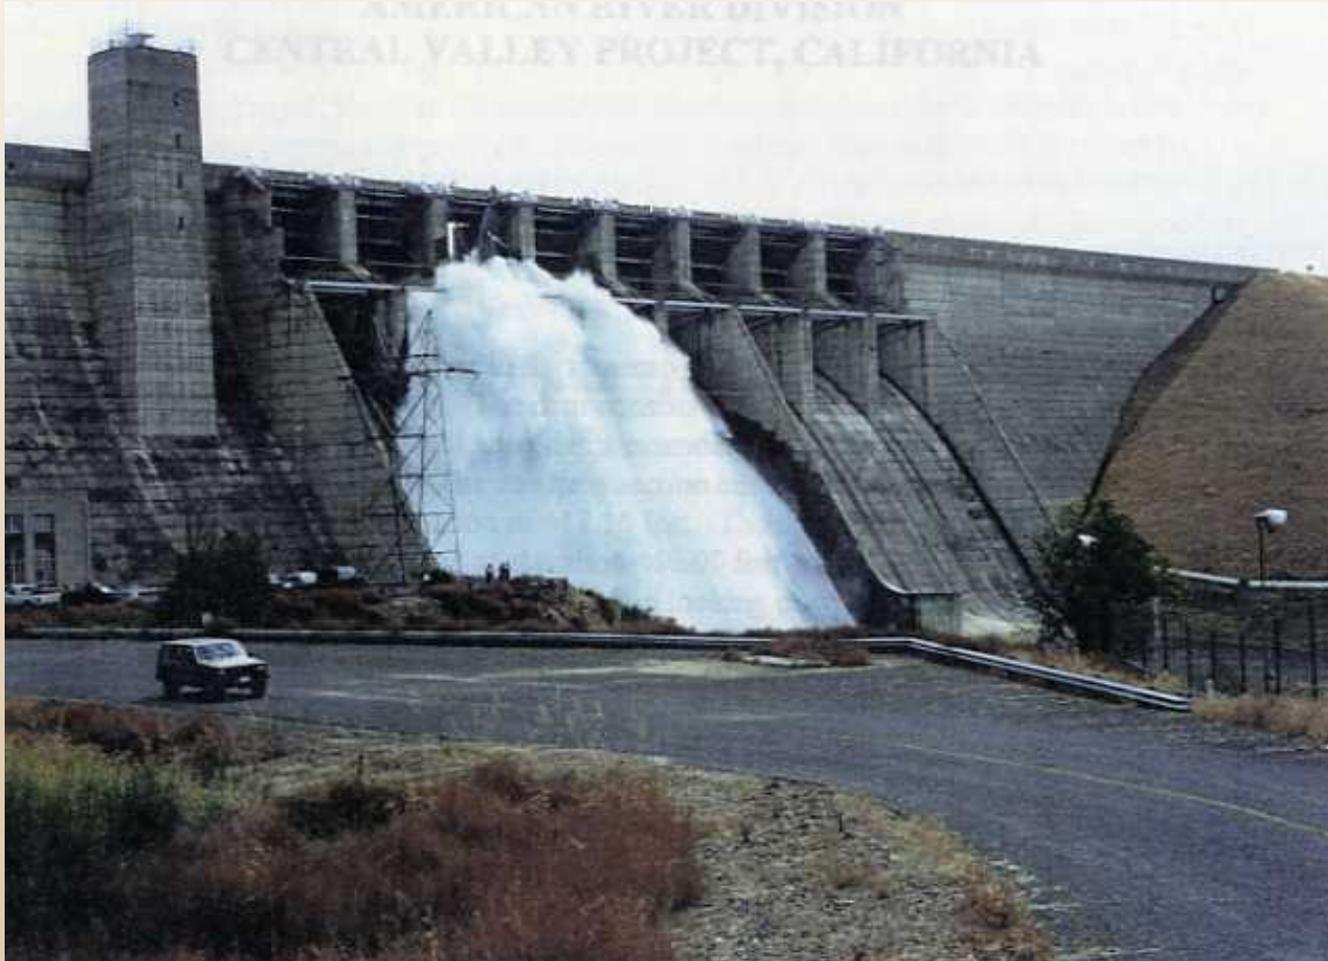
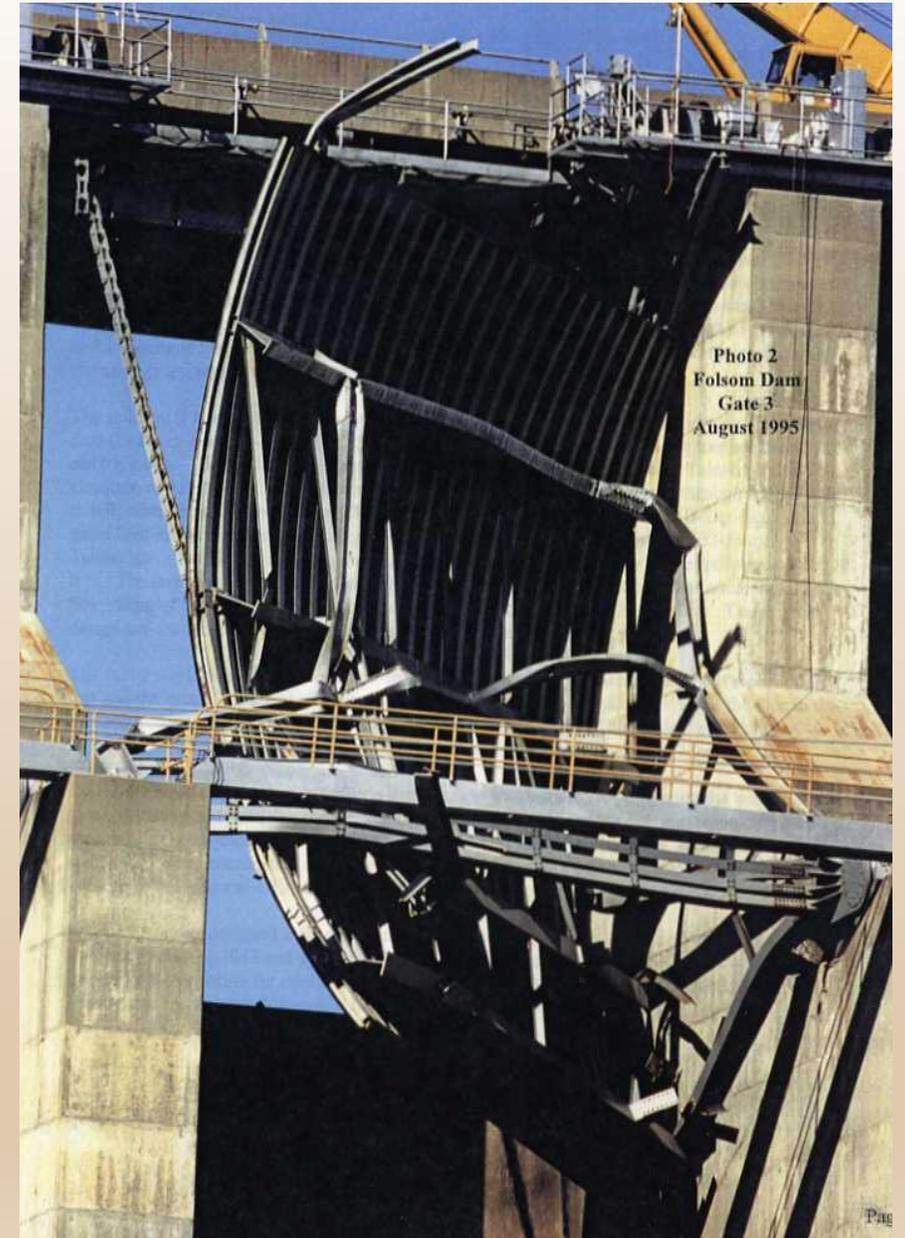
Folsom Gate No. 3 Failure

- Spillway has eight spillway Tainter gates (5 service, 3 emergency)
- Gate No. 3 failed suddenly on 7/17/95 with reservoir full
- Uncontrolled release peak – 40,000 ft³/s
- Failure started at lower strut brace, proceeded to adjacent braces and then arms buckled (determined to be trunnion pin friction)
- Contributing factors
 - Spillway gates weren't designed for trunnion friction loads
 - Large, hollow pin (32" diameter)
 - Reduced frequency of lubrication and lack of weather protection at ends of pin resulted in corrosion and increased friction over time
 - Struts 3 & 4 post failure evaluation led to conclusion about failure sequence

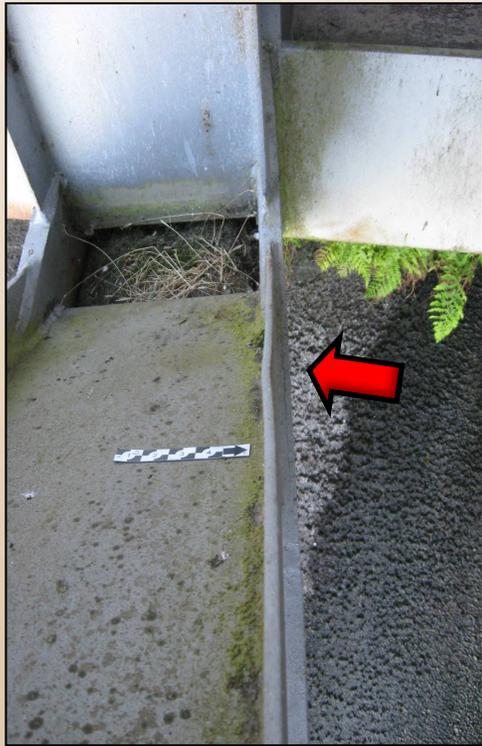
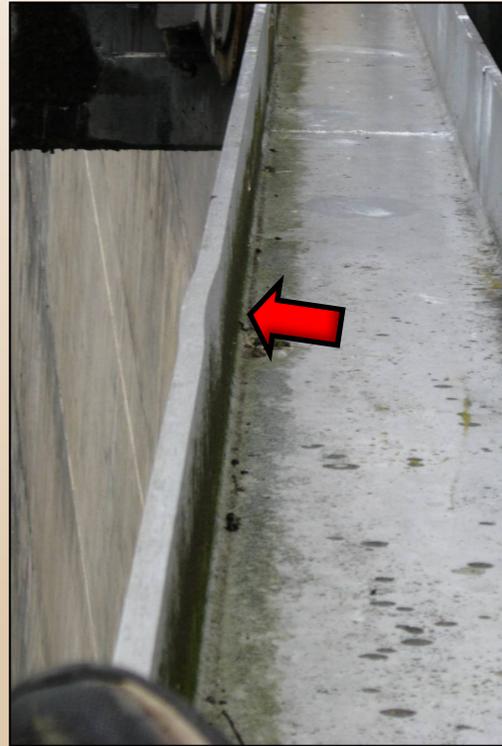
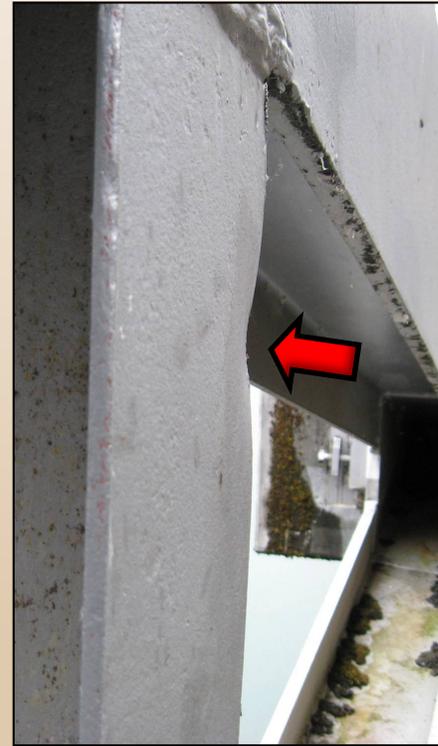
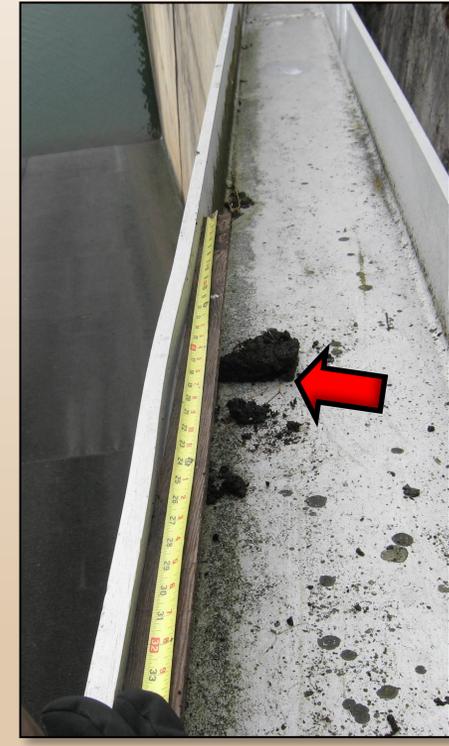
Evidence of Buckling of Strut Arms at Foster Dam

- Top strut arms and diagonals showed signs of distress.

Gates 1 & 2 in 2008: Deformation in North Top Strut; Twist, Bending, Buckling

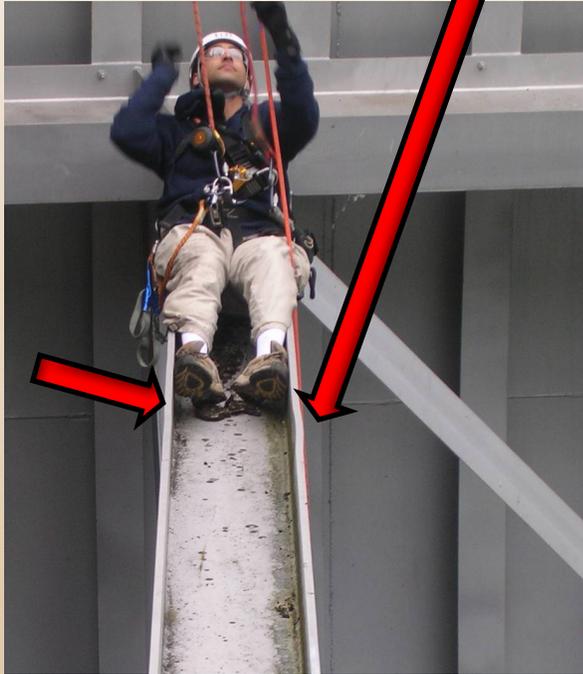
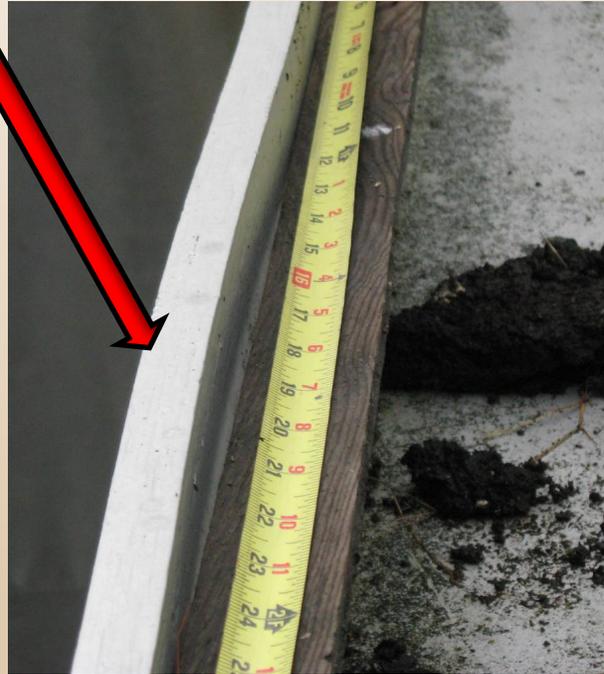
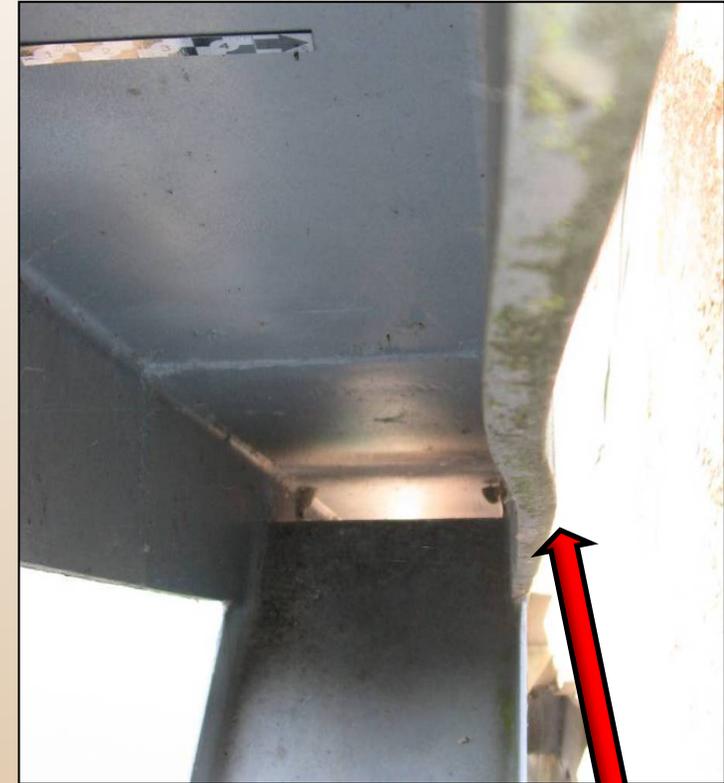
**Gate 3 in 2008:
Deformation occurred
after 2002 inspections**

- Debris damage
- Gates have been operated at full pool for the last two years (powerhouse downtime prompted spill from Tainter gates).
- Deformations were load-induced

- Gate 3 – worst damage to struts – do not use
- Gate 1 – damage to struts – do not use
- Gate 2 – some damage to struts - restricted
- Gate 4 – some damage, restricted

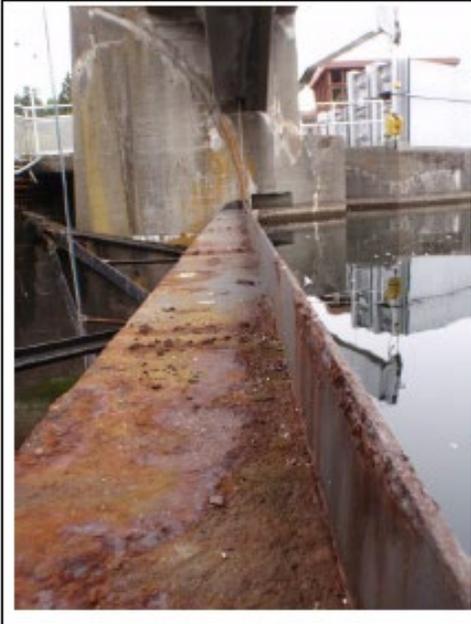
Chittenden Locks Tainter Gates

- Dam was completed in 1916
- Gates are 32 feet wide and 8.5 feet wide; max. differential head -13 feet
- There are no emergency bulkhead slots and no emergency bulkheads.
- Gates underwent rehabilitation in 1944, 1953, 1977 and 1987
- Paint loss and extensive pitting of girders and channels.
- Rivet heads noted to have between 20-100% section loss.
- Gates at end of useful life in regard to safe/reliable operation

- The gates did not meet current criteria with regard to single sided hoisting operations, stall torque, trunnion friction, and/or impact.
- All gates replaced in 2014

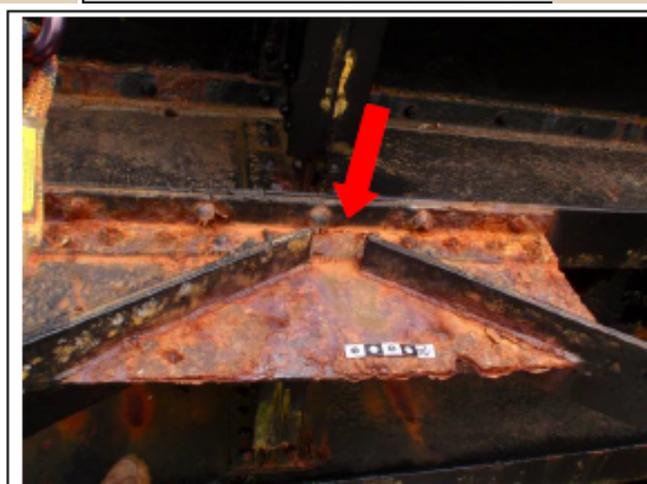
Photo 90: Gate 4 – Heavy corrosion of top horizontal center gusset plate. Up to 100% section loss on downstream edge of plate. Up to 100% section loss of rivets. Welded diagonal strut connections heavily corroded.

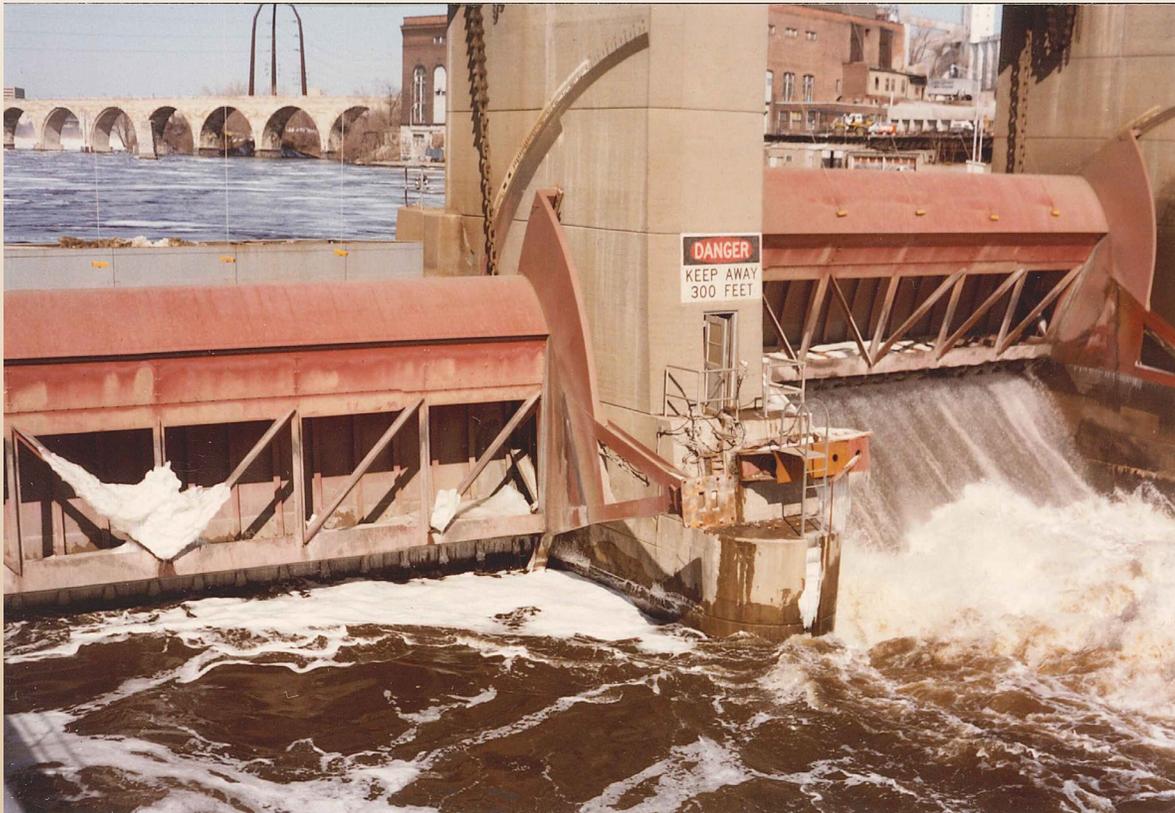
Failure of Lower St. Anthony Falls Trunnion Girder Due to Ice Loading (1982)

- Dam was completed in 1956
- Gates are 56 feet wide and 15.2 feet wide
- Maximum differential head of 25 feet
- Well maintained
- Designed to pass ice/debris over gate crest
- ***Failed on 17 January 1982, at 1500. Temperature was +8°F; the previous night, temp was -20°F.***
- Considered a brittle failure; cracked welds and cracks in base metal subsequently discovered
- Original design did not allow for lateral ice load as now required by EM 1110-2-2702.
- 5,000 lb/ft. ice load would significantly overstress the trunnion girders
- Significant ice loads (>5' thick) have occurred

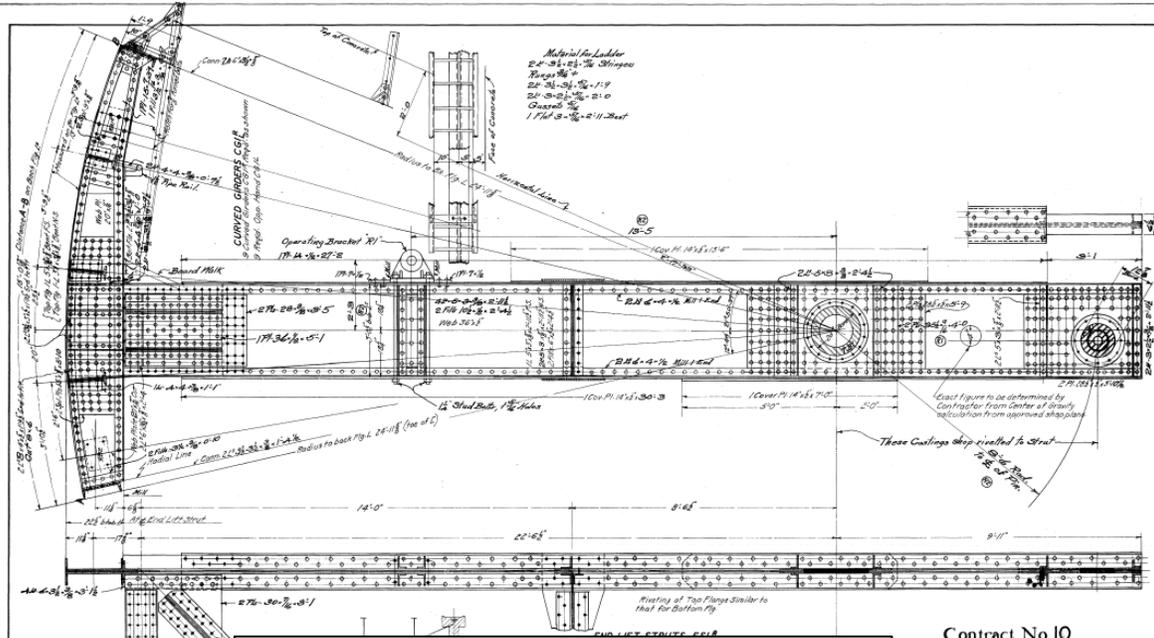
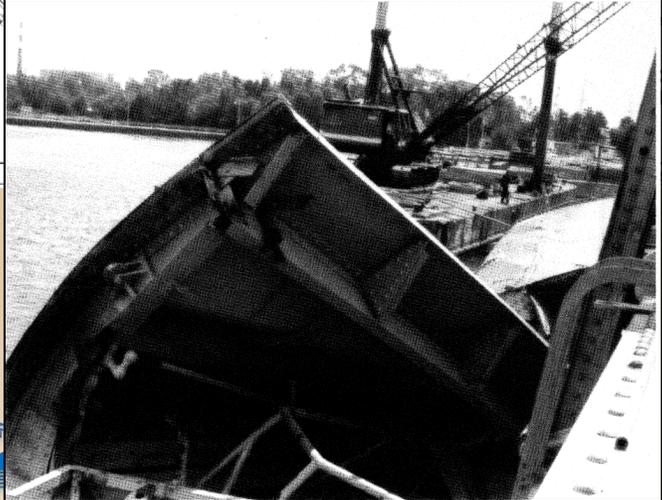
Failure of Dresden Island Tainter Gates Due to Ice Loading (1982)

- Ice problems more numerous and severe in recent years as water quality has improved.
- Ice discharges from the Kankakee River, especially when ice jams break loose upstream, create difficulties in maintaining pool level as well as causing problems with ice at the tainter gates.
- Tainter gate electric motors do not have sufficient power to lift the gates when a mass of ice has accumulated on them.
- The gates are then operated manually using hand cranks or a heavy-duty electric drill.
- Hand chipping and steam are used to free ice from the gates.
- In March, 1982, Tainter gates No. 4 and 9 partially failed as a result of a buildup of floating ice and required replacement.
- Top cantilevered portions of these gates suffered ductile failure due to overload.

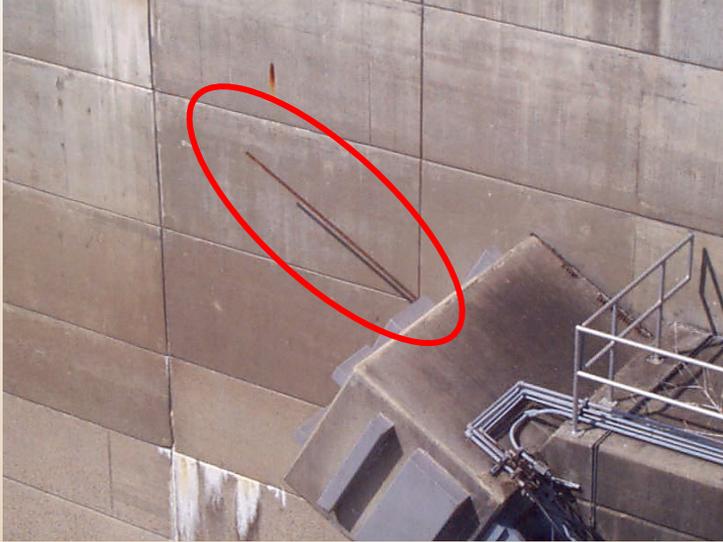
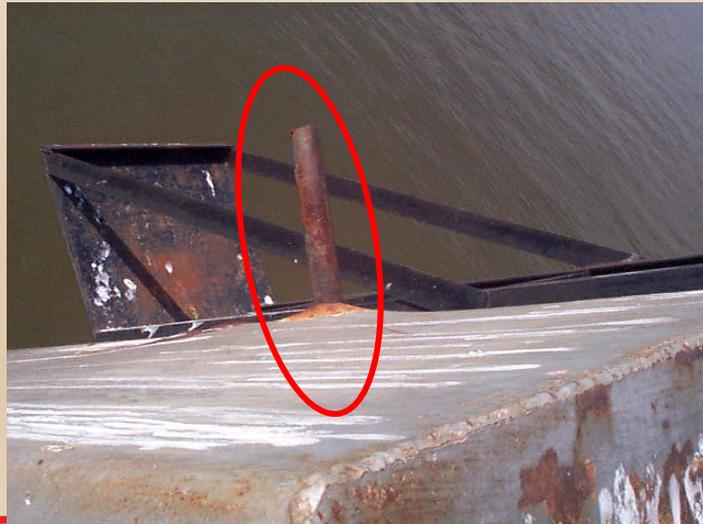
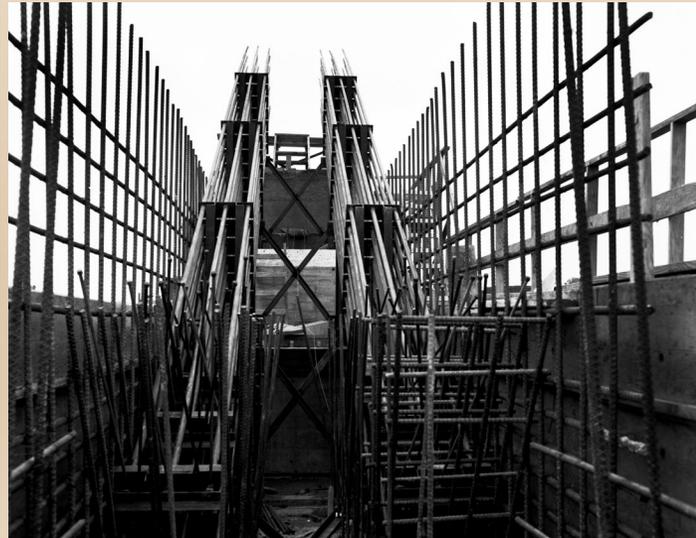
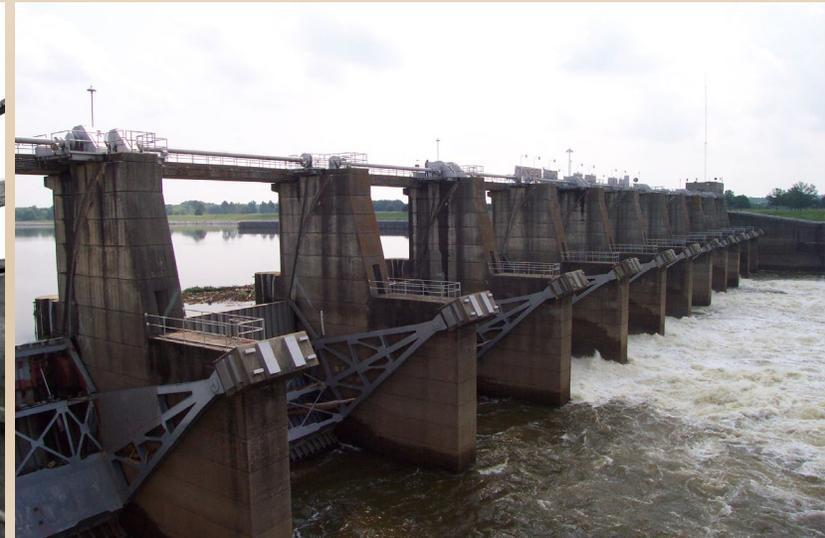
Failure of Trunnion Anchorage Due to Corrosion

- R. F. Henry Dam (Mobile District) – construction completed in 1969
- 12 spillway piers containing 464 main trunnion girder anchor rods, each 1¼-inch diameter
- Radial gates are 50-ft wide by 31 ft tall
- As of November 2007, six anchors failed; one each in piers 1 (in 2006) and 3 (in 1969) and two each in piers 2 (in 1972) and 9 (in 2006).
- Specified rods were brittle. Also 100% loss of grease had occurred.
- Factor of Safety of 1.0 with loss of four rods per pier
- If there is loss of 3 rods, gate will be closed, stoplogs placed
