Testing of Commonly used Fish Screens for Resistance to Invasive Mussel Fouling

Research and Development Office
Science and Technology Program
Final Report ST-2016-5740-1

HL-2016-03

September 2016

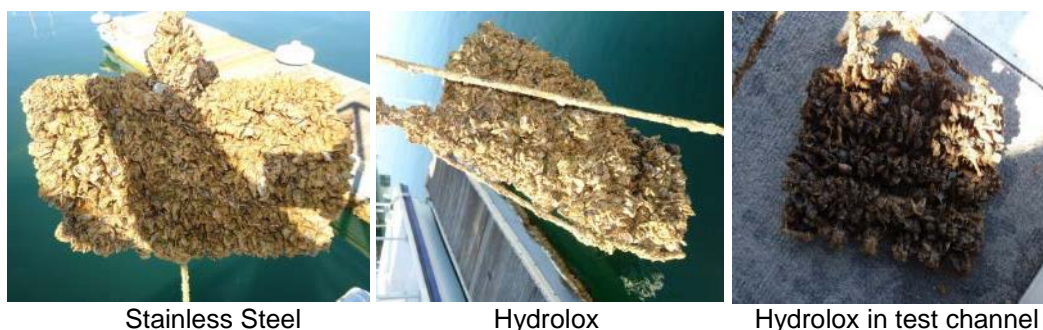
Also, to help assess mussel settlement, static screen samples were hung on the outside of the boat as well as within the test channel for comparison to the test screens. These static samples were most valuable in interpreting test results throughout the study (Figure 15).

Figure 15 Heavy mussel attachment on static screen samples that were submerged about 12 ft below the surface and a control Hydrolox sample submerged about 2 ½ ft below the surface in the test channel (Summer 2013).

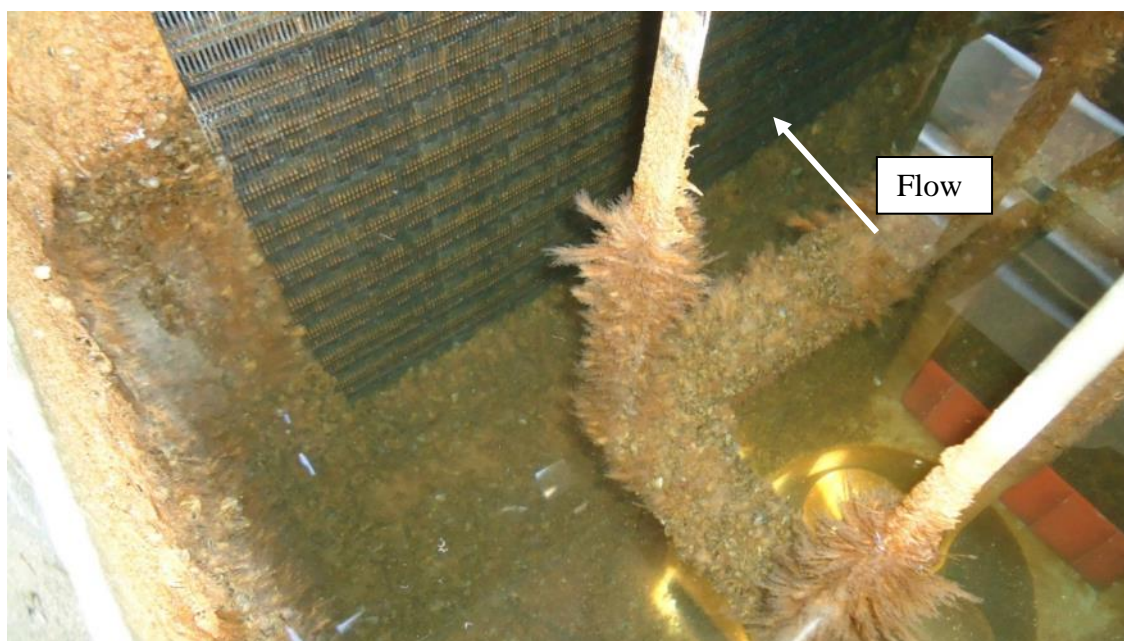
The Hydrolox screen operated continuously from the summer of 2012 to September of 2014. The screen traveled at a linear speed of approximately 1 in/sec which successively exposed a portion of the screen to air for 33 seconds over a rotation cycle (unsubmerged 43% of the time). The only maintenance required by the screen was occasional lubrication of the bearings supporting the rotating shaft at the top of the screen and replacement of the gear sprockets that drive the screen due to wear from the chain which had not been sufficiently tightened. As seen in Figure 16, there was no mussel attachment to the main screen while mussels heavily colonized on the screen frame and surrounding test channel. Two sections of Hydrolox static samples near the bottom of the test channel were also heavily fouled with mussels.

Figure 16 Heavy quagga mussel fouling on the floor and frame of the Hydrolox screen. The screen itself continuously cycled between submerged and unsubmerged and remained mussel-free.

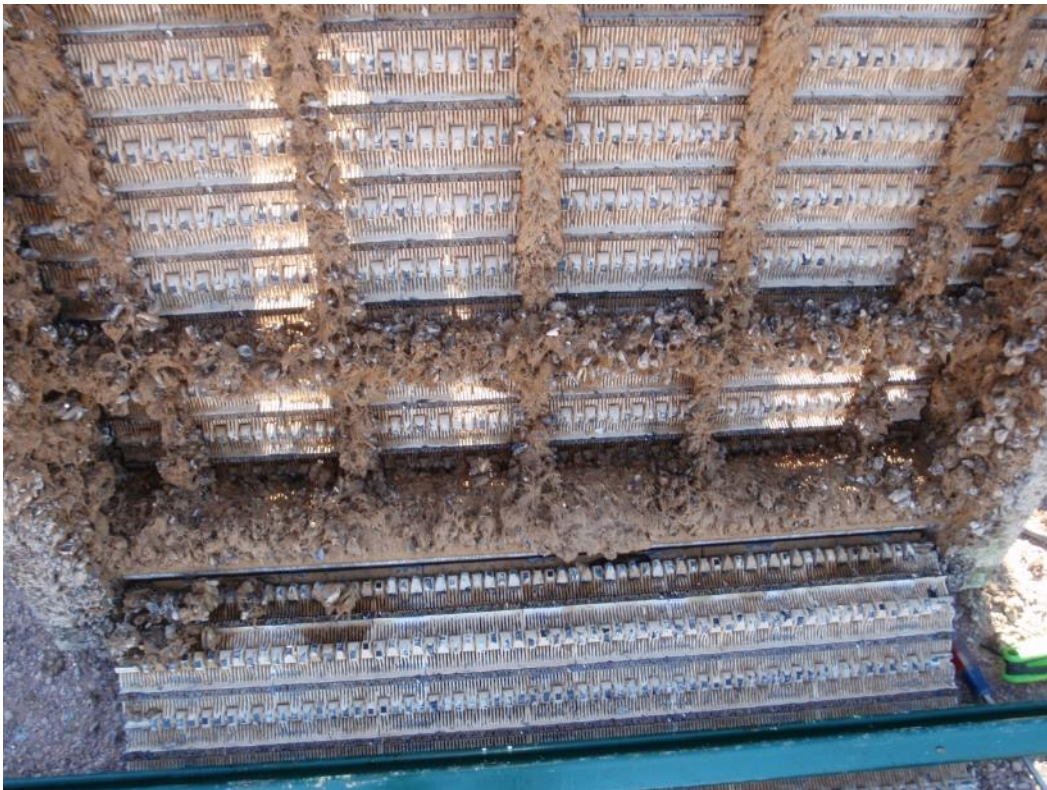
The main Hydrolox screen was removed in September 2014 since it had operated continuously for over 2 years without major problems. Figures 17 and 18 show the inside of the Hydrolox screen and frame after it was removed and disassembled. While there was considerable mussel settlement on the interior frame there was no settlement to the screen itself. This was either due to the screen continually moving in and out of the water or to the stationary roller bar at the bottom of the frame that would scrape the mussels off as it contacted the screen as it moved (Figure 18).

Figure 17 Inside of the Hydrolox traveling screen after 2 years of operation at Lake Mead.

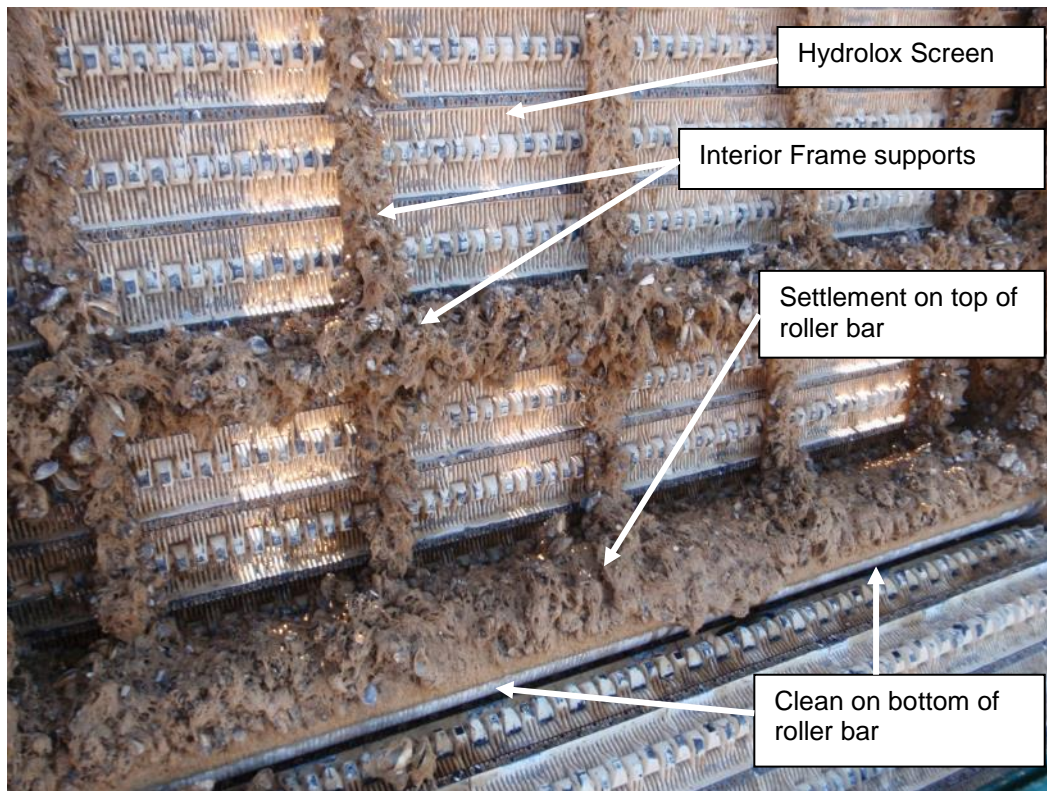
Figure 18 Mussel settlement on the inside of the Hydrolox screen frame.

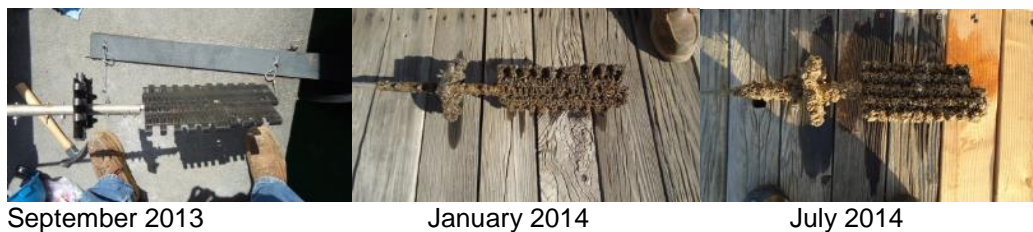
To help understand what prevented mussels from attaching to the moving polymer sections of the Hydrolox, two separate sections of screen samples were mounted on a shaft which rotated the samples at approximately the same speed as the main Hydrolox screen. These samples were placed 12 ft below the water surface and stayed in continuous motion from September 2013 to July 2014. Figure 19 displays the growth of quagga mussels on these rotating control samples over time which shows that quagga mussels will attach and grow on an object in motion if continually submerged. If the roller bar is not the primary factor then the fact that there were no mussels on the main Hydrolox screen suggests that a screen that rotates up and out of the water surface will prevent mussel colonization and provide mussel-free operation on a long-term basis.

Figure 19 Hydrolox sample sections that were mounted below the water surface and rotated at approximately the same speed as the main Hydrolox screen. Despite continuous motion, mussels attached to the samples.

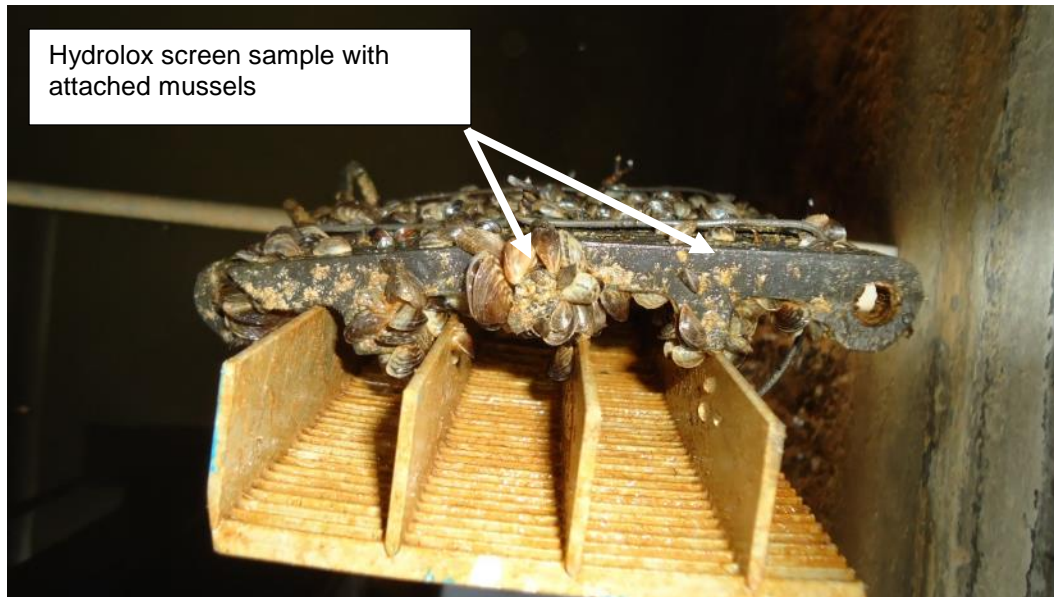
In April 2016 a Hydrolox sample with mussel settlement was attached to the rotating screens to determine if mussels would come off after becoming settled due to cycling in and out of the water. Figure 21 shows that after 1 month of testing mussels appeared to be still alive and were well attached to the screen sample suggesting that mussel attachment may be very difficult to eliminate once they have already settled, even if the screen is continuously moving in and out of the water.

Figure 21 Mussels attached to Hydrolox screen sample (formed attachment while stationary and remained attached after rotation in and out of water for one month).

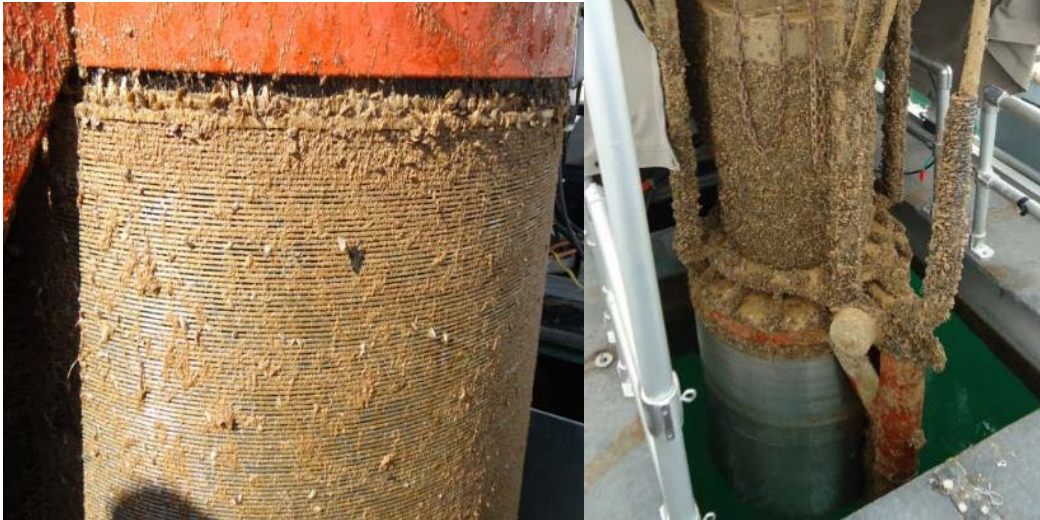
The brushing system on the ISI cylindrical screen operated continuously with cleaning every 8 hours from September 2012 to September 2014 with no problems. The only maintenance task that was performed was replacing one of the sacrificial anodes for cathodic protection of the screen structure which was done in April 2014. While static samples of stainless steel wedgewire were heavily fouled, the surface of the main screen that was brushed remained clean as long as the cleaning system operated as intended. If not, the screen was soon fouled with mussels and biofilm (Figure 22). The Fuji silicone coating was effective at preventing mussel settlement on the portions of the frame and internal flow baffle that were coated. Over time portions of the Fuji coating peeled off and allowed mussels to attach in those areas (see photos in Appendix B). Another concern is that mussels may clog the space between the wedgewires (visually observed in some locations on the screen) that cannot be removed by the brush. Photos were taken and velocity measurements around the outside of the screen were made to verify flow through the screen.

No brushing (2 months)

3 brush cycles per day (18 months)

Figure 22 Biofilm and mussel settlement on ISI screen structure. Screen clogged without brushing. No mussels were present on the exterior main screen that was brushed.

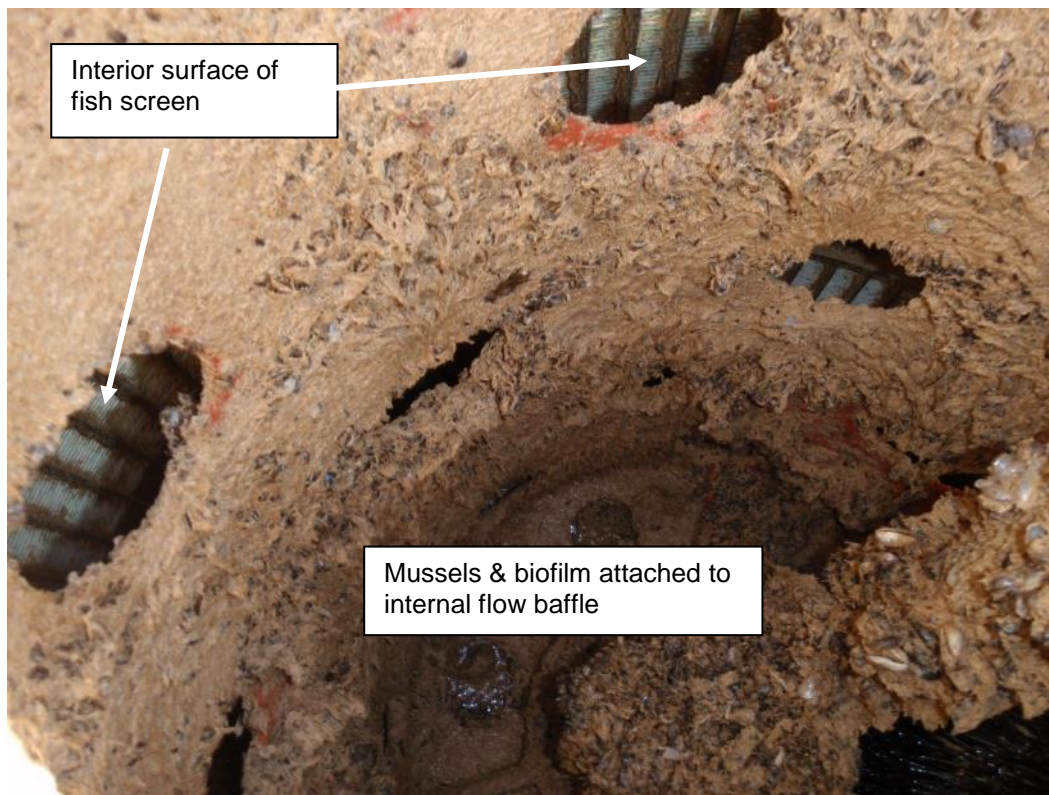
The ISI screen and brushing system were removed and disassembled in September 2014 at test completion. Testing over the 2 year period has shown that the screen was generally protected from mussel settlement as long as the brush cleaning system operated correctly. When the inside of the screen was inspected for mussel settlement it appeared similar to the outside of the screen where there were no mussels on the part of the screen that was regularly brushed (Figures 24, 25, and 26). Biofilm accumulated on the inside of the screen even where it was brushed but did not seem to inhibit flow.

Figure 24 Inside of ISI cylindrical screen after over 2 years of operation. Mussels were attached basically everywhere except for the interior screen that had been continually brushed.

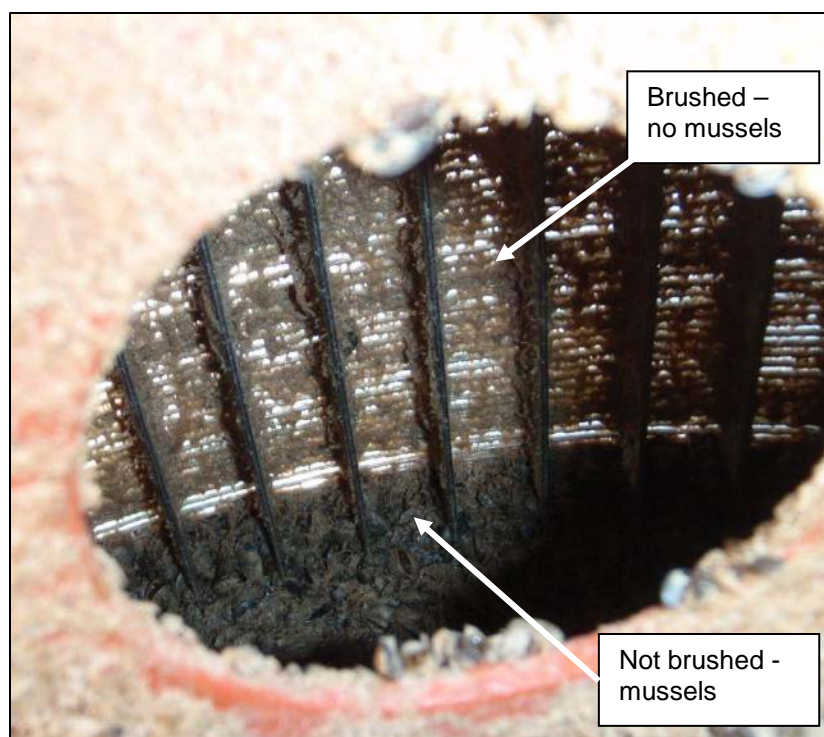
Figure 25 Mussel attachment to the inside screen surface where the brush did not extend.

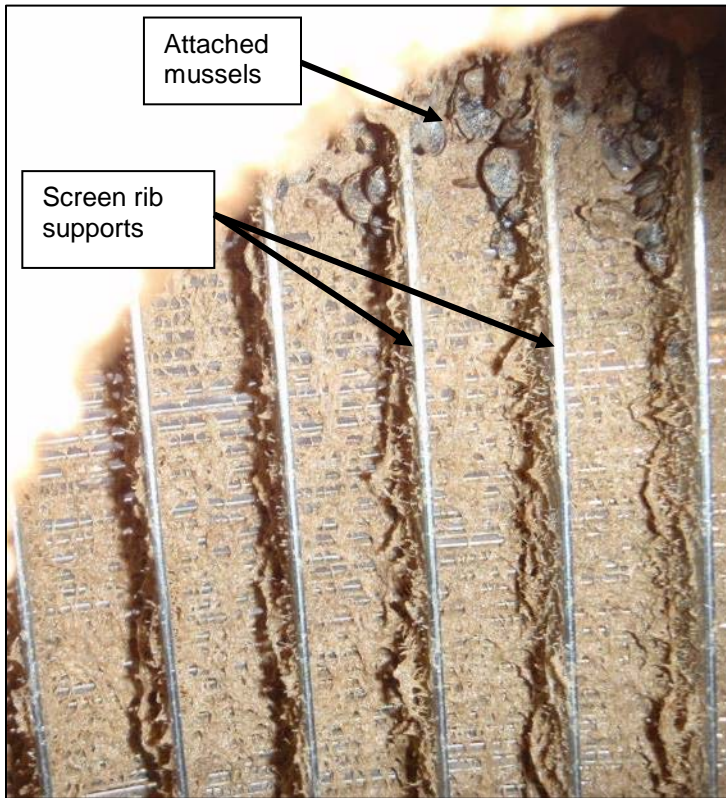
Figure 26 shows there was some mussel attachment in a few areas of the inside screen. These mussels seem to have been protected from the brush by the interior screen rib supports. However, mussel attachment to the inside of the screen was not common and did not seem to significantly reduce flow through the screen. Running the brush in both forward and reverse directions (which is already common practice) will help remove mussels in between the rib supports on the backside for the screen.

Figure 26 Biofilm and mussels attached to the interior ISI cylindrical screen behind the screen support ribs.

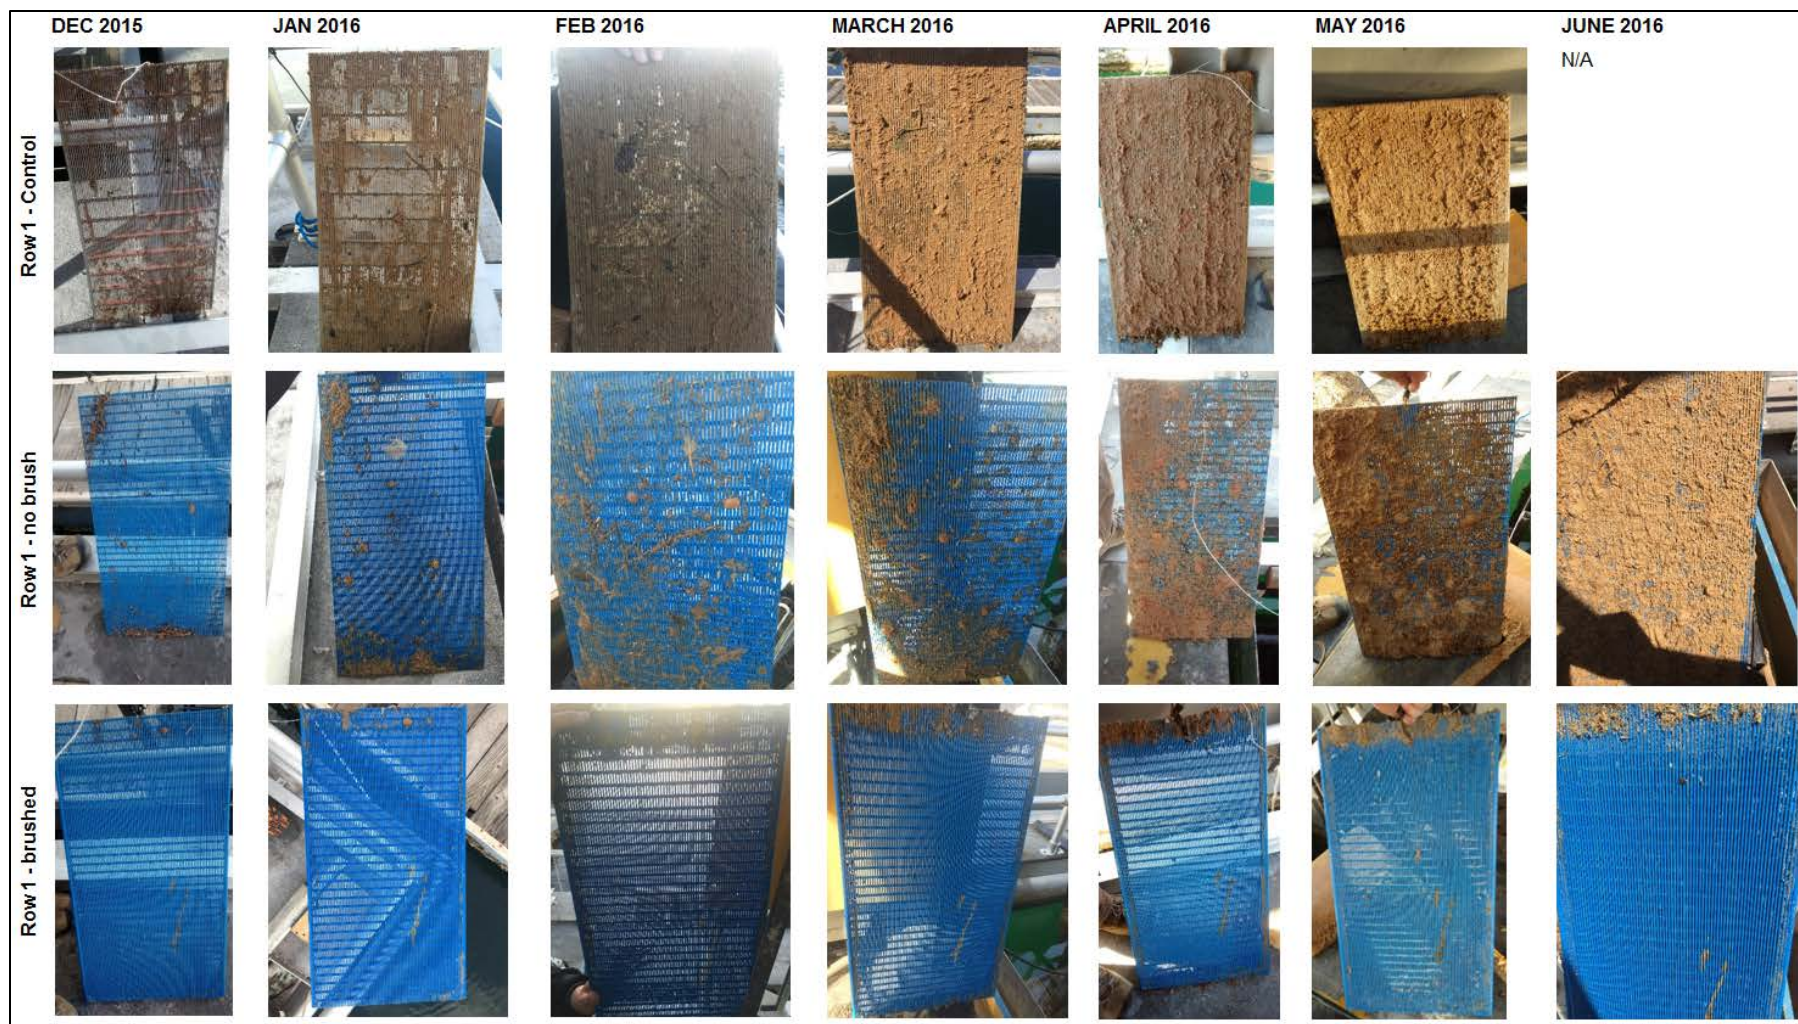
Figure 27 shows the progression of biofilm and mussel attachment on the vertical wedgewire screens (upstream row) from December 2015 through June 2016. The control screen became almost completely covered after only 2 months and remained clogged throughout the test period. The screen with the Jotun coating that was not brushed performed better and was not significantly clogged until about May 2016. The Jotun coated screen that was brushed performed exceptionally well and visually appeared to be in the same condition (screen openings clear) throughout the entire test period. There were no signs of abrasion, wear, or other damage to the coating from the brushing.

Figure 27 Time lapse photo comparison from Dec. 2015 through June 2016 of the first row of flat plate test screens (vertical wedgewire).

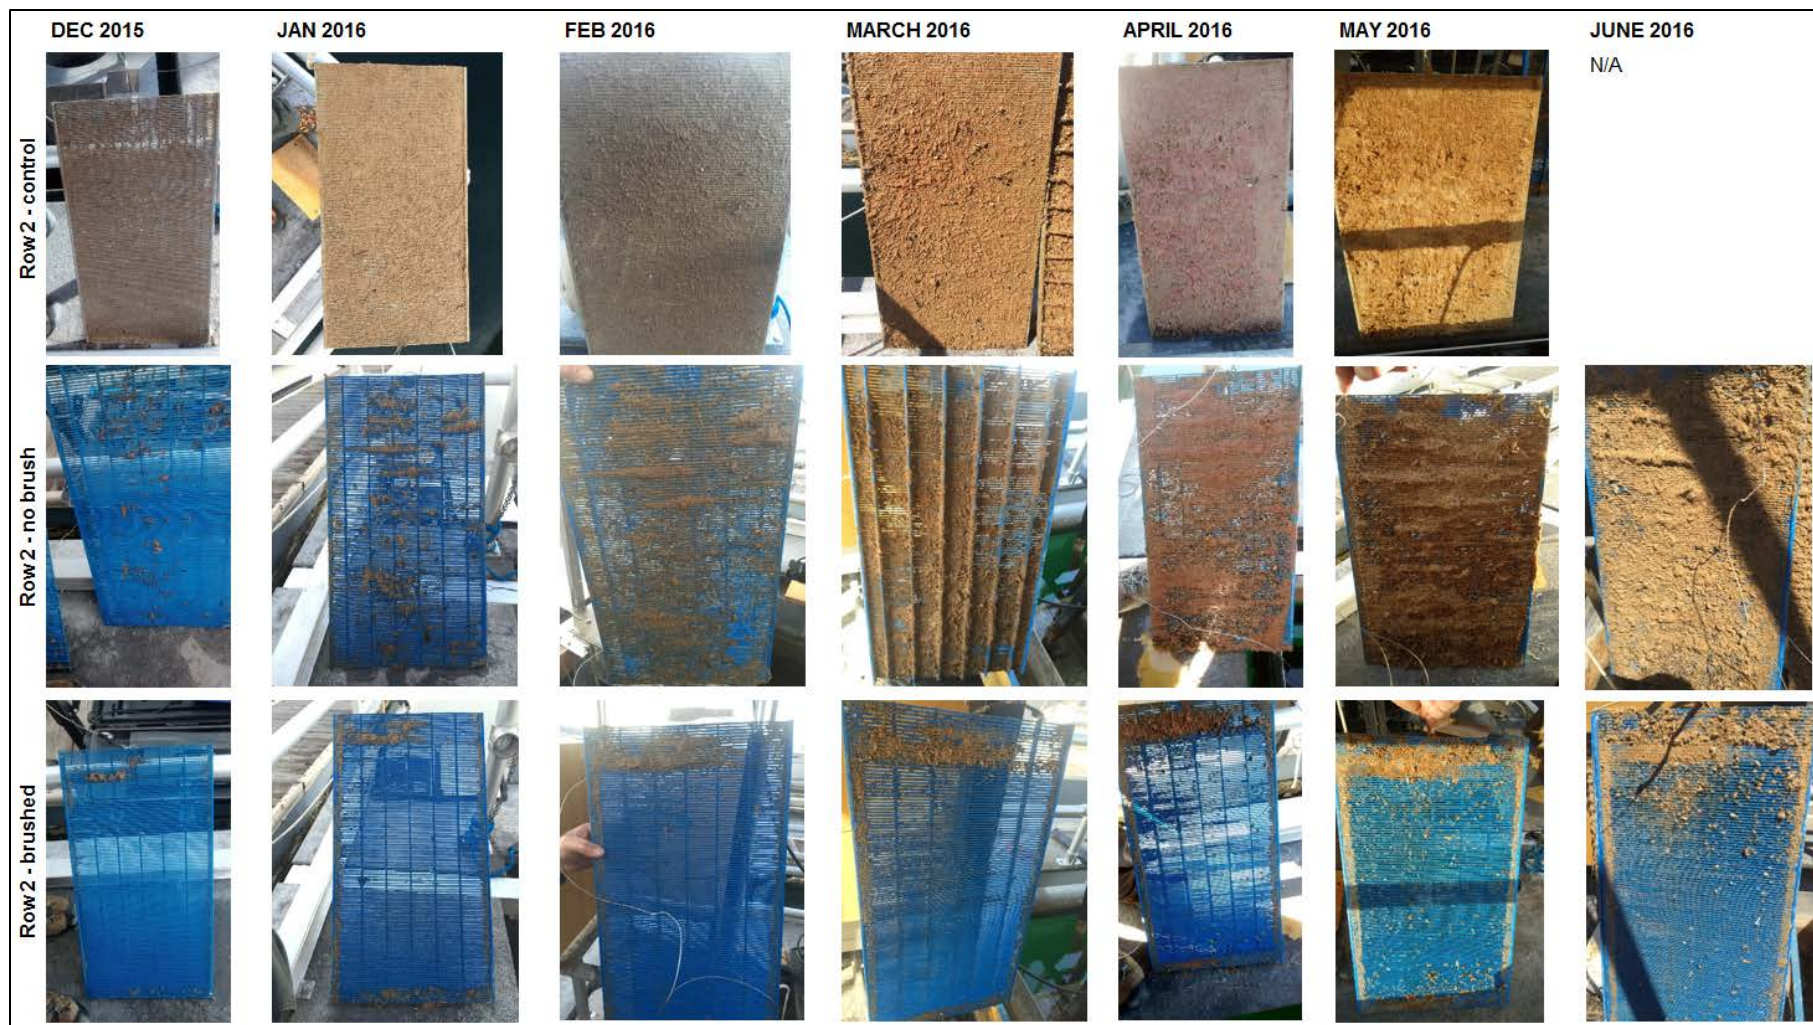
The horizontal wedgewire screens (downstream row) produced similar results which are shown in Figure 28. The only difference was that the brushing motion, which was perpendicular to the wedgewire orientation, was not as effective. Starting in about April 2016 a few of the screen openings were visually clogged and some mussel shell debris remained on the screen even with brushing. Figure 29 presents a visual comparison of the difference in brushed screens with vertical and horizontal wedgewire orientation. Screens with wedgewires aligned with the brushing motion were more effective as the bristles from the brush were allowed to protrude into the screen openings as they passed over the screen.

Figure 28 Time lapse photo comparison from Dec. 2015 through June 2016 of the second row of flat plate test screens (horizontal wedgewire).

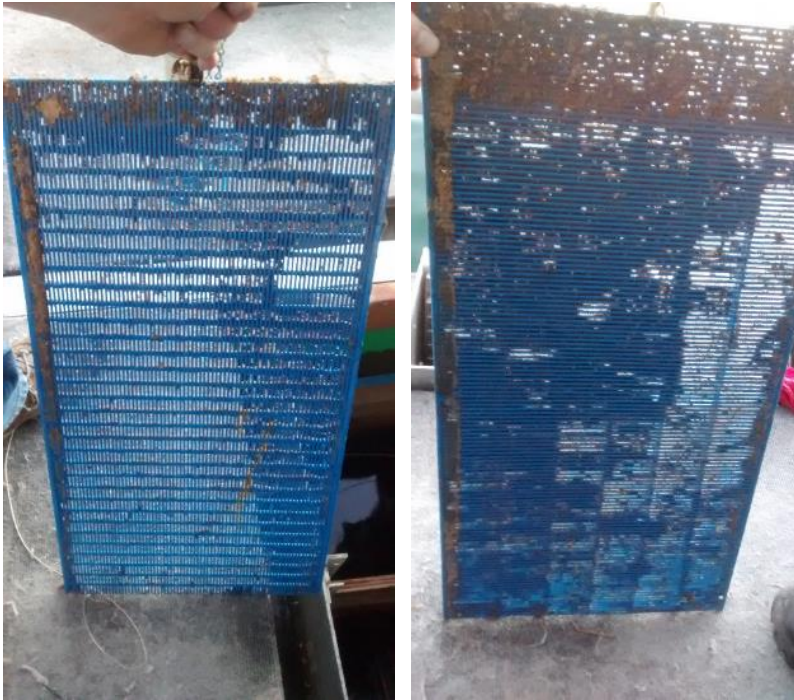
Vertical (parallel to brushing)

Horizontal (perpendicular to brushing)

Figure 29 Vertical and horizontal wedge-wire screens that were brushed. Brushing motion in the same wedge-wire orientation was more effective, keeping screen openings clear.

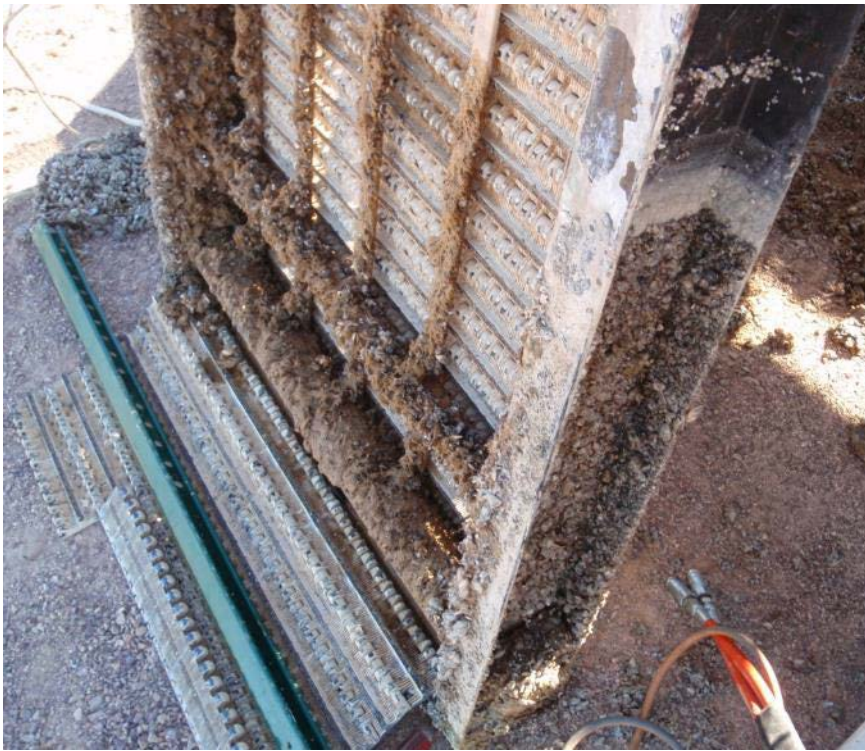
Figure 36 Mussel settlement on Hydrolox frame and interior supports following testing (inside of Hydrolox screen).

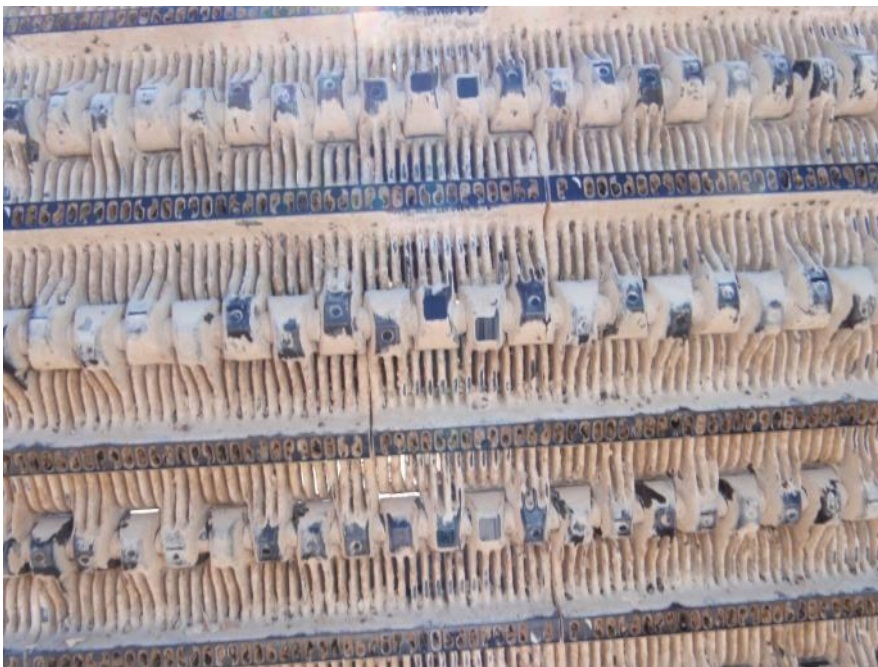
Some biofilm that accumulated on both the outside and inside of the screen may have slightly increased head loss through the screen (see photos in Appendix B). The average velocity through the screen in September 2014 was 0.087 ft/s with a flow depth of approximately 2.8 ft. Unfortunately, there are no baseline data for comparison.

Figure 37 Biofilm built up on the Hydrolox screen (inside of screen looking out).

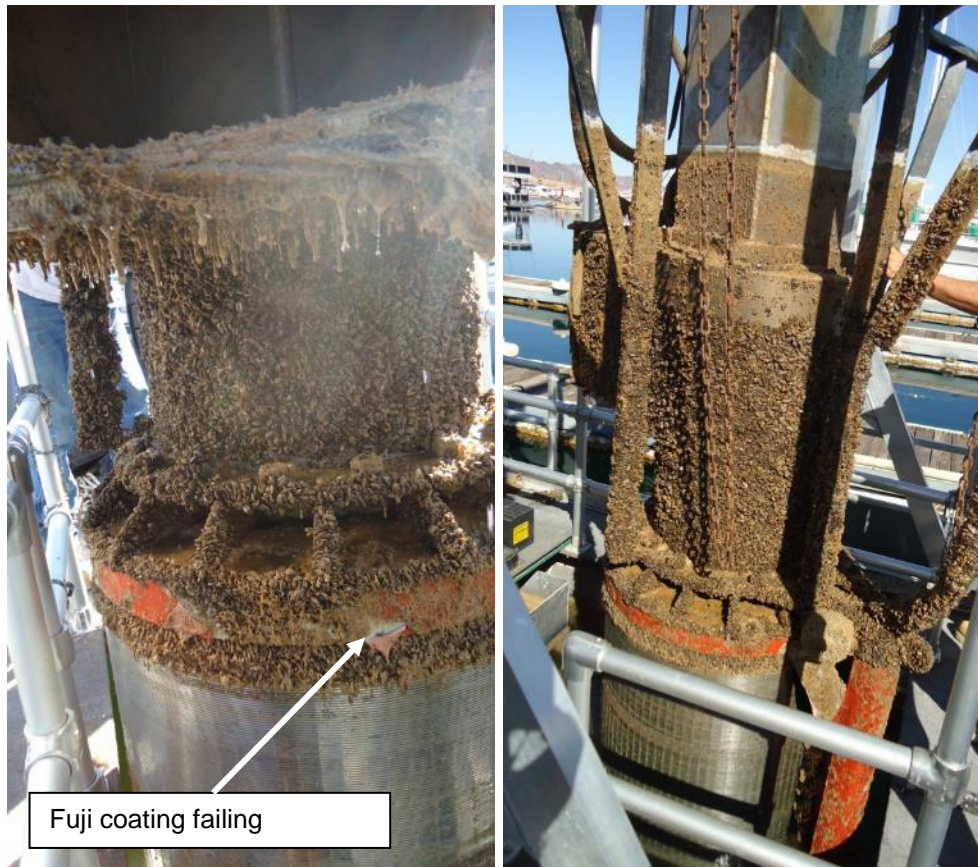
Figure 39 Mussel settlement on ISI frame and screen edges. Mussels did not attach on areas coated with the Fuji Silicone coating. Mussels did attach to areas where the Fuji coating had peeled off.

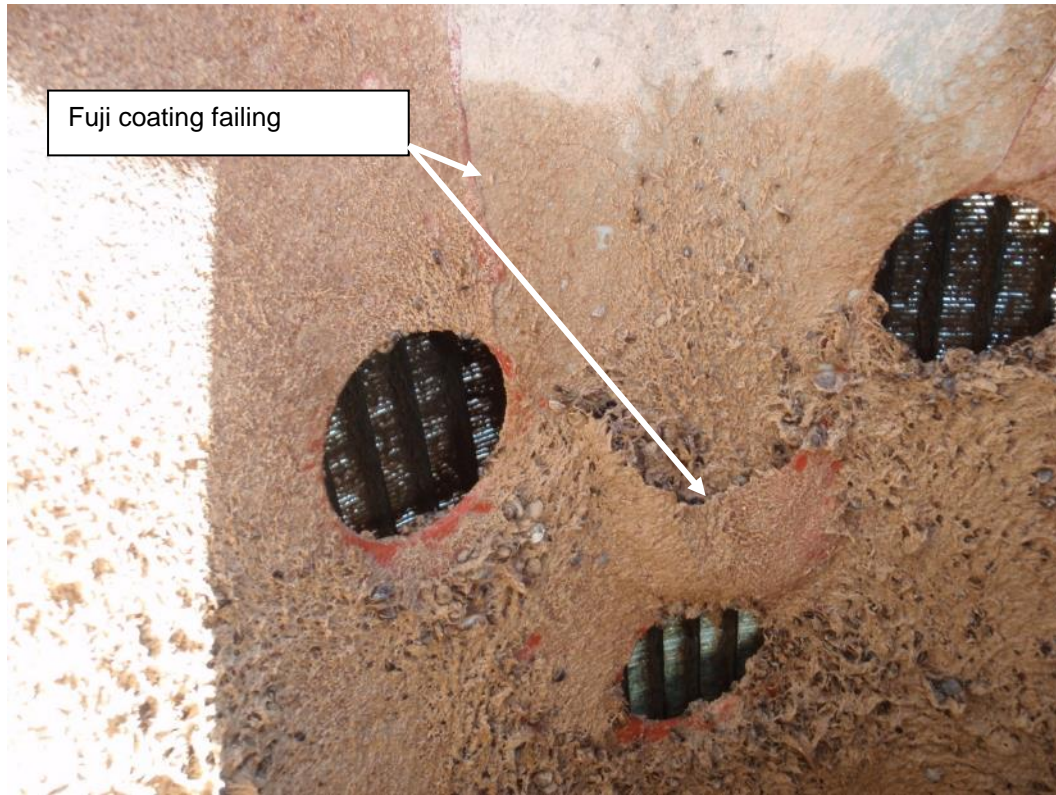
Figure 40 Mussel and biofilm attachment to the inside of the ISI internal flow baffle.
