HYD 137

EXPERIENCES OF THE BUREAU OF RECLAMATION

BY JACOB E. WARNOCK,¹ M. AM. SOC. C. E.

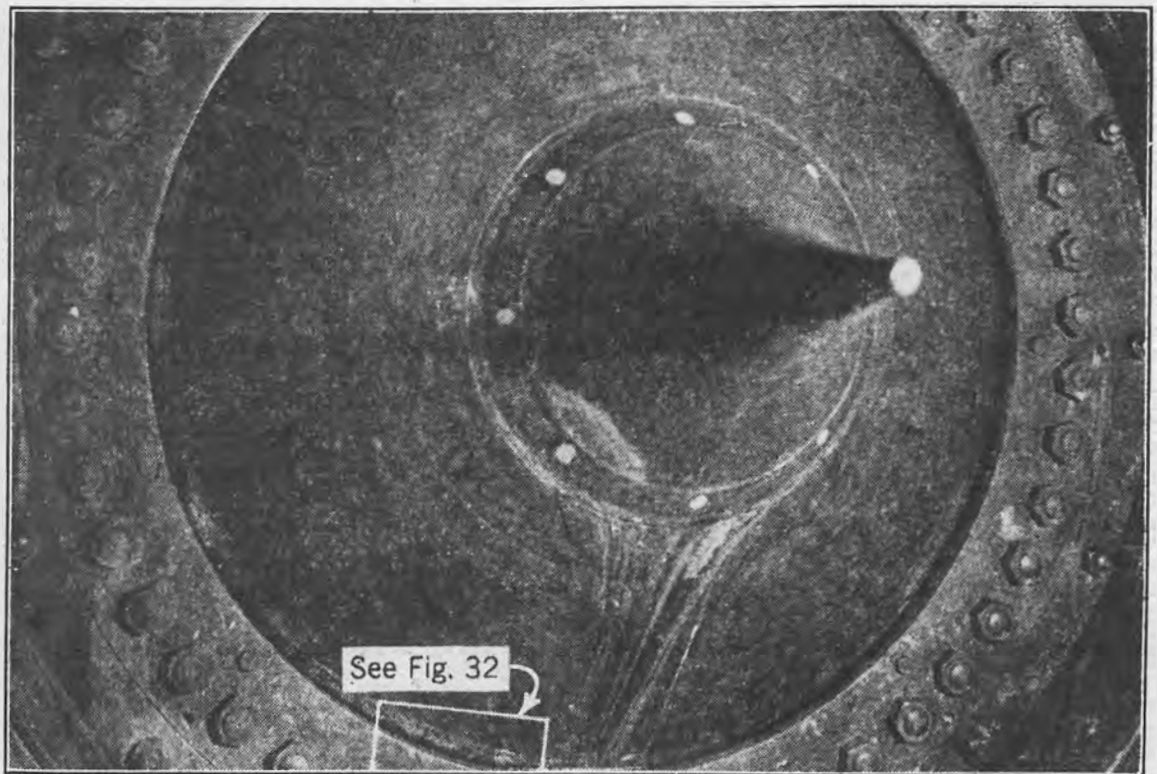
FIG. 31.—PITTING OCCURS AROUND THE PERIPHERY OF A LARGE NEEDLE VALVE, IMMEDIATELY BELOW REGIONS OF SUBATMOSPHERIC WATER PRESSURES

Initial operation at Boulder Dam and Alcova Dam, in Wyoming, produced severe erosion of the needle valves in the outlet structures which was expensive to maintain, since the valves were not readily accessible. The type of damage is shown on the needle in Figs. 31 and 32. In this case, the damage was produced in a relatively short time. Detailed records are not available, but the time was probably about one month at the one-half open position with a head of 145 ft.

Streamlining the needle tips is considered the only practicable means of eliminating damage to this part of the valve; however, damage could be reduced to a minimum by restricting the valve operation to noncritical openings determined by detailed pressure measurements on the prototype or by model tests, or both.

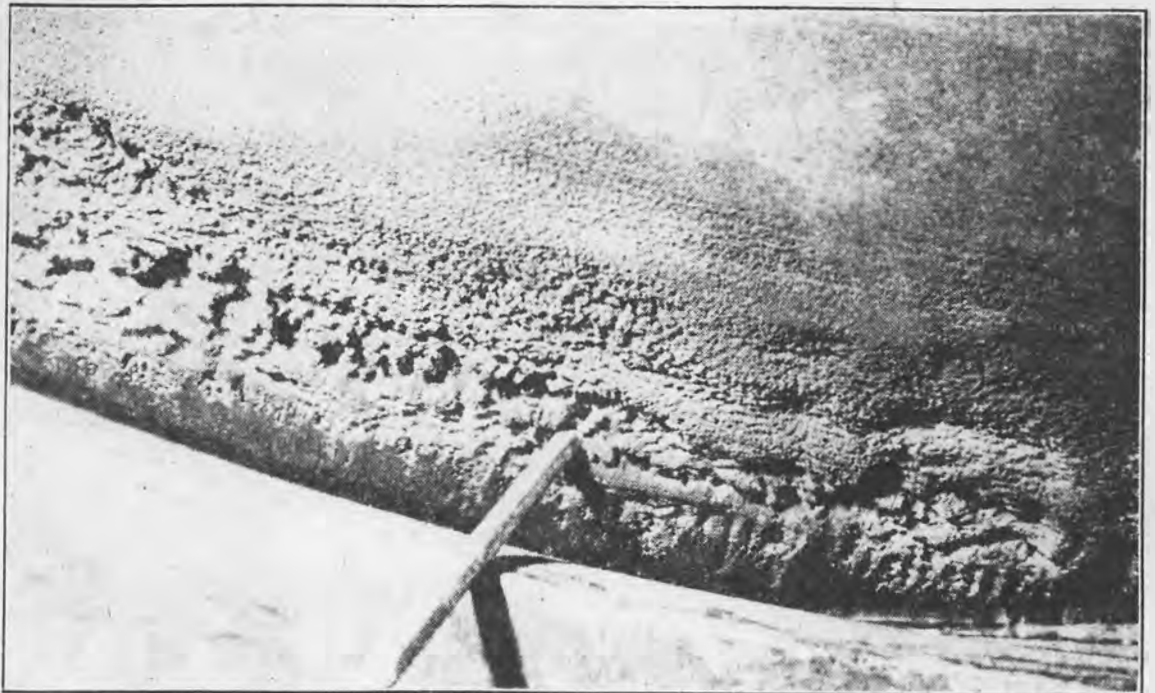
FIG. 32.—ENLARGED VIEW OF SECTION IN FIG. 31 EMPHASIZES THE SEVERE PITTING ON THE SHOULDER OF THE NEEDLE VALVE WHICH REQUIRES EXPENSIVE MAINTENANCE BY WELDING

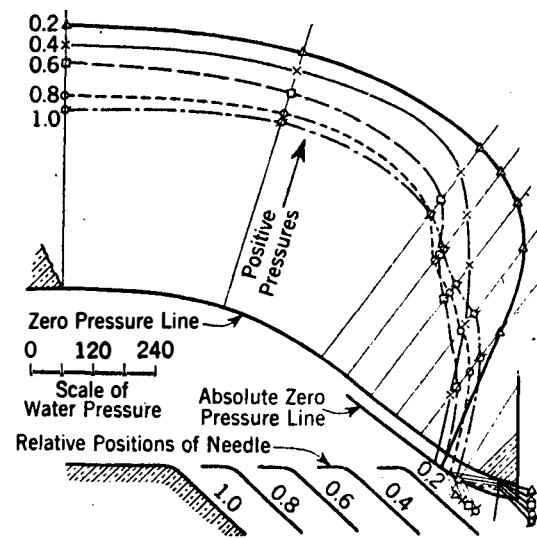
Piezometers installed in the nozzle of one of the 72-in. valves at Boulder Dam showed pressures near absolute zero in a zone (Fig. 33) immediately upstream from the region of erosion or pitting throughout the entire range of the valve. Since the installation of pressure equipment in one of the 72-in. needles would have been intricate, a homologous needle valve with an exit diameter of 5 in. was installed for testing in one of the tunnel-plug outlets at

FIG. 33.—PRESSURE DISTRIBUTION ON THE NOZZLE OF A 72-IN. NEEDLE VALVE (HEAD, 516 FT) SHOWS REGIONS OF LOW PRESSURE WHICH CORRELATE PERFECTLY WITH THE OCCURRENCE OF PITTING

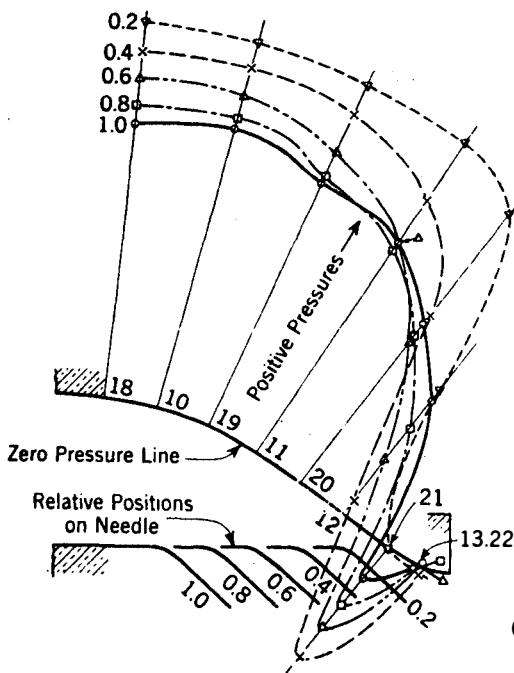
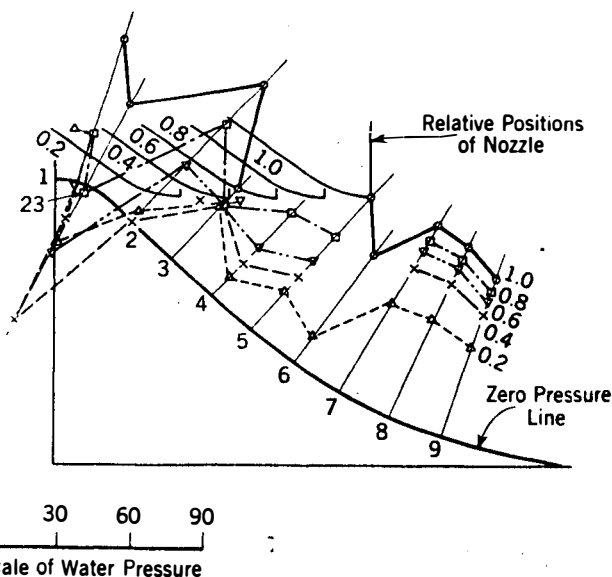
Boulder Dam. The pressure distribution on the needle and nozzle is shown in Fig. 34 for various openings of the valve under a constant head of 150 ft.

FIG. 34.—DETAIL DATA FROM EXTENSIVE TESTS OF A 5-IN. SCALE-MODEL NEEDLE VALVE FURTHER CONFIRM THE PRESSURE MEASUREMENTS AND PITTING OBSERVED ON THE PROTOTYPE

In general, the pressure conditions were most critical at a valve opening of approximately 40%. The results of a wear test (Fig. 35) are shown after six

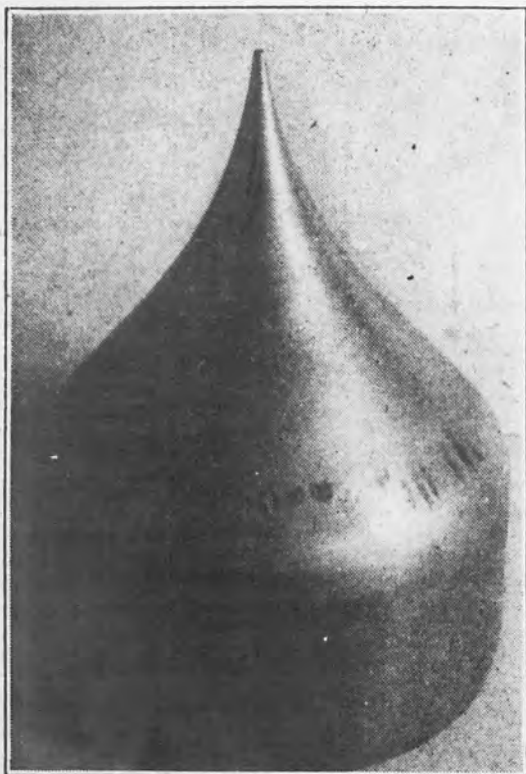
days of operation under a total head on the valve of 460 ft with the valve opening of 40%—the severest condition.

FIG. 35.—PITTING ON THE NEEDLE OF A 5-IN. VALVE, ACCORDING TO THE ORIGINAL DESIGN, AFTER SIX DAYS OF OPERATION (40% OPENING AND $H = 460$ FT)

The original design of nozzle had an expanding water passage which tended to lower the velocity and cause a regain of velocity head. This yielded a higher discharge but created low-pressure areas in the valve. When forces in the low-pressure areas were of sufficient intensity, they produced cavitation with the accompanying pitting.

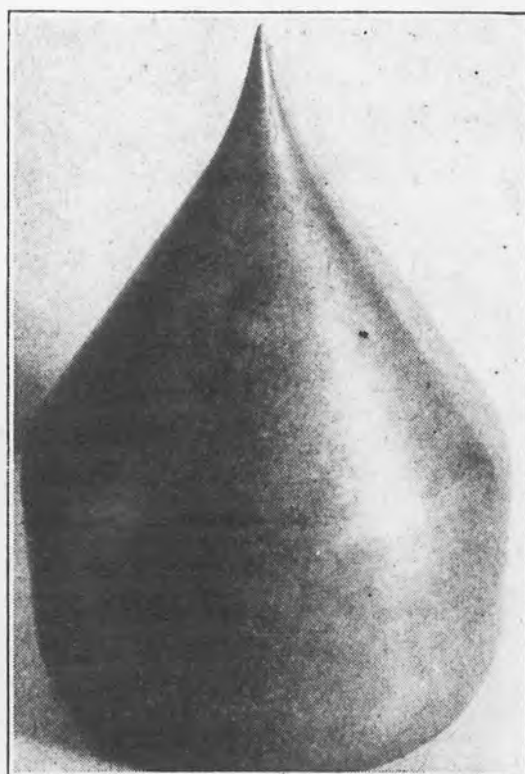
A number of designs were studied in the laboratory using the same 5-in. valve and a design was developed which produced positive pressures at all valve openings and at all heads. This design, when subjected to a wear test, under the same conditions as the original design (except at an opening of 20%, the opening at which the severest conditions occurred), showed no sign of pitting on the needle after eighty-four days of operation (Fig. 36).

FIG. 36.—ABSENCE OF PITTING ON THE NEEDLE OF A 5-IN. VALVE, ACCORDING TO THE IMPROVED DESIGN, AFTER 84 DAYS OF OPERATION (20% OPENING AND $H = 460$ FT)

From the high-head studies of the 5-in. valve, certain specifications were developed to maintain positive pressures on the needle and nozzle of the valve at all openings. The angle between the needle and the nozzle must not be divergent in the direction of flow. The needle and nozzle profiles may be parallel and still maintain positive pressures, but a convergence of one to three degrees is preferable. The seat must be on the tangent portion of the needle; that is, the base diameter of the needle cone must be slightly larger than the outlet diameter of the nozzle. The valve nozzle should have no point of inflection; it should have a sharp edge to maintain the minimum section at

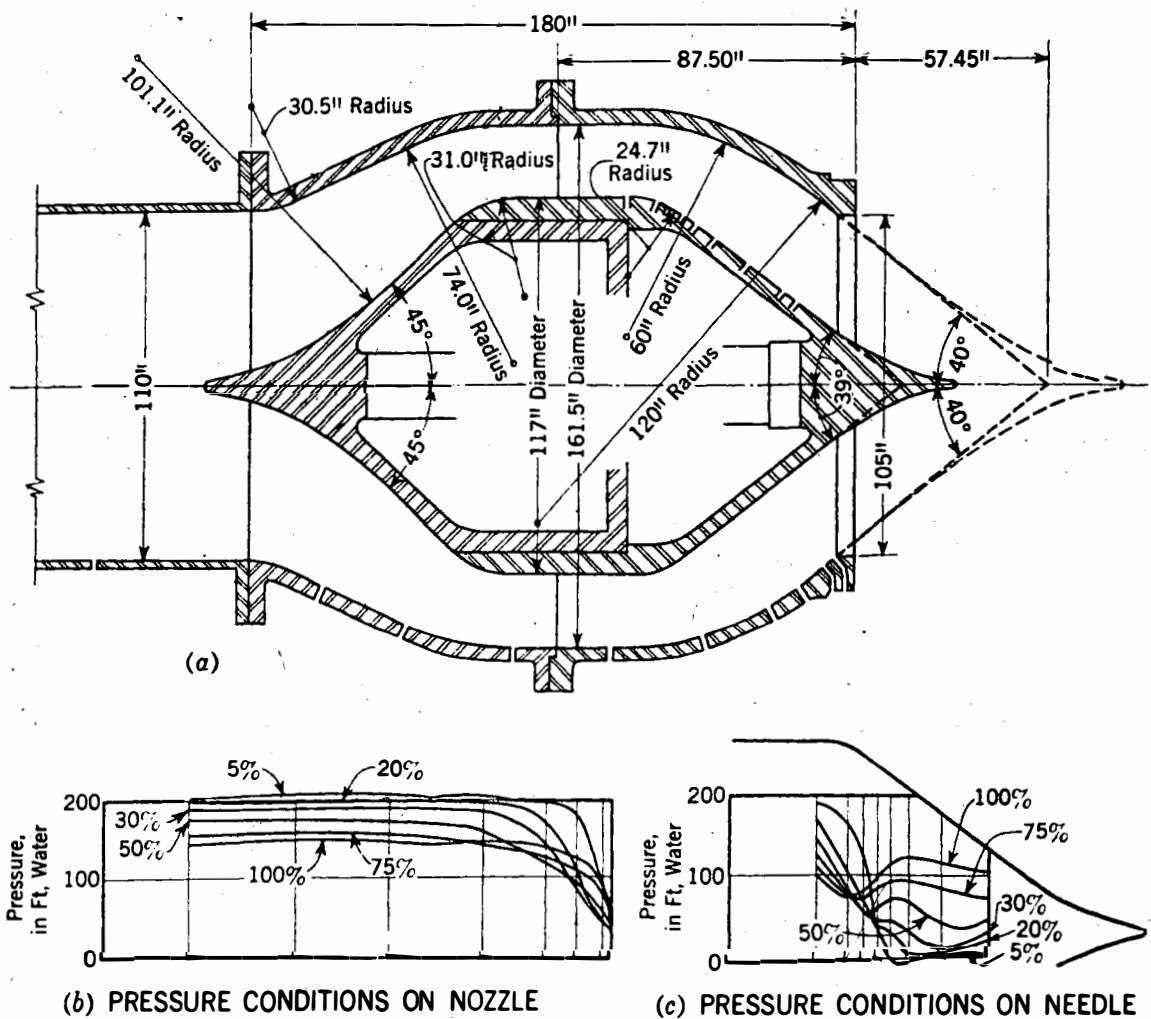
Using a 6-in. valve equipped with piezometric taps throughout the profile of the needle and the nozzle, the design was altered further by increasing the outlet and equatorial diameter and the needle travel until a combination was found in which the cavitating pressures were absent over the entire range of valve opening (Fig. 37) and the discharge capacity was comparable to that of the original valve.

FIG. 37.—COMPLETE ABSENCE OF CAVITATING PRESSURES ON THE NEEDLE AND THE NOZZLE OF A NEW DESIGN OF NEEDLE VALVE, AS DETERMINED FROM A 6-IN. MODEL

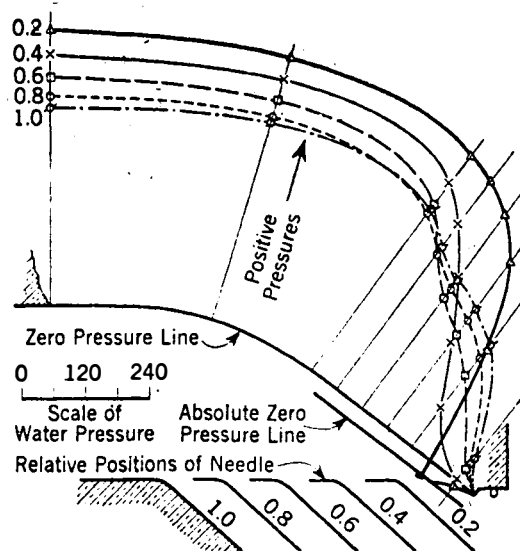
Subsequently, sharp-edged nozzles were installed on certain valves at Boulder Dam and the pressure results show a marked improvement in distribution (Fig. 38). Field reports indicate a minimizing of pitting on those valves so equipped. Operation of the valves with the original nozzle shape at openings where the subatmospheric pressures were less severe, as indicated by model tests, has also tended to reduce the amount of pitting.

FIG. 38.—PRESSURE DISTRIBUTION ON THE NOZZLE OF THE 72-IN. NEEDLE VALVES AT BOULDER DAM, WITH REVISED PROFILE OF NOZZLE

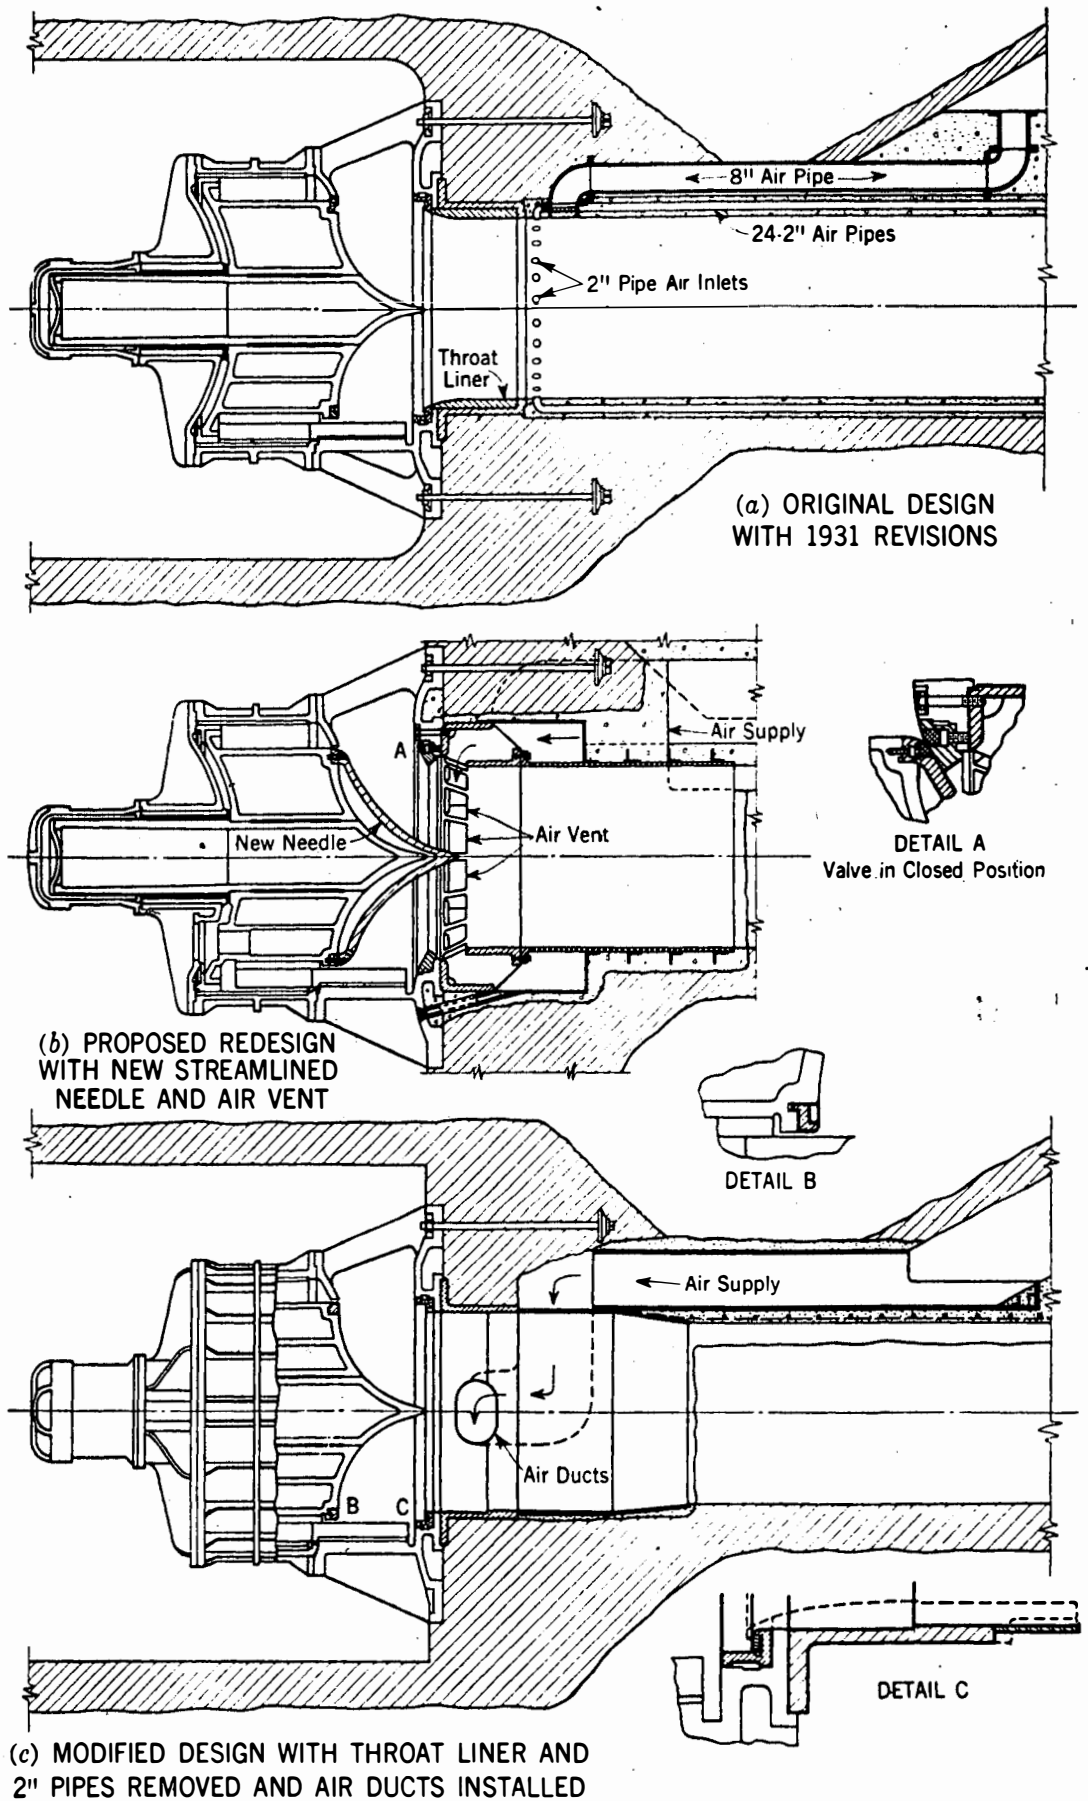
FIG. 39.—BALANCED VALVES IN THE LOWER OUTLETS AT SHOSHONE DAM

In 1930-1931, an attempt was made to relieve the Shoshone situation by installing twenty-four 2-in. pipes and an 8-in. air duct below each valve (Fig. 39(a)). A marked increase in the intensity of the noise accompanying the discharging water resulted, and the experiment was considered unsuccessful. Because of the failure of the vent system, resort was made to the original method of maintenance and the valves were used as little as possible. The pitting was serious and the repairs inadequate, but a more practical method of repair was not apparent.

The model tests showed that the present prototype vent system is inadequate to prevent cavitation for all except a very small range of valve openings. Insufficient air is supplied between 23% and 70% openings, and some of the 2-in. vent pipes on the invert and crown become ineffective at openings above 85%, due to eddies forming immediately downstream from the V-guides. These conditions precluded safe operation of the present installation at ranges of valve opening other than 70% to 85%. Studies of the present installation indicated that the pitting on the valve needles was most severe between openings of 14% and 25%, and that damage to the conduits resulted between 23% and 70% valve opening. The damage to the conduit at these openings probably rendered the air-supply system ineffective and aggravated the destructive action for larger valve openings.

Damage by cavitation and pitting on the valve needles and discharge conduits can be eliminated entirely by a major revision (Fig. 39(b)) of the needle tip, the valve seat, the conduit throat, and the aeration system. This solution will reduce maintenance costs to a minimum and the valves can be operated at any opening without fear of damage due to subatmospheric pressures; but it will reduce the discharge capacity by approximately 20%, a factor to be considered in future revisions.

Minor alterations of the present structure (Fig. 39(c)) will involve: (a) Streamlining of the sealing edge of the plunger; (b) removal of a part of the bronze sealing ring by chipping and grinding; (c) removal of the throat liner; and (d) revamping of the air-supply system. Aeration equivalent to three 12-in. ducts would be adequate in this arrangement, but slightly more area was recommended as information on air requirements in high-velocity flow is limited. Operation of this modified design at openings smaller than 23% will have to be avoided to prevent damage to the needle. The discharge capacity is not affected noticeably by the modification.

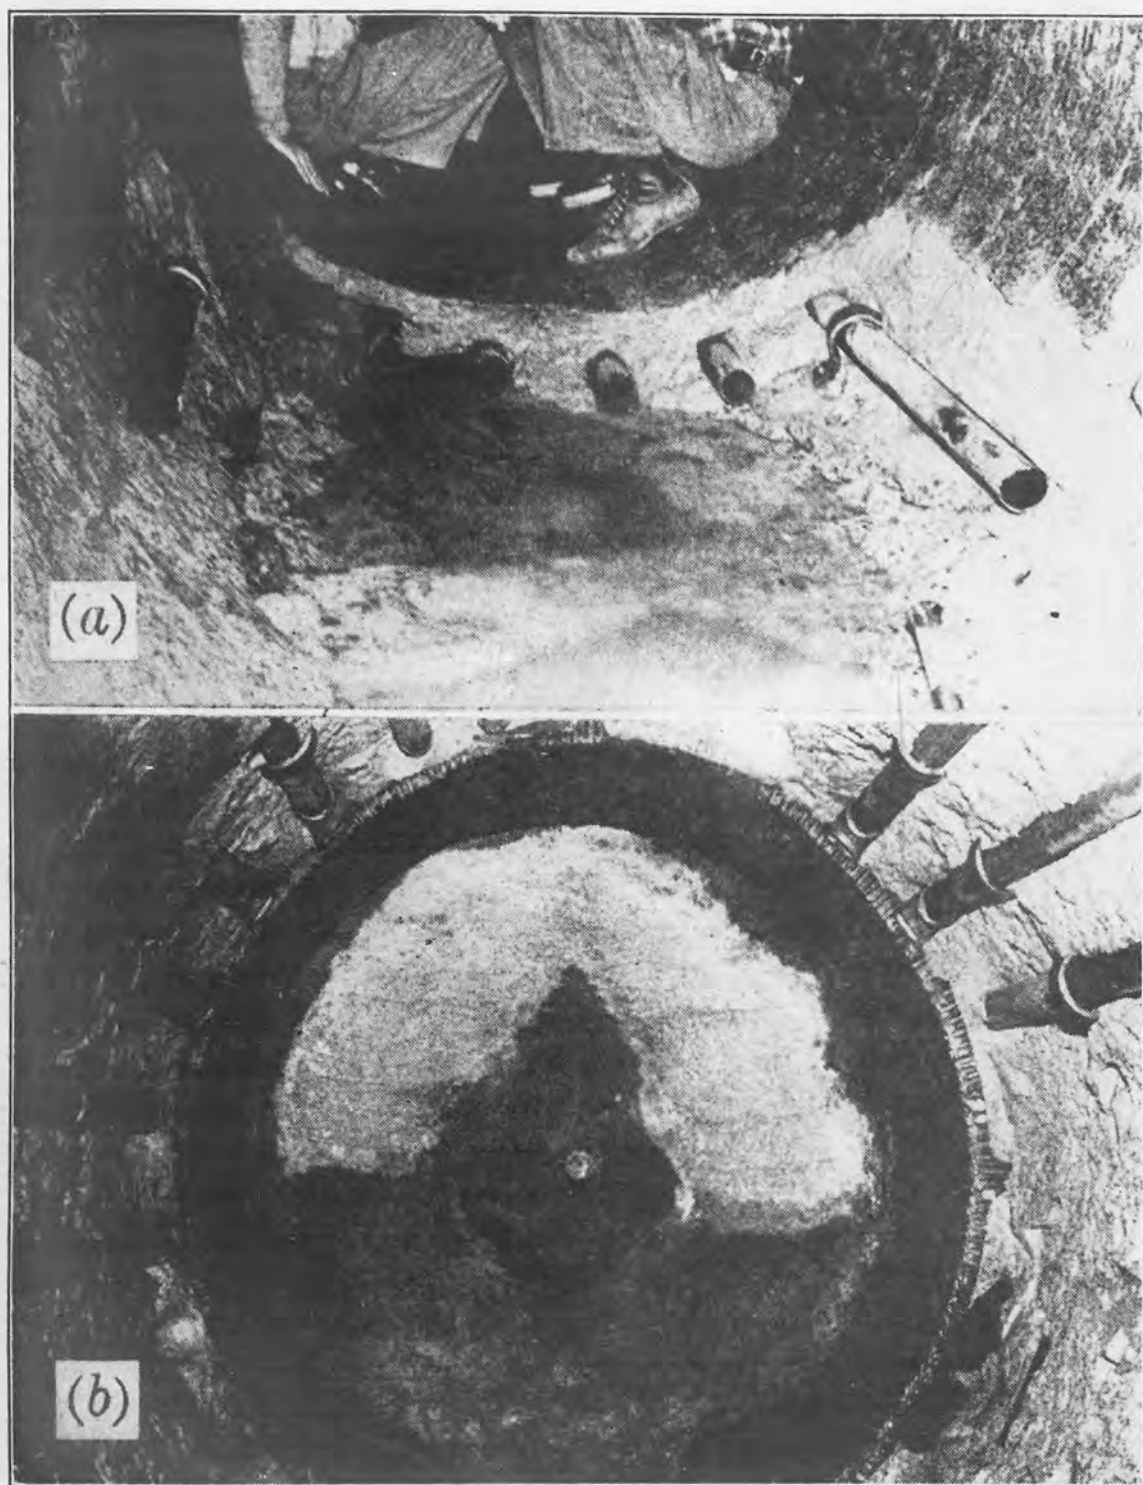
The concrete for several feet downstream from the metal lining in each conduit had been eroded severely and most of the twenty-four 2-in. pipes embedded in the conduit during the 1931 revision had been torn out in the eroded area (Fig. 40(a)). The "semi-steel" (high-test gray iron) conduit liner

below the valve was pitted severely and the face of the needle (Fig. 40(b)) had badly pitted areas (by operation in previous years) on which several kinds of

FIG. 40.—REMAINS OF 2-IN. AIR PIPES, SHOSHONE DAM: (a) Vent of a 52-In. Conduit Facing Downstream from the East Valve; (b) East Conduit

metal had been tried—none satisfactorily. The areas of greatest pitting were below and above the valve guides, where only $\frac{3}{4}$ in. of the original 2 in. of parent metal remained. The extensive welding of previous years, on the

needle face, is apparent in Fig. 40(b). The end of the metal liner was cut off in 1931 when the present installation was made.

itself showed no evidence of additional pitting, and a very small amount of pitting had occurred in the extreme top of the discharge conduit. Forty-seven days of operation at 9% opening in 1942 had caused the damage shown in Fig. 40.

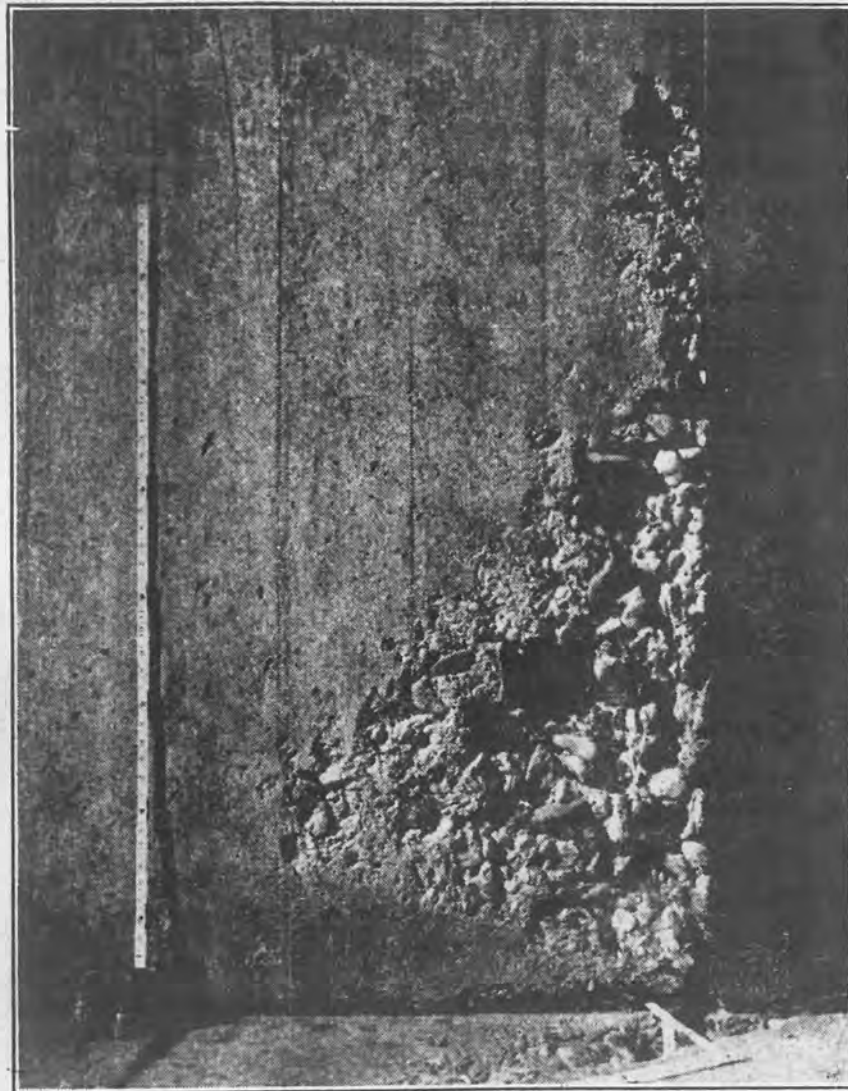
FIG. 41.—PITTED AREA ON THE FACE OF A SPILLWAY PIER IMMEDIATELY DOWNSTREAM FROM THE GATE RECESS AT THE RIGHT, OR CALIFORNIA END, OF GATE NO. 5 AT PARKER DAM

An eroded condition, similar to that on the spillway faces at Bonneville Dam described in a previous paper, began to develop on the faces of the spillway piers and on the spillway crest immediately downstream from the gate slot

(Fig. 41). It first appeared below the gate which had the longest record of operation, but there was evidence of it downstream from the other gates. Subsequent operation of the other gates had gradually developed the same pattern on all ten of the pier faces in lesser degree of intensity. Photographic inspection at approximately yearly intervals discloses some increase in the extent of the area and depth of the erosion, but not sufficient to cause undue alarm, particularly since the power plant has been placed in operation and most of the low-water flow passes the dam through the turbines.

Model studies were undertaken to reveal the cause and means of eliminating pitting at Parker Dam and to prevent it at future installations. Incompleted studies, including all possible circumstances, have revealed several points of interest. The use of transparent models revealed cavitation under the end of the gate in the gate slot as a result of a vortex. Pitting, caused by the collapse of the low-pressure pockets breaking away from the bottom of the vortex, is the only logical explanation of the damage to the pier face.

Insertion of steel plates in the piers in the areas of pitting, as was done on the spillway piers at Bonneville Dam, is also a solution, but one remedying the effect rather than removing the cause.

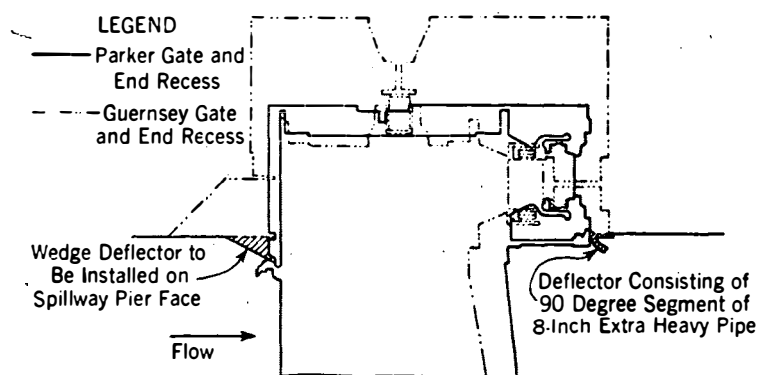
The gate slot at Guernsey Dam is considerably larger (Fig. 42) in horizontal cross section than the gate slot at Parker Dam. As a result, the vortex in the

FIG. 42.—COMPARISON OF THE GATE RECESSES OF GUERNSEY DAM AND PARKER DAM, SHOWING THE LOCATION OF THE DEFLECTORS PROPOSED AS REMEDIAL MEASURES AT PARKER DAM

gate slot at Guernsey Dam was large and slow in rotation with no appreciable reduction in pressure at the core, whereas with the smaller cross section of the gate slot at Parker Dam, the angular velocity was high with a very small core and very low pressures in the core. As in the case of the cavitation zone downstream from a venturi throat, the flow condition was unstable and low-pressure pockets broke away from the bottom of the vortex. Some of the pockets collapsed against the boundary surface, resulting in the destruction of the concrete and metal.

According to the present conception of the condition, the solution appears to be the elimination of the vortex. This can be done in a number of ways, none of which is universally applicable. In the case of Parker Dam, it is proposed to install a wedge-shaped deflector (Fig. 42) upstream from the gate sufficient in extent to deflect the flow of water under the gate away from the

downstream corner of the gate slot, thus negating the formation of the vortex. An additional curved deflector consisting of a 90° segment of an 8-in. extra heavy pipe fastened to the metal at the downstream side of the gate slot will further deflect the flow away from the pier face and provide aeration down to the spillway crest. Another solution, practicable where the spillway crest is sufficiently far above the tailwater to provide drainage, is the extension of the end beams of the gates down into wells in the spillway crest, thus making them continuations of the gate slots. These gate-beam extensions will then serve as followers and will fill the gate slot as the gate is raised, providing continuity of the spillway pier face. In the case of a gate 50 ft high, the follower is considered structurally feasible in lengths to 6 ft. The model studies indicated that a follower length of from 2 ft to 3 ft is all that is necessary, since the occasion and duration of operation at the larger openings are infrequent and short.

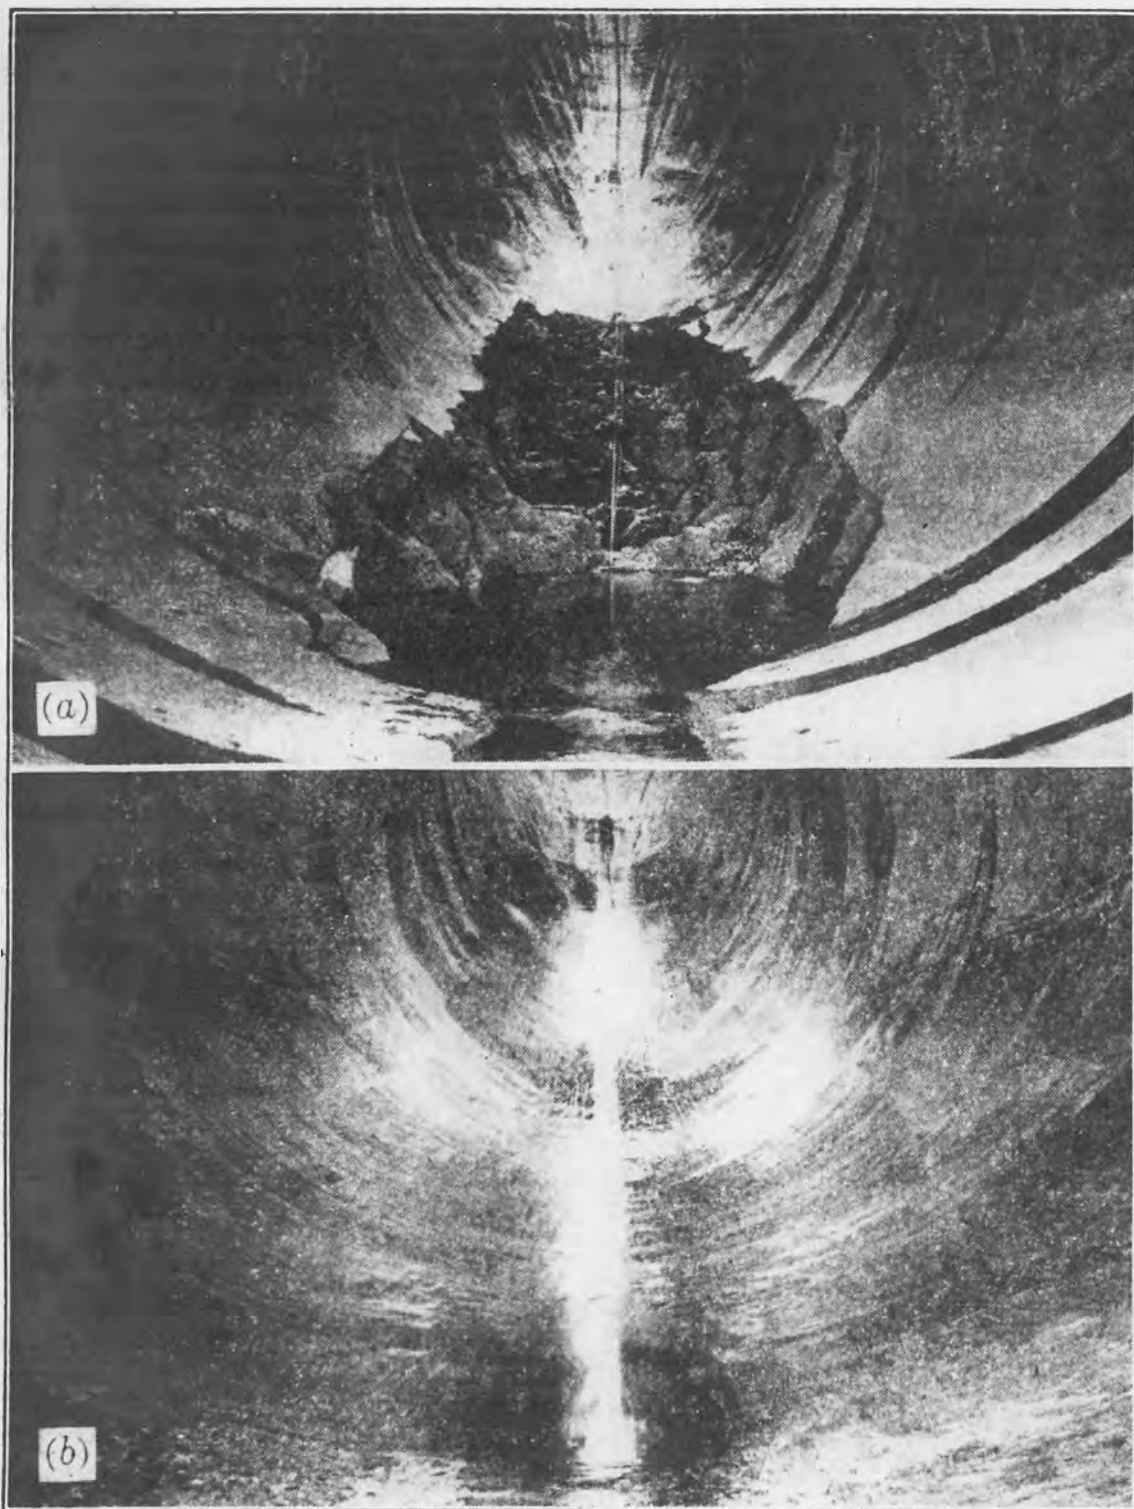
During a routine inspection of the spillway tunnels on December 12, 1941, an eroded area was discovered in the bottom of the curve connecting the inclined and horizontal portions of the spillway tunnel (Fig. 43(a)). The hole was approximately 115 ft long and 30 ft wide, with a maximum depth of 45 ft below invert grade.

The repair (Fig. 43(b)) of the damaged area has been described elsewhere (28). The chief concern here is an attempt to analyze the cause of the erosion. A number of theories have been advanced. In the opinion of the writer, the primary cause was misalignment of the tunnel a few feet upstream from the upper end of the eroded area. With an extremely high velocity down the inclined portion of the tunnel (at least 150 ft per sec), the stream followed the invert profile down to the hump; but as it flowed over the hump, the water could not follow the sudden change in grade and a cavitation region formed between the sheet of flowing water and the concrete. The pressure in that region was the vapor pressure of the water, but since this condition was very unstable, the low-pressure pocket or cavity intermittently passed downstream

FIG. 43.—CAVITATION IN THE SPILLWAY TUNNEL ON THE ARIZONA SIDE, BOULDER DAM: (a) Eroded Area After Unwatering; (b) After Completion of Repairs

In making the repairs to the tunnel, aside from providing concrete having the most suitable qualities practicable, extra effort was made to provide a smooth continuous surface with no humps or depressions. Two major humps and several minor humps in the invert above the eroded area were entirely eliminated by bushing and grinding, using a template cut to the true radius of curvature. Rock pockets were cleaned, patched, and then ground to conform to the surrounding concrete. Accumulations of grout and mineral deposits were removed. The surface of new concrete in the eroded area was finished carefully to produce a sound, continuous, uninterrupted surface. The surface was given a final grinding with a small terrazzo machine to remove board marks and objectionable offsets, leaving an extremely smooth surface. Minor bulges in the surface were removed by bushing followed by grinding, using a template cut to the correct radius of curvature. Considerable care was used in grinding the surfaces adjacent to the old concrete lining to remove all offsets and other irregularities.

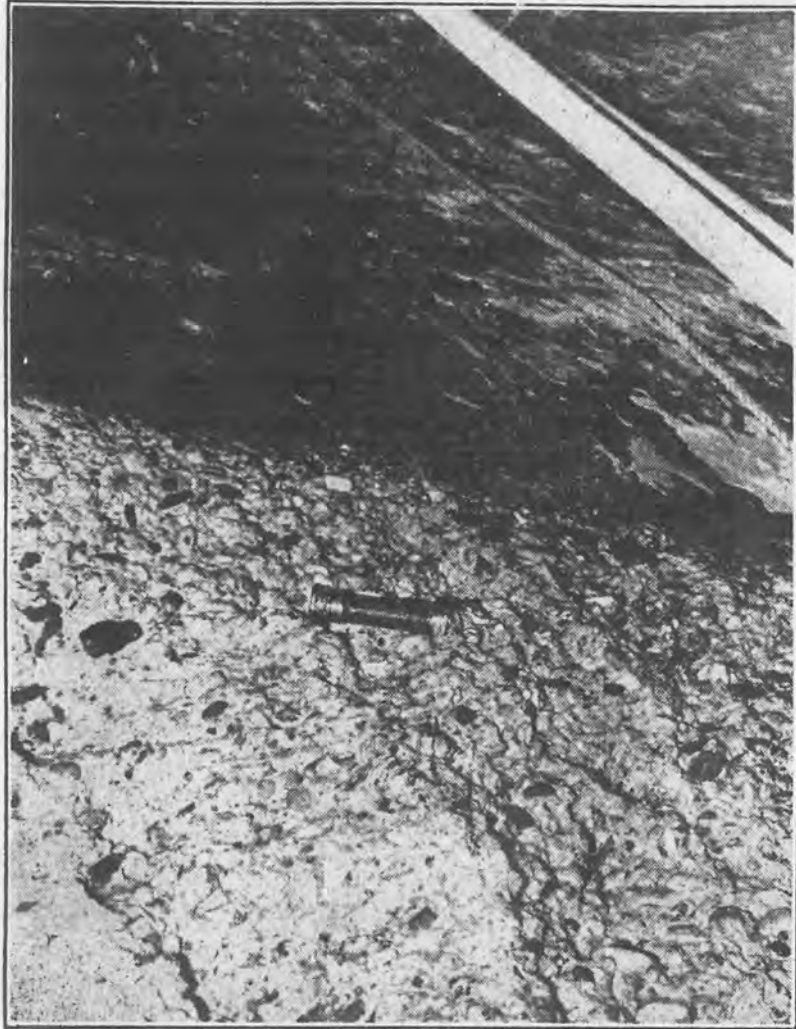
in the region of higher pressures, collapsed and disintegrated or pitted the concrete as shown in the foreground of Fig. 44. The misalignment is defined by the position of the rope in Fig. 44.

FIG. 44.—PITTED SURFACE DOWNSTREAM FROM THE MISALINEMENT IN THE TUNNEL AT THE UPSTREAM END OF THE ERODED AREA
