UNITED STATES
DEPARTMENT OF THE INTERIOR
BUREAU OF RECLAMATION

Laboratory Report No. 187
Hydraulic Laboratory

Subject: Test operation of 84-inch Needle Valve By-pass Outlet in Bay
R-9 of Right Powerhouse—Grand Coulee Dam—Columbia Basin
Project

Subject: Condition of 84-inch needle valve outlet after test operations of August 7, 8, and 9, 1945--Grand Coulee Dam-- Columbia Basin Project

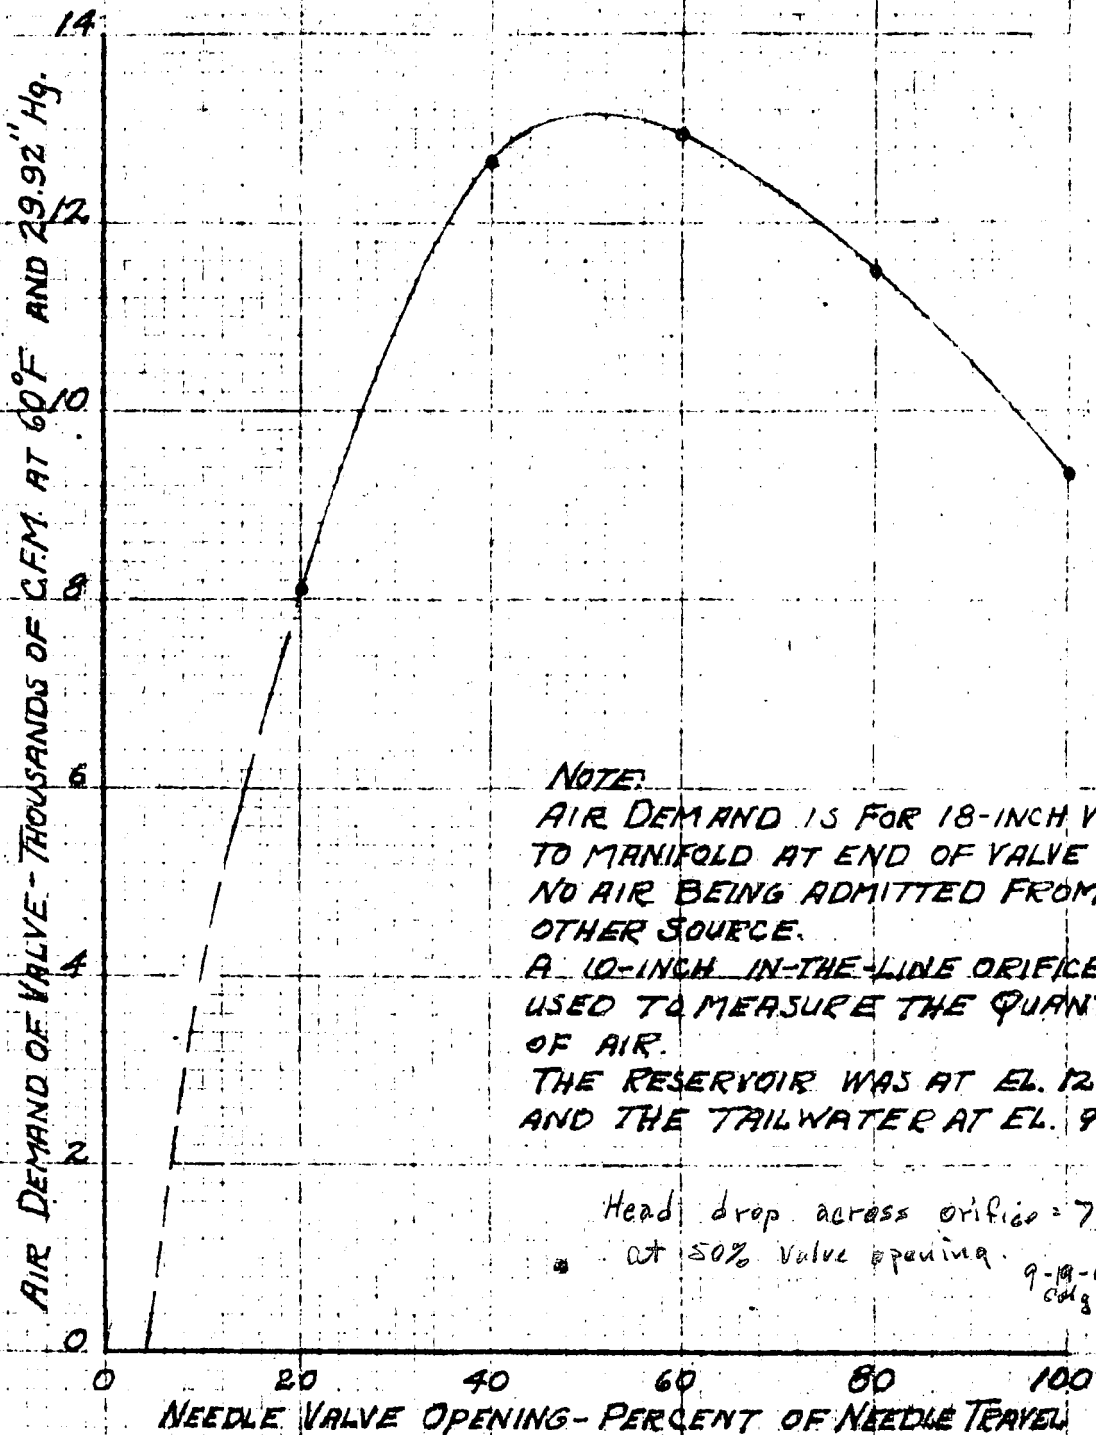
FIGURE 1

GRAND COULEE DAM

AIR DEMAND OF 84-INCH NEEDLE VALVE IN SPILLWAY BY-PASS OUTLET
 J.W.B. 6-12-45

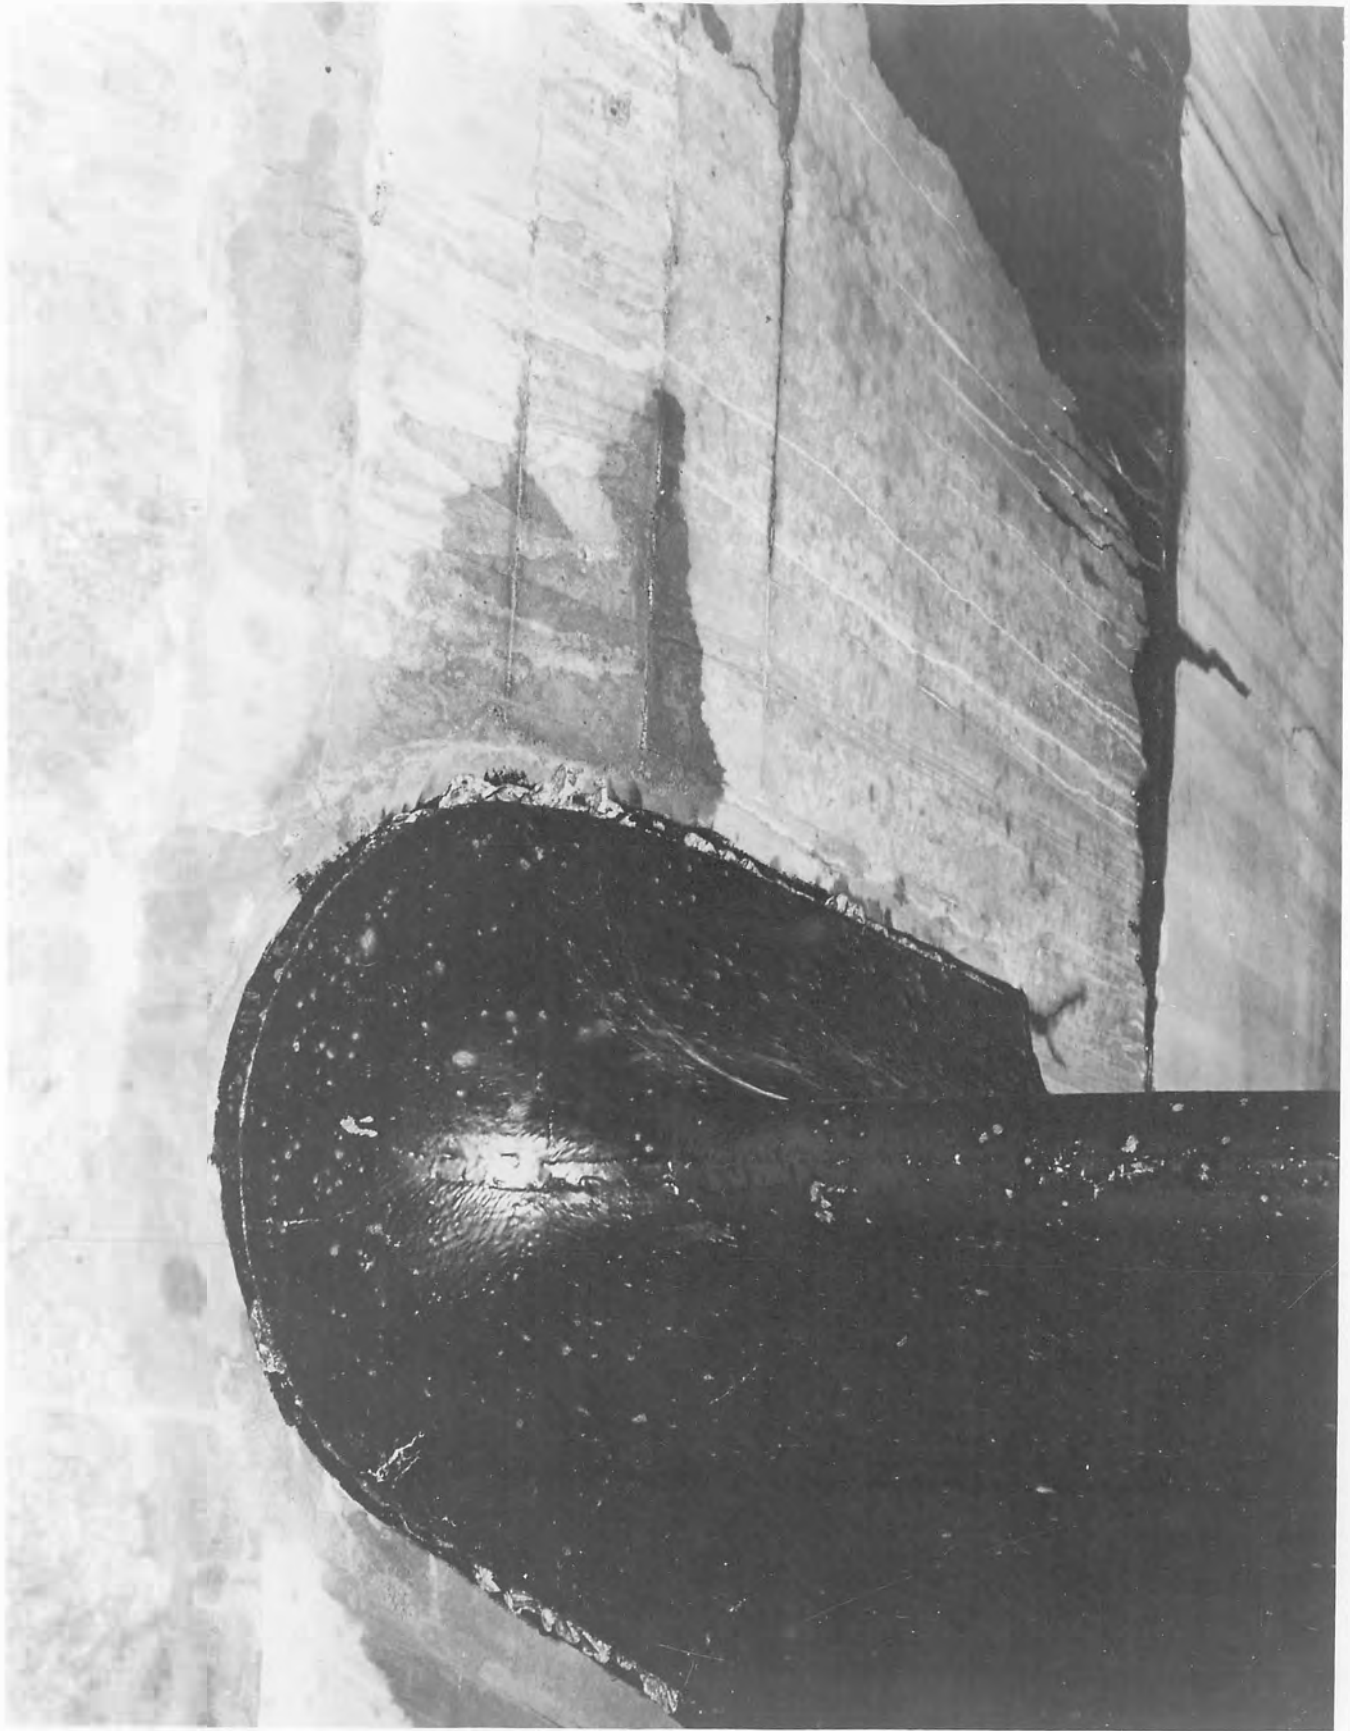
At many points the concrete edges adjacent to the metal noses of the draft tube piers, in both the top and bottom of the draft tube, were chipped as if pried out by a bar placed in the joints between the metal noses and the concrete. The cause of this condition was not apparent.

The breaks in the concrete edges adjacent to the metal noses of the draft tube piers appeared to be unchanged from those observed during the inspection following the initial test. The chipped edges shown adjacent to the pier nose on the attached photographs are typical of this condition, Figure 2 (photo #13046).

Fig. 2. Photograph 13046-3, June 7, 1945: View from floor of draft tube showing chipped edges in concrete adjacent to top of the metal pier nose in draft tube R-9.

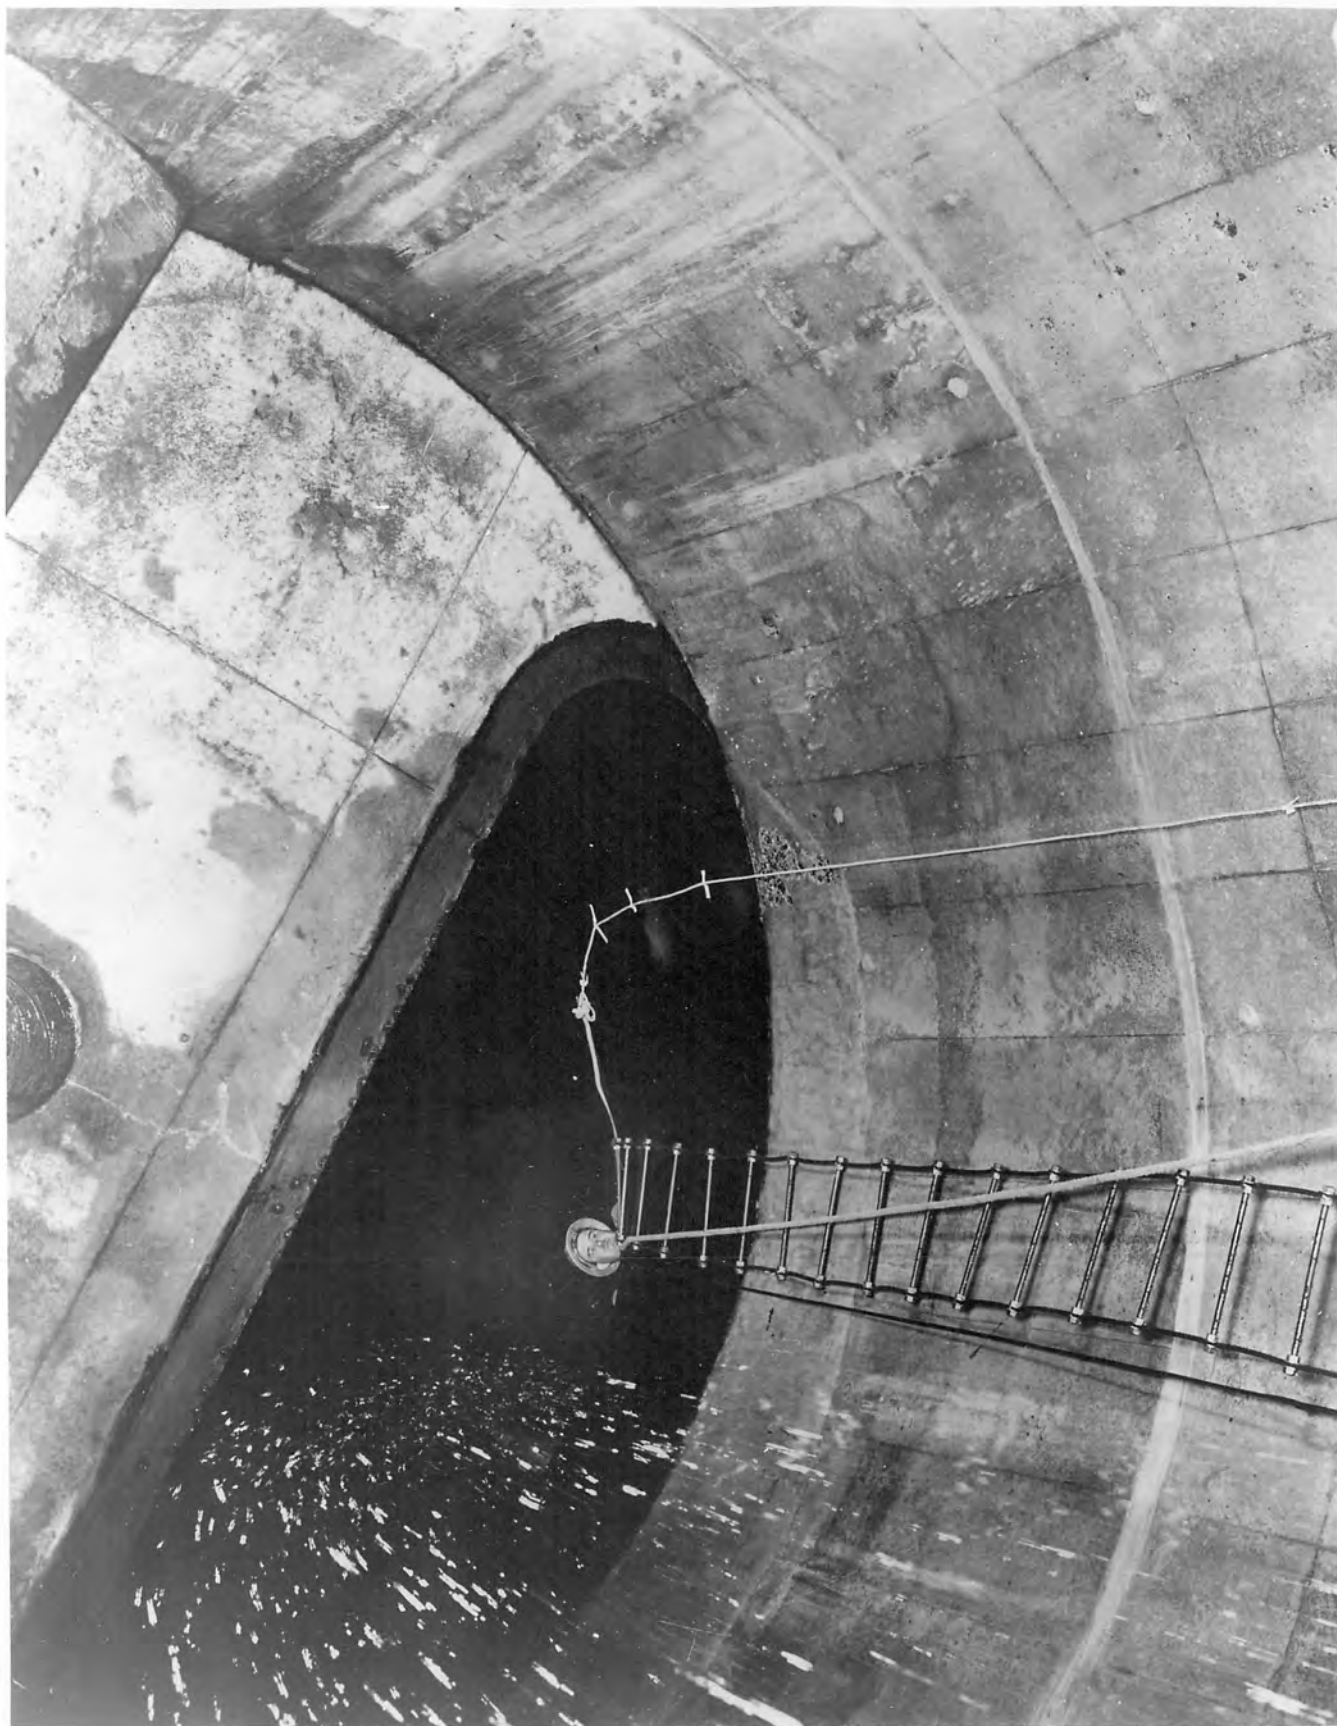
The pitted areas in the concrete adjacent to the exit of the elbow immediately below the areas from which the paint had been removed are parts of the areas resulting from the conditions created by the last welded joint of the transition elbow. This is shown clearly in Figures 3 and 4. A wedge of concrete plastered on the curved wall below the exit of the transition elbow may be seen in these figures also. The wedge was placed when the curve of the elbow exit failed to coincide with and extended over the concrete immediately below in this region. The face of this wedge slopes back from the vertical plane to the wall of the dome inside the concrete anchor block. This in itself would produce a point of inflection at the back edge of the transition exit of the inner curve if the last section of the elbow terminated in the vertical plane. This is not the case, however, as the surface of this section slopes downstream at an angle of at least $4\frac{1}{2}$ degrees at the centerline. This characteristic, evolving from the segmental construction of the elbow, is shown clearly in the side elevation, drawing 222-D-9187. In addition to these two factors, the wall of the dome within the concrete anchor block flares outward over most of the length of the elbow exit and to its right, producing an overhang which adds to the discontinuity. This condition is shown in section F-F, and Y-Y, drawing 222-D-9250. Although the three factors mentioned above are additive insofar as the discontinuity at the elbow exit is concerned, any one of the three are considered of sufficient magnitude to create a region of sub-atmospheric pressure capable of producing cavitation.

Fig. 3. Photograph 13044-3, June 7, 1945: View from floor of draft tube showing pitting by cavitation in the inner curve at the left side of the steel elbow and in the wall of the anchor block immediately below, after operation of the R-9 outlet for tests on May 25 and June 5, 1945. Discontinuities in flow boundary accentuated by small rope passing over damaged areas.

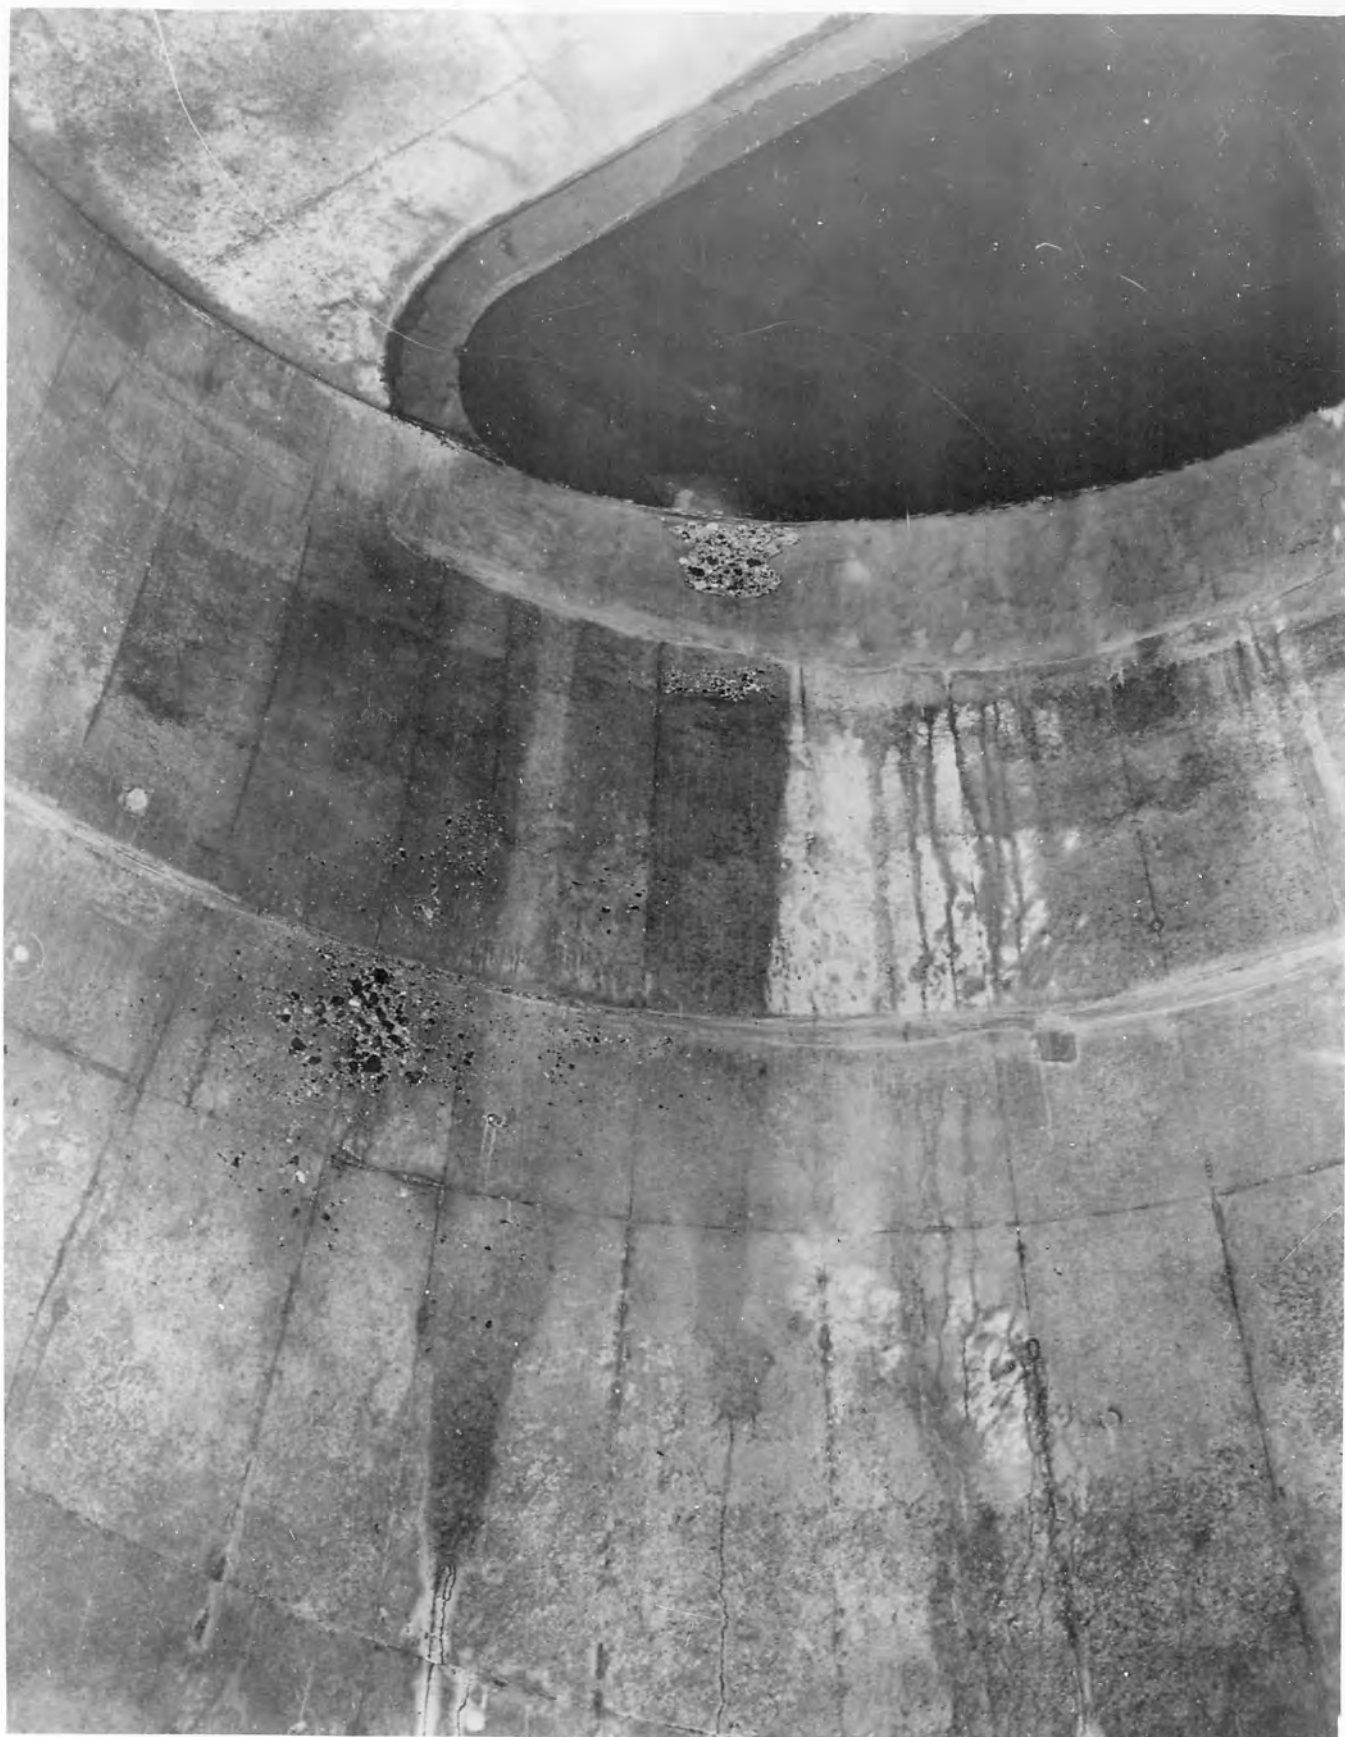
Fig. 4. Photograph 13042-3, June 7, 1945: View from draft tube floor showing pitting by cavitation in the inner curve at the right side of the steel elbow and in the wall of the anchor block below after the operation of the R-9 outlet for tests on May 25 and June 5, 1945.

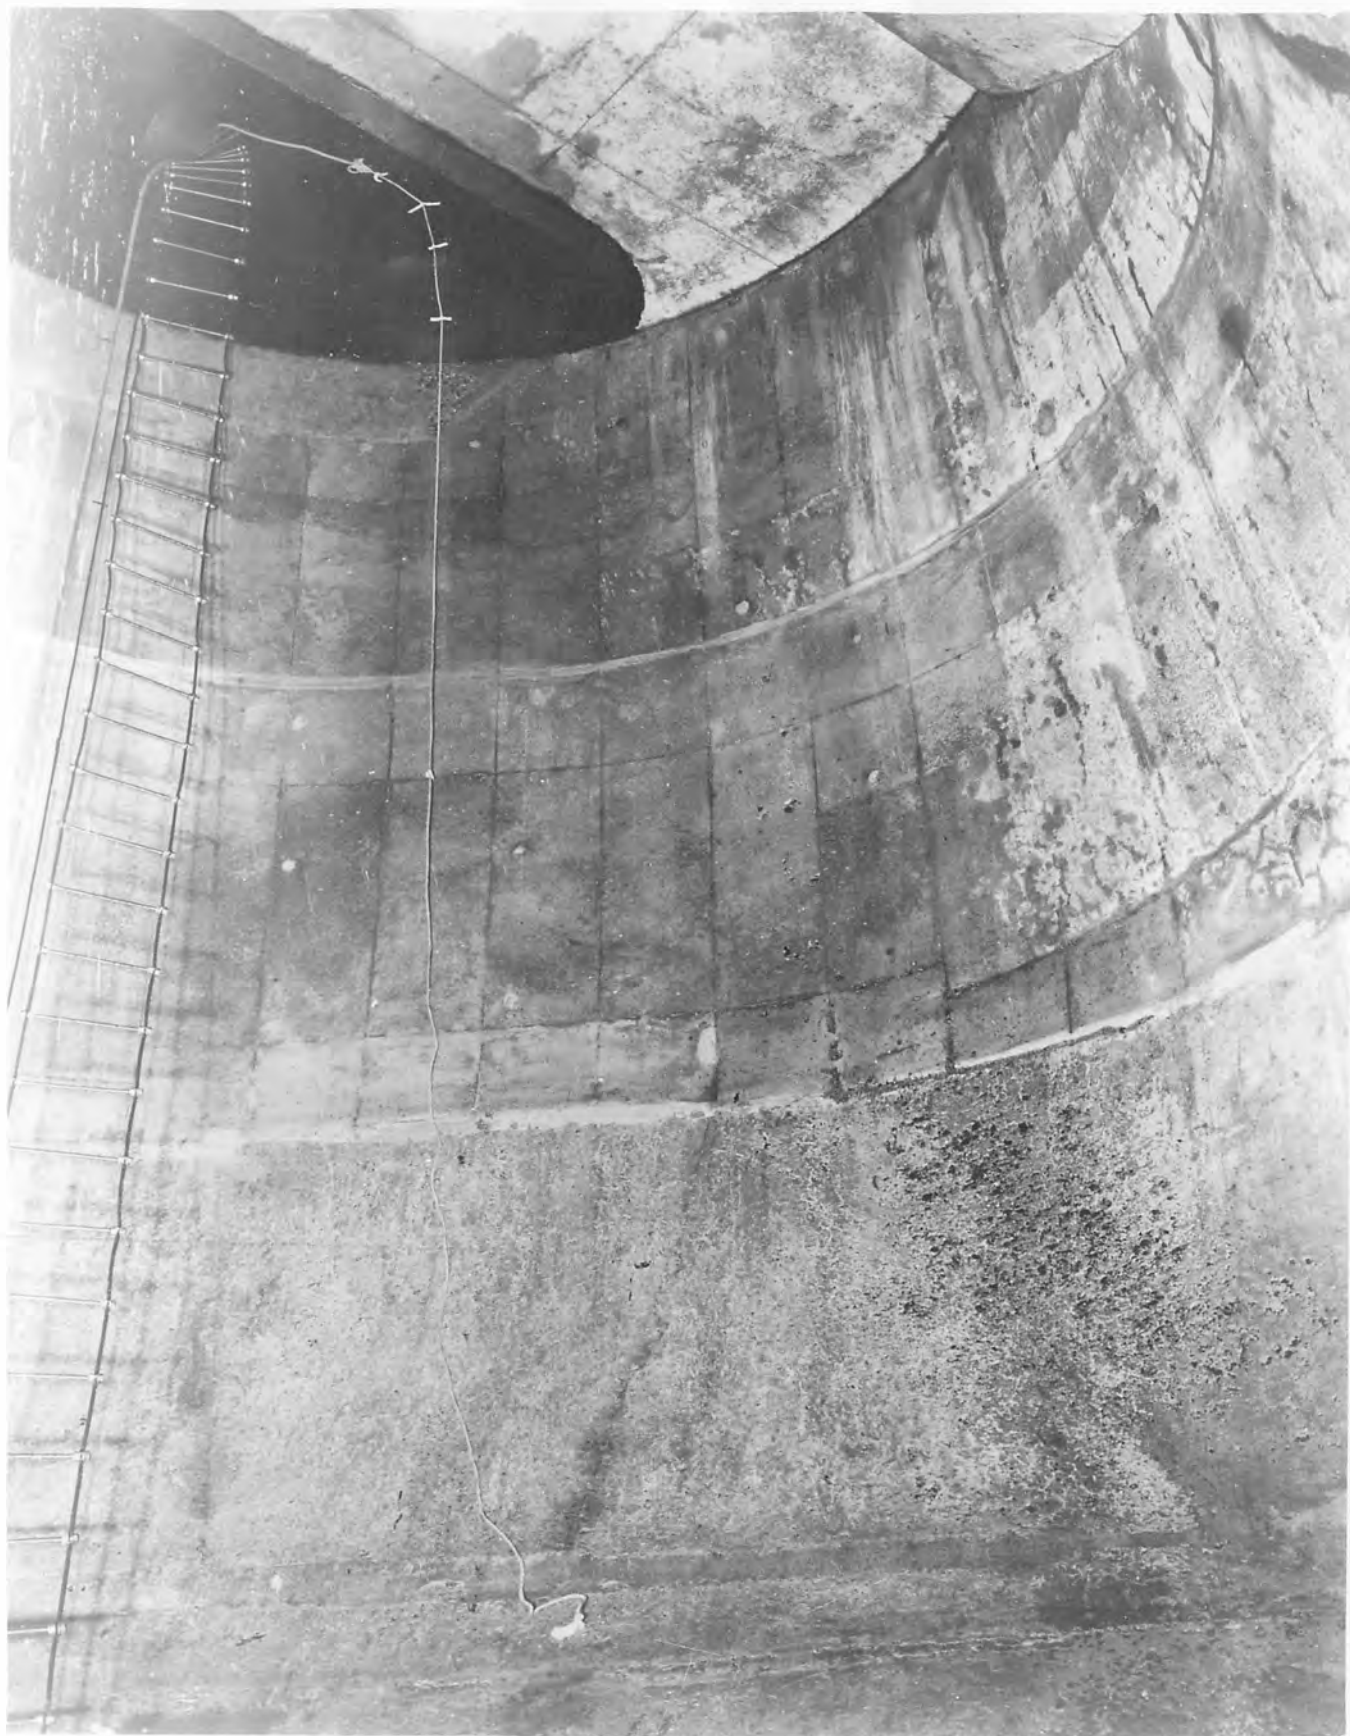
Fig. 5. Photograph 13051-3, June 7, 1945: View from floor of draft tube showing pitting by cavitation in the inner curve at the left side of the steel elbow and in the wall of the anchor block and draft tube directly downstream, after operation of the R-9 outlet for tests on May 25 and June 5, 1945.

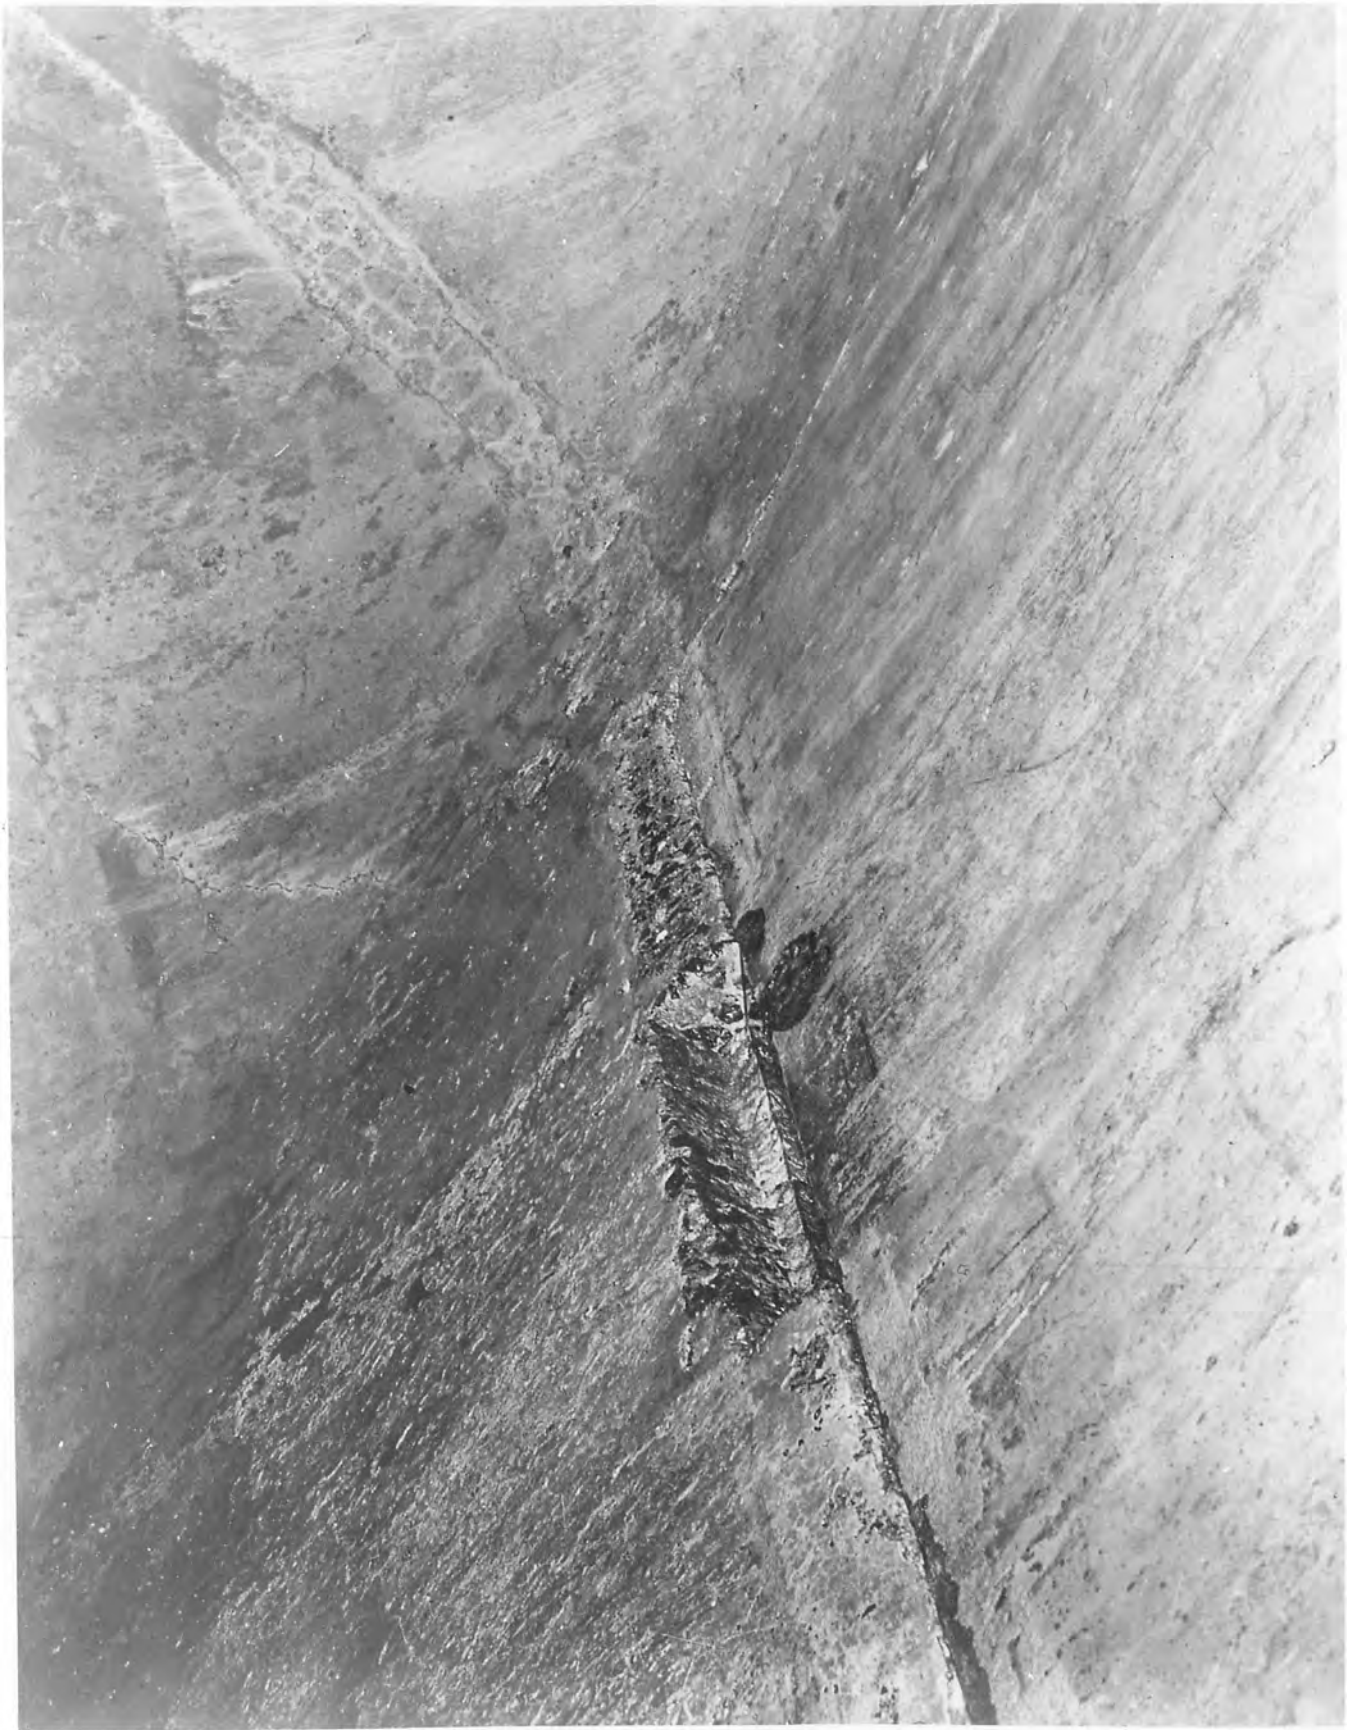
Many thin stoned patches in and near the joints in the floor of the vertical curve at the back of the draft tube had been torn out in addition to those noted during the previous inspection. These will not be replaced since they form only minor roughness and no doubt would be torn out again when subjected to the high velocity flow.

Fig. 6. Photograph 13045-3, June 7, 1945: View from floor of draft tube showing recess in joint upstream from draft tube piers from which patch has been torn by flow from 84-inch needle valve, after operation of the R-9 outlet for tests on May 25 and June 5, 1945.

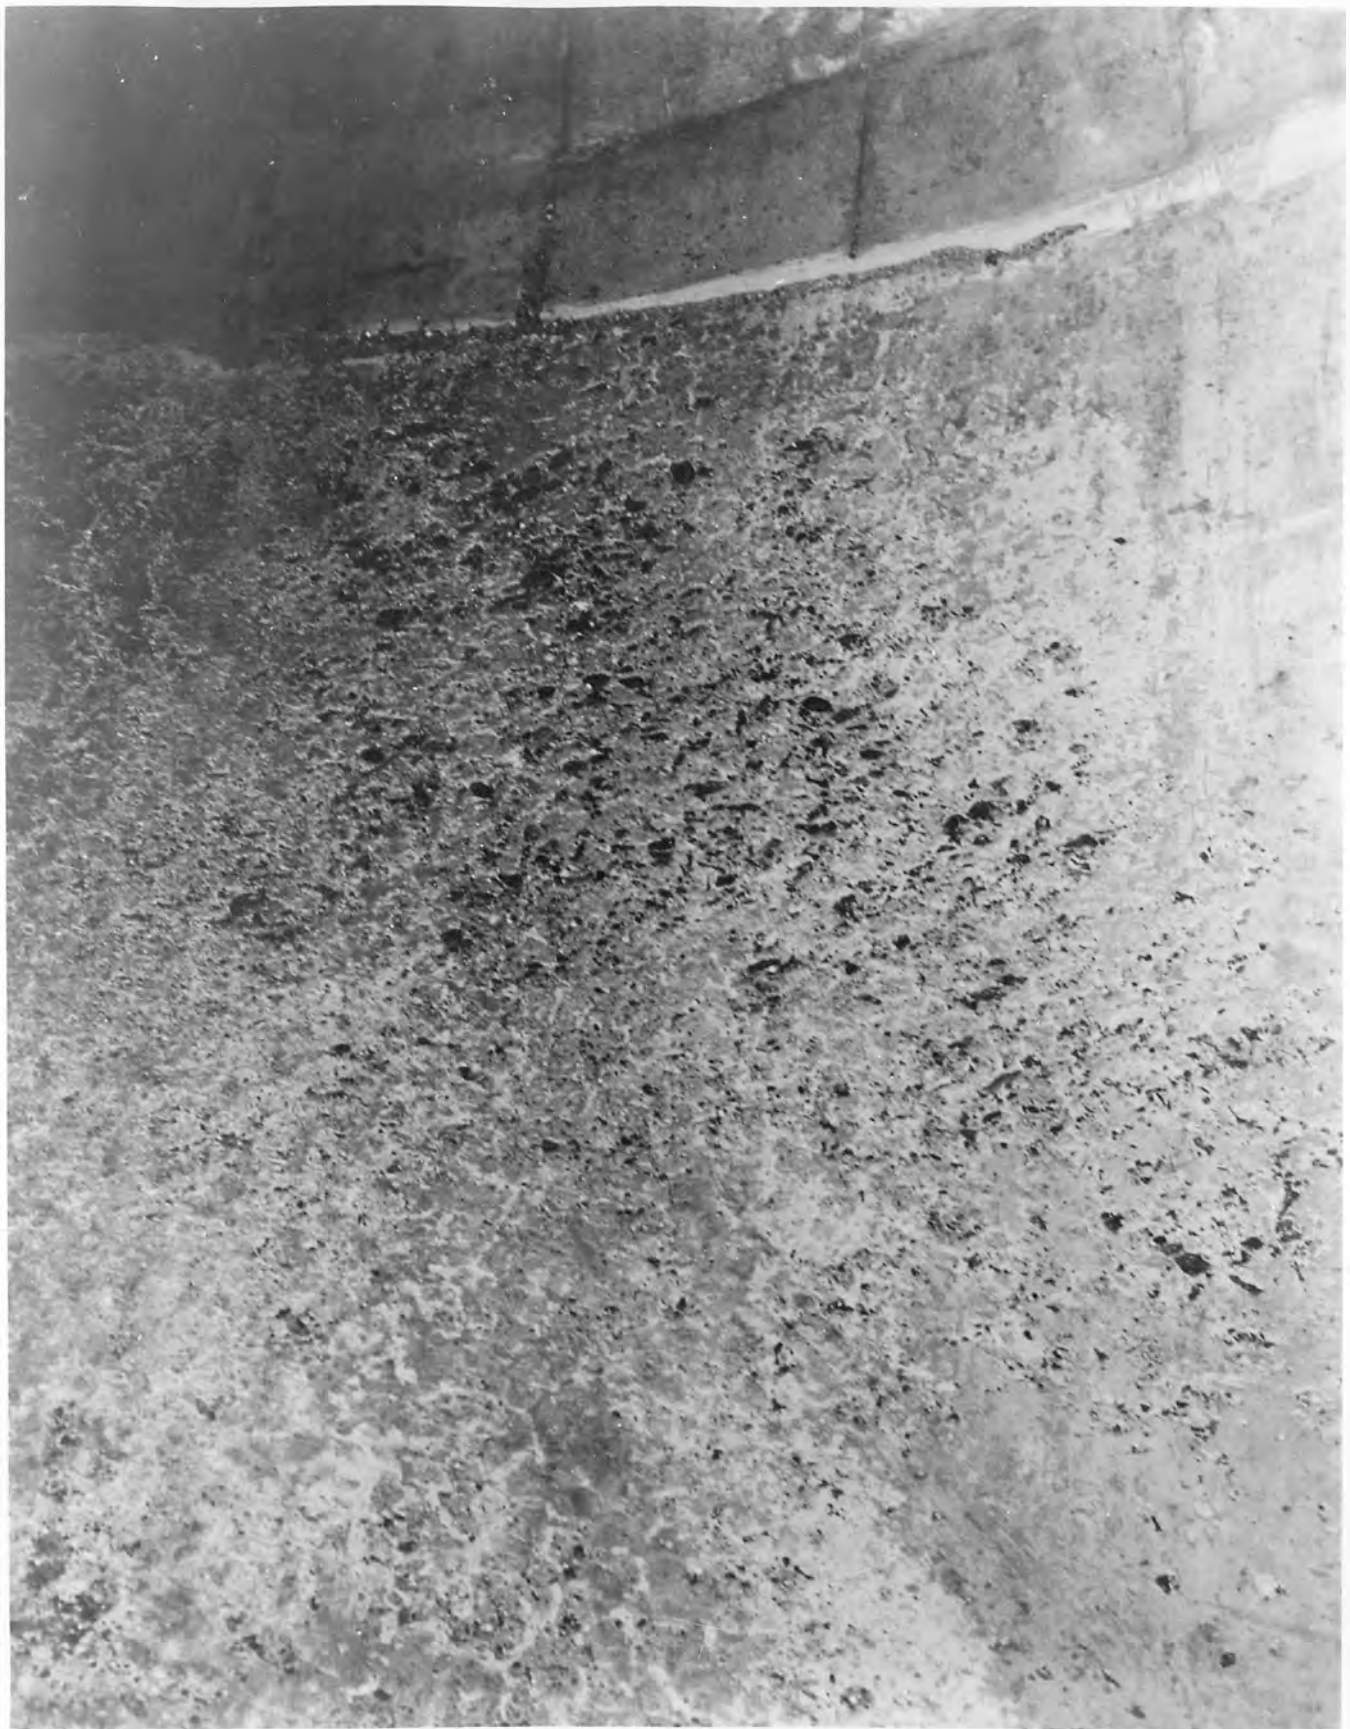
Fig. 7. Photograph 13041-3, June 7, 1945: View from floor of draft tube, showing pitting by cavitation at the junction of the anchor block with the old construction in the vertical curve at the back of the R-9 draft tube after operation of the outlet for tests on May 25 and June 5, 1945.

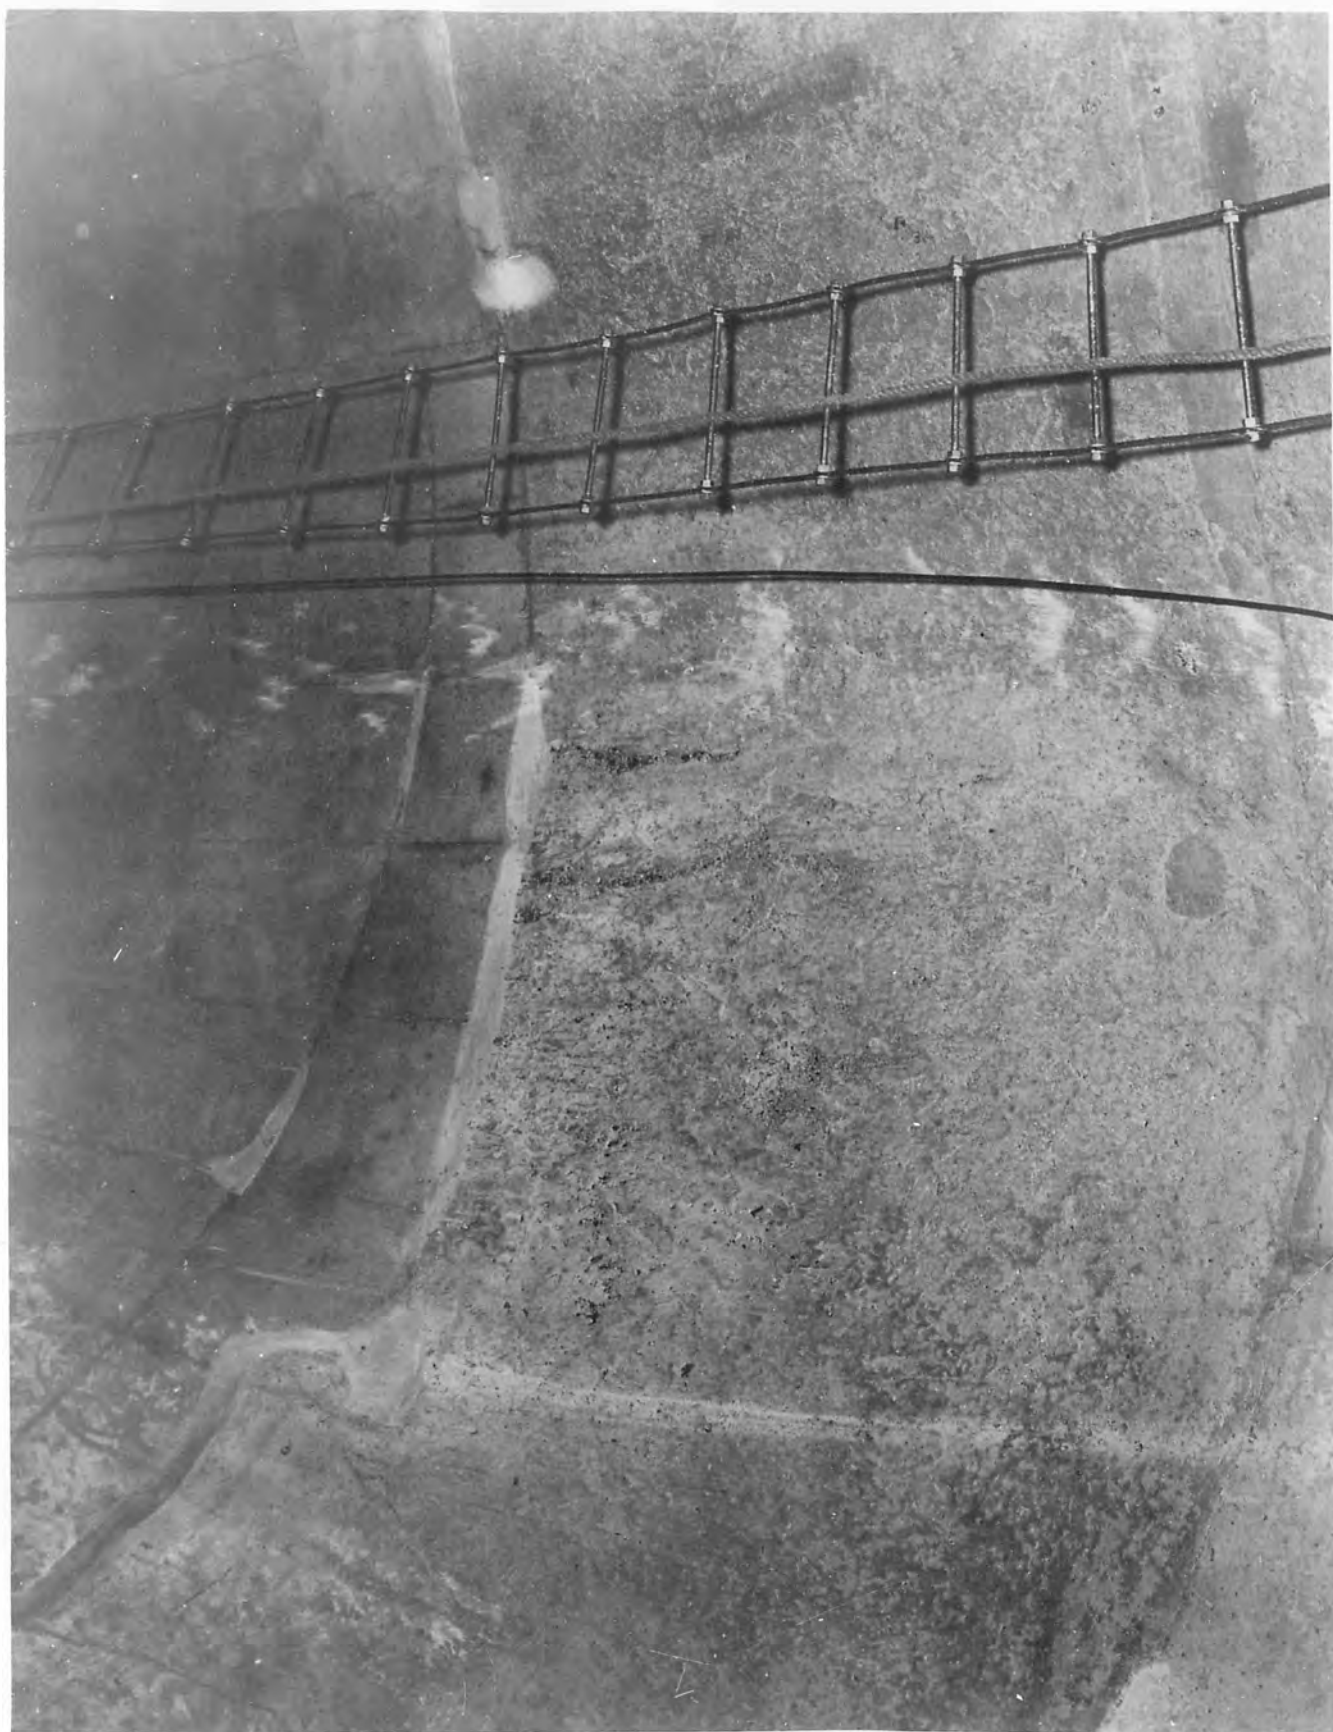
Fig. 8. Photograph 13043-3, June 7, 1945: View from draft tube floor showing pitting by cavitation at the junction of the anchor block with the old construction in the vertical curve at the right side of the R-9 draft tube entrance below the transition elbow after operation of the R-9 outlet for tests on May 25 and June 5, 1945.

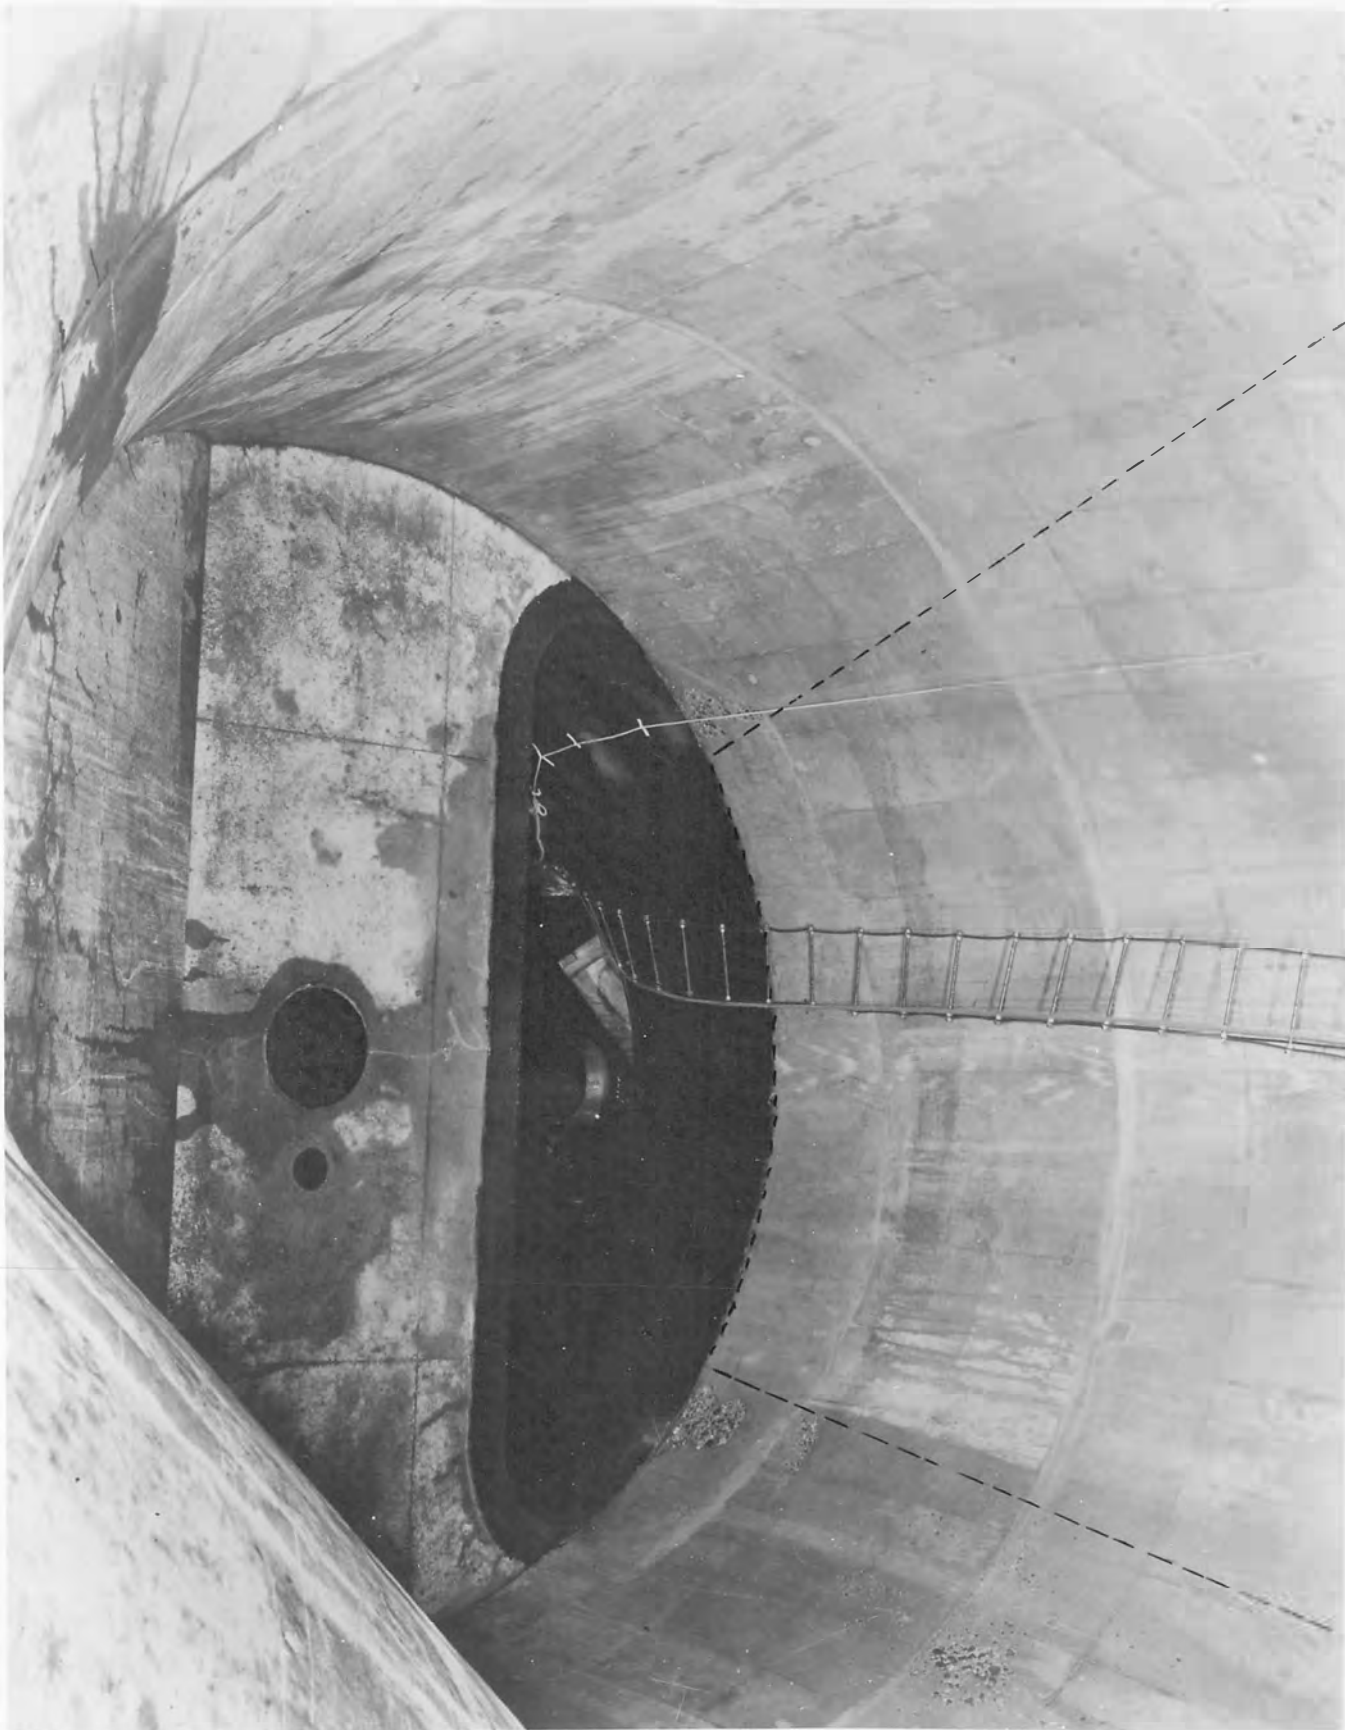
That pitting has occurred directly under the elbow at and below the joint between the old and new construction, as well as downstream from it and extends in varying degree across the surface over which the flow passes is considered evidence that a region of sub-atmospheric pressure, of the proper magnitude to cause cavitation, exists behind the valve jet above this elevation. The bands of pitting along the walls downstream from the outer extremities of the exit of the transition elbow indicate that the zone of cavitation is sealed along the sides by the flow as it spreads and plunges to the vertical curve in the floor of the draft tube. The dotted ink lines on Figure 9 (photo #13050) show the approximate limits of the cavitation zone. It is believed that the admission of air into the dome of the concrete anchor block through the 18-inch pipe at its crown will not be of noticeable benefit until some passage has been provided to convey the air from the upper region of the dome to the underside of the jet as it plunges from the exit of the transition elbow. Apparently the air taken in by the valve does not reach this cavity in sufficient quantity to relieve the negative pressures to prevent the cavitation. Since the zones of cavitation in the R-9 outlet are sealed from the air in the dome of the anchor block and since they originate in and near the elbow exit, there should be very little influence from the variation in tailwater, thus any solution to the problem under present conditions should serve as well for lower tailwater elevations.

Fig. 9. Photograph 13050-3, June 7, 1945: View from floor of draft tube showing relative location of pitting by cavitation in inner curve of transition elbow and concrete wall of anchor block and draft tube directly below, after operation of the R-9 outlet for tests on May 25 and June 5, 1945.
