UNITED STATES
DEPARTMENT OF THE INTERIOR
BUREAU OF RECLAMATION

Laboratory Report No. 187
Hydraulic Laboratory

Subject: Test operation of 84-inch Needle Valve By-pass Outlet in Bay
R-9 of Right Powerhouse—Grand Coulee Dam—Columbia Basin
Project

Subject: Condition of 84-inch needle valve outlet after test operations of August 7, 8, and 9, 1945--Grand Coulee Dam-- Columbia Basin Project

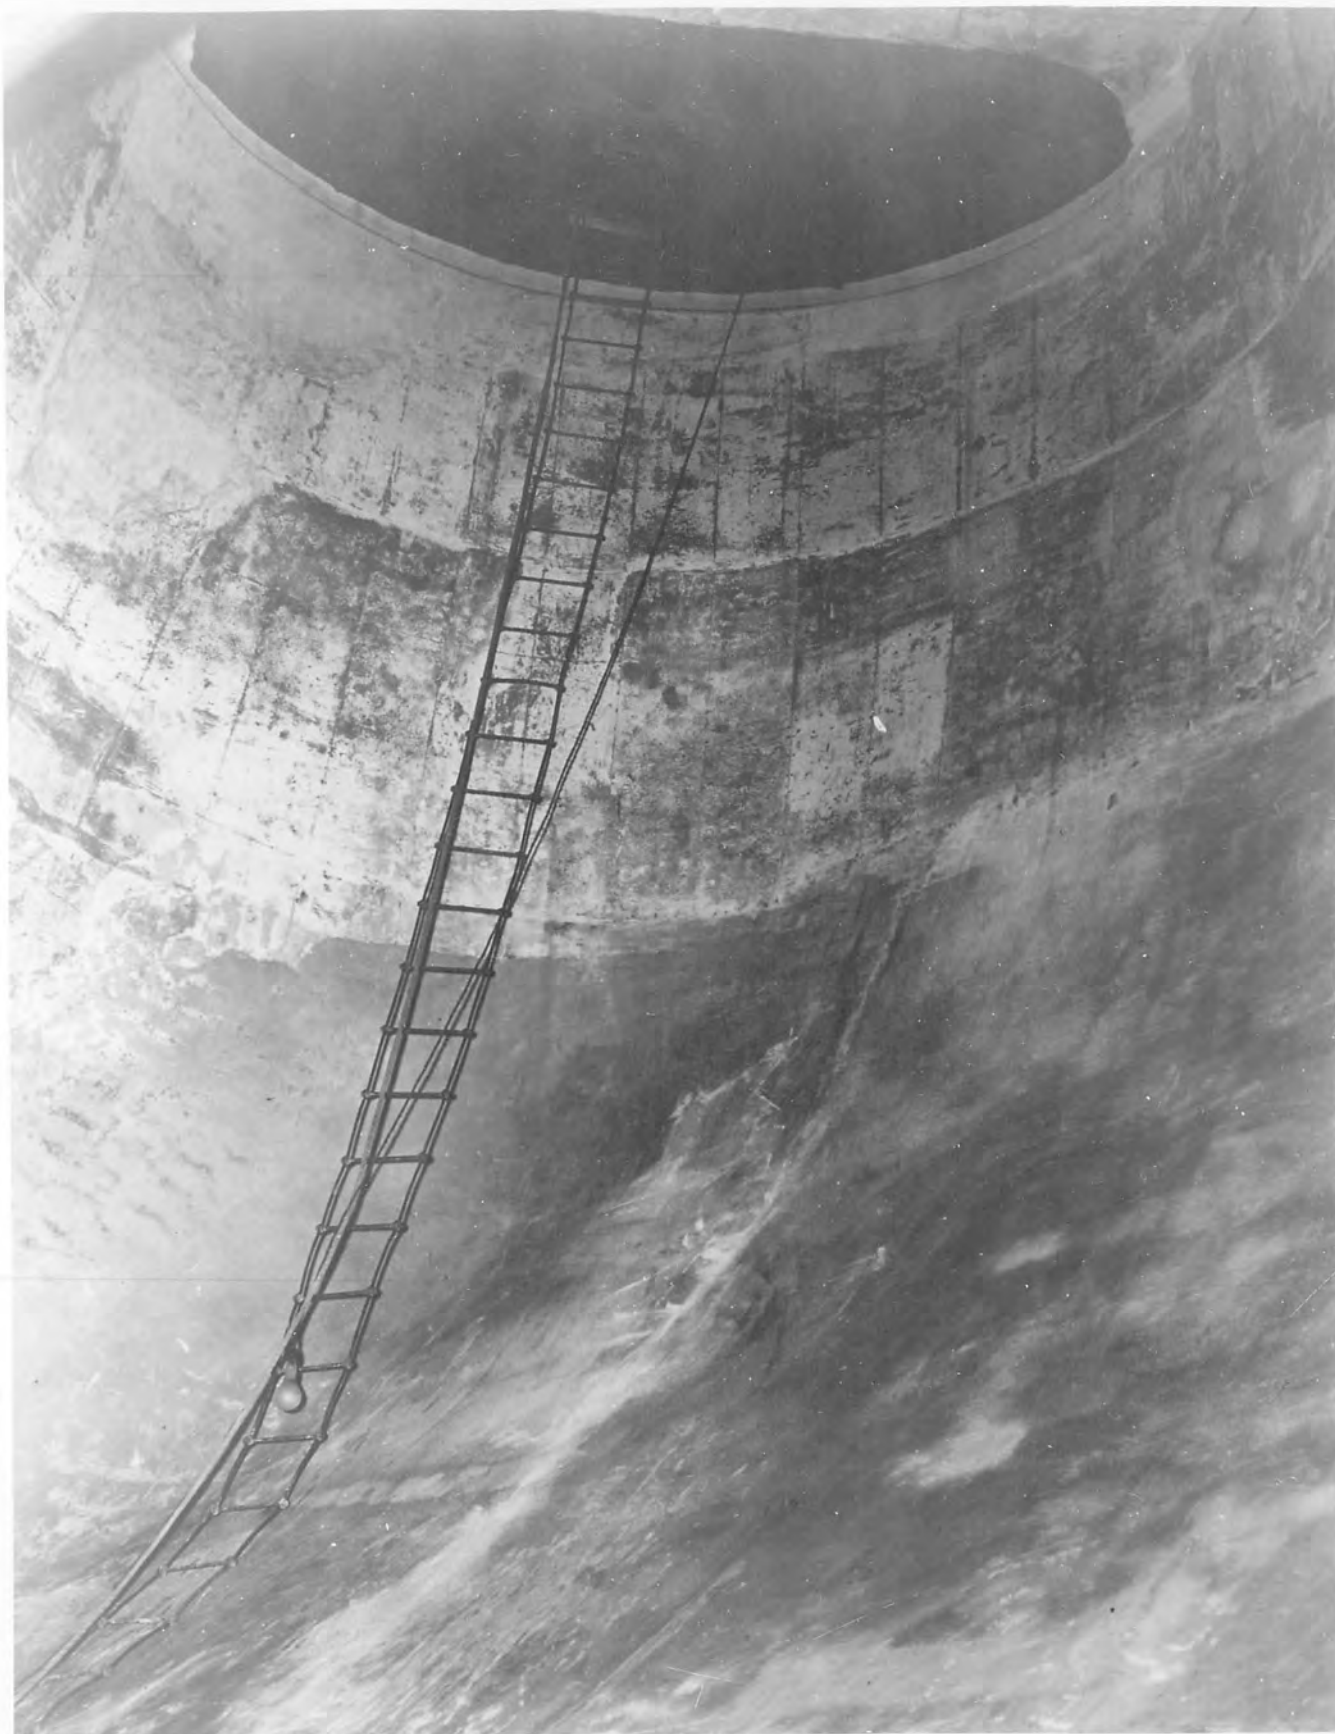
The walls of the anchor block and draft tube as they appeared before the test of August 7 after the above alterations and repairs were made are shown in Figure 1 (Photograph 13213-3).

- (4) All pitted areas in the wall of the anchor block below the elbow exit and in the curved surface at the back of the draft tube were chipped and repaired and all prominent irregularities removed from the wall.

- (5) The patch near the construction joint 17'-9" upstream from the nose of the left draft tube pier was replaced, keyed and doweled.

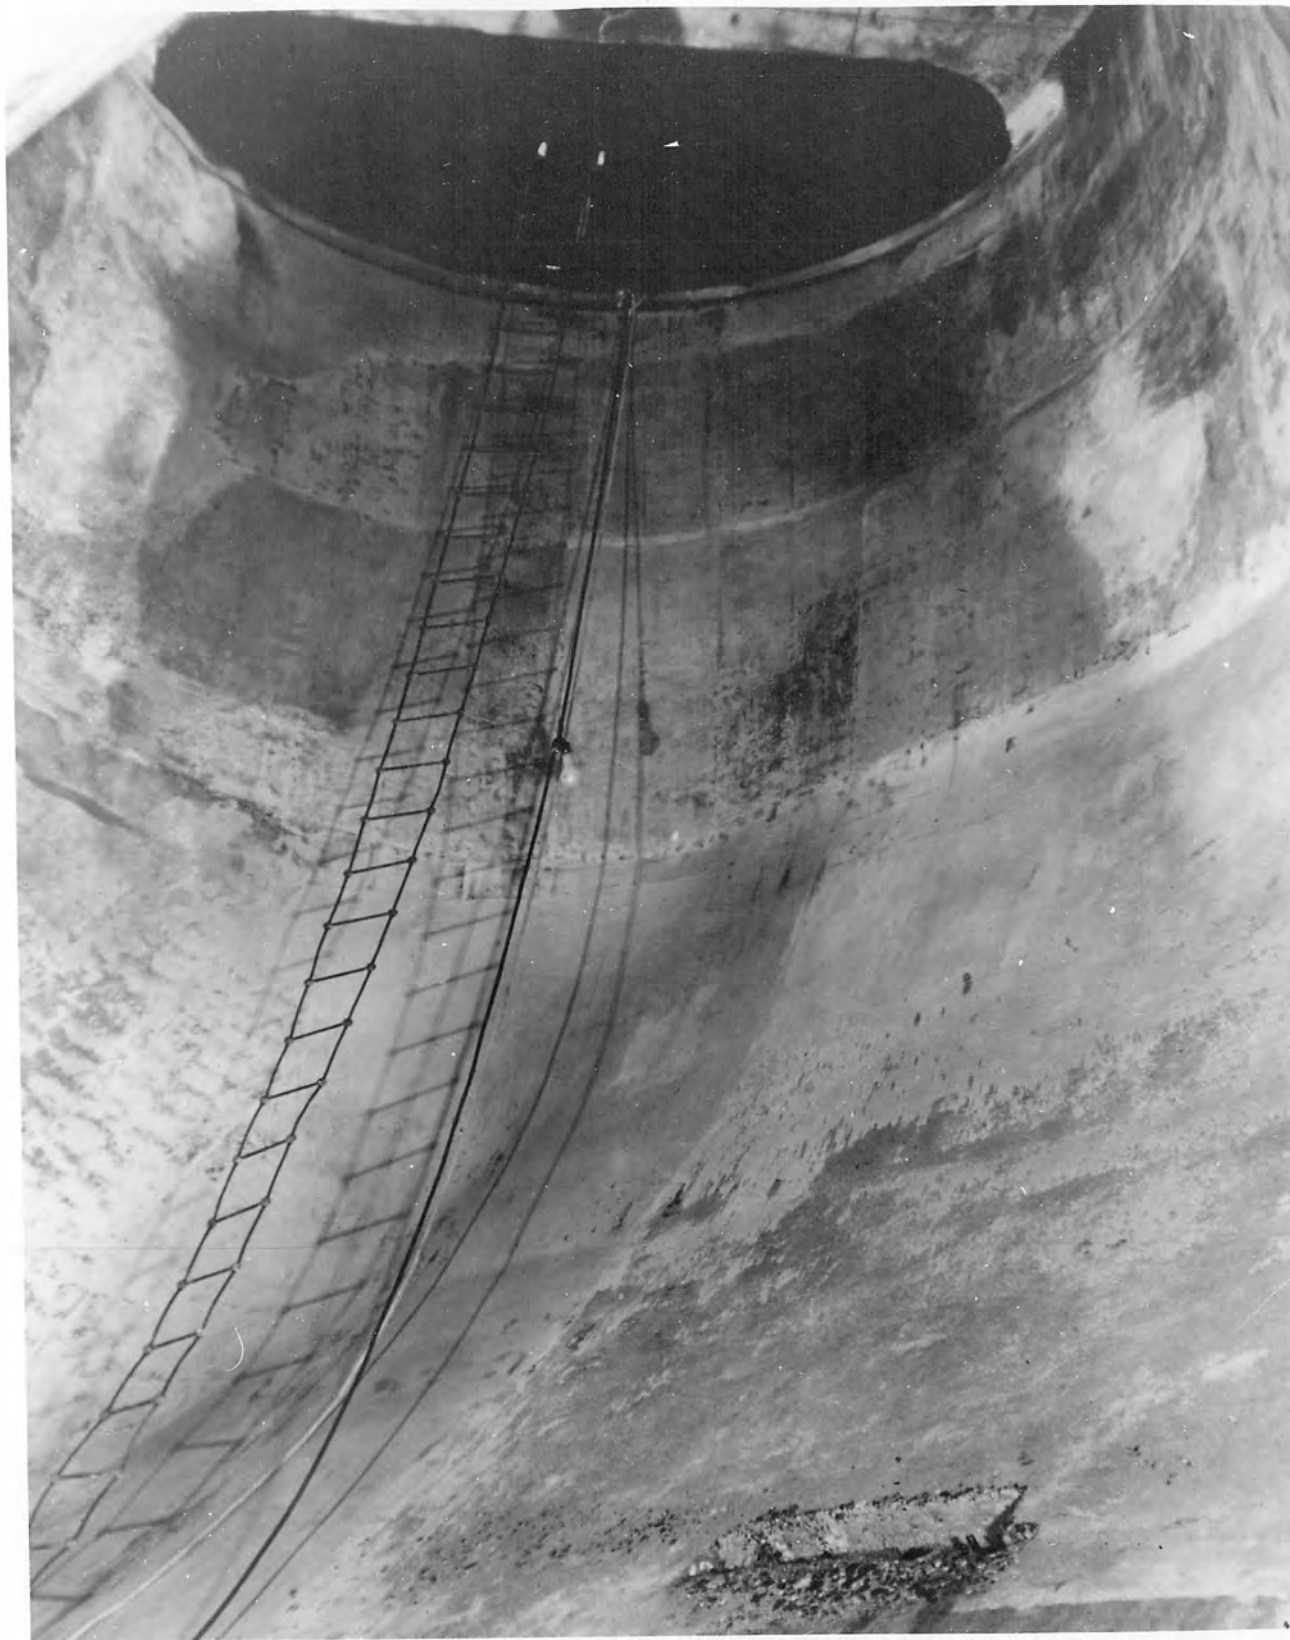
Photograph 4930-2, August 8, 1945: View from draft tube floor showing extent of cavitation in wall of anchor block at back of draft tube and near the recess from which a concrete patch had been torn during operation of the R-9 outlet for approximately 6 hours at full capacity on August 7, 1945.

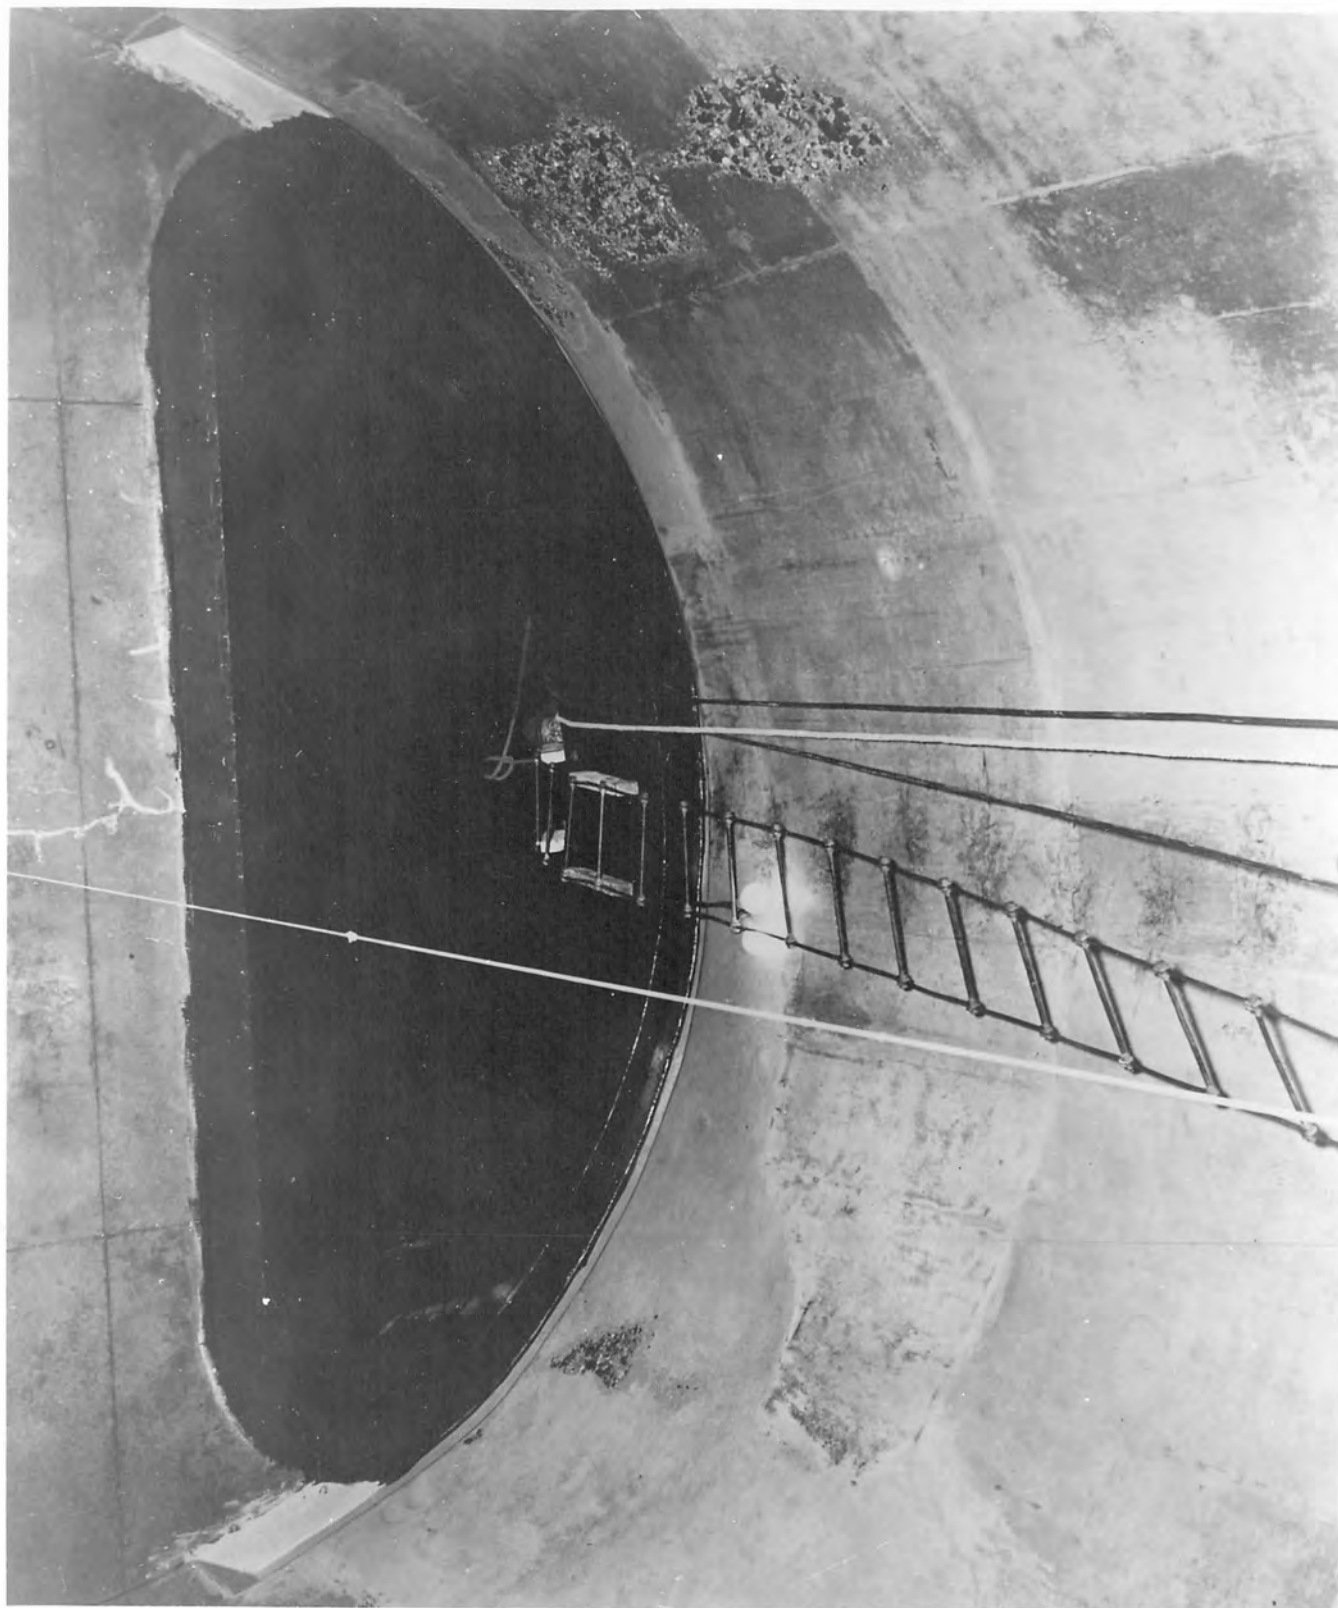
The areas on the surface of the inner curve of the transition elbow from which the paint had been removed during the operation on August 7, had increased in size. (Figure 3, Photo 13247-3) Although only one area about 6 inches in diameter, 3.5 feet to the right of the centerline on the seventh section of the transition elbow had a spongy appearance, all seemed to have been caused by cavitation. Apparently the chipping and grinding of the weld beads at the joints between the sections of the elbow had not reduced the discontinuities in the bounding surface of the elbow sufficiently to eliminate the cavitation. The position of the areas was established for future reference if it becomes necessary to correct flow conditions in the elbow (Figure 4).

elbow exit were larger and deeper than for the operation of August 7. The change on the right side was small while that on the left was quite extensive, the concrete being plucked to a depth of about three inches in two areas, (Figure 3, Photo 13247-3). A comparison of the conditions after 23 hours operation with that after 6 hours shows that the second and lower pitted area on the left side formed during the last 17 hours of operation. It is believed that the second area resulted from a local condition caused by the first after it reached sufficient proportions to induce a discontinuity in the flow boundary. If this is the case pitting by cavitation might be considered progressive and considerable damage would result before the boundary is sufficiently removed to cause the pitting to cease.

Photograph 13247-3, August 10, 1945: View from floor of draft tube showing pitting by cavitation in the inner curve at both sides of the steel elbow and in the wall of the anchor block immediately below after operation of the R-9 outlet at full capacity for approximately 23 hours on August 7, 8, and 9, 1945.

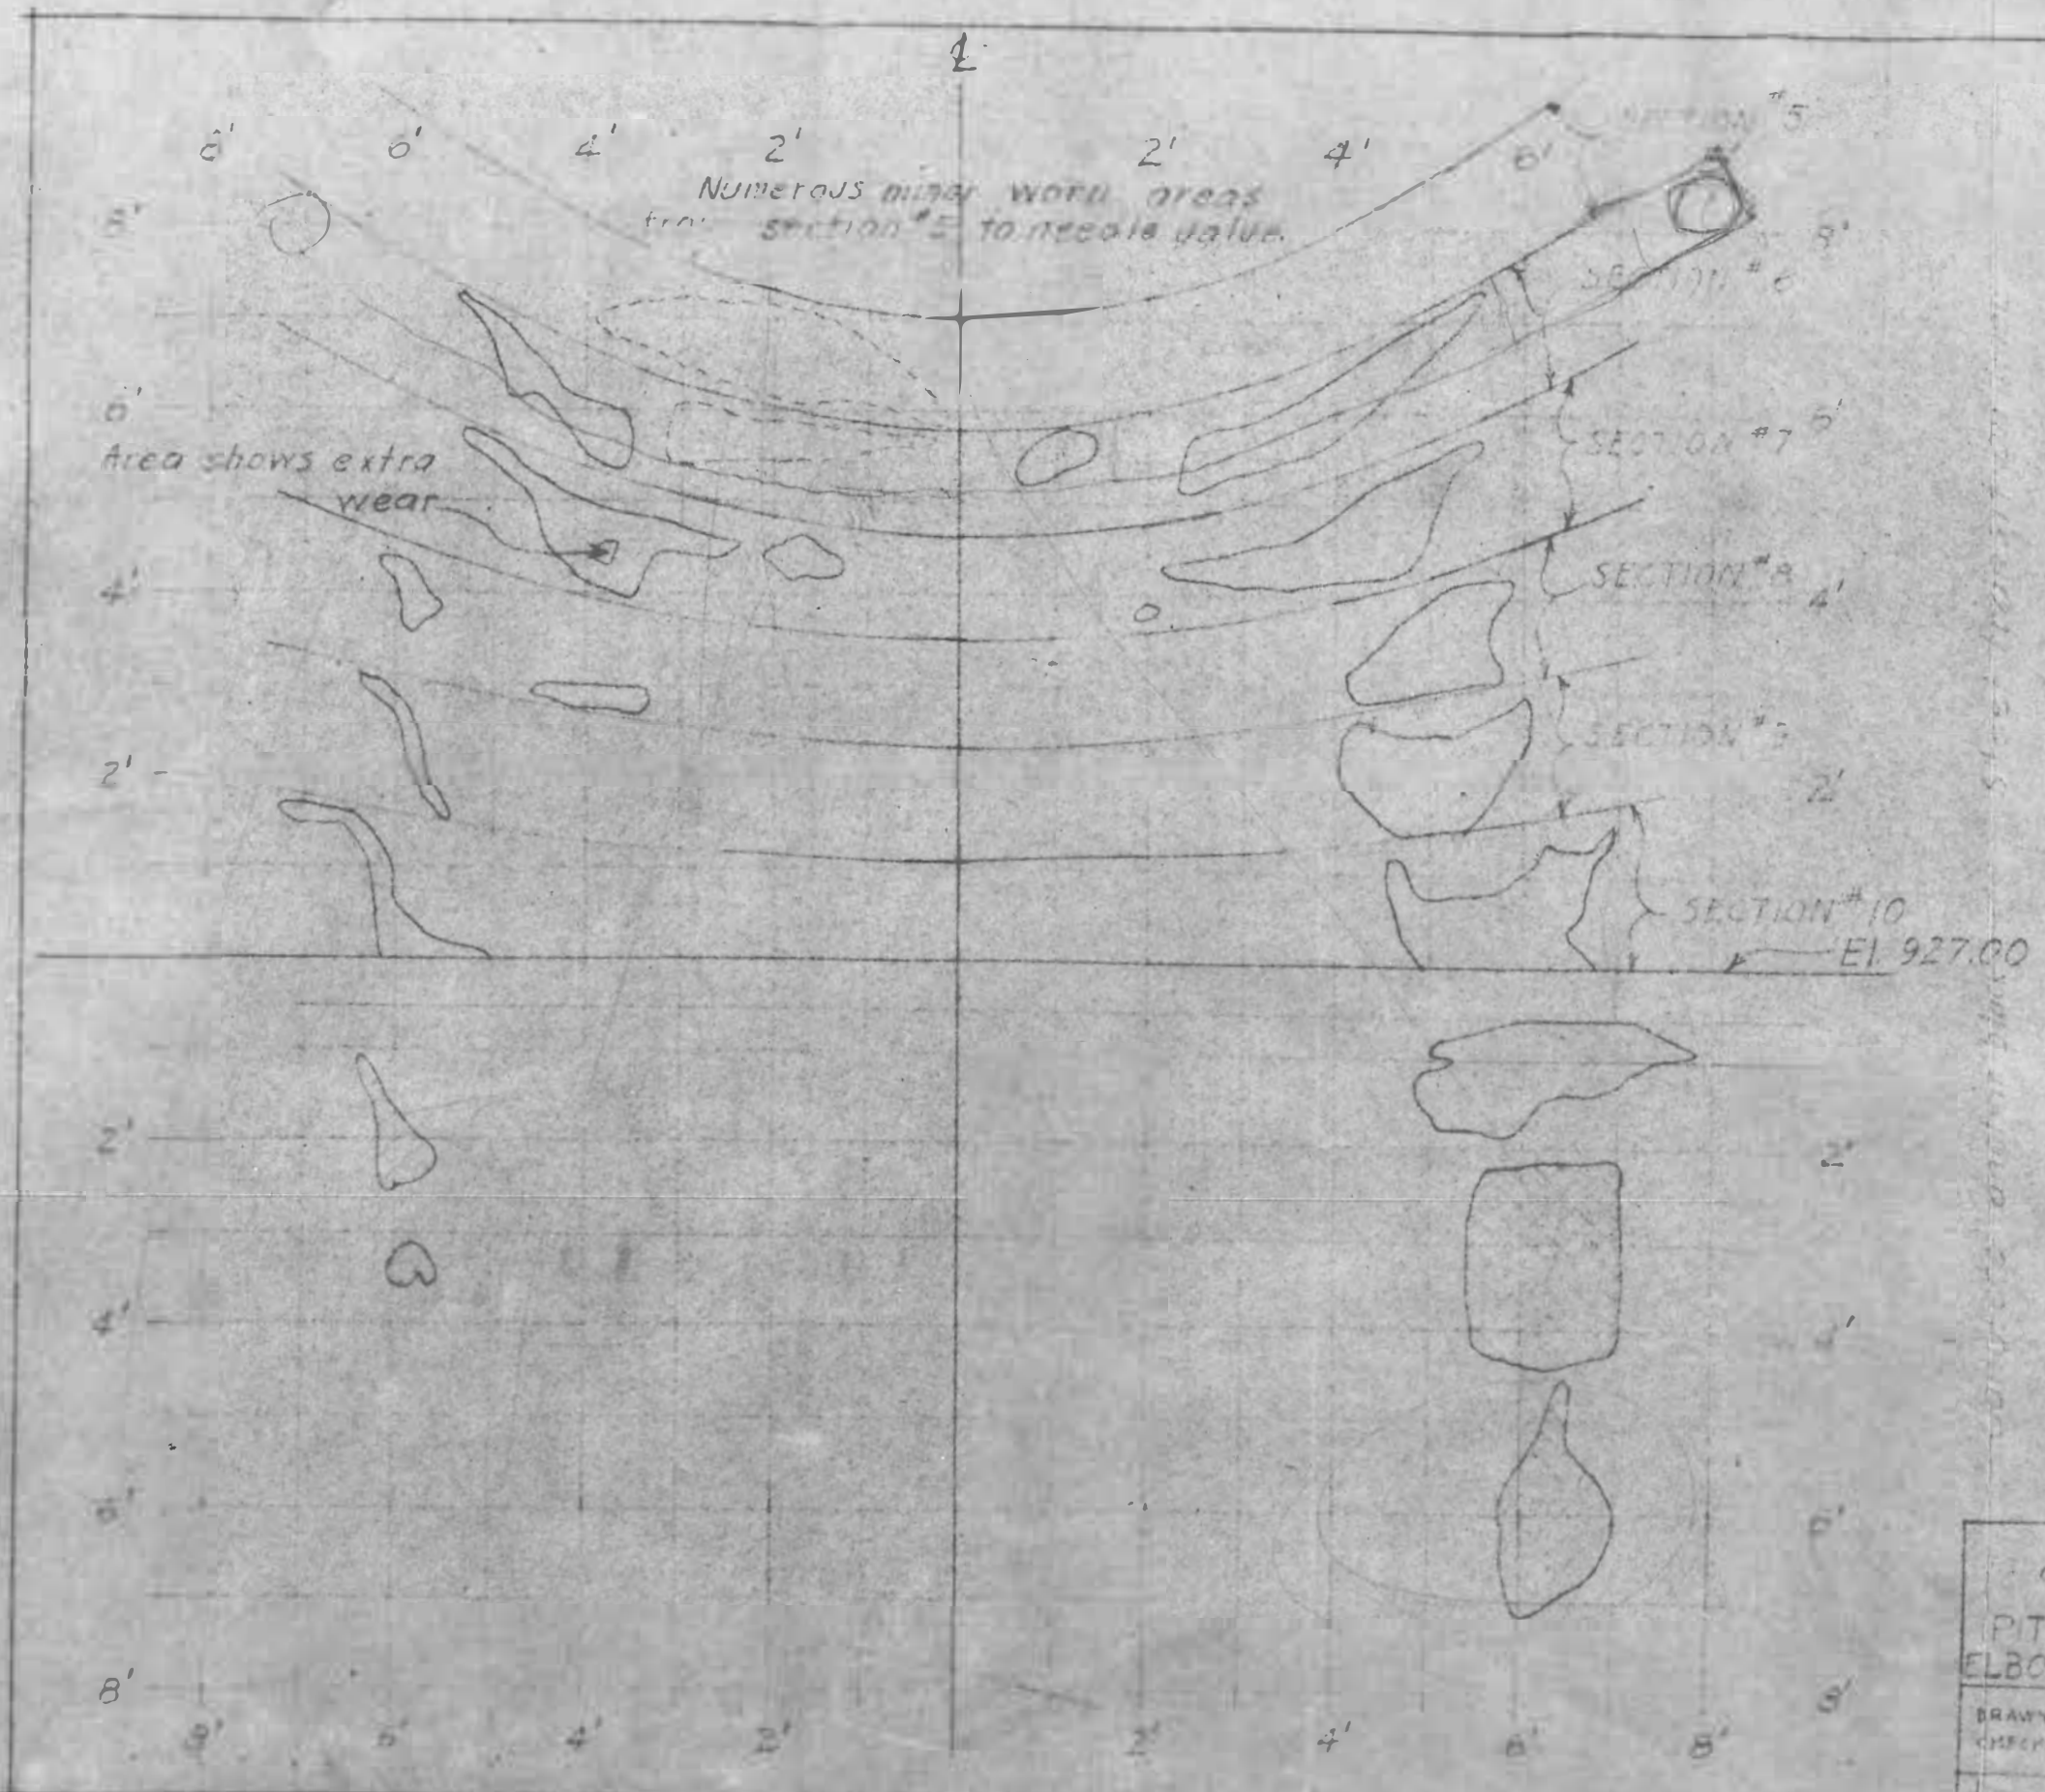
Figure 4

Developed view of steel liner and concrete anchor block - showing pitted areas.
View looking upstream toward needle valve.

Dashed line shows boundary of a group of worn areas.

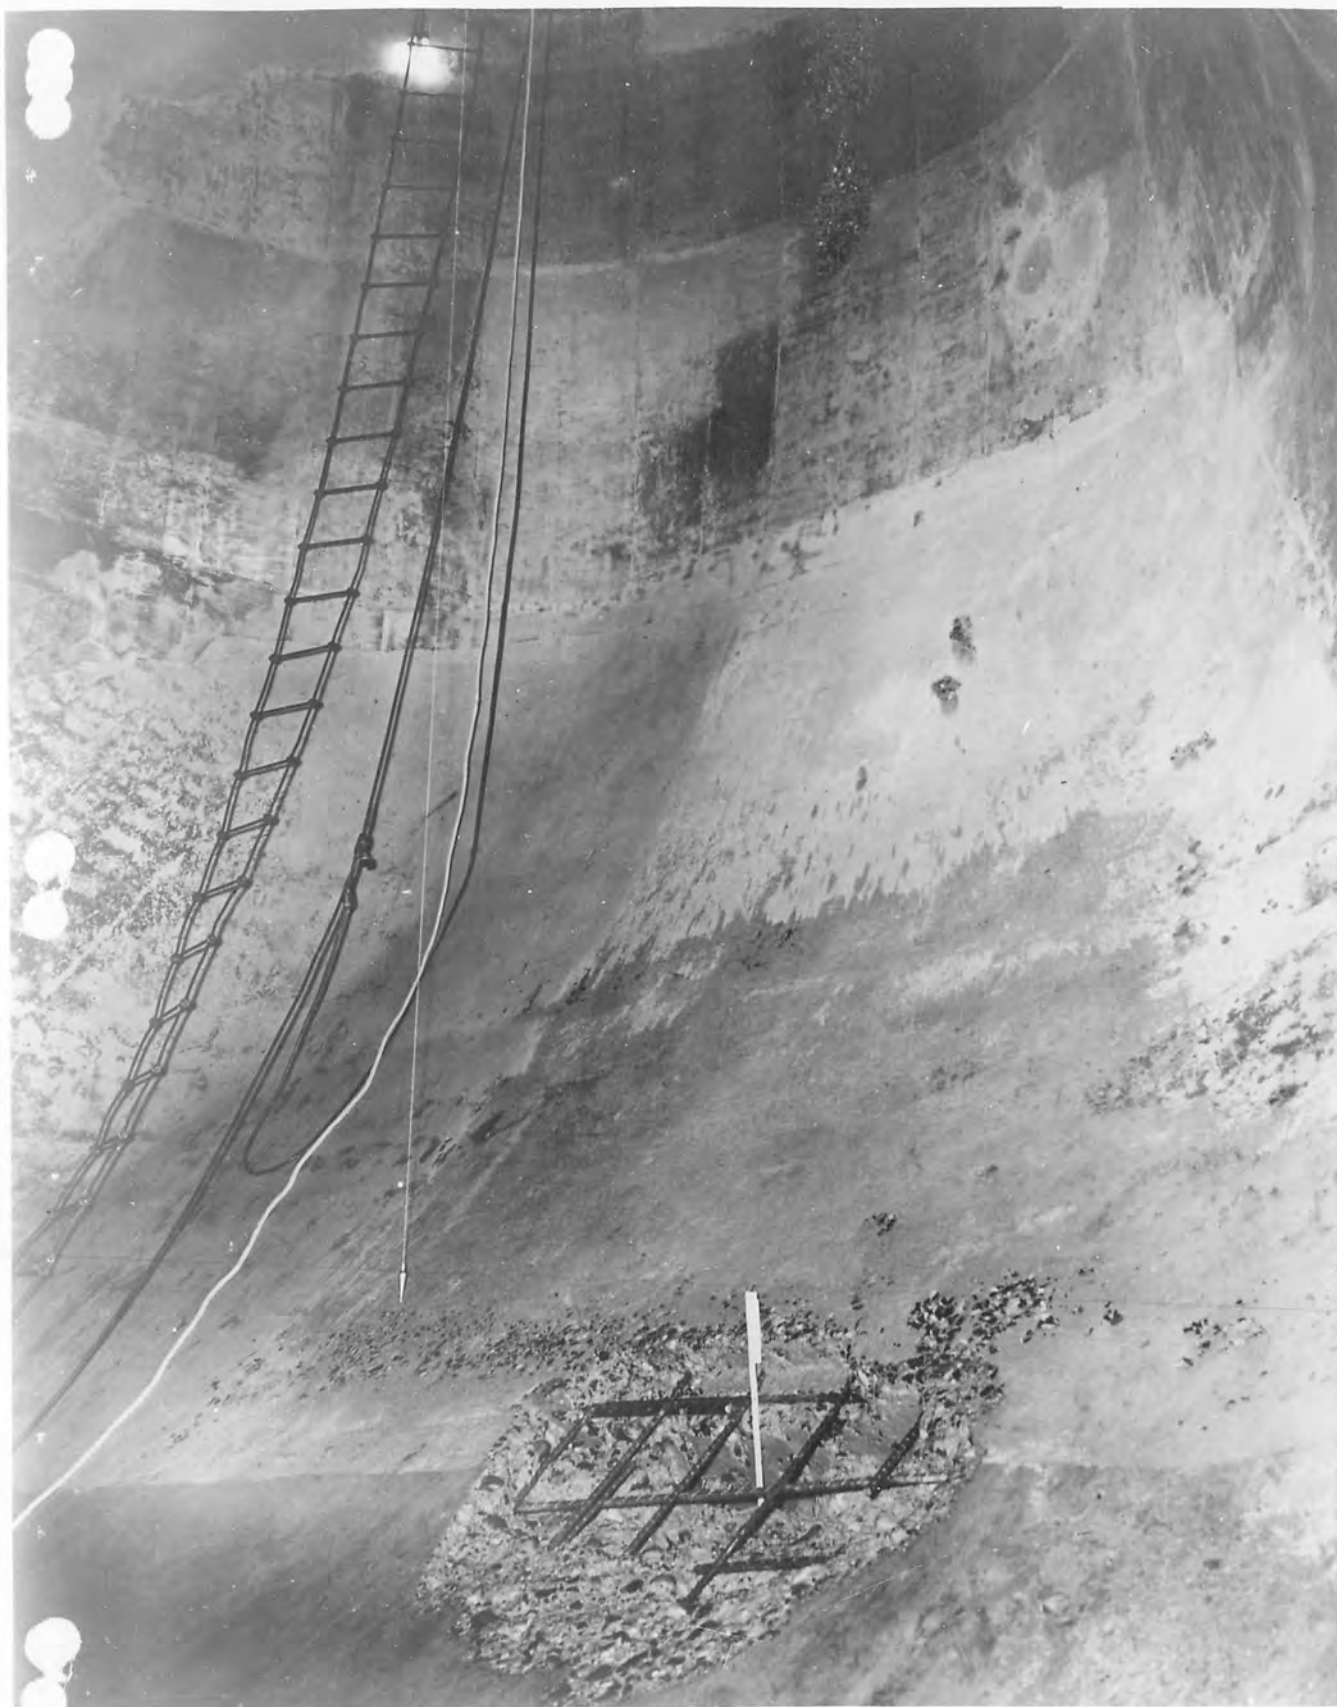
Photograph 13246-3, August 10, 1945: View from draft tube floor showing extent of cavitation in wall of anchor block and in floor of draft tube in vicinity of recess from which patch was torn during first six hours of operation, after operation of the R-9 outlet for approximately 23 hours on August 7, 8, and 9, 1945. Plumb bob indicates centerline of 18-inch vent in top of anchor block.

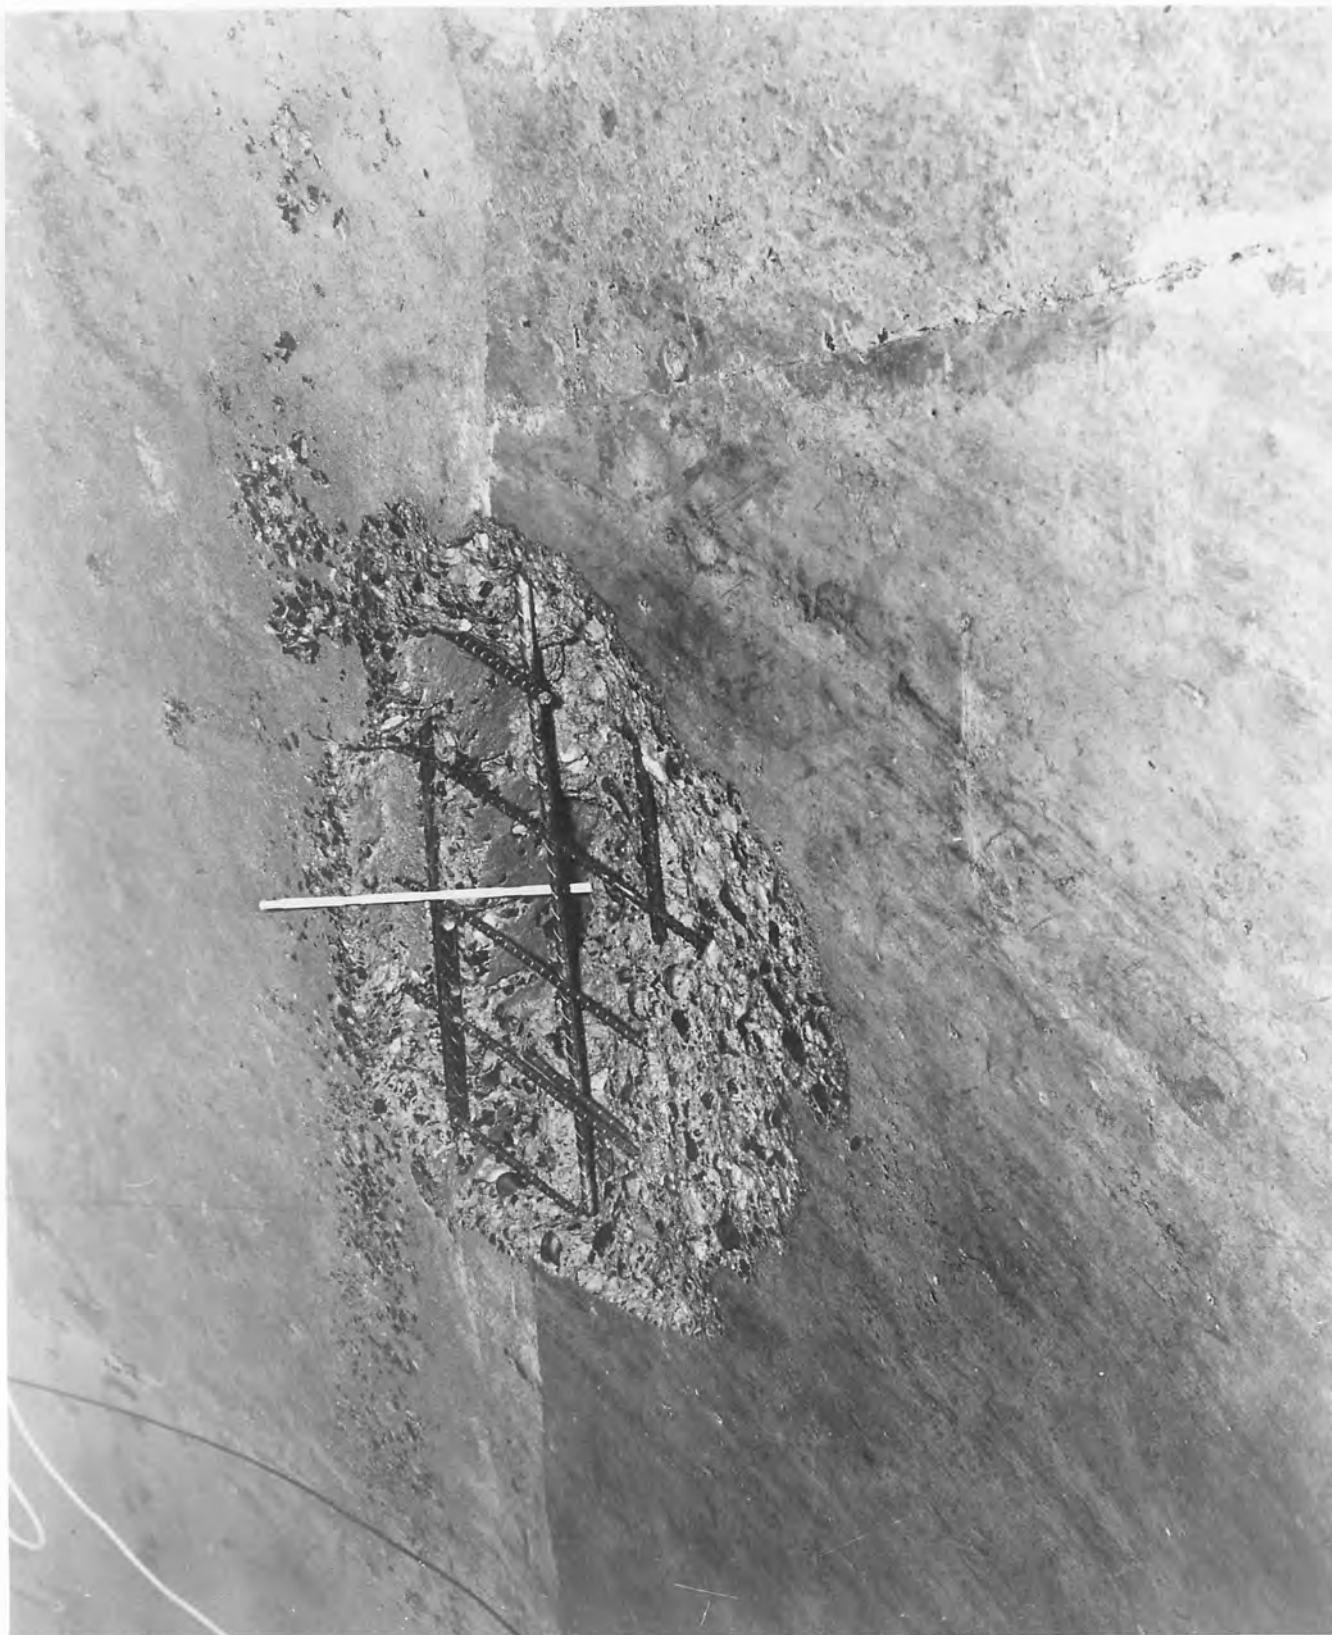
After a total of 23 hours operation a band of shallow pits had formed in the concrete surface along the top and both sides of the recess from which the patch had been torn during the first six hours, (Figure 6, Photo 13242-3). The area at the downstream edge and to each side of the recess was pitted severely for a distance of five feet below its upper edge, exposing several bars of reinforcing steel, (Figure 7, Photo 13252-3). All the wire ties at the intersections were missing and the bars were battered severely where they contacted one another during the test. The wear in the east-west bars was to the left of the natural intersection, indicating large transverse forces. A short section was missing from one of the bars. The metal of the broken ends was bright so the breaks were attributed to severe vibration induced by the flowing water. The maximum depth of the pitted zone was 18 inches at the construction joint and the area, including the recess, was about five feet in diameter. The source of the cavitation producing this damage was not apparent immediately, but was believed to originate from either irregularities in the flow boundary or the tendency of the high-velocity jet from the elbow to deflect after striking the curved surface. A survey of the concrete surface adjacent to the pitted area, made several days after the inspection, disclosed the first to be the more likely cause. Sections taken across and perpendicular to the construction joint 17' -9" upstream from the draft tube piers showed a discontinuity in the surface about one foot upstream from the joint, with the surface receding suddenly at this point to meet the concrete below the joint. The surface receded a maximum of 3/4 inch to the right of the patch recess. A typical section showing the discontinuity, and a grid system showing the extent of the survey, the low area and the boundaries of the new patch, which is to remove the discontinuity, are contained on figure 8.

Photograph 13242-3, August 9, 1945: View from draft tube floor showing pitting by cavitation in area near joint 17'-9" upstream from draft tube pier nose from which patch was torn, after operation of the R-9 outlet for approximately 23 hours at full capacity on August 7, 8 and 9, 1945.

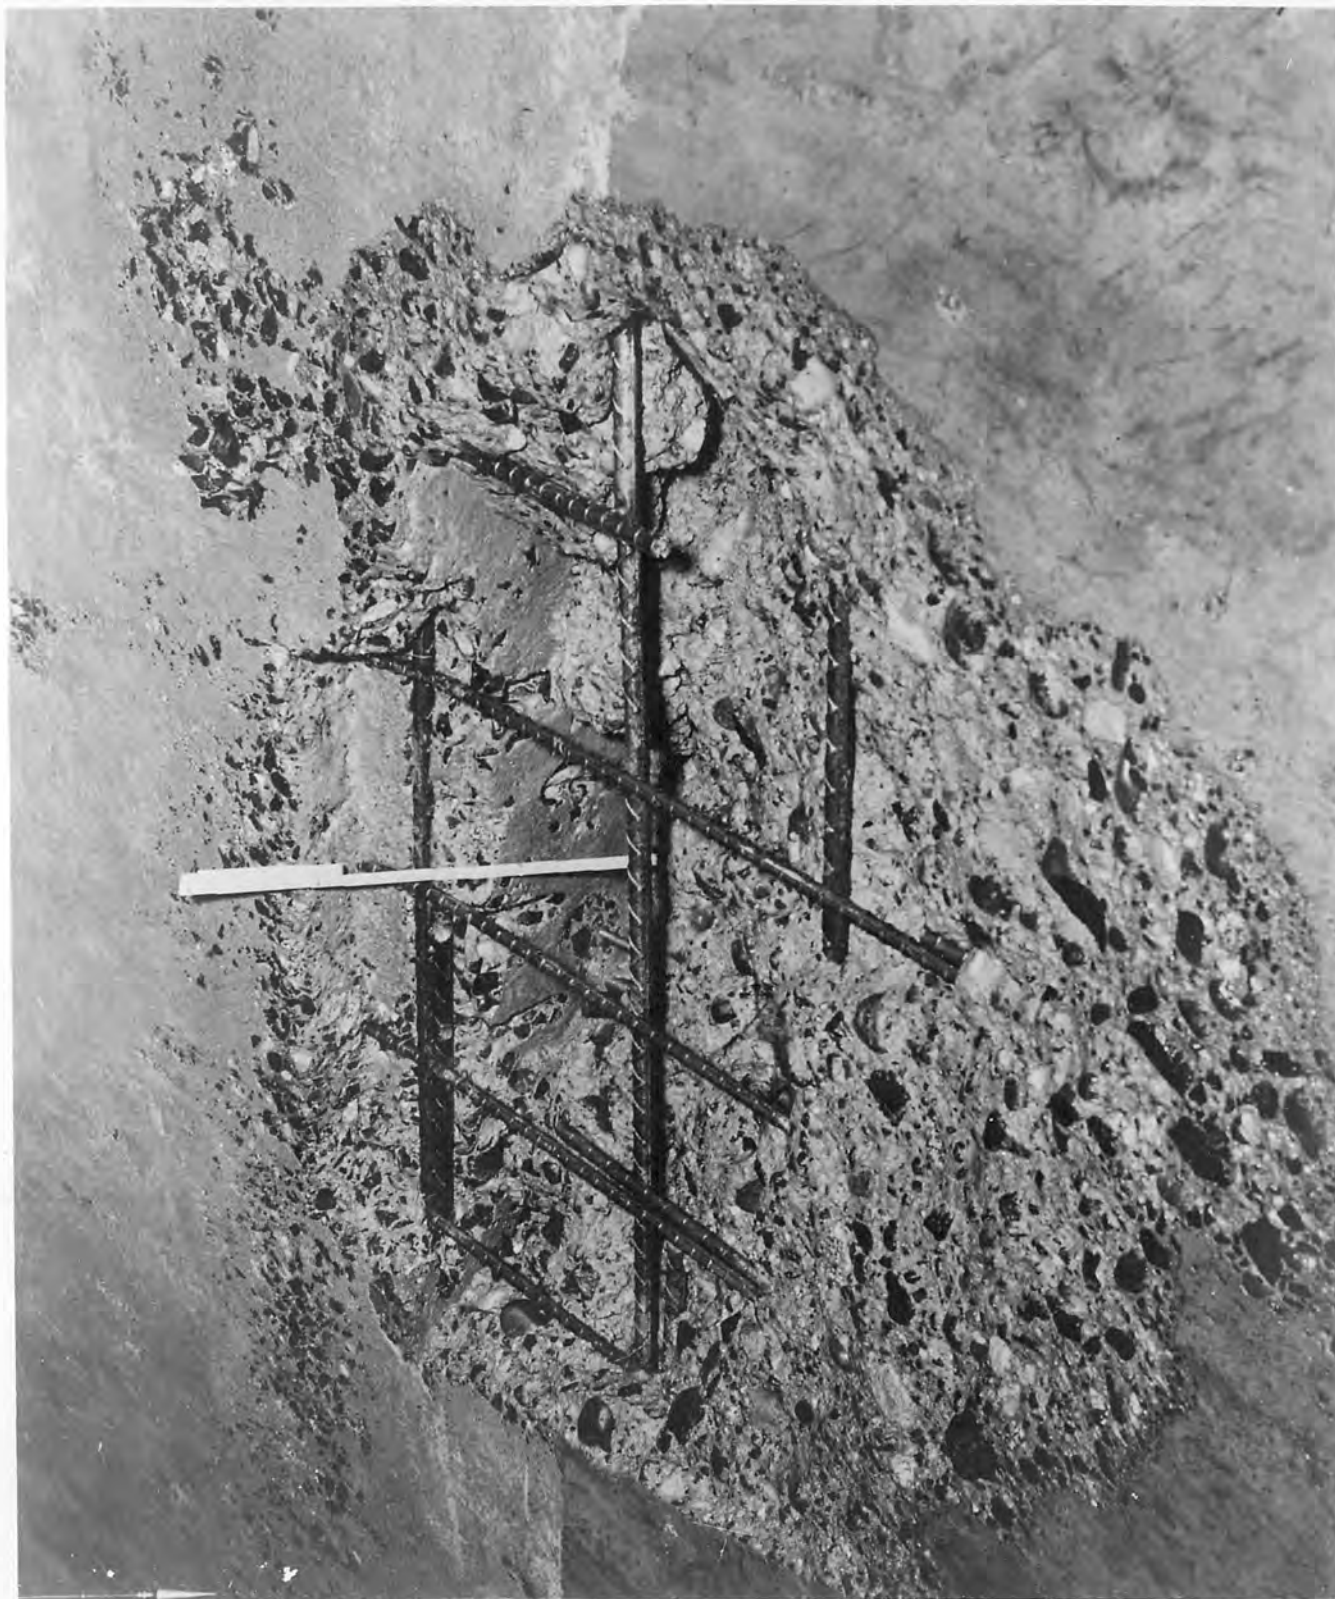
Photograph 13252-3, August 10, 1945: View from draft tube floor showing pitting by cavitation in area near construction joint 17'-9" upstream from draft tube pier nose from which patch was torn, after operation of the R-9 outlet for approximately 23 hours at full capacity on August 7, 8 and 9, 1945. Plumb bob at left indicates center of 18-inch vent pipe in top of anchor block.

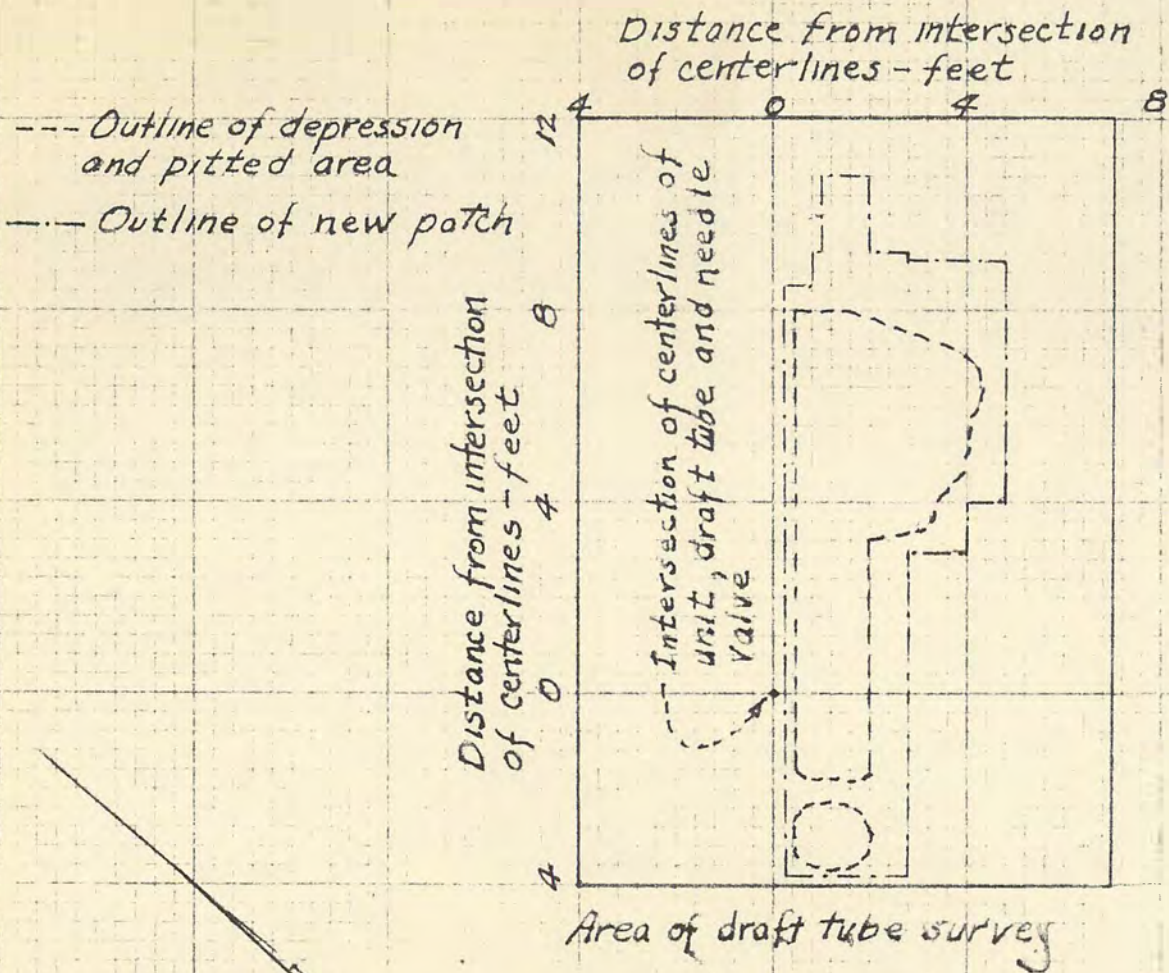
Figure 8

Survey of Curved surface at back of draft tube R-9 after test operations of August 7, 8 and 9, 1945

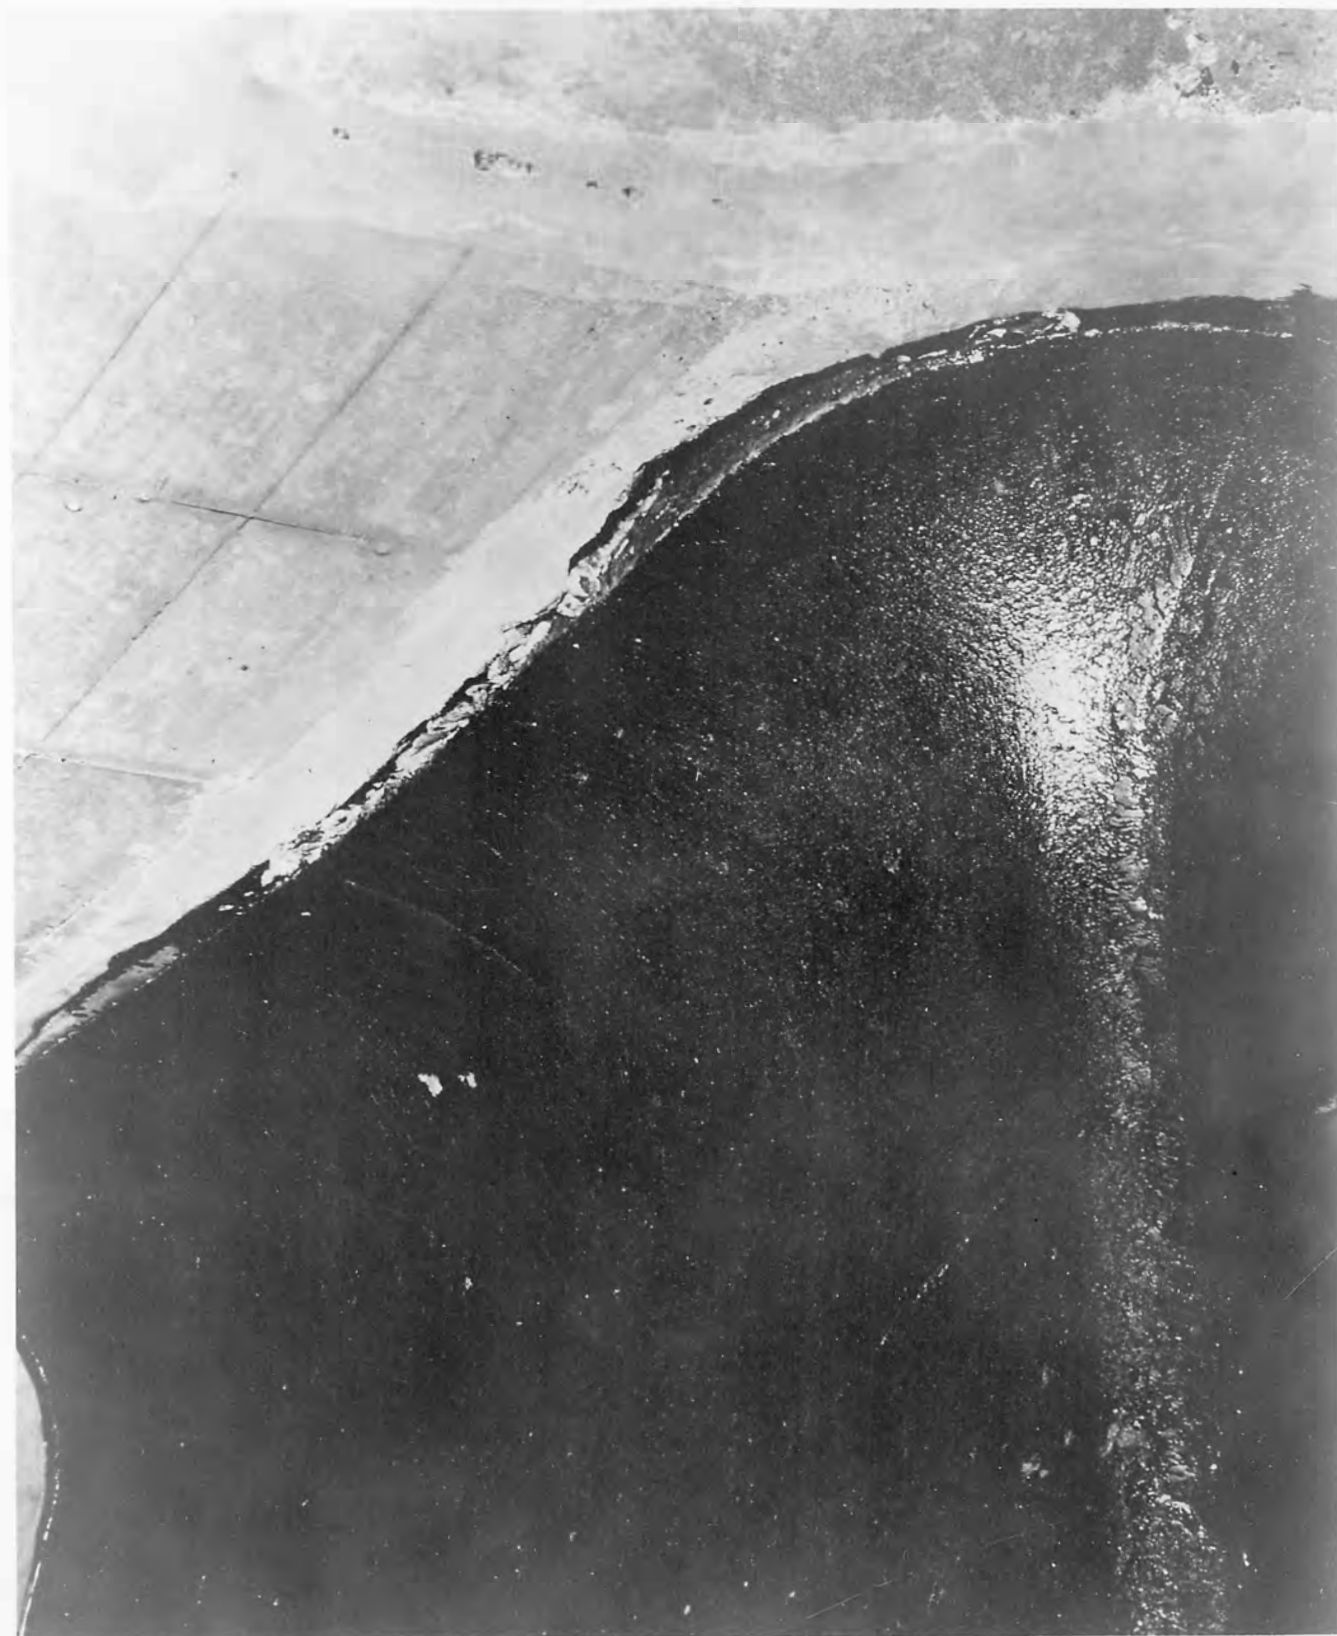
There had been a substantial increase in the amount of concrete broken from the edge of the joint between the concrete surface of the draft

tube and the nose casting of the left pier, (figure 9, Photograph 13248-3). The cause was not apparent as examination of the pier noses indicated no movement. However, the cracks in the concrete portion of the piers immediately downstream were more prominent than on previous inspections. The condition might be due to zones of local cavitation caused by water passing through the joint at high velocity.

Photograph 13248-3, August 10, 1945: View from draft tube floor showing chipped edge in concrete adjacent to top of metal pier nose, left pier of draft tube R-9 outlet operated at full capacity for approximately 23 hours.
