UNITED STATES
DEPARTMENT OF THE INTERIOR
BUREAU OF RECLAMATION

Laboratory Report No. 187
Hydraulic Laboratory

Subject: Test operation of 84-inch Needle Valve By-pass Outlet in Bay
R-9 of Right Powerhouse—Grand Coulee Dam—Columbia Basin
Project

Subject: Condition of 84-inch needle valve outlet after test operations of August 7, 8, and 9, 1945--Grand Coulee Dam-- Columbia Basin Project

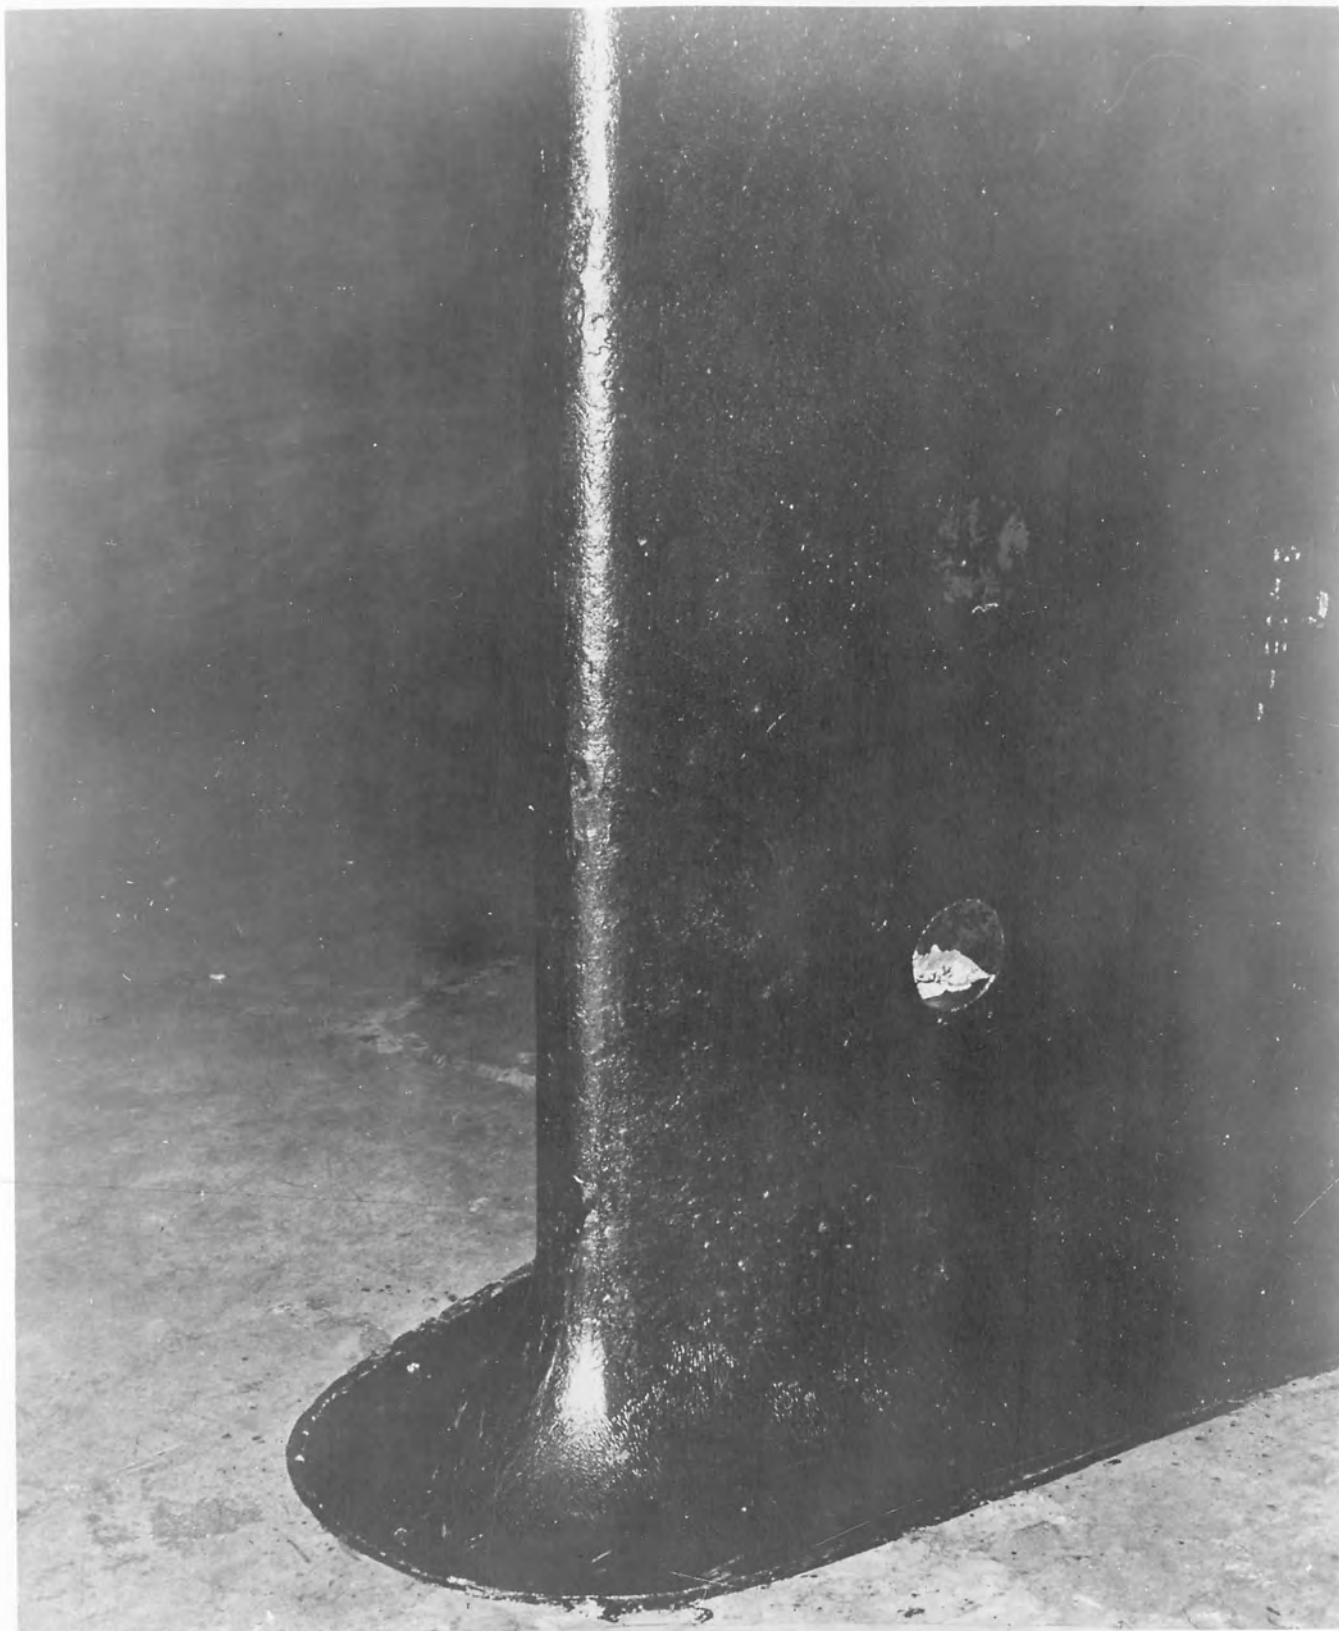
A portion of the concrete filling the lower 6-inch hole in the right side of the nose casting of the right pier was missing (figure 10, Photograph 13250-3). The cavity had the appearance of a fracture caused by a severe blow. No cause for the break was apparent. A small corner of the concrete in the hole immediately above was missing. Inspection disclosed a sizeable void below the surface adjacent to the casting.

Photograph 13250-3, August 10, 1945: View from draft tube floor showing hole in right side of the right draft tube pier nose from which part of concrete is missing after operation of the R-9 outlet at full capacity for approximately 23 hours on August 7, 8 and 9, 1945.

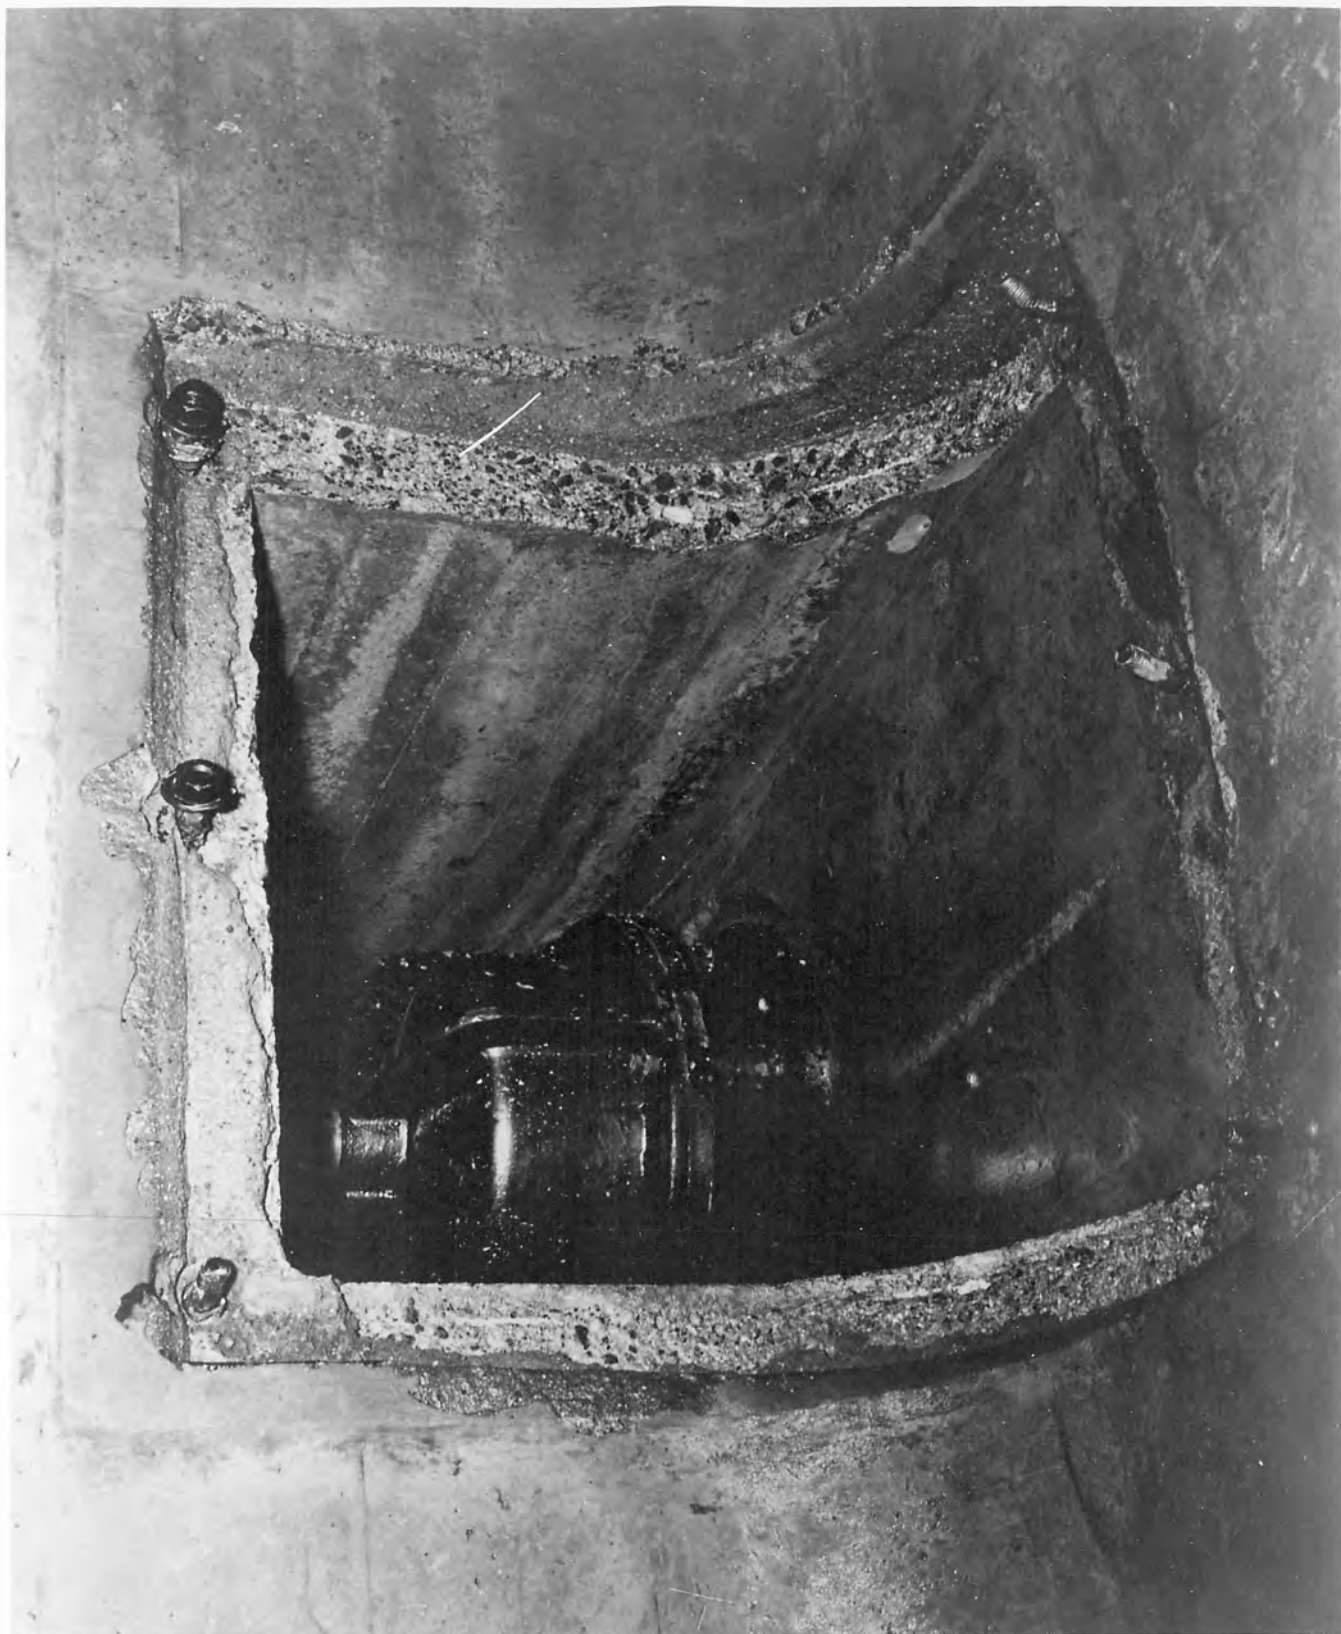
Two of the cast gratings to the draft tube unwatering valves were missing from their recesses in the center passage between the draft tube piers. Evidence was that the gratings had been torn from the anchor bolts by severe vibration and moved into the tailrace by the outlet flow. Some of the anchor bolts had been flattened on the upstream and downstream side, the nuts were missing from many of them, the threads on all had incurred various degrees of damage and many were bent or stretched, (figure 11, Photograph 13247-3). One bolt in the right pier had been stretched so severely that the nut would almost slide back and forth over the threads. Apparently the vibration loosened the gratings sufficiently to allow the bolts and nuts to pass through the slots in the top of the gratings, transferring the entire force to the bolts passing through the bases and eventually tearing the gratings from these bolts. Since the nuts were missing from all three of the lower bolts in the left pier it is presumed that this grating was torn out as a unit, possibly without damage. The presence of two of the three nuts in the right pier indicates damage to the grating torn from this pier.

Photograph 13249-3, August 10, 1945: View from draft tube floor showing recess from which grating to draft tube drain valves was torn during operation of the R-9 outlet at full capacity for approximately 23 hours on August 7, 8 and 9, 1945.

Examination of the two remaining gratings disclosed the nuts to appear tight with the paint covering unbroken. However, several of the washers could be moved easily. Such conditions may or may not have existed on all of the gratings prior to the test operations on the R-9 outlet. Tremendous oscillating forces must exist in the draft tube to remove the gratings whether or not they were anchored tightly. Pressure changes due to either cavitation or variations in the flow region would seem the most logical sources of such oscillation. The gratings in all the draft tubes in the right powerhouse should be tightened thoroughly before the outlets are operated.
