HYDRAULIC LABORATORY REPORT NO. 190

HYDRAULIC MODEL STUDIES ON
REPAIRS TO THE CALIFORNIA WASTEWAY
YUMA PROJECT
ARIZONA-CALIFORNIA

January 2, 1946

Subject: Repairs to California Wasteway--Yuma Project--Arizona-California.

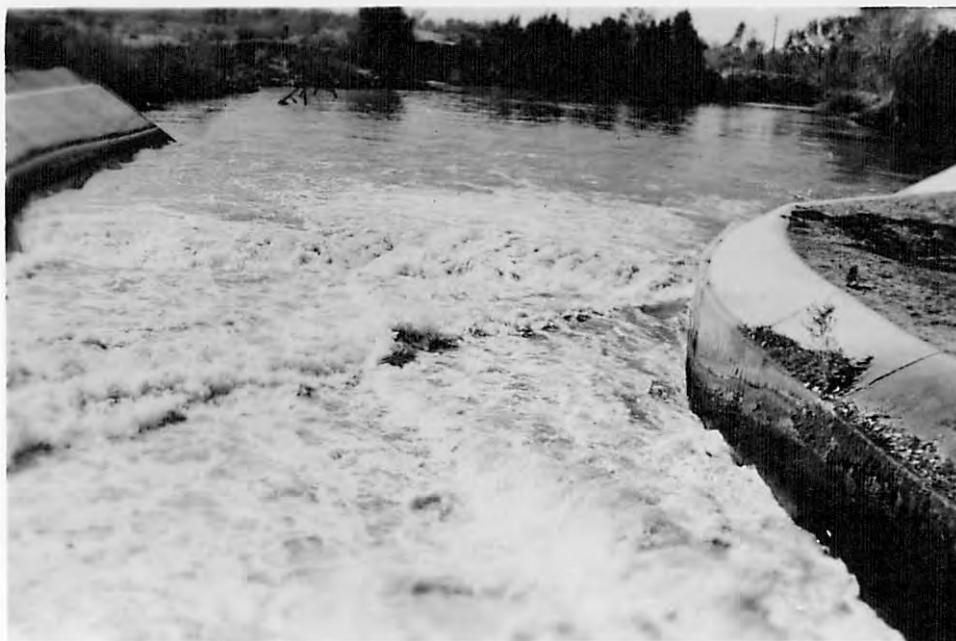
FIGURE 1

portion of the flow was concentrated along the left side of the stilling pool, (figure 1).

At the present, the tailwater elevation is approaching the limit at which the stilling pool will function effectively. Due to the unsymmetry of the structure, the hydraulic jump is imperfectly formed at the left side of the stilling pool and considerable erosion of the rock protection downstream from the structure is occurring. Rock has been placed in the canal at the downstream end of the stilling pool to protect the wasteway structure as a temporary measure.

Looking downstream from gate structure. Discharge
approximately 1000 second-feet.

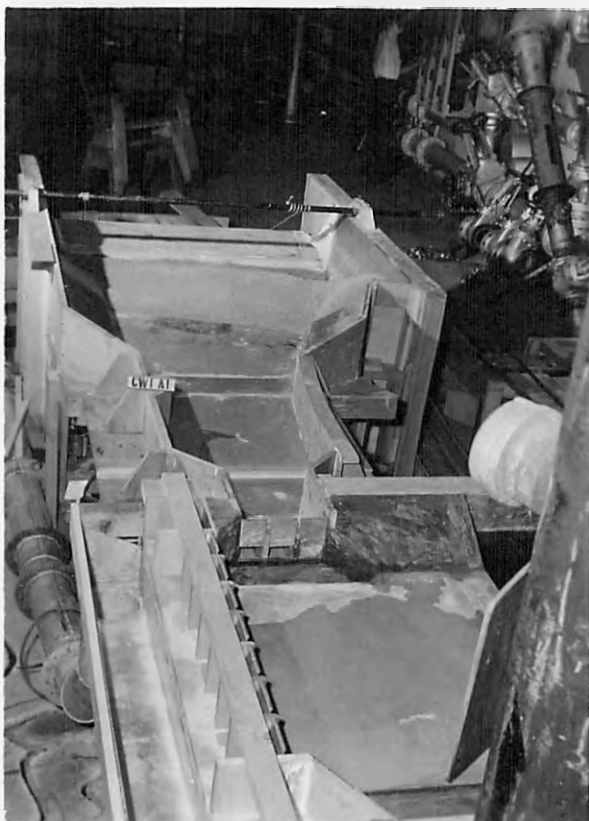
Test Procedure. The operation of the wasteway showed various objectionable features (figure 3). Flow through the wasteway gate structure was undesirable as the two downstream (with relation to the canal) gates were running full while the upstream gate flowed half full. Several types of vanes were tried at the entrance to correct this condition. Vanes proved

A. Model of present structure.

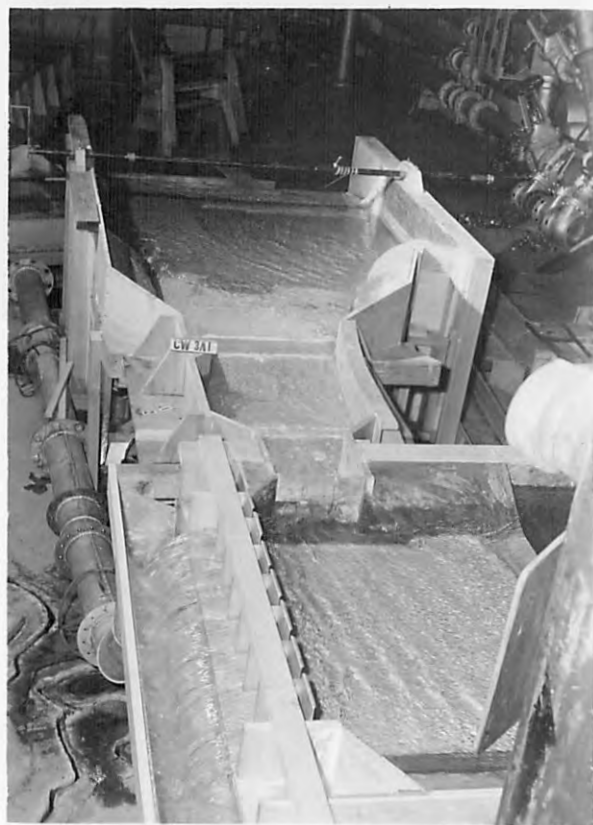
B. Flow of 1000 second-feet through Wasteway.

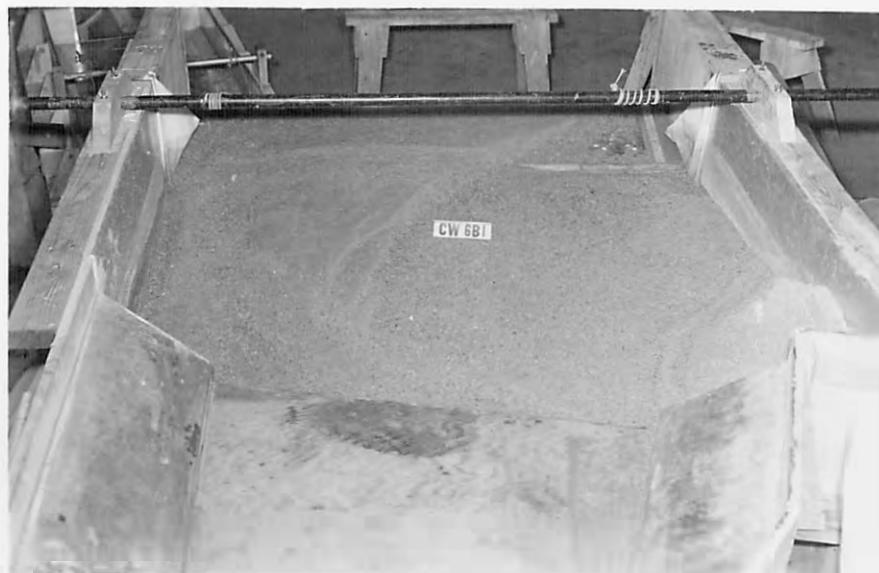
The unsymmetrical alignment of the stilling pool was the next problem needing correction. A hydraulic jump formed diagonally across the stilling pool causing considerable erosion at the left end of the pool. A solution to this problem would be to direct more of the flow to the right side of the stilling pool. Vanes were placed in the chute on the 3:1 slope to distribute the flow more uniformly across the apron. This idea was later discarded as the vanes were difficult to construct and at least twelve would be required to produce satisfactory results. After much consideration it was decided that a training wall, replacing the warped section of the canal on the right side, would be more economical than the vanes (figure 4). This training wall improved the stilling pool operation but the tailwater was still insufficient to produce a satisfactory jump. The tailwater elevation was raised, however, by placing a sill three feet high in the stilling pool. This produced a satisfactory hydraulic jump.

C. Erosion of left side after flow of 1000 second-feet.

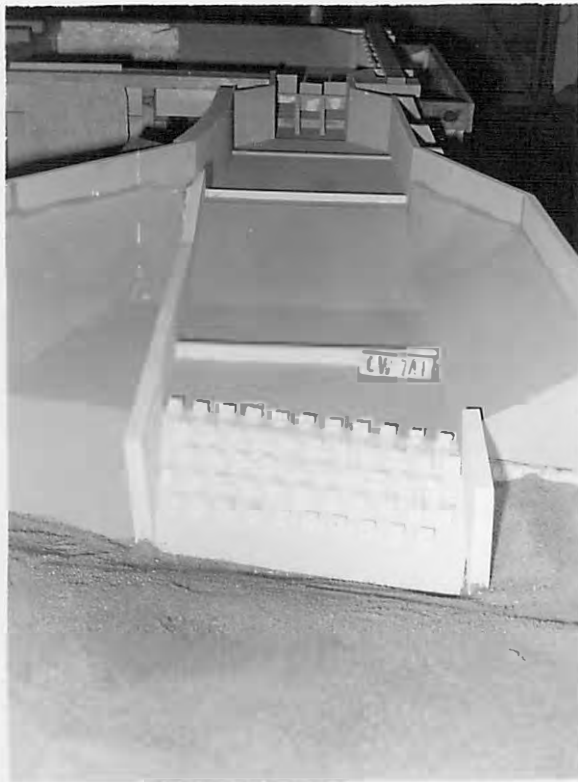
A. Looking upstream apron uncovered.

5. Recommended design. The hydraulic laboratory recommends that a sill two feet high be placed above the 3:1 slope, that a vertical training wall be constructed in the stilling pool to provide more symmetrical flow, that a sill three feet high be placed in the stilling pool, and that the 2:1 sloping apron with teeth be placed downstream from the end of the stilling pool apron (figure 5A). Figure 5B shows the river bed in place for the recommended design.

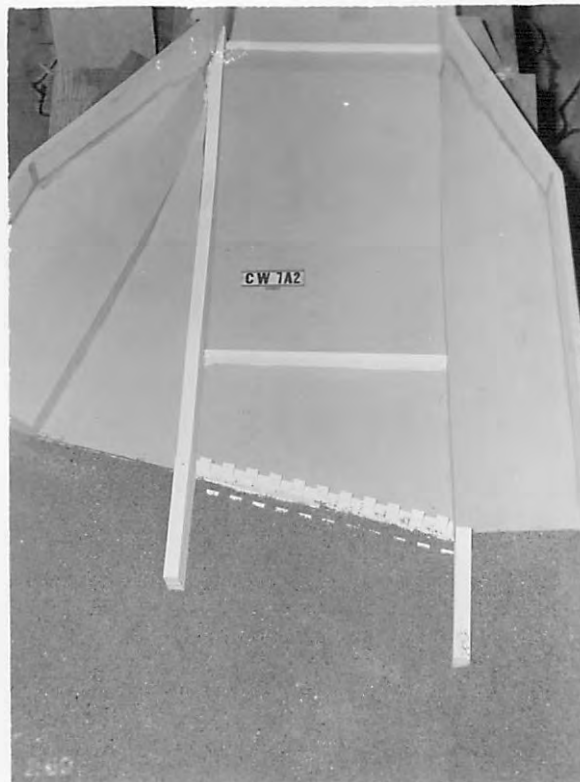
B. Looking upstream apron covered.

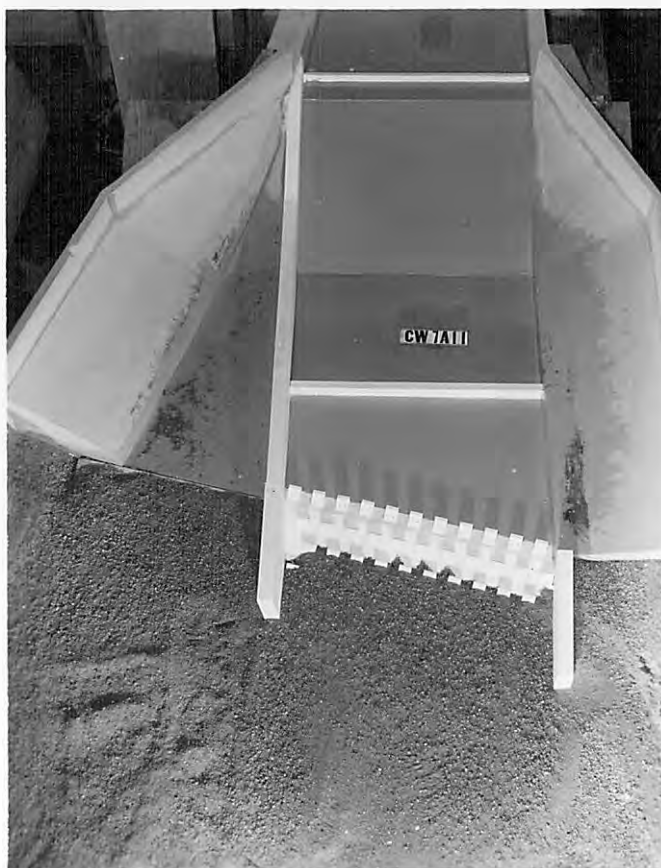
The recommended design of the wasteway was tested with different quantities of water from 500 second-feet to 2000 second-feet. Figures 6 and 7 show flows of 1000 and 2000 second-feet for various tailwater elevations. At all times the operation was satisfactory. Figure 8A and B show the scour pattern after a flow of 2000 second-feet for a period of $1\frac{1}{2}$ hours. This flow uncovered the tops of the second row of teeth on the 2:1 sloping apron.

A. Looking upstream. Erosion after $1\frac{1}{2}$ hours 2000 second-feet flowing.

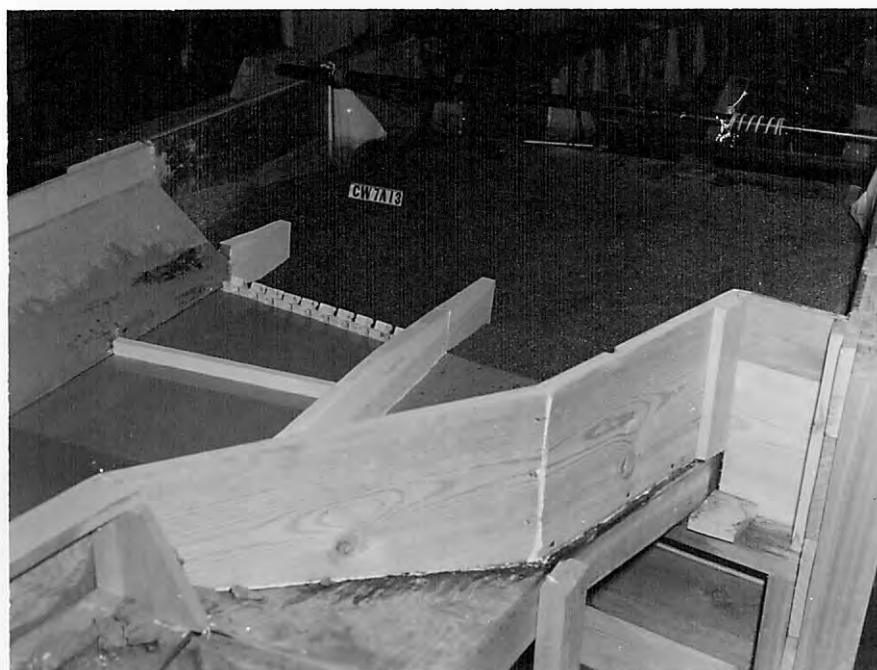
B. Looking downstream. Erosion after $1\frac{1}{2}$ hours 2000 second-feet flowing.

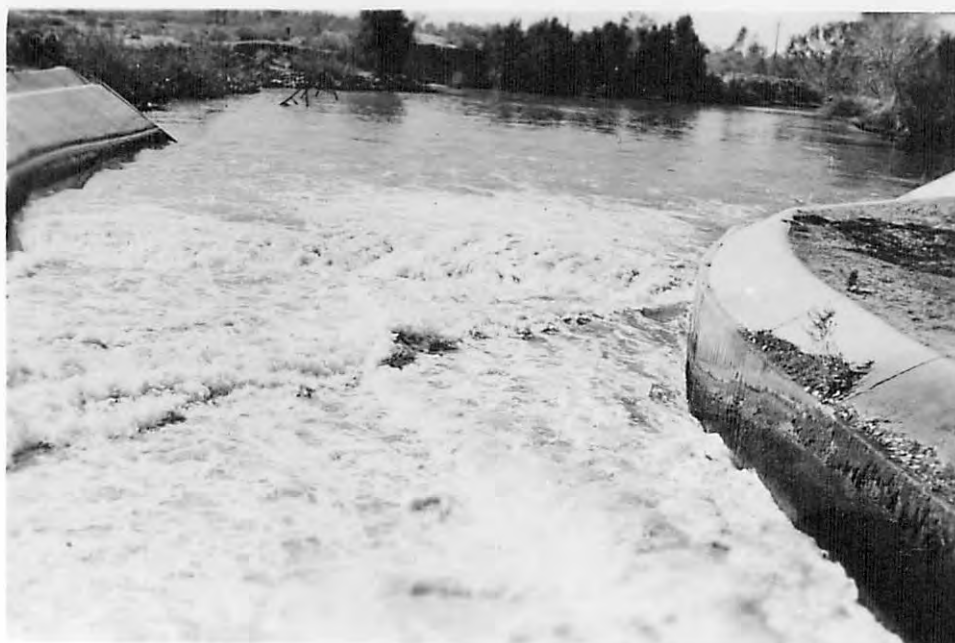
FIGURE 1

Considerable erosion has occurred on the left bank of the channel downstream from the structure. This erosion has progressed considerably during the period 1945-1946, as may be seen by a comparison of Figure 1 with Figures 2 and 3.

Looking downstream from gate structure. Discharge
approximately 1000 second-feet.

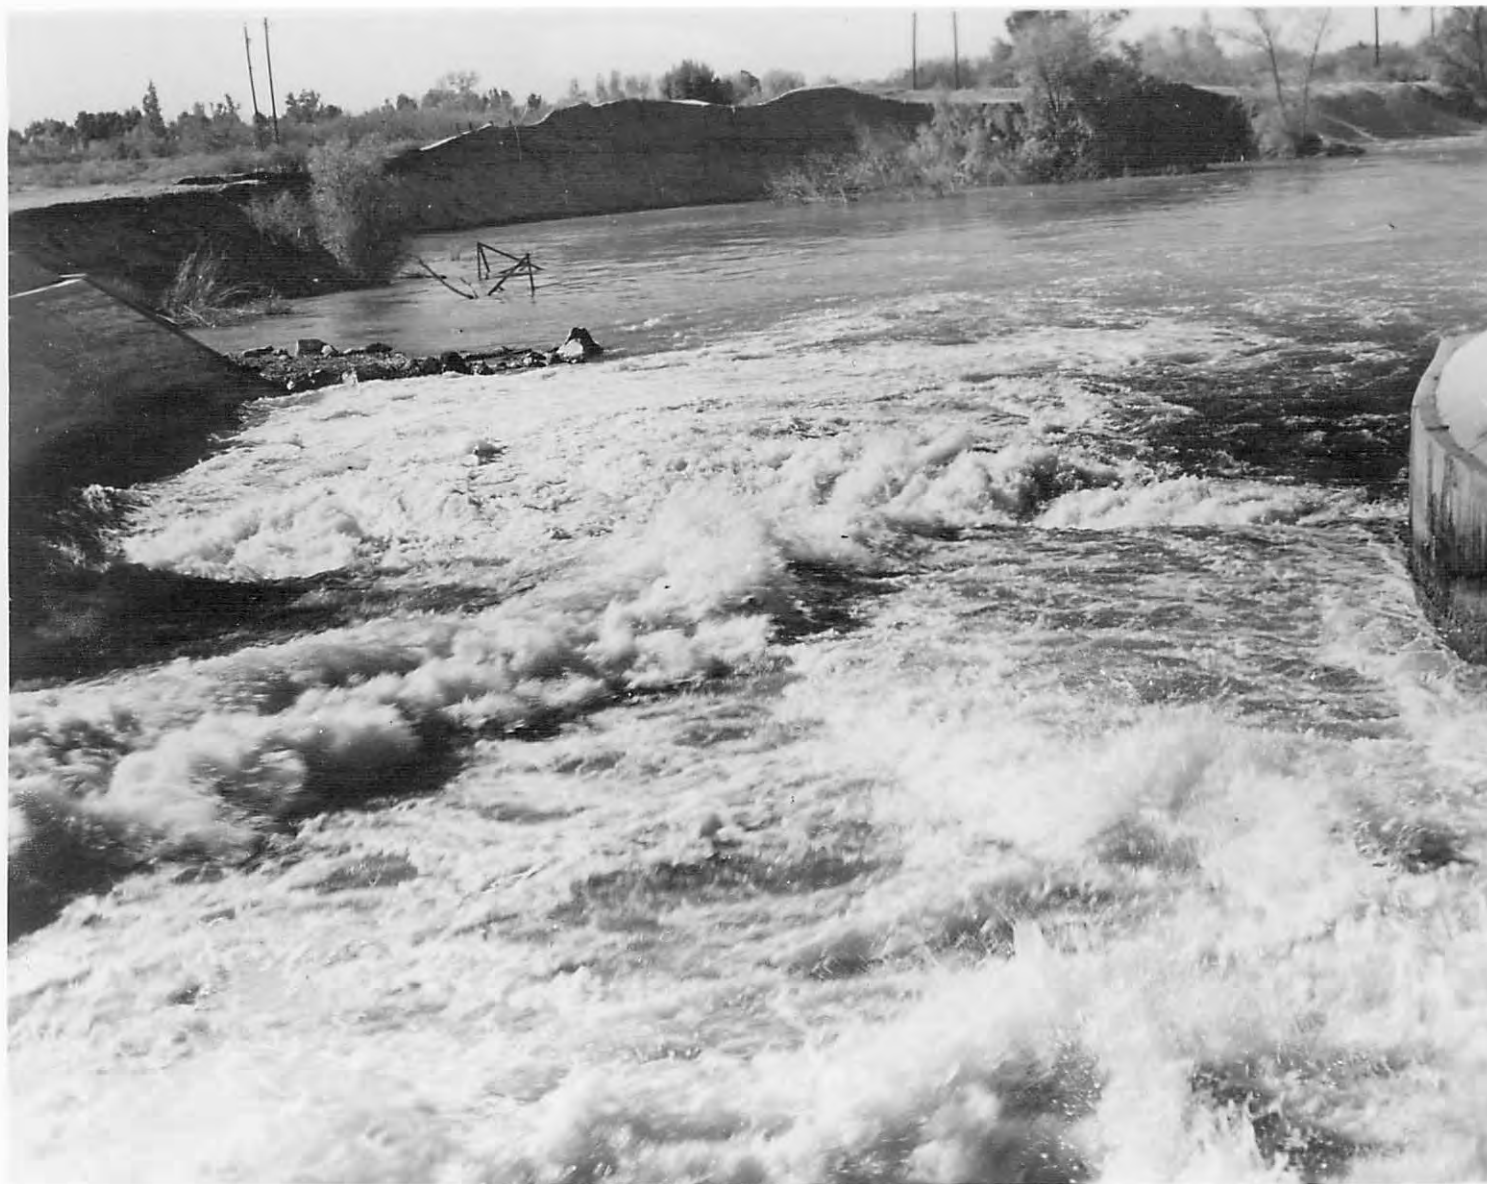
4. The repairs as recommended in Hydraulic Laboratory Report No. 190 had not been accomplished at the time of the visit. The gate tender at the structure stated that shortage of power in the area had necessitated operating Siphon Drop Powerplant continuously at near maximum capacity; hence the wasteway had been in almost continuous operation and extensive repairs were not possible. However, during periods of low flow late in 1945, work was begun on the placing of heavy rock below the wasteway to form a sill and protect the structure from undercutting. Five hundred cubic yards of quarry-run rock were placed in 1945, and additional rock was placed in 1946. The total yardage is not known by the author. The sill may be seen in Figure 2. This sill has been effective in retaining sufficient tailwater in the pool for the formation of a hydraulic jump. However, a large whirl in the pool, a result of unsymmetrical alignment of the pool and chute, and entrance conditions, causes water to flow upstream in the right portion of the pool and the jump forms diagonally, Figure 2.

Chute and Pool Conditions--Discharge Approximately 1600 Second-feet. January 16, 1947.
California Wasteway--Yuma Project--Arizona, California.

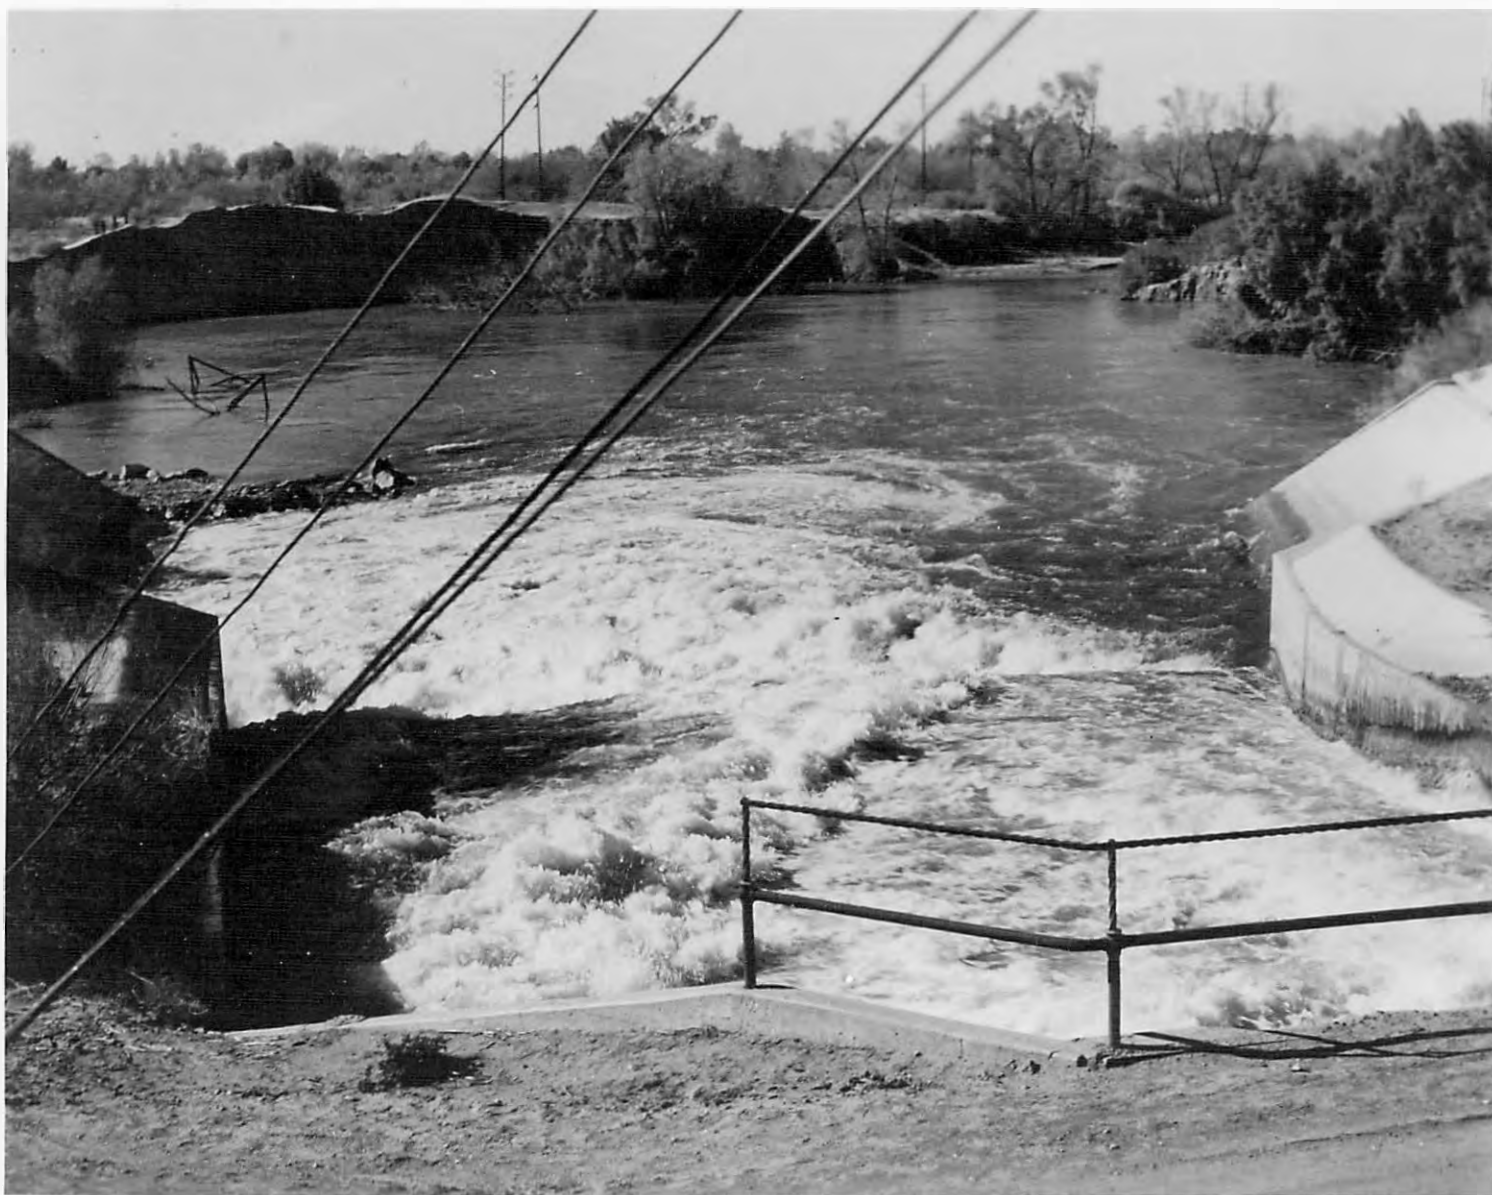
Chute and Pool Conditions--Discharge Approximately 1600 Second-feet. January 16, 1947.
California Wasteway--Yuma Project--Arizona, California.

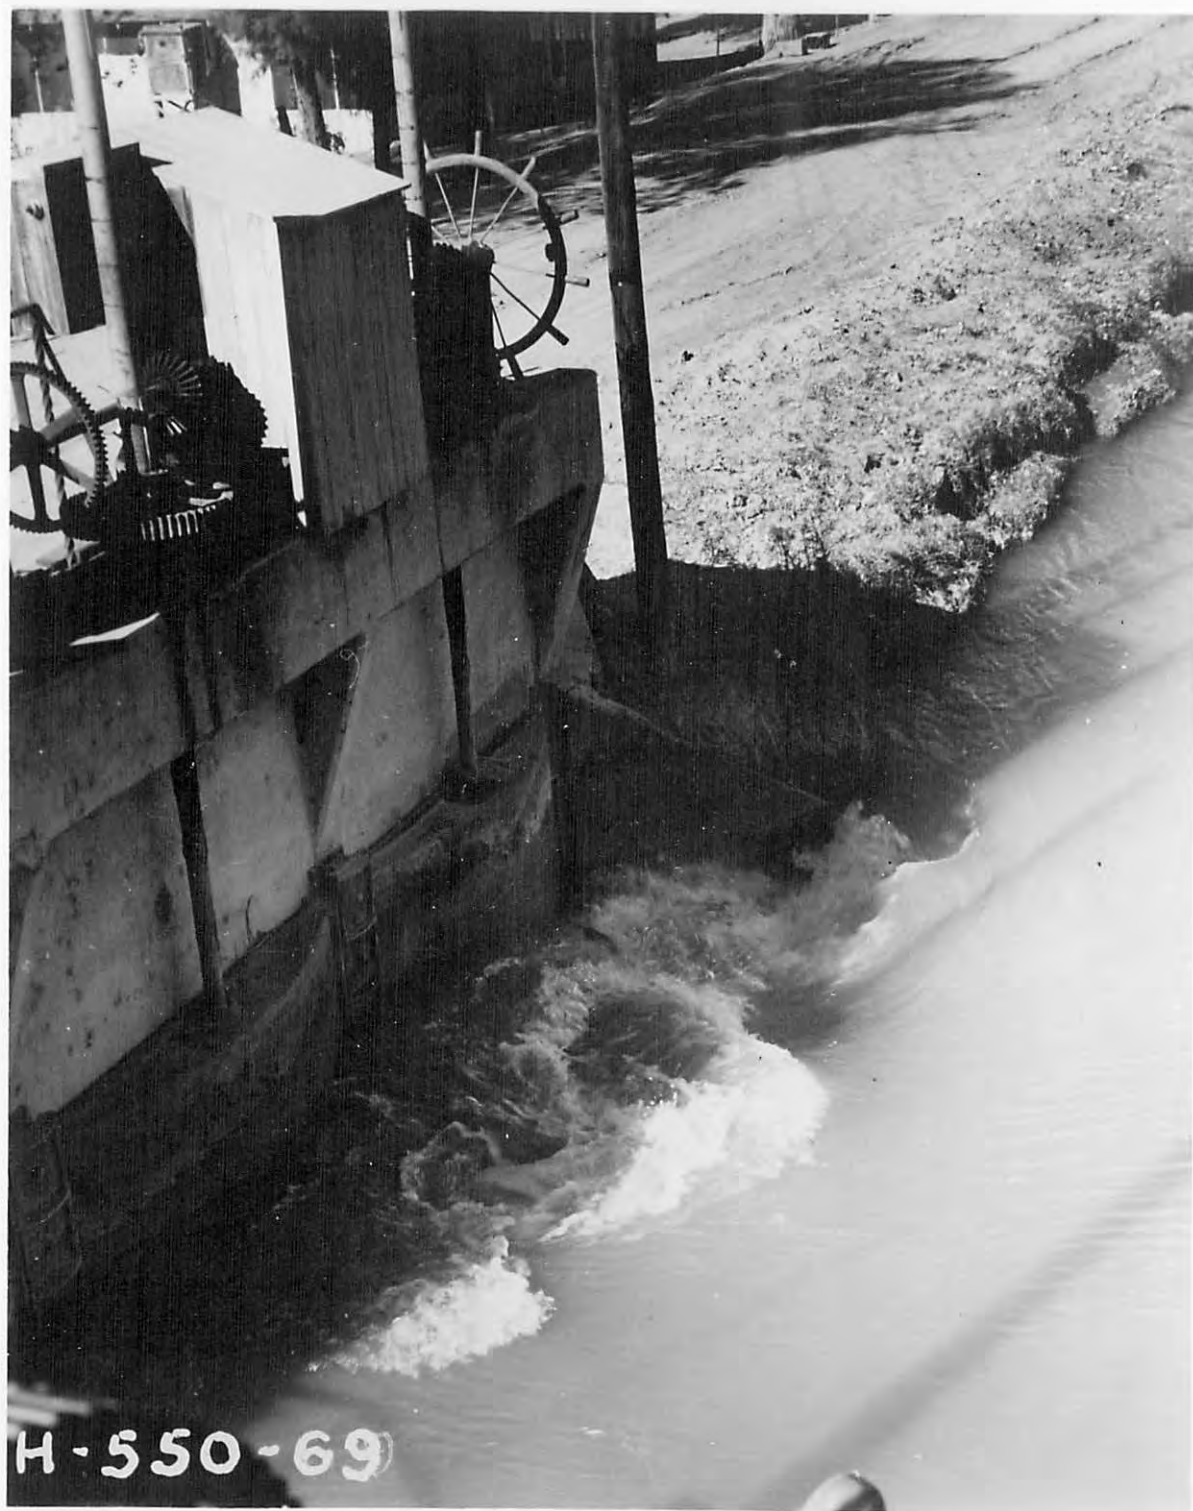
5. The maximum capacity of the wasteway is governed by the inlet structure which is oriented at right angles to the flow in the canal. When this flow is checked to maximum water-surface elevation and the wasteway inlet gates are completely open, entrance conditions as shown in Figure 4 exist and the flow is limited to approximately 1,600 second-feet. The undesirable entrance conditions contribute to the rough flow in the pool, particularly, at high discharges.

Entrance Conditions at Upstream End of
Structure--Discharge Approximately 1600
Second-feet. January 16, 1947.
