STUDY OF STILLING POOL
AT STATION 25 + 19
SOUTH CANAL - UNCOMPAHGRE

Hydraulic Laboratory Report No. 200

Subject: Study of flow conditions in stilling pool of chute at Station
25+19 in the South Canal of the Uncompahgre Project.

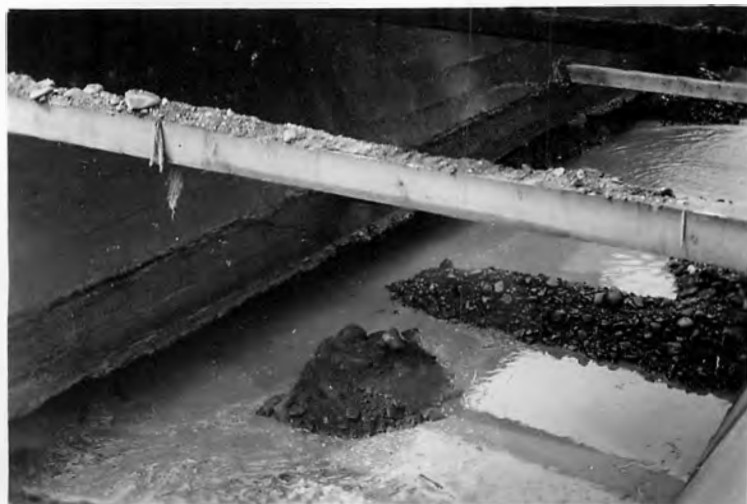
C - Break below Seven-drop section
Looking downstream

On April 29, 1936, a break occurred in the floor of the canal below the section generally referred to as the "Seven-drop Section," (figure 3). It was necessary to shut the water out of the canal to make repairs. In changing the discharge in this canal the rate of change, whether an increase or decrease, is never more than 100 second-feet per hour. At this rate upwards of eight hours are required to empty the canal when it is flowing full and an equal amount of time is required to raise the flow from zero to maximum discharge. As soon as the water started to recede at the chute two men were stationed at the gages and instructed to record the gage reading every 15 minutes. This was done and the data were plotted on the tailwater curve sheet (figure 6).

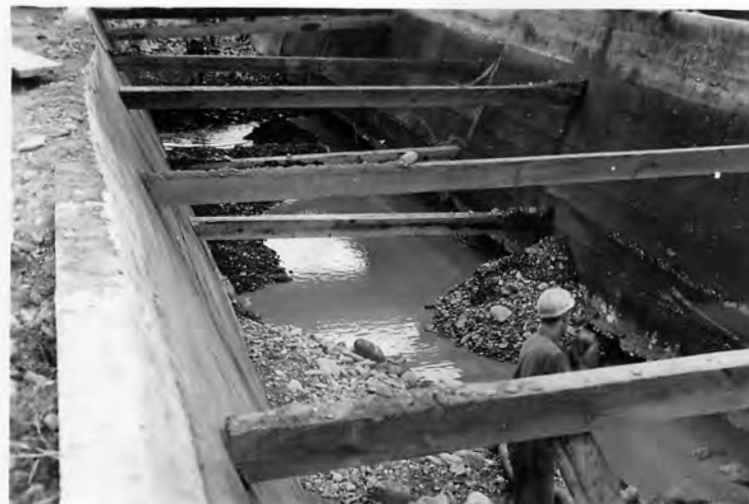
D - Break below Seven-drop section
Looking upstream

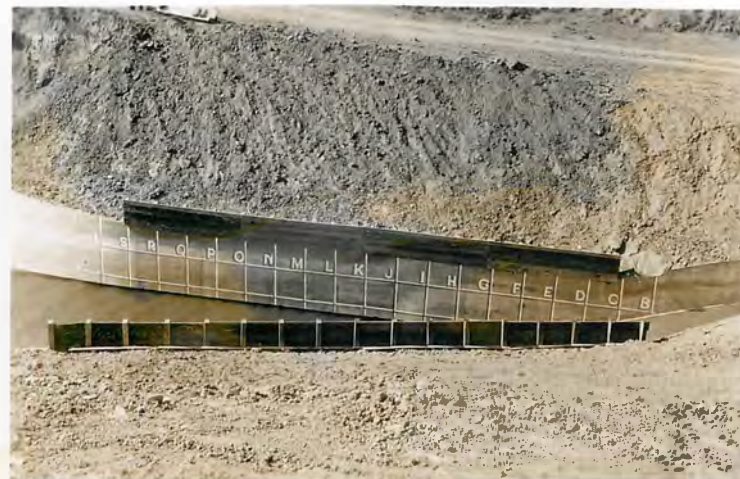
D - Grid lines on pool lining

pictures that the grid systems did not agree. A check of dimensions of the prototype grid system disclosed that due to an error in measurements the horizontal lines had been placed six-tenths of a foot lower than the same lines on the model. This error resulted because the pool was filled with water to depth of approximately $6\frac{1}{2}$ feet and the top of the training wall was necessarily used as a control point.

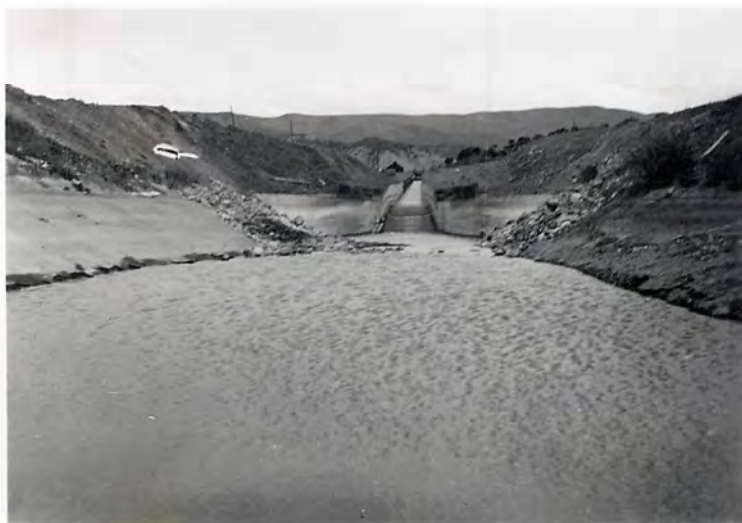
A wave or roller forms intermittently near the intersection of the jet and the backwater (approximately station "E") and moves rapidly downstream through the pool. There is an occasional surge that travels from one side wall toward the other. This action makes a rough water surface and causes a wave to travel along the banks of the earth section downstream from the pool and considerable erosion results. This erosion has been checked by dumping several yards of large boulders along the banks downstream from the end of the new lining and upstream from a section of old lining that formed part of the pool of the drop replaced by the chute. The specifications called for removal of the old drop, widening of the earth section and placing a rock paving on the bottom and sides for a distance of 20 feet from the end of the lined pool. Due to the lateness of the season and the consequent urgent need for water in the canal the contractor was allowed to withdraw from the job as soon as the concrete lining was poured. The concrete section of the old drop was left approximately $2\frac{1}{2}$ feet above the floor of the new pool. The banks were not cleared and a slab of old lining projects approximately eight feet into the canal from the right bank a short distance below the new pool. The dumped riprap further restricted the channel below the pool and some of it had been carried by the water or rolled on top of the floor of the new pool.

A - Restriction below stilling pool looking upstream

If the canal section had been cleared and the dry rock paving placed according to specifications very little damage to the earth sides of the canal would have resulted. The additional width of the canal section would have allowed the roller to spread and it possibly would have been dissipated a short distance from the end of the lining.

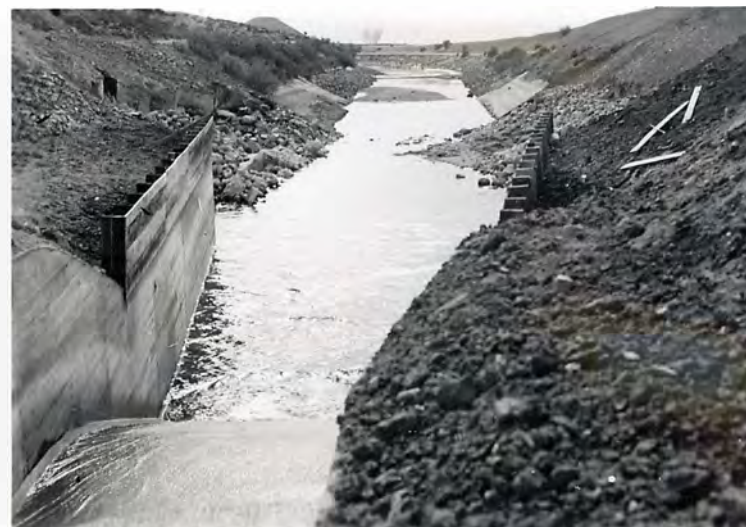
B - Restriction below stilling pool
Looking downstream

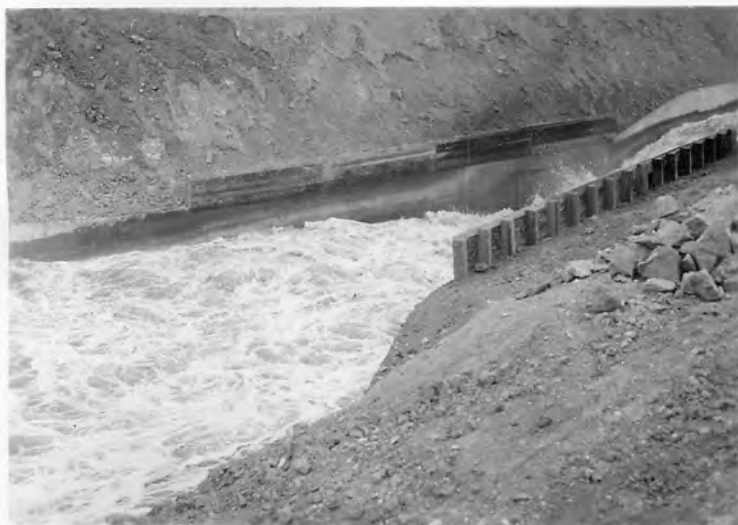
The flow conditions in the pool are generally satisfactory. However, there is periodic splash that overtops the side walls of the pool near the point where the jet impinges on the tailwater. This splash would normally do no harm if returned to the pool by drains. The type of material in the backfill of this particular structure does not readily adapt itself to drainage and is inclined to slide when saturated. Should the backfill around the pool become saturated this tendency to slide would exert a tremendous pressure on the side walls and would very probably result in damage to the structure. In this specific instance higher side walls would correct the condition. Wooden splash walls have been installed which partly, but not entirely, eliminate the saturation of the backfill.

Spray from pool with discharge of 800 second-feet

It has been thought that the conditions cited above would be of interest to the design sections as indicating the desirability of providing for drainage or other protection of stilling pool embankments under similar circumstances.

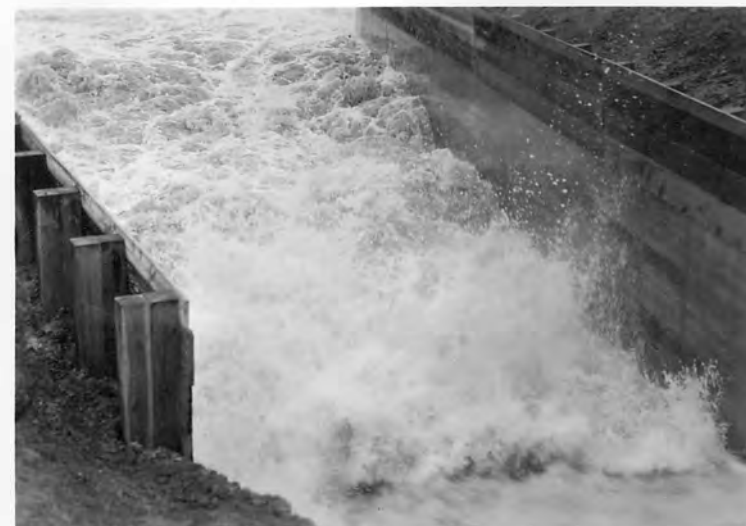
D - Upstream end of hydraulic jump.
