UNITED STATES  
DEPARTMENT OF THE INTERIOR  
BUREAU OF RECLAMATION

Laboratory Report No. HD-251  
Hydraulic Laboratory  
Written by: C. E. Lane  
Checked by: J. L. Gilliland  
Reviewed by: L. J. Roberts

Subject: Failure of heating elements in water heaters.

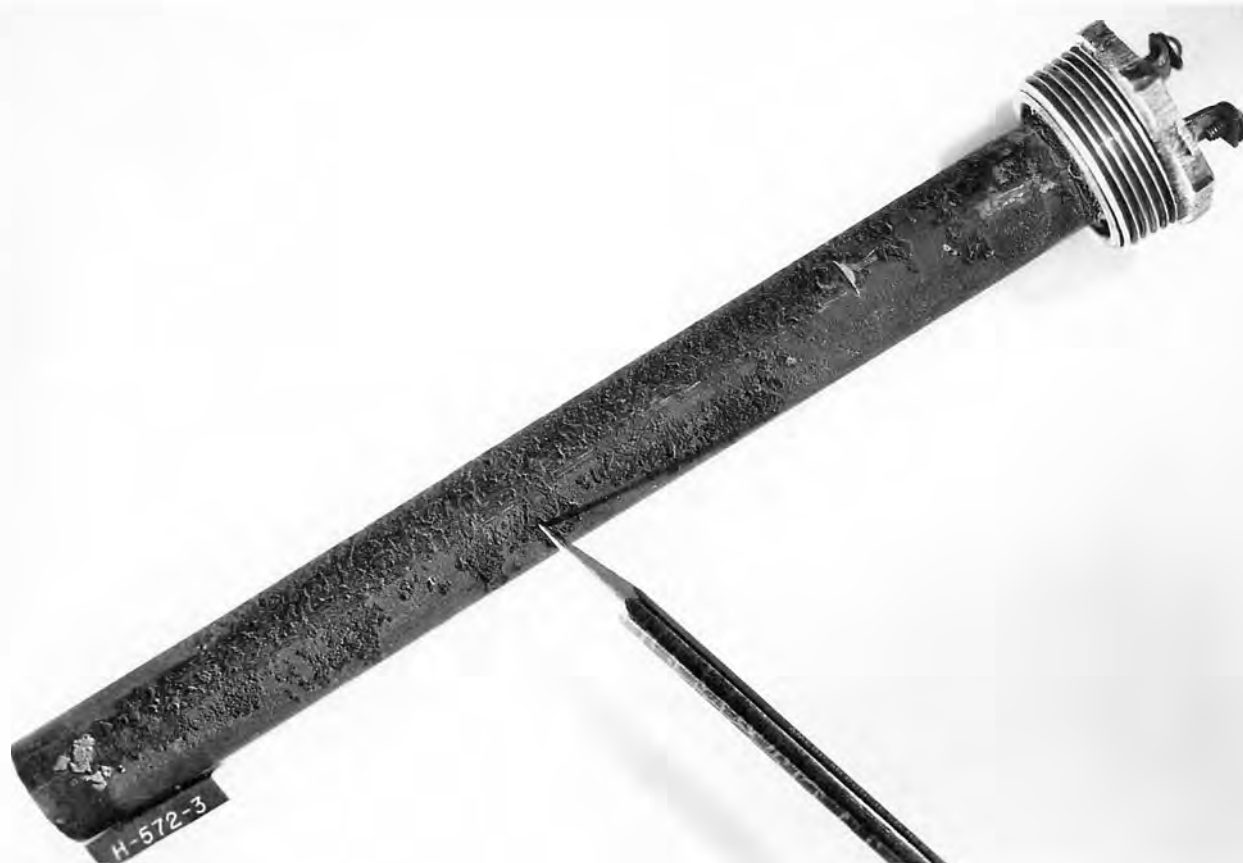
Figure 1

Measurements made on the electrical section of the heating element showed that they met the power requirements stamped thereon. Other tests made on the jacket showed that it was made of ferrous material. Failure of the element was due to corrosion of the jacket which had proceeded to an advanced degree, as shown in Figure 1. Figure 2 shows an enlarged section of Figure 1.

Examination of the water-heater jacket showed no tendency toward a scale deposit. Rather, it indicated that the water at Estes Park is a scale solvent, since the metal surface is deeply pitted with very little scale present. The formation of a protective scale therefore cannot be relied upon to prevent the corrosive reactions from taking place.

The cylinders containing the heating elements in the purchased heaters were found to be installed in a horizontal position approximately 10 inches above the bottom of the tank. The maximum corrosive activity took place on the upper side of the jacket. This would be expected since the flow of water in the immediate region of the jacket is upward due to the temperature gradient. The bubbles of dissolved air liberated from the water on the lower side of the jacket are carried away, while the bubbles on the upper side are protected, and since free air is composed of approximately 21 percent oxygen, the components for continued corrosion are present. As the corrosion

Corrosion of heating element jacket.

A jacket made from suitable material would minimize the corrosive activity in this particular case. Copper or high-copper brass is recommended. Copper, being on the negative side of hydrogen in the electrochemical series, would be restrained from going into solution. The use of a copper jacket for the heater element, however, introduces galvanic cell action between the copper and the iron water tank. A slight amount of corrosion would result with the iron of the tank going into solution. The electrical current flow would be minimized in this case since the amount of mineral matter in the water is small. In addition, the area of the copper is small compared to the area of the iron and the galvanic couple should not greatly accelerate the present corrosion rate of the tank. To further eliminate the corrosion due to the galvanic couple, however, an electrical insulator could be used in mounting the heater unit in the tank.

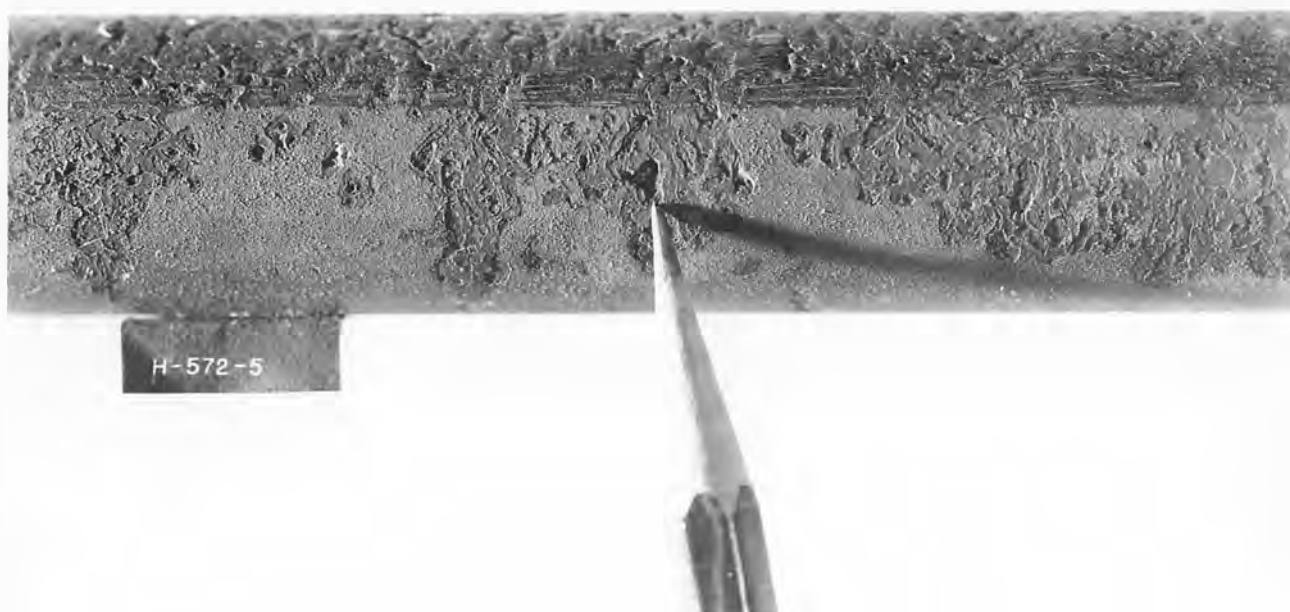
Enlarged view of pitted jacket surface.
