UNITED STATES
DEPARTMENT OF THE INTERIOR
BUREAU OF RECLAMATION

AN INVESTIGATION CONCERNING
THE PROTOTYPE BEHAVIOR
OF MORNING-GLORY SPILLWAYS

Hydraulic Laboratory Report Hyd-254

NOVEMBER 19, 1948

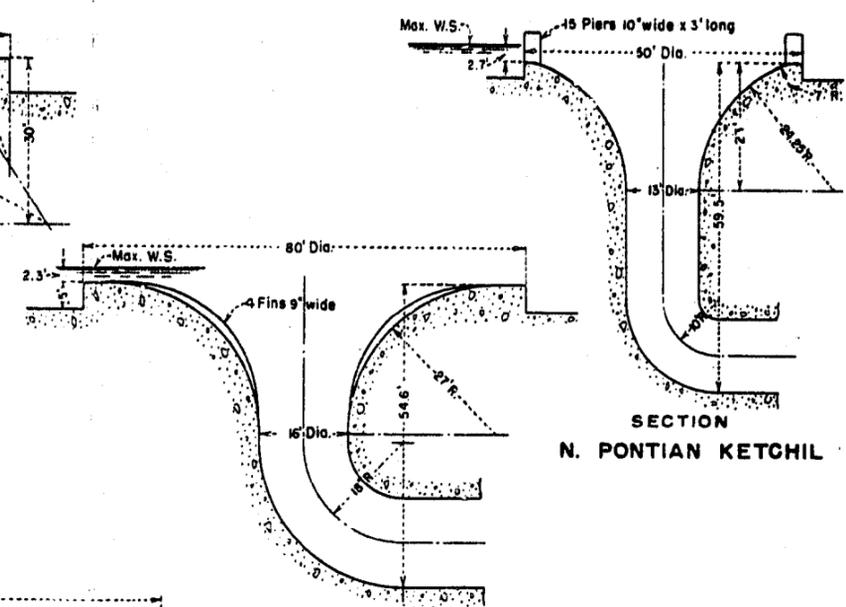
SECTION N. PONTIAN KETCHIL

"This spillway is situated in the Malayan forest where cyclonic storms occur of such intensity as to uproot large trees and carry them for considerable distances. An emergency overflow was provided in case the bellmouth became partially blocked."

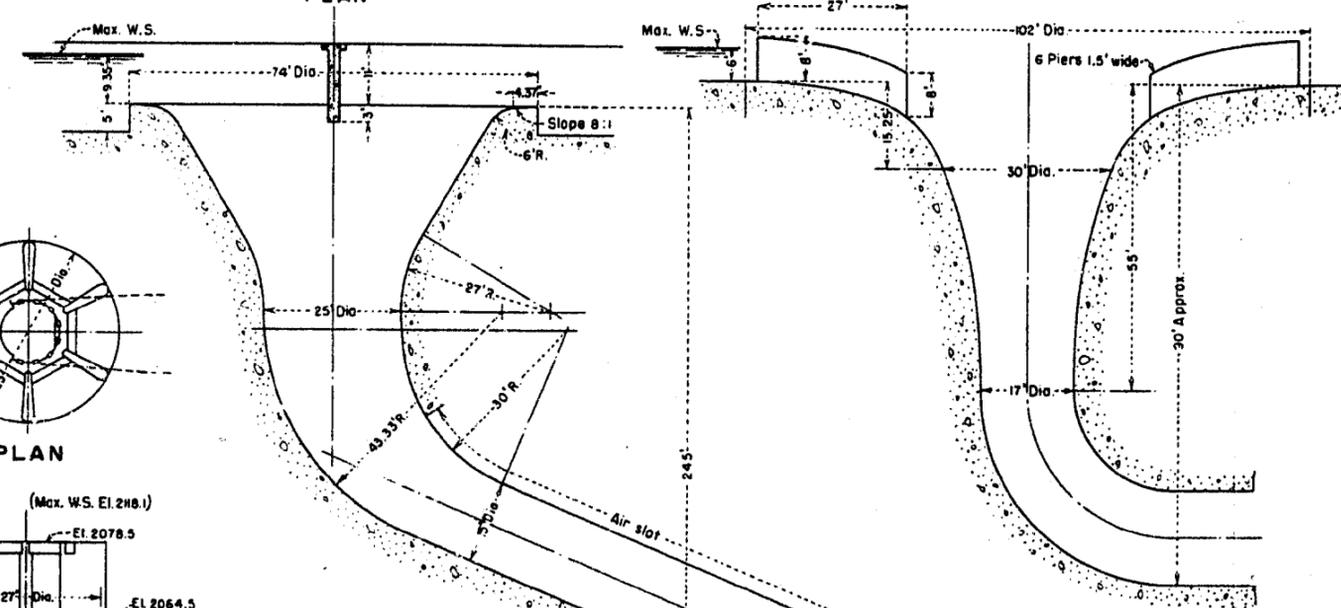
SECTION P. MANUHERIKIA FALLS

"Erosion of the concrete has been experienced at or near the vertical bend of the tunnel and also more particularly at the crest curve in the vicinity of construction joints. It is suggested that construction joints be avoided at the crest.

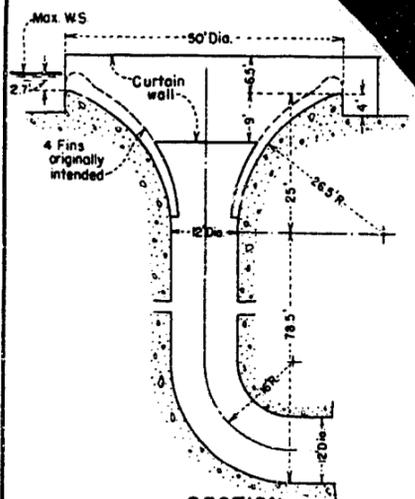
SECTION O. BURNHOPE

"The vertical bend in the tunnel is lined with cast iron. One record of a moderate flood is recorded at Burnhope involving a discharge of 1,440 second-feet. No undesirable operating conditions are on record."

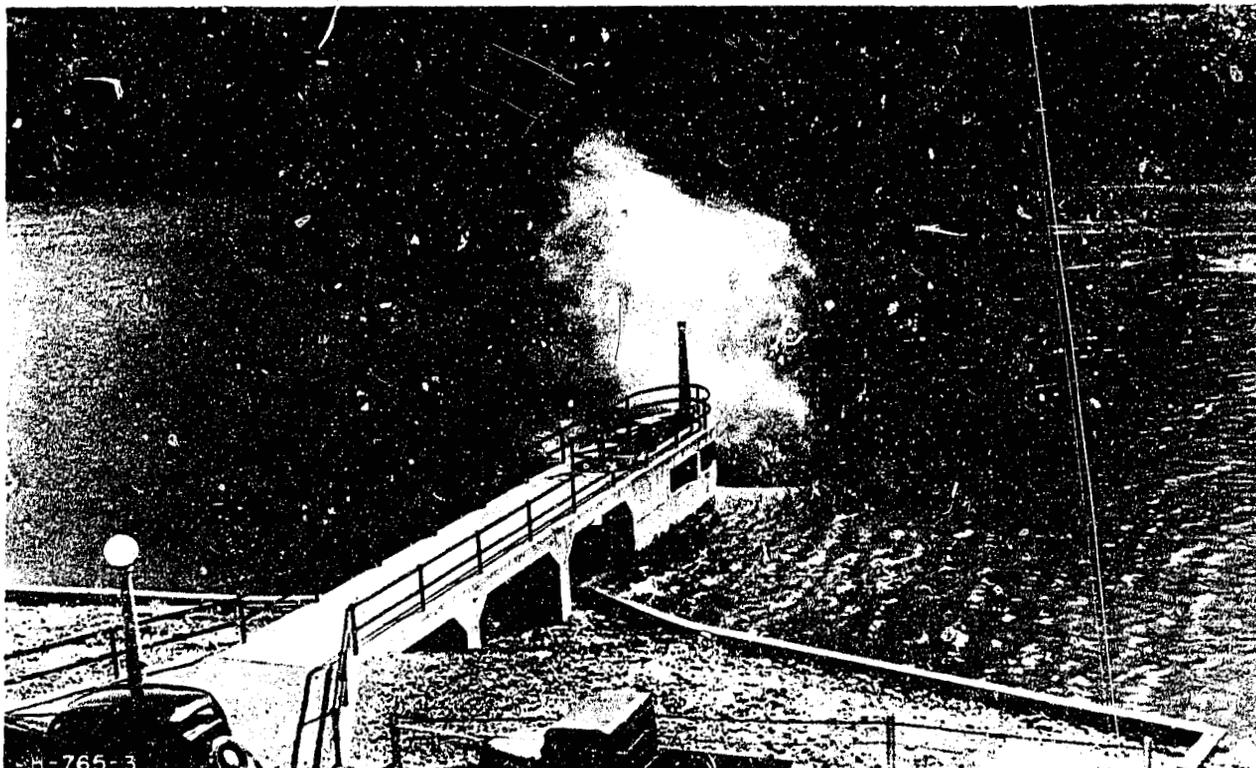
the water falls in a solid sheet toward the center of the spillway shaft, apparently entraining air there faster than it can be released at the outlet end of the spillway tunnel, causing the air pressure to increase until sufficient to break through the sheet of falling water. The air emerges with enough force to carry spray 50 or 60 feet above the level of the gate crest. This phenomenon occurs sometimes as often as once every 5 minutes, depending upon the tailwater elevation, which is influenced also by water released through the needle valve outlet. For flows less than the above-stated, the excess entrained air can apparently move back up the spillway shaft unhampered. For flows greater than 1.5 feet over the crest, the air pressure is not sufficient to break back; and it is forced out through the outlet end causing spray and water to be thrown high into the canyon.

"No evidence of flutter of the jet has been noticed, thus indicating that the air supply provided to the underside of the nappe through the 8-inch air pipes is adequate. Furthermore, no evidence of vibration has been apparent in the spillway tunnel. Inspections of the spillway, vertical shaft, the elbow, and the tunnel downstream have disclosed no indication of cavitation erosion or erosion of any kind. These inspections have been conducted annually since first operation of the spillway in 1936."

A. Owyhee Dam Spillway-illustrating updraft of spray when operating at approximately 1,200 c.f.s.

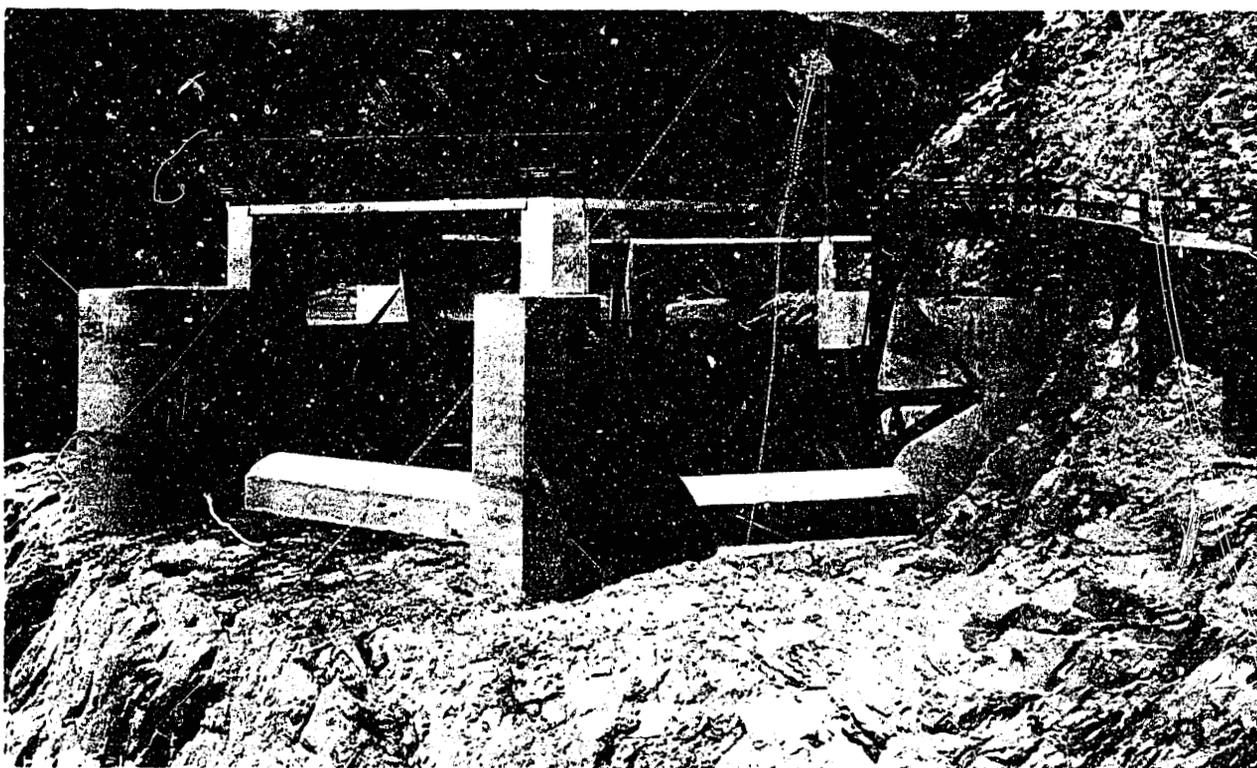
The original morning-glory spillway, consisting of a free crest, (Figure 1-B) was completed in 1926. After several years of operation additional storage was needed. The morning-glory portion was revised in 1936 to embody radial gates and piers, as shown in Figures 1-C and 3-B. An account of the model studies made in connection with the revision can be found in Hydraulic Laboratory Report HYD-159, Bureau of Reclamation, November 15, 1944.

B. Gibson Dam Spillway-showing arrangement of radial gates and piers
