SEEPAGE MEASUREMENTS--
LOWER-COST CANAL LINING PROGRAM--
TUCUMCARI PROJECT, NEW MEXICO

Hydraulic Laboratory Report No. Hyd. 303

February 16, 1951

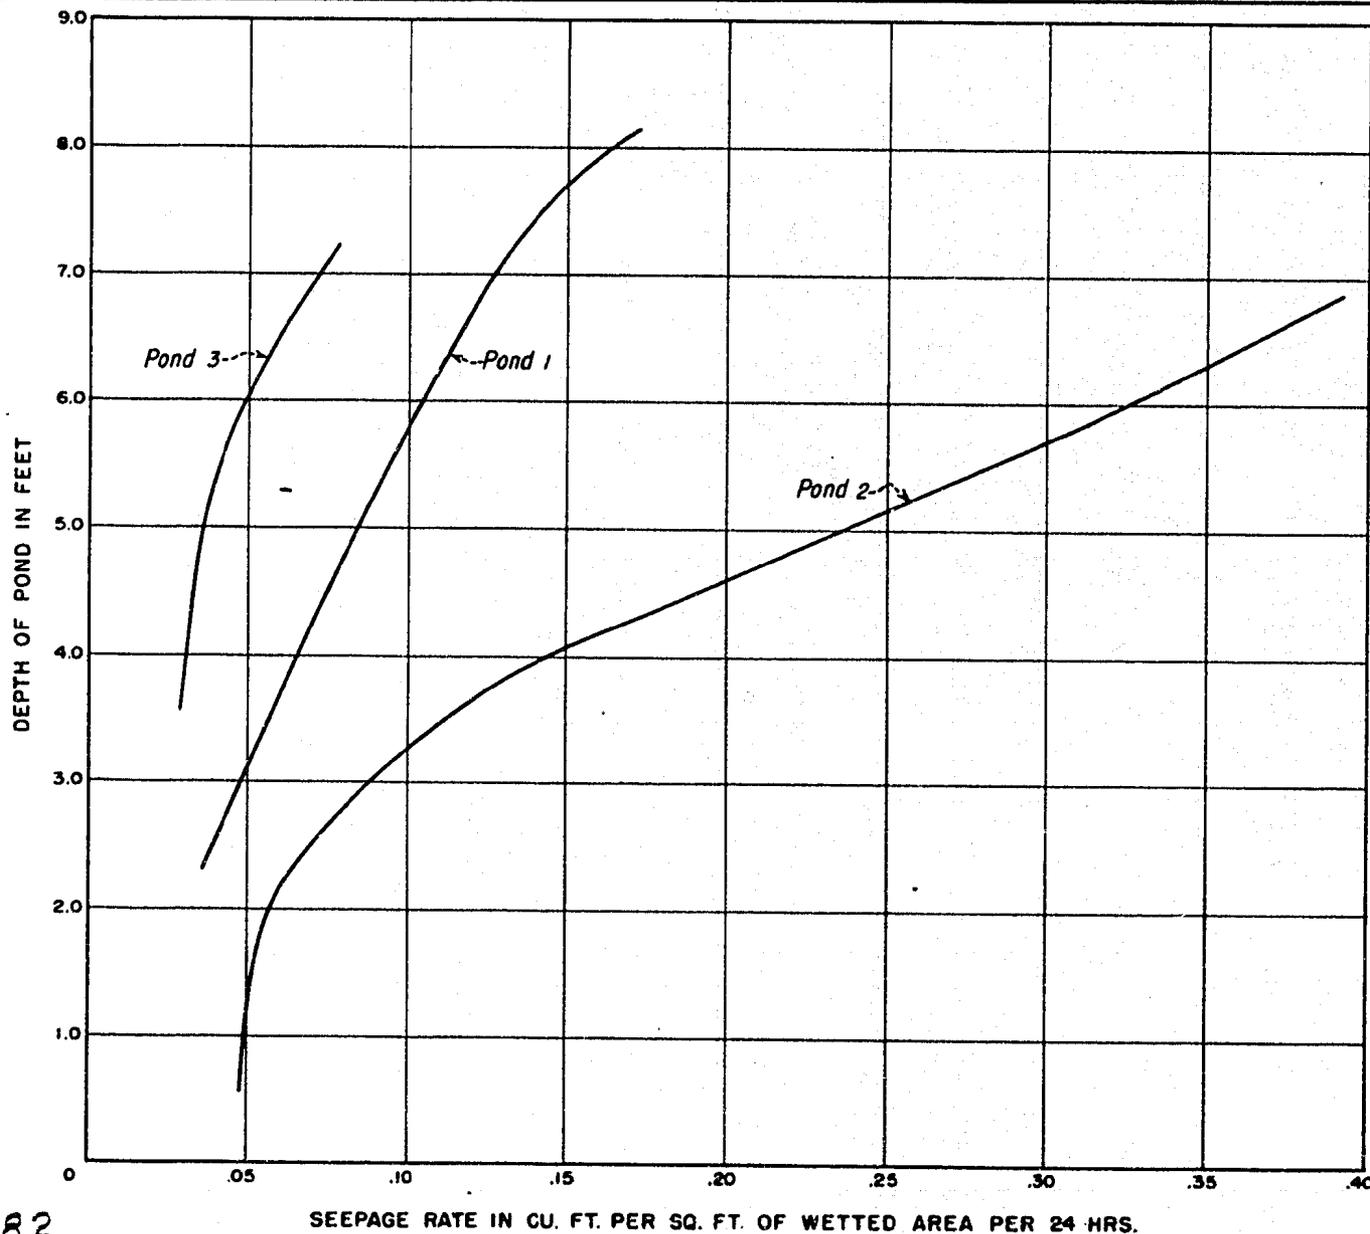
TUCUMCARI PROJECT-NEW MEXICO
 1949 SEEPAGE STUDIES
 PONDING TESTS-CONCHAS CANAL

The seepage rates as obtained from ponding in the three test reaches of the Conchas Canal are shown in Figure 8. The seepage rate is plotted against depth of water in the canal. Comparative seepage rates for a common depth are given in the following table.

Pond number	Type of lining	Depth (in feet)	Seepage rate
2	Unlined	7.0	0.40
1	Clay lined--Specifications No. 1076	7.0	0.13
3	Clay lined on left side and bottom only	7.0	0.07
	by Project forces

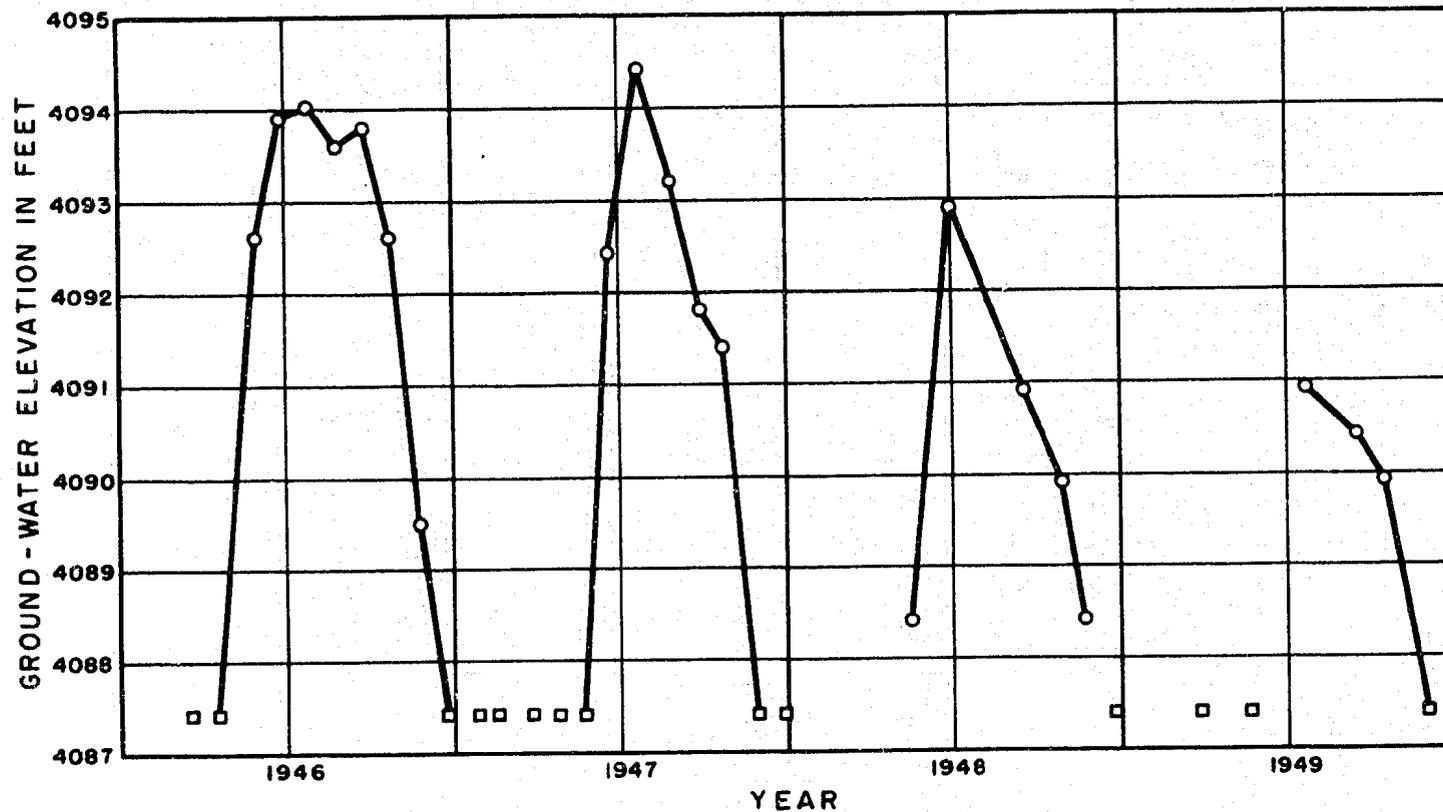
TUCUMCARI, NEW MEXICO
1949 SEEPAGE STUDIES
GROUND WATER WELL-STATION 2563+00
CONCHAS CANAL

on this well are shown in Figure 9. During the first 2 years of project operation, the ground-water table came to within 2 feet of the surface of the ground while in 1949 the ground water was over 5 feet below the surface of the ground.

In 1946 and 1947 small seepage areas developed in several of the fields adjacent to the canal but disappeared in 1948 and 1949 when the ground-water table dropped. The lower ground-water table and the disappearance of the small seepage areas were apparently due to reduced seepage rate resulting from the silt blanket, Figures 2 and 3, deposited in the canal.
