UNITED STATES DEPARTMENT OF THE INTERIOR BUREAU OF RECLAMATION

HYDRAULIC LABORATORY TESTS OF SEALS FOR HIGH-HEAD COASTER AND FIXED WHEEL STRUCTURAL STEEL GATES

Hydraulic Laboratory Report No. Hyd. -311

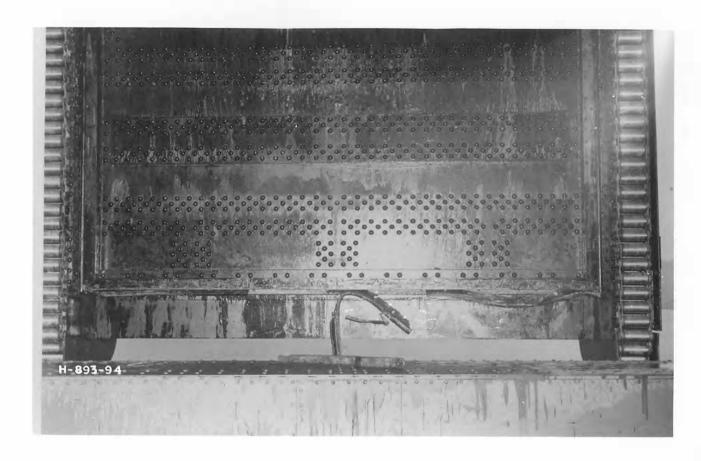
Failure of bottom music note seal with 90 degree brass shield vulcanized to hollow bulb, November 7, 1949.

Music Note Bottom Seal Failure of U-3 Coaster Gate Shasta Dam, California.

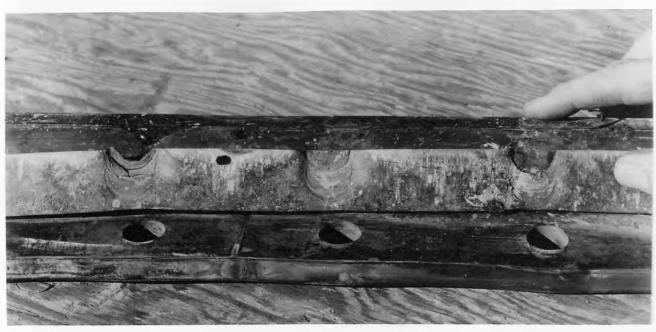
A. Loose 90 degree brass shield showing Allen head clamp plate screw markings, indicating the severe pinching of seal bulb between clamp plate and seat. Same seal as Figure 5.

Severe Mutilation of the Bottom Music Note Seal of U-3 Coaster Gate Shasta Dam, California.

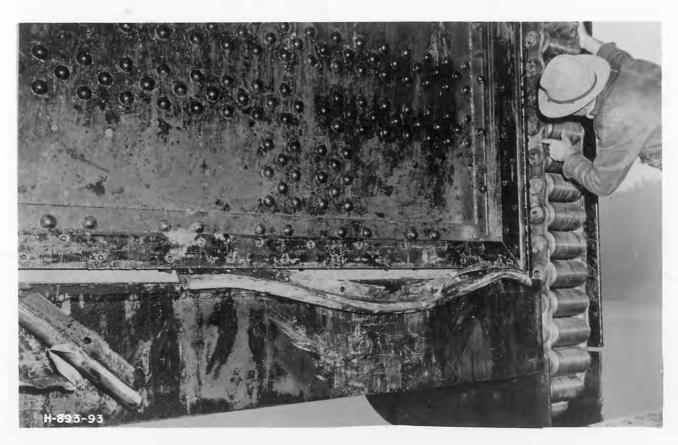
B. East portion of damaged seal shown in Figure 5.

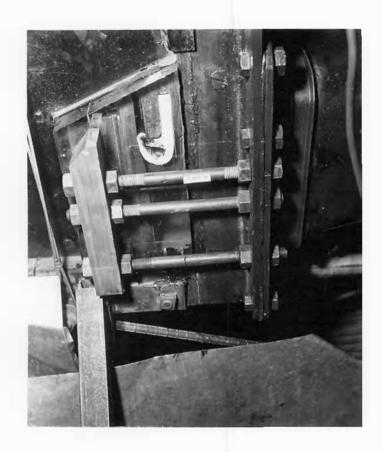
A. End view of seal, assembled with zero seal-to-seat gap, showing the pinched bulb after reaching the seat bevel at 40 feet head. Further closure of gate would pull the seal off the test gate.

Manner the Hollow Bulb Music Note Seal Fails at Low Heads without a Sharp Corner at Upper Edge of Seat Bevel.

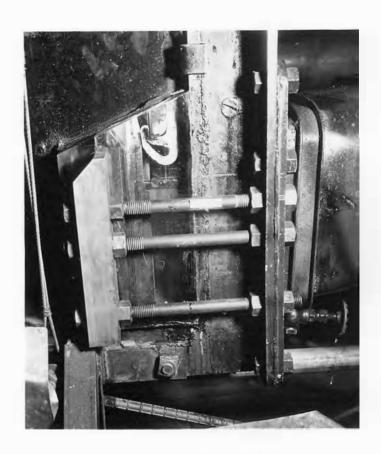
B. At 55 feet head the seal bulb gets pinched on vertical steel surface before the seal bulb reaches the seat bevel, zero seal-to-seat gap.

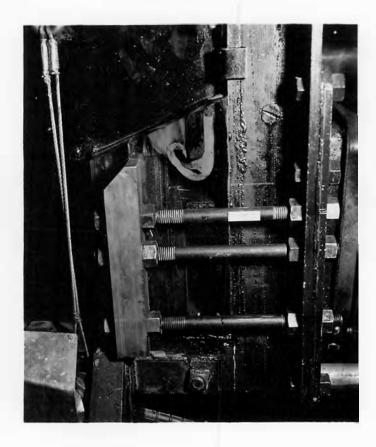
A. End view of seal showing bulb deformation at 195 feet head--no gate movement after applying head. Zero seal-to-seat gap.

Manner the Hollow Bulb Music Note Seal Fails at Higher Heads—with a Sharp Corner at Upper Edge of Seat Bevel.

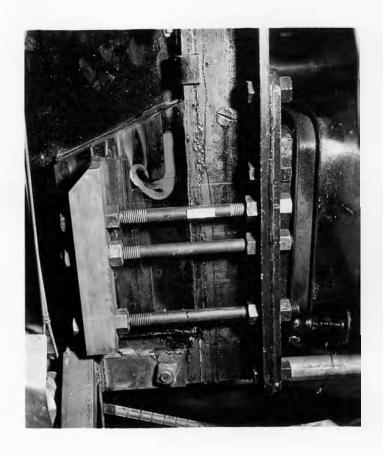
B. End view of seal at 160 feet head, zero seal-to-seat gap. Similar bulb pinching occurs at all heads above 40 feet. Further closure of the gate would pull the seal off the test gate.

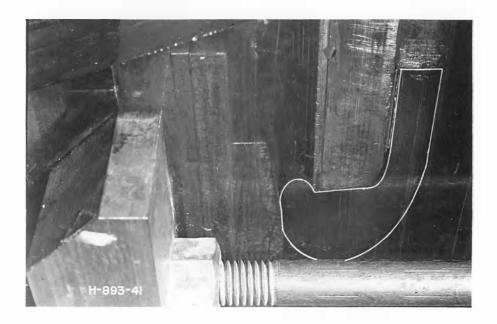
The seal bulb becomes pinched during gate closure at 195 feet head and at a large seal-to-seat gap, 5/16 inch. Without a 90 degree brass shield, seal bulb "wraps" itself around the end of the seal stem clamp plate.

Behavior of the Solid Music Note Seal without a Brass Shield.

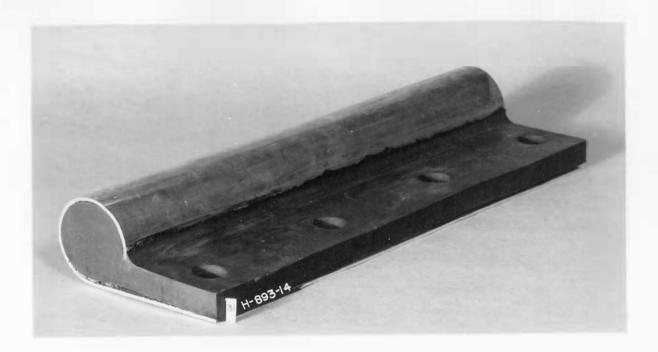
The primary failing of these seals was the poor bond between the brass and the rubber, as may be seen in Figure 16. Further, if the seal bulb was severely pinched, between the stem clamp plate and seat, the bent shield around the bulb does not return to its full round shape. Also, if the shield on the outside of the stem bent appreciably, it did not return to its flat shape. Two seal sections with different shield designs were tested with continuous extension of the seal bulb, by having the five 1/4-inch pipe holes open in the angle iron.

${\bf A}_{\star}$. Note the poor bond between brass shield and rubber which was typical on seals with large shields.

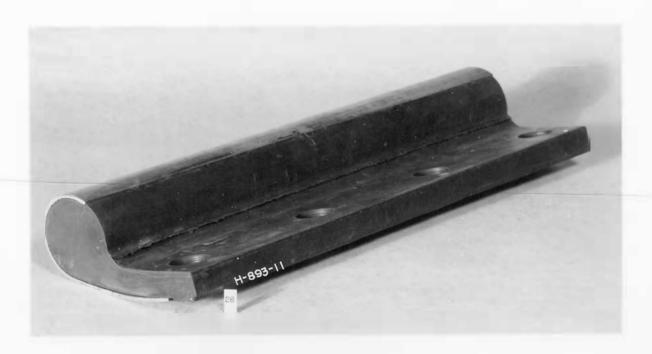
A solid bulb seal with a brass shield on the outside of the stem and continuing around to the bulb center line is shown in Figure 16B. However, the shield slipped past the bulb center line during the curing operation on the section tested. With the only change in the test gate assembly of zero seal-to-seat gap, the behavior of this seal was observed for gate openings and closures at 60-, 92-, and 150-foot head. At the 150-foot head, gate closure was impossible because the seal bulb caught on the seal seat at the upper corner of the bevel (Figure 15B). This very clearly shows that a brass shield is required on the upper quarter of the bulb surface adjacent to the stem to prevent the bulb from "wrapping" itself around the lower end of the clamp plate as shown. Nearly 100 percent of the bond area was broken between the rubber and brass shielding on the stem.

B. Brass shield slipped during molding and shield does not reach to end of stem. The bent shield is the result of laboratory tests.

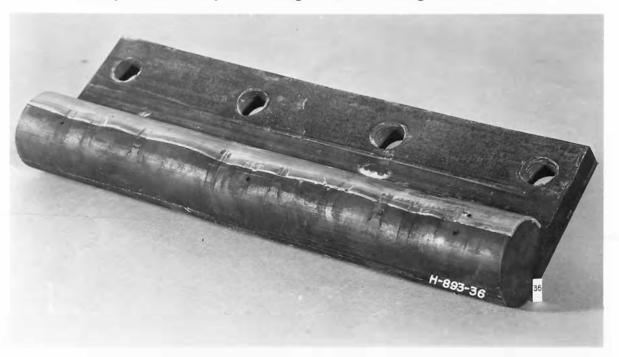
B. Solid bulb music note seal with 90 degree brass shield on bulb. This seal was used with the above seat. The damage was sustained in seating.

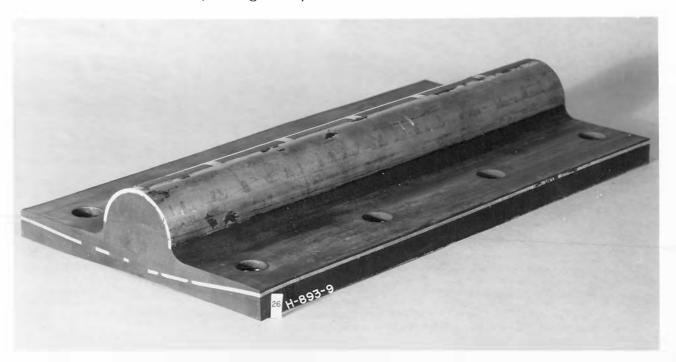
B. Seal with 180 degree, slotted brass bulb shield. Two piece, brass stem reinforcing plate shifted during molding. (See Figure 27).

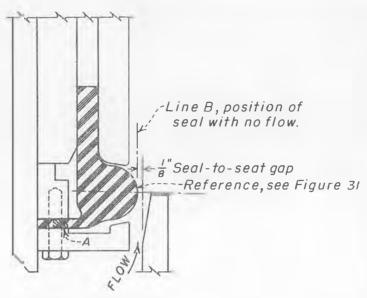
The seal bulb remained extended above 97 feet of head because water leaked through the four 7/16" diameter spacer pin holes in the thin rubber bolted section, point "A". These holes were stretched to an elliptical shape. When bulb retraction was attempted, the pressure behind the bulb could not be reduced sufficiently for retraction. Similar leakage is likely to occur through capscrew holes.

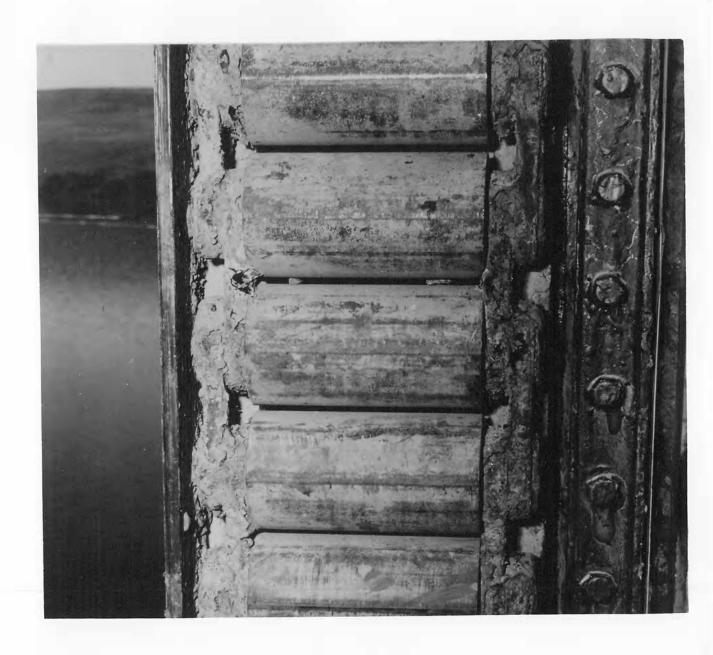
R-6 coaster gate (formerly L-3) lower right roller chain. Photo shows corrosion of the steel chain links. This gate was in service from June, 1941 until November, 1949, and from April, 1950 until August, 1950. The chains are in an inoperable condition, and it may be noted that their sliding action in operation has slightly flattened the contact surface. After removing the rust from the links, many pits were found to be in excess of 1/16 " in depth. August 30, 1950.

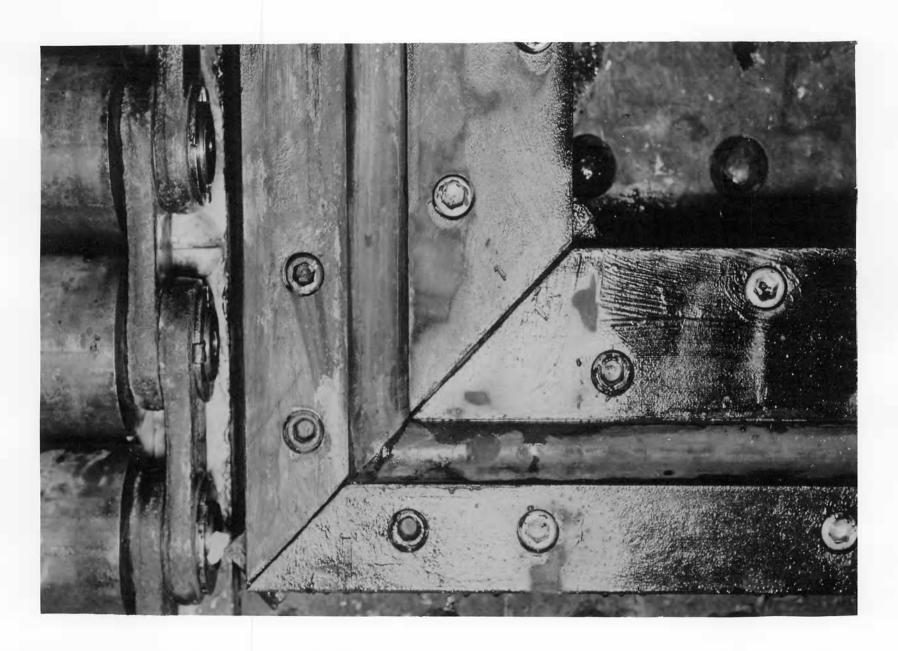
The special rubber seal (Drawing No. 222-D-14970) is shown on the R-6 coaster gate after completion of the simulated emergency closure tests. The photo shows the condition of the lower east corner of the seal. October 11, 1950.

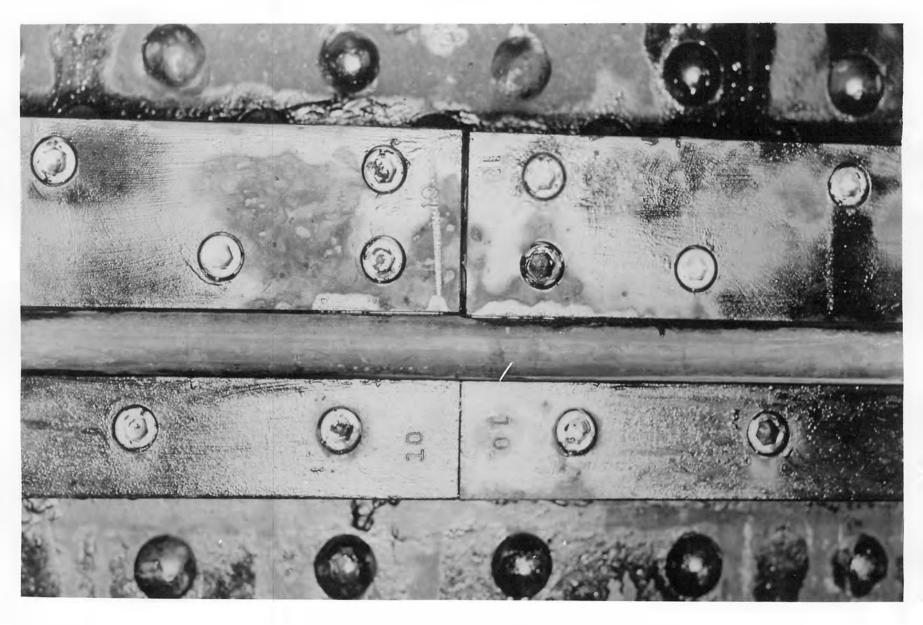
The special rubber seal (Drawing No. 222-D-14970) is shown on the R-6 coaster gate after completion of the simulated emergency closure tests. The photo shows the condition of the midpoint of the lower seal. October 11, 1950.

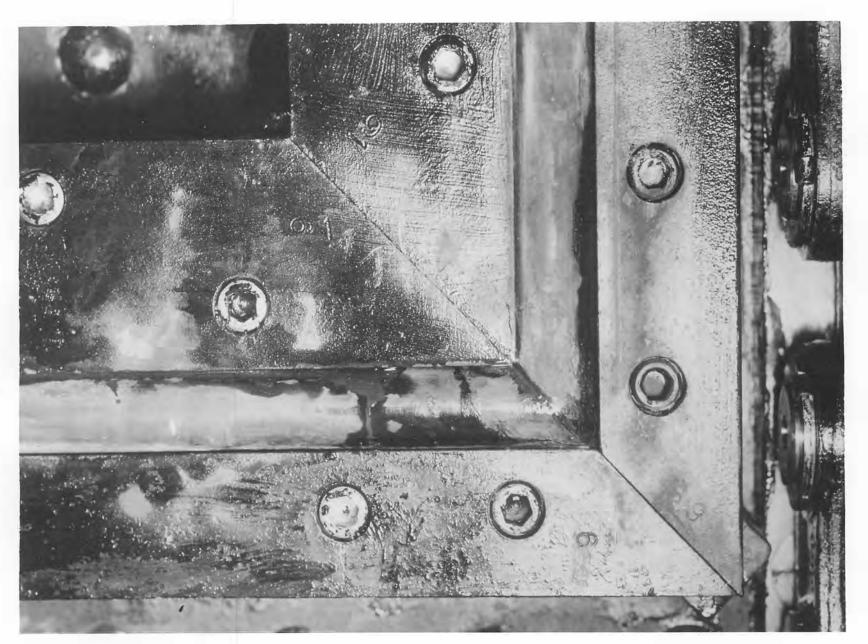
The special rubber seal (Drawing No. 222-D-14970) is shown on the R-6 coaster gate after completion of the simulated emergency closure tests. The photo shows the condition of the lower west corner of the seal. Note the space between the lower clamp bar and the seal. October 11, 1950.

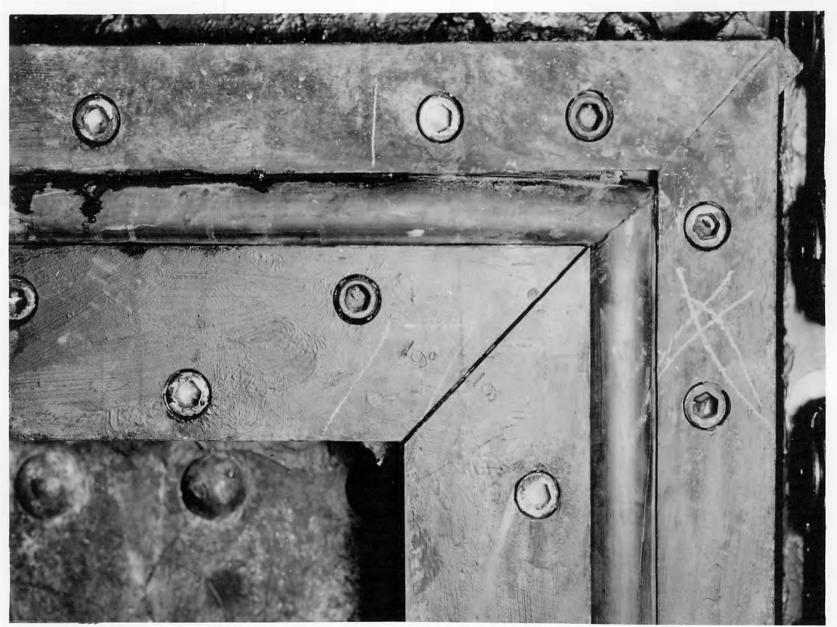
The special rubber seal (Drawing No. 222-D-14970) is shown on the R-6 coaster gate after completion of the simulated emergency closure tests. The photo shows the upper west corner of the seal. The pulled down condition of the seal at the corner was present before the tests and does not appear to have been altered during the tests. October 11, 1950.
