HYDRAULIC MODEL STUDIES FOR THE  
REHABILITATION OF THE SPILLWAY CHANNEL  
TIETON DAM--YAKIMA PROJECT, WASHINGTON

Laboratory Report No. Hyd-343

July 18, 1952

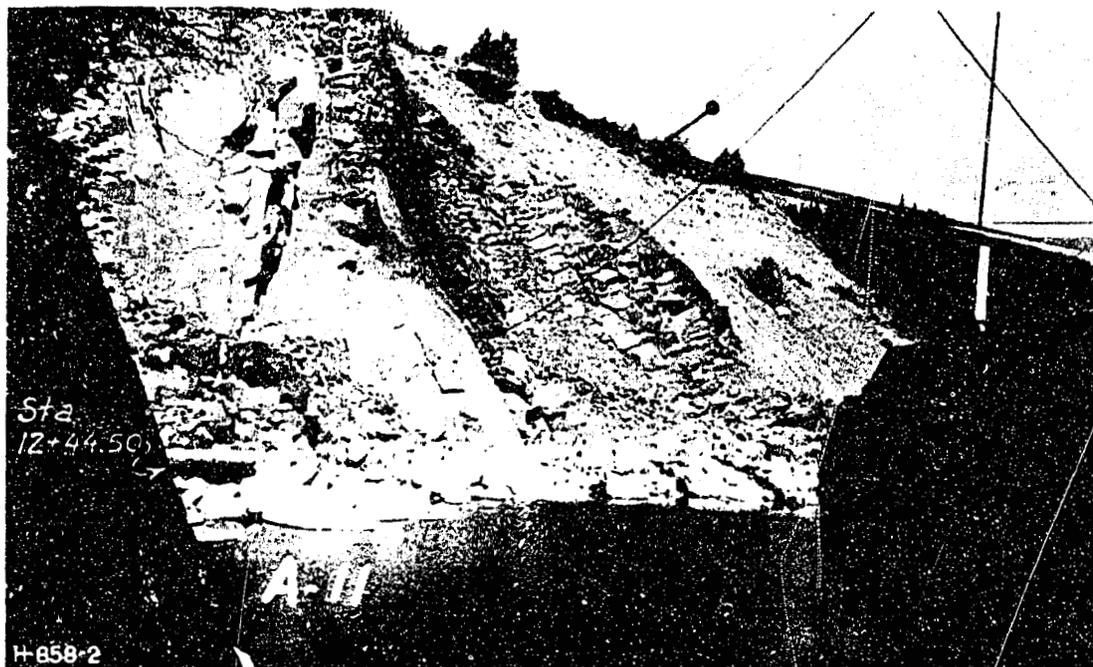
A. Looking downstream at end of chute. Note absence of left wall below Station 12+44.50.
