HYDRAULIC LABORATORY REPORT NO. 37

REPORT ON INSPECTION TRIP TO CORRELATE PRESENT
HYDRAULIC DESIGN PRACTICE AND
THE OPERATIONS OF STRUCTURES IN THE FIELD

J. E. Warnock

August 8, 1938

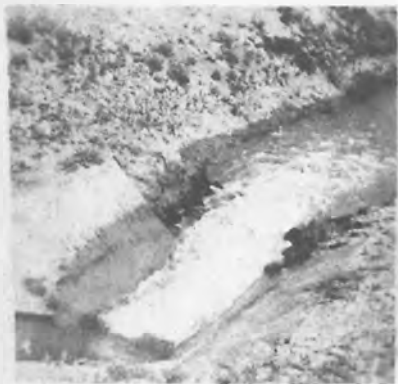
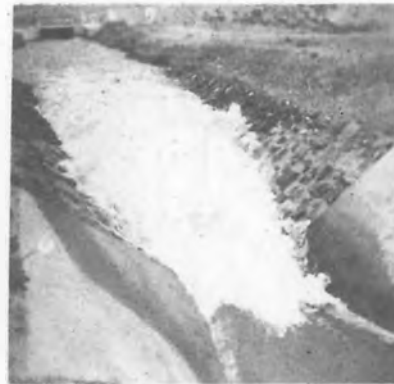
FIGURE 1 - HYDRAULIC CONDITIONS IN TRAPEZOIDAL DROPS

4. Many examples of the first two types of drops were examined during the trip. Without exception, the trapezoidal inclined drops were functioning unsatisfactorily while the flow conditions in the rectangular inclined drop were very good. The design of the typical drop utilizing a trapezoidal section in the stilling pool has been found in the laboratory to be fundamentally wrong and the observations in the field verify those findings. Every structure of this type examined behaves in the same manner and appears to be grossly underdesigned, especially where used in easily eroded soil. The high-velocity jet down the slope of the drop is concentrated in the center of the structure by the sloping sides and this jet prevails through the structure with practically no dissipation of energy. The energy is finally dissipated by boundary friction on the floor of the channel but the turbulent zone accompanying the dissipation continues for a considerable distance downstream with sufficient force to scour the banks even at flows below capacity. For instance, on the Owyhee project at station 137+00 on the Kingman Lateral (figure 1), the original riprap was soon piled in the center of the canal below the structure. Heavier riprap did not stay in place primarily because the most severe turbulence occurs downstream from the structure instead of on the concrete apron. The riprap was finally grouted in place to hold it. The extent of

Owyhee North Canal Lateral 10.5
(Spec. 681-D, Drawing No.
40-D-2074

Owyhee Kingman Lateral
Sta. 137+00 (Spec. 577,
Drawing No. 48-D-845)

maintenance can be seen in the photograph. Smaller structures of the same type, such as used on North Canal Lateral 10.5, have presented similar problems of maintenance. The length of stilling pool was insufficient and the turbulence was partly in the pool and partly on the riprap. In those cases, because of the lesser energy content, hand-placed riprap has been sufficient protection. On South Canal Lateral 17.7 in a distance of 1.1 miles, there is a series of 22 drops, including the turnout from the main canal. The first five of these structures at the upper end of the canal were observed in operation in company with Watermaster George A. Haycock at Nyssa, Oregon. The turnout drop (Spec. 619, Dwg. 48-D-1093) with a designed capacity of 66 second-feet has a rectangular pool in which a hydraulic

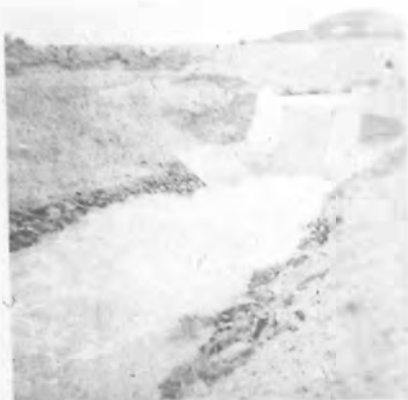
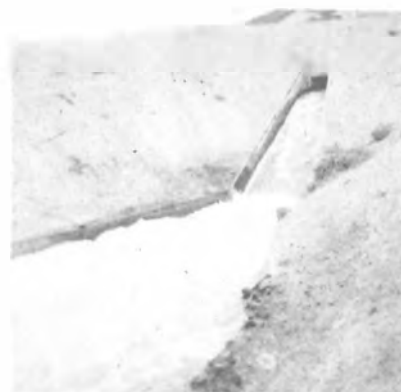
FIGURE 2 - STRUCTURES IN OWYHEE SOUTH CANAL LATERAL 17.7

Trapezoidal Drop at
Sta. 2+90

Turnout Drop.

jump forms (figure 2) whereas the other structures in the lateral are of the trapezoidal type. The dissipation of energy at the turnout drop is entirely within the pool and according to the watermaster, very little maintenance has been required. On the other hand, at the trapezoidal drops immediately downstream (figure 2) where the same amount of water is flowing, about 50 feet of riprap has been added to stop scouring. Even then the disturbance extends downstream to the end of the riprap. Another fault of these particular structures has been the deficiency of the cut-off wall at the upstream end. During the first months of operation, practically every one of the trapezoidal structures was undermined at least once and some of them more often.. The maintenance crew extended the cut-off walls vertically downward at least four feet below lateral grade without sloping them to correspond to the banks of the canal. The additional cut-off wall and the additional riprap finally stabilized

the structures. It might be well to emphasize the desirability of constructing cut-off walls with vertical instead of sloping ends as this particular point was encountered at several phases. A line of similar drops in a lateral on the Vale project was described by Superintendent J. S. Moore at Yakima as an "operator's nightmare." The scour and seepage question on a similar line of structures on the Kittitas South Branch canal extension was solved by paving the lateral between the drops.

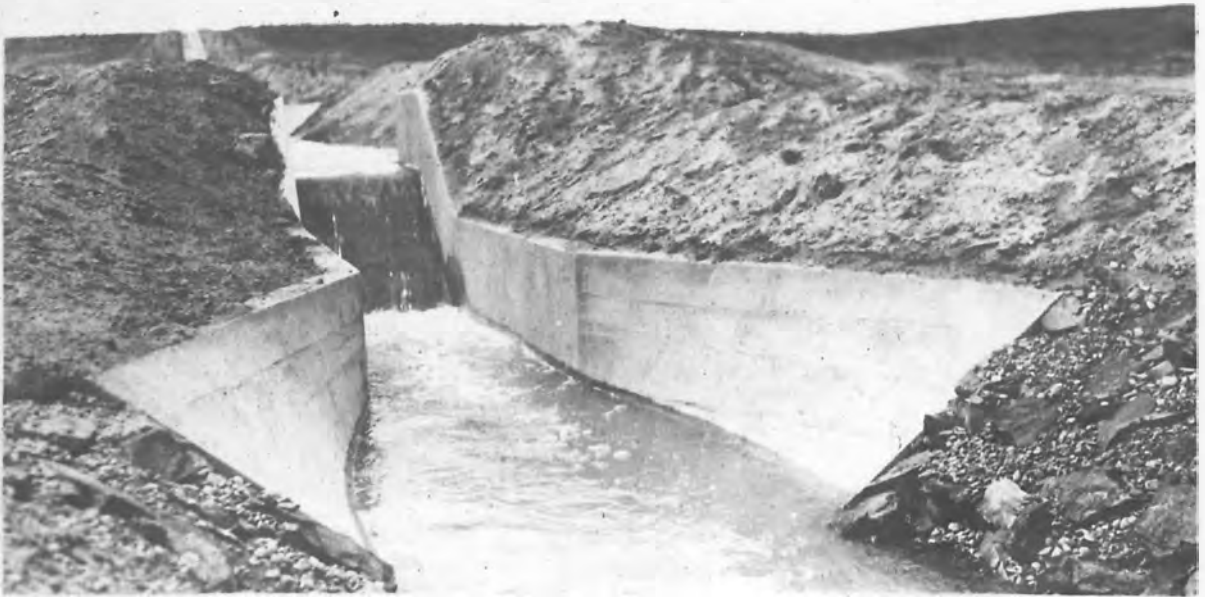
On drawing no. 40-D-2626, the wing walls are shown at right angles to the center line of the lateral. This causes sharp corners at the entrance which tends to crowd the stream to the center of the drop. The wing should be curved in plan or placed at an angle of about 45 degrees to the center line. The principal objection that could be obtained to this type of structure was that of excessive first

Figure 4 - Rectangular Inclined Drop at Oghee South Canal
Lateral 5.7 - 2.5, Station 122+25

cost. Appearances are that some savings could be made in the present structures by reducing the pool length, particularly if dentates or sills are used at the end of the pool. This excess of length has been previously noted in the laboratory and was verified in the field. The exact amount of reduction can only be determined at the conclusion of the studies now in progress. It is the belief of the writer that if the cost of maintenance of the trapezoidal inclined drops were added to the first cost that there will be little cost difference between a trapezoidal inclined drop and a properly designed rectangular inclined drop. To date we have found no way to properly design a trapezoidal inclined drop. Furthermore, it is recommended that in future designs, a single rectangular chute be used where possible instead of a series of drops.

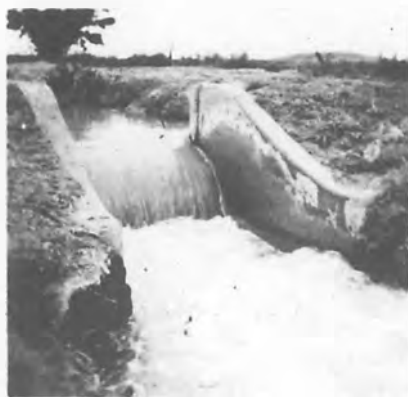
Figure 5 - Rectangular Weir Drop in Gem District D-Line

Although this structure is in an erodible material and has been in operation several years, there is no evidence of serious scour and little maintenance has been required. This structure was particularly interesting in comparison with conditions found at a check drop structure on Owyhee South Canal Lateral 5.7 - 2.5 at station 313+55 (figure 6). The latter structure is a standard no. 10 rectangular inclined drop such as shown on drawing no. 40-D-2626 with

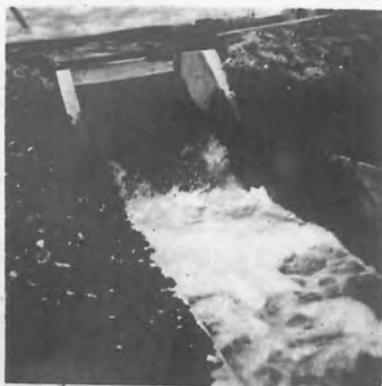
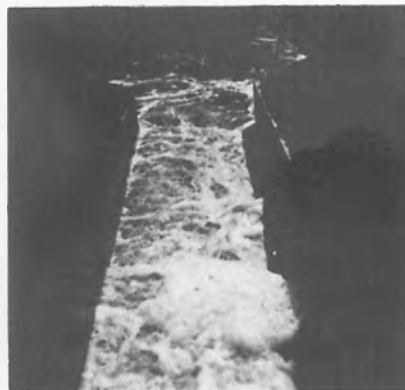
Figure 6 - Flow Conditions in Inclined Rectangular Drop at Station 313+55 on Owyhee South Canal Lateral 5.7 - 2.5

slots formed in the side walls at the crest in both this structure and the one below so that check boards could be inserted to raise the water surface in the lateral above and below to admit water to the turnouts. With these check boards in place, the conditions were very poor because the check board on the crest caused a disrupted flow down the inclined portion and the excessive tail water below

caused drowning of the jump. It is one thing to design a structure for a given set of conditions and another to have them completely altered in the field as is the case when check boards are inserted. A drowned hydraulic jump is undesirable in that the jet of water continues through the pool causing scour in the channel below. It was in this connection that the rectangular weir drop in the Gem District D-line proved interesting. A drop of this type or a modification thereof appears as a possible solution to the problem of checking in drop structures. The head could be varied to meet any irrigating condition and the structure will still function properly. Furthermore, it does not appear to be an expensive structure. Its effectiveness in preventing scour in the channel below could probably be improved by a study of different shapes of floor. It is suggested that an attempt be made to design a satisfactory structure of this type.

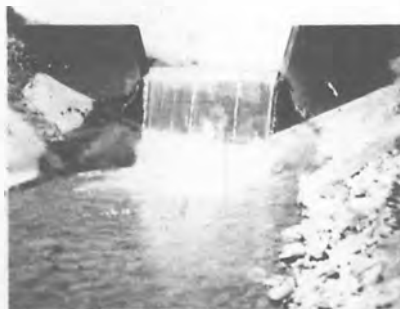
Figure 7 - Trapezoidal Weir Drop in Kittitas North Branch Canal Lateral 17.7

this case, it is an 8-foot Cipolletti weir used to measure the flow in Kittitas North Branch Canal Lateral 17.7. After five years of operation there is no evidence of scour, which can be accounted for by the fact that a large amount of the energy in the free-falling sheet of water is destroyed by impact on the exposed inclined slope and by the fact that the soil is gravelly and nonerodible at this point. An improvement could be made, however, in the upstream protection in this structure. A slab of concrete conforming to the section of the lateral extends about three feet upstream. In the early spring, pocket gophers, field mice, and sage rats favor the region beneath these slabs in hunting for tender roots. When the canal is started water flows through the passages made by the rodents undermining the structure. The maintenance department then has

difficulty excavating under the sloping slab to puddle the earth and form a tight seal. If, instead of paving the slope, vertical wing walls were placed at an angle of 45 degrees upstream from the cross wall intersecting the canal bank at or slightly above maximum water surface, a puddle pocket would be formed on each end of the cross wall. During construction these pockets could be backfilled by puddling. Later, if rodents get into these sealing pockets, their passages could be closed by wetting and rodding. If it is necessary to excavate, it is a simple matter to backfill.

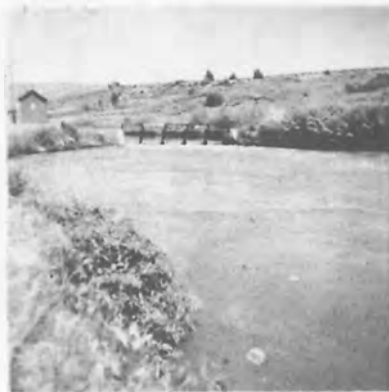
8. As mentioned in paragraph 3, the check drop used on the Sunnyside Main canal is a special case. The original designed capacity of the canal was much less than that now being carried. As the demand increased, larger quantities were handled. The resulting increase of velocity scoured the canal to such an extent that a series of 23 or 24 check drops were constructed in the canal. The scour downstream from at least 18 of these drops has been a source of continuous trouble since the drops were constructed.

Figure 8 - Drop 2 at Station 156+00 on Yakima Sunnyside Main Canal

The first two were designed for a capacity of 1,076 second-feet and for many years have been handling 1,300 second-feet. Attempts to stop this scour have been primarily by riprapping, but little or no improvement has been accomplished. At Drop 2 (figure 8) the width of the canal a short distance downstream from the structure is at least 50 percent greater than the normal width, and Superintendent Moore says that the hole in the center is about 15 feet deep. The size of the hole scoured below these structures is excessive considering the very small amount of drop. The stream of water through the control is concentrated in the center of the canal and the high velocity prevails for several hundred feet downstream with little dissipation. As this high velocity water leaves the drop, there is a difference in water level due to the velocity head. This causes

an inflow of water on each side near the structure. This inflow is harmful; (1) as it causes a heavy flow upstream to replace that carried away by the high-velocity stream; and (2) as it disrupts all tendency toward the formation of a hydraulic jump. To completely solve this problem it will be necessary to make a model study of a typical structure. It is believed that the majority of the faults can be remedied by extending the abutment wall sufficiently far downstream so that the adjacent water will not be drawn into the stream and a hydraulic jump is permitted to form. The intermediate training walls were included in the Marshall Ford stilling pool for this same purpose. The flow conditions through the structure itself can be greatly improved by streamlining the steel brackets which support the flashboards. Consideration has been given for several years to a redesign of these structures and Superintendent Moore at Yakima has submitted a request for this redesign. Design and construction of a model is in progress now and it is planned to proceed with the study so that plans for remodeling one or two structures will be available by October 1.

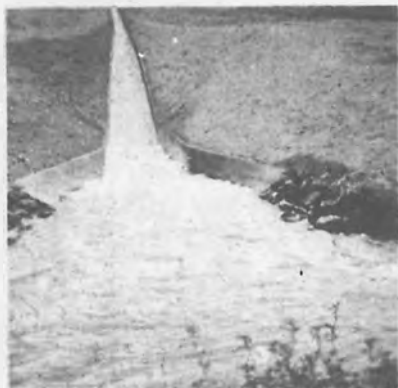
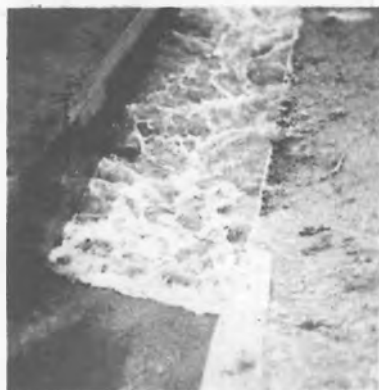
plant, all of the chutes in groups 1 and 2 were functioning in an excellent fashion. The action in the pool of the chute at Owyhee South Canal Lateral, station 471+50 (figure 9) can best be described as a "thing of beauty." The chutes of group 3 have required considerable maintenance to prevent serious erosion both in the stilling pool and downstream from it.

Figure 9 - Chute at Sta. 471+50 on Owyhee South Canal Lateral 5.7

10. The designed capacity of the chute at station 471+50 (Dwg. 48-D-1944) is 26 second-feet. The discharge in figure 9 is practically full capacity. The flow down the chute and through the hydraulic jump was well distributed with no back flow. Even though the water from the chute enters the Gem District Canal at an angle of 90 degrees there is no erosion except a little "beaching" due to surface waves. A small chute on Owyhee North Canal Lateral 43.6 (figure 10) with a drop of 210.5 feet and a designed capacity of

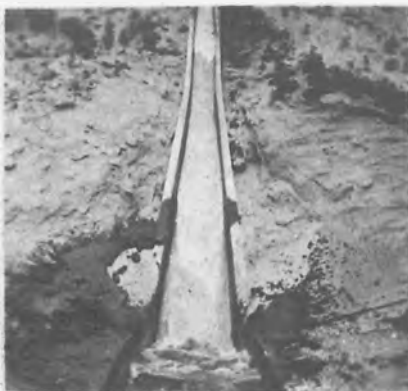
FIGURE 10 - CHUTE ON OWYHEE NORTH CANAL LATERAL 43.6

7 second-feet was operated for the first time on the day of the writer's visit. The structure was designed by the field office and there was much skepticism as to what would happen when it was operated. A flow of 1.1 second-feet while far from the designed capacity behaved very well and there was indication that the pool would handle the maximum capacity satisfactorily. The waves of water and air shown in figure 10 are very interesting and will be discussed at length under Jacobson's Gulch Wasteway where the same phenomenon was observed. At the Mabton Canal Chute (figure 11), which is also

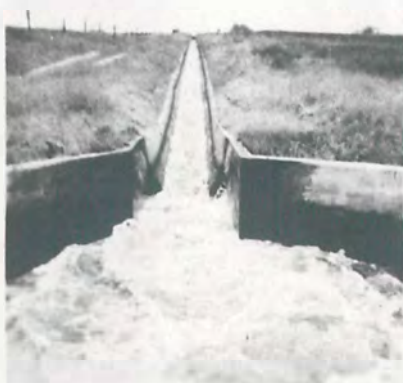
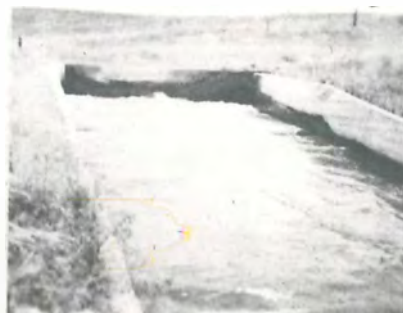
FIGURE 11 - MABTON CANAL CHUTE

Flow in Chute and Pool

Flow Entering Pool from Right

a field design, the flow conditions would have been good except for one error in design. The chute has very slightly sloping sides and the pool sides are vertical. An offset on each side was inserted to care for the difference in slope. This offset allows back flow in the pool which disrupts the dissipation of energy.

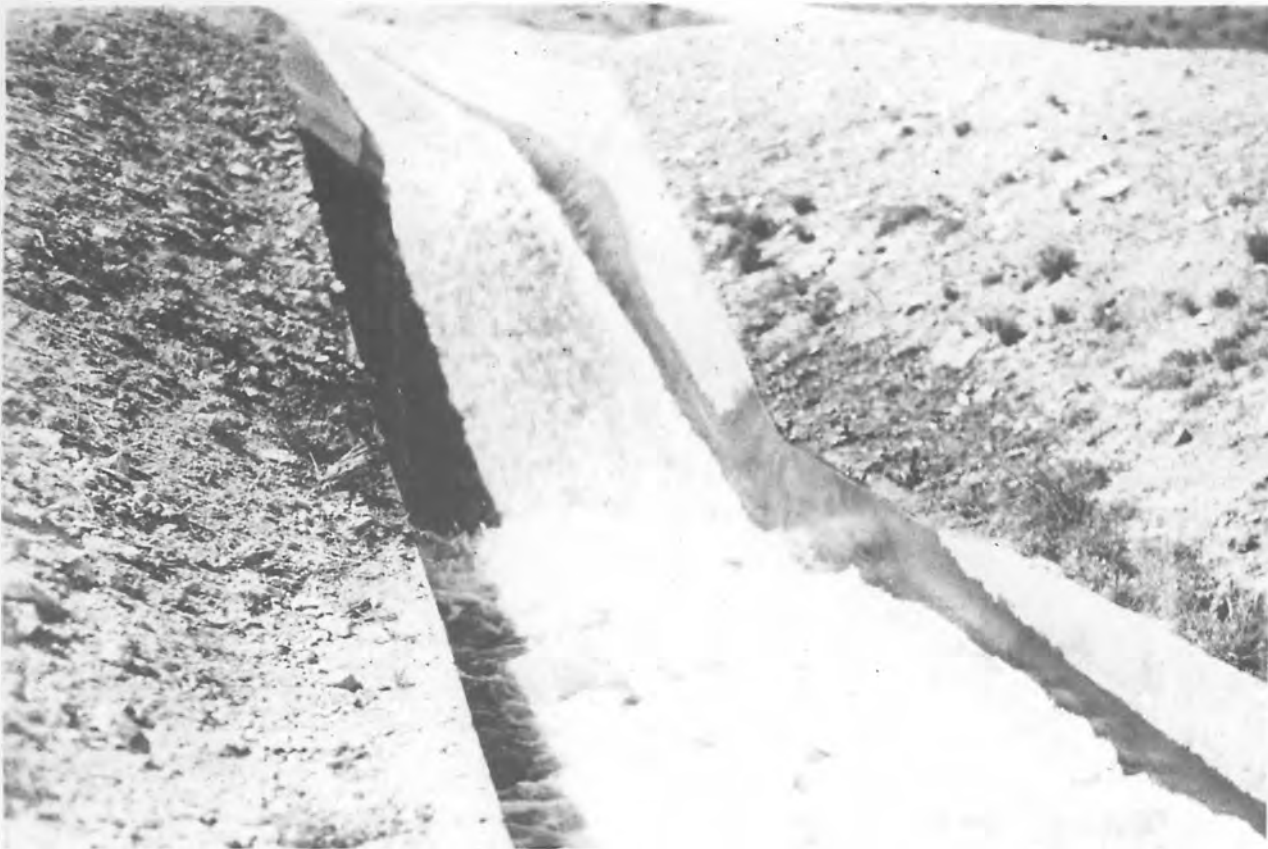
11. The chute at station 7+40 (figure 12) on Owyhee North Canal Lateral 38.7 with a designed capacity of 26 second-feet was performing nicely with a flow of 15 second-feet. There was no evidence of scour below and little maintenance has been required. The design of this structure is shown on drawing no. 48-D-1591, specifications no. 725-D. The chute at station 26+50 (figure 13) on Owyhee South Canal Lateral 5.7 has a designed capacity of 126 second-feet and was flowing at approximately 60 second-feet when examined. There was some "beaching" in the canal banks due to wave action as can be seen in the upper center of figure 13, but there was no evidence of ground scour. A similar structure (figure 14) at the end of Owyhee Advancement Lateral (Spec. 665-D, Dwgs. 48-D-1250 and 1260) has a capacity of 18 second-feet and was carrying

FIGURE 12 - CHUTE AT STA. 7+40 ON OWYHEE NORTH CANAL LATERAL 38.7

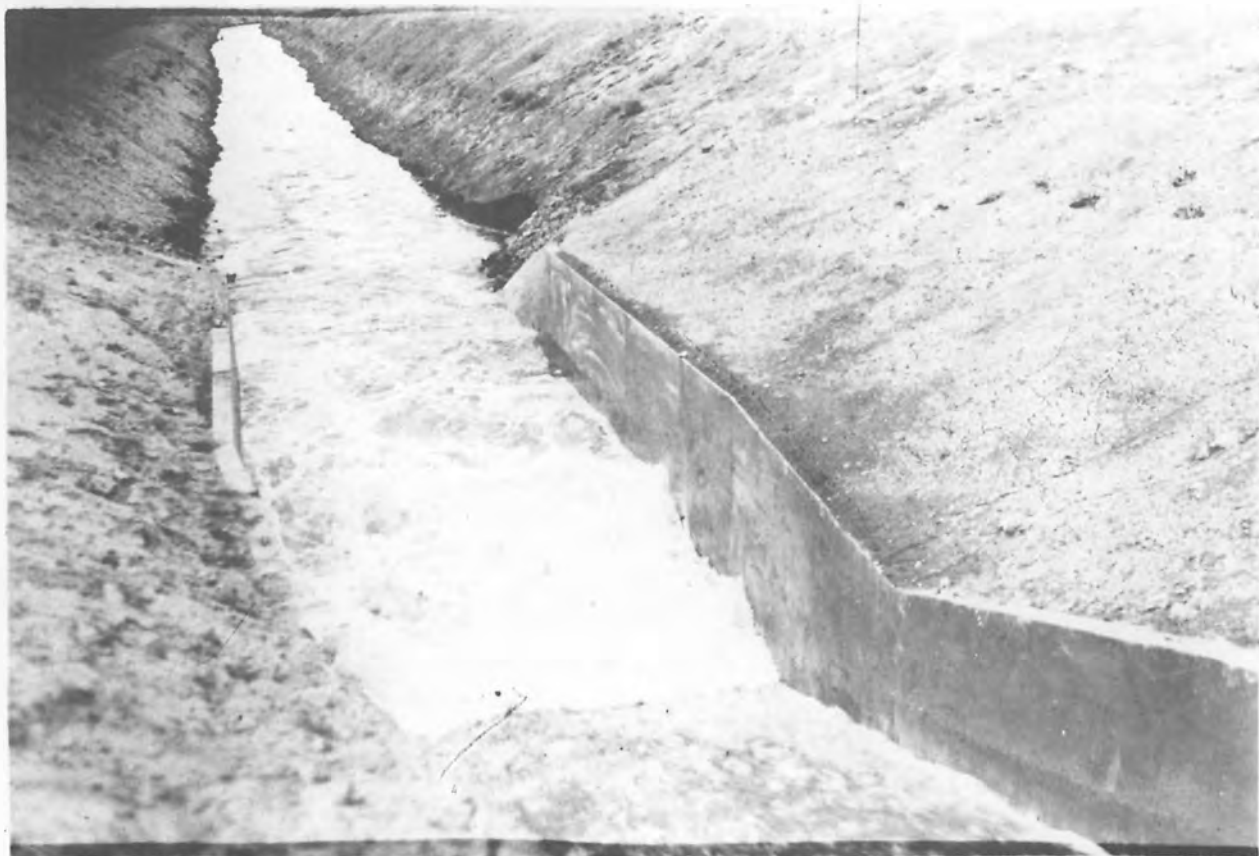
FIGURE 13 - CHUTE AT STA. 26+30 ON OWYHEE SOUTH CANAL LATERAL 5.7

4 second-feet when inspected. The jet of water down the chute was shooting into the pool on the left side and a return whirl or eddy current which develops on the right, flows over the jet disrupting

the feeble attempts to form a hydraulic jump. The lower end of the chute should have been flared much more gradually so that the sides of the transition would be vertical. A photograph of the complete structure could not be obtained because of a wooden flume over it. Considering the second group of structures as a type, it appears that if the transition between the sloped paving in the chute and the vertical pool walls is correct, the combination is a good one.

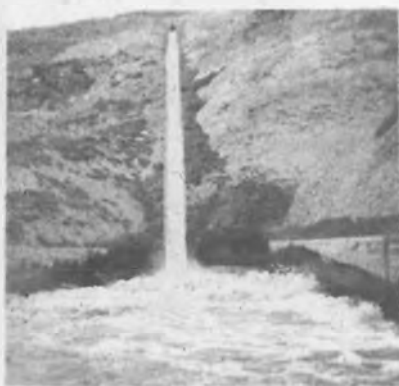
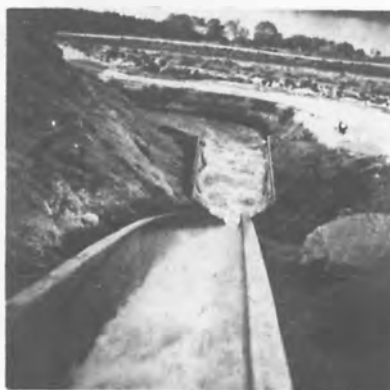
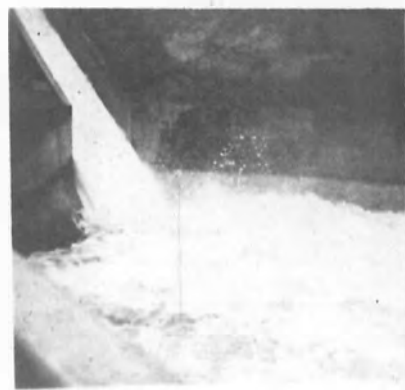
FIGURE 15 - CHUTE AT STATION 88+60 ON OWYHEE MITCHELL BUTTE LATERAL

12. In the third group of chutes, the flow conditions in the chute portions were satisfactory except in the Mitchell Butte Lateral Chute at station 88+60 (Spec. 563, Awg. 48-D-639) (figure 15).

Turbulence in Pool

Spray at Vertical Curve

Jet Entering Pool

There the vertical curve is too sharp and the water tends to spring free from the channel causing considerable spray. It was stated in the field that at the time of construction, it would have been necessary to fill under the chute portion to conform to the specifications and that the steep portion of the structure was moved back into the mountainside to obtain an undisturbed foundation. It was conjectured, but not confirmed, that the vertical curve was not altered in the change. If that is the case, the change should not affect the flow conditions. The trouble appears to be one of designing a vertical curve in which the degree of curvature is greater than the natural trajectory of the water stream. The same condition was observed by Assistant Engineers Thomas and Wilsey on Kittitas Main Canal Wasteway, station 1146+30 and has been reported as existing on a similar chute on the Sun River Spring Valley Canal at station 677+00. The designed capacity of this chute is 200 second-feet, the maximum flow to date has been 166 second-feet and the flow at the time the photographs were made was 115 second-feet. As this spray condition increases in severity with an increasing discharge, there is some doubt whether 200 second-feet can be carried past this vertical curve. In the stilling pools the same turbulence or violent disturbance consisting of unstable and fluctuating boils, eddies, and whirls occur as in the drops of the trapezoidal inclined type previously described. The jet of high-velocity water continues through the pool to the downstream end. This jet carries away the water in the pocket on each side of the transition and the water flowing in to replace it causes the eddy on each side. Despite the large size of the pool, the disturbance extends beyond the end of the pool. The rock fill in the channel opposite the end of the Wippel Creek Wasteway on the Kittitas North Branch Canal as shown in figure 16 is

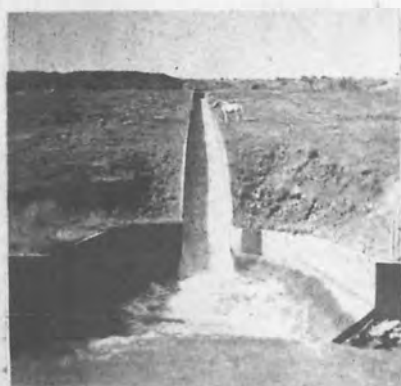
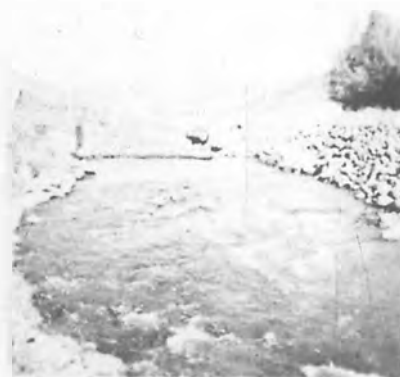
FIGURE 16 - CHUTE AT KITTITAS WIPPEL CREEK WASTEWAY

Turbulence in Stilling Pool

Rock Fill Opposite End of Lined Pool to Check Erosion

mute evidence of the maintenance required to control a structure of this design. When the pool of the Mitchell Butte Chute was unwatered last fall, a hole was found in the middle of the stilling pool apparently cut by the milling action of rocks either carried down the chute or carried back into the pool by the severe return eddy which prevails continuously. Photos 1306 and 1307 (Owyhee) showing the extent of the hole were examined during the discussion of this damage. Although extensive riprapping has already been done along the canal bank downstream from the pool, there is still some erosion.

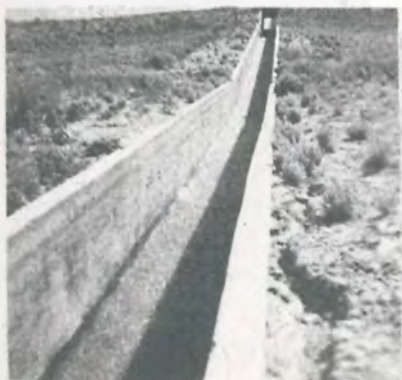
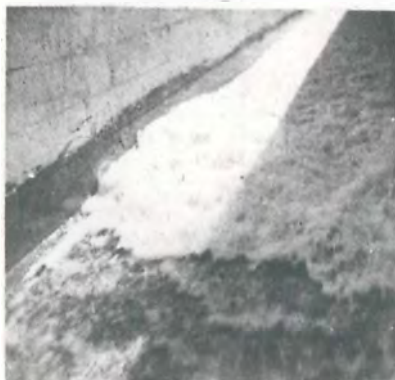
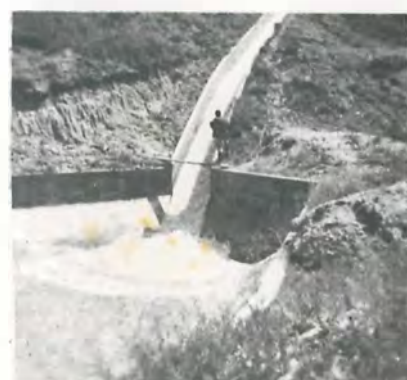
FIGURE 17 - JACOBSON'S GULCH WASTEWAY AT STA. 2877+60 ON OWYHEE NORTH CANAL

13. Considerable time was spent at Jacobson's Gulch Wasteway (figure 17) studying a wave phenomenon in which the lower or

Wave Forming at Sta. 5+56

Wave of Air and Water Down Steep Portion of Chute

Wave in Pool caused by Traveling Wave

boundary layer was traveling at a considerably lower velocity than the waves on top. This curious condition was first studied where the chute entered the stilling pool. While the flow was only about 5 second-feet there was considerable disturbance as each of these waves or slugs of air and water reached the pool surface. The first reaction was that these waves were caused by the entrance condition at the upper end of the chute. Subsequent examination disclosed that such was not the case. Beginning at the upper end the water flows down the first section of the chute with a ripply surface resembling curly hair. As it passes the first vertical curve, very distinct waves form which gradually draw apart as the velocity of the water accelerates. As these waves pass over the last vertical curve, they absorb air to such an extent that they give the impression of having been inflated. In figure 17, the picture on the left shows a wave just as it formed below the first vertical curve, the center photo shows a close-up of a wave as it passed down the steep chute just

before it hit the pool, while the last picture shows the disturbance in the pool caused by an impinging wave and two other waves approaching the pool. They are traveling so fast that only a fleeting glance is obtained of them. An idea of their speed can be obtained from the fact that the pictures were made with a shutter speed of 1/300 second. In this particular case this peculiarity of flow might be said to be of no significance, but the same condition was found by Thomas and Wilsey on the Kittitas wasteway, and Mr. Fred C. Scobey during a recent visit to the laboratory described a similar condition in California where a flow of 20,000 second-feet could be discharged in a chute but because of this wave condition 2,000 second-feet could not be handled. The cause or probability of this occurrence is vague as yet. Additional study may disclose the mechanics.

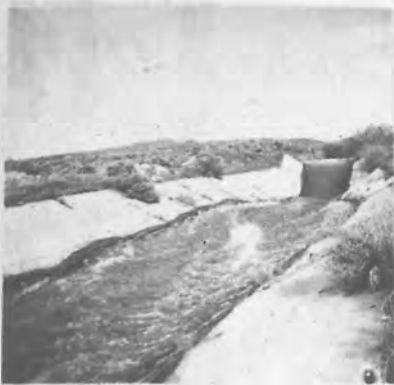
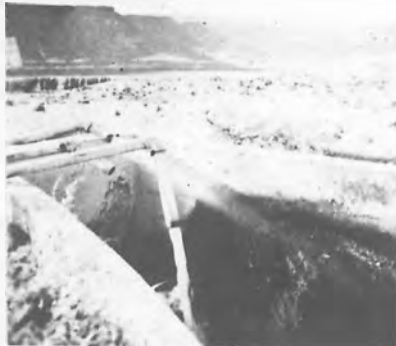
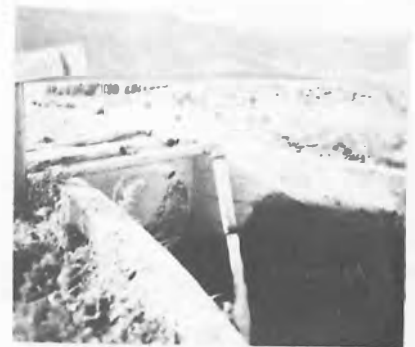
FIGURE 18 - ENTRANCE CONDITIONS AT GLENN'S FERRY SIPHON ON KING HILL PROJECT

17. The worst case of this vibration and air entrainment was seen at the Glenn's Ferry Siphon across the Snake River on the King Hill project. The water flows into the wood-stave pipe above critical velocity and passes through the critical stage from 100 to 150 feet downstream from the entrance. Four $1\frac{1}{2}$ -inch vents have been installed at approximately 25-foot intervals beginning about 100 feet below the entrance. The piping to these vents has been extended up to the siphon entrance as shown in figure 16. As observed on this particular occasion, no. 2 vent (numbering from the top down) blew air about 80 percent of the time. After a lull during which all vents were quiet, no. 4 belched practically solid water, then no. 2 resumed blowing, first air and water, then air only during the 80 percent period. There is a very noticeable vibration of the conduit in the region of vents 3 and 4 which can be seen by the eye or felt by the hand. Air was escaping through cracks at vent 3 and water was squirting through cracks below vent 4. Vents 1 and 3 did not function during my visit. A turnout valve about 150 feet below

Flow in Approach Channel

Vents at Inlet to Siphon

vent 4 blows air occasionally and becomes badly clogged with weeds. Weeds also occasionally clog the vents which may have been the reason they were not working. A surge tank has been constructed about 150 feet back of the outlet of the siphon (figure 19). According to

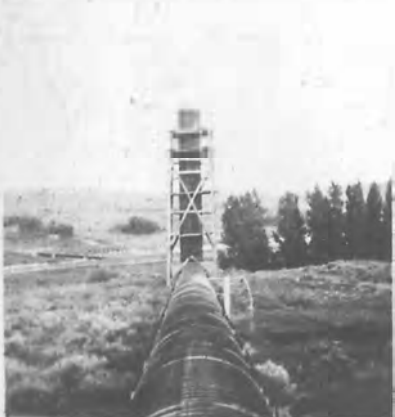
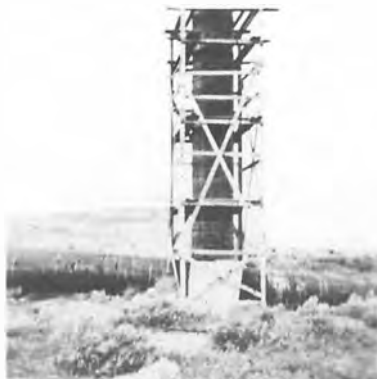
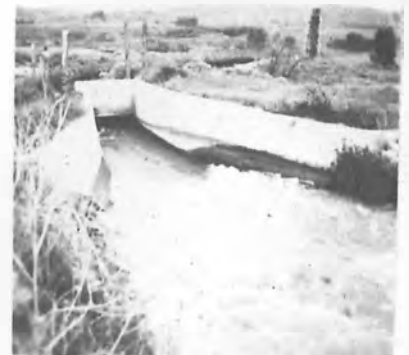
FIGURE 19 - OUTLET OF GLENN'S FERRY SIPHON ON KING HILL PROJECT

Surge Tank About 150 Feet From Outlet

Close-up of Surge Tank

Flow Conditions at Siphon Outlet

the ditch rider who has been on that job for eight years, a great improvement was made in the flow conditions at the entrance. Prior to that the inlet had acted like a bellows. Conditions similar to

18. A possible solution of this excess head problem, especially on the longer structures, would be the inclusion of a regulating device near the outlet end of the siphon. This device would be a variable hump installed in a rectangular section of the outlet leg of the siphon and its variation would be controlled remotely at the inlet end to raise the water surface in the approach canal above the intake portal. The ditch rider could regulate this adjustable hump as part of his routine duties. The hump itself should have slopes sufficiently flat to pass any entrained debris. An automatic mechanism controlled by a float in the approach canal could be installed to lower this hump in case of excess flow conditions such as a cloudburst in a contributing drainage area. This idea is embryonic but it is believed to have possibilities.

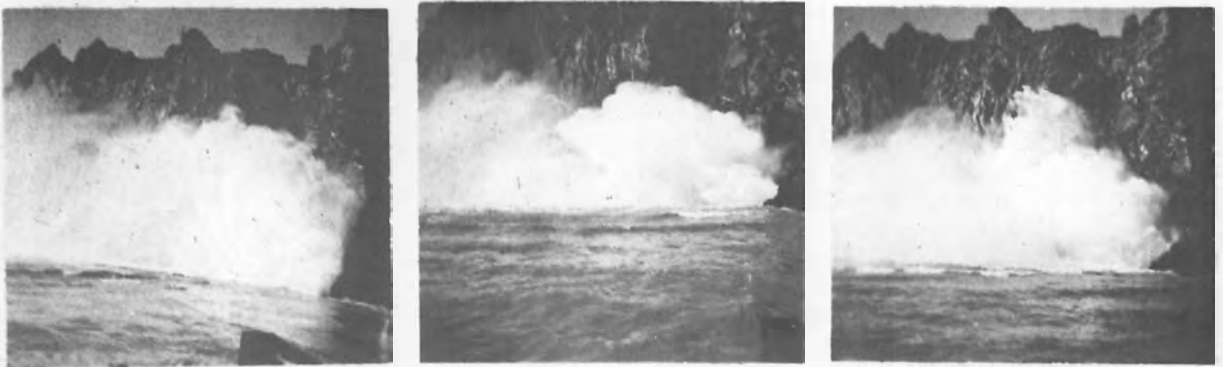
21. At Owyhee Dam the reservoir was sufficiently filled to allow a flow of 3,000 second-feet to be released either through the glory-hole spillway or needle valves. It has been realized for some time that the behavior of a jet of water from a model needle valve was quite radically different from the prototype. The disintegration of the jet from the prototype valve as it strikes the air has to be seen to be realized. The action of the Owyhee valves was observed both from a vantage point immediately beneath them and from the end of the observation gallery in the left abutment. From the first point the "rain" beneath the jets equalled in intensity the downpour during a severe thunderstorm and it fell all along the area beneath the jets. From the second point the impact of the remnants of the jet could be seen as it reached the surface of the stilling pool. As the jet strikes the surface it appears to ricochet and strike a second time farther downstream rather than plunge into the pool. This is due to the lesser density of the air-water mixture in the jet as compared to the solid water in the stilling pool. So far as the dissipation of energy is concerned the absorption of air causes the jet to impinge over a wider area and with less force than a jet of solid water. The ring gate in the glory-hole spillway was manipulated sufficiently to give discharges from 1,000 to 3,000 second-feet. With a discharge of 1,000 second-feet, spray was intermittently ejected sufficiently high to be carried by the wind onto the operating platform. As the gate was lowered and the discharge increased the ejections ceased. Outside of the inconvenience, this spray is causing no damage. With the 1,000 second-foot discharge, the flow into the stilling pool below was undisturbed, but as the flow is increased an unexpected disturbance occurs which, so far as is known, was not detected on the model. The stream of water from the spillway tunnel creates waves on the surface of the stilling pool. These waves travel across the canyon, reflect, and return. As they strike the oncoming high-velocity stream from the tunnel an incident occurs which for lack of a better term is called an "explosion." With this particular flow the spray from the explosion is thrown two-thirds the distance up the adjacent cliff. The caretaker says

that with larger discharges this spray is thrown to the top of the cliff. Figure 21 shows three different explosions.

FIGURE 21 - DISTURBANCE DUE TO SURFACE WAVES IN STILLING POOL COLLIDING WITH HIGH-VELOCITY STREAM FROM OWYHEE SPILLWAY TUNNEL. DISCHARGE 3,000 SECOND-FEET

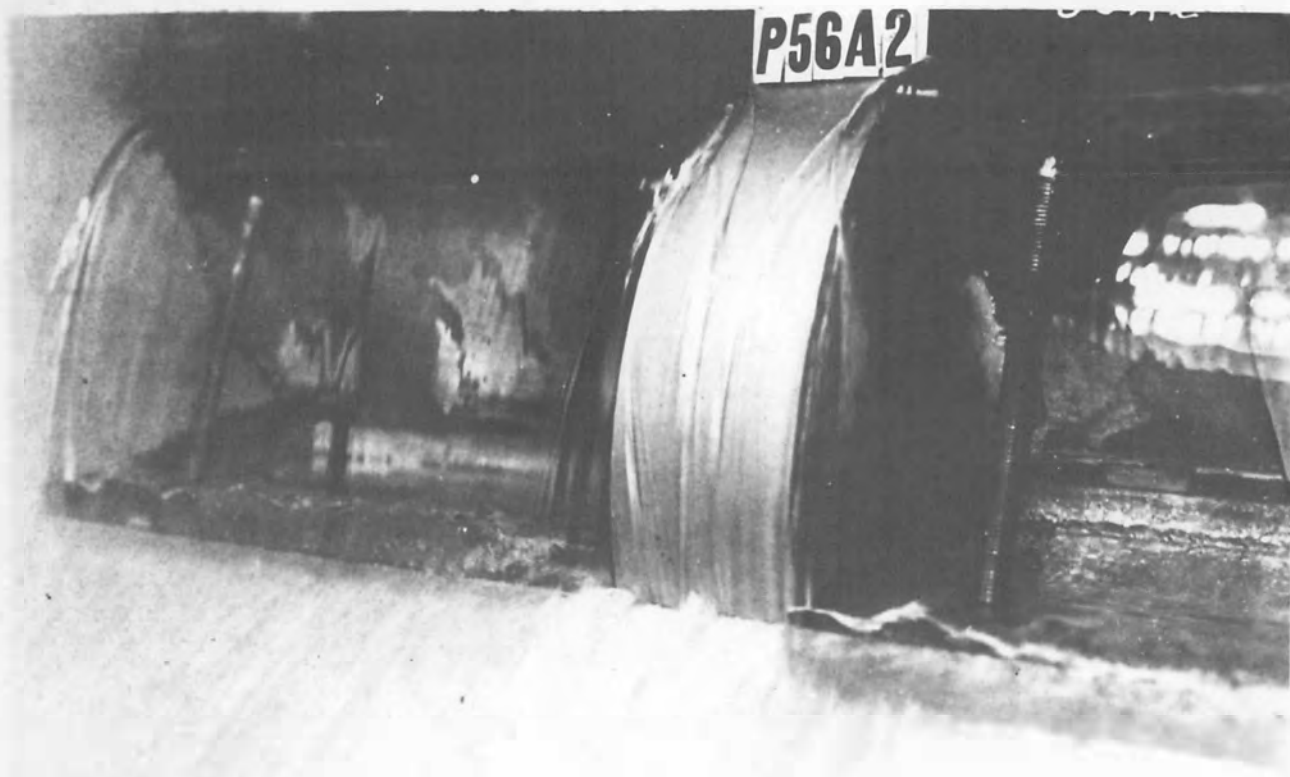
21. At Black Canyon Dam particular interest was paid to the question of vibration at certain gate-operating conditions. As described by Mr. George R. Larson, Assistant Engineer, the vibration occurs when about one foot of water is flowing over the gate. This vibration problem has been studied in the Fort Collins laboratory on the 1:40 model of the Grand Coulee and Shasta spillway crests and the cause is believed to be the lack of aeration at very low discharges. At certain flows the path of the sheet of water is practically vertical and of sufficient thickness to seal against the piers forming an air chamber between the downstream face of the drum gate and the sheet of falling water. The air is evacuated by the falling water and the pressure is lowered in this chamber. The sheet of water is pulled back toward the face of the drum gate until the surface tension of the water can no longer support this low pressure. The surface of the water is broken, air rushes in to relieve the low pressure, and the sheet of water springs quickly back to its true trajectory. The vibration evidently is caused by the latter. Since the air space is relatively small, this evacuation of air and relief occurs at short intervals. Mr. Larson could not estimate the frequency of this vibration but the intensity was sufficient to be felt in his home some distance below the dam. When the gate setting is such that the vibration occurs, a slight change of position by either raising or lowering eliminates it. Figure 22 shows the conditions at which vibration occurs on the model of the Grand Coulee and Shasta spillway crests. The vibration can be stopped by admitting air to replace that carried away by the overflow. On the model this could

FIGURE 22. - AIR ZONE UNDER IRUM. GATE IN RAISED POSITION ON
1:40 MODEL OF GRAND COULEE AND SHASTA SPILLWAY CRESTS

be done by breaking the water surface with a pipe or stick or by inserting vents through the piers. It is believed that a complete cure of the vibration at Black Canyon Dam could be obtained by air vents through the piers into the zone beneath the gate in its raised position. The flow conditions with the gate partly lowered are shown in figure 23.

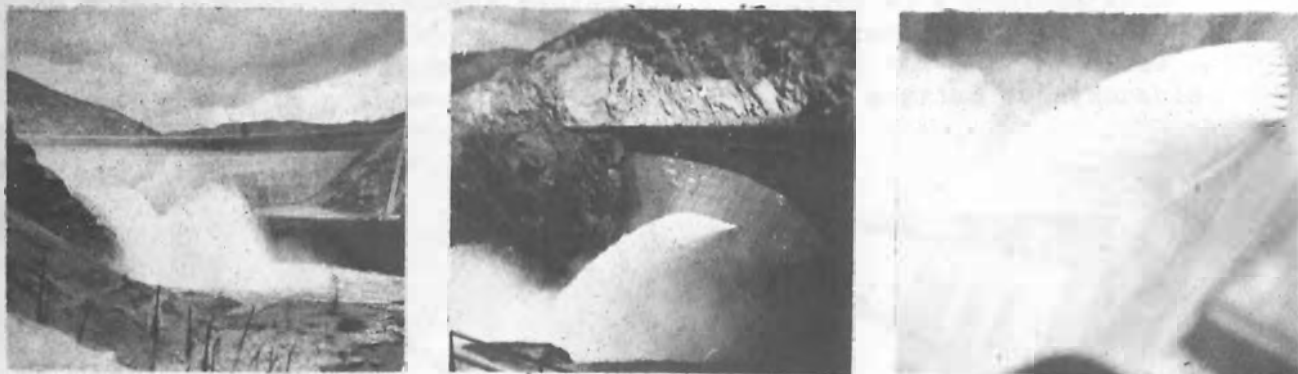
22. Eight of the 10 sluiceways at Arrowrock Dam were discharging a total of about 8,000 second-feet (figure 24). As at Owyhee, the jets from these sluiceways start to ravel as soon as they strike the air and by the time the jet strikes the water surface below very little remains of what might be termed a jet. The inflow of air into the sluiceway vents, the entrances of which are below the balustrade near the top of the dam, causes a disturbing noise similar to several large trucks backfiring or machine guns

FIGURE 24 - EIGHT SLUICWAYS AT ARROWROCK DAM DISCHARGING 8,000 SECOND-
FEET

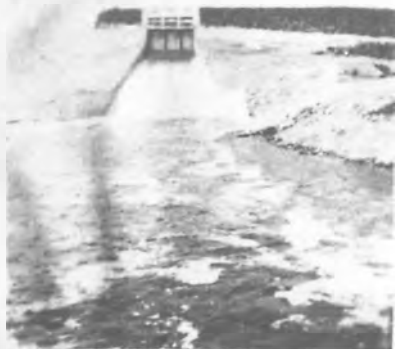
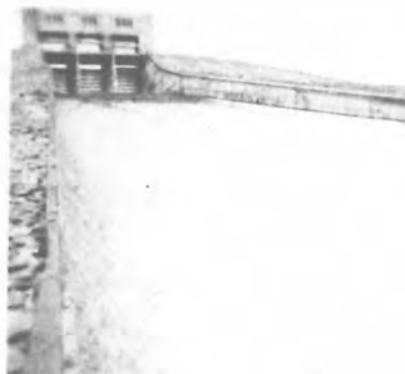
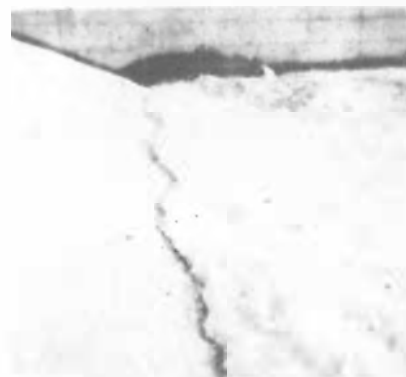
FIGURE 35 - CONDITIONS IN ALCOVA SPILLWAY CHANNEL

however, attempted to collect such fragments of information as available on the subject during this trip. The discharge of 400 second-feet through the needle valves was not sufficient to give any indication of its behavior. However, Assistant Engineers C. W. Thomas and E. F. Wilsey had visited the structure on May 18 while enroute from Cle Elum, Washington, to Denver at which time 3,800 second-feet were being discharged through the needle valves. The action in the outlet-works stilling pool was quite rough with a severe wave breaking over the top of the wall at the break in alinement. The extent

Spillway as Seen from the Highway Bridge

Flow Condition with Discharge of 4,000 Second-Foot

Flow in Spillway Channel Entering Stilling Pool

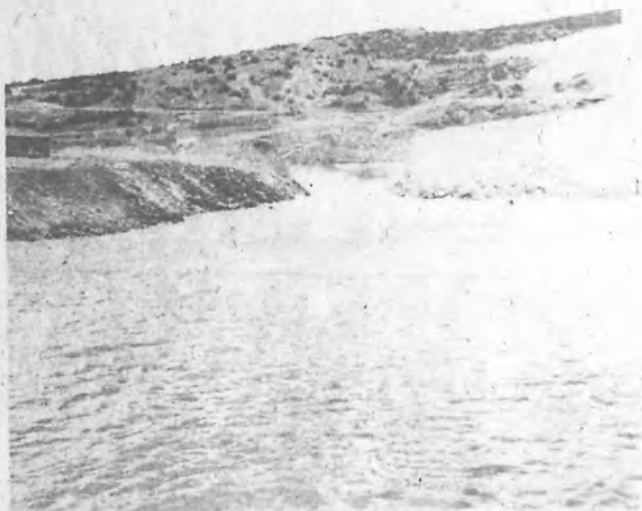
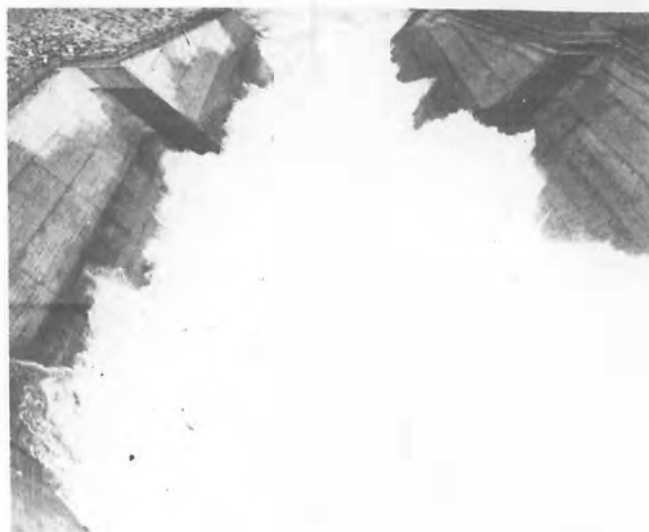
FIGURE 36 - CONDITIONS IN ALCOVA OUTLET WORKS STILLING POOL WITH DISCHARGE OF 3,800 SECOND-FOOT

of the splash is indicated by the wetted area in figure 36. A hole eroded by the waves can be seen in the upper right-hand corner. The splash is more severe on the right side of the pool due to the concentration of flow on that side caused by the bend in the tunnel above. The design of the entire outlet works is not considered as satisfactory. In the first place, the needle valves discharging into the tunnel create a flow condition which is unsatisfactory. Furthermore, the combination of the bend in the tunnel and the stilling pool with sloping sides creates excessive turbulence in the stilling pool. In fact, there seems to be no definite dissipating action in the pool beyond that of literally "wearing itself out." It is suggested that the behavior of this outlet works be watched rather closely and frequent inspections be made to detect any destructive action by the turbulent flow caused by the needle valves.

Tunnel Outlet

Conditions in Stilling Pool

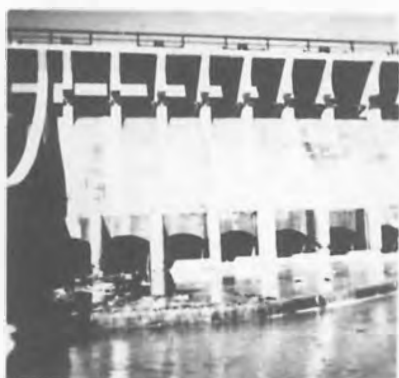
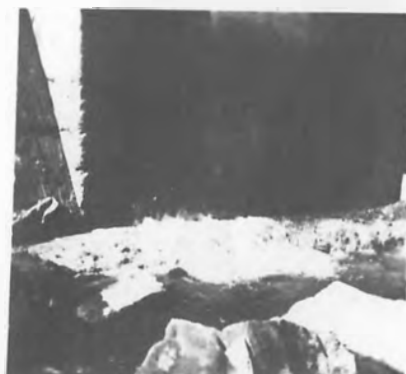
FIGURE 37 - CONDITIONS AT FOOT OF JACKSON LAKE DAM

the salmon start through in such manner as to practically fill each pool in the ladder with fish. The period of actual operation at Bonneville Dam has been so short that little data were available as to the actual efficiency of the ladders. In fact, those in charge of the fish handling were more concerned with the fingerling migration downstream than with the fish migration upstream. The mechanical fish screens below the entrance to the Sunnyside Main canal and the Tieton Main canal have not been entirely satisfactory particularly because of the poor distribution of velocity of approach to the screens. At Jackson Lake Dam (figure 37) the only water being released was the flow through the fishway. Apparently the stream

View Showing Lack of
Tail Water

Close-up of Flow From
Fish Ladder

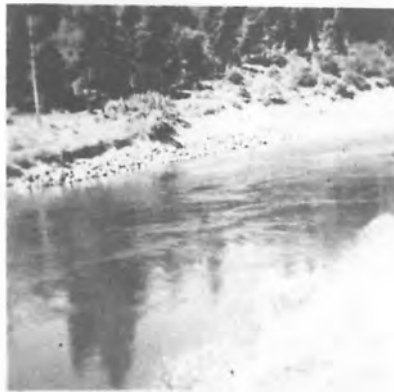
34. In the Kittitas Main canal, there is a transition from lined to unlined earth section at station 710+50. The turbulence and return eddies caused by the change of velocity due to the increase of area and reduction of slope has cut into both banks. This is a condition prevailing wherever there is a transition from lined to unlined section, but it is aggravated at this particular point by a curve in the channel immediately above the change of section which causes a concentration of the turbulence on the right bank. According to Superintendent J. S. Moore this condition is worse at fractional capacities than at maximum. The riprap necessary to stabilize the bank at this particular point is shown in figure 38. If the lining was carried through the transition the turbulence would occur in the lined section and the scour would be avoided. It is suggested that the lined transition be used in future designs.

FIGURE 38 - TRANSITION FROM LINED TO UNLINED SECTION
AT STATION 710+50 - KITTITAS MAIN CANAL

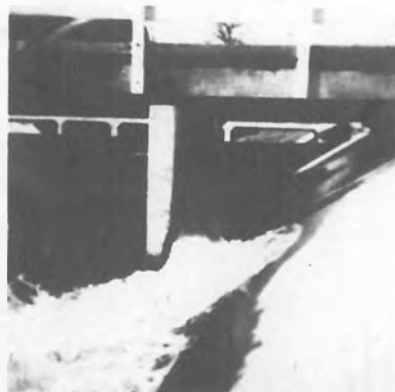
37. In the Naneum Creek Wasteway at station 886+06.0 on the Kittitas North Branch Canal (Dwg. 33-D-496, Spec. 496) a 2-foot 6-inch by 2-foot 10-inch rectangular culvert was provided to carry the normal flow of Naneum Creek under the canal. This culvert has right-angle bends near the entrance and outlet. Floating bits of timber catch in the outlet bend and cannot be removed until the end of the season. Much better flow conditions would have been obtained with an improvement of the alinement particularly at the outlet. The flow from the culvert is shown in figure 39.

FIGURE 39 - FLOW FROM BYPASS CULVERT UNDER
NANEUM CREEK WASTEWAY - KITTITAS NORTH BRANCH CANAL
