HYDRAULIC LABORATORY REPORT NO. 42

REPORT ON INSPECTION TRIP TO
STUDY OPERATIONS OF OUTLET
WORKS - ALCOVA DAM - KENDRICK
PROJECT

Denver, Colorado
November 16, 1938

Subject: Report on inspection trip to study operation of outlet works, Alcova Dam, Kendrick project, Wyoming.

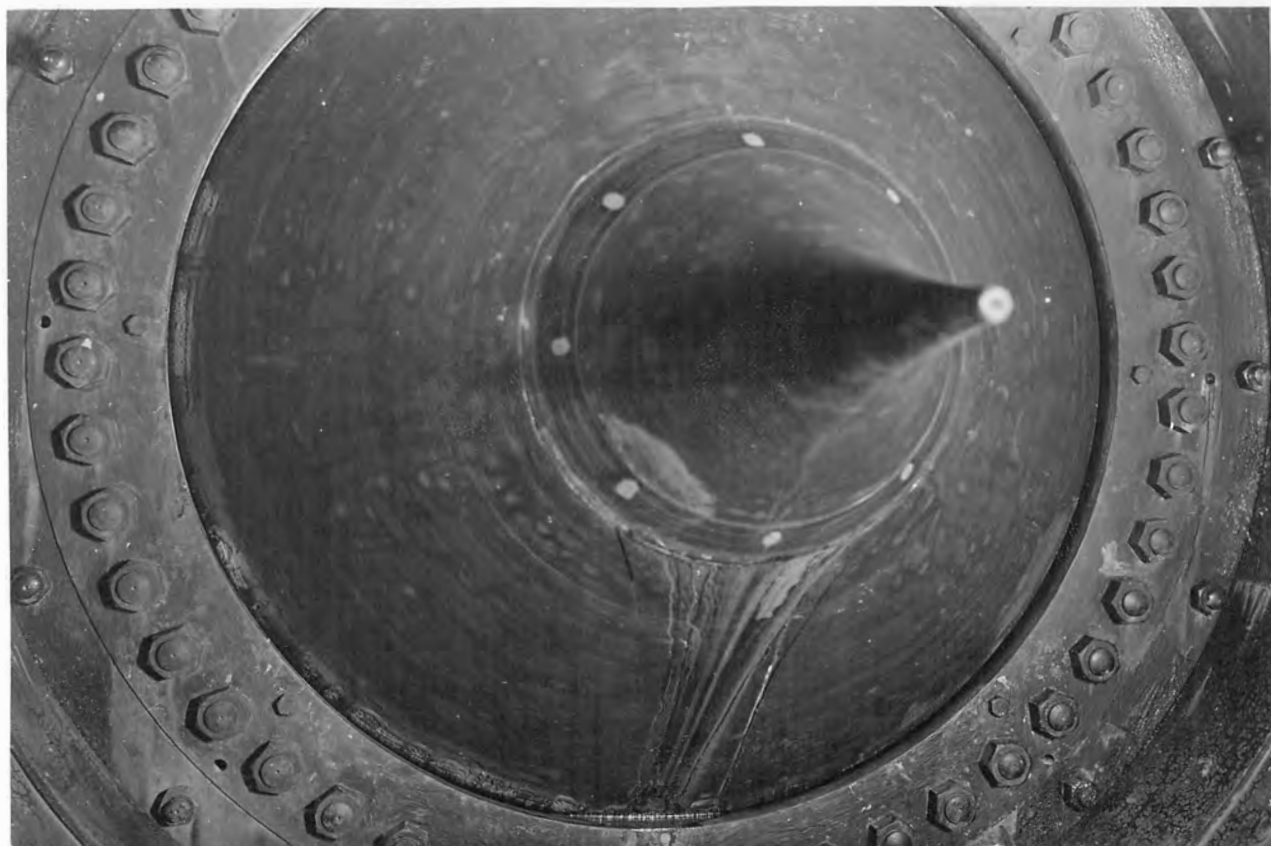
6. Both needle valves show evidence of cavitation. Damage to the needle and to the bronze nozzle seat is more pronounced in the right or no. 2 valve, where the semisteel portion of the needle immediately downstream from the bronze seat is pitted to a depth of approximately one-quarter inch in concentrated areas (figures 3, 4, and 5). These areas extend from 6 to 8 inches downstream from the bronze seat, and from 18 to 24 inches around the periphery of the needle, and are separated by areas of little or no damage. The pitted areas do not extend into the bronze seal ring. The nozzle seat is not damaged. In the left valve, the results of the cavitation are evidenced by channeling in both the bronze nozzle seat and the bronze needle seat. The channels are more or less evenly distributed over the entire periphery of the rings and on the needle, and extend into the semisteel portion. In both valves, the pitting is downstream from the seal, since no leakage occurs when the valves are closed.

VALVE NO. 2 - EXTENT OF DAMAGE DUE TO CAVITATION.

length of time that the valves have been operated. These valves will require repair at frequent intervals if they are operated to any great extent. Such maintenance will be costly because the valves are not readily accessible. The present nozzle seats could be replaced with seats of improved design at a very nominal cost. It is probable that this change would not entirely correct the cavitation conditions but would diminish them. Replacement of the needles, as well as the seats, would be necessary to eliminate the conditions. Although this would necessitate a greater initial expenditure, it would, no doubt, be more economical than the cost of maintenance over a period of years. If these changes are made on the valves, in addition to relieving the cavitation difficulties, the air demand would probably be materially reduced and the question of air supply would be solved, at least in part. The exact amount of reduction of air demand gained by this change cannot be definitely stated.

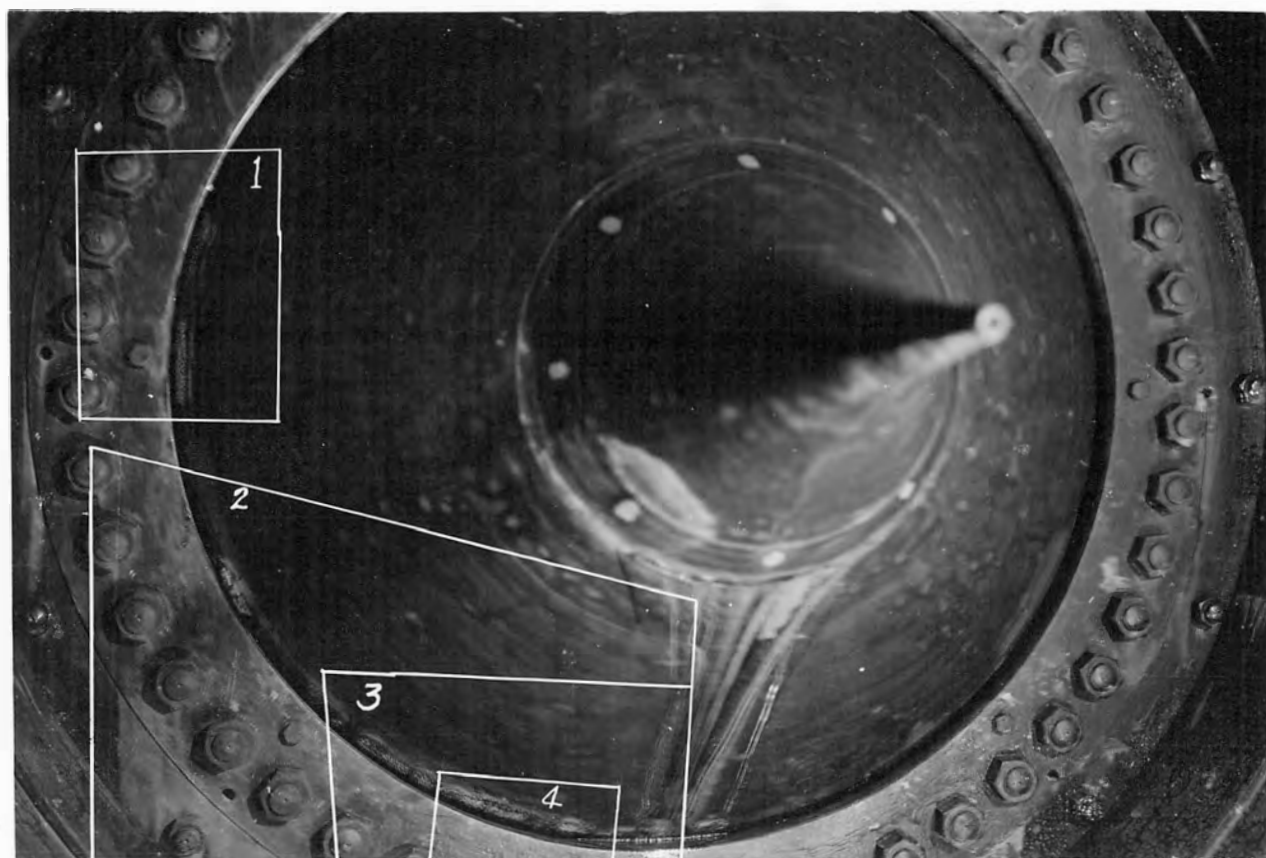
VALVE NO. 2 - MARKED AREAS ARE SHOWN IN THE FOLLOWING PHOTOGRAPHS.

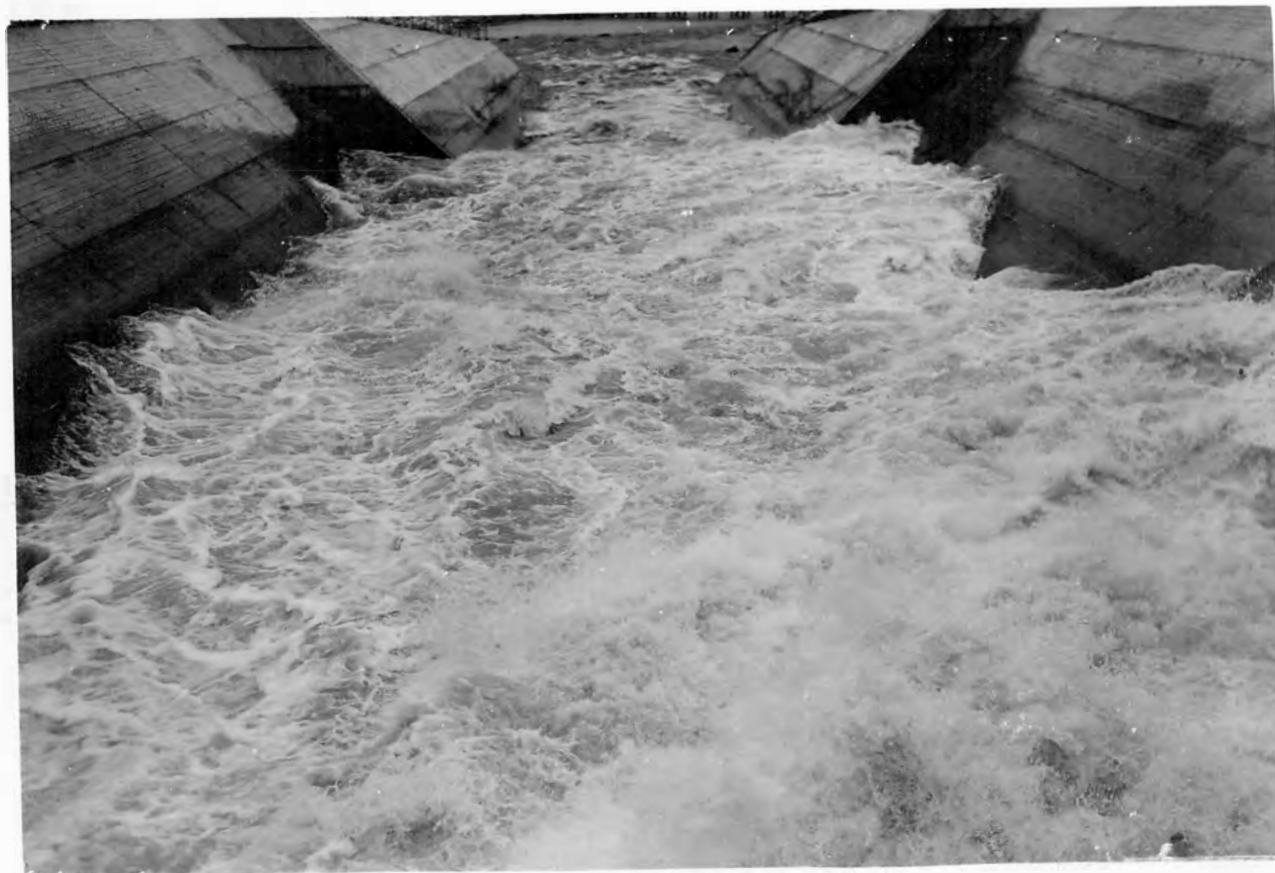
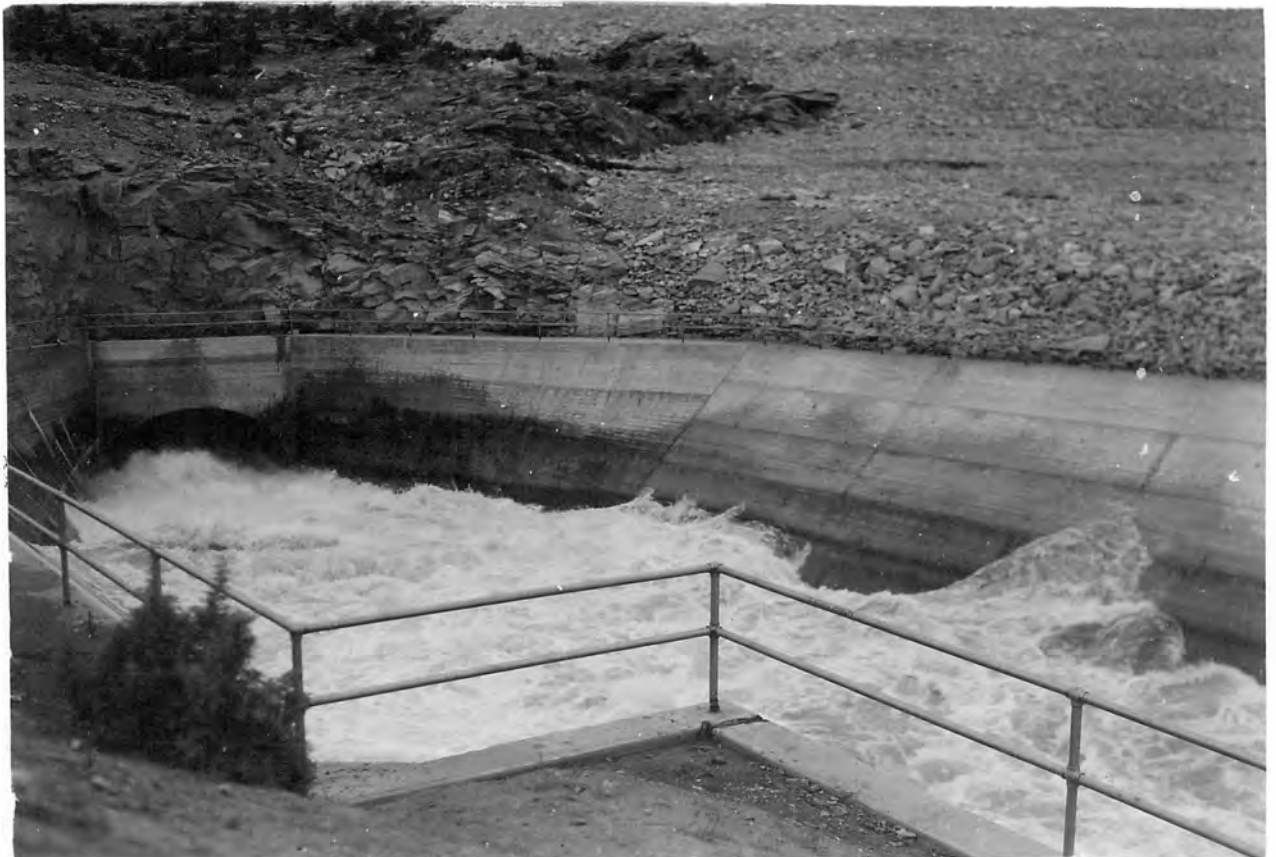
12. Flow conditions in the stilling pool for four valve settings are shown in figures 6, 7, 8, 9, and 10. The hydraulic jump occurs within the tunnel for discharges below approximately 2,000 cubic feet per second, and conditions in the pool are fair. At higher discharges, the pool is very rough and turbulent. At discharges above 2,000 second-feet, there is a return flow along the left pool wall near the tunnel portal that enters the hydraulic jump from the side, thus impairing the stability of this phenomenon, and waves are produced in the pool. These waves overtop the walls of the stilling basin for discharges above approximately 4,000 second-feet. The tunnel did not flow full at any discharge (figures 8, 9, and 10). The flow leaves the lined section of the pool at high velocity (figure 10). The boulder-strewn stream bed downstream from the pool (figure 11) is sufficient protection against erosion in the bed. However, erosion of the right bank at the end of the lining is quite severe and has exposed most of the cut-off wall (figure 11). In fact, some of the large riprap was moved during the relatively short time that the tests were being made. The riprap on this bank was dumped from the top. The left bank shows little or no tendency to erode (figure 11). The difference in stability is due to the fact that the riprap on the left bank was placed and swings back on a long arc from the end of the concrete. If the right bank is allowed to erode until it is similar in plan to the left bank, and then covered with placed riprap, the tendency for erosion in this area should be completely eliminated. The sharp offset in the walls and floor of the stilling pool at station 15+00, causes the flow to leave the walls, and possibly the floor, immediately downstream from the square corner. An expansion joint traverses

VALVES 25% OPEN - DISCHARGE 1645 SECOND-FEET.

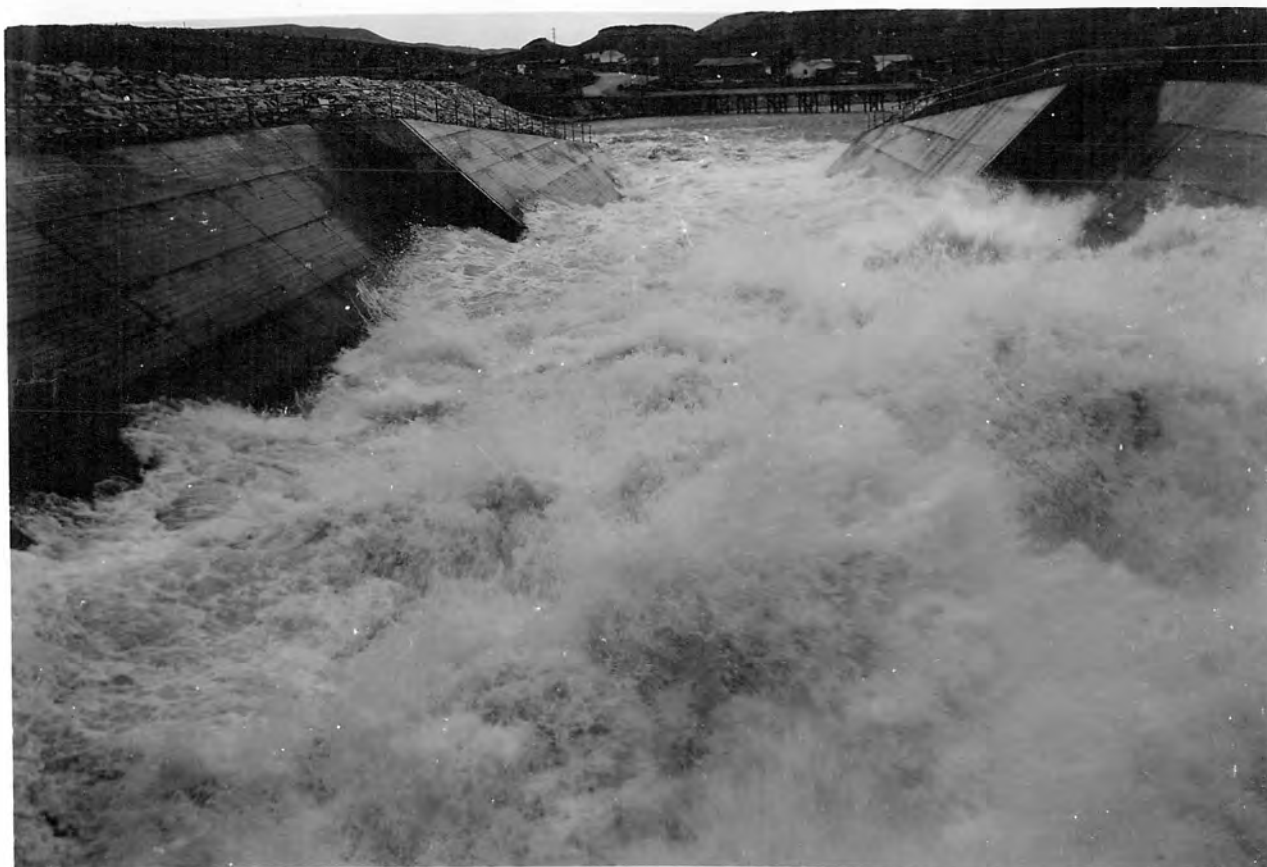
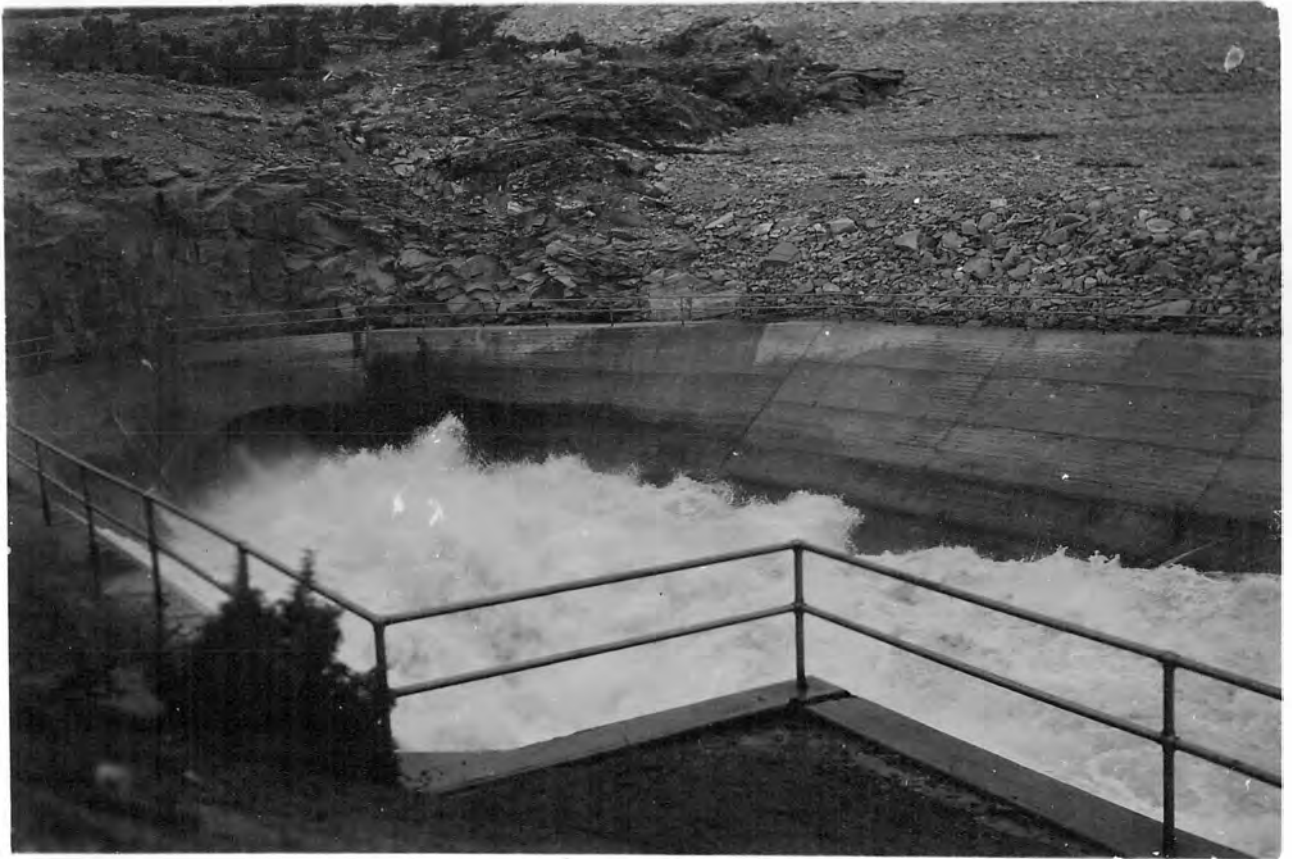
VALVES 50% OPEN - DISCHARGE 3175 SECOND-FOOT.

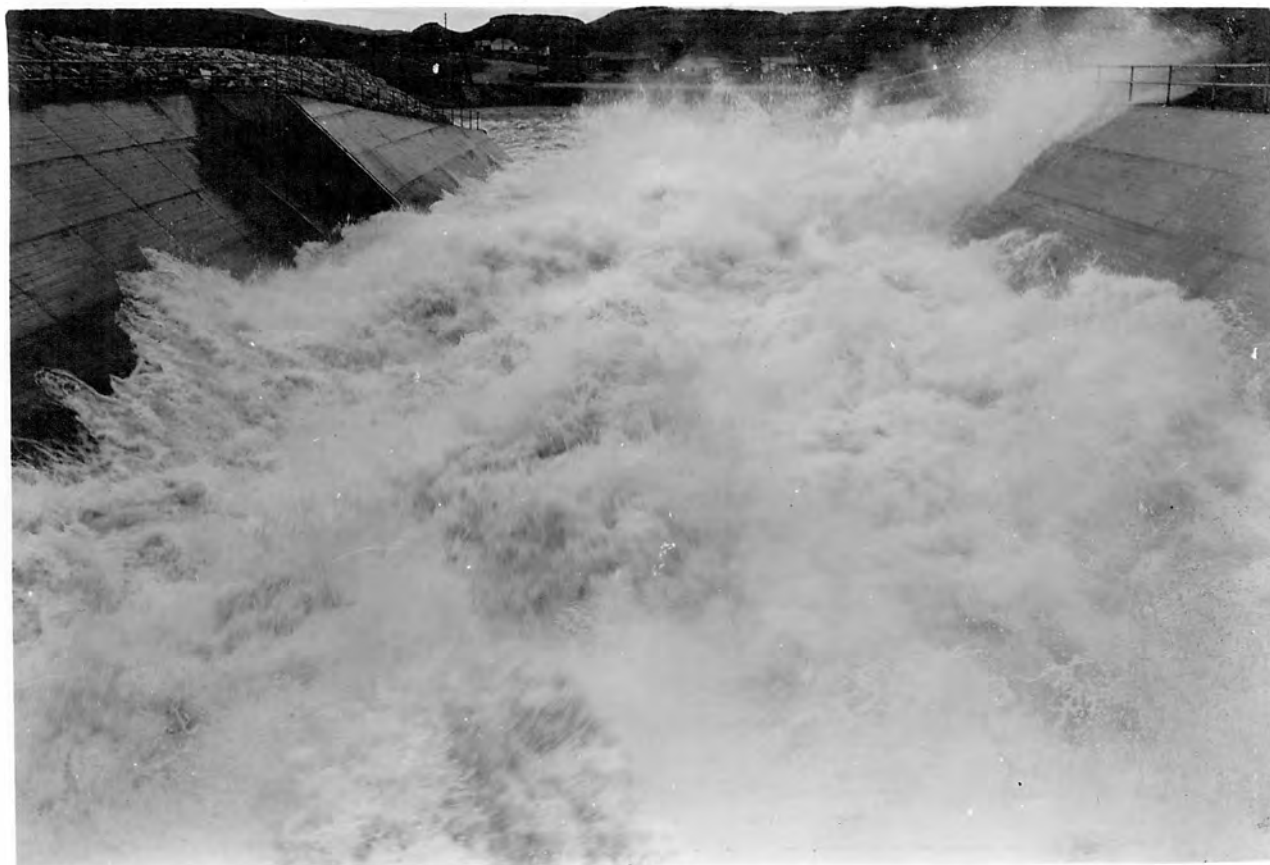
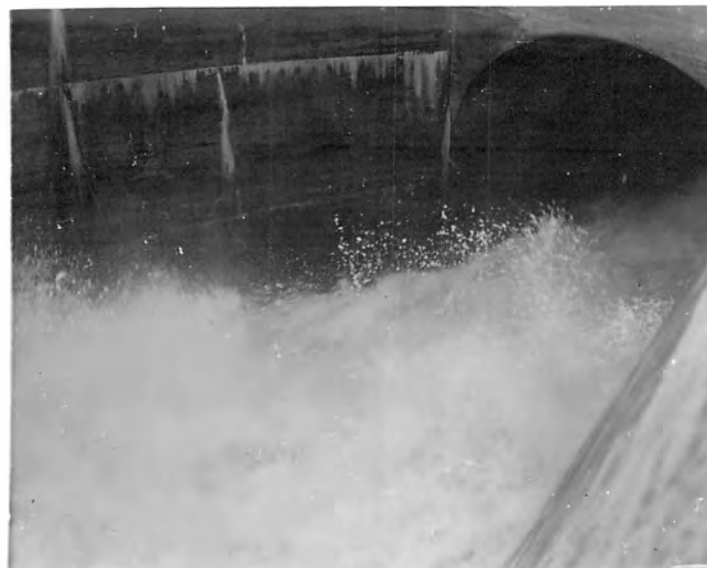
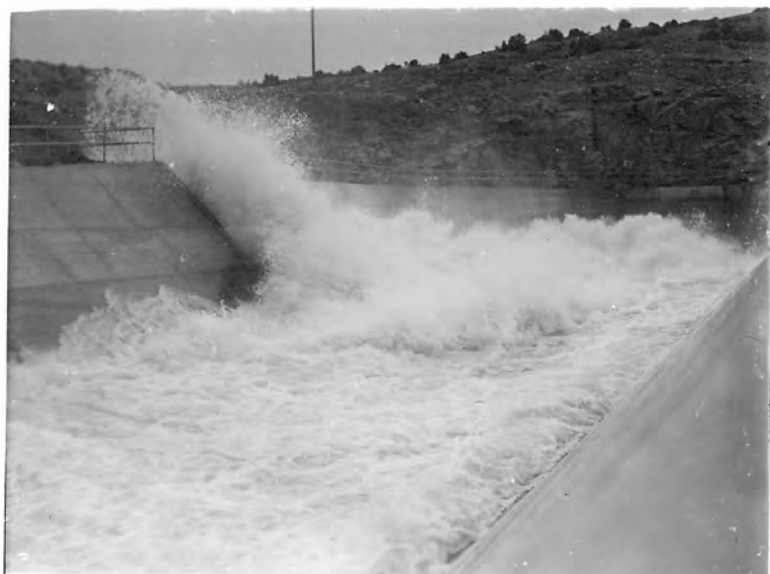
VALVES 100% OPEN - DISCHARGE 4825 SECOND-FOOT.

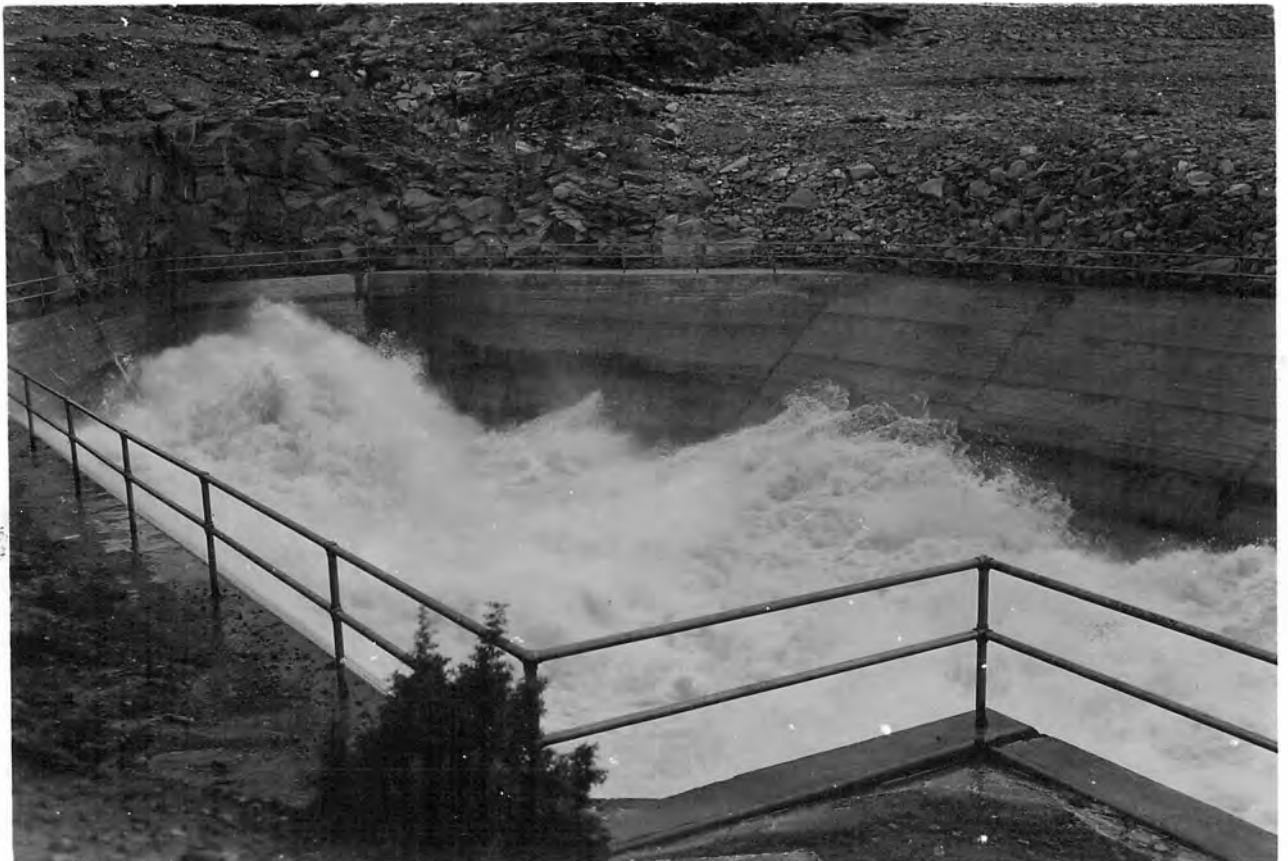
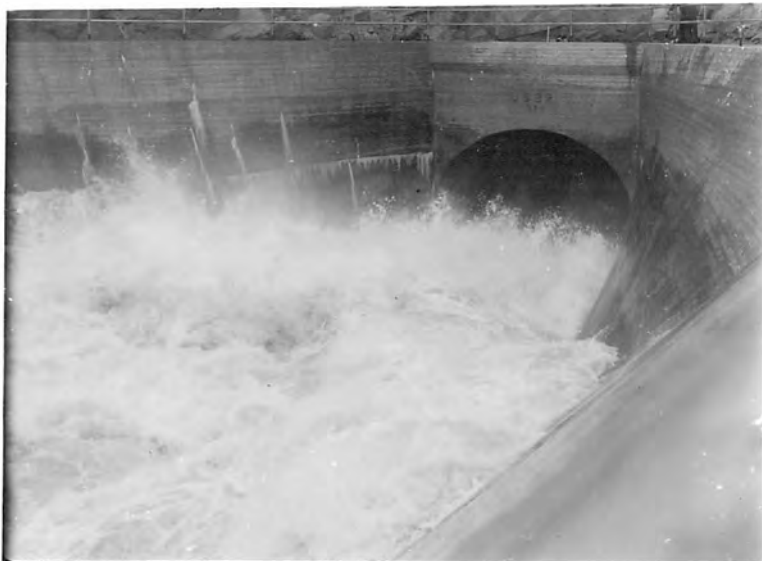
VALVES 75% OPEN - DISCHARGE 4145 SECOND-FEET.

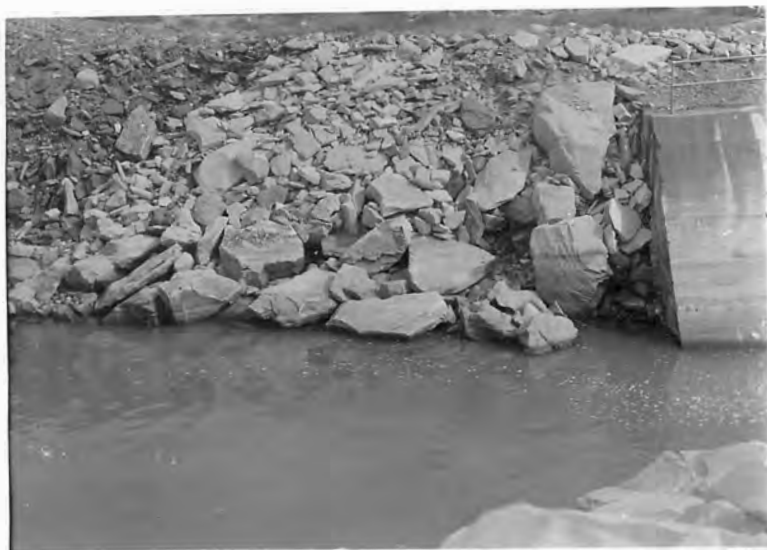
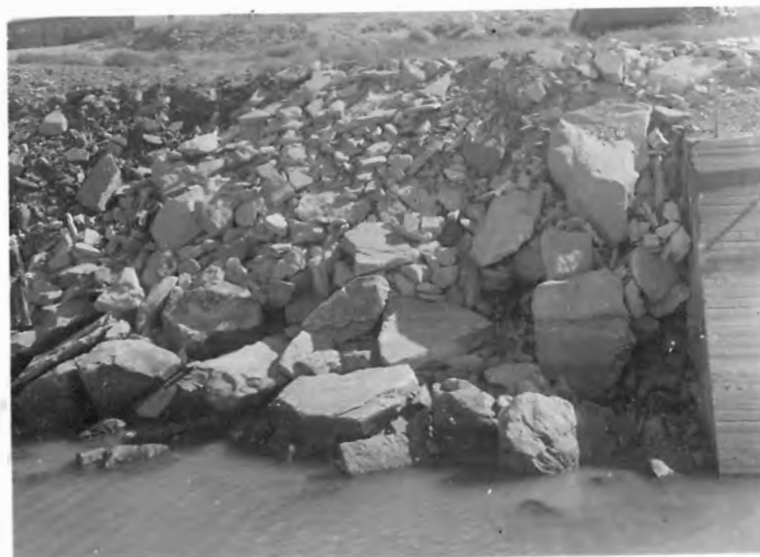
RIGHT BANK - RIPRAP AT END OF POOL.

22. Conditions in the stilling pool. Although the flow conditions in the stilling pool are not satisfactory, no damage aside from that outlined in paragraph 12 has resulted. The water that overtops the walls of the pool has eroded some material, but the right side of the pool, where most of the overflow occurs, is on rock and little damage can result. The sound character of the river bed below the pool is very resistant to retrogression. If the contraction joint is grouted and the

riprap on the right bank at the end of the pool is repaired, no further maintenance should be necessary for some time.

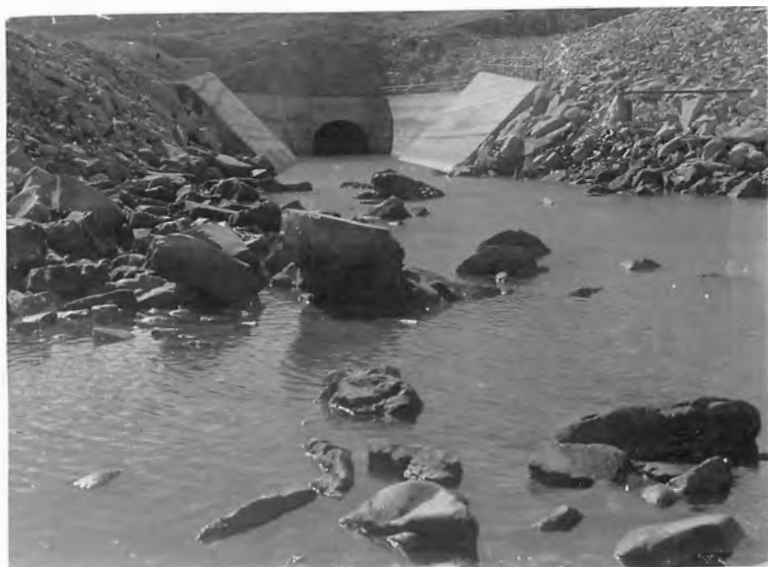
STREAM BED DOWNSTREAM FROM POOL.

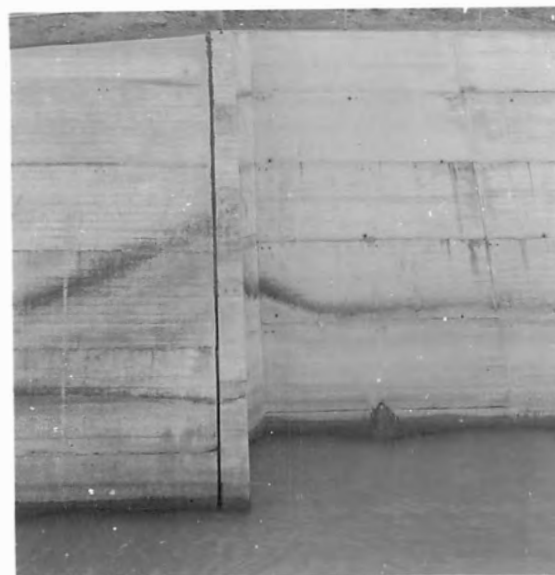
EXPANSION JOINT AT STA. 15 + 00.

the pool at this point (figure 11). The mastic in this joint had been removed to a depth of 2-1/2 feet due to the low pressure. The joint in the floor appeared to have suffered no damage. It is suggested that the remaining plastic be removed from this joint and the joint grouted to avoid possible damage to the walls.
