UNITED STATES  
DEPARTMENT OF THE INTERIOR  
BUREAU OF RECLAMATION

WHY CLOSE TOLERANCES ARE NECESSARY  
UNDER HIGH-VELOCITY FLOW

Hydraulic Laboratory Report No. Hyd-473

October 20, 1960

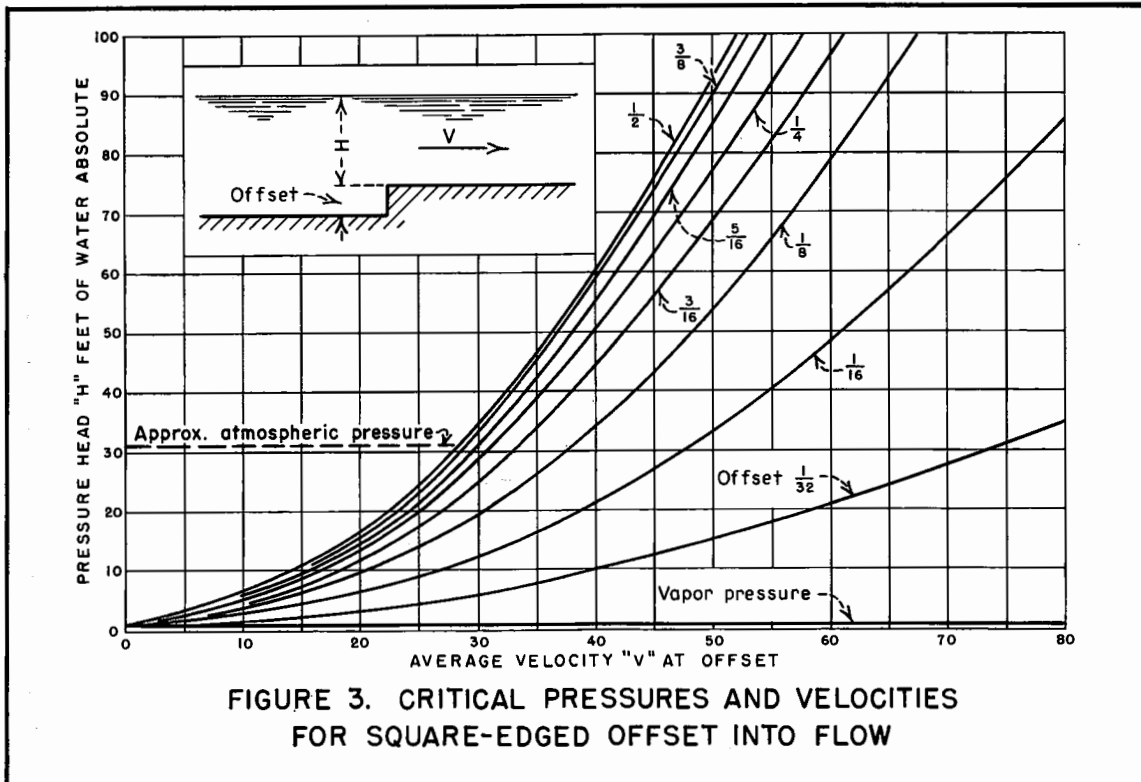
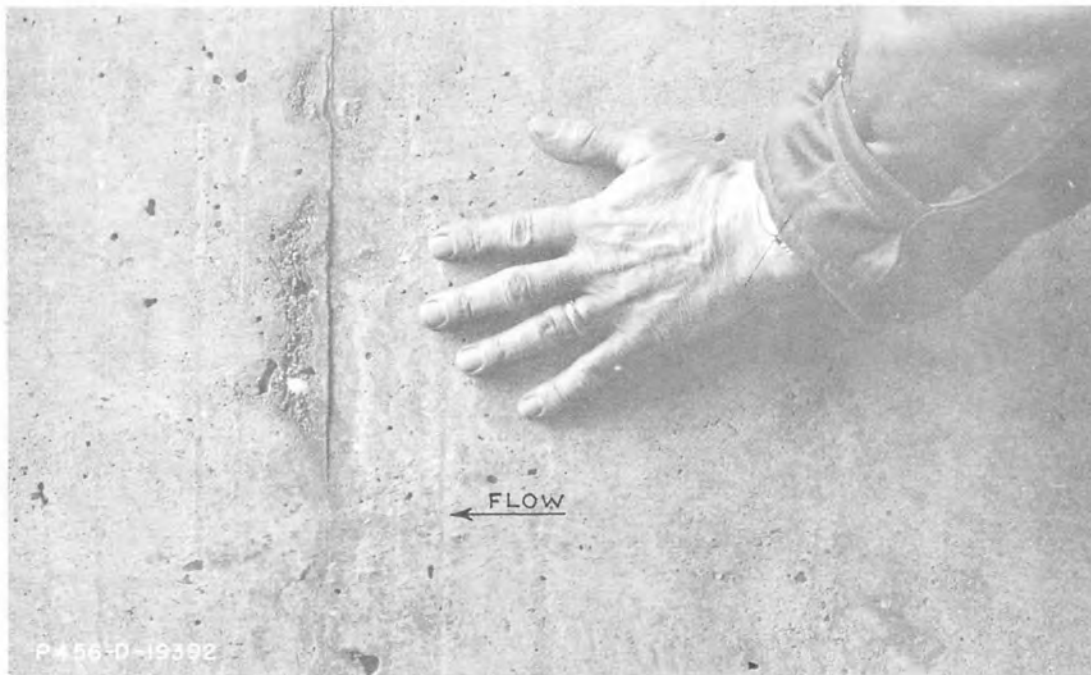
**Figure 4--Cavitation-erosion downstream from 1/8 inch into-the-flow offset, atmospheric fluid pressure, and velocity of 100 feet per second--Palisades Dam Outlet Works.**

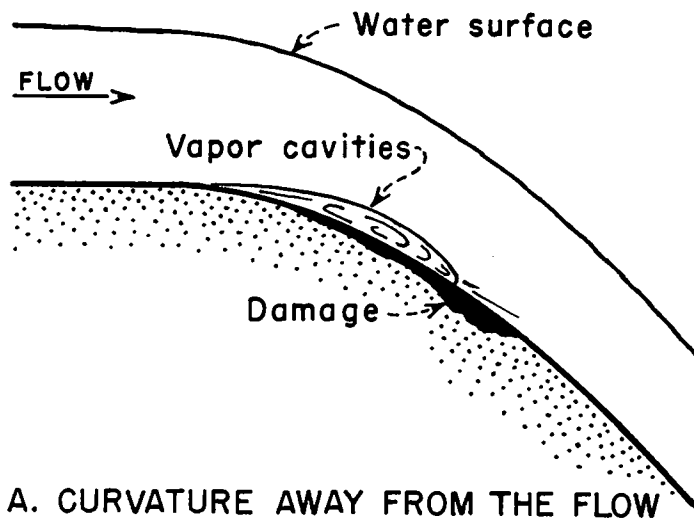
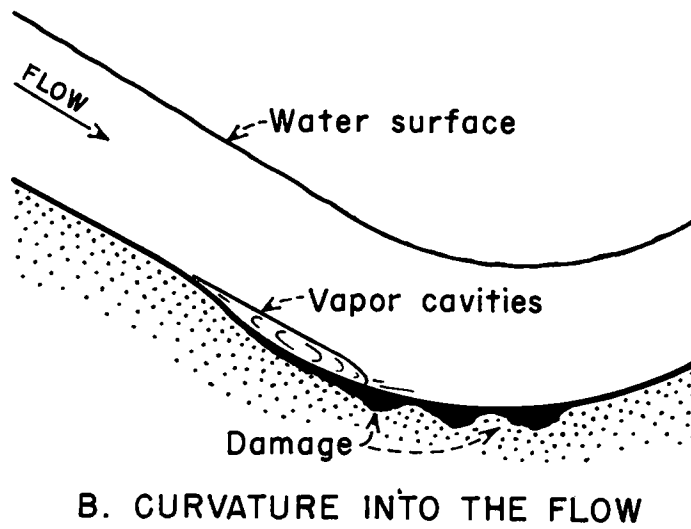
FIGURE 5. CAVITATION ON CURVED SURFACES

Actually cavitation damage may reach a stable condition or may progress to reach extensive proportions, Figure 5. In cases where the surface curvature is away from the flow cavitation damage will, where the curvature is just right (Figure 5A), reach a point where recirculation occurs. This raises the pressure above the vapor pressure and cavitation ceases.

In cases where surfaces encroach upon the flowing stream (Figure 5B), the cavitation will be progressive causing extensive damage. Unfortunately most cases are of a progressive nature.

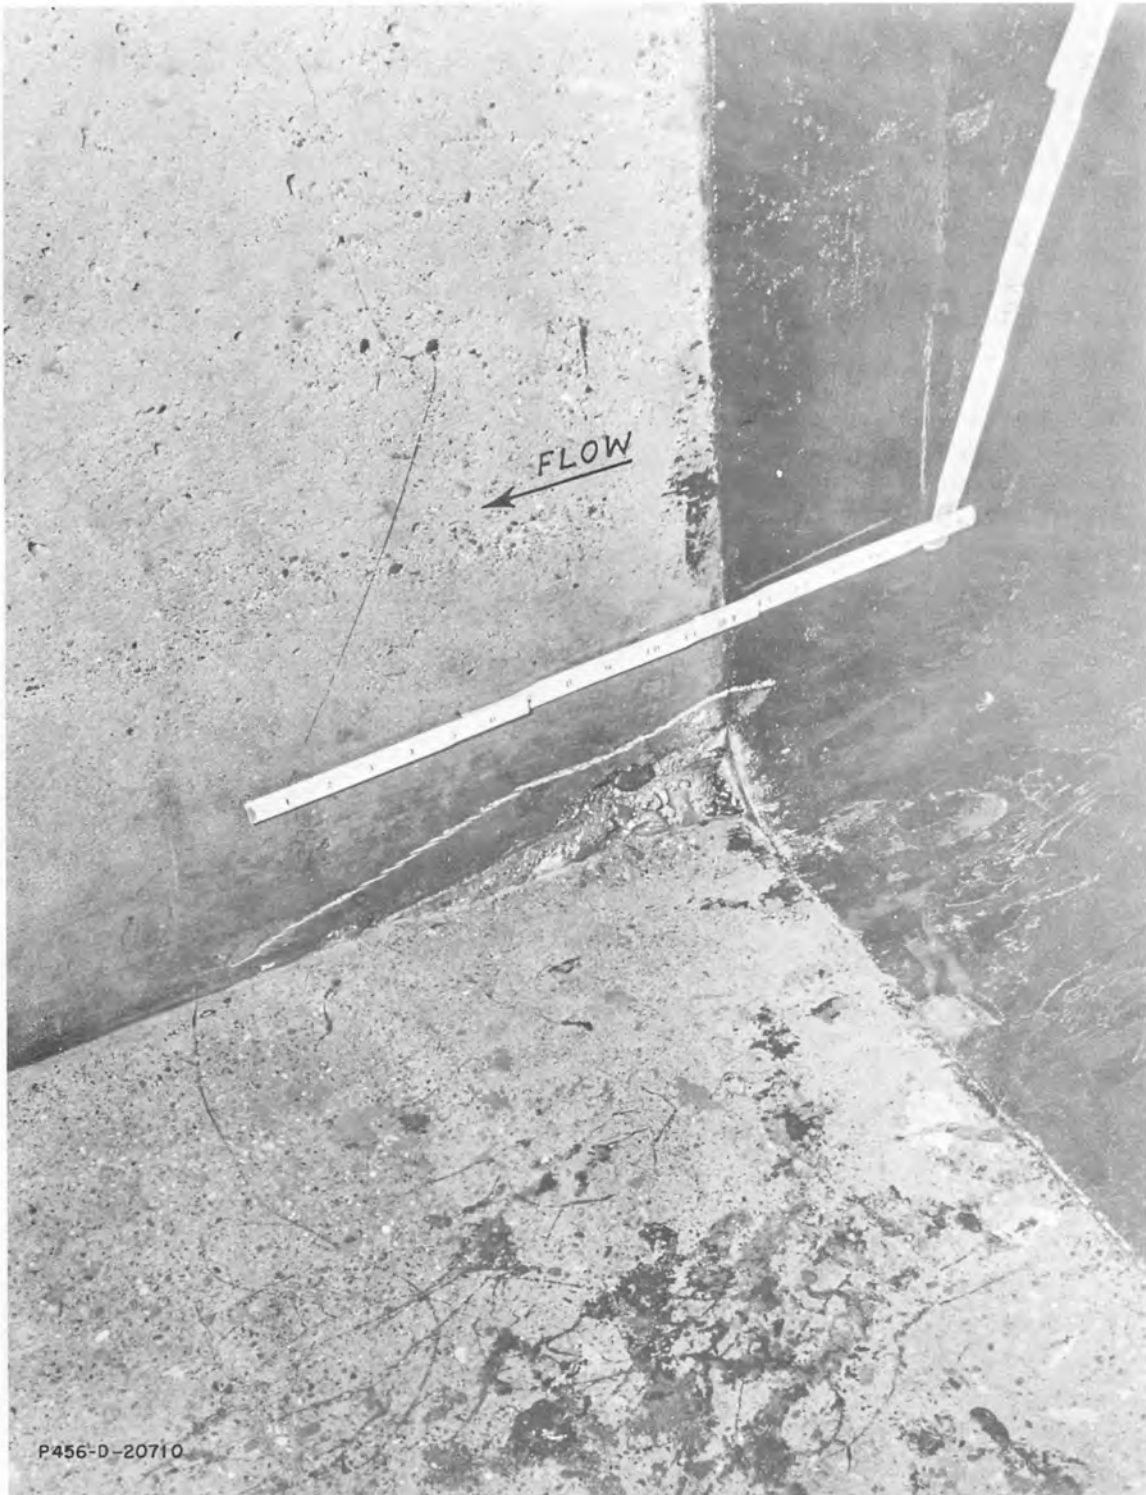
Figure 6--Slight cavitation-erosion, slope away from flow at fillet downstream from outlet gate frame--Palisades Dam.

This type of alinement change (Figure 6) was the cause of considerable damage downstream from one of the gates at Palisades Dam (Figure 7). The slope change occurred at a corner immediately downstream from the gate frame where a concrete fillet about 10 inches long sloped outward from the curve of the metal to the sharp corner in the concrete. The eroded area was several feet long, about 2 feet wide with a maximum depth of 7 inches. The irregularity was of the type shown in Figure 1D. Repair was made in such a way that the rate of slope change was sufficiently gradual to prevent pressures of vapor pressure magnitude.

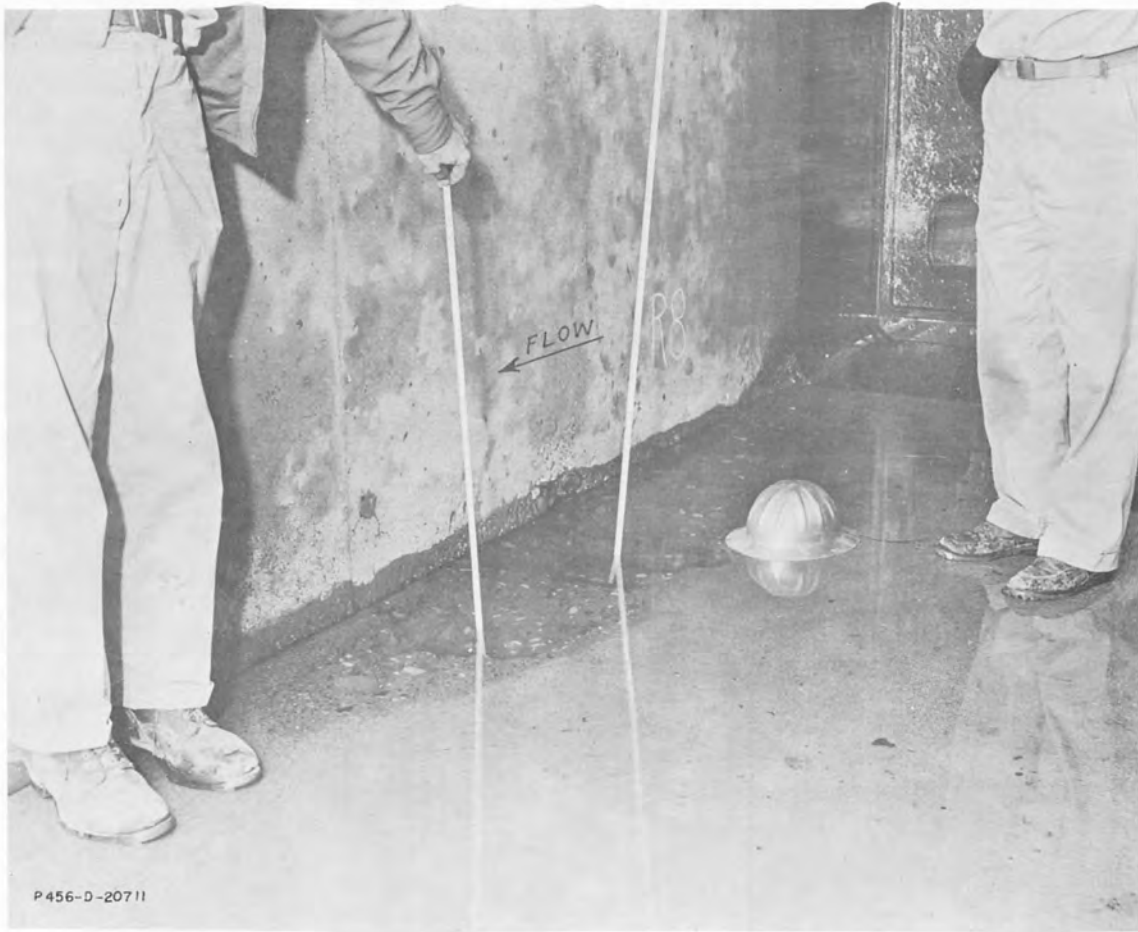
Figure 7--Progressive cavitation-erosion caused by slope away from flow at fillet downstream from outlet gate frame--Palisades Dam.

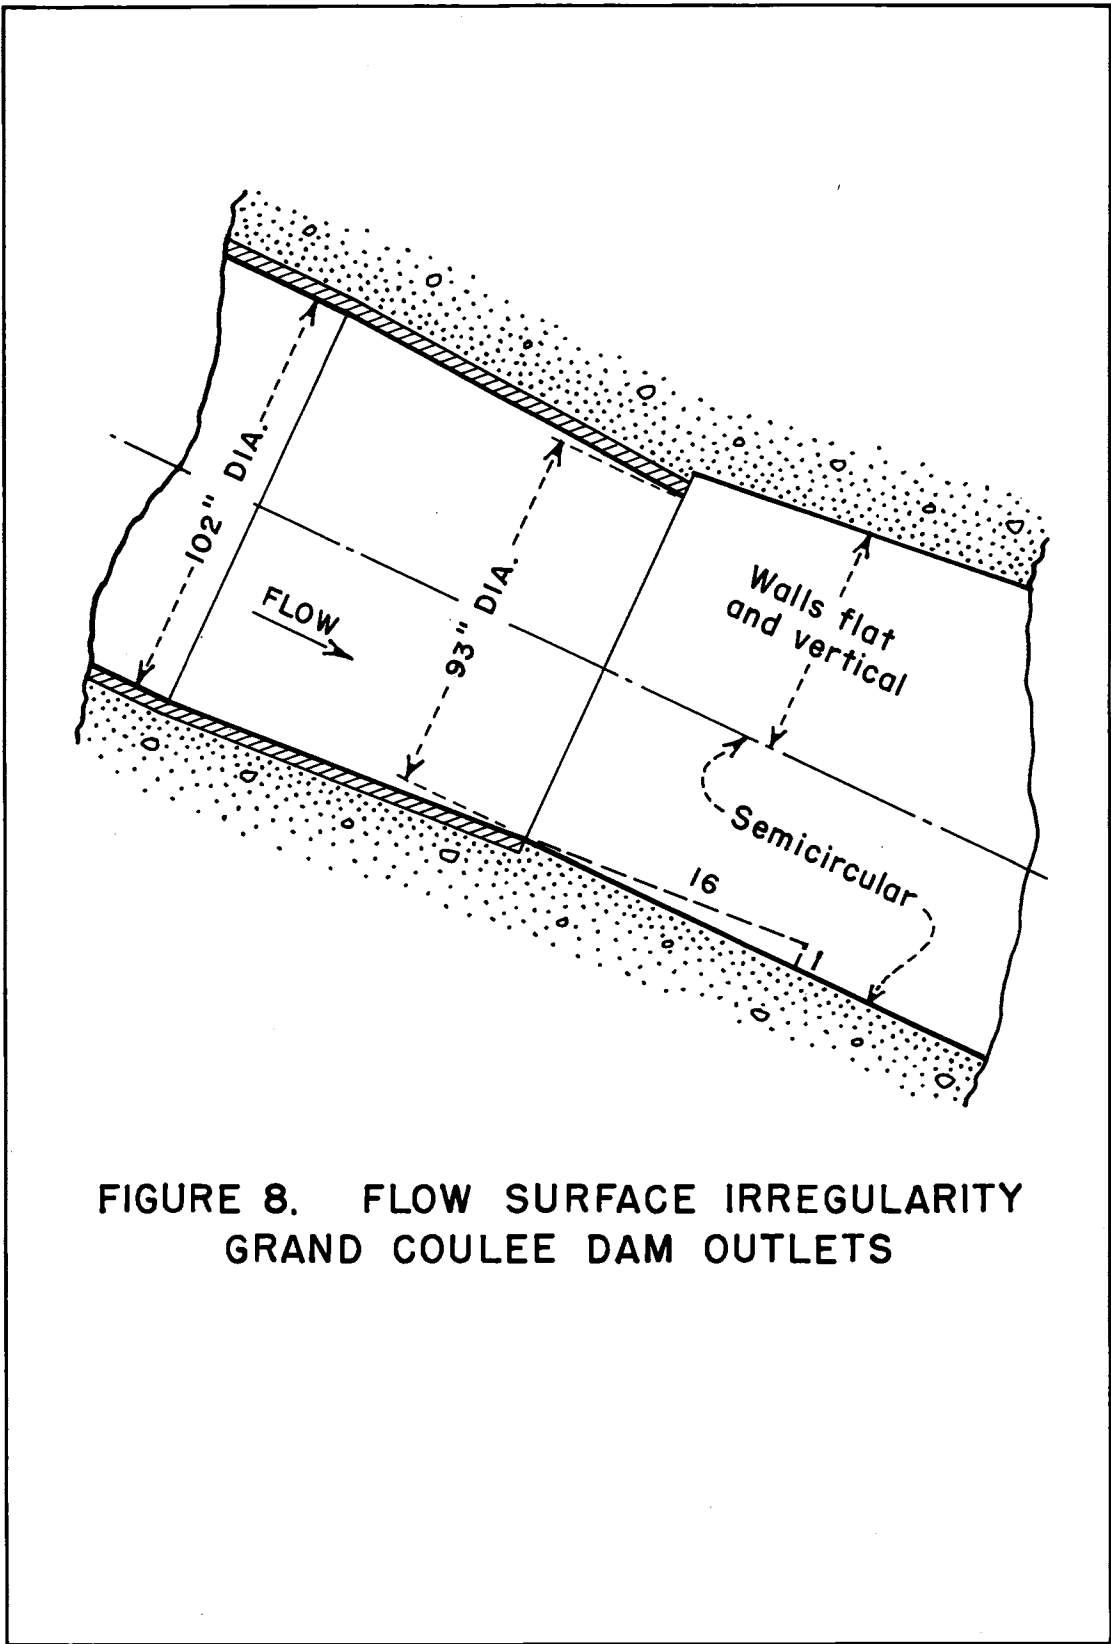
FIGURE 8. FLOW SURFACE IRREGULARITY  
GRAND COULEE DAM OUTLETS

flow surfaces of highhead structures was realized only in recent years. An example of an irregularity designed in a surface some 22 years ago is the exit cone and trough in the upper and intermediate tiers of outlets at Grand Coulee Dam (Figure 8). The abrupt change in alignment of the surfaces, at the rate of about 1 in 16, occurs where the surface of the exit trough continues beyond the cone. This forms an irregularity similar to that shown in Figure 1D. Progressive cavitation-erosion resulted from this irregularity when the outlets recently were operated for flood control purposes (Figure 9). The damage varied widely for the 40 outlets due to various lengths of operating periods, differences in head, local bulges in concrete surfaces, offsets into and away from the flow, and various roughnesses in the concrete. Figure 10 shows the general pattern of early-stage erosion below the cone in one of the conduits.

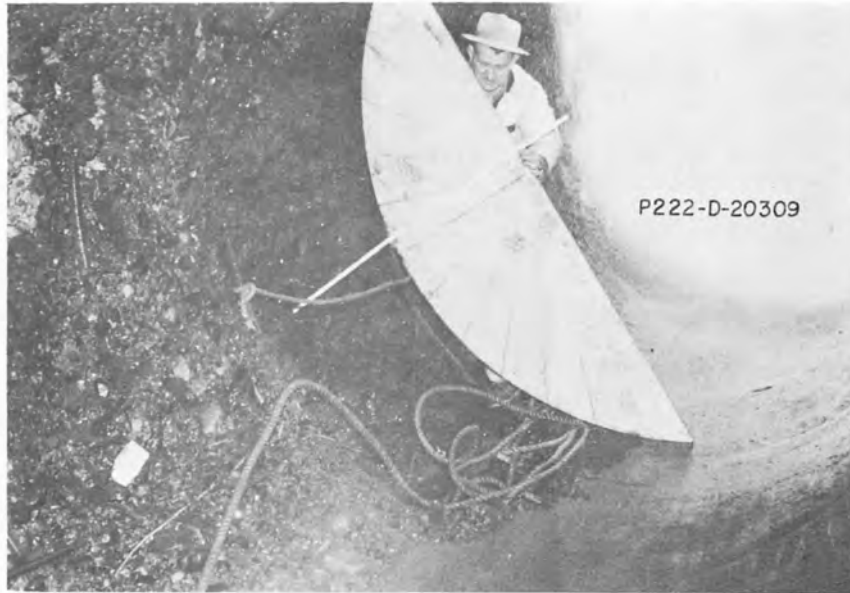
Figure 9--Severe cavitation-erosion in concrete exit trough downstream from liner cone--Grand Coulee Dam Outlet.

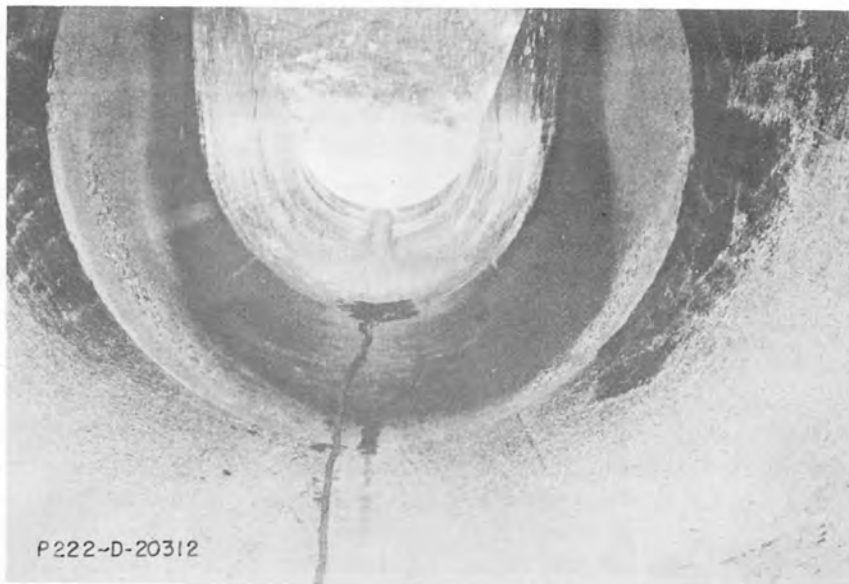
Figure 10--Typical early-stage cavitation-erosion in walls of concrete exit trough downstream from liner cone--Grand Coulee Dam Outlet.

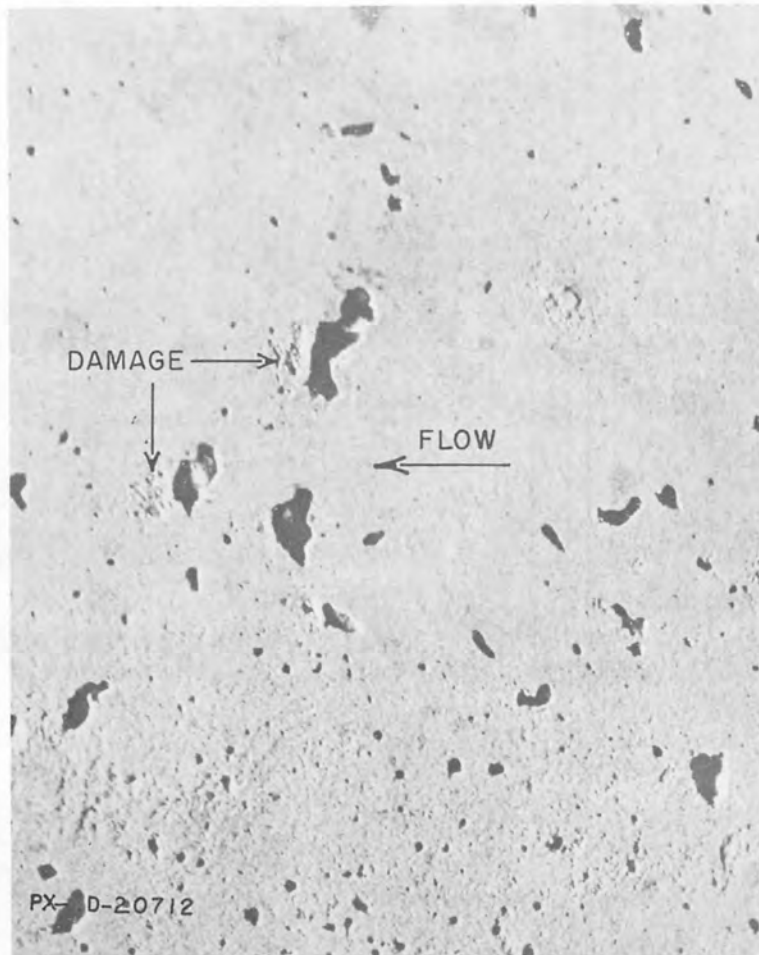
Transverse grooves (Figure 1E), including gate slots, can be a source of much trouble. In this type of irregularity, the low pressure zone forms just downstream from the downstream corner (Figure 2E). A section through a void or "bug hole" is similar to that of a transverse groove. Damage by cavitation has been observed downstream from bug holes of about 1/2-inch diameter and larger (Figure 11). On this basis it is believed that bug holes and voids should be filled to form smooth continuous surfaces when flow velocities exceed about 50 feet per second. The hole depth and width, and the flow velocity will influence the cavitation potential of such irregularities. To date, there have been insufficient observations to establish any definite relationships. Some work on gate slots has been done in the laboratory <sup>2/</sup>, but considerable field data covering a wide range of the variables would be extremely useful.

Figure 11--Cavitation-erosion downstream from "bug holes" in concrete. Velocity about 100 feet per second, pressure about atmospheric.
