**DRAWDOWN TESTS
ON EARTH COVER MATERIAL
PLACED OVER AN ASPHALT MEMBRANE
EAST BENCH CANAL--MISSOURI RIVER
BASIN PROJECT, MONTANA**

General Report No. GEN-29

November 1, 1961

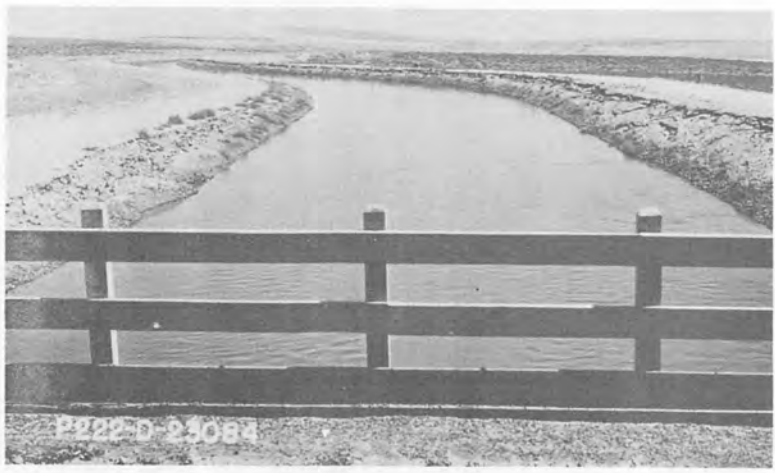
Figure 1

Sloughing failure of soil cover material on or near asphalt membrane linings in canals has created maintenance problems particularly in the Missouri River Basin and Columbia Basin Projects. An example of a failure, which occurred on West Canal near Station 3606+12, Columbia Basin Project, is shown in Figure 1. In this particular case, the side slopes were 2:1 and freeboard was 1.5 feet.

(a) View Showing Extent Of Damage

Slippage Of Earth Cover Material Over Asphalt Membrane, West Canal
Near Station 3606+12, Columbia Basin Project

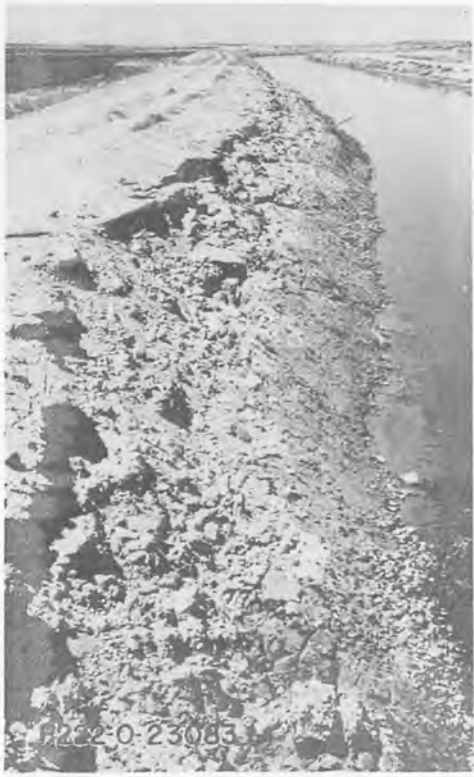
(b) Closeup Of Bank Failure

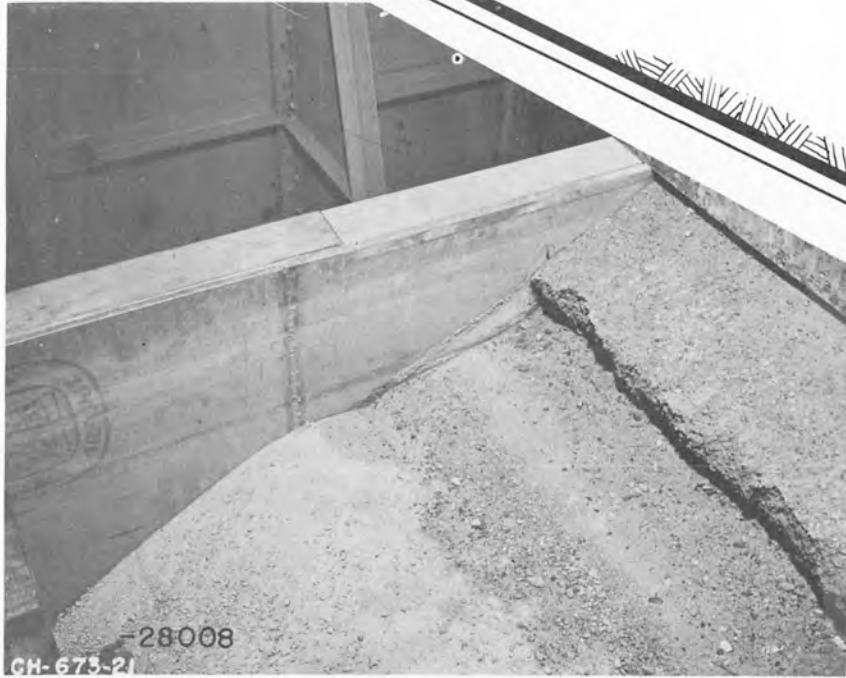
From observations of the condition of the sloping bank upon saturation and from past experience with wave studies in the laboratory, it was decided that the cover material might be susceptible to wave damage. Resistance of the cover material to wave action was, therefore, tested using a hand-operated plunger-type wave generator to produce waves having a period of 1 second. Two waves were generated, 0.1 and 0.2 foot in height, in the pool which was 3.9 feet deep. The 0.1-foot-high waves were allowed to impinge on the saturated sloping bank for 5 minutes followed by the 0.2-foot-high waves for 3 minutes, after which the model was carefully drained. The beach that was formed is shown in the photograph and profile of Figure 11. The cover material became armored with pebbles as shown in the photograph. The wave action caused the cover material to consolidate and lose its mushy characteristics in the wave zone. Measurements of the volume removed by wave action showed that 0.33 cubic foot of cover material per foot of bank was eroded.

The earth cover material described in this report should withstand drawdown rates up to 2.0 feet per hour without sloughing. When subjected to surface water waves, the cover material eroded rapidly at first, but soon became rather firm and armored with the coarse material. After 8 minutes exposure to waves 0.1 and 0.2 foot high, the erosion of cover material per lineal foot of canal bank was 0.33 cubic foot.

**BEACHING EROSION PRODUCED BY SMALL WAVES
EAST BENCH CANAL DRAWDOWN TEST
1:1 SCALE SECTIONAL MODEL**

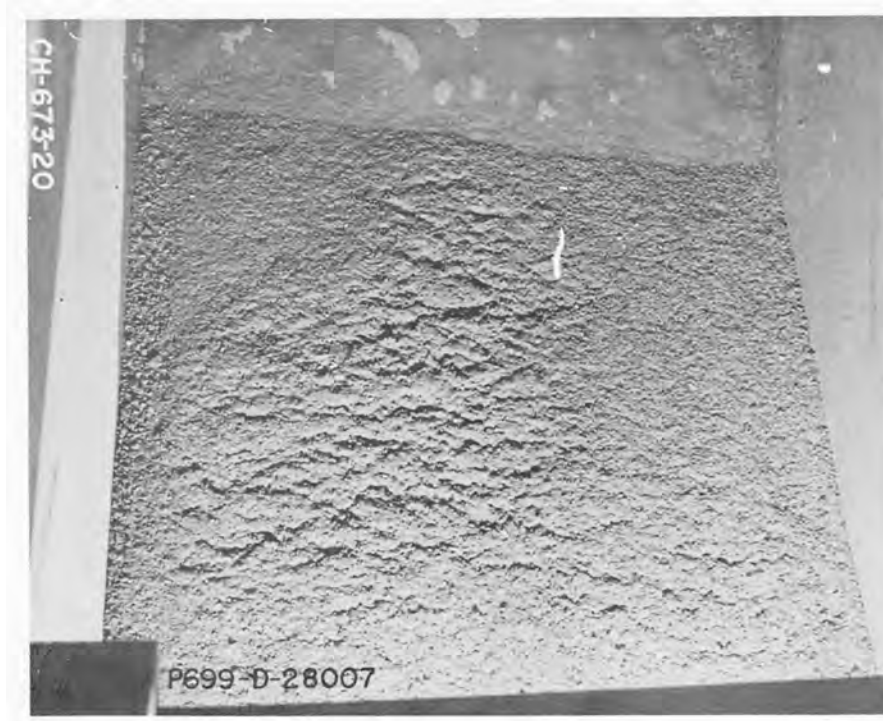
The drawdown rates were increased from 0.042 to 2 feet per hour as shown in Figure 9. No major damage to the cover material was found. However, at the rate of 2 feet per hour, the earth cover material on the sloping bank developed surface cracks that were parallel to the falling waterline. Figure 10 shows the cracking just above the water surface. Close inspection revealed that the cracks did not penetrate into the cover material to any great depth and consequently, they could not be considered major damage. Rates of drawdown greater than 2 feet per hour were not tested because greater rates would not normally be encountered in a canal even if a canal break occurred.

Surface Cracks Forming Just Above Waterline
When Drawdown Rate Was 2 ft/hour. Looking
Down The Slope
East Bench Canal Drawdown Tests
1:1 Scale Sectional Model
