MEMORANDUM TO CHIEF ENGINEER

SUBJECT: TEST TO DETERMINE OPERATING
CHARACTERISTICS OF TUNNEL PLUG OUTLET WORKS

AT BOULDER DAM

BOULDER CANYON PROJECT

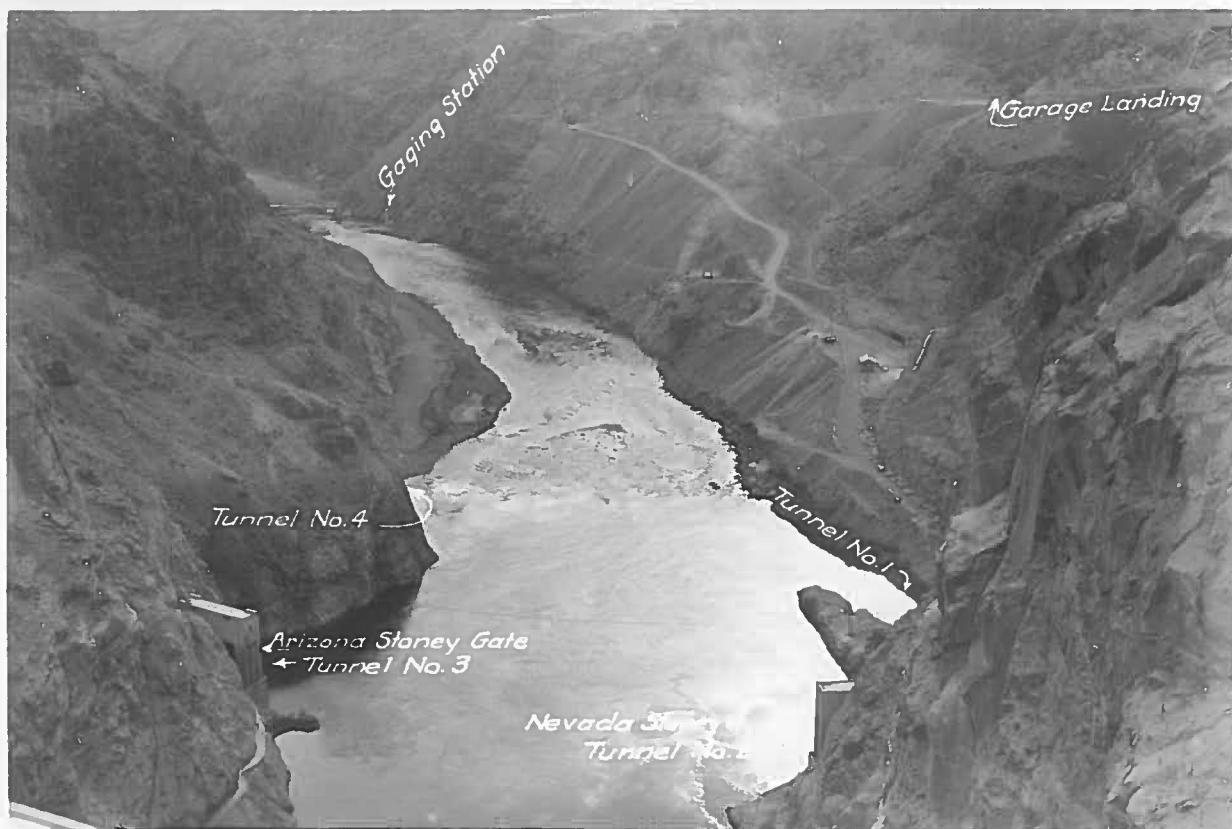
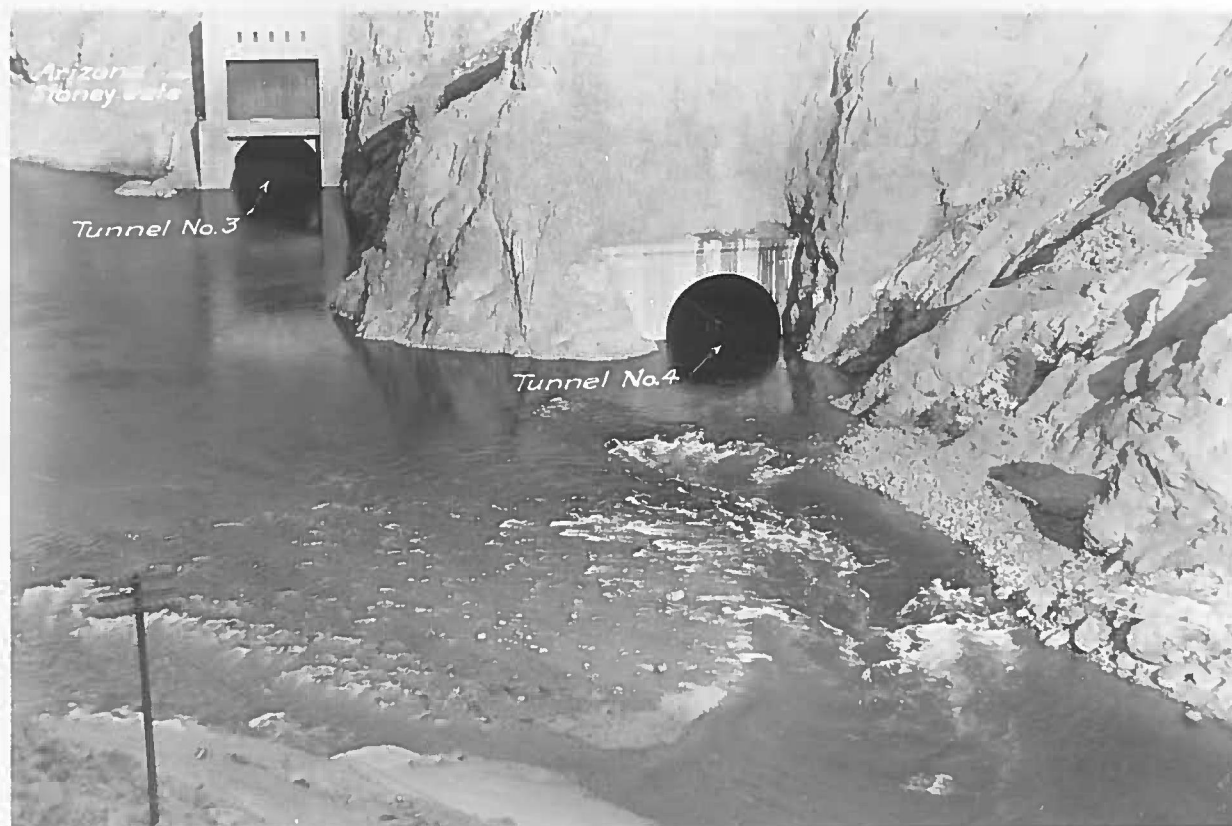
A. BAR IN RIVER BELOW SPILLWAY TUNNEL PORTALS ON DECEMBER 12, 1938,
BEFORE TEST PROGRAM - AS SEEN FROM 150-TON HOIST

B. BAR IN RIVER BELOW SPILLWAY TUNNEL PORTAL ON DECEMBER 12, 1938,
BEFORE TEST PROGRAM - AS SEEN FROM GARAGE LANDING.

(d) The bar across the river channel below the spillway tunnels should be removed.

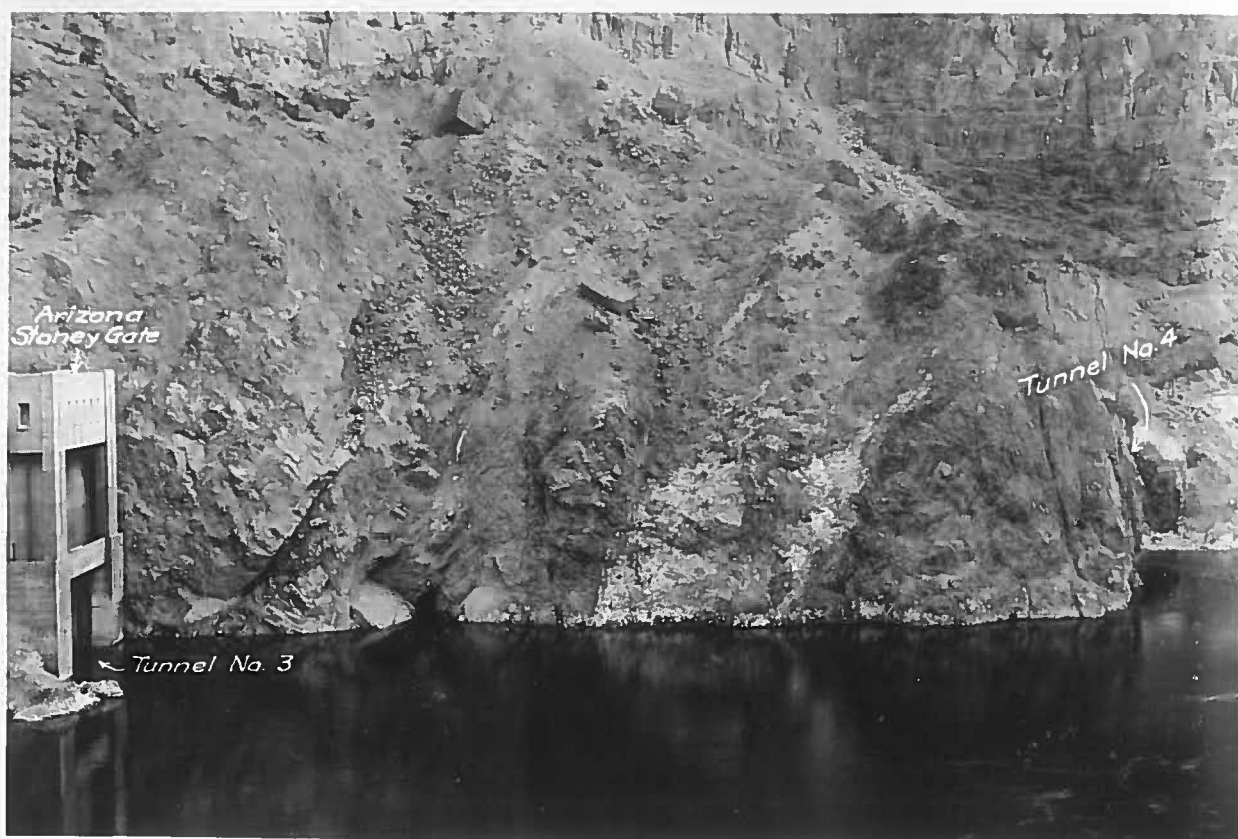
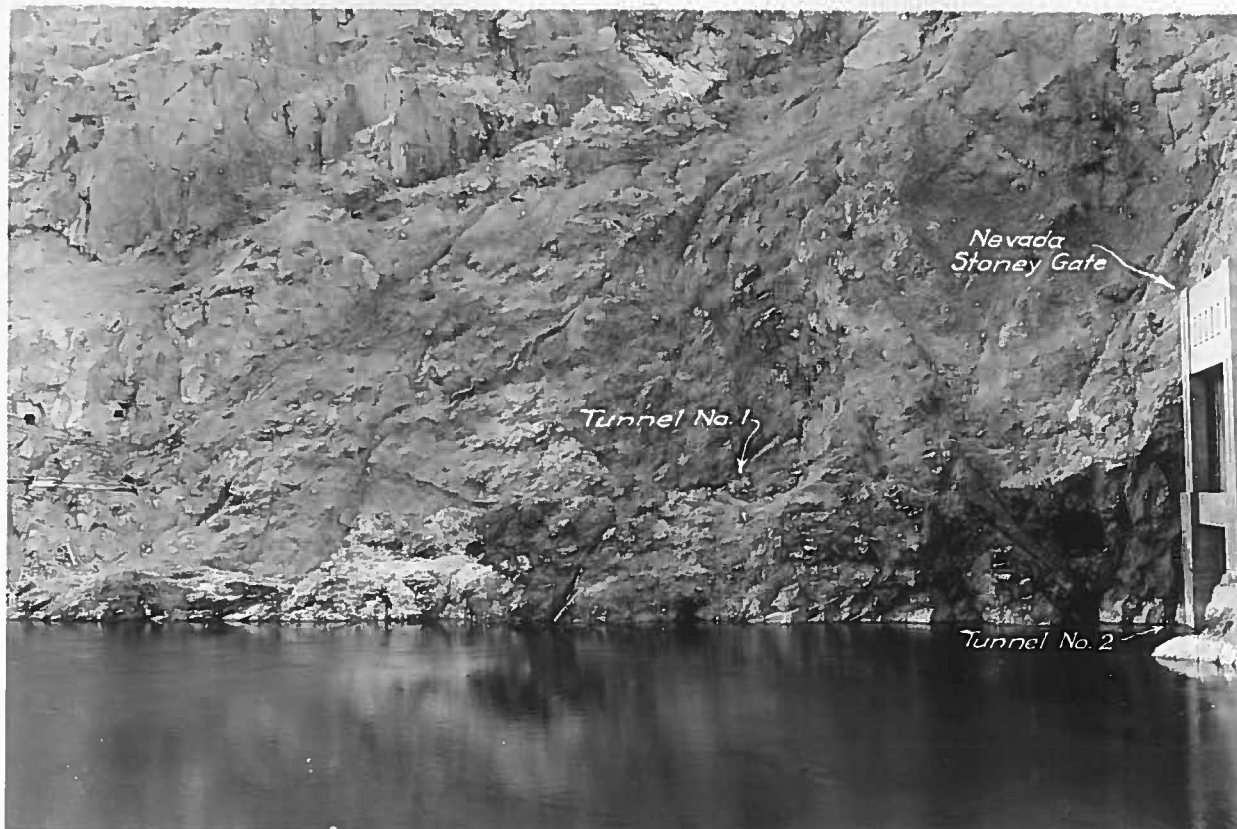
A. ARIZONA STONEY GATE STRUCTURE AND CANYON WALL ON DECEMBER 12, 1938.

B. NEVADA STONEY GATE STRUCTURE AND CANYON WALL ON DECEMBER 12, 1938.

(g) The Stoney gate seats at the downstream end of the outlet works tunnels were so severely damaged during the initial operation by the impact of debris sluiced from the tunnel invert that they cannot be satisfactorily used for unwatering the tunnels. The Nevada gate structure appears to be in a worse condition than the Arizona gate.

(b) The guides and seats of the Stoney gates on the downstream portals of the tunnels should be repaired to permit unwatering operations for which they were designed and installed.

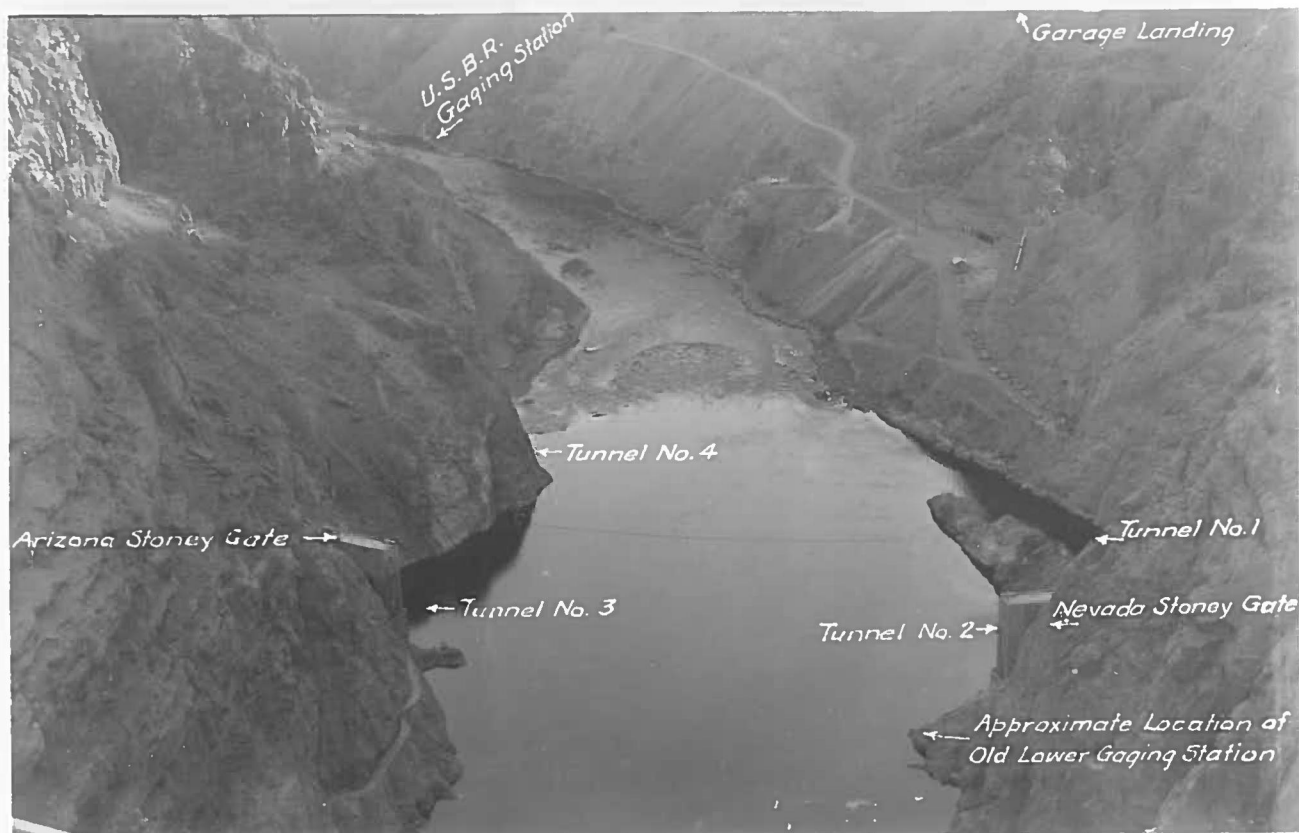
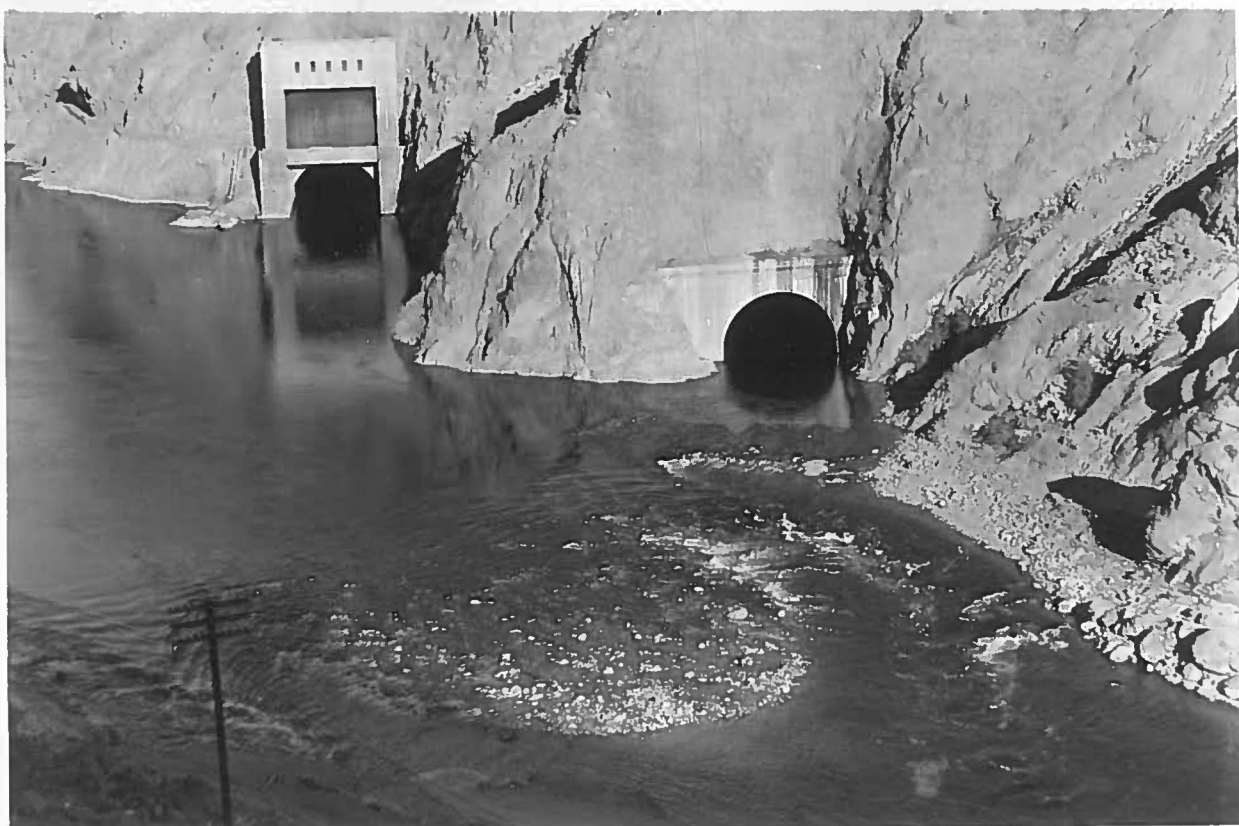
A. BAR IN RIVER BELOW SPILLWAY TUNNEL PORTALS ON DECEMBER 13, 1938.
AFTER OPERATION OF TUNNEL NO. 3 - AS SEEN FROM 150-TON HOIST.

B. BAR IN RIVER BELOW SPILLWAY TUNNEL PORTALS ON DECEMBER 13, 1938.
AFTER OPERATION OF TUNNEL NO. 3 - AS SEEN FROM 150-TON HOIST.

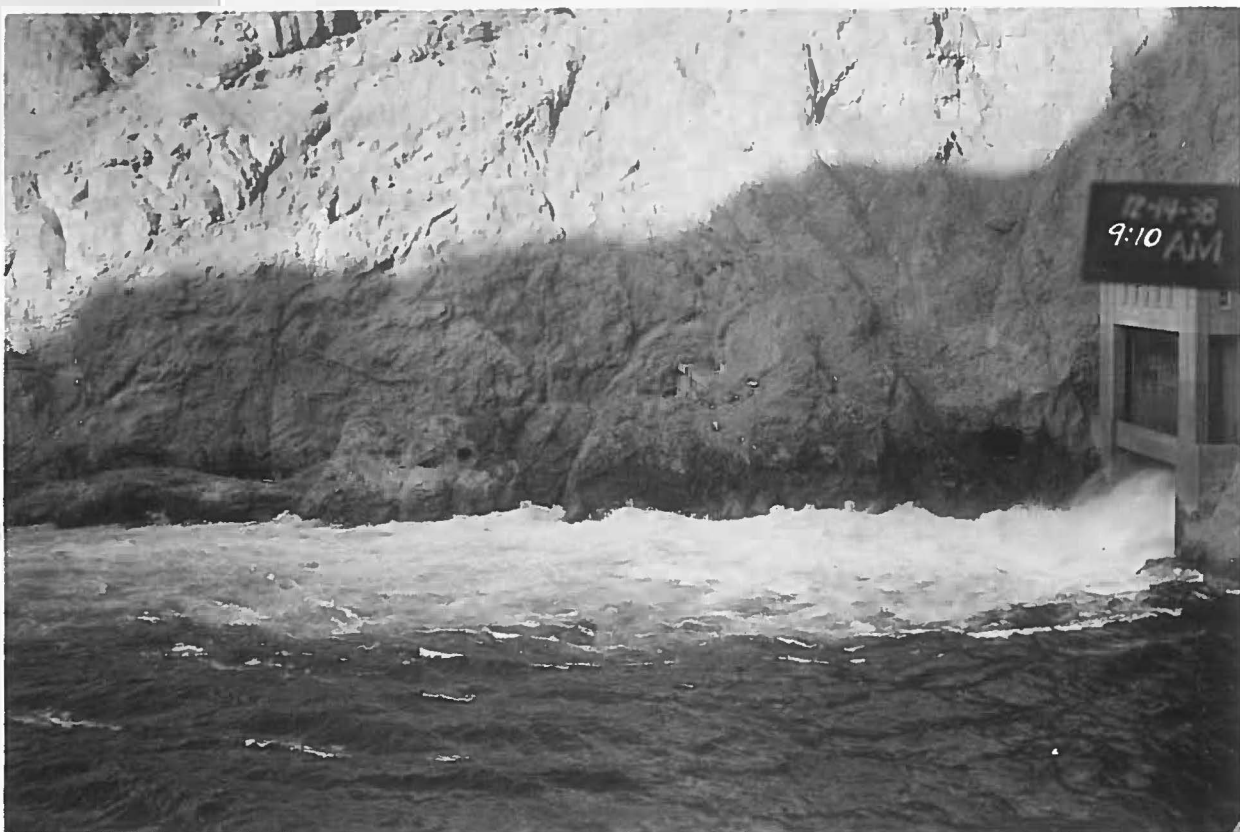
A. CONDITIONS BELOW NEVADA TUNNEL NO. 2 WITH DISCHARGE OF 4,000 SECOND-FEET

(c) The worst condition of operation appeared with flows of 3,000 to 5,000 second-feet through the Nevada tunnel and no flow through the Arizona tunnel. The completion of recommended improvements should result in better flow conditions even at those discharges.

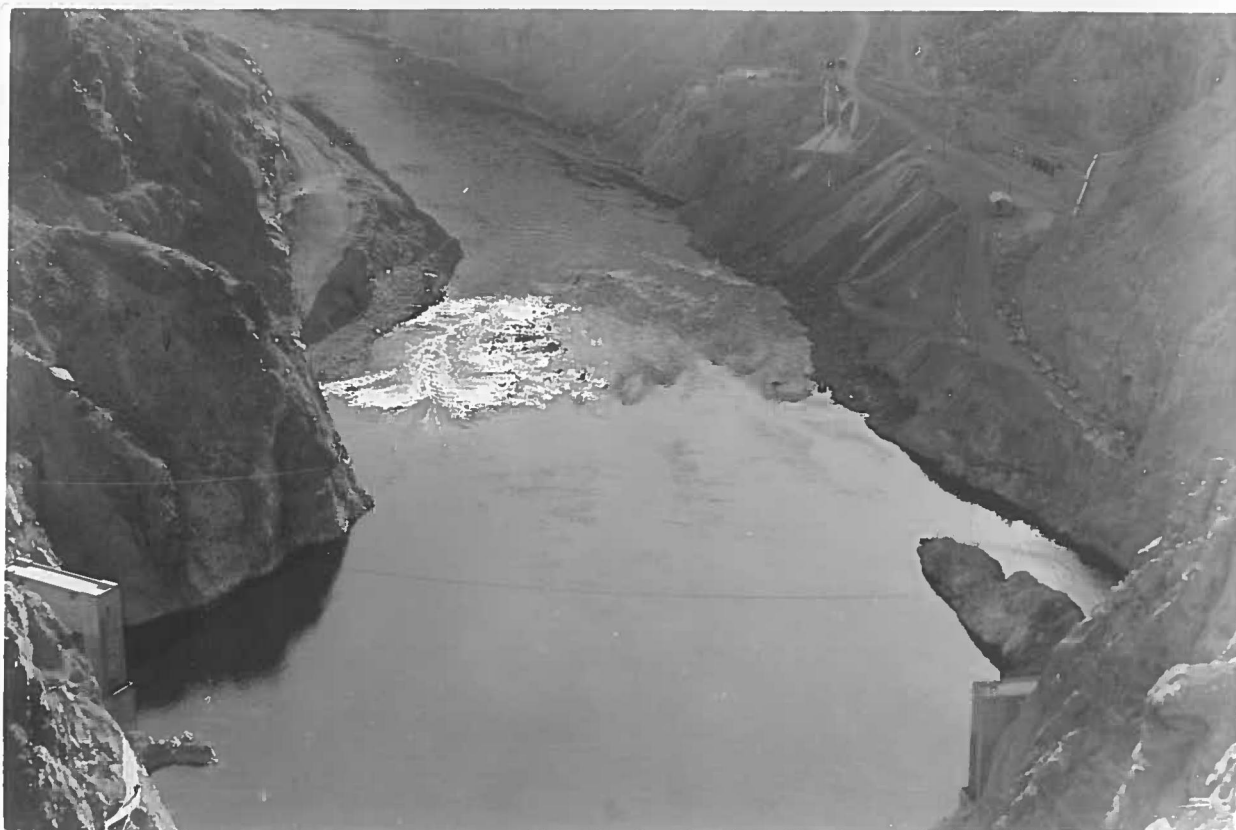
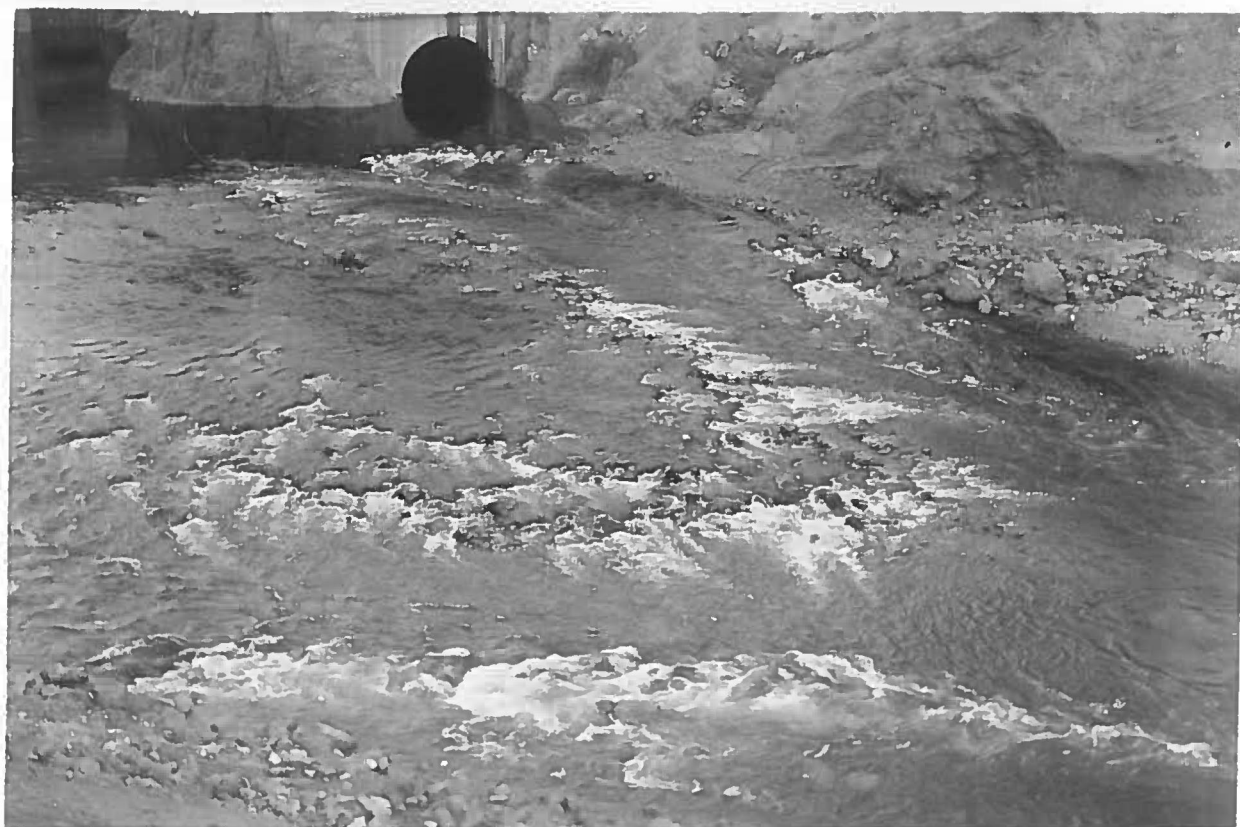
A. BAR IN RIVER BELOW SPILLWAY TUNNEL PORTALS AT CONCLUSION OF TEST PROGRAM - AS SEEN FROM 150-TON HOIST.

B. BAR IN RIVER BELOW SPILLWAY TUNNEL PORTALS AT CONCLUSION OF TEST PROGRAM - AS SEEN FROM GARAGE LANDING.

7. Bar in river channel below spillway tunnel portals. Material left in the river bed after construction, or washed in as a result of outlet operation, has formed a bar across the river channel immediately below the downstream portal of the spillway tunnel. The extent of this bar can be seen in figures 1, 6, and 16. The

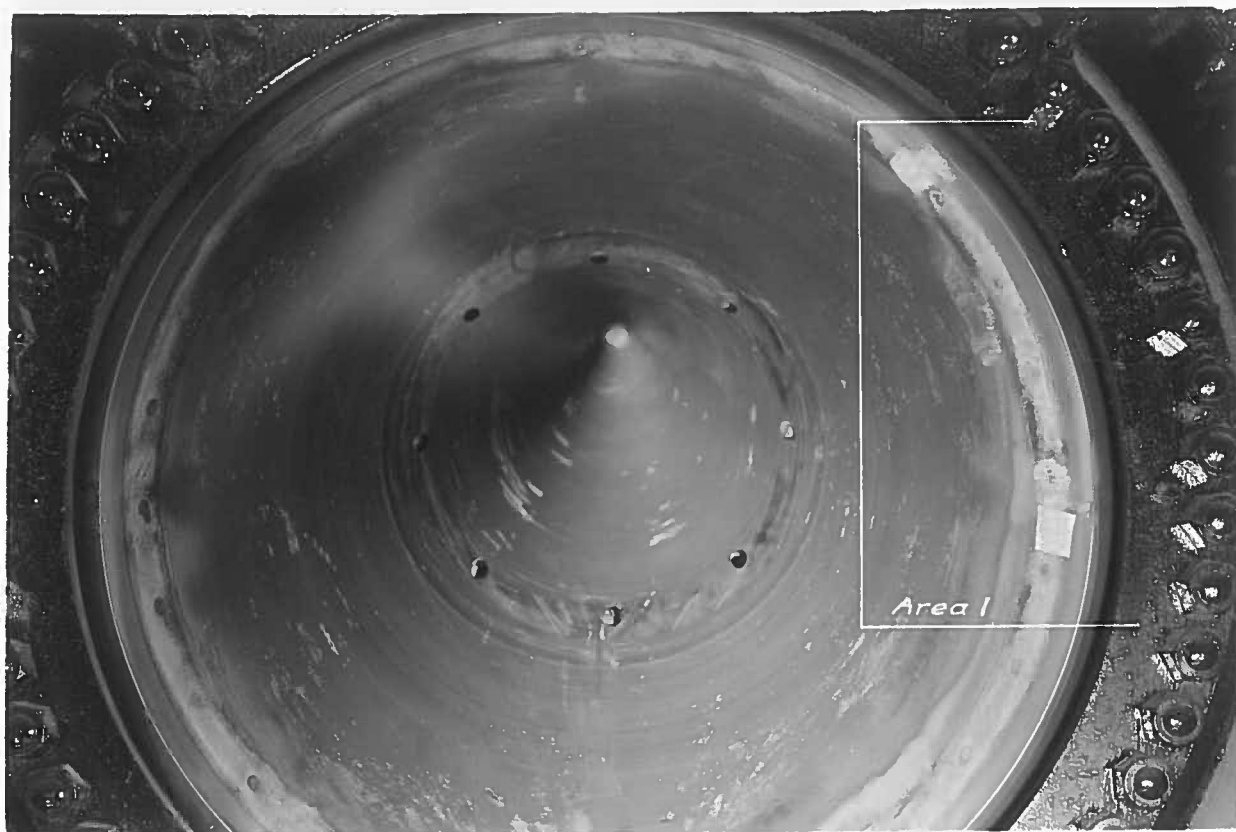
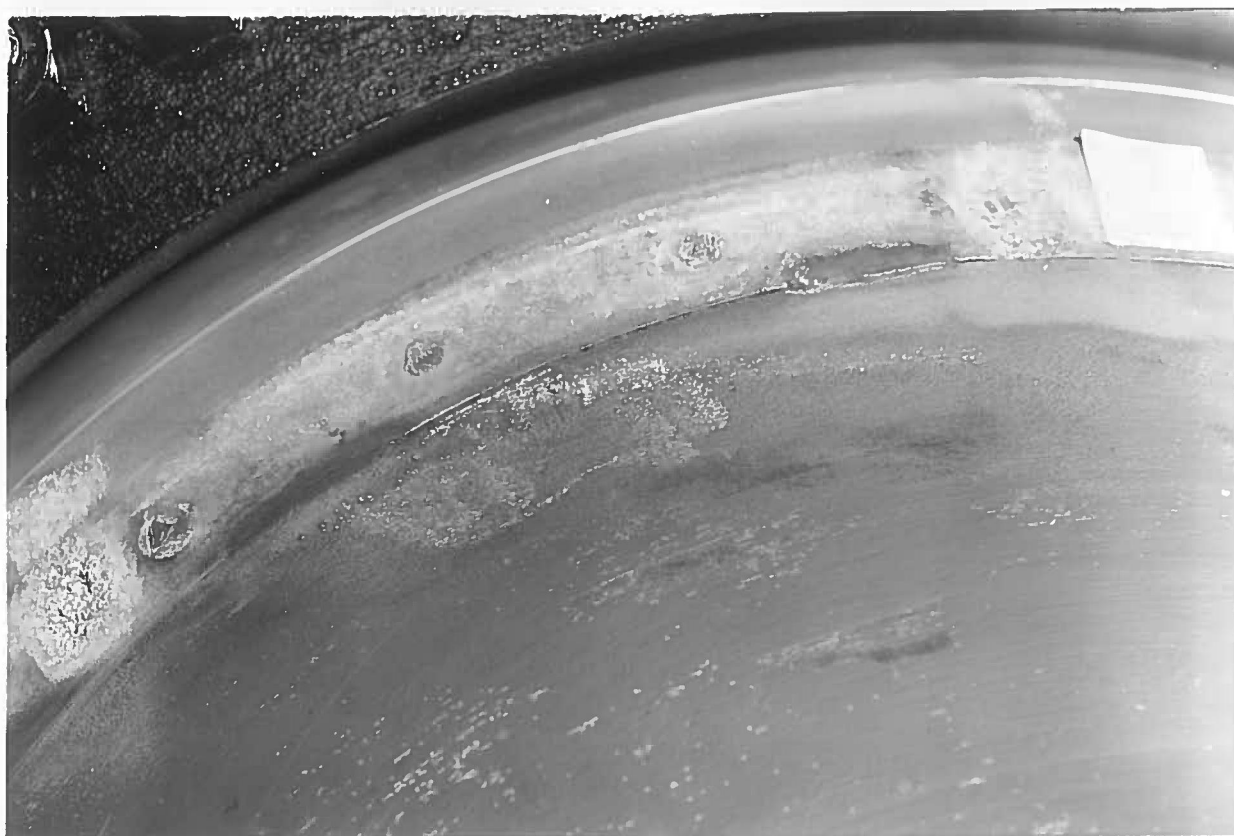
4. Cavitation on needle valves. As a matter of interest, the cavitation which is occurring on the faces of the needle valves, both in the tunnel plug and in the canyon-wall outlets, was examined. Photographs of particular examples are included in figures 17 and 18. A peculiar condition was noted in the rust marks on the inside of the needle-valve body. The flow pattern through the valve body was manifested in the same way as shown by paint tests made in the laboratory. In places, due to cross flow, the direction as indicated by the rust marks was normal to the main stream. This particular condition is shown in figure 18.

A. ENTIRE NEEDLE

B. CLOSE-UP OF AREA 1

CAVITATION ON NEEDLE VALVE A-10 IN ARIZONA TUNNEL PLUG OUTLET WORKS.

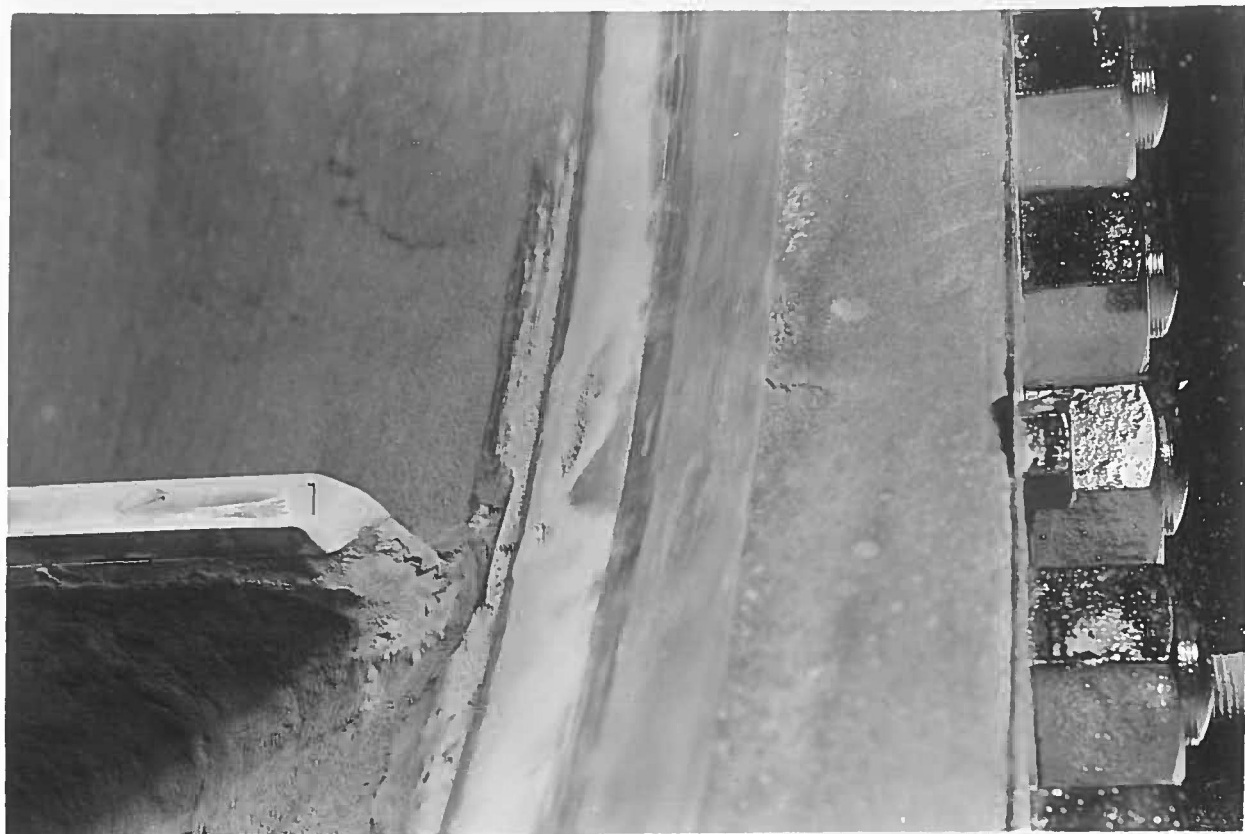
A. CAVITATION AT DOWNSTREAM END OF NEEDLE GUIDE.

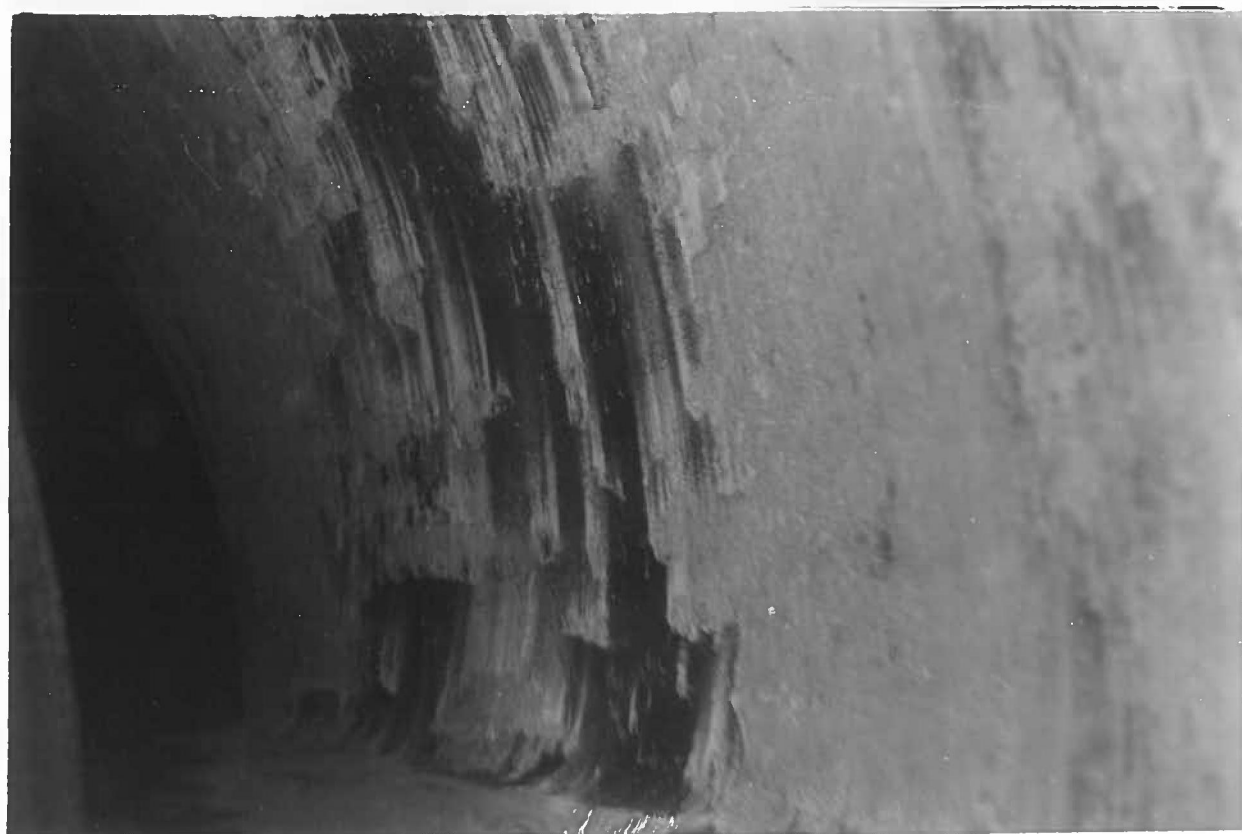
B. FLOW LINES IN RUST ON INSIDE OF NEEDLE VALVE BODY.

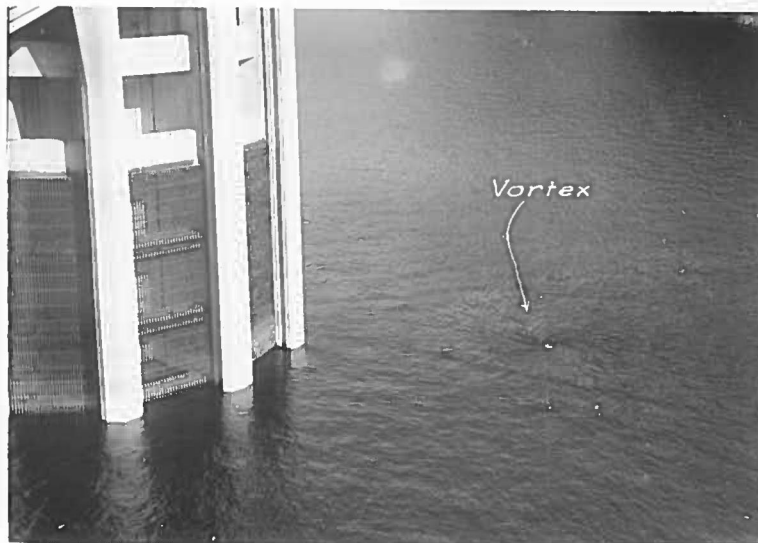
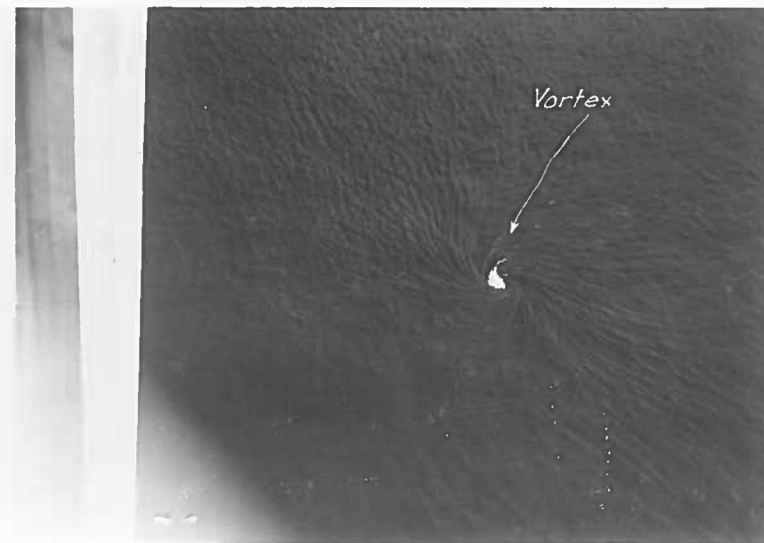
VORTEX NEAR ARIZONA TOWER - ARIZONA OUTLETS WIDE OPEN - DECEMBER 13, 1938

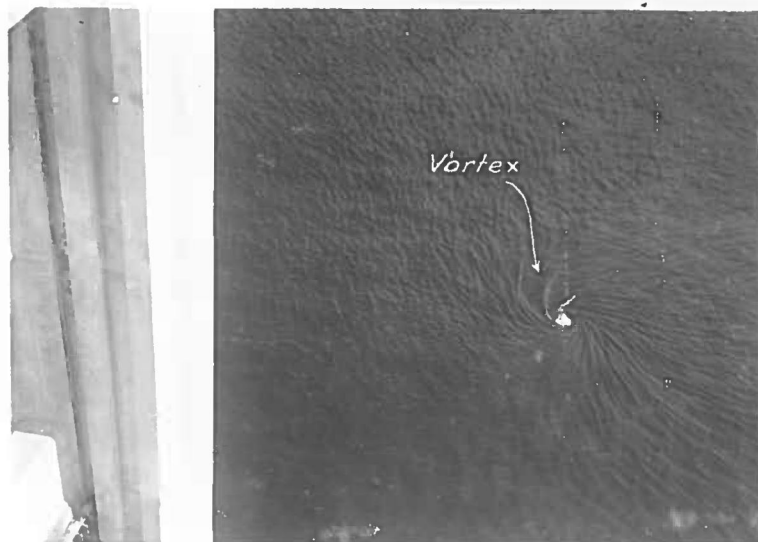
VORTEX NEAR ARIZONA TOWER. - DECEMBER 13, 1938
