UNITED STATES
DEPARTMENT OF THE INTERIOR
BUREAU OF RECLAMATION

REDESIGN OF CHECK DROPS
SUNNYSIDE MAIN CANAL
YAKIMA PROJECT - WASHINGTON

H. G. DEWEY, JR., JUNIOR ENGINEER

February 28, 1939.

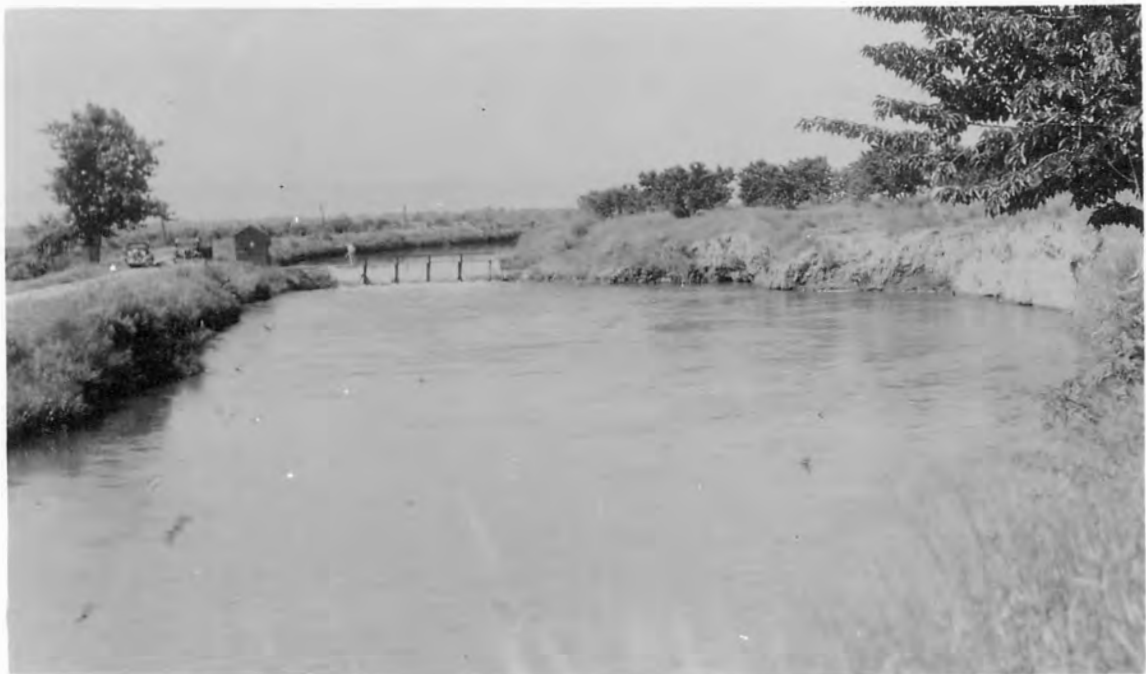
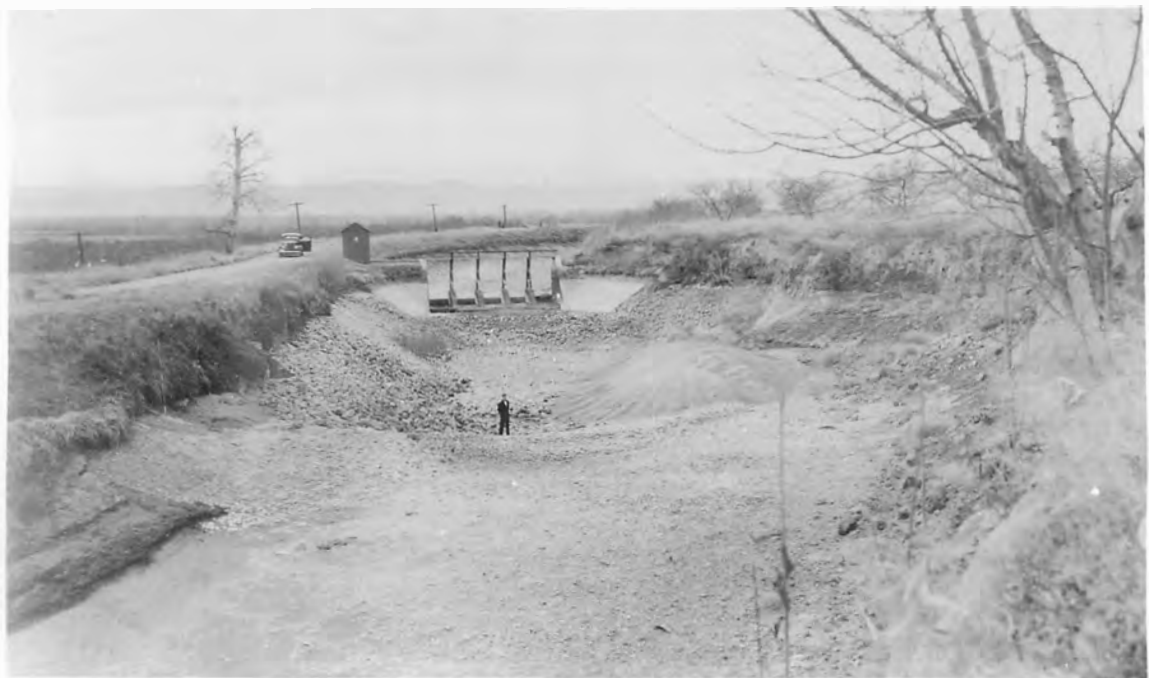
On July 16, 1938, the Superintendent of the Yakima project submitted a letter to the Chief Engineer, requesting that a study be made of this problem. In paragraph (1) of this letter, it was stated: "From time to time during the past 15 to 20 years, various members of the organization have made suggestions and plans for remodeling some 20 or more drops or checks of standard design on the Sunnyside canal to prevent or reduce excessive scouring and erosion in the light volcanic ash soils below these structures." In paragraph (6), it was stated: "You will recall, no doubt, that this matter was discussed with you at the time of your visit to the project in March. I have also conferred with Mr. McBirney and Mr. Warnock relative to the problem. It occurs to me that a test on a model of this design would be enlightening in reaching a solution." In paragraph (9), it was stated: "It is requested that your office make a study of this problem, looking toward a suitable modification of these structures, and furnish designs for our use in connection with a C.C.C. work program to be undertaken this fall on at least one drop, such as no. 4, illustrated herewith," figure 1 of this report, "which is typical of the worst conditions."

The scour in the model appears to be more severe than in the prototype, as shown on figures 1, 10, and 11. This was expected since the sand in the model was more saturated and less compacted than the material in the field. The scour to the riprapped canal bottom for a distance of 20 feet downstream from the drop was not excessive, but, beyond this point, the canal bottom was heavily scoured. Observations on the model revealed that, as the flow passed over the flashboards, it was partially deflected upwards by the weir wall at the lower end of the check basin. This had a tendency to reduce the amount of scour just below the drop. But, as the flow passed downstream to the end of the riprapped transition, high velocities prevailed along the bottom of the canal, which scoured a large hole (figure 9B) into which the riprap near this region was deposited. This may explain the reason why the riprap at the prototype structure is continually washed into the pool below the drop.

It will be noted that the scour pattern in the model (figure 8) is symmetrical about the center line of the canal whereas the scour at the prototype (figure 1) is on the left side of the canal. This difference in scour pattern is due principally to the fact that there was no curvature in the canal alignment in the model above or below the drop structure whereas the canal curves to the left upstream from the prototype drop structure and to the right downstream. Another factor contributing to the prototype scour pattern has been the method of placing the flashboards. These have been placed unsymmetrically so as to divert the flow from the scoured section of the canal. The model showed definitely, however, that scour will be excessive below

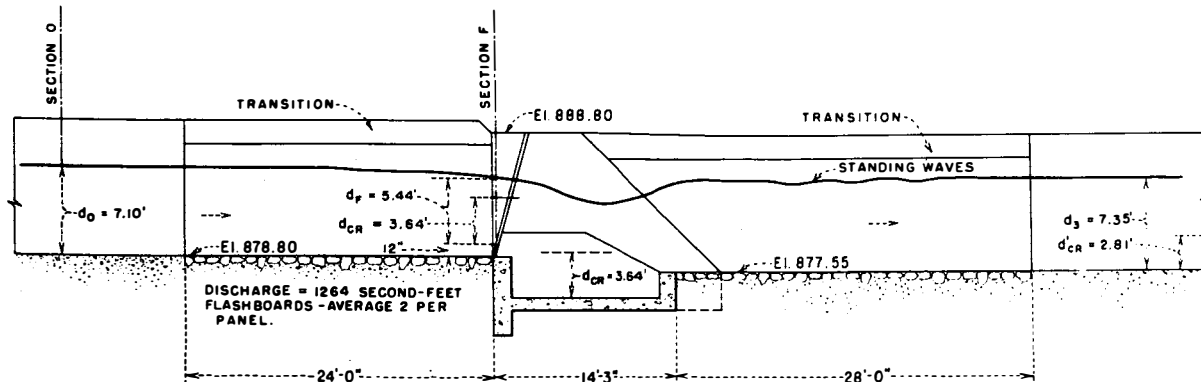
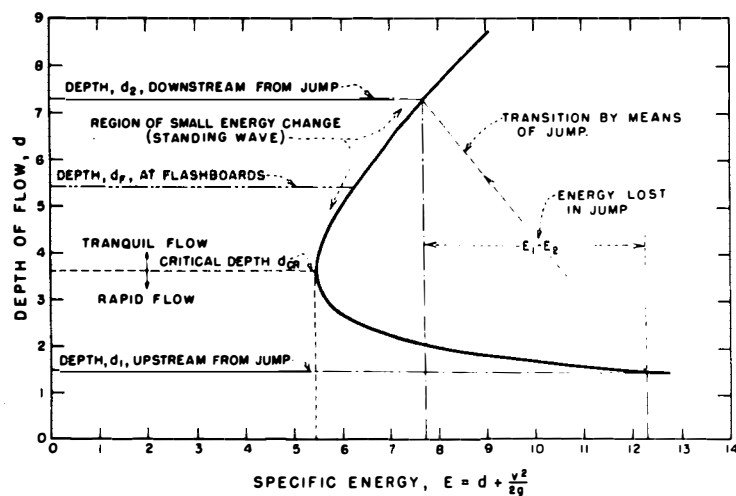
DEPARTMENT OF THE INTERIOR
BUREAU OF RECLAMATION
YAKIMA PROJECT - WASHINGTON
REDESIGN OF CHECK DROPS - SUNNYSIDE MAIN CANAL
HYDRAULIC MODEL STUDIES - 1:15 SCALE
HYDRAULIC ANALYSIS AT CHECK DROP 4

and the depth of flow, d , and plotting, as ordinates, d , the depth of flow. Figure 4C shows the specific-energy diagram for check drop no. 4. It has been plotted for a discharge of 1,264 second-feet through the rectangular section having a width of 32.13 feet. It must be understood that the specific energy varies with the depth of flow in a section and is referred to the bottom as a datum which may change from section to section. At one particular depth of flow for the given discharge, the specific energy is a minimum. This depth at which a given discharge flows with a minimum specific energy is called "critical depth." It is now possible, by referring to the specific-energy diagram, to trace the change of specific energy in the flow with a change of depth in a section.

5. The hydraulic jump. Referring to figures 4B and 4C, it is seen that a hydraulic jump is the phenomenon by which rapid flow at a depth, d_1 , below critical depth passes in an abrupt manner to tranquil flow at a depth, d_2 , above critical depth. The amount of specific-energy head lost in the jump is represented by $E_1 - E_2$. Now, for a constant cross section, the velocity, V_1 , above the jump has been reduced to a velocity, V_2 , below the jump.

8. Comparison of losses. If the losses inherent in the flow were known from section F to any other points in the check basin, it would be possible to write Bernoulli's equation to determine the depth of flow at these points. With this data, the loss of specific energy could be determined through the structure. It is known, however, that the loss of specific energy in a standing wave is about five percent. The loss of specific energy in a hydraulic jump was seen previously to be much greater. Assume that, at check drop no. 4, sufficient energy is available to form a hydraulic jump. Then, let $d_1 = 1.50$ feet, and, if the discharge is 1,264 second-feet, $V_1 = 26.21$ feet per second. The conjugate depth, therefore, will be $d_2 = 7.30$ feet with a velocity $V_2 = 5.38$ feet per second (figure 4B). Now, $E_1 = 12.30$, and $E_2 = 7.76$; the loss $E_1 - E_2 = 4.54$ (figure 4C). The loss in energy will be

$\frac{4.54}{12.30} \times 100$, or 36.8 percent as compared to about 5 percent in a standing wave.

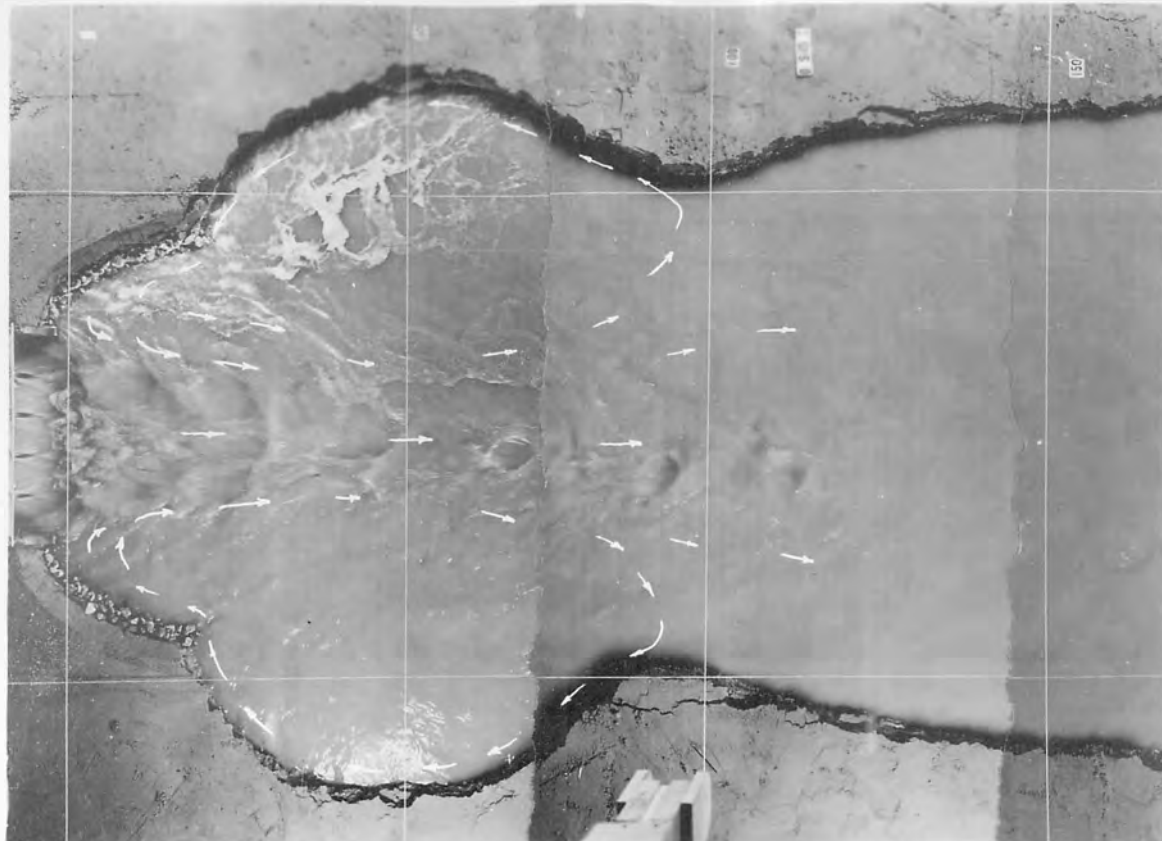
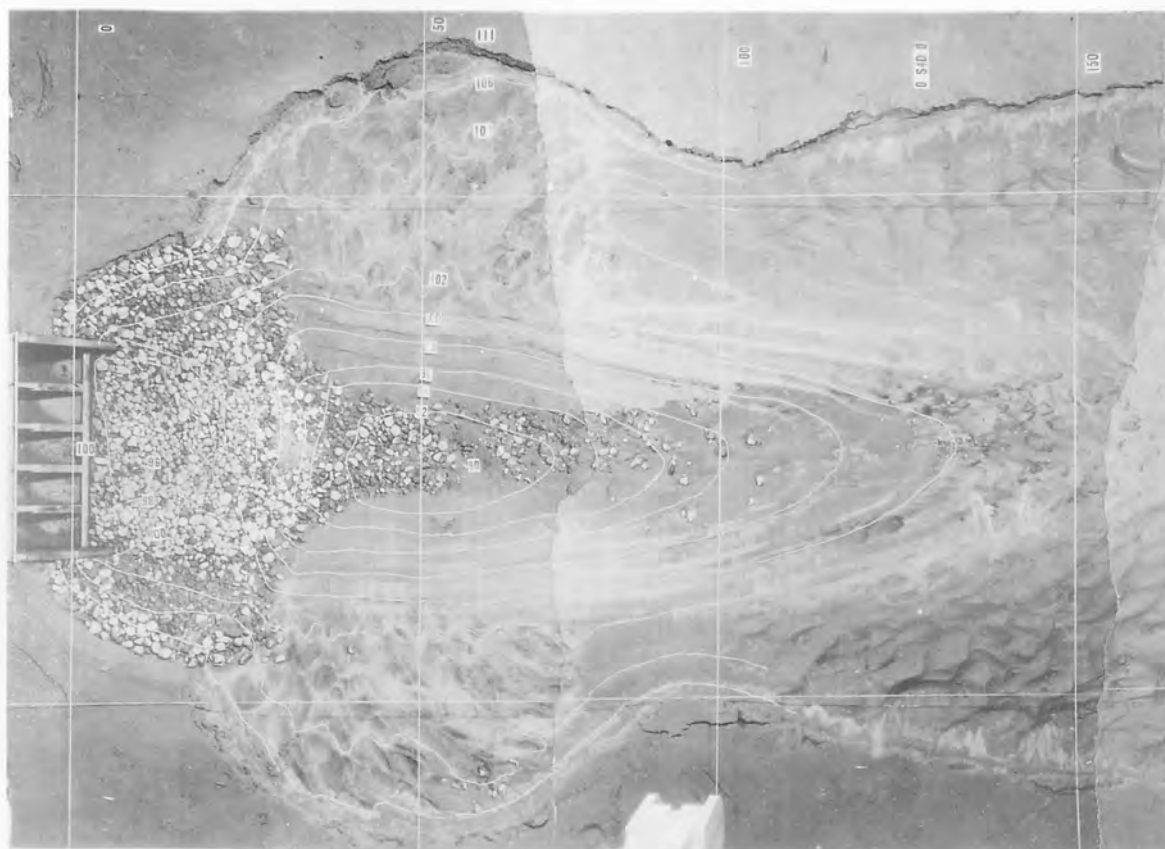
A. SCOUR AFTER 21 HOURS - DISCHARGE 1300 SECOND-FEET
 UPSTREAM WATER SURFACE ELEVATION 886.25
 DOWNSTREAM WATER SURFACE ELEVATION 884.55
 FOUR FLASEBOARDS PER PANEL

B. SCOUR AFTER 26 HOURS
 MODEL ELEVATION 100.0 EQUALS PROTOTYPE ELEVATION 877.55

the poor flow distribution extending downstream (figure 8A). The flow through the other panels was symmetrical, but it had a tendency to pile up on the upstream face of the steel brackets and remain split as it plunged into the check basin. This disturbance did not prevail after the flow had reached the region of the standing wave (figure 8A).

The standing wave, as discussed on page 8, formed over the check basin (figures 8A and 9A), and additional waves, accompanied by excessive velocities, extended downstream about 150 feet. The higher velocity flow was concentrated near the center of the canal, but, on each side of the canal, starting at a point about 75 feet below the drop, the direction of flow was upstream. This peculiar combination of flow downstream at the center of the canal and upstream along the $\frac{1}{2}$ to 1 side slopes formed a large eddy along each side of the canal (figure 8A). The upstream component of these eddies had sufficient velocity to cut into the canal banks and produce excessive scour.

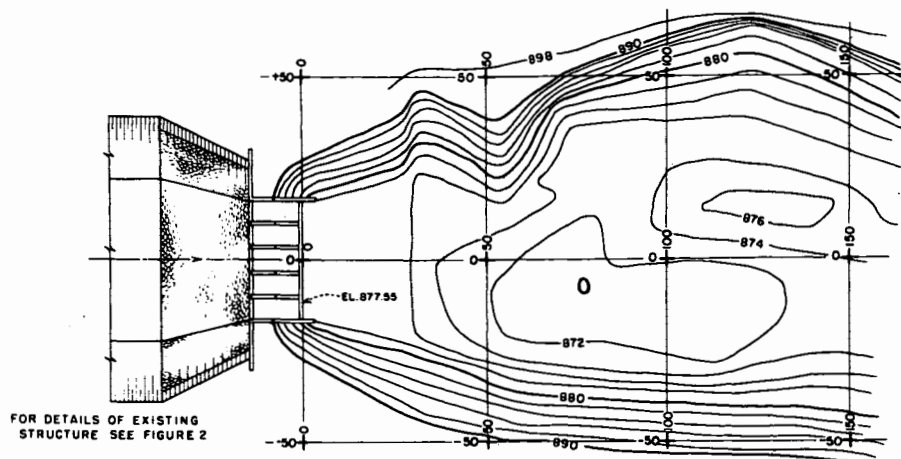
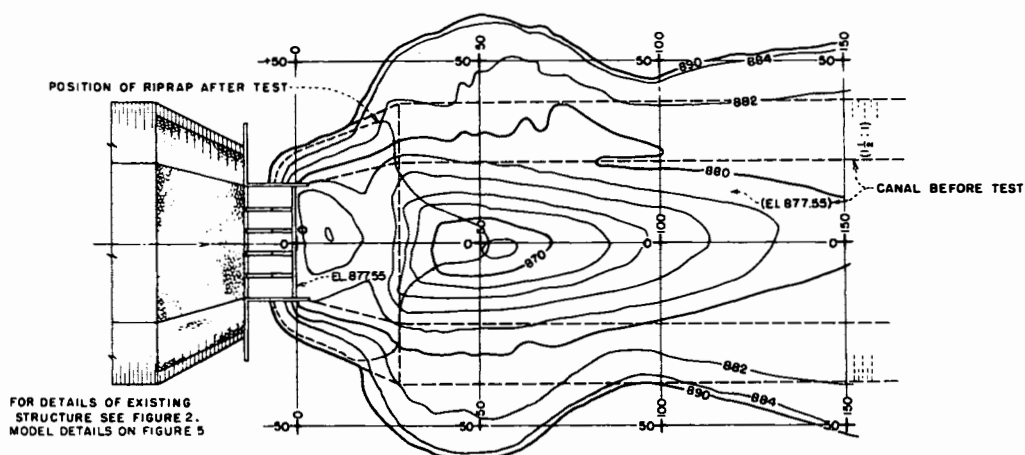
A
TOPOGRAPHY IN POOL BELOW DROP FROM FIELD SURVEY
AT EXISTING STRUCTURE CHECK DROP 4

B
TOPOGRAPHY IN POOL BELOW DROP FROM TEST
OF 1:15 SCALE MODEL OF EXISTING
STRUCTURE CHECK DROP 4

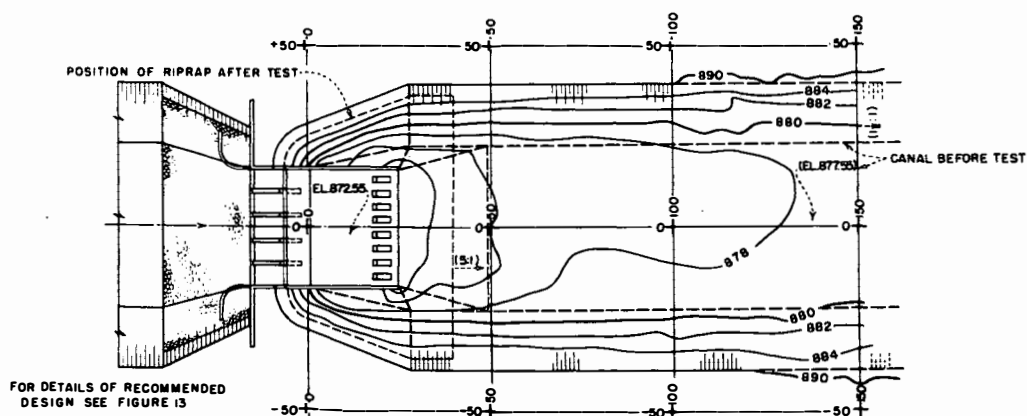
C
TOPOGRAPHY IN POOL BELOW DROP FROM TEST
OF 1:15 SCALE MODEL OF RECOMMENDED REDESIGN
OF EXISTING STRUCTURE CHECK DROP 4

A scour test was made on this design similar to the one made on the model of the existing structure. At the end of 26 hours, the scour in the model was slight (figures 10C, 15B,

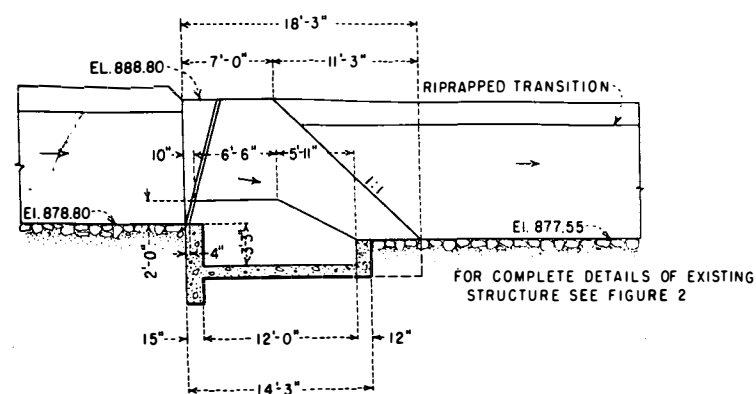
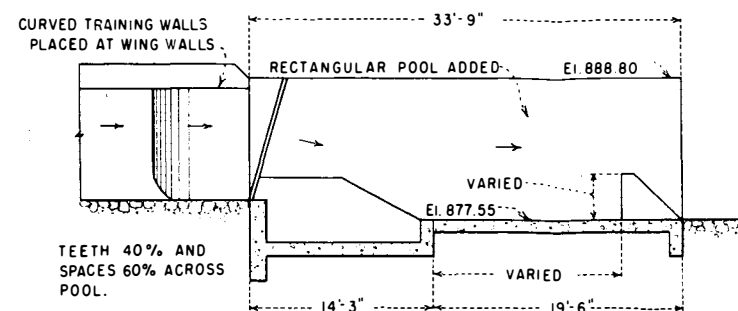
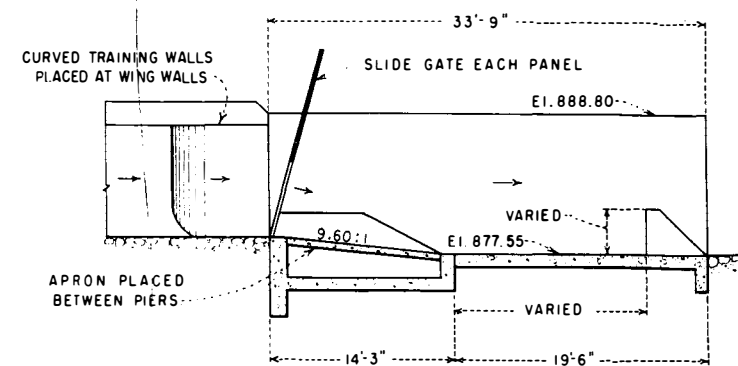
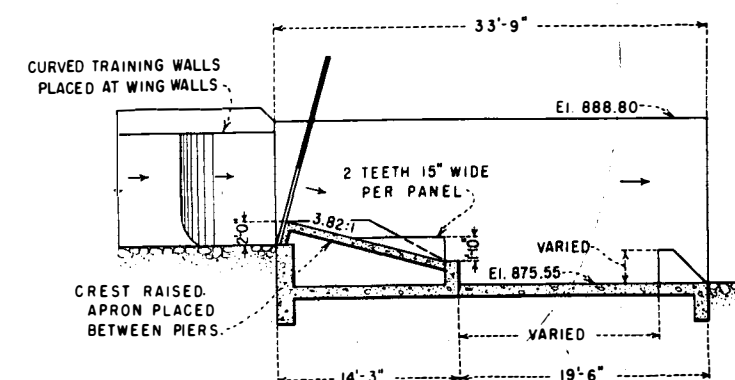
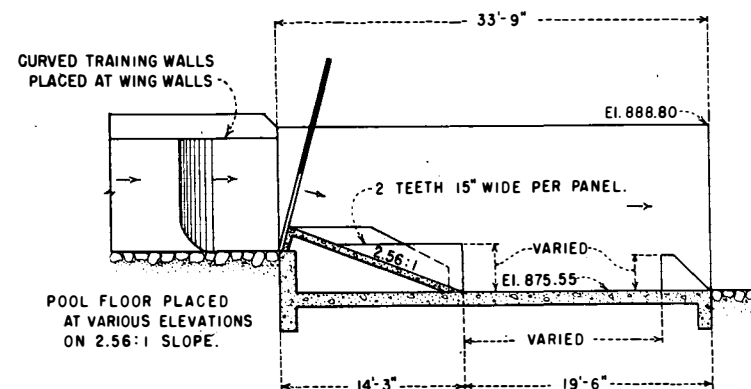
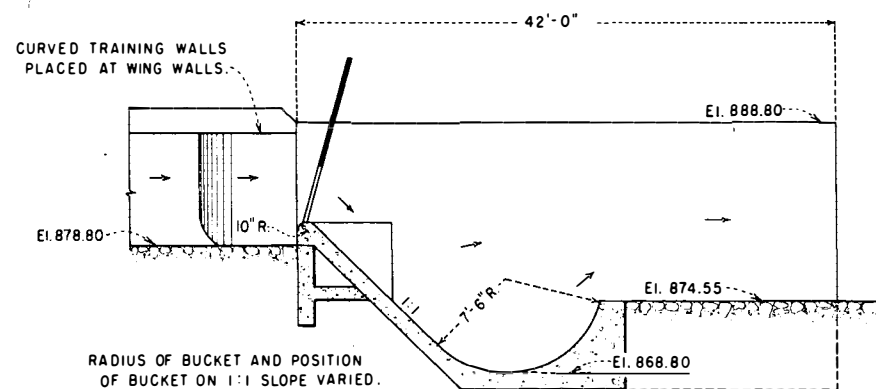
DEPARTMENT OF THE INTERIOR
BUREAU OF RECLAMATION
YAKIMA PROJECT - WASHINGTON
REDESIGN OF CHECK DROPS - SUNNYSIDE MAIN CANAL
HYDRAULIC MODEL STUDIES - 1:15 SCALE
DESIGNS INVESTIGATED IN MODEL OF
EXISTING STRUCTURE CHECK DROP 4

13. Model tests leading to the recommended design.
Before a satisfactory solution to this problem could be obtained, it was necessary to investigate many designs in the model and use the best features of each. Each design investigated was tested with various discharges, tail-water depths, and flashboard arrangements. Careful study was made on the performance of each design especially at maximum discharge since, at that discharge, the most unfavorable conditions existed. Before studies could be made on the elimination of the standing waves and excessive velocities, it was necessary to make the flow symmetrical at the approach and below the check basin. To improve the flow at the approach, the steel brackets were streamlined (figure 12J), and curved training walls were added to the wing walls (figure 12B). The flow was improved to such an extent that curved training walls were adapted to succeeding designs since they eliminated the draw-down or dished effect in the flow at each side panel. Although the streamlining to the brackets improved the flow, it was found later that the streamlining would not be required. To improve the flow below the check basin, a rectangular stilling pool was formed by extending the vertical side walls downstream (figure 12B). This prevented the return flow of the side eddies from submerging the main stream as it left the check basin.

With the symmetry of the flow greatly improved through the drop structure, it was possible to make a careful study of the flow to determine the procedure necessary for the elimination of standing waves and excessive velocities. Observations revealed that, as the jet plunged over the flashboards into the check basin, it did not closely follow along the stilling-pool floor but was deflected upwards by the weir wall at the downstream end of the check basin. This condition caused most of the higher velocity flow to be concentrated near the surface, which made it not only difficult to eliminate the standing waves but made teeth in the stilling pool (figure 12B) ineffective in dispersing the high velocity. If the jet could be made to follow the stilling-pool floor, it would be possible to greatly reduce the tendency for standing waves to form, and teeth would have some effect on the velocities. To accomplish this, the design shown on figure 12C was tried. In this design, a sloping apron was placed between each pier from the top of the upstream weir wall to the top of the downstream weir wall of the check basin. As a result, the entering jet had a tendency to follow the stilling-pool floor. This tendency was slightly increased when slide gates were used at the steel brackets instead of flashboards (figure 12C). With slide gates in place, the direction and the velocity of the jet

were more nearly parallel to the apron between the piers. The teeth in the stilling pool were now more effective, and it was noted that the velocities below the drop were slightly less. For small discharges, the standing waves were partially eliminated, but, for maximum discharge, it was necessary to raise the slide gates to such an extent that the jet no longer followed the apron into the stilling pool. As a result, the standing waves still formed. This design, however, was improved by providing more depth of stilling pool and increasing the slope of the apron (figures 12D and 12E). With these improvements, the tendency of the jet to follow the apron into the stilling pool was further increased. This rendered the teeth still more effective, and the velocities were further decreased, especially with the added depth of pool. The standing waves still persisted, however, as in the other designs.
