HYDRAULIC MODEL STUDIES OF THE BARTLETT DAM SPILLWAY SALT RIVER PROJECT, ARIZONA

Report No. Hyd-576

**by
G. L. Beichley**

October 2, 1967

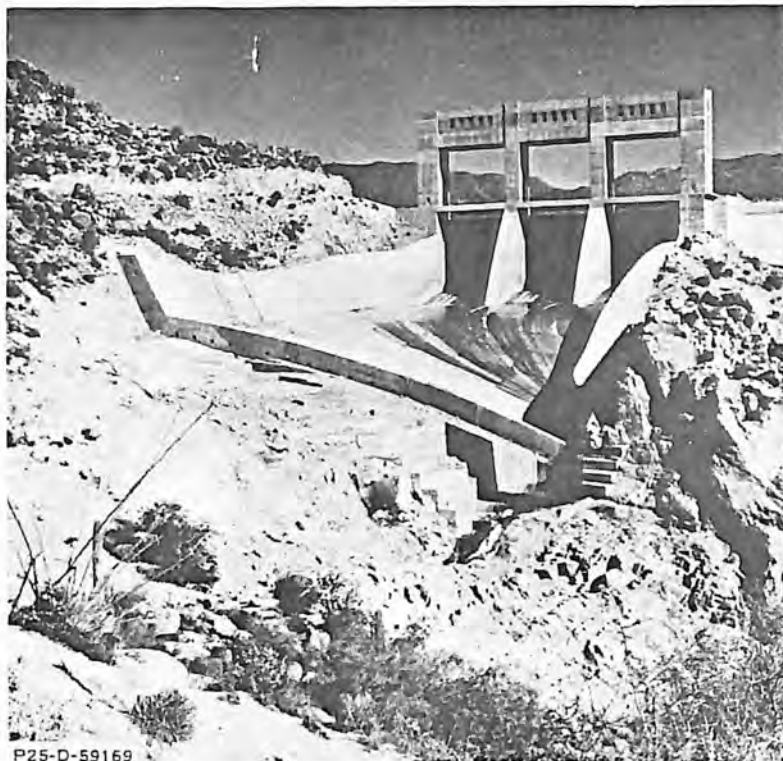
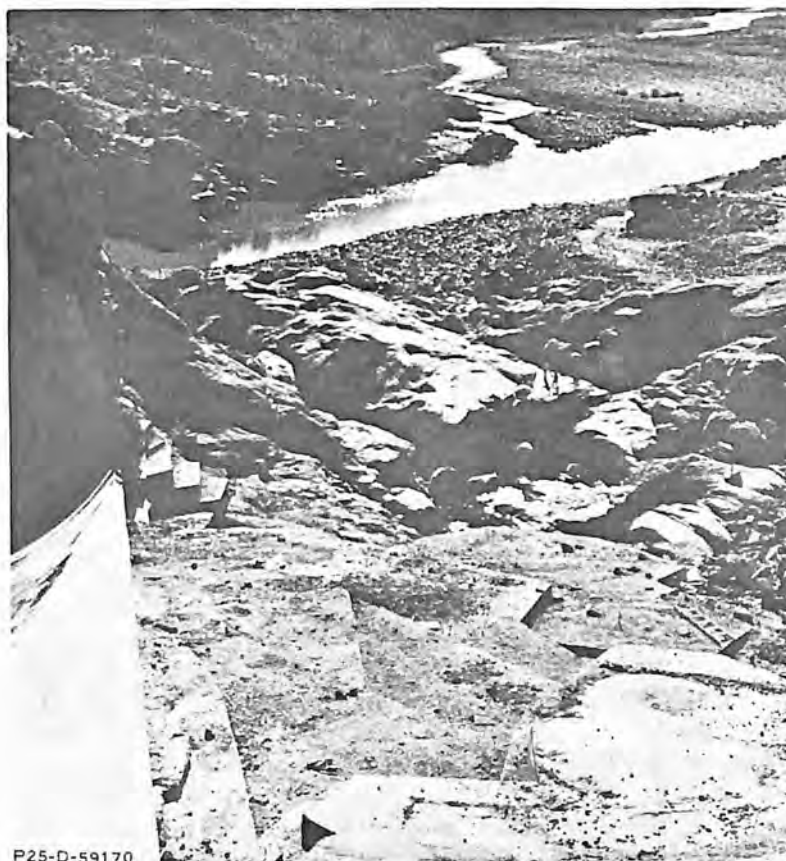
Figure 2
Report No. Hyd-576

Floods in 1942 and 1965-66 severely eroded the excavated channel. Prior to the 1965-66 flood, the channel was repaired by placing mass concrete in retaining walls and blocks in the badly eroded portion of the channel near the downstream end of the chute (Figure 2). The 1965-66 spillway flows, estimated at 28,500 cfs (806.55 cms) from near-maximum reservoir elevation, washed out or undermined these concrete slabs and blocks in several areas (Figure 3). Erosion of the rock was quite rapid where the concrete had overlain the weak, weathered granite. At the base of the steep portion of the eroded channel, about 100 feet (30.48 meters) downstream from the concrete chute, one hole was eroded in the weathered rock to a depth of about 15 feet (4.57 meters).

BARTLETT DAM SPILLWAY
DISCHARGE CHANNEL EROSION AND REPAIRS
PRIOR TO THE 1965-66 FLOOD

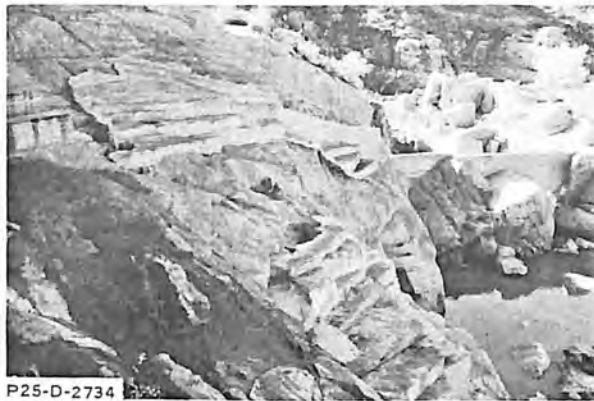
A. Note the undermining of previous channel repairs.

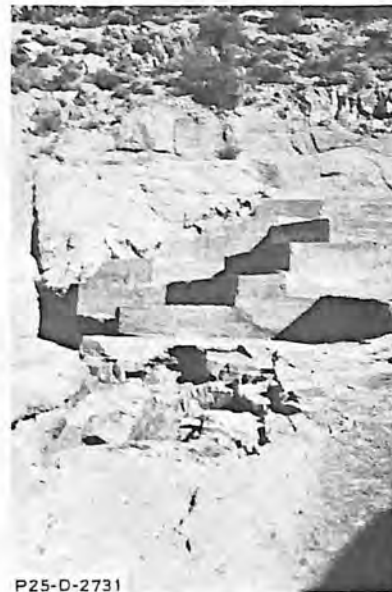
B. View looking towards right bank.

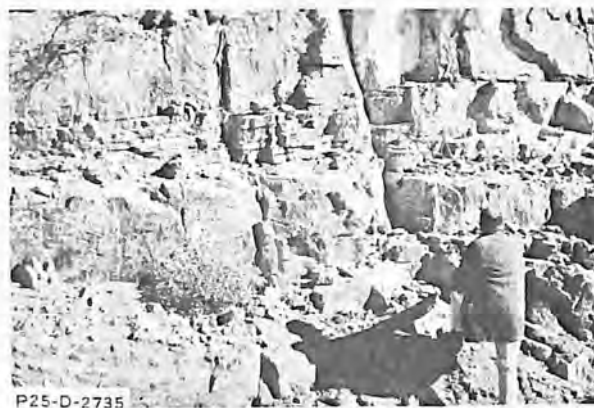
C. Note both vertical and horizontal joints in the weathered rock.

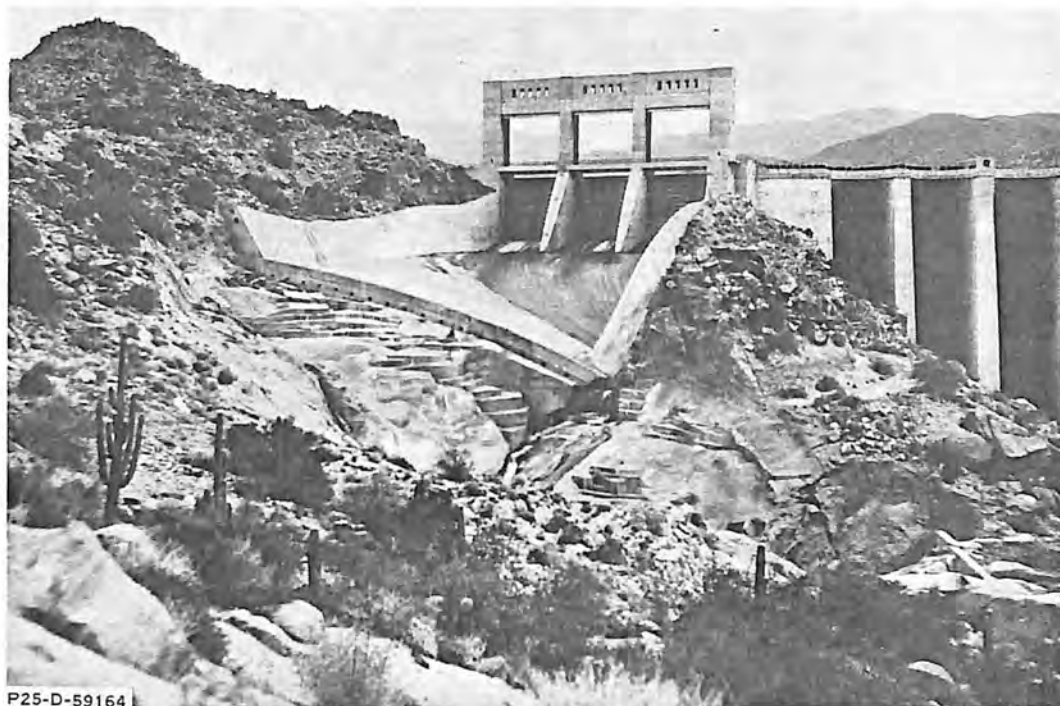
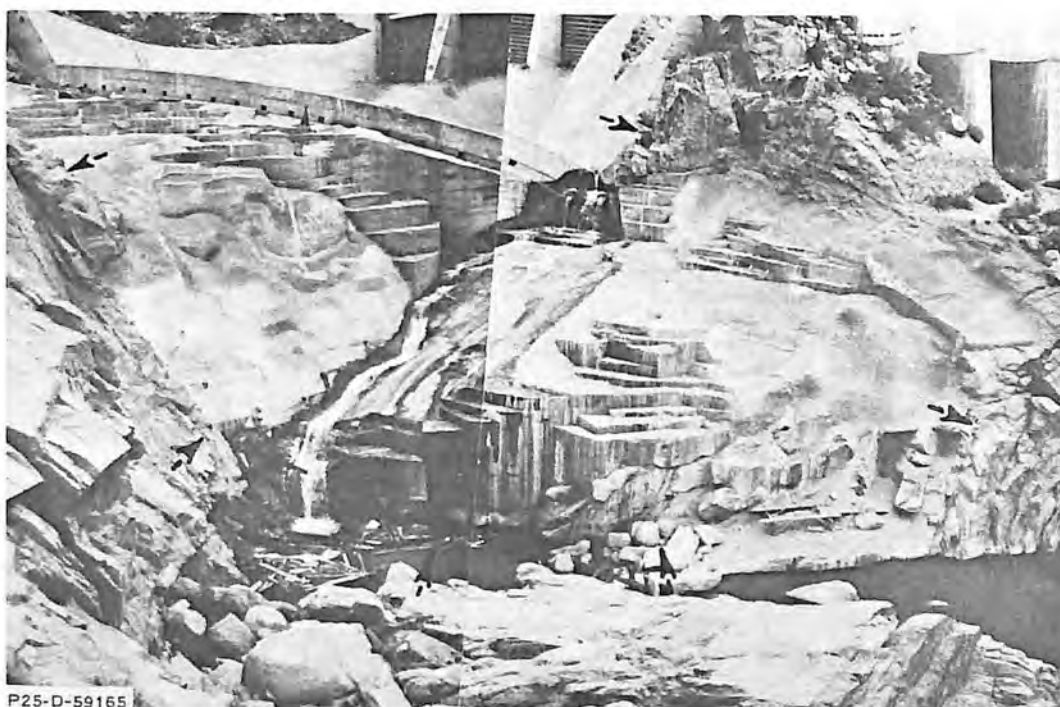
Spillway discharges have eroded a 15-foot (4.57-meter)-deep hole at the base of the steep slope in the prototype discharge channel

(Figure 4). Further spillway operation possibly will increase the size of this hole and undermine the concrete paving on the steep slope. This hole should be filled with concrete extending from the existing concrete on the upstream side to the rock on the downstream side of the pool (Figures 7 and 11). Sloping this concrete fill downward from approximately elevation 1635 to elevation 1615 in the direction of flow along the existing channel (Figure 7) will flush loose rock downstream during spillway operation.

Water stands in a 15-foot (4.57-meter)-deep hole eroded at the base of the steep slope. Areas subject to future erosion are indicated by the arrows.

3. The deep erosion hole at the base of the steep slope should be filled with concrete (Figures 4, 7, and 11). This concrete fill should extend from the existing concrete on the upstream side of the hole to sound rock on the downstream side and should slope downward to the left in the direction of flow to flush loose rock from the channel.

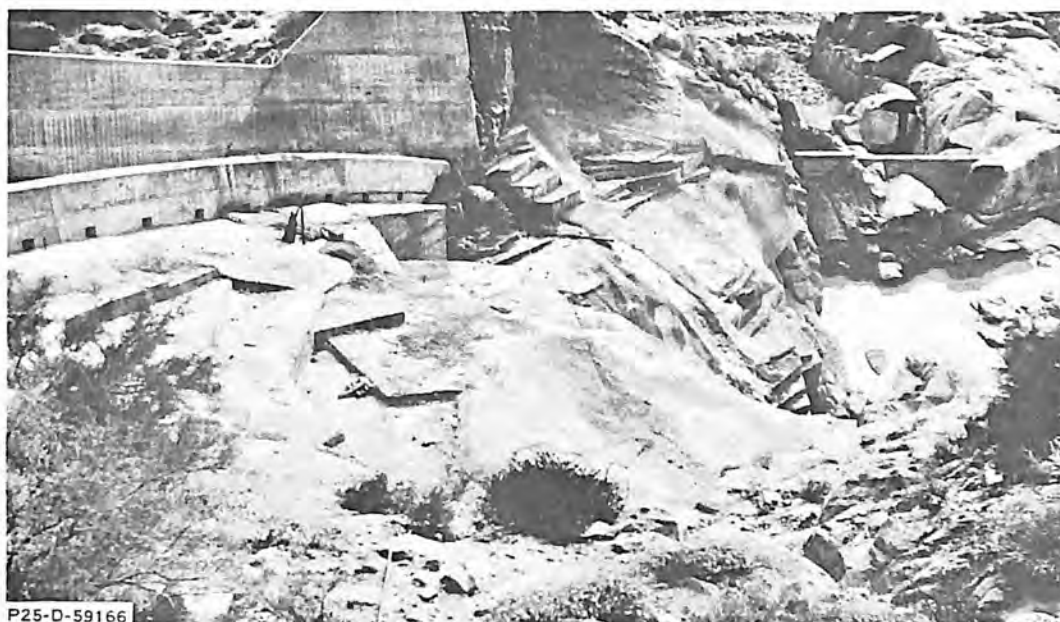
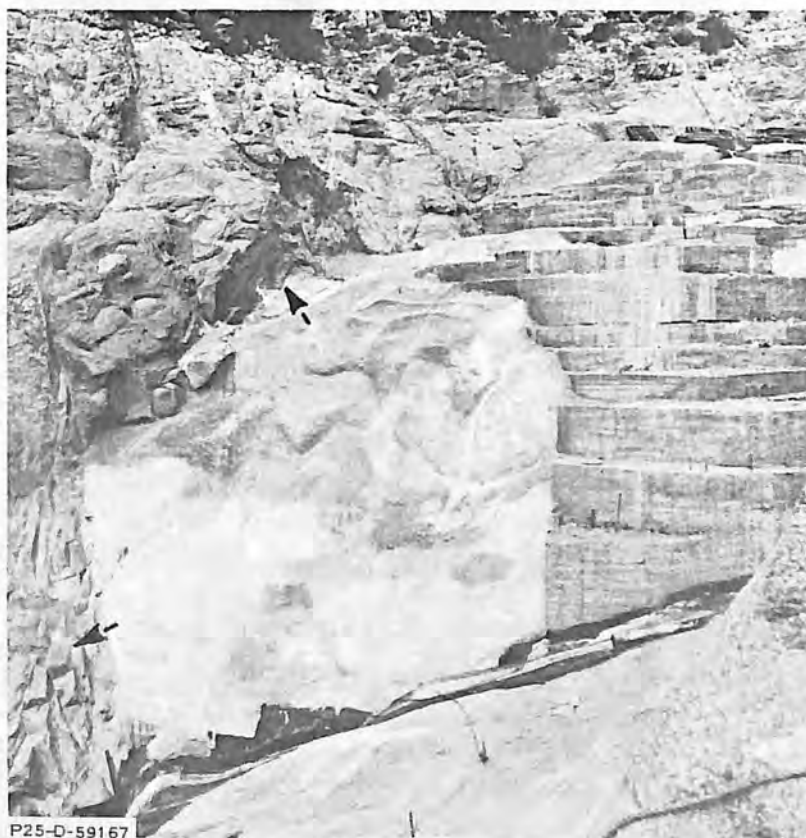
Figure 5
Report No. Hyd-576

Even with all three gates equally opened, portions of the flow impinged on the left and right sides of the discharge channel beyond the limits of the paved area. These areas of impingement are subject to erosion during future spillway discharges (Figures 4, 5, and 8). Erosion on the right side will occur far enough downstream that it is not likely to endanger the structure or undermine the paved area (Figure 5). Erosion may occur adjacent to the left concrete wall of the spillway chute and farther downstream along the left bank (Figure 4). The paving should be extended to prevent this erosion (Figures 9 and 11).

Areas subject to future erosion are indicated by the arrows.

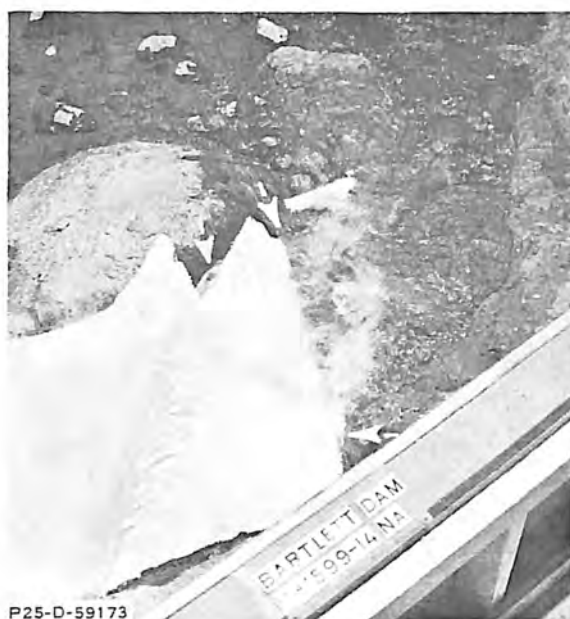
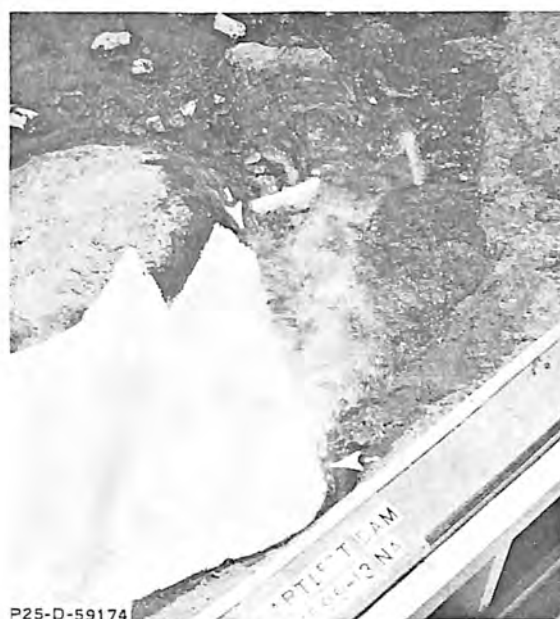
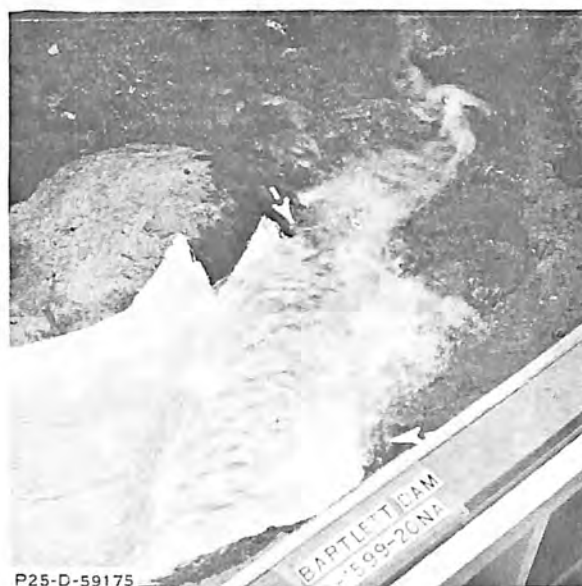
The model was operated at discharges up to 50,000 cfs (1,415 cms) to determine flow conditions that might have caused the erosion. At discharges of 10,000, 20,000, and 50,000 cfs (283, 566, and 1,415 cms) flow from the spillway impinged on the areas that had been badly damaged in the prototype channel (Figure 8). The severest damage appeared to have occurred where the impact forces of the jet had apparently loosened and eroded the rock at the weathered joints. Initial tests made with the erodible channel indicated that the erosion began at the left downstream corner of the concrete-lined chute and progressed downstream as the discharge increased (Figure 9). This test confirmed the belief that the major portion of the erosion was due to flow impact rather than to rocks churning in the turbulent flow.

The areas of flow impingement on the left and
right banks beyond the white paved area are
indicated by the arrows.

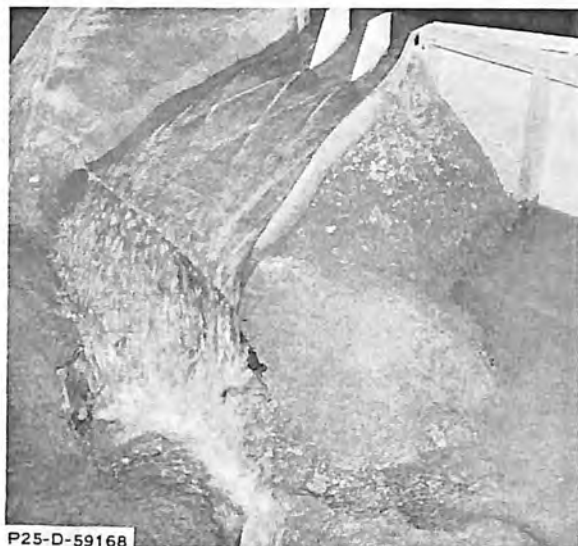
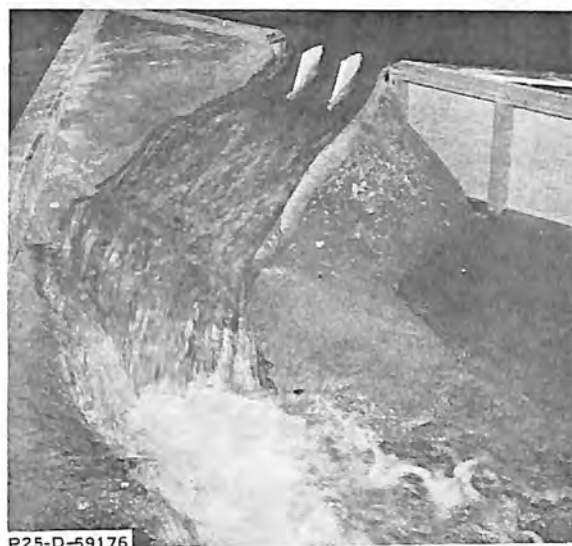
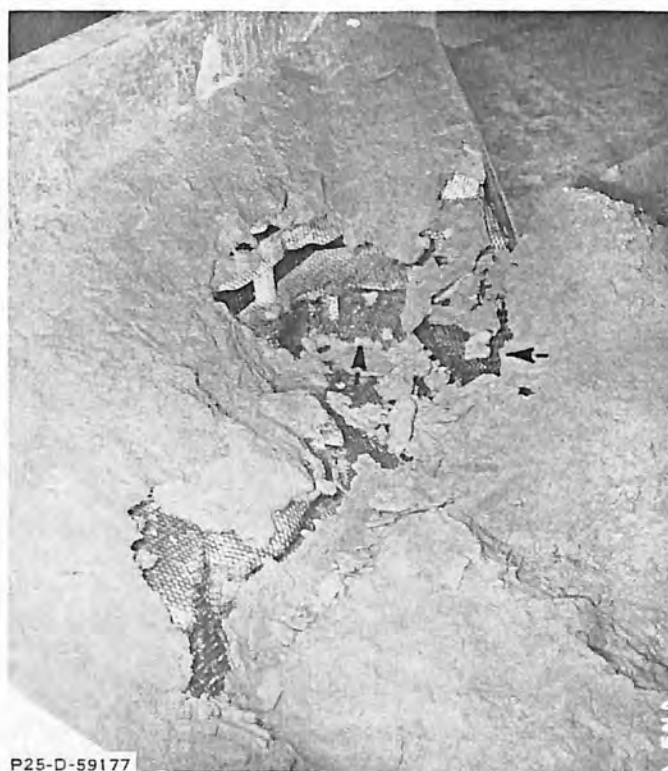
C. Erosion resulting from flows of 30,000
and 175,000 cfs (849 and 4,952.5 cms)

Areas requiring additional concrete protection are indicated by the arrows.

2. Repairs made after the 1965-66 floods appear to be well located for protection of the channel against further erosion, but the paving should be extended a little higher and farther downstream along the left bank (Figures 4, 9, and 11).

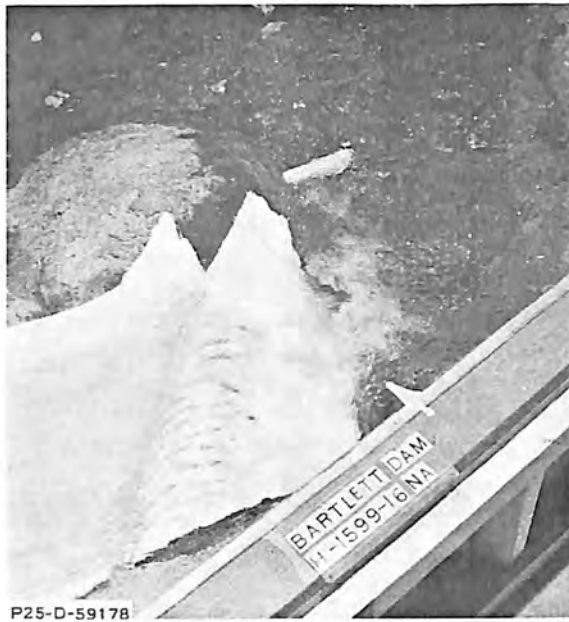
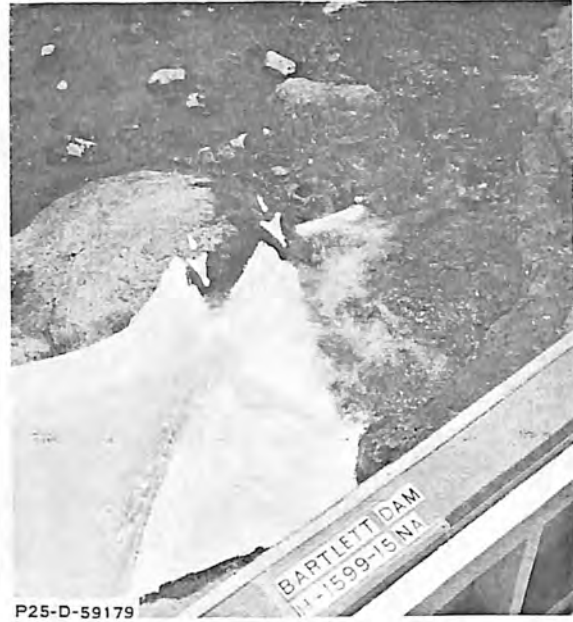
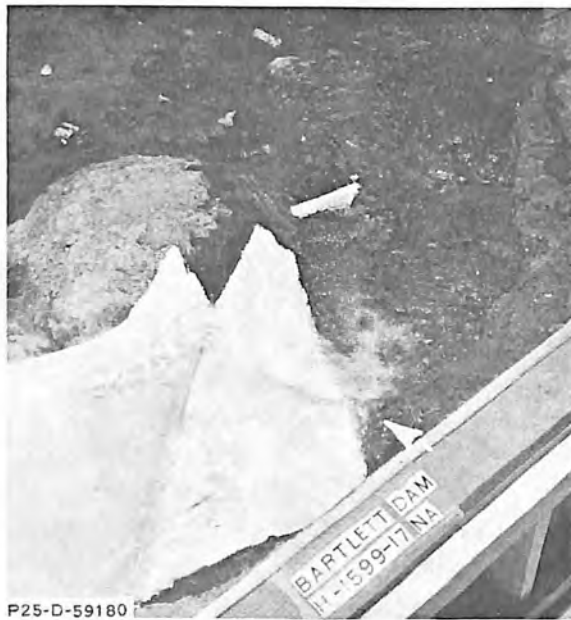
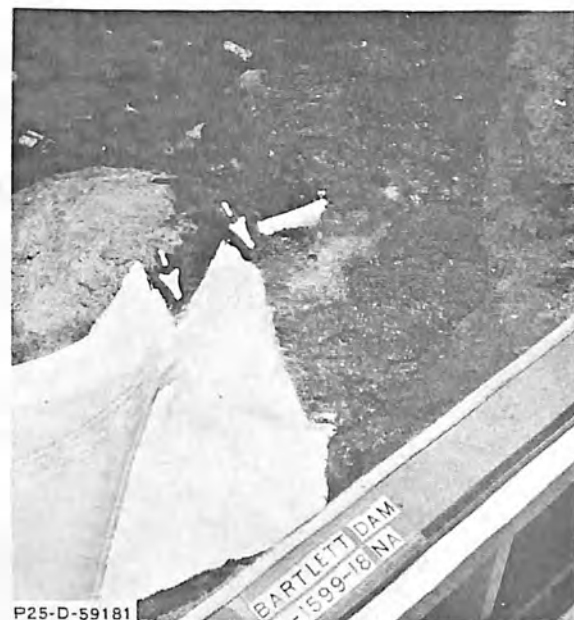
Various combinations of operating gates were tested (Figure 10) to determine the combination that would provide optimum flow distribution in the chute. These tests showed that closing the right gate reduced the flow impingement on the right bank along the edge of the paved area and increased the impingement along the left bank. With the left gate closed, the reverse was true. These flow conditions were more pronounced when either the left or right gate was operated singly. The tests showed that all three gates should be opened equally for best flow distribution from the chute.

The areas of flow impingement on the left and right banks beyond the white paved area are indicated by the arrows.

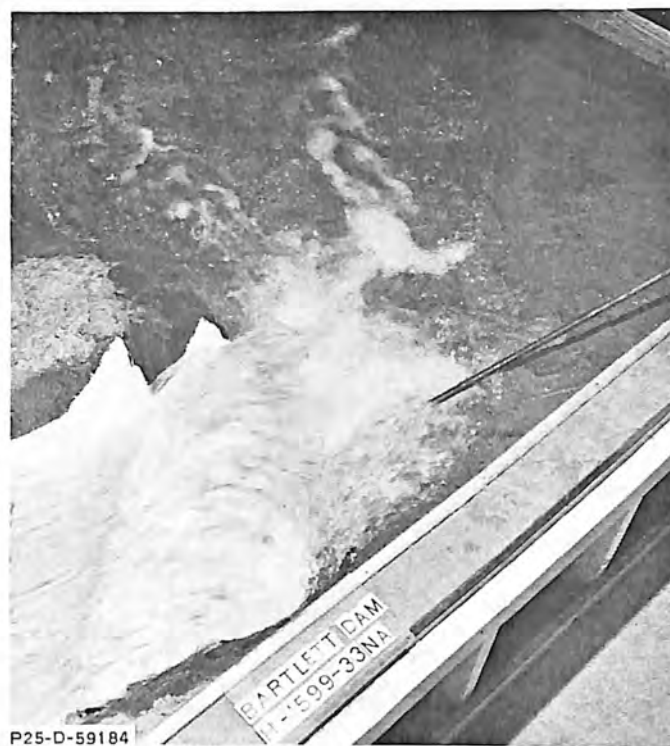
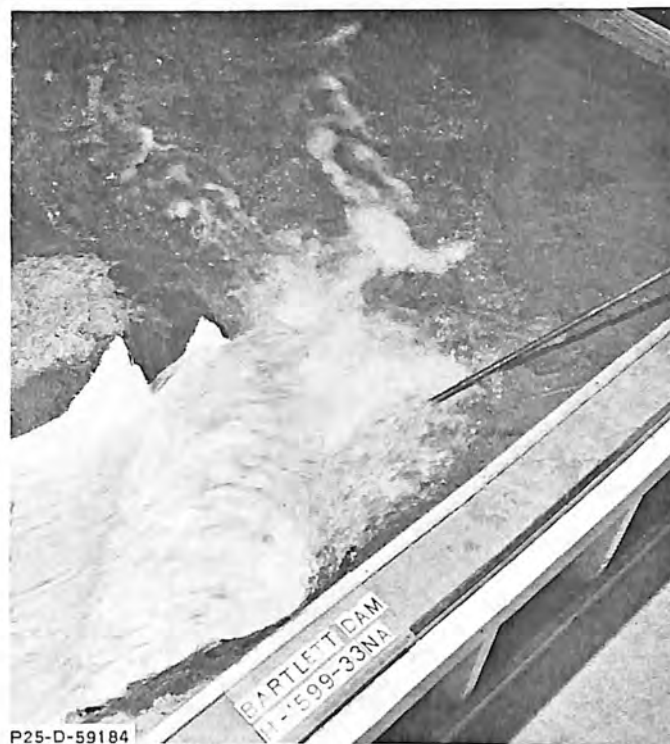
4. At flows greater than about 50,000 cfs (1,415 cms) part of the jet will impinge in the downstream portion of the channel beyond the paved area (Figure 12); however, erosion damage will be sufficiently remote that the foundation of the spillway should not be endangered.

At flows of 100,000 (2,830) and 175,000 cfs (4,952.50 cms) (Figure 12) part of the jet impinged near the first ridge in the downstream portion of the discharge channel beyond the paved area. Discharges of these magnitudes will probably cause considerable erosion in the prototype channel remote from the spillway chute.

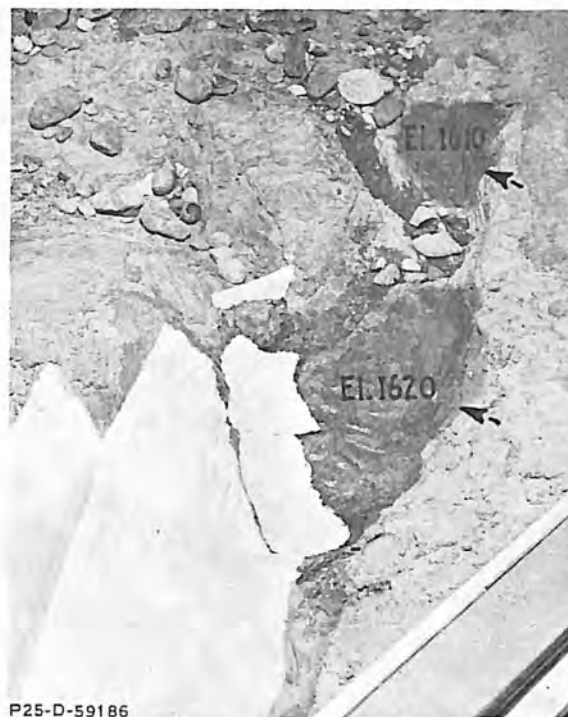
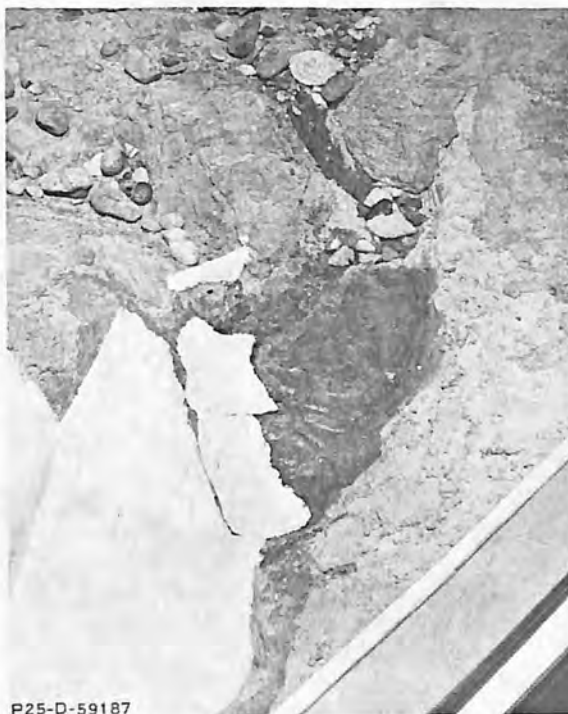
The two ridges were constructed in the model so that they could easily be removed and the channel could be tested with and without the ridges in place (Figure 13). Tests were run at discharges of 20,000 cfs (566 cms) and 50,000 cfs (1,415 cms) to determine the effect of removing either or both ridges. The tests showed that any loose rock that might fall into the channel will flush from the area, with or without the ridges in place.

A. First and second ridges are removed to the elevation shown. Ridge locations are indicated by the arrows.

B. First ridge only is removed.

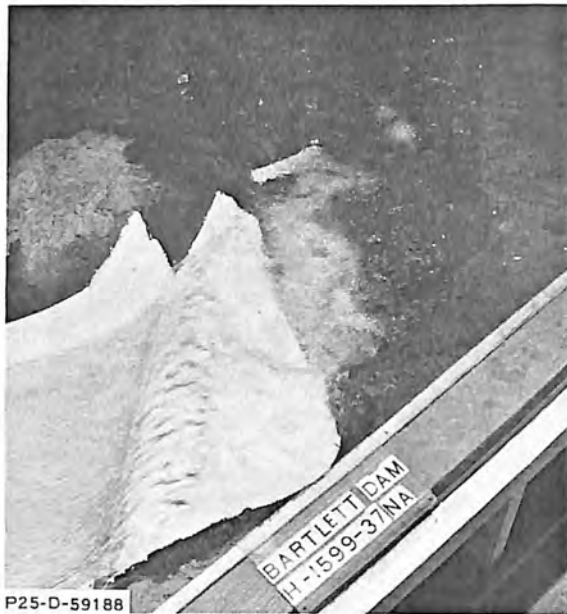
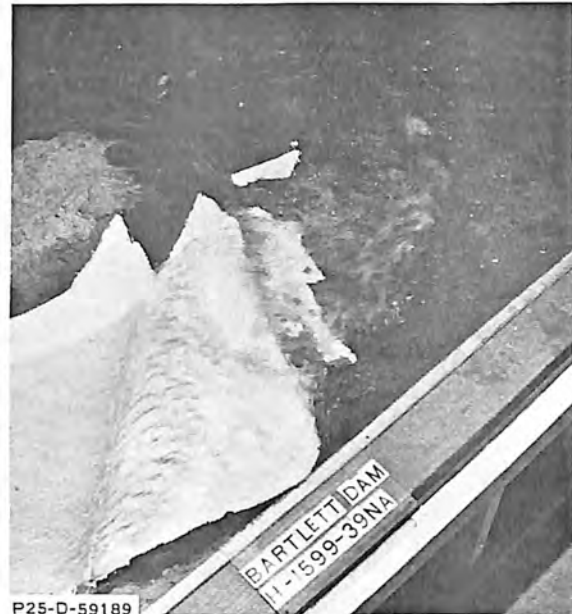
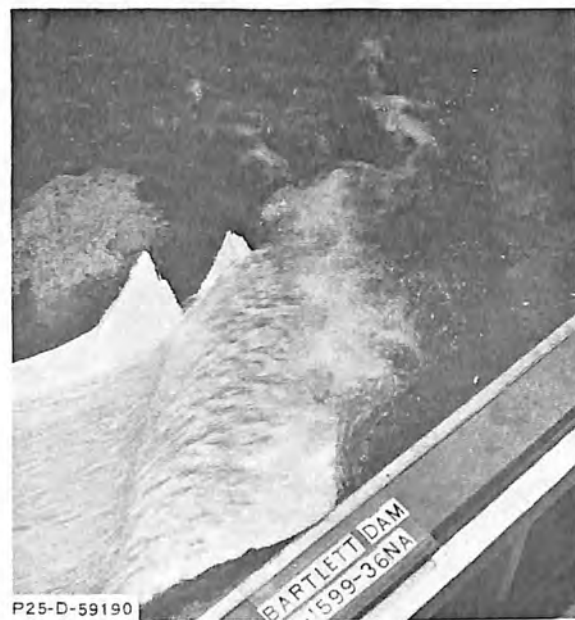
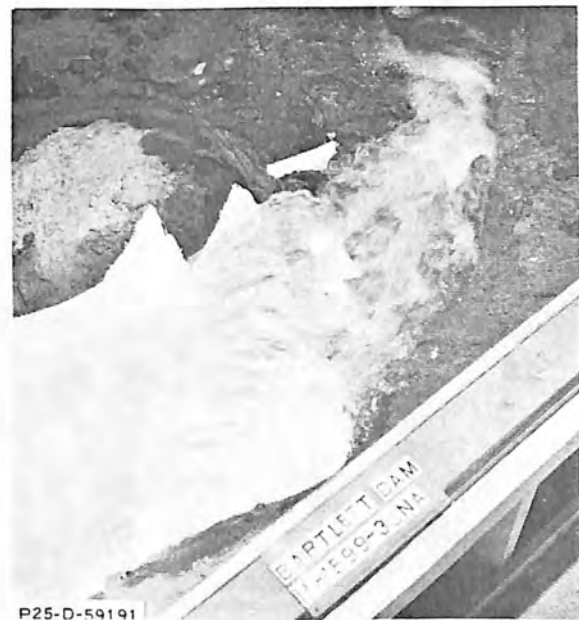
7. The upstream ridge and the existing weir in the left branch of the channel help form a shallow pool at the base of the paved slope for flows up to 50,000 cfs (1,415 cms) (Figure 14). This pool aids in absorbing some of the energy in the jet and in reducing erosion.

Actually, the upstream ridge and the existing weir at approximately elevation 1640 in the left branch of the discharge channel (Figure 14) maintain a pool for flows up to 50,000 cfs (1,415 cms). This pool appeared to absorb part of the energy of the falling jet which would reduce the erosion damage (Figure 14); and, therefore should not be removed.

A. Recommended concrete fill

B. Concrete fill with first ridge removed is not recommended
