UNITED STATES
DEPARTMENT OF THE INTERIOR
BUREAU OF RECLAMATION
CUSTOMHOUSE
DENVER, COLORADO

May 15, 1940.

From Associate Engineer C. W. Thomas

Subject: Report on inspection trip to correlate hydraulic laboratory design and the field operation of 102-inch River Outlets - Grand Coulee Dam - Columbia Basin Project.

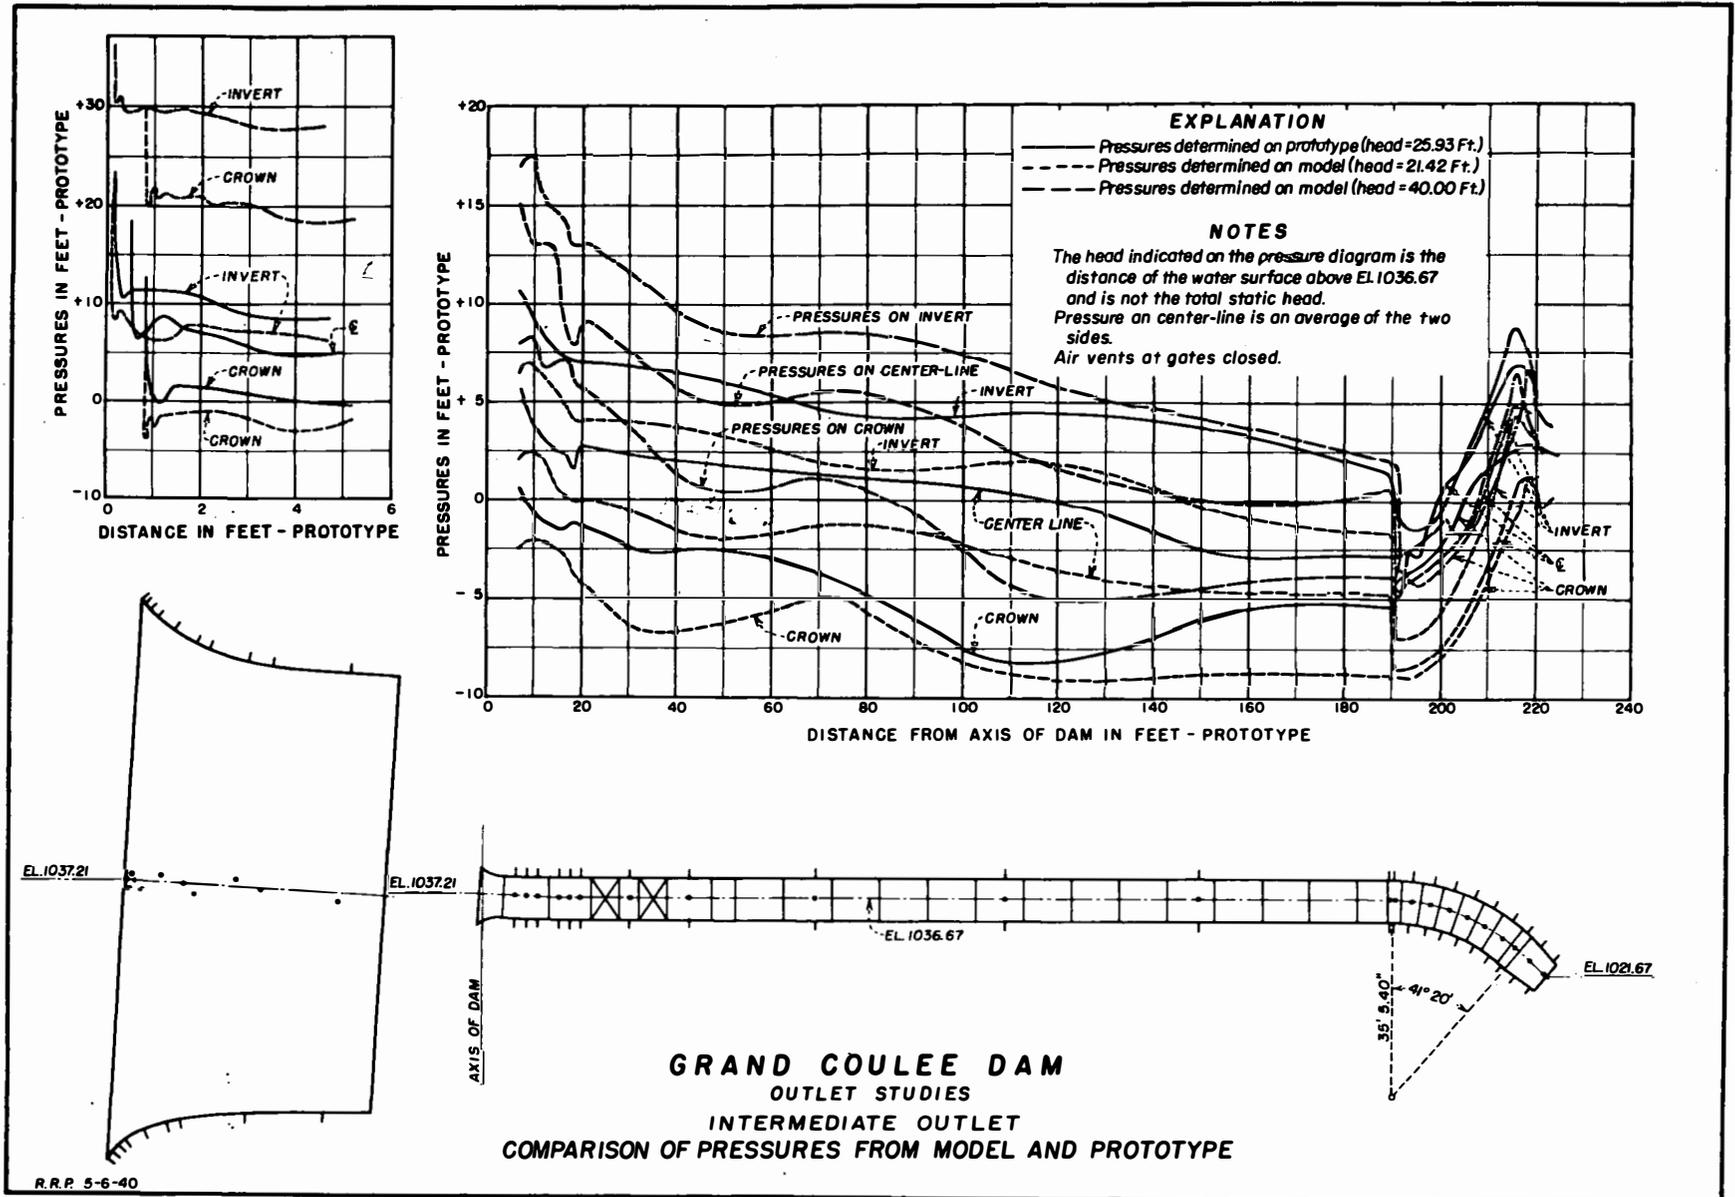
FIGURE 4

6. The results of the pressure measurements are shown on figures 4, 5 and 6. A comparison of the pressures obtained from the 1:17 scale model and those obtained from the prototype for similar heads is shown on figure 4. The general characteristics of the pressure curves are quite similar, but the hydrostatic pressures in

the prototype are slightly greater than the pressures in the model. The pressure curves shown are for low heads only and the relationship may change for the higher heads. Figure 5 shows a comparison of the pressures with the air vents to the control gates open and with these vents closed. The conduit does not flow full when the air vents are open. This is true for the entire range of heads tested. For the low head, a large air bubble in the top of the pipe extends from the control gates to the downstream portion of the elbow. This bubble decreases in size as the head increases (figure 6). It should entirely disappear with a slight additional head.

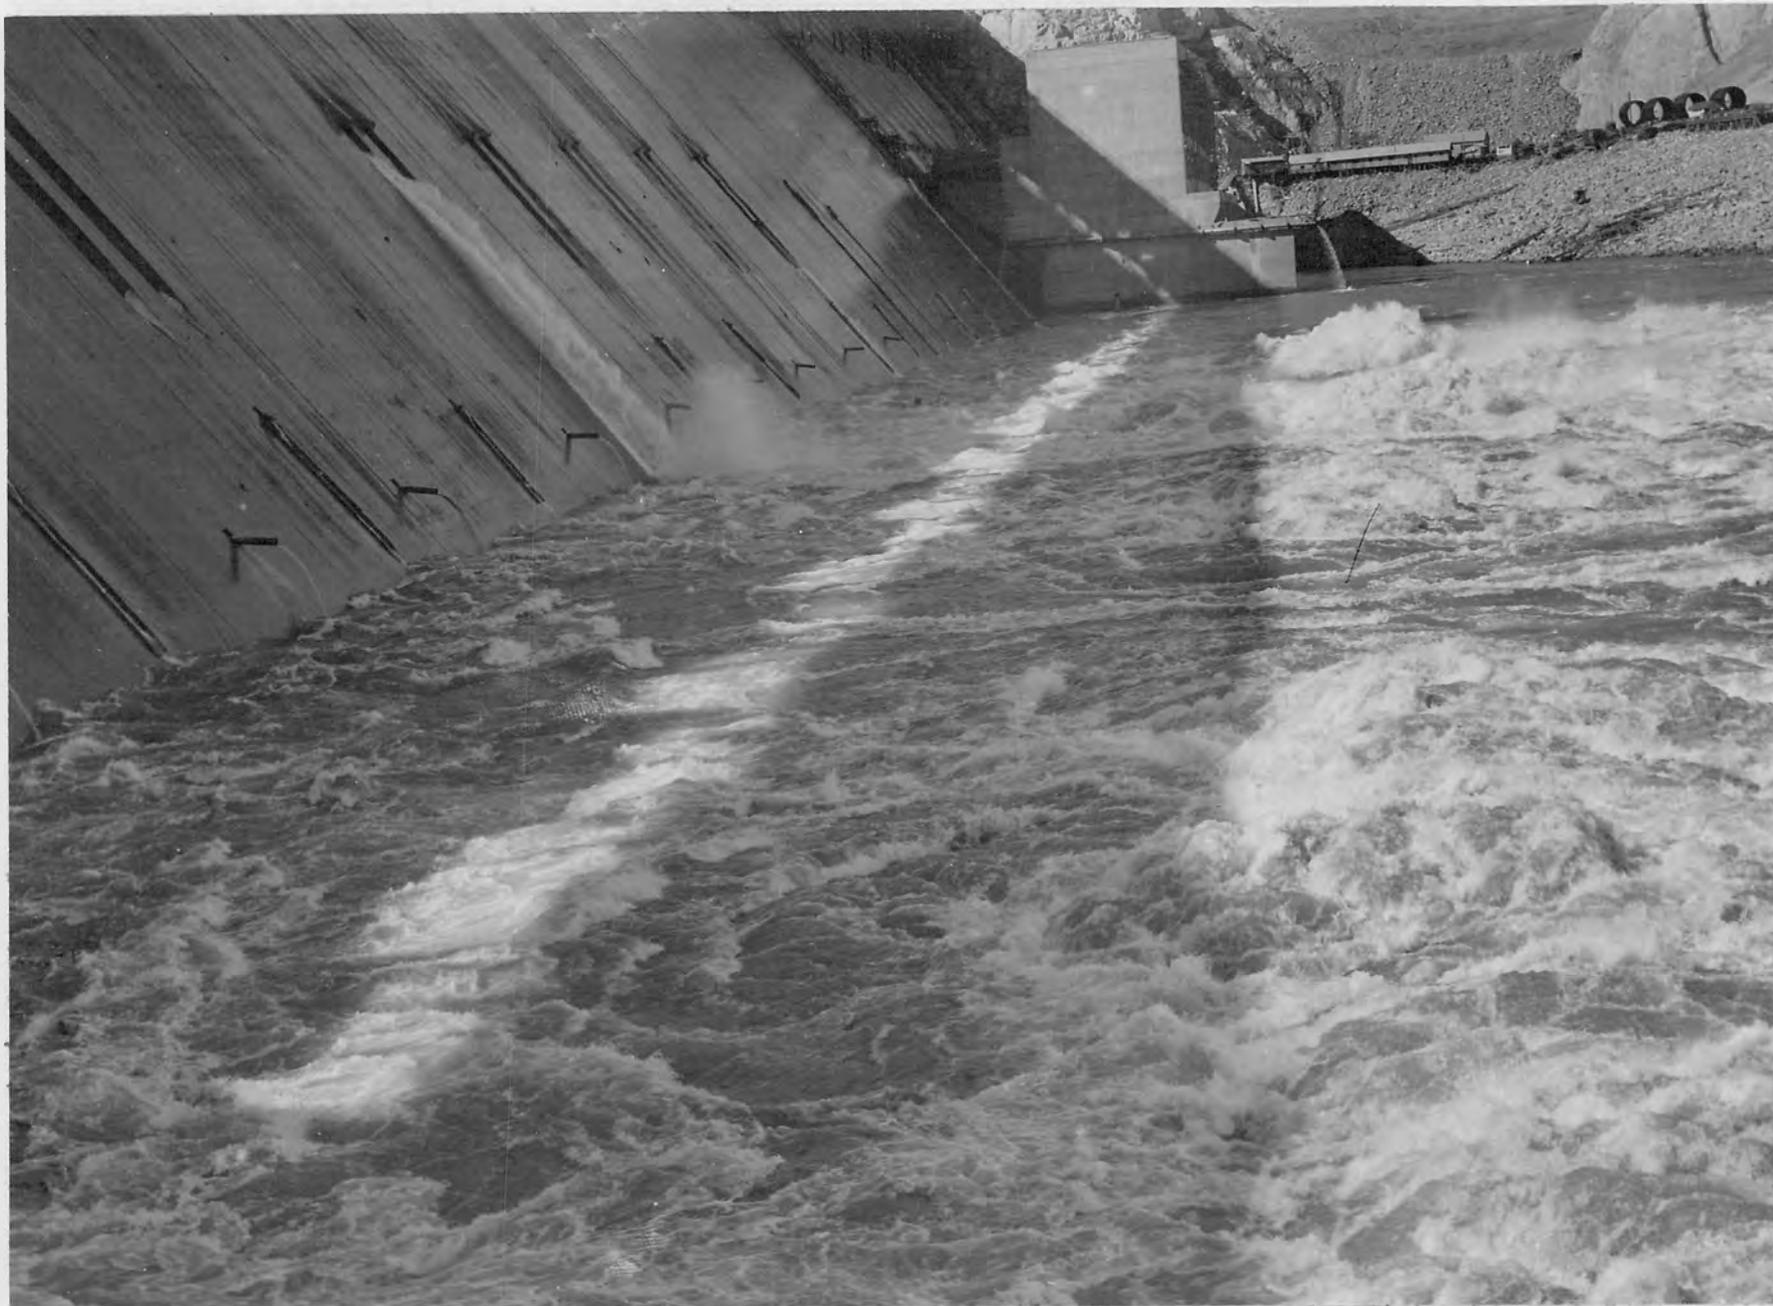
8. Flow conditions at the exit of the conduit and down the face of the spillway are satisfactory. When the air vents to the control gates are open, air is drawn into the conduit and causes a "belching" effect when this air is expelled from the exit of the tube. This disturbance continues down the face of the spillway and causes an intermittent spreading of the jet. The openings to the discharge channel air vents are covered at times due to this spreading. However, on the whole the discharge conditions are very good. The jet follows the face of the spillway from the exit to the tailwater and in no place does it show signs of springing clear. There is a nominal disintegration of the jet, but very little spray until it impinges on the tailwater (figure 7). The discharge channel air vents for the Elev. 1036.67 outlets were observed to function properly. No means of measuring the air demand to these vents was available, but spray and curing water was drawn into the 6-inch inlets when the conduits were discharging. A number of these vents

EAST OUTLET IN BLOCK 51 AT ELEVATION 1036.67 DISCHARGING - RESERVOIR ELEVATION 1059.4 - MARCH 28, 1940

are clogged with waste materials from construction. Although it is not necessary that they be cleaned before the high water this season, long periods of operation should be avoided until the cleaning is completed and the vents are operating properly.

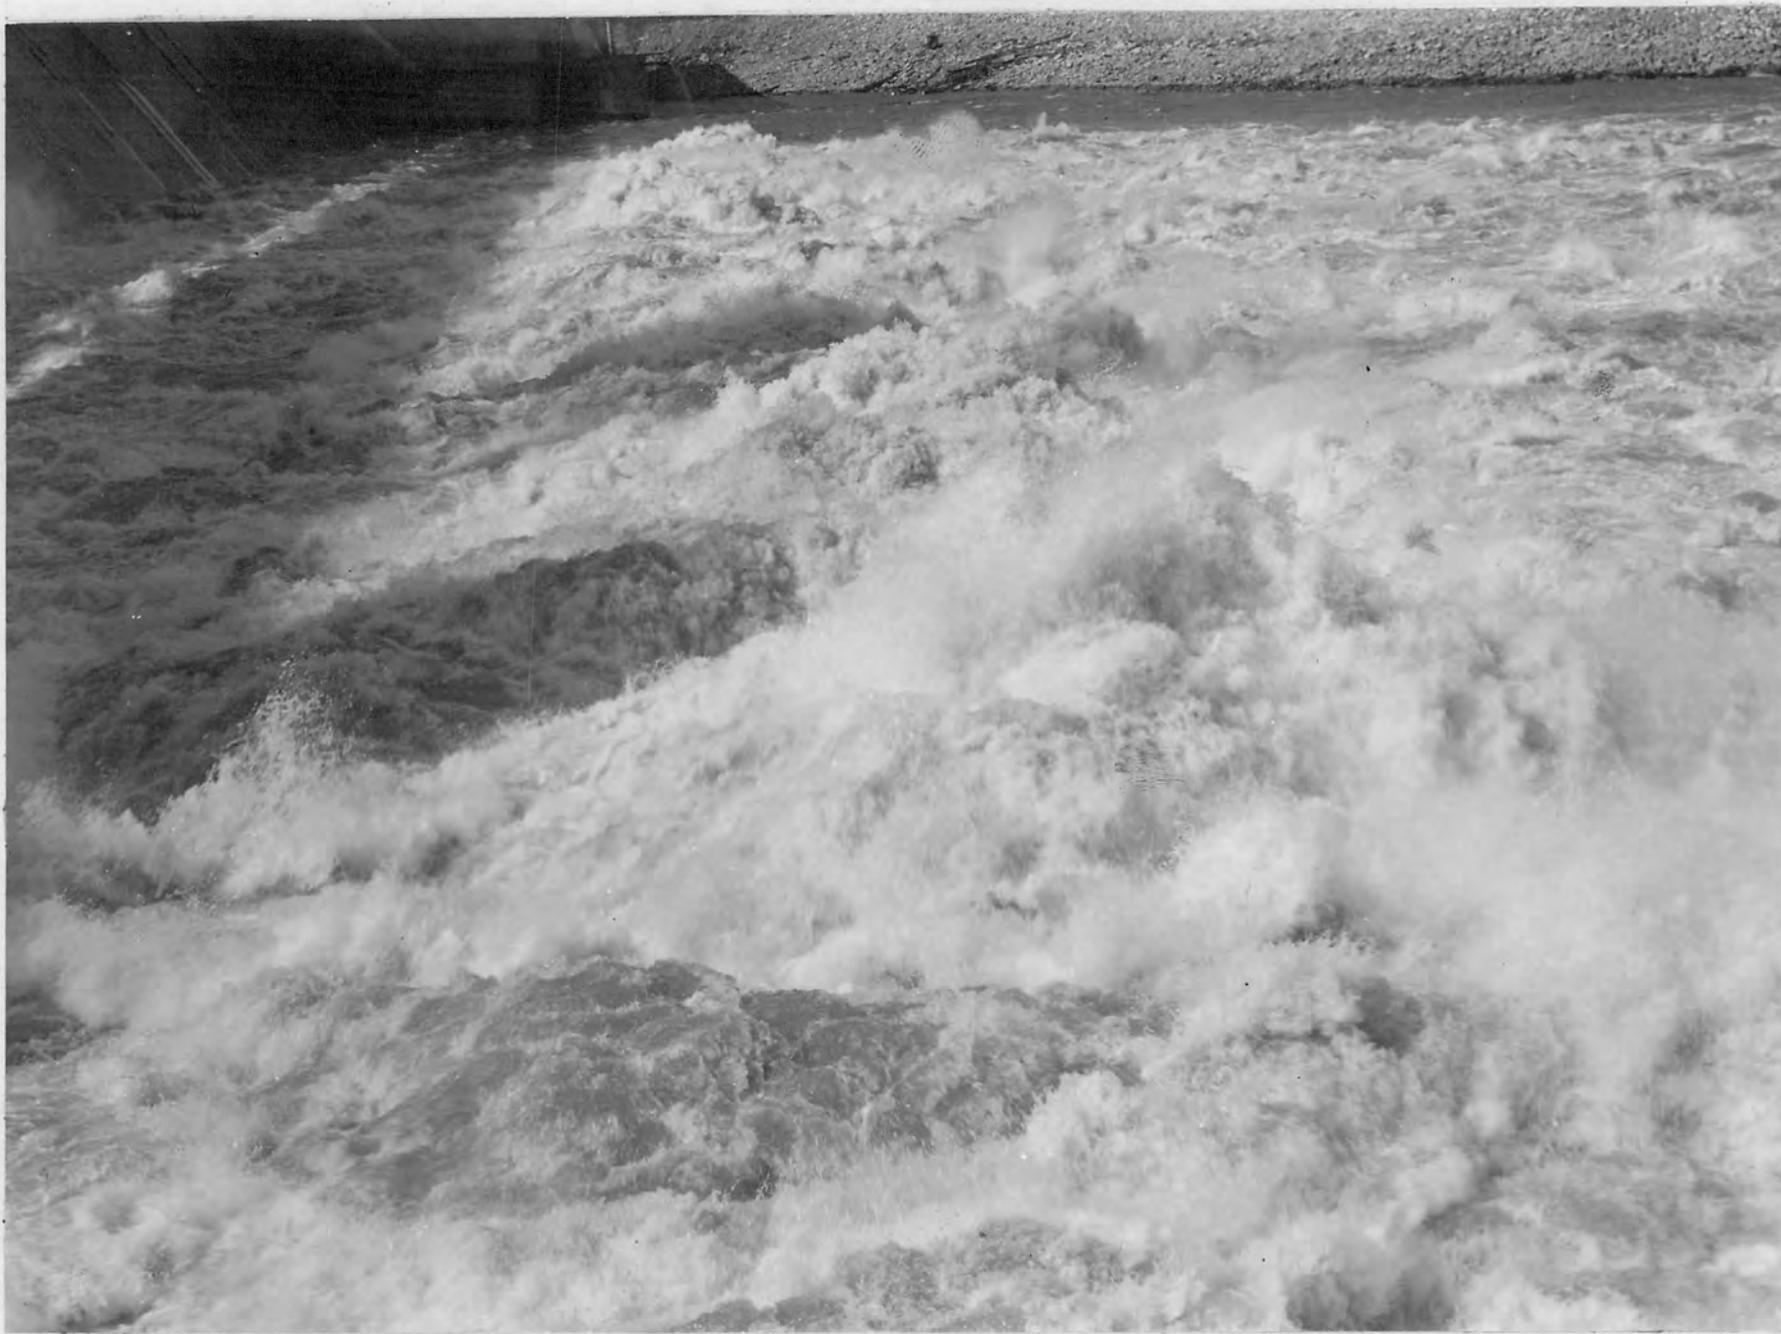
9. The hydraulic conditions in the bucket when the Elev. 936.67 outlets are discharging very closely resembles the action observed in the models. A line of boils appears over the bucket lip. The surface flow divides at this point, a portion returning toward the dam and the remainder proceeding downstream (figure 8). The water surface along the face of the spillway is approximately 10 feet lower than the average crest of the line of boils. This differential increases when the Elev. 1036.67 outlets are opened. The lower water surface along the face of the spillway causes logs and floating debris to collect in that area. This material is unsightly and is thrown against the face of the dam by the action of the water. Some scouring of the concrete results. The water surface over the bucket will remain low throughout the range of operation of the outlets and the spillway, hence it may be necessary to provide a rake to remove floating debris periodically. No unexpected hydraulic phenomena were observed in the spillway bucket. For the combination of openings and heads that prevailed during the observations the hydraulics are satisfactory.

FLOW CONDITIONS IN BUCKET - 18 LOWER OUTLETS AND ONE INTERMEDIATE OUTLET DISCHARGING -
RESERVOIR ELEVATION 1063.4 - DISCHARGE 76,900 SECOND-FEET - MARCH 30, 1940

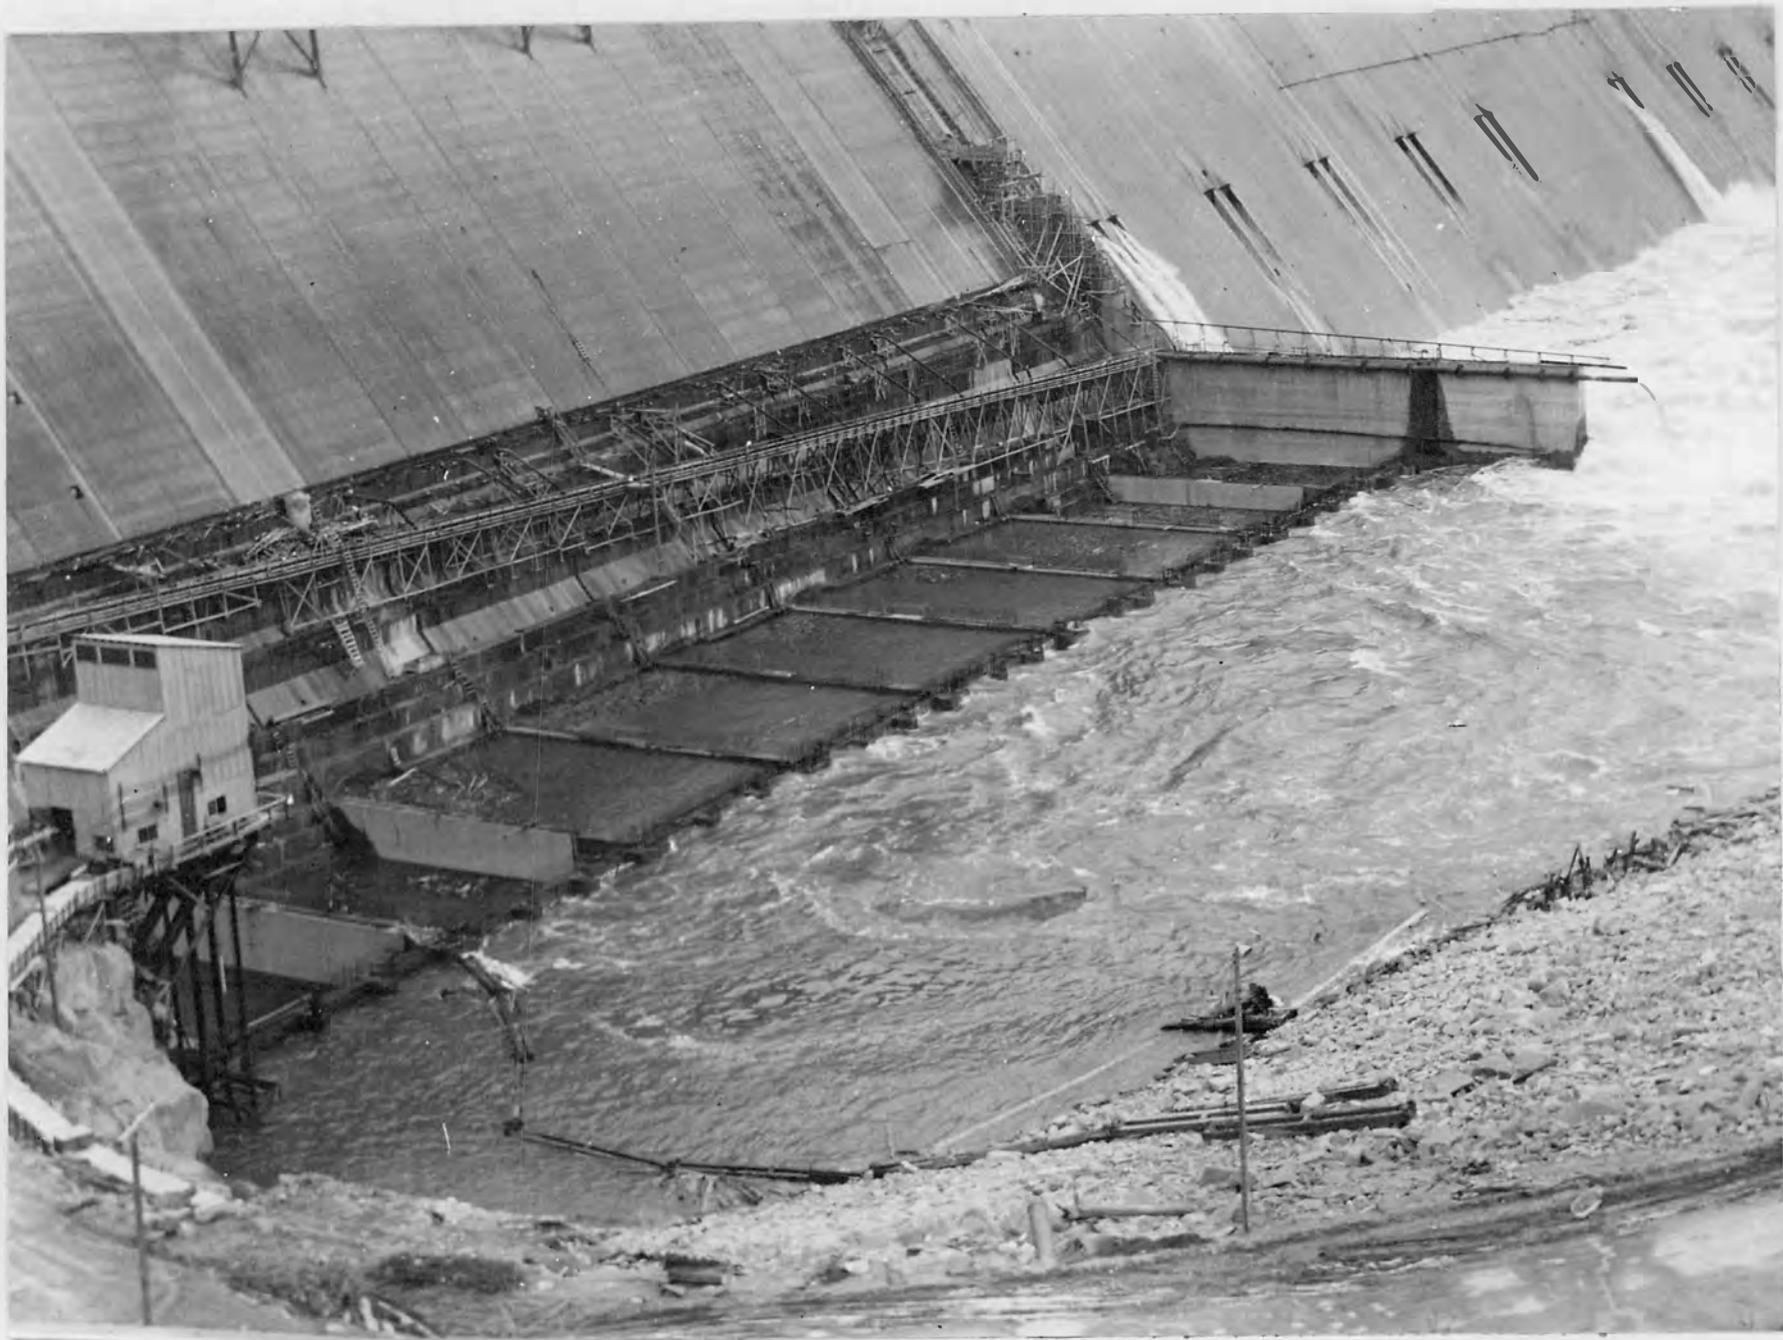
10. With certain combinations of outlet openings, a large slow eddy develops in the right tailrace. The flow from the outlets strikes the river bank near the junction with the tailrace excavation and is turned to the right and upstream. The current then continues across the tailrace striking the powerhouse foundation near the center approximately perpendicular to the axis of the dam. The current has sufficient velocity to fill the central wheel pits before the end pits are filled (figure 9). A similar condition may result from the operation of the drum gates near the end of the spillway. If gates near the center of the spillway are operated the flow will continue down the river without impinging on the banks of the tailrace excavations.

EDDY IN RIGHT TAILRACE - DISCHARGE 93,840 SECOND-FEET - APRIL 9, 1940

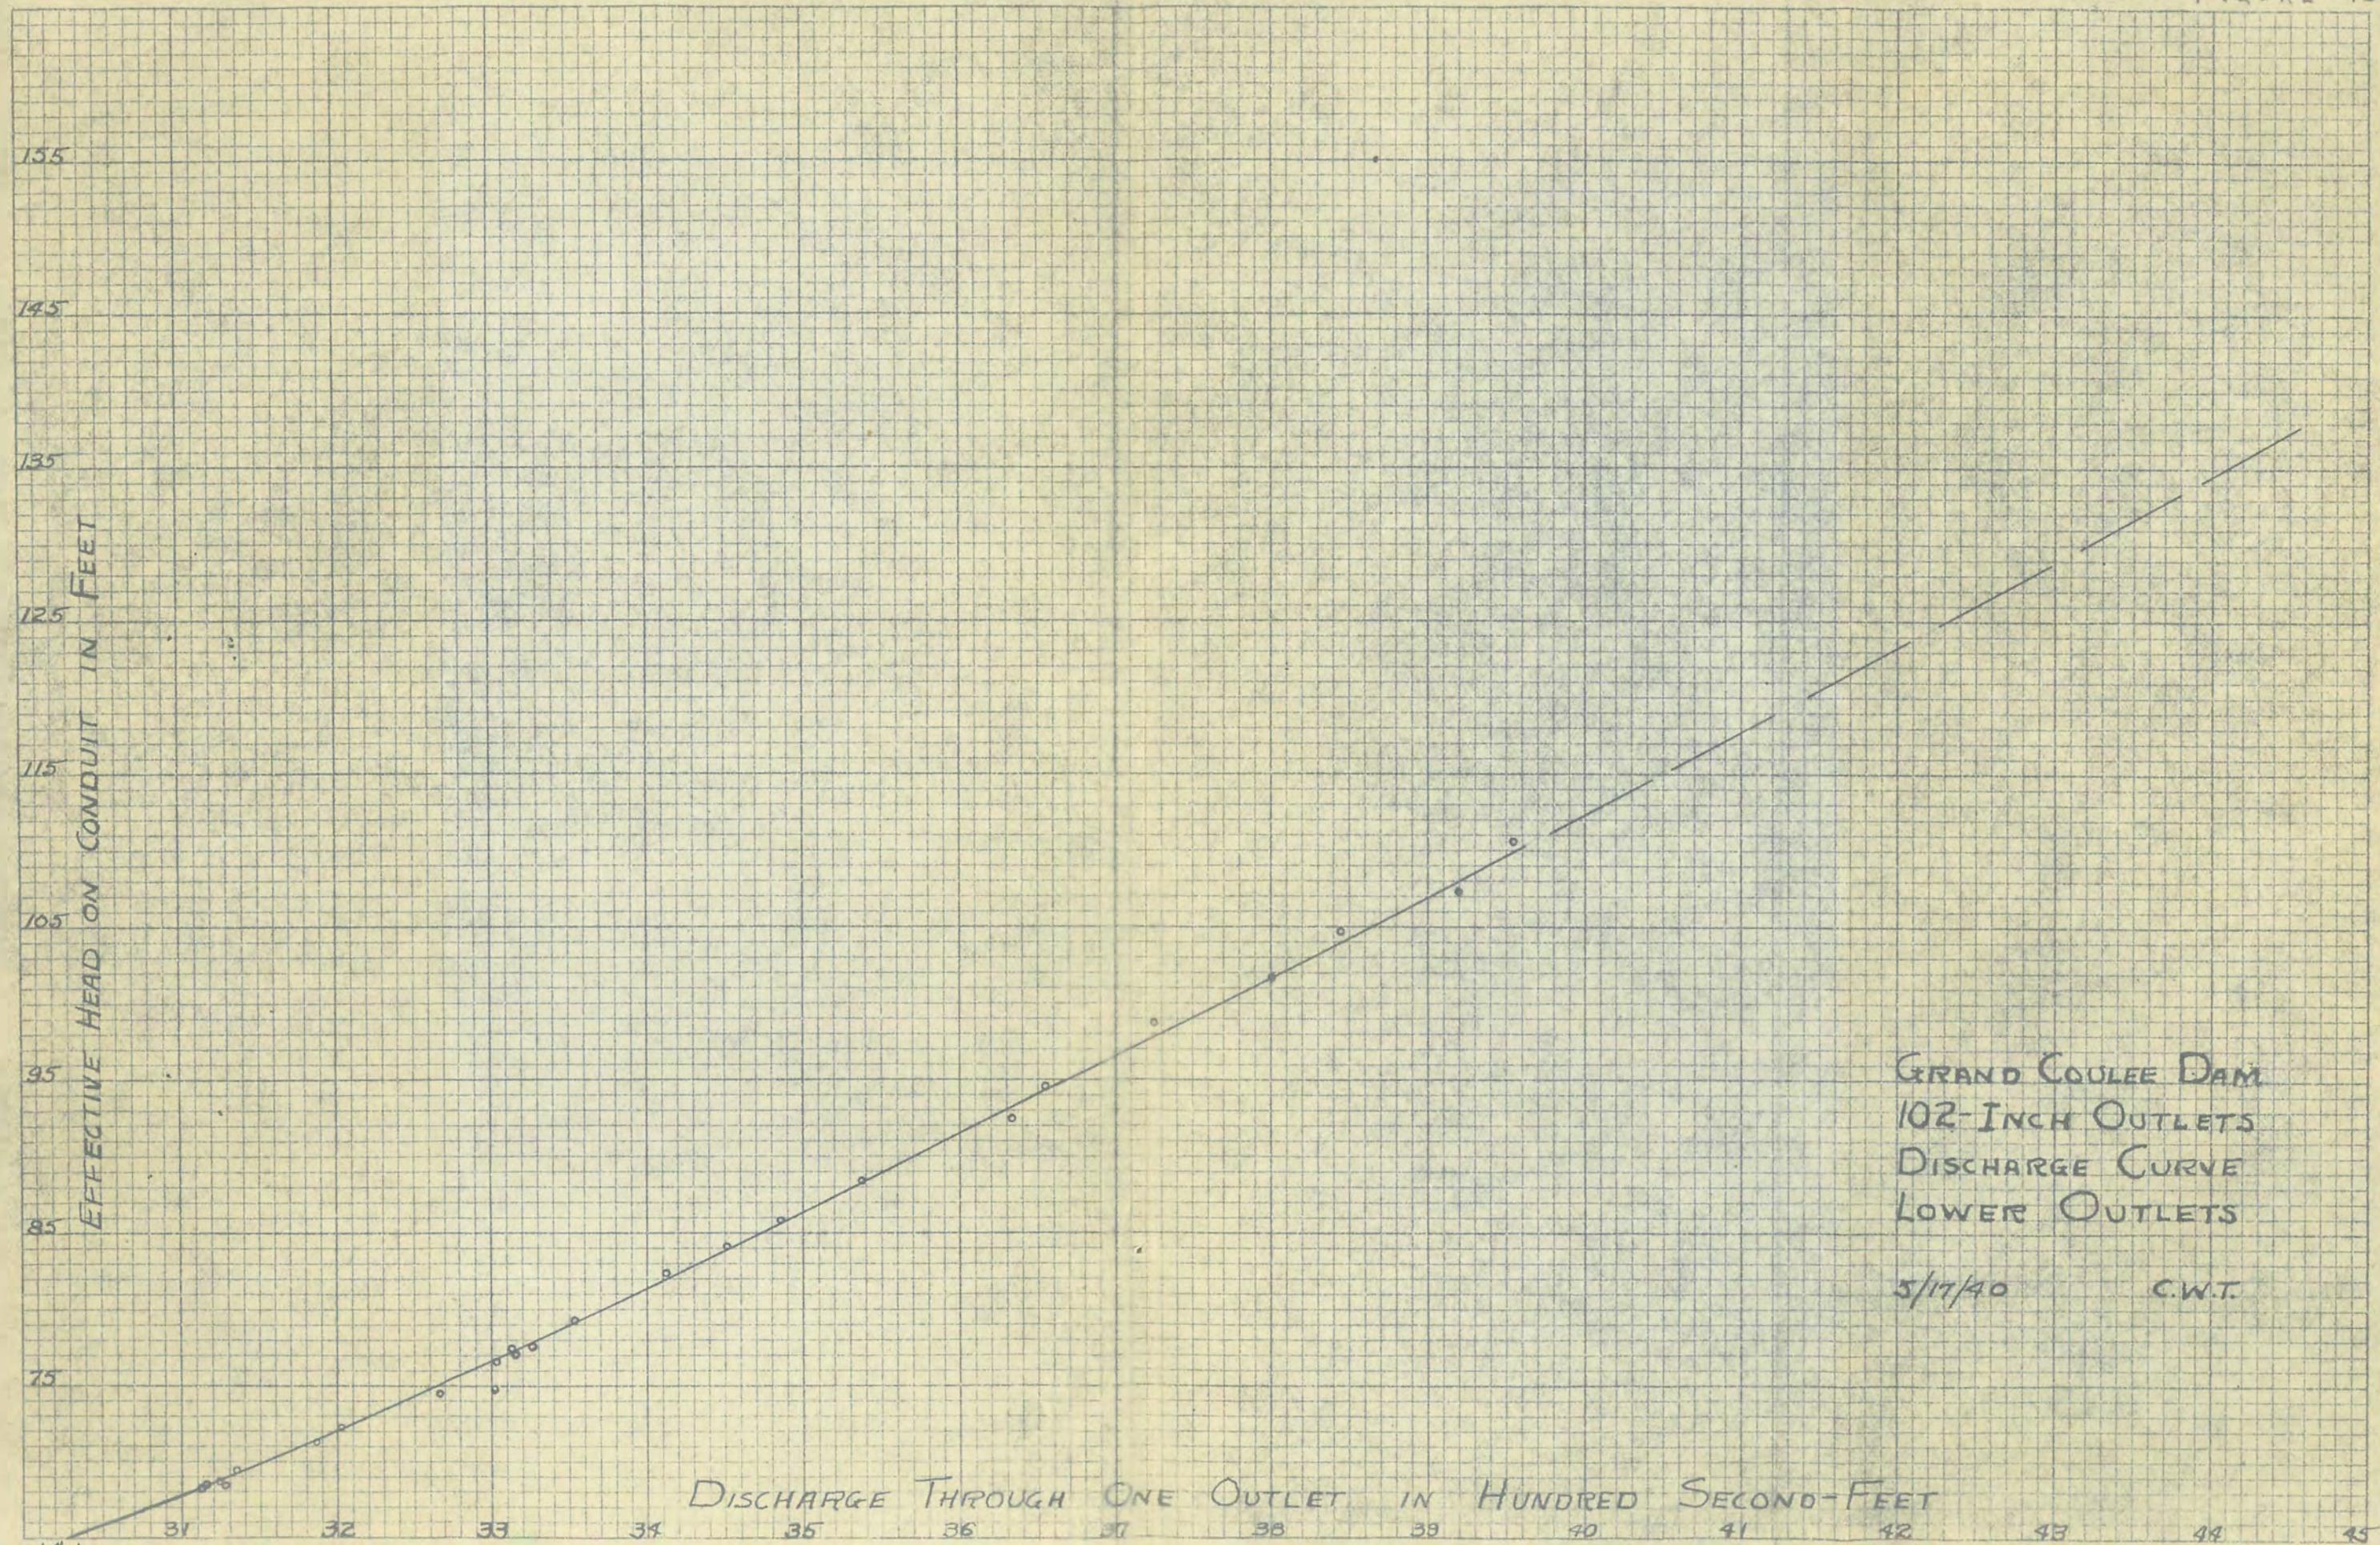
GRAND COULEE DAM
 102-INCH OUTLETS
 DISCHARGE CURVE
 LOWER OUTLETS
 5/17/40 C.W.T.

12. The discharge data is shown in figures 10 and 11. The discharge for the lower outlet (figure 10) is based on the rating table for the river downstream as determined by the U. S. Geological Survey. The data shown on the curve were obtained before the intermediate outlets were opened. The discharge for the intermediate outlet (figure 11) was determined by taking the difference between the river discharge and the discharge through the lower outlets shown on figure 10. Both curves are based on a relatively small range of heads and caution must be employed in extrapolating the data. Additional data for extension of the curves will be available at a later date.
